Technical Review of the Comcast Cable System Serving Seattle, Washington

Dick Nielsen
Senior Engineer

CBG Communications, Inc.

May, 2009

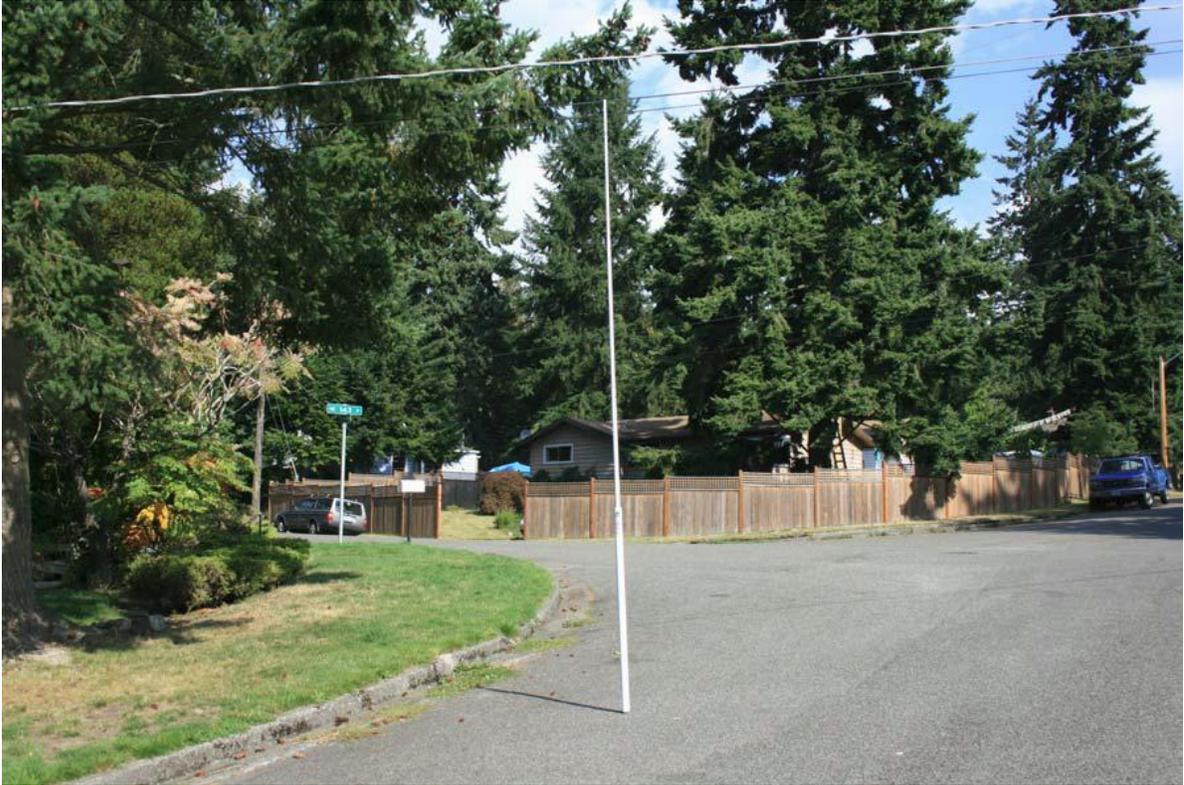
Drop clearance to the ground is a sizable issue in the northwestern corner of the City, with drops as low as less than 12 feet over roadways when the NESC requires a minimum of 15 feet 6 inches. CBG noted approximately 28 locations, included in Appendix B, of drops below the NESC required 15 feet 6 inches. With the maximum clearance of trucks being 13 feet 6 inches, these drops are in danger of being torn down. In addition to damage to the reliability of the drop in question, there is also the potential for injury and damage to the truck, the residence and other facilities on the utility pole. A low drop from the pole or residence is also a tripping hazard for the public. Because of the prevalence of low drops, Comcast needs to fix this problem in the City. In addition to drops listed as non compliant with Codes in Appendix B of this report, there were numerous drops that were measured that make the clearance requirement, but only by 1 or 2 inches, potentially creating a problem in the future, as the headroom may dwindle because of ice loading, tree branches adding weight to the drop, a pole shifting slightly or in the case of a midspan drop, the span between the poles changing slightly over time. As Comcast cures problems with low hanging drops, drops that are a few inches within specification should also be addressed in a proactive manner.

14311 22nd Ave NE – Drop is only 13’ 5” over road. NESC Section 23 requires 15’ 6”

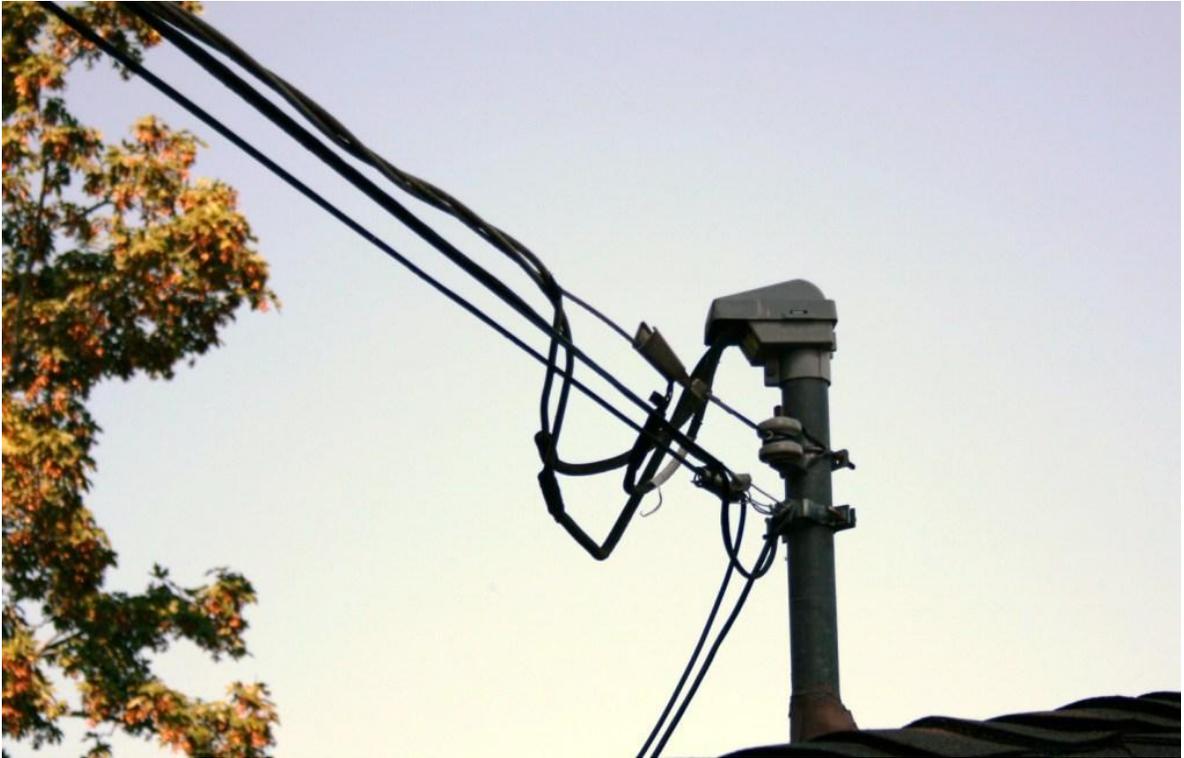
We found approximately 80 instances where Comcast has utilized a power mast to connect the drop to a residence. This finding, when applied City wide, suggests a significant issue of non compliance with NEC Code 820.10 which only allows drops to be attached to masts not carrying power. In addition, many of these drops are too close to power at the home and therefore present a danger to Comcast personnel of coming into contact with power while installing or repairing the drop. This issue needs to be addressed by Comcast with a plan to cure the existing violations and to ensure that installation of future drops are not made to power masts.

Cable TV drop attached to power mast.

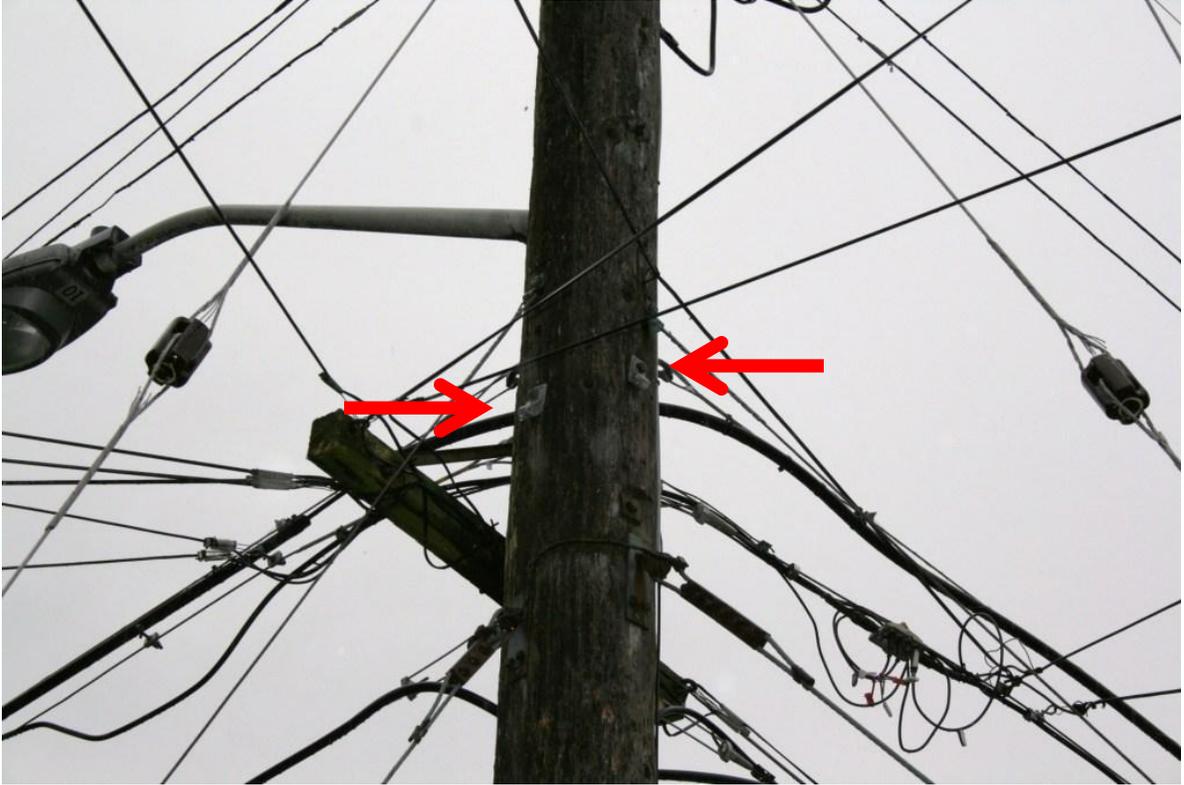
There are also many incomplete pole transfers, missing down guys and missing down guy guards. Based on the Kramer.Firm Report and the subsequent letters from Comcast to the City, Comcast stated they were going to focus on fixing these problems throughout the City, but, except for bonding and grounding of subscriber drops, they have not to any appreciable degree. Comcast must develop a methodology, or improve on its current processes, that discover construction related issues such as these and includes a plan to make repairs in a timely manner.

Missing down guys

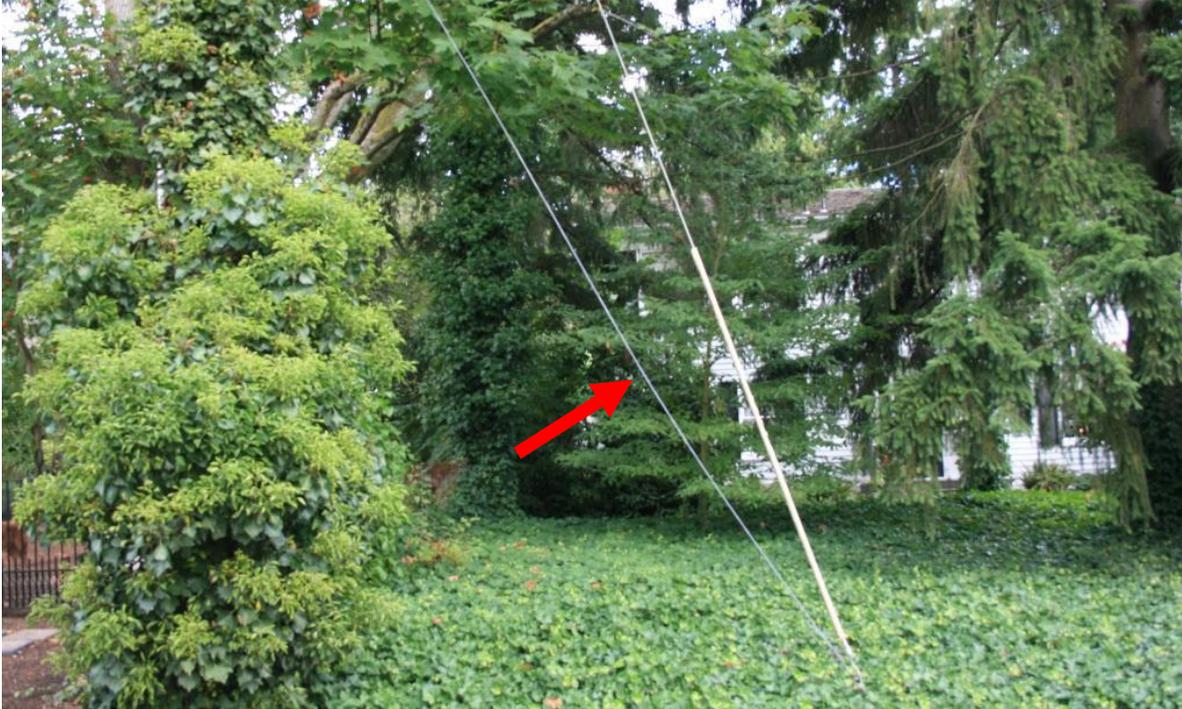
Loose down guy and missing guy guard

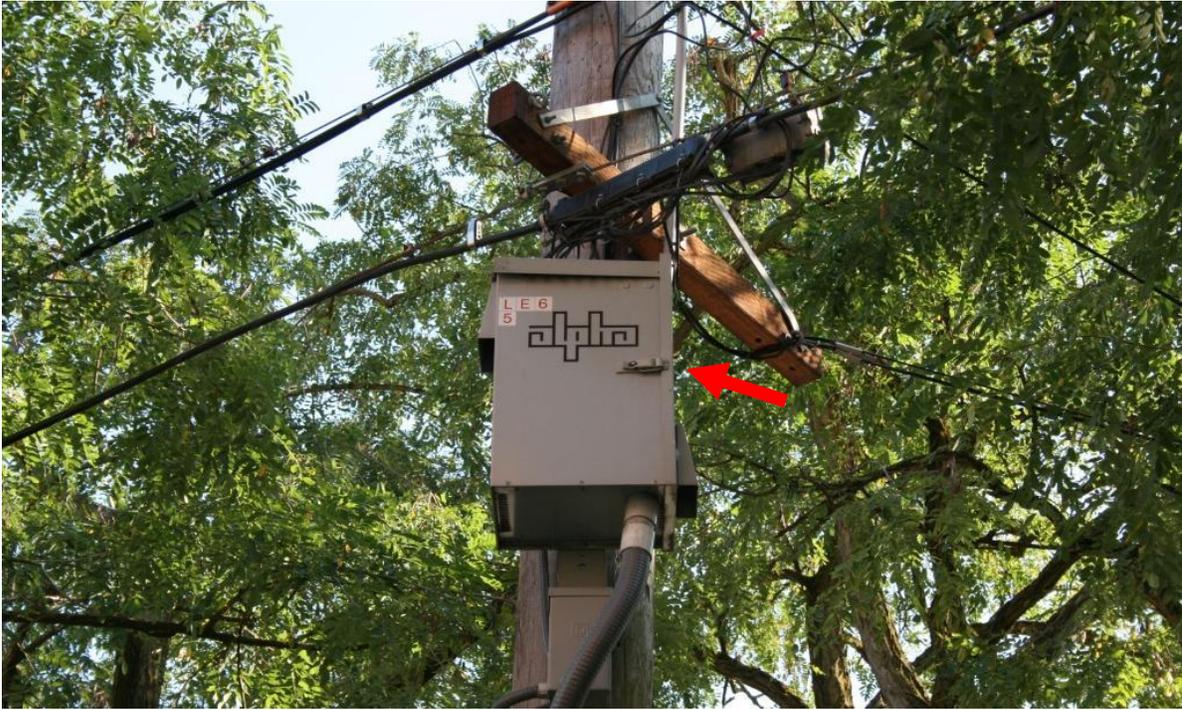
CBG found only a couple of power supplies throughout the areas driven that have been locked and noted 18 power supplies that do not have locks which secure the electrical equipment inside the enclosures from entrance by unauthorized individuals. As pointed out in the Kramer.Firm Report, these power supplies are required by NESC Code 224B2c to be locked. Furthermore, as was also discussed in the Kramer.Firm Report, CBG found 9 abandoned power supplies still attached to poles in the City. Considering Comcast upgraded its plant eight to 10 years ago in all areas of the City, there is no reason for these supplies to still be in place. They take up valuable space on poles, can be unsafe to personnel working on the poles and are unsightly.

Unlocked power supply

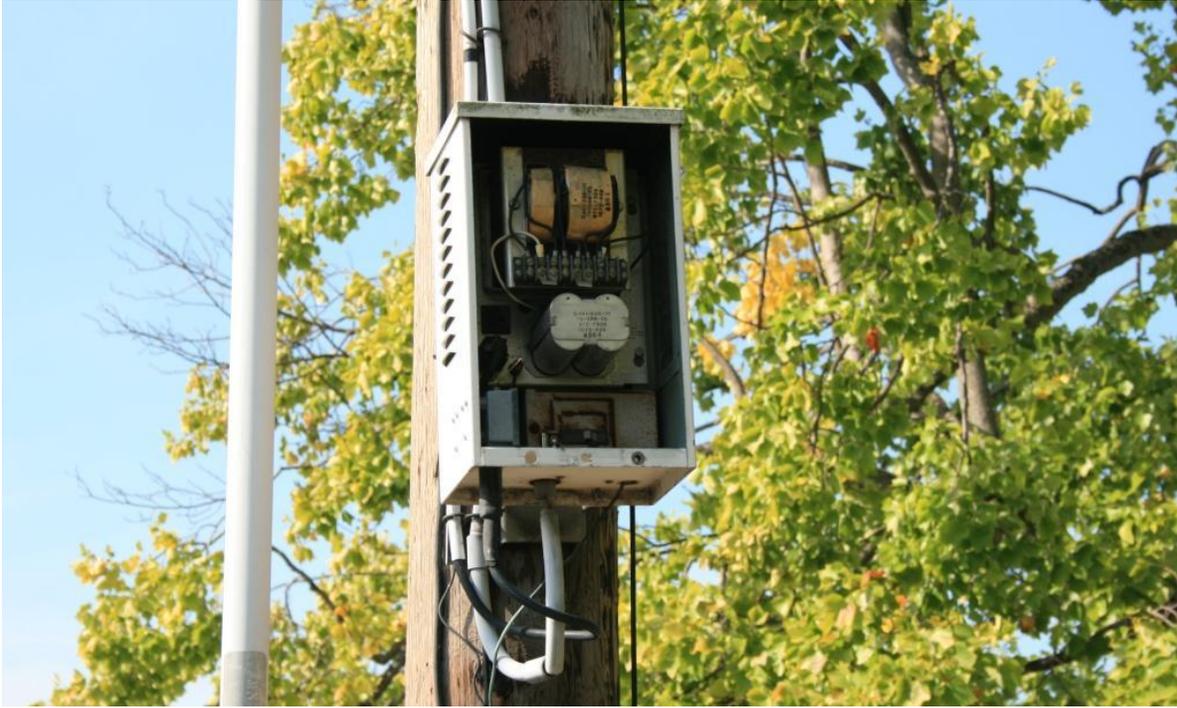
Obsolete power supply (Power is disconnected)
