January 23, 2013

Adapt Project No. WA12-17775-PH2

Subject: Limited Phase II Screen Fire Station No. 6 101 23rd Avenue South Seattle, Washington 98114

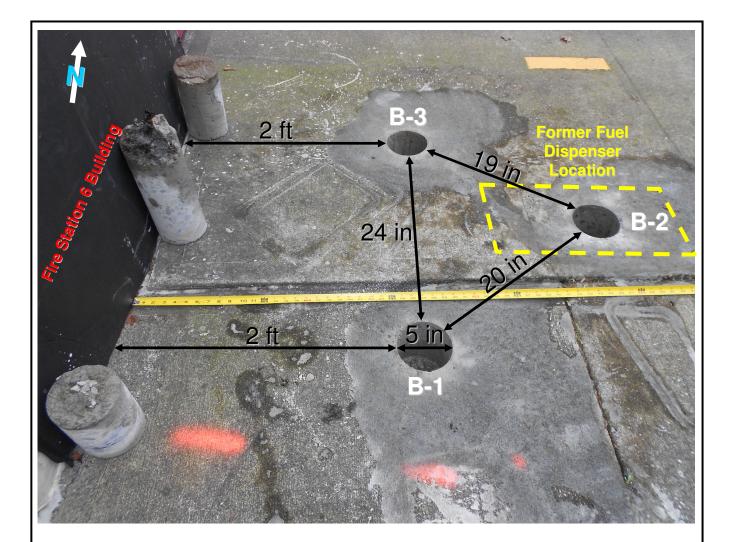
The above photograph of the site is taken looking north at the location of the former fuel dispenser and hand auger boring locations. The photograph shows each of the borehole after concrete coring and prior to hand augering with approximate distances labeled. Borehole B-1 and B-2 reach a depth of five feet below ground surface (bgs), however, B-3 encountered concrete slab at approximately 1.5 ft bgs which halted advancement. Recovered soil samples were be collected from each exploration for description, screening, observation for field indications (visual and olfactory) of potential impacts, and for quantitative laboratory analyses.

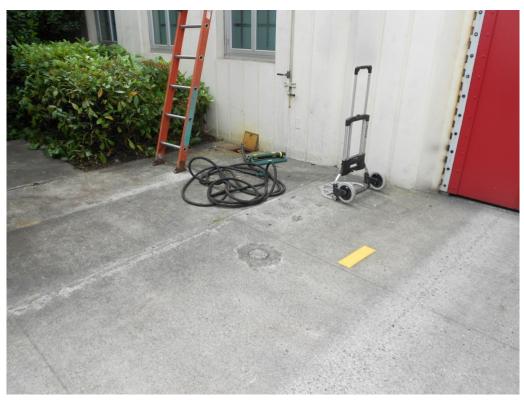
1. Looking southwest at the location of the former UST and fuel dispenser prior to field activities.

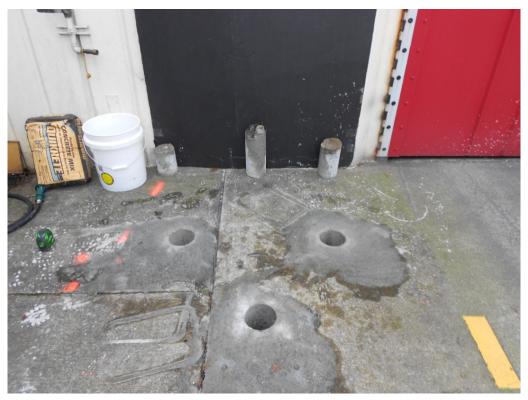
2. Looking west at the borehole locations after concrete coring and prior to hand augering. The boreholes were designated B-1, B-2, and B-3 from left to right, respectively. The concrete cores for each borehole are lined along the Fire Station building adjacent to their respective borehole.

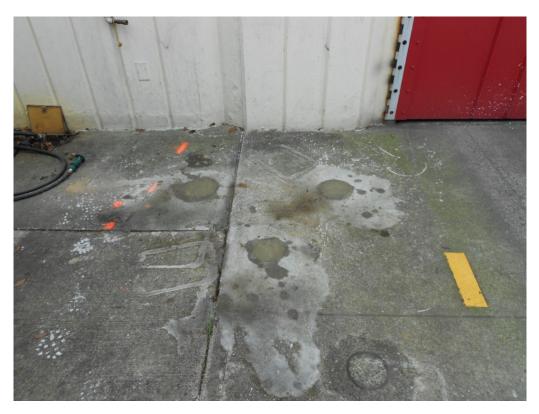
3. Looking west at the borehole after hand augering and the borehole have been sealed with fresh concrete.

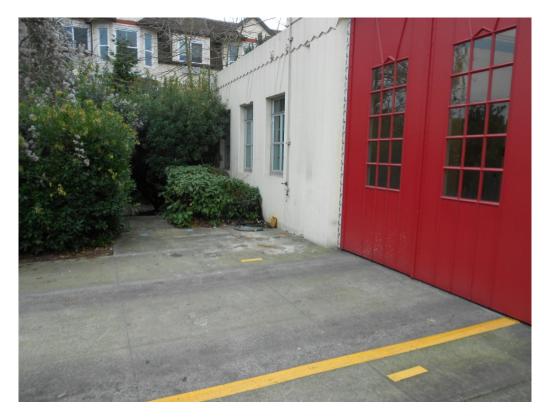
4. Looking southwest at the location of the boreholes after all field activities.
