## Inspection Report

**Prepared for: Phinney Neighborhood Association - Bill Fenimore**

**Property Address:**  
Greenwood Senior Center  
525 N 85th St  
Seattle WA 98103

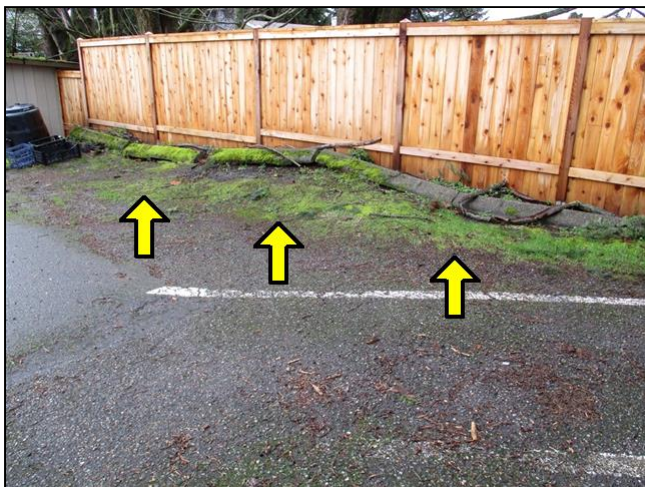
The asphalt parking areas are useable, but tree roots have damaged the asphalt in the SW corner of the parking area and needs to be repaired, re-sealed and re-striped. When the parking area is repaired, sealed and re-striped, a proper number of handicap accessible parking spaces should be created. Re-sealing and re-striping should be performed as normal maintenance every 2 to 5 years, depending on the amount of traffic on the asphalt.

Asphalt parking area is damaged

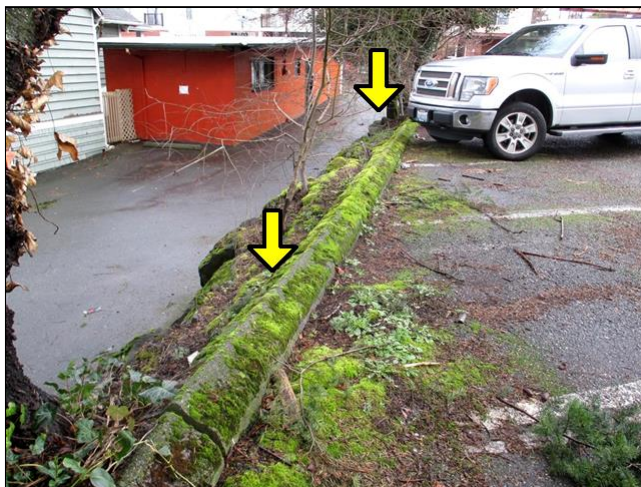
Along the west side of the the parking area, the curb/guardrail is not sufficient to prevent cars from driving over the embankment. A guardrail or higher curb should be installed to prevent cars from going over the edge of the embankment.

Install a guardrail or larger curb

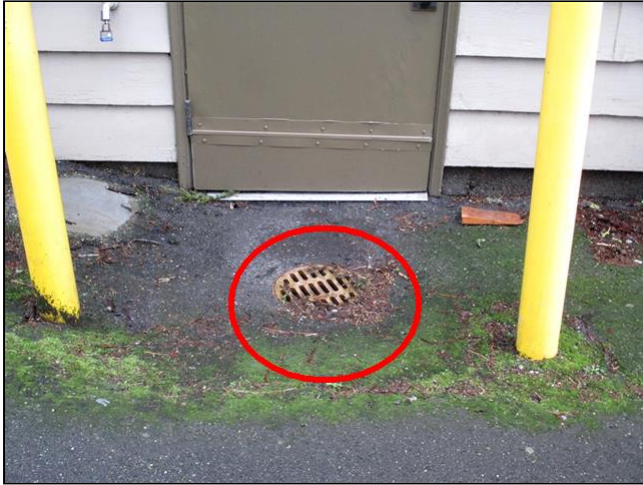
There are storm drains located on the property. No visible problems were noted with the storm drains, but you may wish to have a qualified person flush the drains to their termination point to verify that it is functional.

Flush out the storm drain

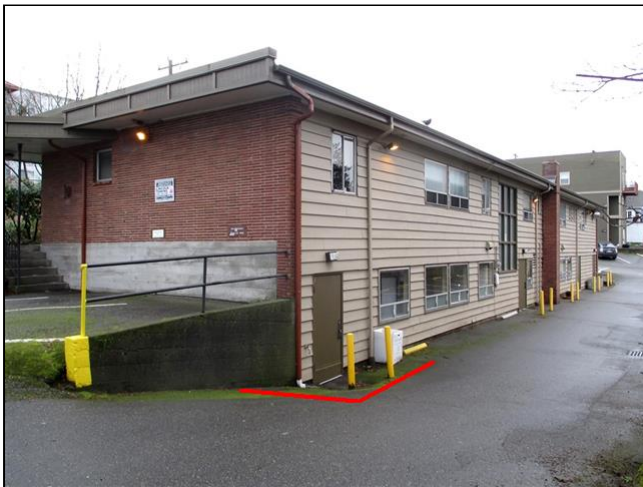
There are indications of water intrusion inside the exterior door on the southwest corner of the basement. Water likely drains beneath the exterior door and into the basement when the storm drain becomes clogged. A licensed asphalt contractor should install an asphalt berm in the parking area uphill from this door to direct rain water away to decrease the likelihood of water intrusion into the basement.

Install an asphalt berm to direct water away from the door

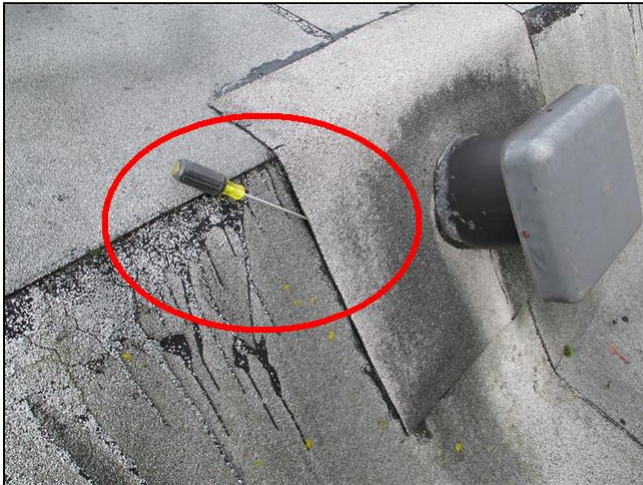
No leaks were detected with the roof at the time of the inspection. However, the roofing materials are older and nearing the end of the typical design life for this type of roofing material. Due to the age of the roofing materials, there is an increased risk of developing leaks. It is our opinion that the roofing materials will need to be replaced in the near future.

Several seams on the sloped areas of the rear section of the roof are not sealed properly, which leaves these areas especially vulnerable to leaks. The roof has leaked recently, as indicated by the water damage observed in the women's bathroom on the main level of the building.

Seams in the roofing materials are not sealed properly

A licensed roofing contractor should evaluate the roof to provide you with a second opinion on the condition of the roofing materials and provide you with a cost for replacement. The roofing contractor should perform a cut test to determine how many layers of roofing materials are present. This is required to determine whether the old roofing materials will need to be removed prior to replacement or if the new roofing materials can be installed over the existing layers.

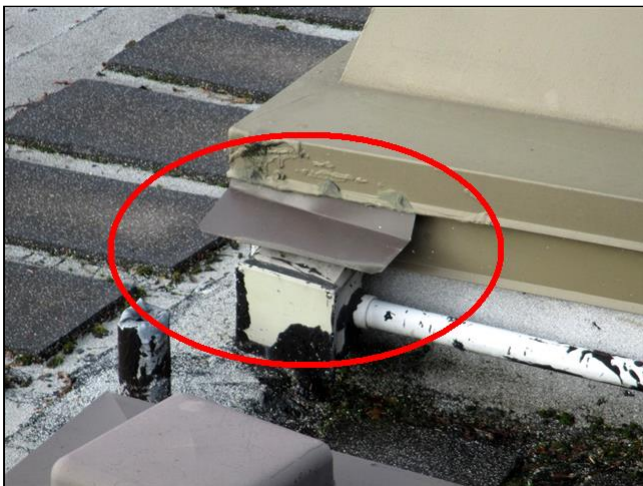
The majority of the roof flashings appear to be in acceptable condition. However, there is a small piece of flashing that has been installed on the side of the one vent fan located above the water damaged area in the women's bathroom. It appears this flashing was installed in an attempt to repair the roof leak. However, the flashing was not installed well and serves as a temporary solution at best. The roof should be repaired properly by a licensed roofing contractor.

Incorrect flashing installation

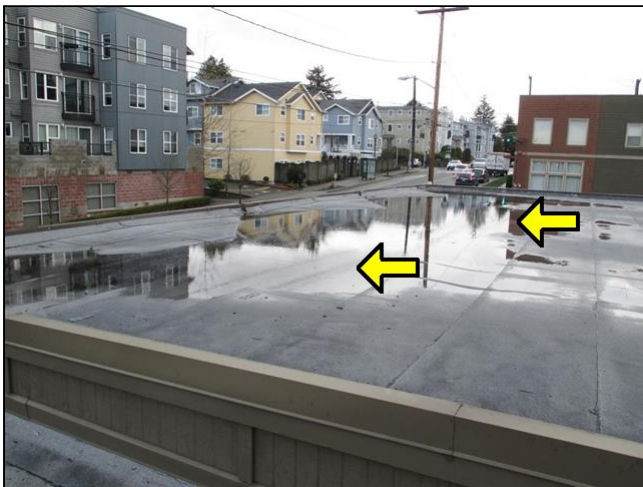
water pond on the roof for extended periods increases the potential for leaks. A licensed roofing contractor needs to improve the slope of the roof and lower the roof drains so that water can drain freely off the roof.

Water is ponding on the roof

After the drains on the roof are repaired and the slope of the roof is improved, the contractor should flush out the downspouts and underground drains to their termination point to verify that they are draining properly.

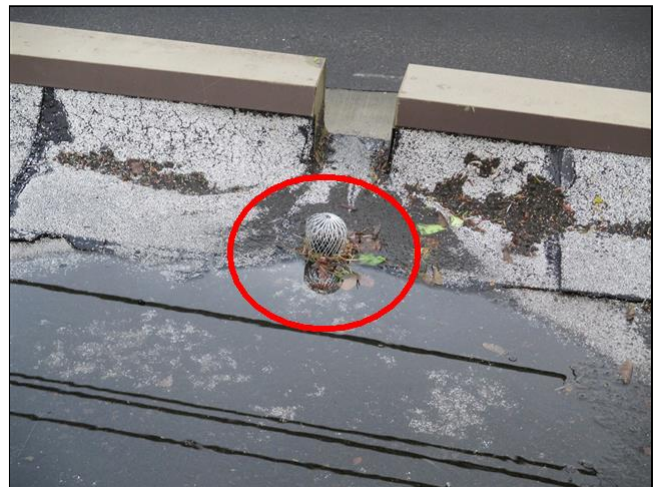
Drains are installed too high

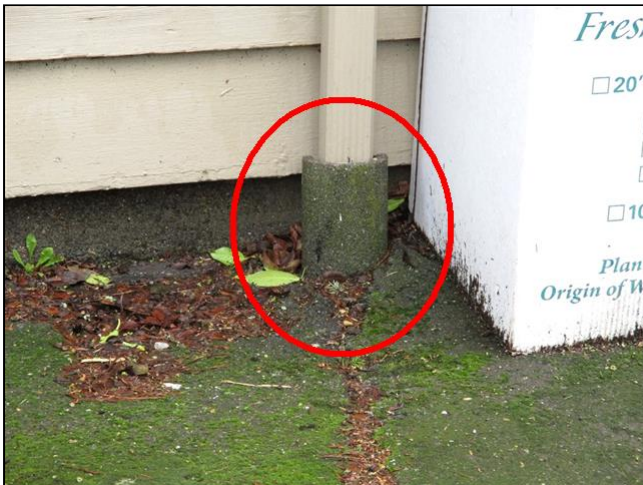
The underground drain lines for the downspouts on the older section of the building are the old concrete type. In has been our experience that this type of old drain is often clogged or broken underground. The drains should be monitored during heavy rains. If the drains are clogged underground, they can either be repaired, or simply cut off at ground level and have extensions added to discharge the water at least four feet away from the building.

Old concrete drain system

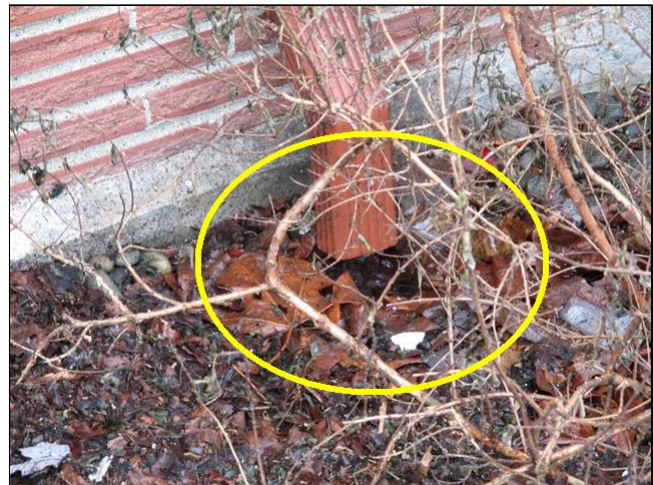
One of the downspouts on the front of the building is discharging at the foundation. The downspout should be connected to the underground drainage system so that water drains properly away from the foundation.

The downspouts discharge at the foundation

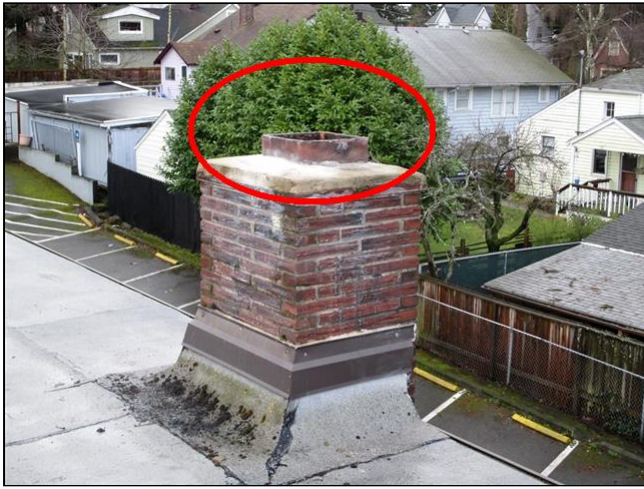
The brick chimney is in acceptable condition, but there is no weather cap/spark arrestor installed at the top. A weather cap/spark arrestor should be installed to prevent water from flowing down the chimney.

Install a weather cap on the chimney

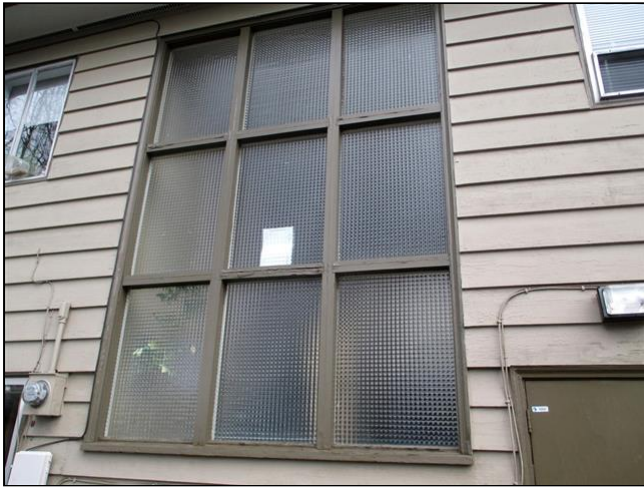
The brick veneer on the exterior of the building is in acceptable condition. However, the wood window trim around the large window at the back of the building and the wood trim on the small wall between the lower roof and the upper roof are decayed and need to be replaced. The paint is peeling on the wood siding and trim boards throughout and should be re-caulked and re-painted in the near future to prevent damage to the cladding materials.

Wood trim is decayed on this window

When the wood trim is replaced, it should be installed to meet the current building codes, which require all protruding wood trim to be flashed. Having flashing installed above the protruding trim will decrease the likelihood of the trim decaying in the future.

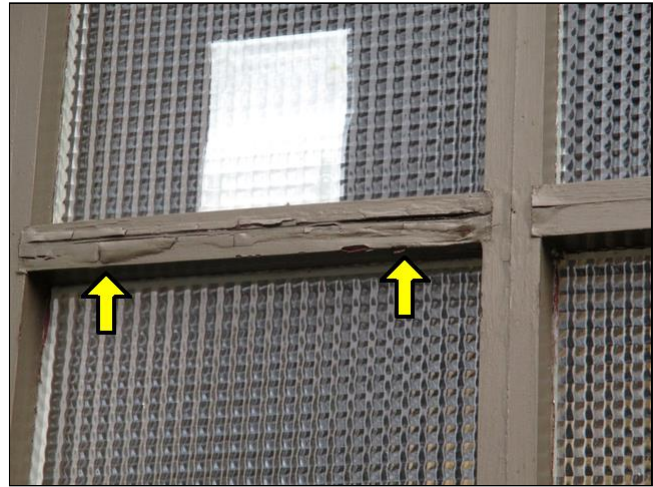
Decayed window trim

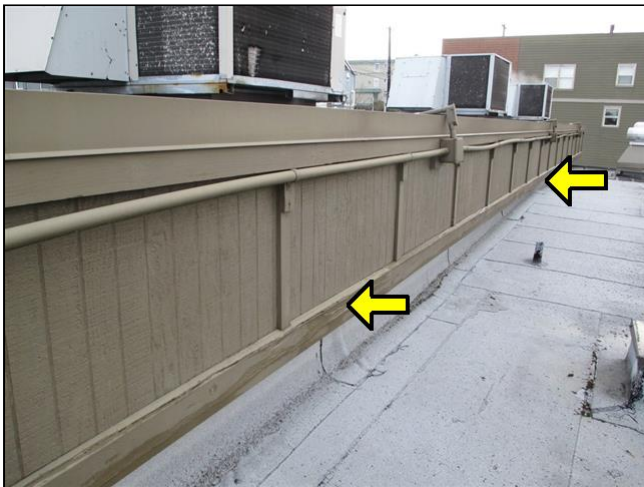
Decayed trim boards

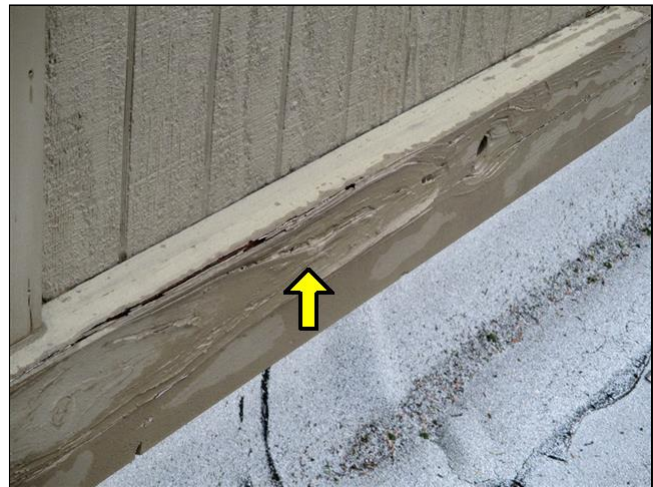
Decayed trim boards

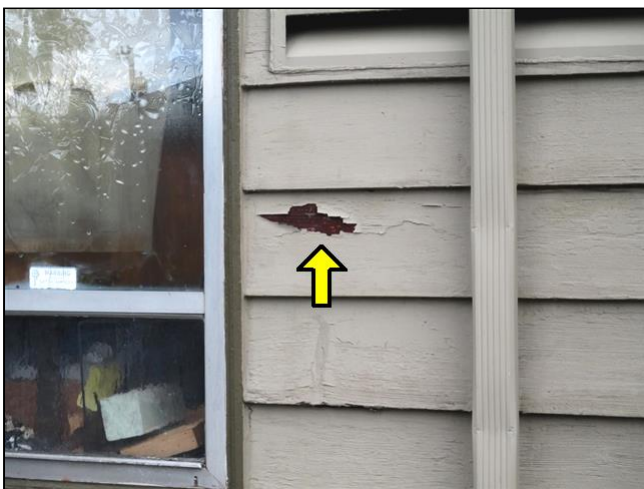
The exterior of any building needs to be kept well painted to prevent damage from exposure to sun, wind, and rain. The wood and/or composite siding/trim components on the exterior of the building should be re-painted every 5 to 8 years, depending on the quality of the paint that was used and by the quality of the contractor that applied the paint. Typically, the south and west sides of the building will show signs of wear first, since these sides are generally exposed to the most weather. It is always better to be pro-active and repaint the building before the paint begins to peel, because once the paint peels, the old paint must be removed before new paint can be applied, which increases labor costs.

Paint is peeling on the siding

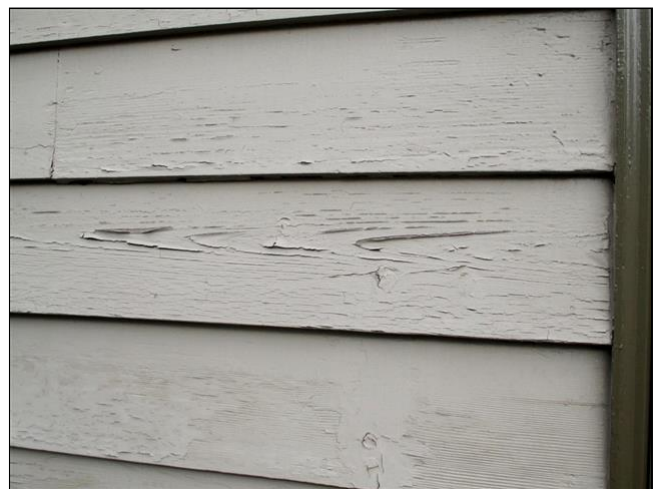
Paint is peeling on the wood siding

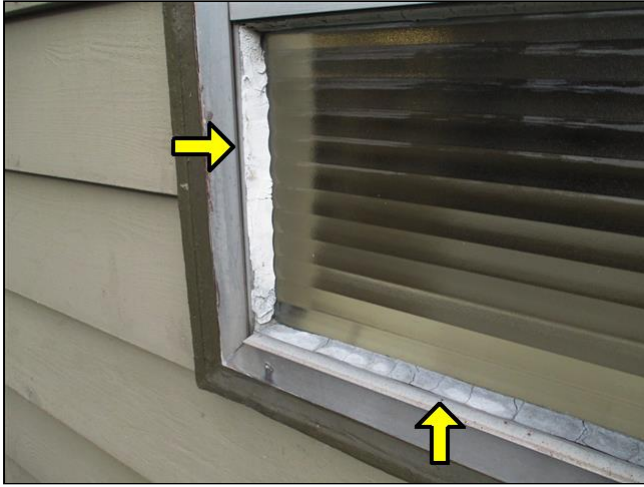
The windows in the building are the old metal-framed single pane type windows. The windows are in poor condition and should be replaced to prevent leaks and to reduce heating and cooling costs.

The old windows are in poor condition

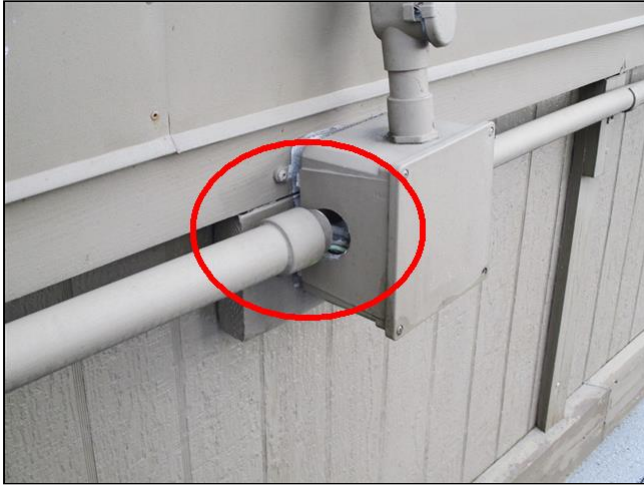
The building is wired with copper conductors within rigid metal conduit. No deficiencies were noted with the wiring in the building, except there is one electrical conduit that is disconnected from the junction box on the roof. A licensed electrician needs to repair the conduit for safety reasons.

Conduit is disconnected from the junction box

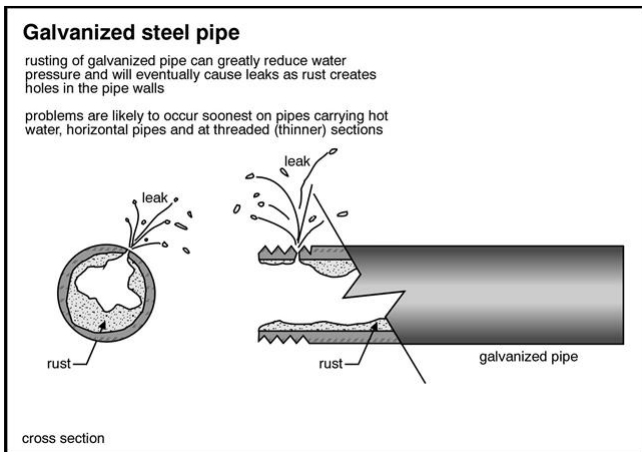
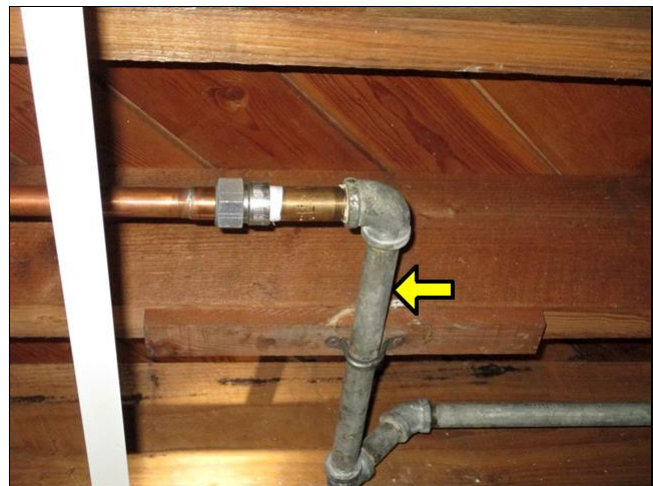
The building was originally plumbed with galvanized steel water supply pipes. This type of piping material typically lasts 40 to 50 years and will produce rusty looking water from time to time and the water volume in such pipes will gradually be reduced by a build-up of minerals within them. It appears that some of the water pipes have been replaced with copper pipes. However, galvanized steel pipes were observed in the building, and when tested, there was a reduction in water volume when two or more plumbing fixtures were in use at the same time. This indicates the remaining galvanized steel pipes are in poor condition. Therefore, you should budget for replacing the remaining galvanized steel water supply piping in the near future. Ideally, this would be done in the near future before the pipes begin to leak.

Galvanized steel pipes

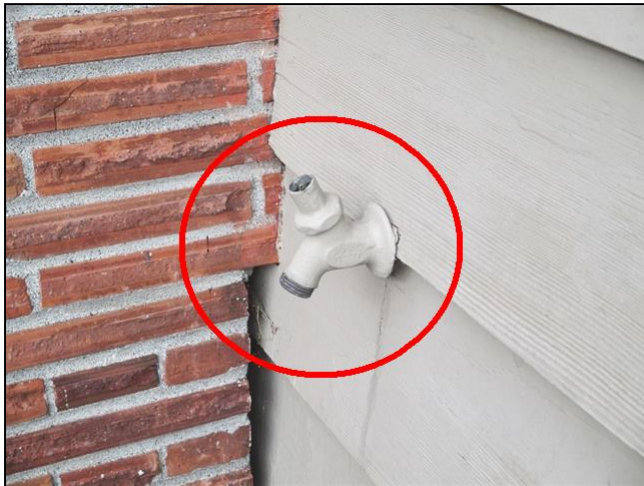
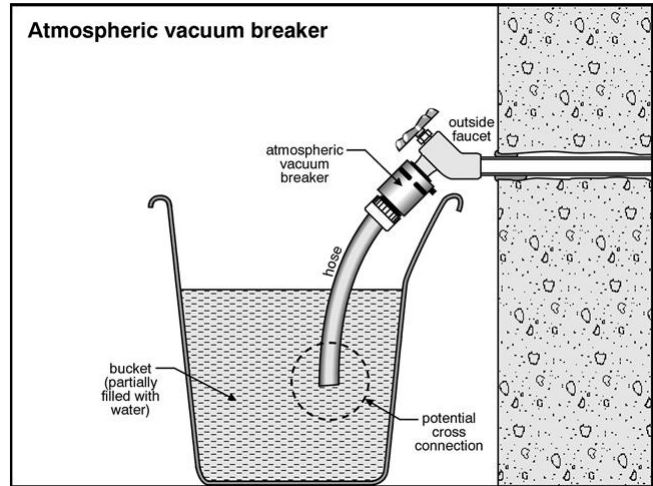
The hose bibs do not include anti-siphon valves, which could potentially contaminate the drinking water with water siphoned from the yard if the garden hose is left in a pool of water. For this reason, it is considered a potential health

hazard. These valves are relatively inexpensive and can be purchased at most major hardware stores. Anti-siphon valves should be installed to prevent yard water from being siphoned into the domestic water supply lines.

Install an anti-siphon valve

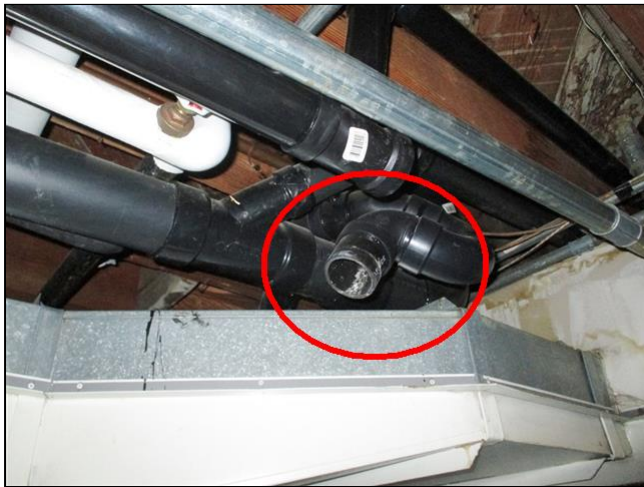
(2) There are several drain pipes in the main electrical room in the basement that are not connected and do not have caps installed at the ends. It could not be determined whether these pipes are currently in use. A licensed plumber should evaluate these drain pipes and make repairs necessary to prevent leaks into the building.

No cap on the end of the drain pipe

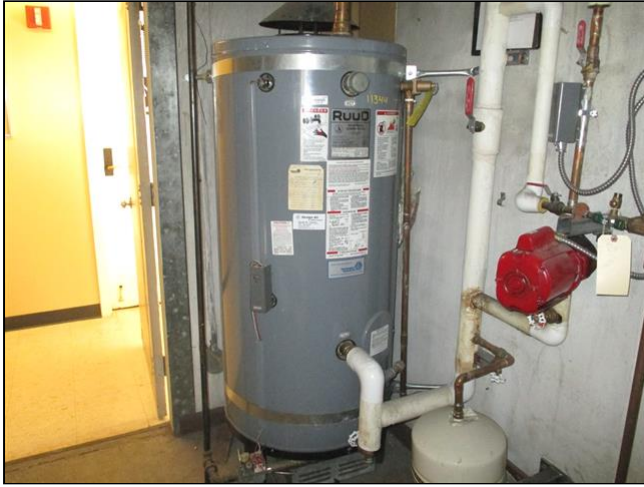
Hot water is provided by a 25-year old, 82-gallon gas-fired water heater located in the boiler room. The 25-year old water heater is functional but is past the typical design life of 10 to 15 years for this type of water heater. It should be replaced due to its age. When the water heater is replaced, it must be installed to meet the current plumbing codes, which would include a drip pan, seismic straps and an expansion tank.

Replace the old water heater

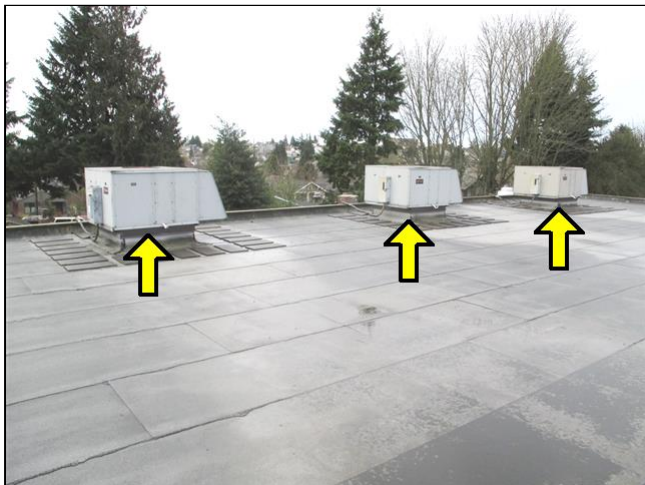
Three heat pumps on the roof

A licensed HVAC contractor should evaluate the heat pumps and provide you with costs for replacement of the heat pumps and provide you with a second opinion regarding the relocation of one of the heat pumps to the upper office area.

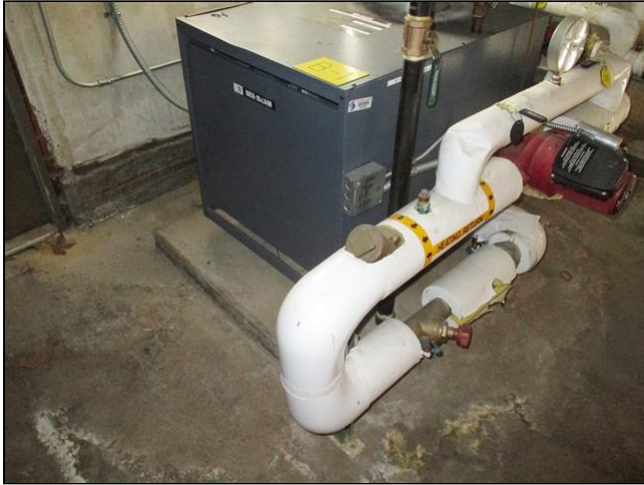
(2) Heat for the south side of the building and the basement is provided by a 5-year old boiler in the basement. This type of boiler typically has a design life of 20 to 30 years.

The boiler heats the building through the radiators that are located throughout the building and by radiant floor heat in the lobby area. The boiler is functional and in acceptable condition. However, a licensed mechanical contractor should evaluate the boiler and verify that the heat is balanced throughout the building, so that the office spaces are not too hot or cold. The mechanical contractor should also provide the building manager with operating instructions for the boiler, thermostats and the heat pumps.

5 year old boiler

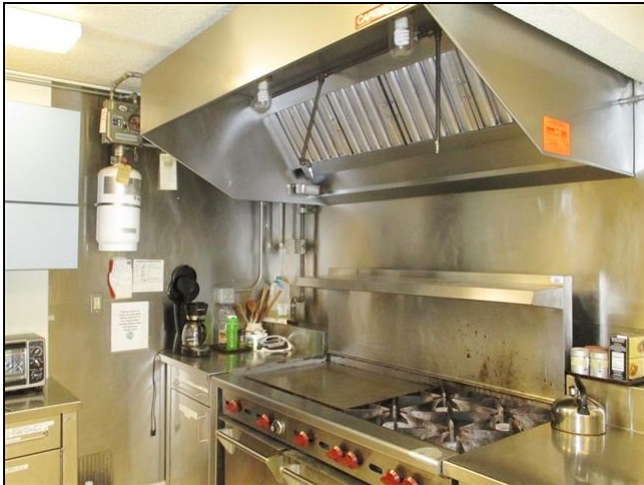
(1) The large kitchen exhaust fan and fire suppression system have been cleaned and inspected recently and are current with their annual inspections.

Kitchen exhaust hood in acceptable condition
