On March 07, 2017 I visually inspected twenty three trees located at the project site at the intersection of South Irving and Yakima Avenue South in Seattle, Washington. The visual evaluation was performed to determine size, species, overall health and site conditions of project site.

TREE SKETCH
March 11, 2017

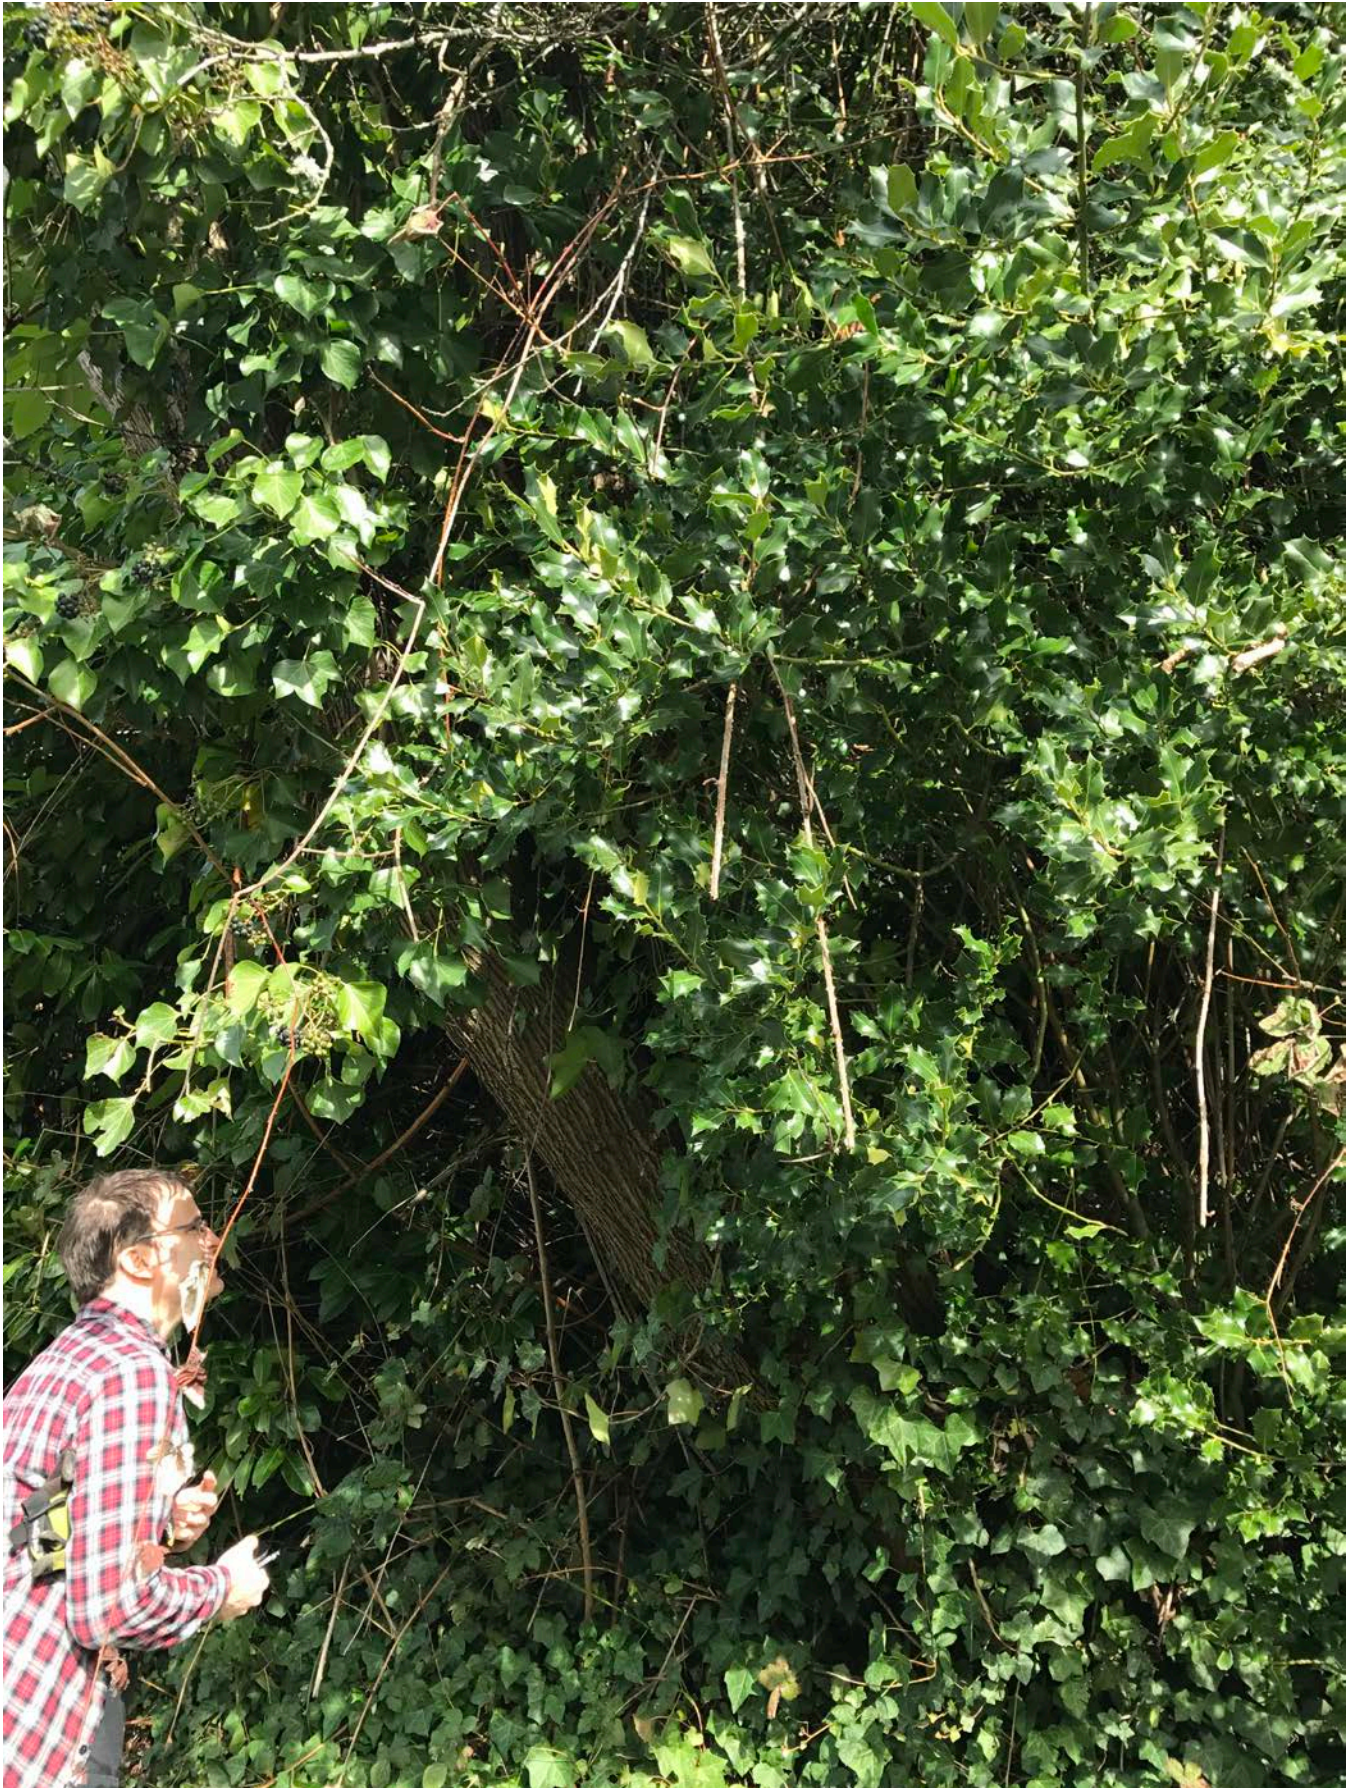
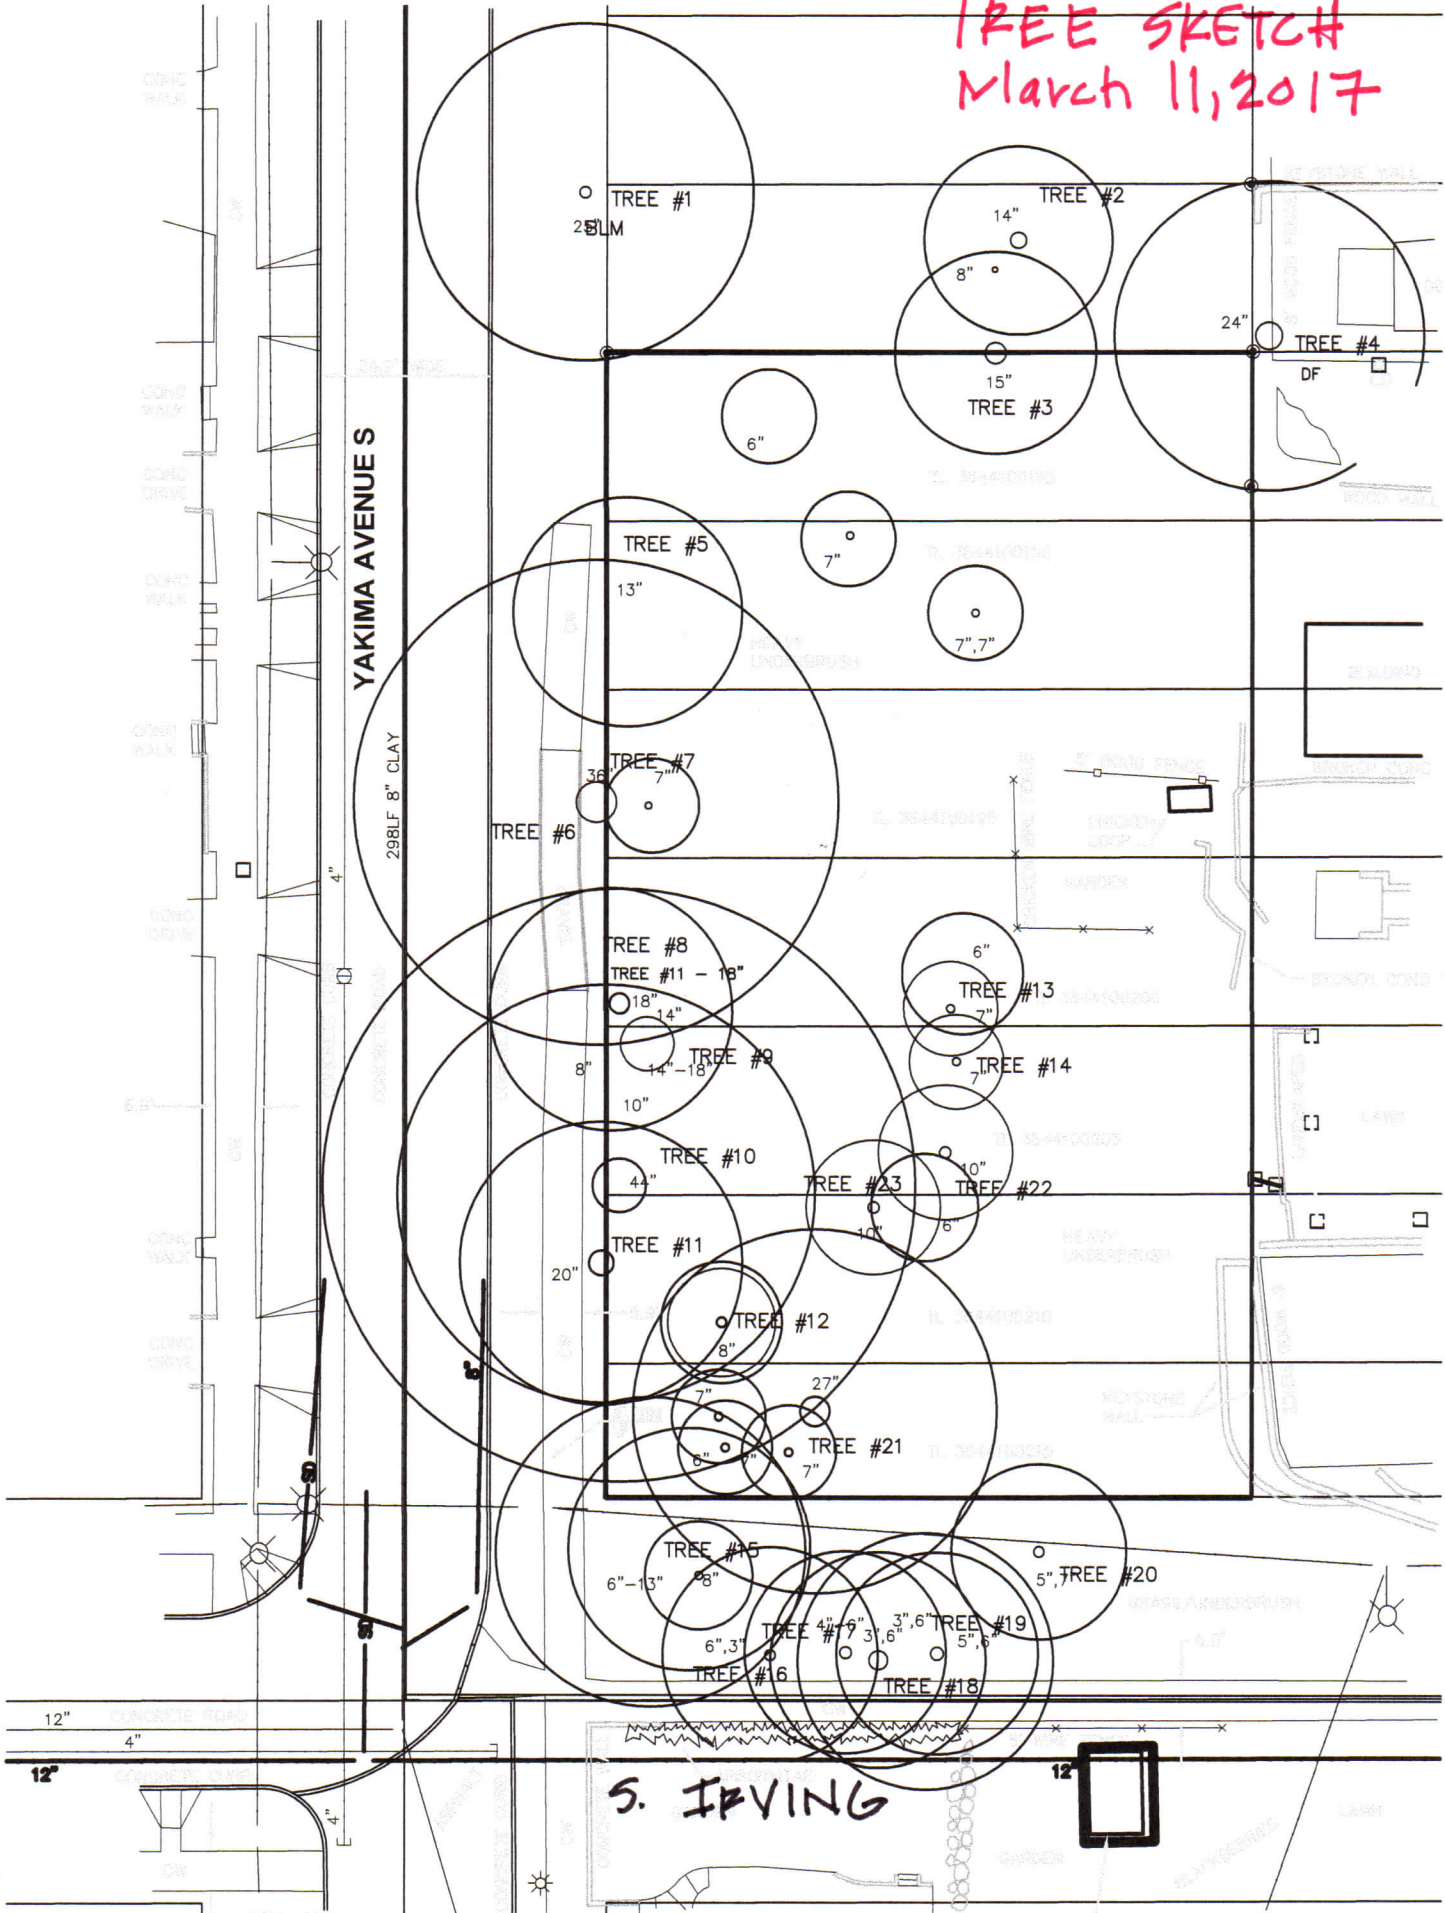
Table One – See attached Tree Sketch dated March 11, 2017 for corresponding numbers and surveyed locations of trees.

Tree #	Botanical Name	Common Name	DBH	Visual Condition /Comments
1	<i>Acer macrophyllum</i>	Big Leaf Maple	Multi stem	Fair Covered in ivy
2	<i>Alnus</i>	Alder	Multi stem	Poor - Covered in Ivy
3	<i>Acer macrophyllum</i>	Big Leaf Maple	Multi stem	Poor – covered in ivy splits into 3 codominant stems
4	<i>Pseudotsuga menziessii</i>	Douglas Fir	24"	Fair - Covered in Ivy
5	<i>Acer macrophyllum</i>	Big Leaf Maple	Multi stem	Poor Covered in ivy
6	<i>Acer macrophyllum</i>	Big Leaf Maple	Multi stem	Fair Fair Covered in ivy
7	<i>Acer macrophyllum</i>	Big Leaf Maple	Multi stem	Fair Fair Covered in ivy
8	<i>Acer macrophyllum</i>	Big Leaf Maple	Multi stem	Fair Fair Covered in ivy

9	<i>Acer macrophyllum</i>	Big Leaf Maple	Multi stem	Fair Fair Covered in ivy
10	<i>Acer macrophyllum</i>	Big Leaf Maple	Multi stem	Fair Fair Covered in ivy
11	<i>Acer macrophyllum</i>	Big Leaf Maple	Multi stem	Fair Covered in ivy
12	<i>Acer macrophyllum</i>	Big Leaf Maple	Multi stem	Fair Covered in ivy
13	<i>Prunus emarginata</i>	Bitter Cherry	4"	Fair Covered in ivy
14	<i>Prunus emarginata</i>	Bitter Cherry	6'	Fair Covered in ivy
15	<i>Prunus emarginata</i>	Bitter Cherry	6"	Fair Covered in ivy
16	<i>Prunus emarginata</i>	Bitter Cherry	4"	Fair Covered in ivy
17	<i>Prunus emarginata</i>	Bitter Cherry	6"	Fair Covered in ivy
18	<i>Prunus emarginata</i>	Bitter Cherry	6"	Poor Covered in ivy
19	<i>Prunus emarginata</i>	Bitter Cherry	6"	Fair Covered in ivy
20	<i>Prunus emarginata</i>	Bitter Cherry	8"	Fair Covered in ivy
21	<i>Acer macrophyllum</i>	Big Leaf Maple	Multi stem	Fair Covered in ivy
22	<i>Prunus emarginata</i>	Bitter Cherry	8"	Fair Covered in ivy

23	<i>Prunus emarginata</i>	Bitter Cherry	6"	Fair Covered in ivy

In order to inspect and evaluate the health of these trees the ivy needs to be removed. The following three steps should be followed.

Cut a circle of English ivy around the tree trunk. Free a four foot tall section completely around the trunk. Ivy dangling on the tree will eventually dry up and fall down.

Pull and remove ivy from in a 6' radius around the tree trunk, removing as many roots as possible.

If the trees are to remain the ivy should be removed completely from the bank and suitable native shrubs and groundcovers installed to assist in stabilizing the steep slope. Tree protection around the entire grove should be installed per City of Seattle standard plan no 133.
