# ASBESTOS AND LEAD SURVEY

1529 – 4<sup>th</sup> Avenue West  
Seattle, Washington

Prepared for: Seattle Public Library  
1000 Fourth Avenue, 11<sup>th</sup> Floor  
Seattle, Washington 98104-1109

Project Number 12-11002

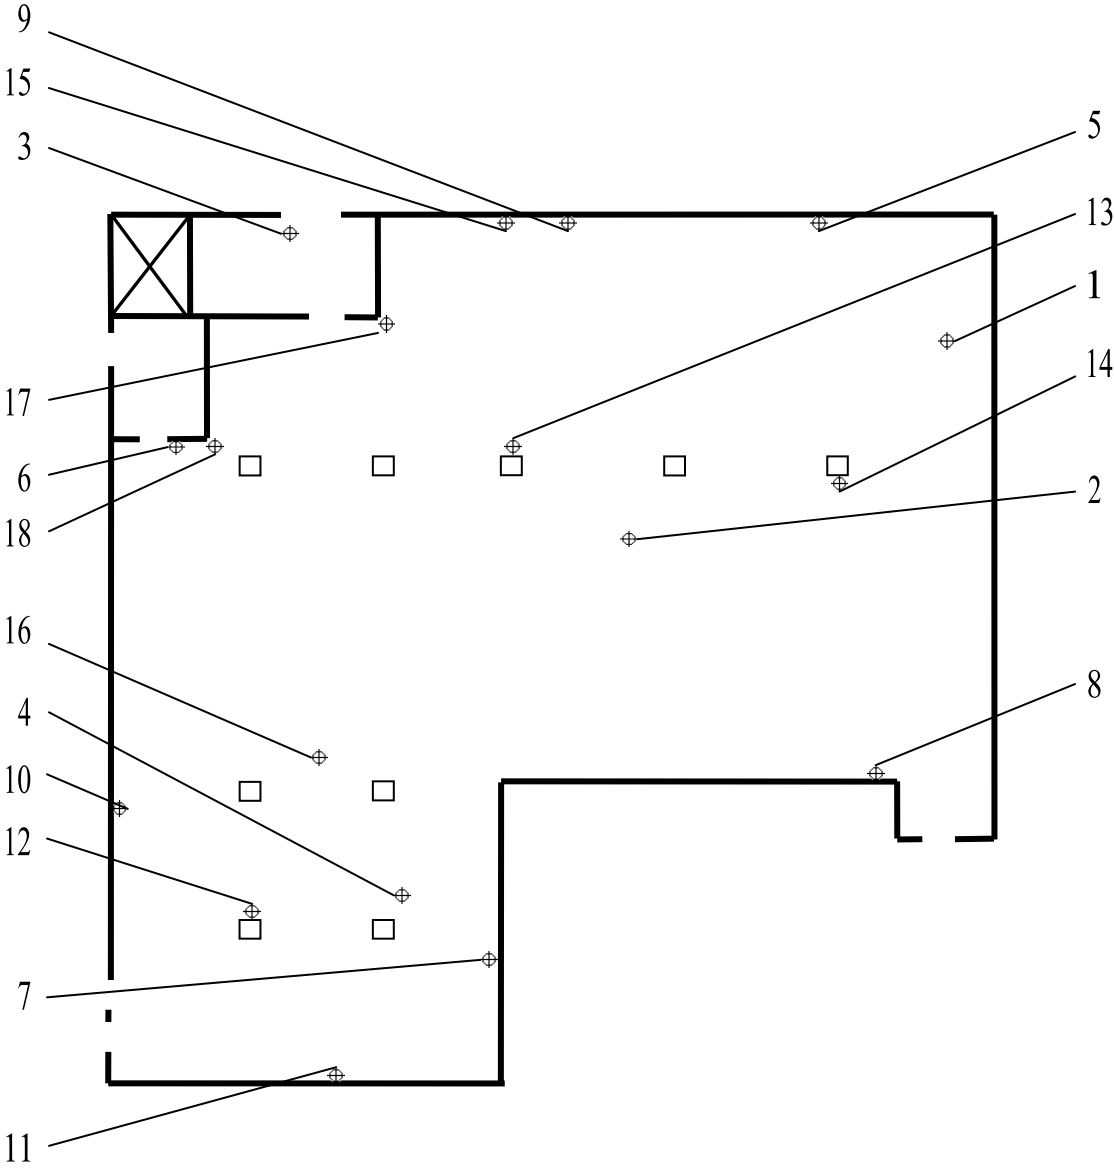
Figure 1. Approximate asbestos sampling locations. Main floor north interior. 1529 – 4<sup>th</sup> Avenue West. November 2, 2012.

Overall, a total of 18 samples were collected from the subject area of the building and analyzed for asbestos content (sample numbers 1 through 18) (Figure 1). Samples were analyzed by Novo Laboratory in Burien, Washington. Novo is an accredited laboratory for the analysis of asbestos-containing materials.

As indicated in Table 1, asbestos was detected in the 12-by-12-inch floor tile and mastic (sample numbers 1 through 4). This floor tile and mastic is typical throughout this main floor north interior area of the building.

Asbestos was also detected in the cove mastic (sample numbers 5, 6 and 7), but at concentrations that are below the regulatory limit of >1%.

Generally, materials that contain >1% asbestos, such as the floor tile and mastic as noted above, must be properly removed and disposed of by a licensed asbestos abatement contractor prior to any renovation or demolition activity that may disturb the materials.

Materials that contain <1% asbestos, such as the cove mastic as noted above, generally do not have to be removed by an asbestos abatement contractor prior to any renovation or demolition activities that may disturb the materials. A general contractor can perform this work. However, please note that Labor & Industries (L&I) requires that many of the same worker protection measures be taken (respirator, taping off the work area, keeping the materials wet during removal, air monitoring, etc.) when working with this material as though it contains >1% asbestos. Therefore and at a minimum, workers must have asbestos awareness training (an approximate 8-hour class) prior to working with this type of asbestos material.
