DRAFT Preliminary Seismic Evaluation

**The Seattle Public Library –
Queen Anne Facilities Building**

1529 Fourth Avenue West
Seattle, WA 98119
MLA Project No. 2014.105.2

October 15, 2014

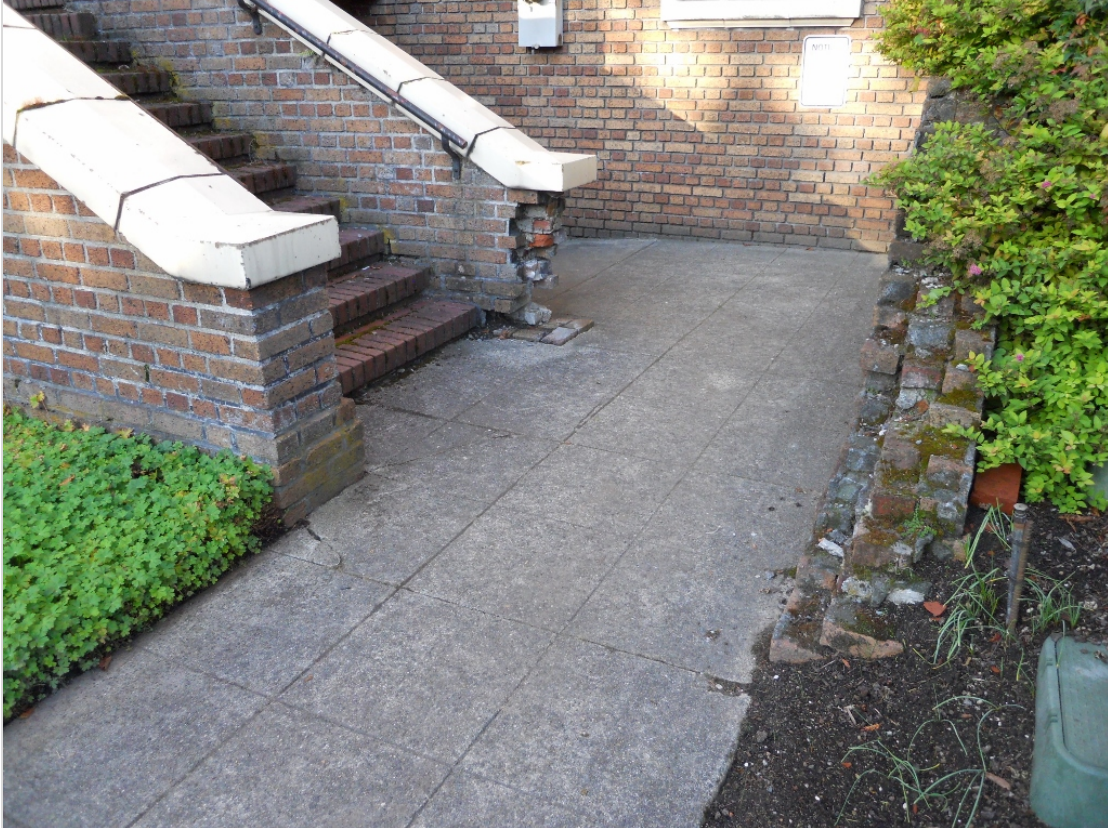
1. The exterior masonry wall banister alongside the front steps is crumbling at its low end. (see Photo 1)
2. The fire-proofing concrete that encases the steel floor beams has numerous rock pockets, however the locations that we observed did not have cracking of the type reported in the 2008 CPL memo.

We did not observe any indications of existing damage from previous earthquakes in the portions of the building's masonry walls that we viewed. The observed damage in the exterior brick wall banister may be from a non-seismic cause because it is highly localized damage to a short wall that is otherwise lightly loaded. This wall's degradation, however, demonstrates the brittle performance of unreinforced masonry after it has been subject to overstresses.

Photo 1: Damaged banister

3. Because it occurs at ground level, the current extent of localized damage to the exterior banister is presently low risk to life safety. We recommend repair, however, to prevent further unraveling of the brick banister.
