2019 Project Review Sheet (2020 Construction)

Project #	19-271
Project Title:	Repair sidewalk
Location:	Neighborhood: Belltown, 98121 Area: Northwest corner of 5th Avenue and Blanchard Street from end of building to mid-block

YVYC 2019: Project 19-271, Northwest corner of 5th Avenue and Blanchard Street from end of building to mid-block

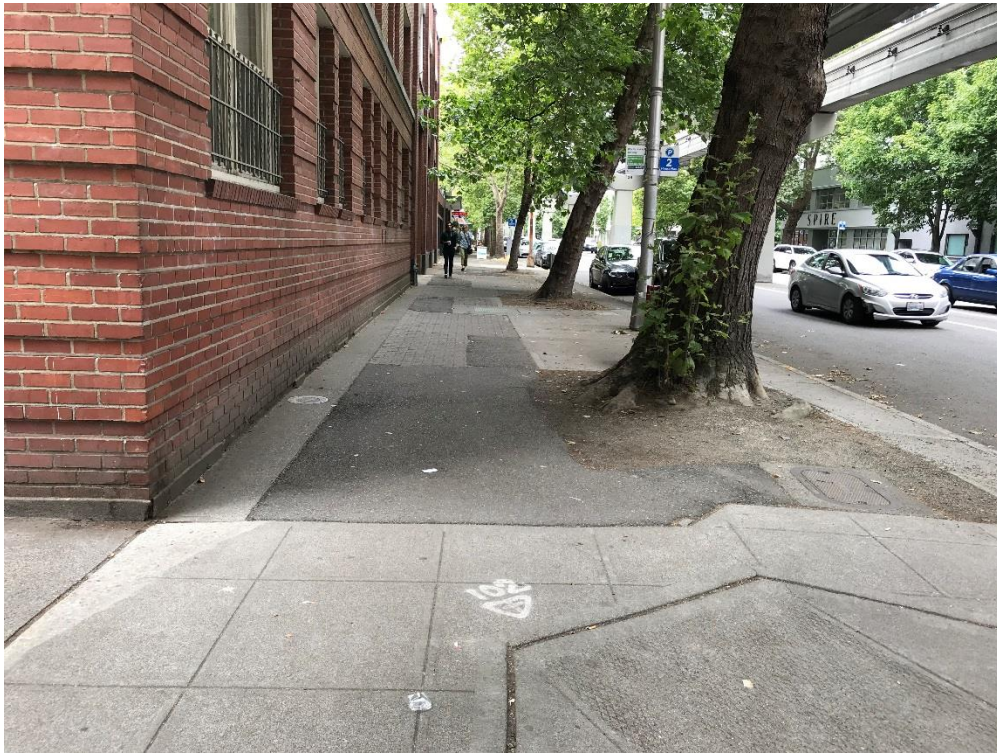
Figure 1: View norths from the corner of 5th Ave and Blanchard St.

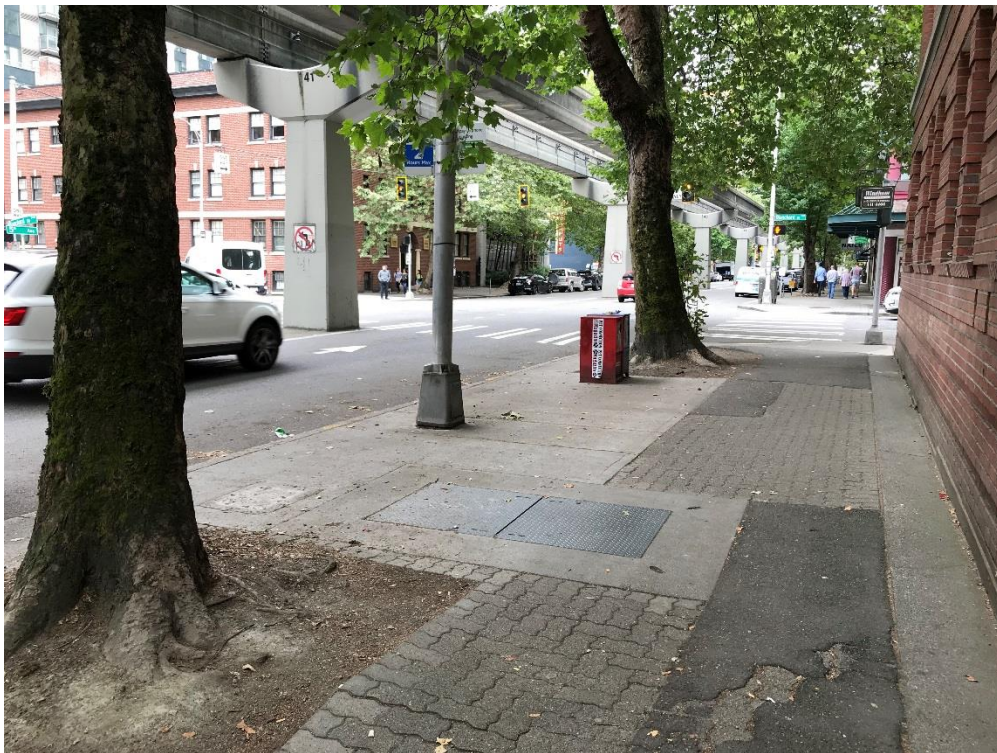
Figure 2: View south towards the corner of 5th Avenue and Blanchard St next to the SPU vault.

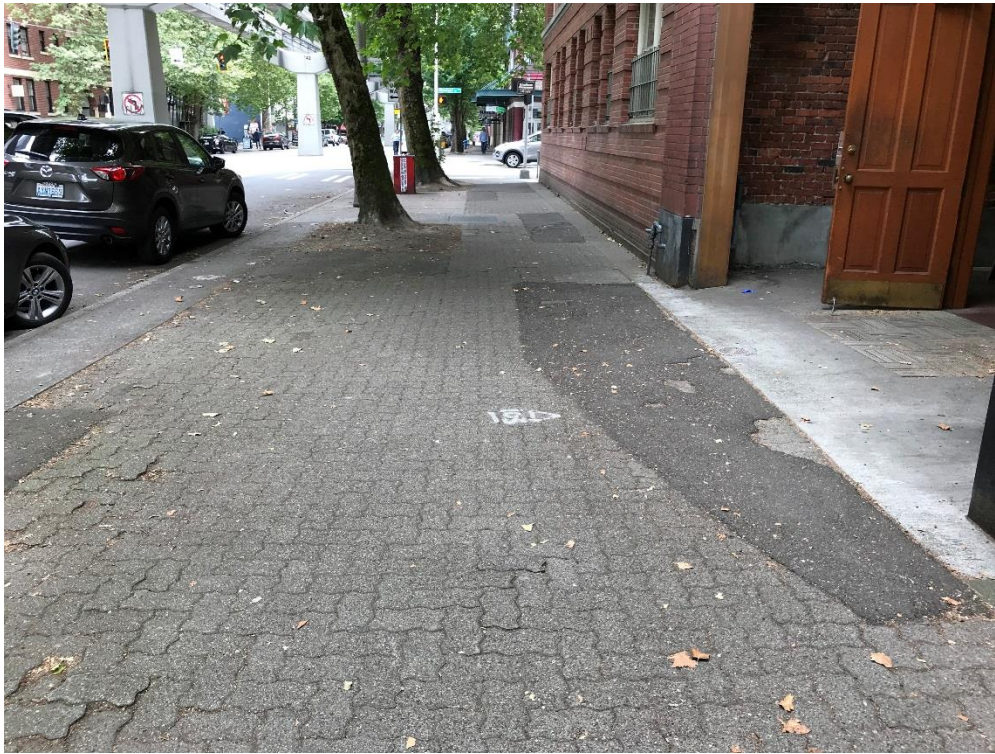
Figure 3: View south from roughly 80 ft north of Blanchard St.

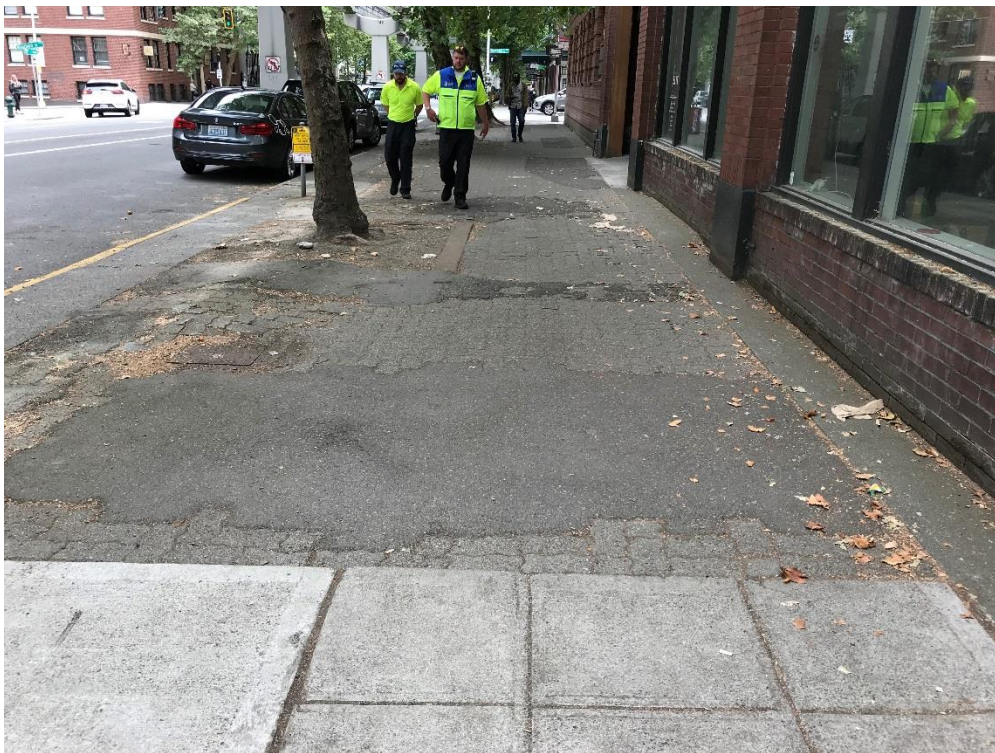
Figure 4: View south from roughly 120 ft north of Blanchard St.

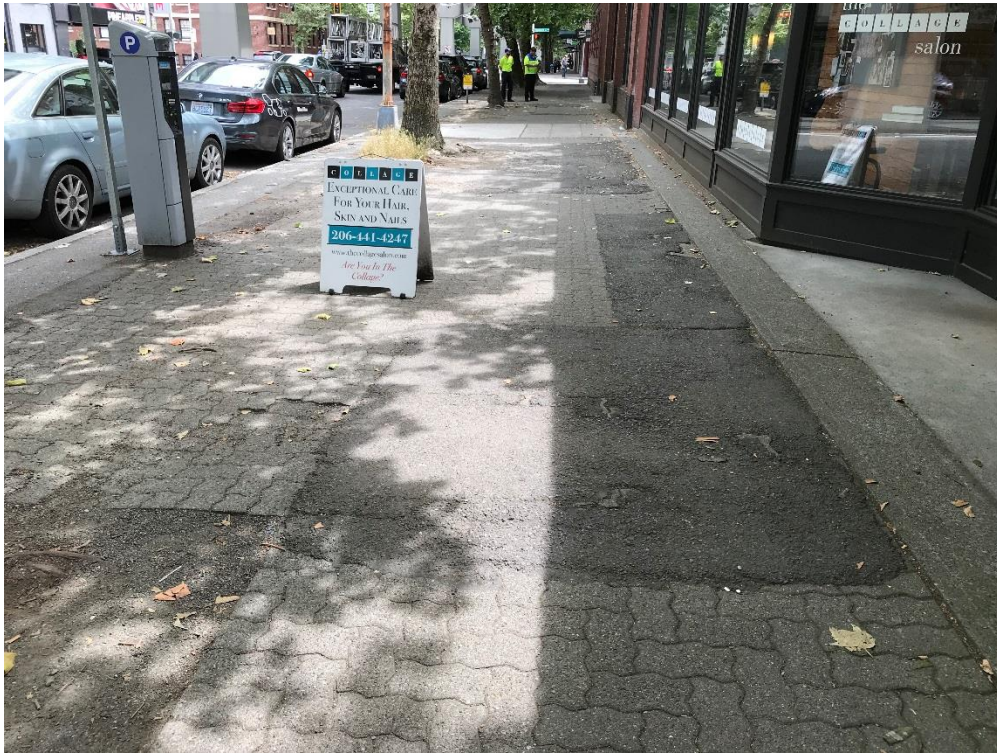
Figure 5: View south from roughly 225 ft north of Blanchard St.

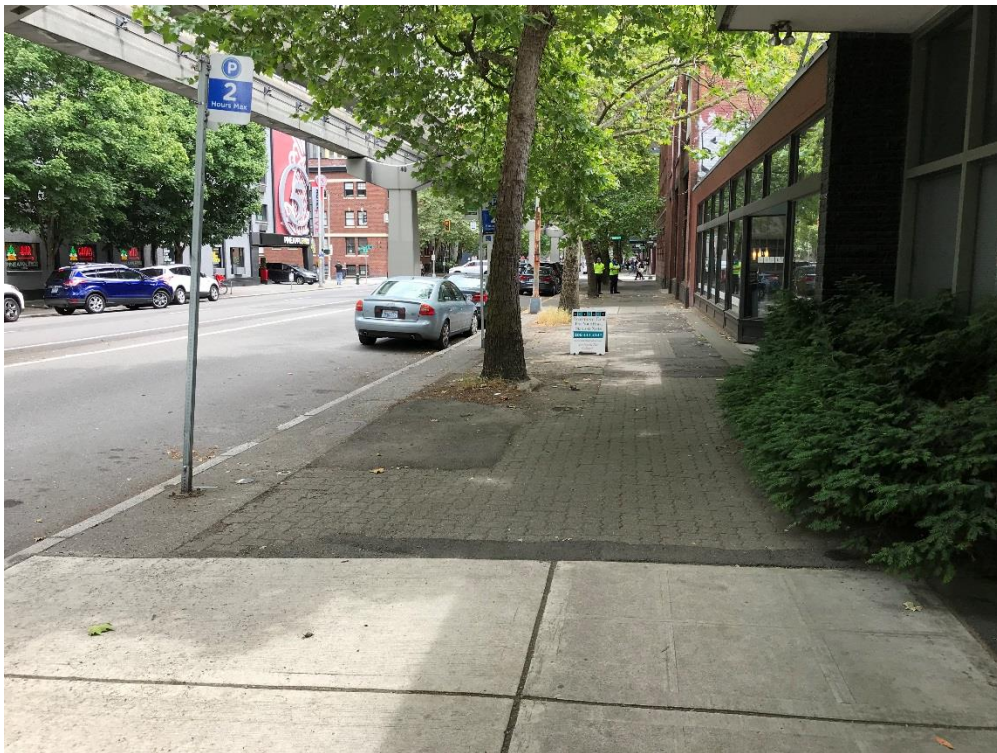
Figure 6: View south toward Blanchard St from the midblock at the recently rebuilt section.
