MAGNUSON COMMUNITY CENTER SEATTLE PARKS AND RECREATION

ARCHITECTURAL AND ENGINEERING
MAINTENANCE EVALUATION STUDY

September 2017

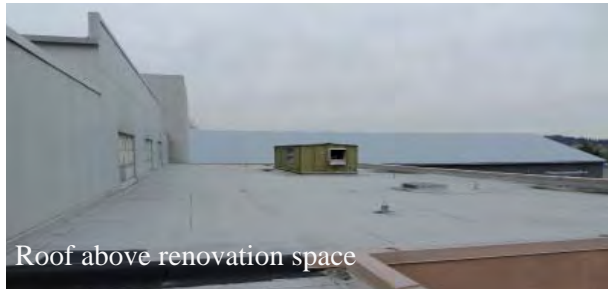
Roof above renovation space

Roofing: The roof was indicated to have been replaced in 2000. The roof material and all flashings appear to be in good condition with no leaks being reported by staff. Additionally, a fall protection system was added during the 2002 renovation.

Windows: The windows are a metal frame system, with some appearing to be original. No insulated glazing was noted. Several of the windows appear to be operable. The windows are in various conditions, ranging from newer aluminum framed windows to painted glazing at the clerestory windows.

Recommended Action: Clean debris from roof corners and scuppers.

Recommended Action: Replace windows with insulated units complying with Historic Preservation requirements. Alternatively, provide interior storm windows to meet current energy code requirements

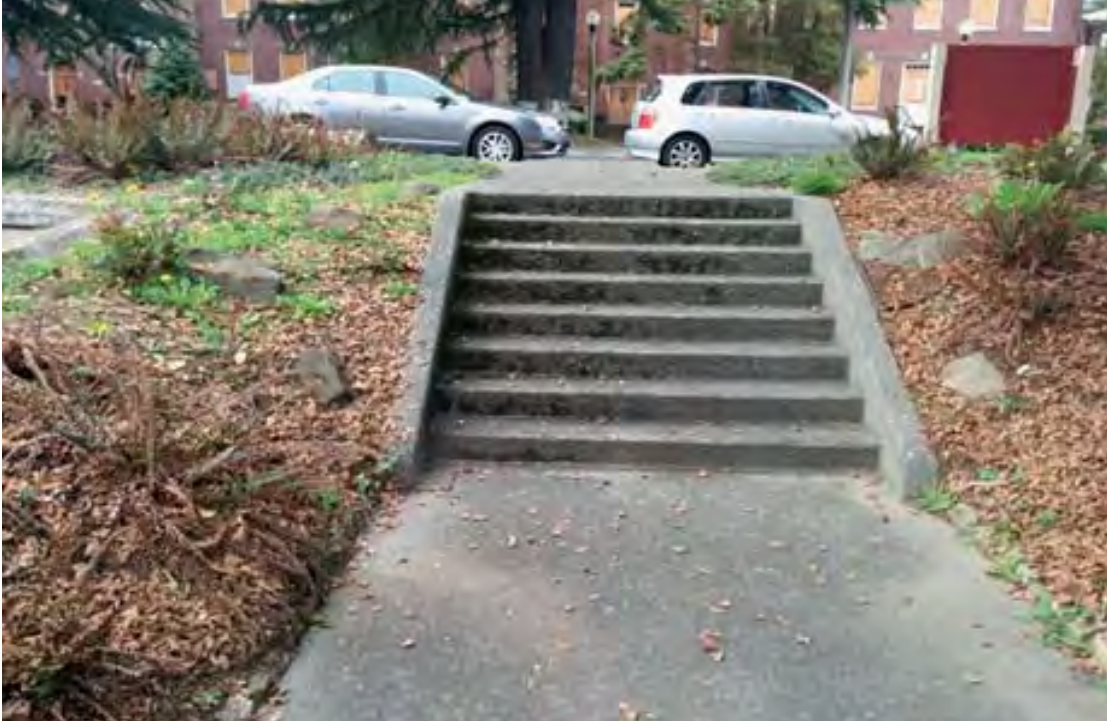
- The stairs located outside the entrance of the community center entrance has one handrail on its southern side but the stairs are missing a handrail along the northern side. The stairs along the southern portion of the site has no handrails.

3. Provide handrails at stairs.

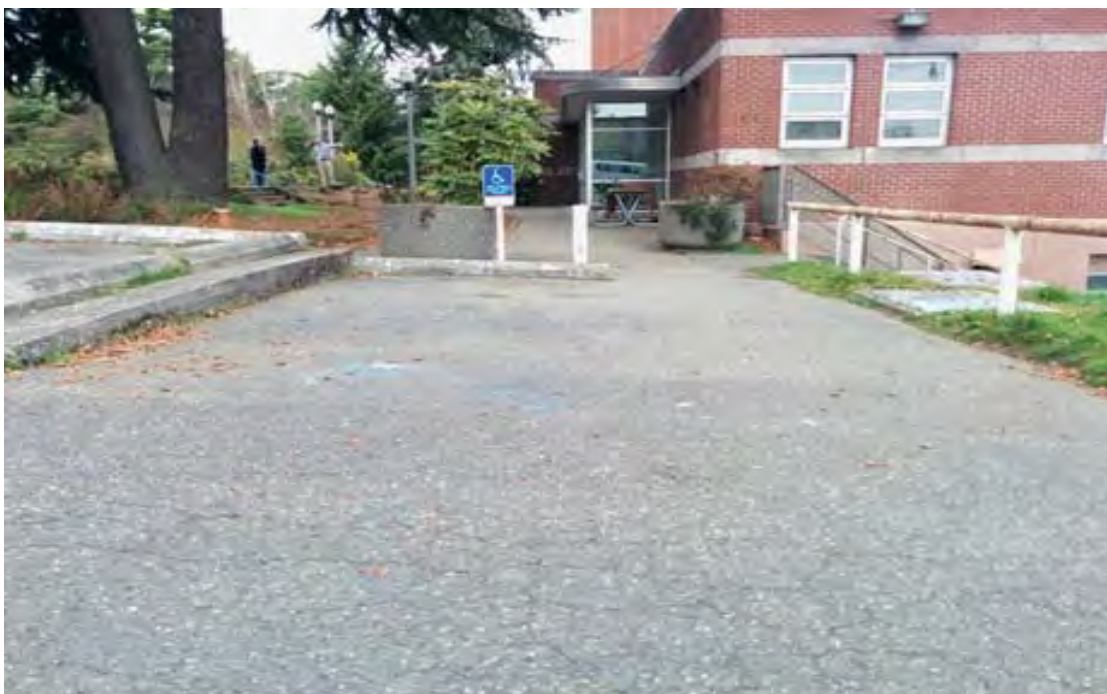
- There is one main parking area associated with the building, located to the south and accessed from 62nd Ave NE. The site survey was limited to evaluation of the handicapped parking stall, the remainder of the lot was not evaluated. There is (1) handicapped parking stall (8.0' minimum width available 5.0' aisle). Markings are in poor condition and not visible, a sign is provided to designate the handicapped parking stall. The pavement is in fair condition with little spalling and some longitudinal cracking, but no visual evidence of subgrade failure. Slope of stall and aisle exceeds the maximum slope of 2.00% in any direction. A concrete wall approximately 1.0' tall is located on the western edge of the parking stall.

4. Demolish and relevel the handicapped parking stall to be less than 2.0% in any direction. Repave and restripe and paint stall to meet ADA standards.

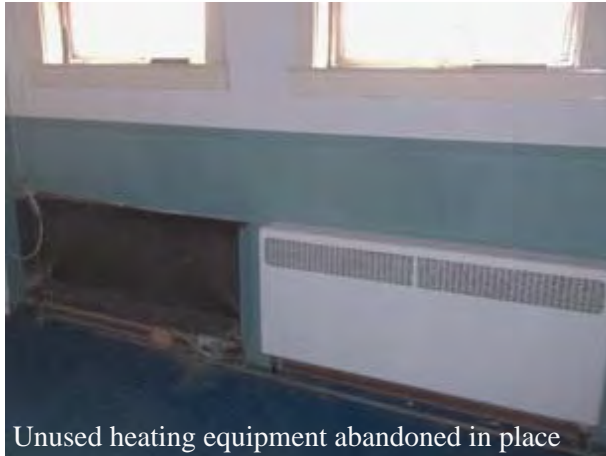
- No mechanical equipment currently serves this space.
- Original space heating was provided by low pressure steam radiators installed on the perimeter of the space. However, the steam system was disconnected c. 2003 and no steam supply is currently available to radiators.

Unused heating equipment abandoned in place

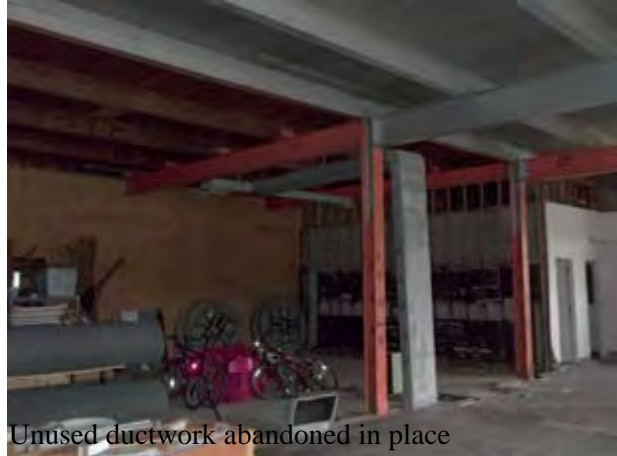
Unused ductwork abandoned in place

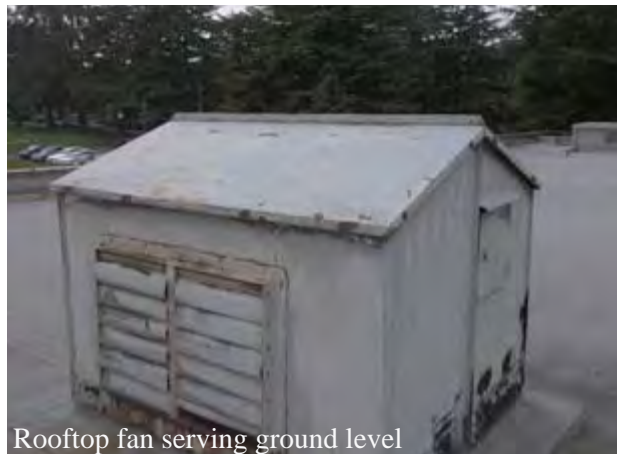
Rooftop fan serving ground level

- A centrifugal exhaust fan serves the Women's restroom and locker rooms for the ground level and is located on the roof in a penthouse. Exhaust for ground floor restroom and locker rooms is via a mechanical shaft located in an adjacent closet on the main floor.
- Electrical power to the exhaust fan appears to be disconnected.
- Exhaust fan is corroded and in poor condition.

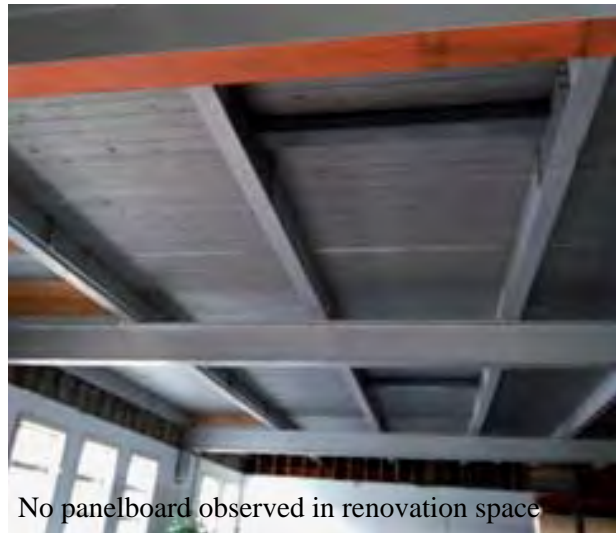
No panelboard observed in renovation space

1. Provide new panel or relocate existing D or E to feed new loads in the scope of work space.
2. Provide new fire alarm devices to match existing building FACP to cover the scope of work space and connect to existing fire alarm control panel system.
3. Provide receptacles to match new space layout.
4. Provide new LED lighting fixtures and provide integrated battery backup for emergency lights. Include standalone lighting control system that meets 2015 Seattle energy code requirement to suit new space layout.

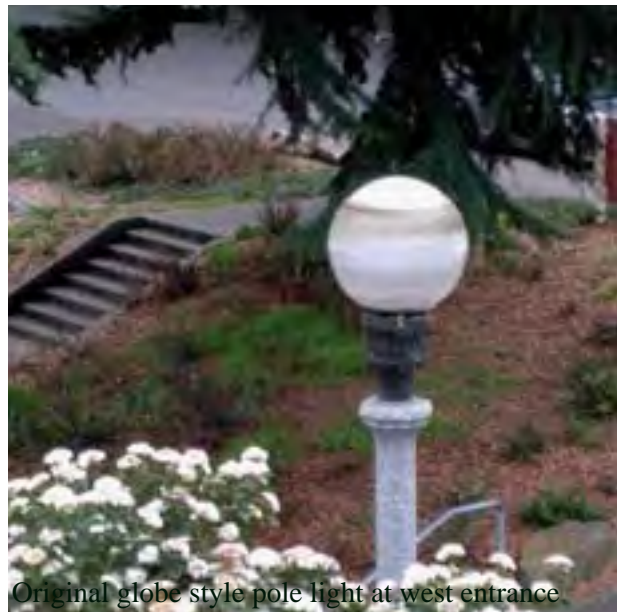
Exterior lighting was observed around the building perimeter. The fixtures are antiquated and aged globe style street lights without built in reflectors. There were no wall mounted fixtures observed at the west building entrance.

Original globe style pole light at west entrance
