January 25, 2014
HWA Project No. 2014-177-21

ESA
5309 Shilshole Avenue NW, Suite 200
Seattle, Washington 98107

Subject: **GEOTECHNICAL ENGINEERING INVESTIGATION**
Cheasty Trail Pilot Project
City of Seattle Parks and Recreation
King County, Washington

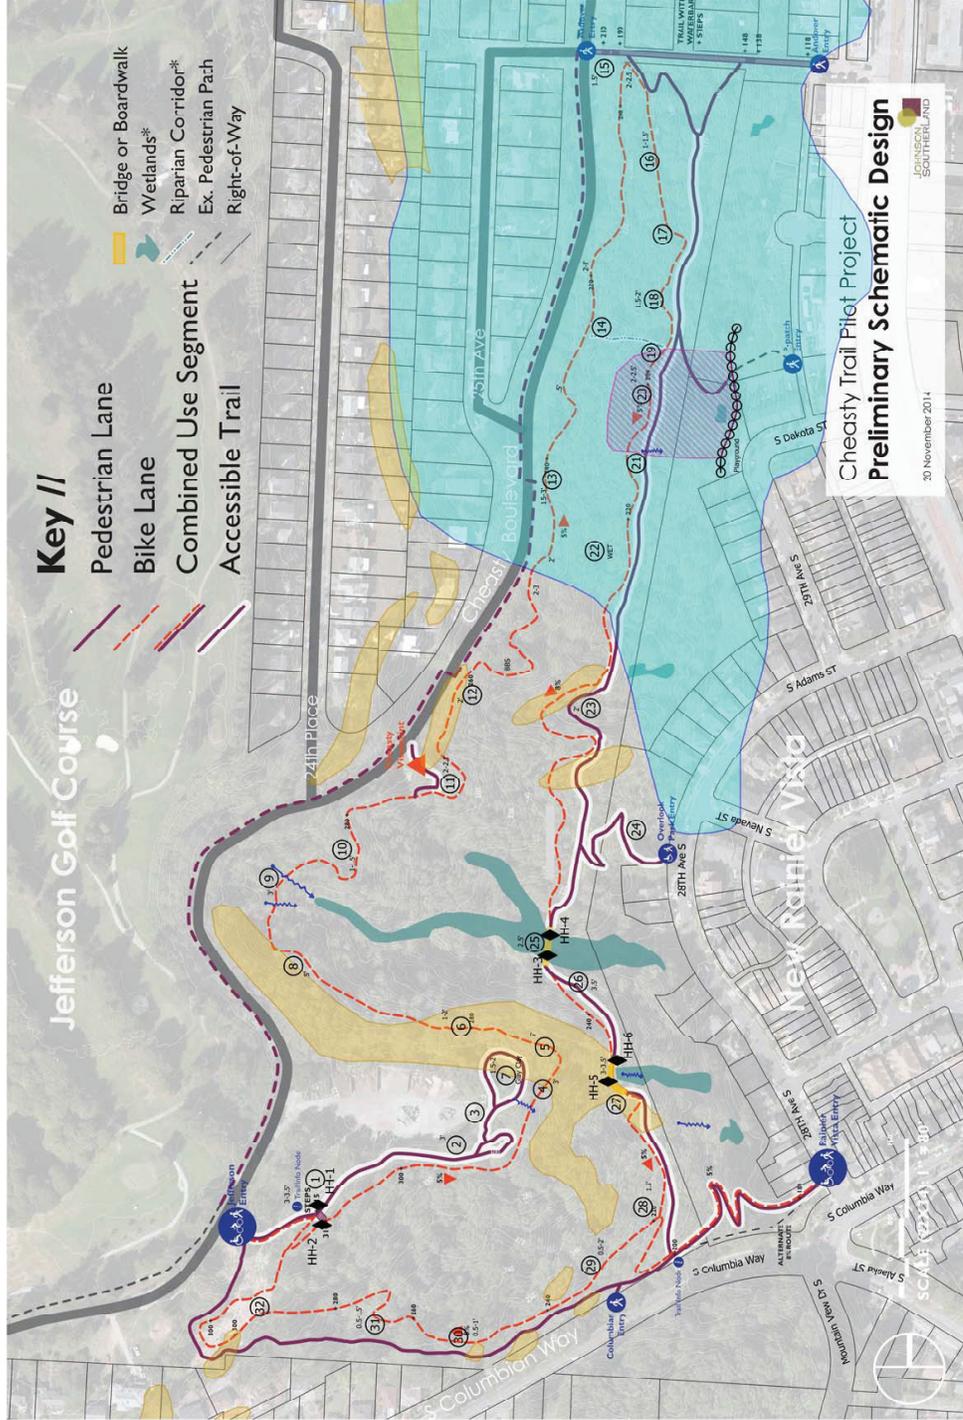
Slopes exceeding 40 percent were mapped by City of Seattle along portions of the southern half of the site (see [Figure 2](#), yellow hatching). The main portion of this is along the northern slope below the materials yard and above the main stream.

Ground water seepage was observed in several locations, most of which were closer to the bottom of slope than the top. The approximate locations in which ground water seepage was observed during our site visits are indicated in [Figure 2](#). The exception was ground water seepage below Cheasty Blvd at the head of the large stream valley. These seepages formed the head ends of surface drainages. Based on the geologic mapping, it is likely that most of the seepage emanates from granular soils just above their contact over hard silts and clays. The presence, specific locations, and flow quantity of ground water seepage should be expected to vary seasonally.

Ground water seepage zones and the resulting surface runoff were observed at a number of places along the trail corridor. Specifically these were observed near waypoints 4, 9, 14 (surface

pipeline for stormwater), 21 (in or adjacent to deep-seated slide area), 25 (north riparian zone), and 27 (south riparian zone). Other areas of seepage could become apparent during and after trail construction. The trail should not be constructed with wet crossings of seepage or runoff, as bicycle and foot traffic will cause disturbance of wet soils that will result in rutting and erosion of the trail (requiring higher maintenance) and silty runoff (impacting wetlands and streams down gradient).

In general, the proposed mountain bike trail alignment is appropriate. However, specific modifications to the trail alignment should be considered during final design. We recommend that the trail alignment be modified to avoid locations of identified groundwater seepage and observed slope instability.

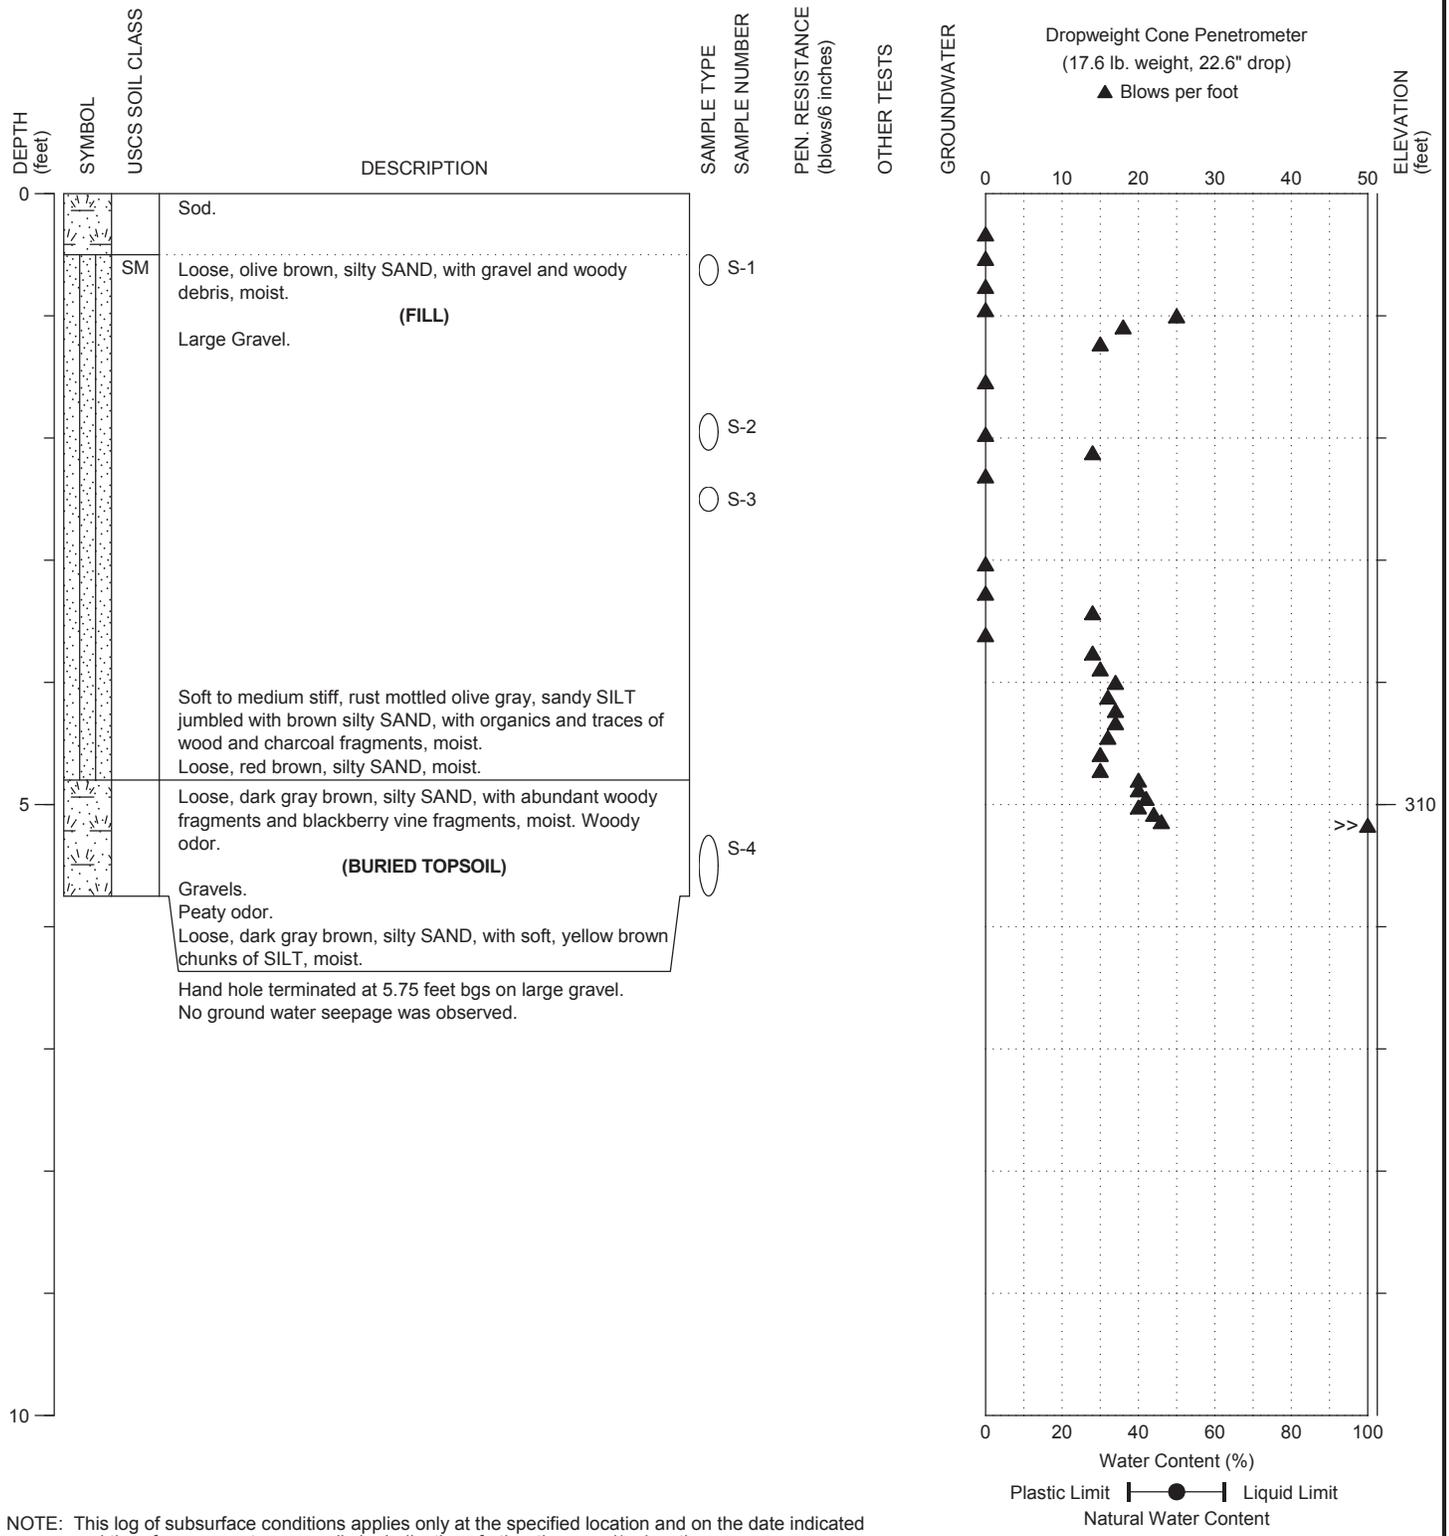
BORING:
 HH-1

Fill: Fill soils consisting of very loose to loose, brown, gravelly, silty, sand with woody debris and organics were encountered in handhole HH-1 at the proposed top of steps. This fill material appeared to have been placed during grading of the area for the materials yard just to the north.

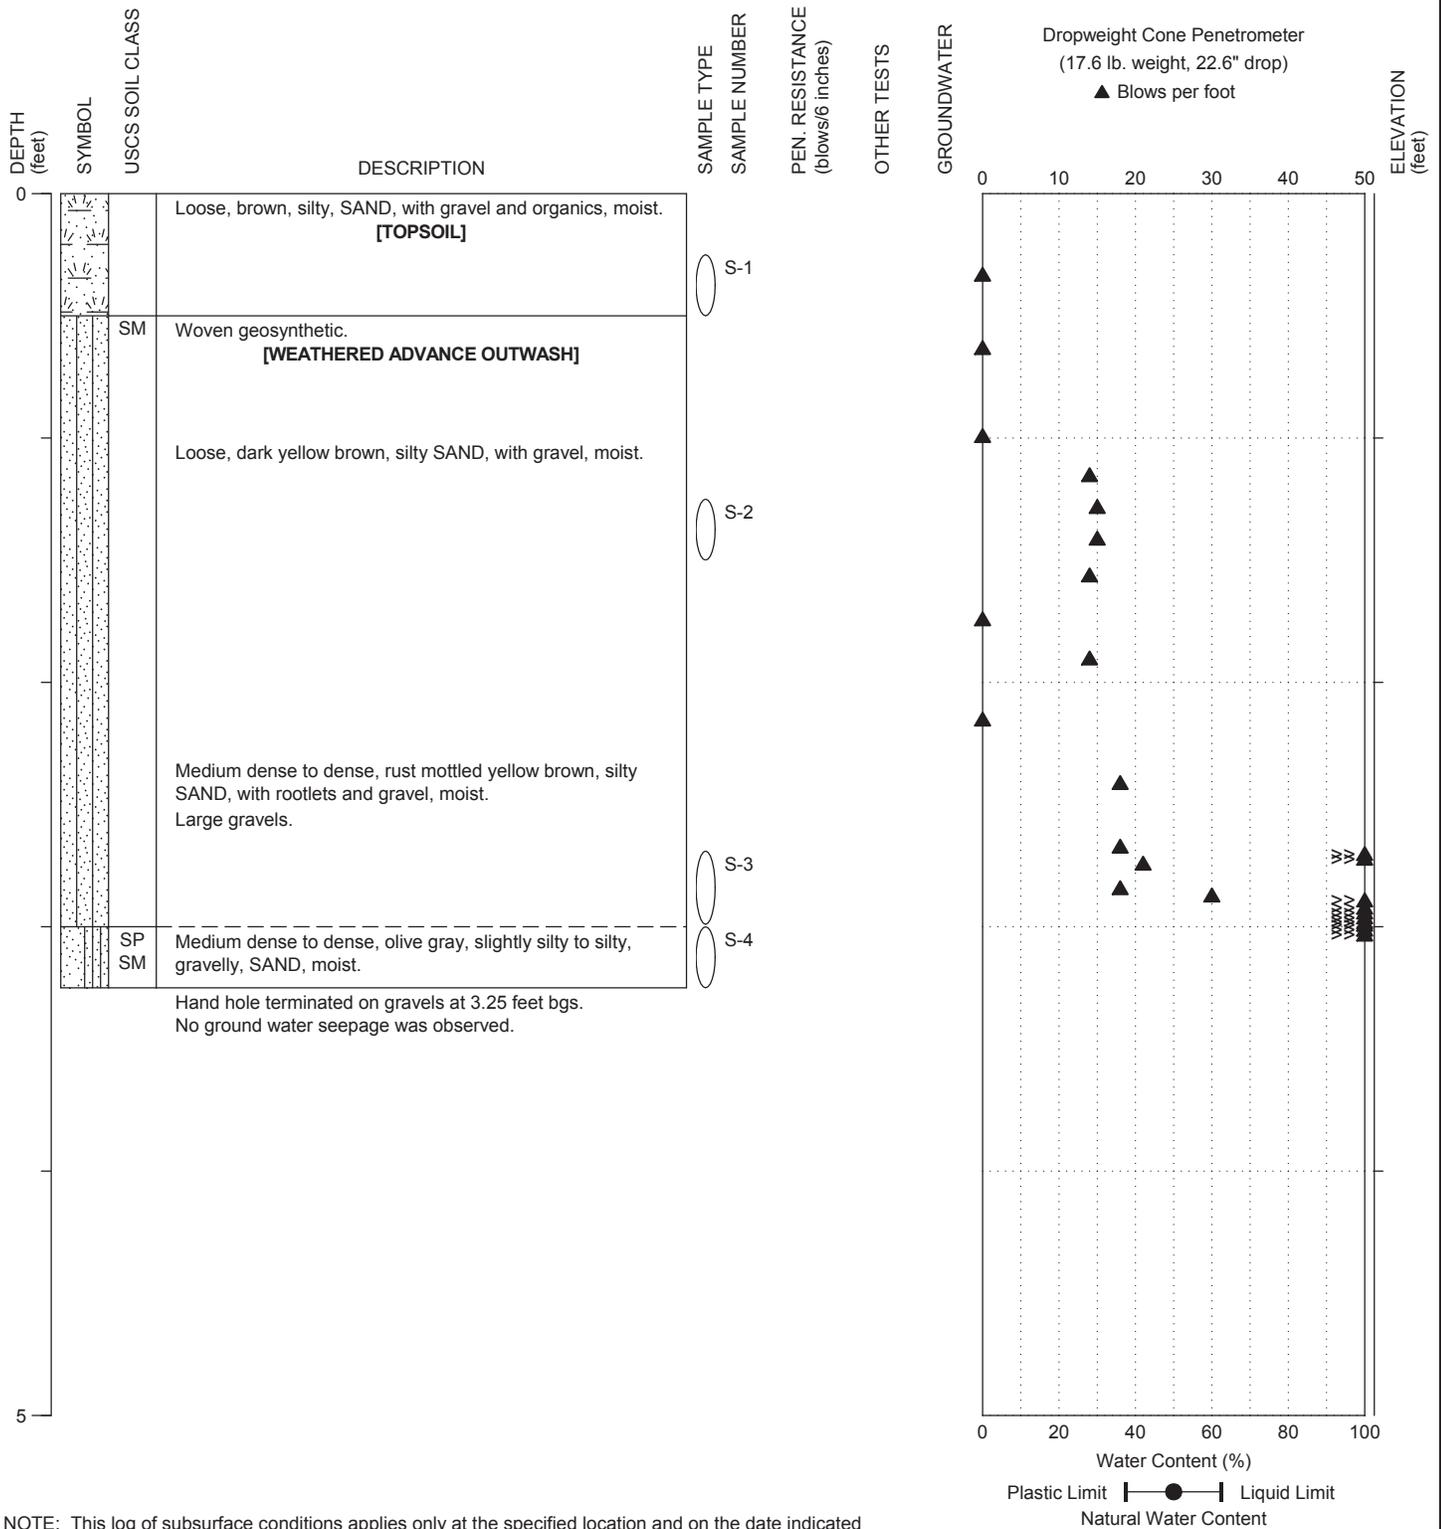
Weathered Advance Outwash: Loose grading to dense, silty sand was encountered in HH-2 under the geosynthetic fabric. Color, presence of rust mottling, and density indicate a high degree of weathering near surface with the degree of weathering lessening with depth. Hand hole HH-2 was terminated in this unit.

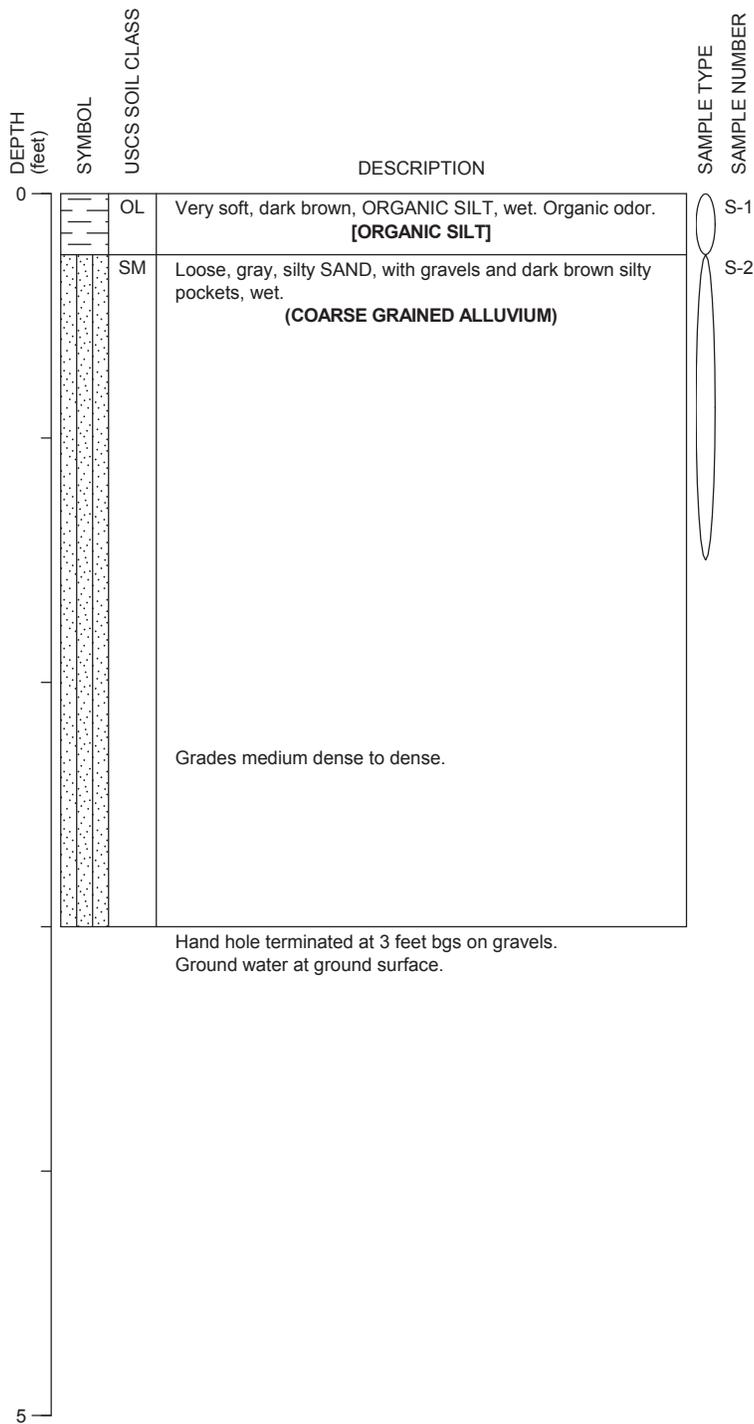
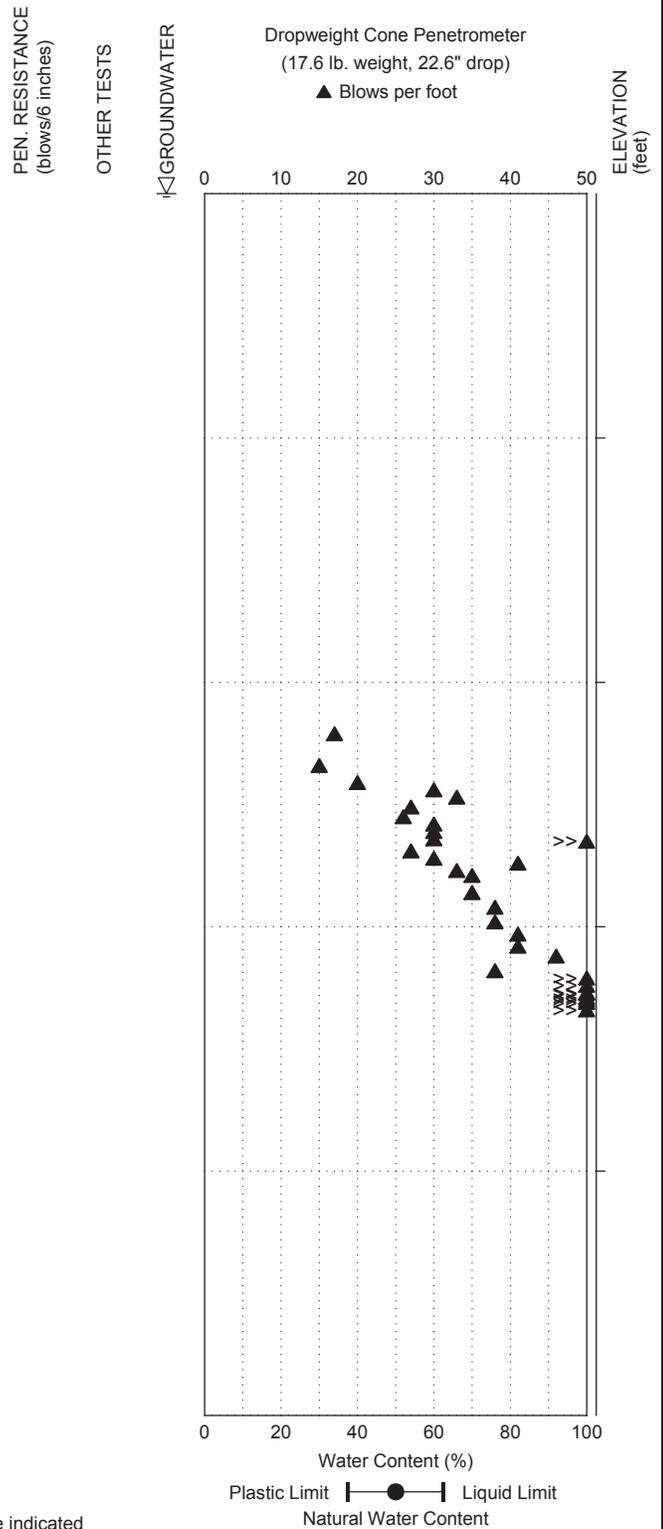
BORING:
 HH-3

Course Grained Alluvium: Course grained alluvial deposits were encountered below a depth of 0.25 feet in hand borings HH-3 and HH-4. These soils consisted of very loose grading to dense, gray, silty, fine to coarse sand and gravel.

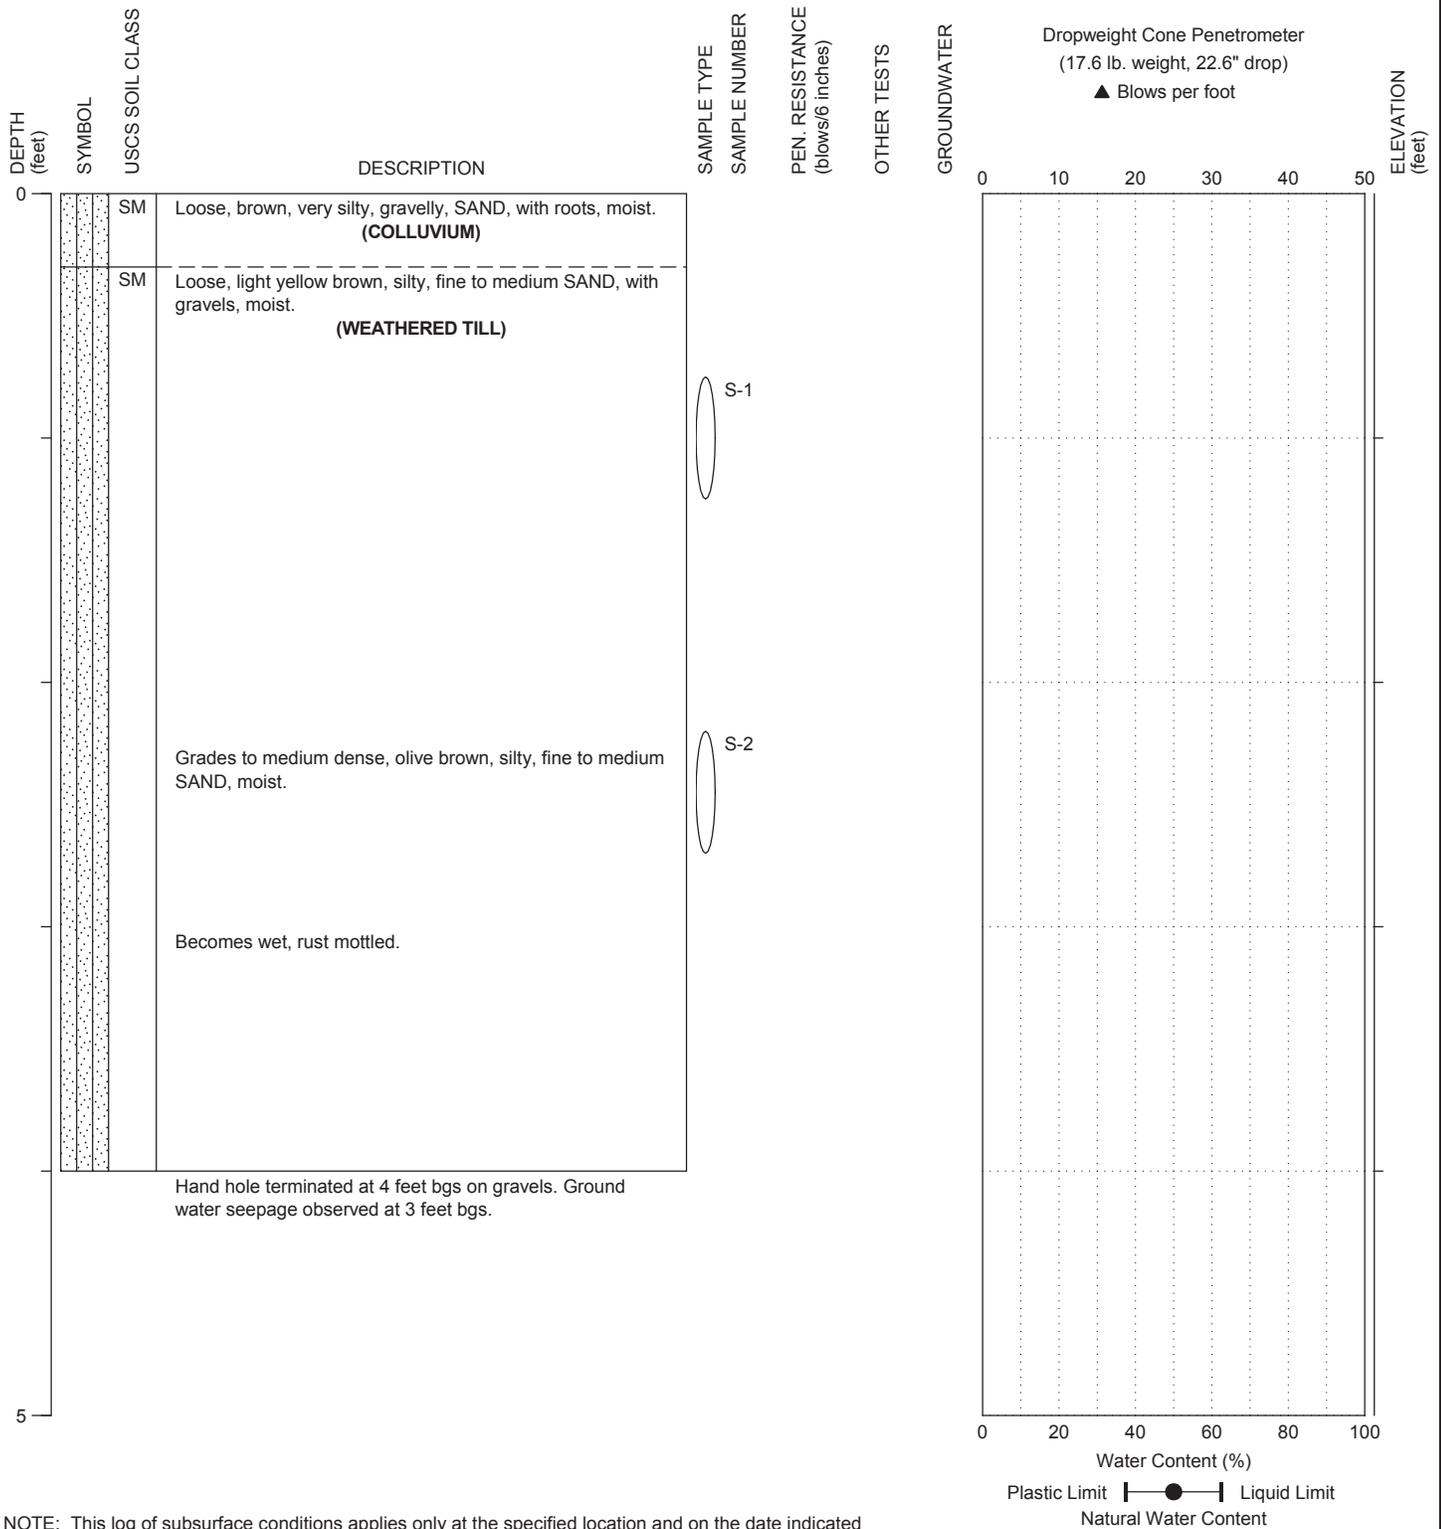
BORING:
 HH-6

Weathered Till: Course grained deposits were encountered below a depth of 0.25 feet in hand borings HH-5 and HH-6. These soils consisted of very loose grading to dense, gray, silty, fine to coarse sand and gravel.

Ground water was observed in three of our explorations. Handholes HH-3 and HH-4 were dug in a wetland. Water levels observed in each hand hole were at ground surface, and 1 foot below ground surface respectively. Seepage was observed from saturated soils below 3 feet below ground surface in HH-6.
