Warren G. Magnuson Park

### MEMORANDUM

To: Nicholas Vann, State Historical Architect,  
Department of Archaeology & Historic Preservation  
From: Kevin Bergsrud, Sr. Planning & Development Specialist  
Date: October 25, 2013  
Re: Building 18 Roof Stabilization Project

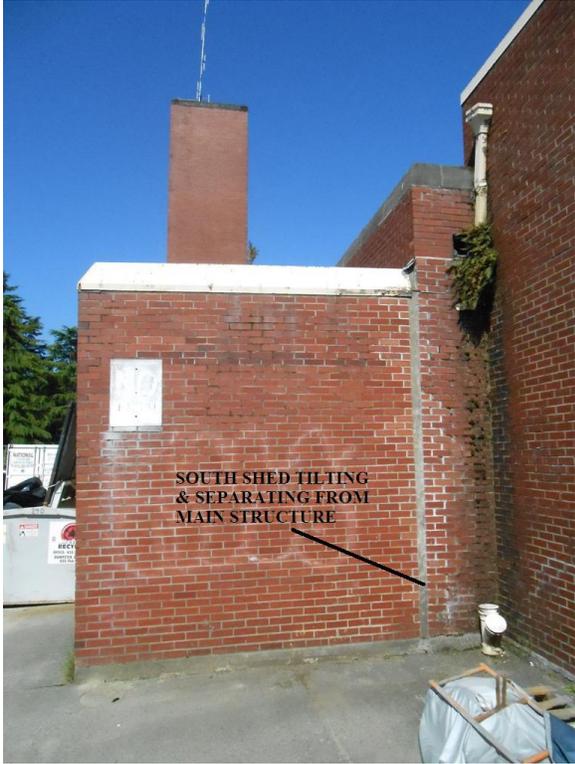
**Figure 7: South Storage Shed – East Elevation**

SOUTH SHED TILTING  
& SEPARATING FROM  
MAIN STRUCTURE

- Demolish one-story addition (shed enclosure) on the south side (1952 – 650 SF) as it is detaching from main building and the entire roof area has failed. A raised slab will remain and asphalt will be feathered-in to reduce trip hazards. Existing windows will be covered with plywood and painted black. Note that removal of this addition will expose an original 1930s south wall, windows and brickwork;
