# SEATTLE PARKS AND RECREATION

## MAGNUSON BUILDING 2

### Roof Analysis Study Upgrade

## Final Report

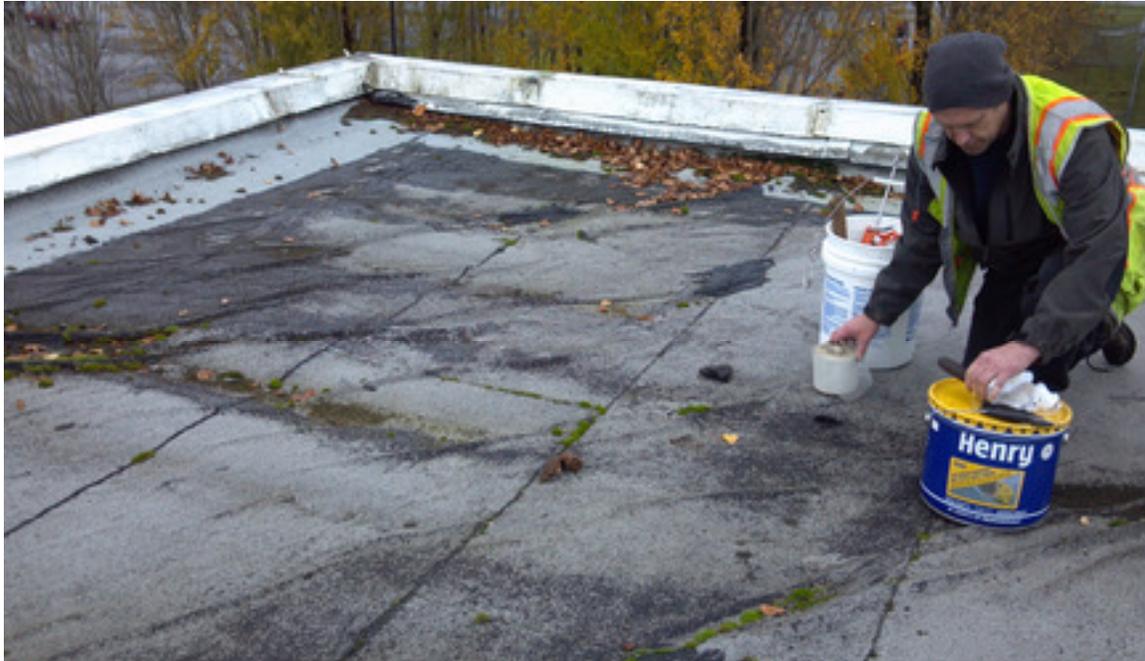
roof membrane at the NE corner of the North Roof. We were not able to determine the exact cause of the observed condition; but we believe it is related to deterioration of the roof deck at this location due to sustained water infiltration.

Photo 1-Northeast Corner of North Wing. Roofing Material is Deteriorated and Wrinkled.

1. Replace all rotted decking
2. Remove and replace existing roof membrane
3. Add new ½" plywood over entire deck.
4. Construct new crickets at roof drains
5. Replace roof drains and rain water piping routed through the building interior.
6. Replace all flashings.
7. Recommended roof assembly:
  - a. Complete tear-off
  - b. Rosen paper
  - c. Two-ply base-sheet (first ply nailed; second ply set in hot asphalt)
  - d. Two intermediate roof plies set in hot asphalt
  - e. Granulated cap sheet set in hot asphalt
8. Remove all non-functioning mechanical equipment and patch roof deck. Install new roof curbs for all function mechanical equipment.

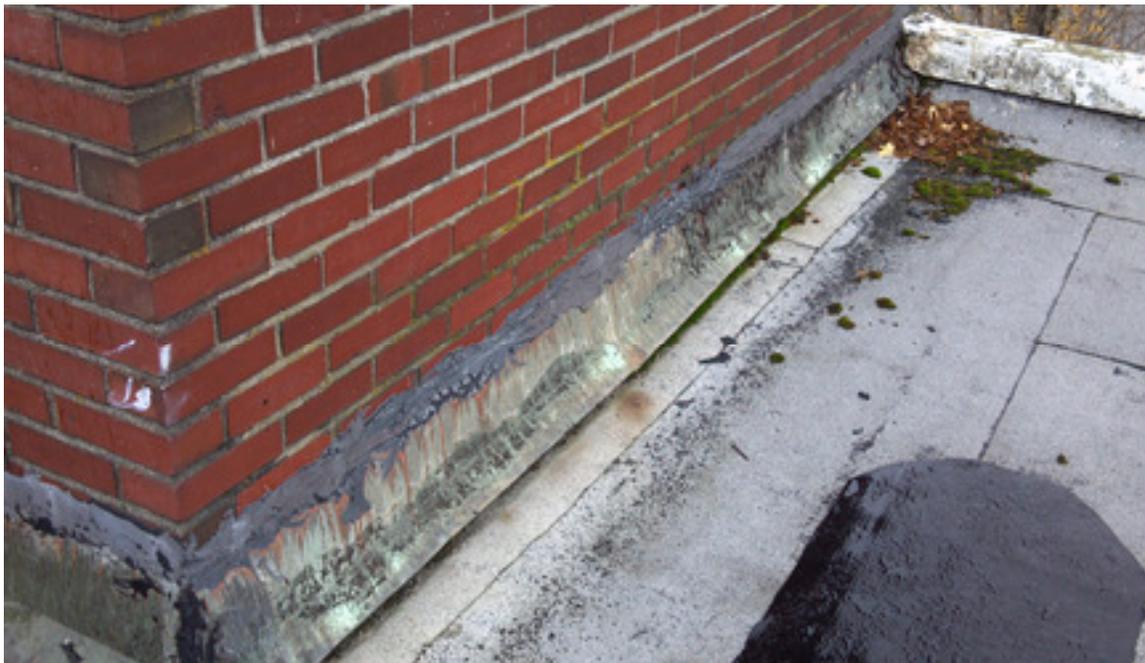
Photo 2-Flashing and Roofing at North Elevator Room

All of the existing flashings should be replaced. This would extend to cap flashing at exterior walls; base flashing at clerestory transitions; equipment curb flashings and the vertical membrane flashing at parapets.

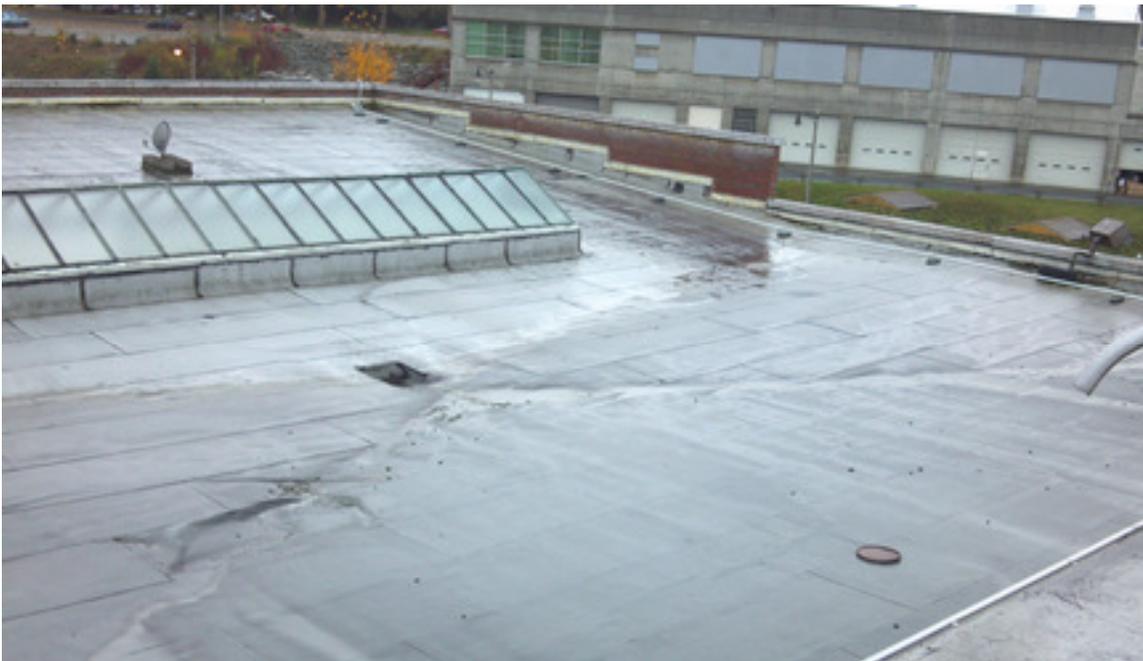
The existing roof drains are routed through the interior of the building. The drains appear to be inadequately sized; they should all be replaced. The condition of the piping serving the roof drains is not determined at this time. This piping has rusted out in other Sandpoint buildings we have observed (Building 18 and Building 30).

Photo 4-Southwest Corner of North Hangar, Showing Interior Roof Drain.

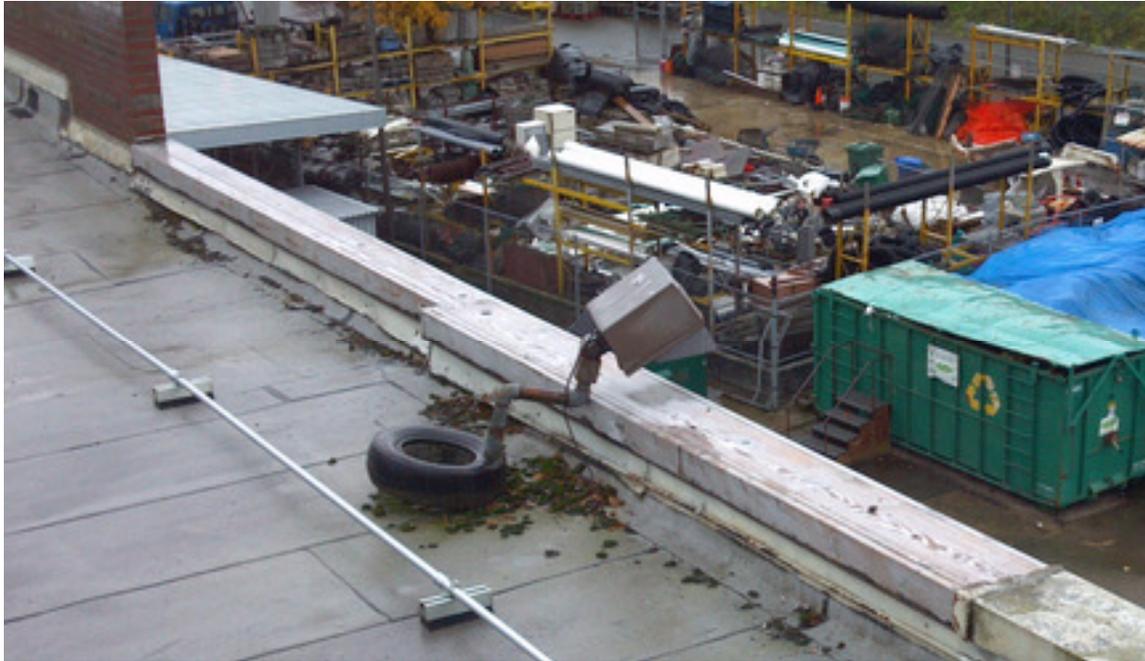
Photo 5-West Edge of North Hangar, Showing Missing Cap Flashing

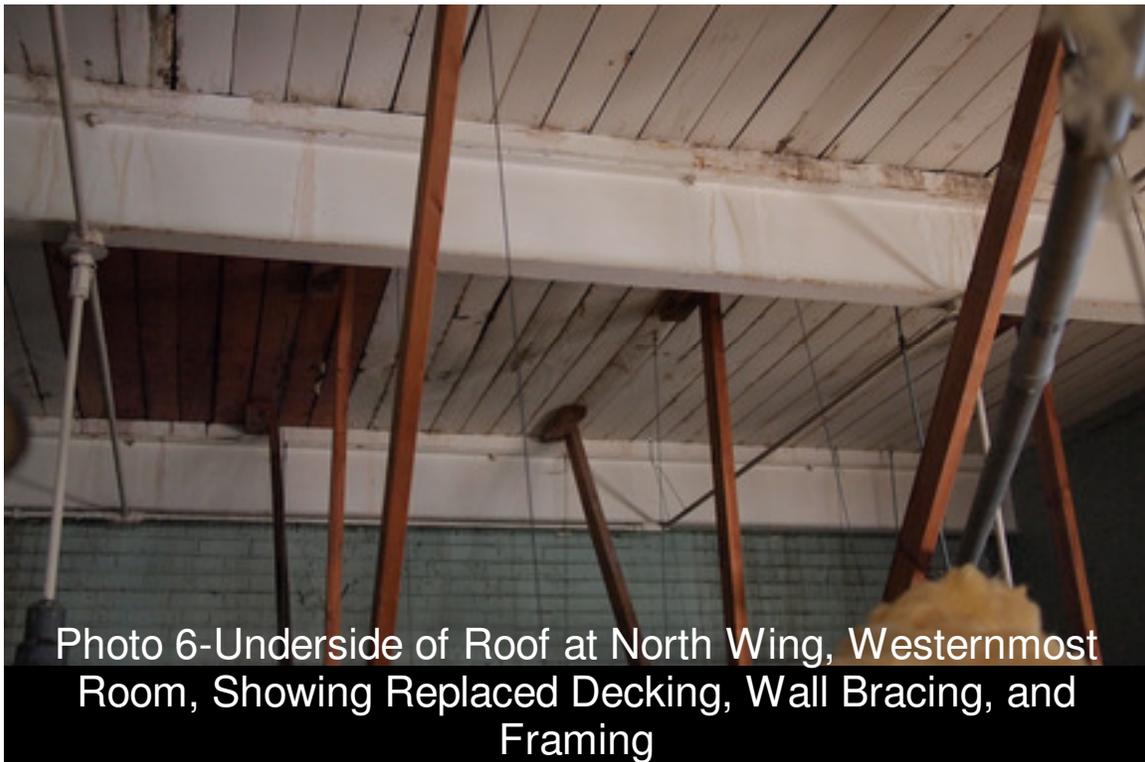
Photo 6-Underside of Roof at North Wing, Westernmost Room, Showing Replaced Decking, Wall Bracing, and Framing

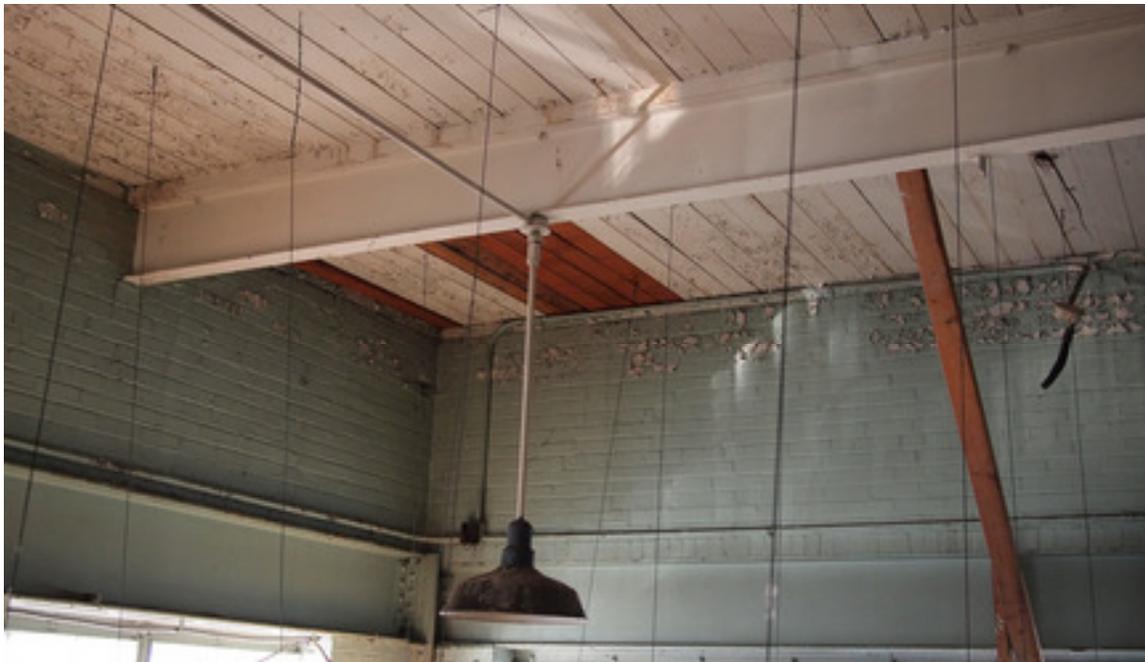
**Photo 7-Northwest Corner of North Wing, showing locations of future seismic restraint locations**

1. Add Roof-Wall Ties at N, W and E Walls:
  - a. Perpendicular wall ties at 4' o.c.
  - b. Transfer in-plane shear to walls with continuous angle
  - c. Provide Ties at each steel beam bearing directly on unreinforced masonry (E and W walls only)
2. Provide positive collector attachment at the roof line at each frame in the north south direction.
3. Provide in-plane shear transfer to frames/walls at south side on north wing
4. Provide upgraded connection of north office wing frames to main hangar frames

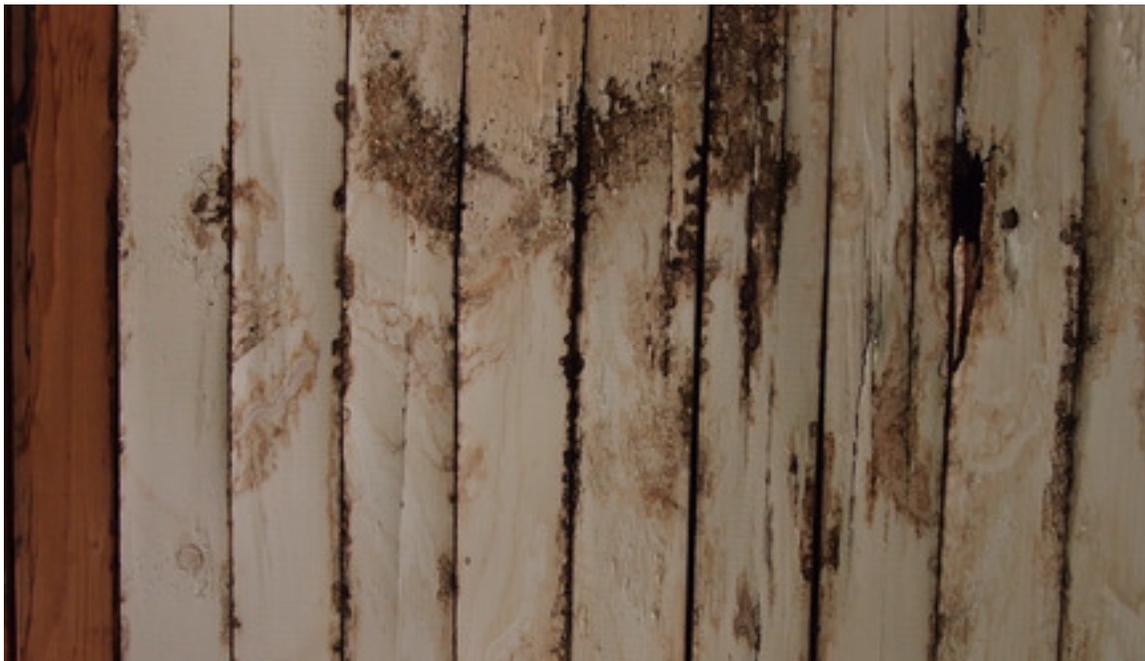
appears to be widespread deterioration of the tongue and groove wood decking. We also observed significant “wrinkling” of the

**Photo 8-Soffit of Roof Deck at North Wing, Showing Deteriorated and Replaced Decking**

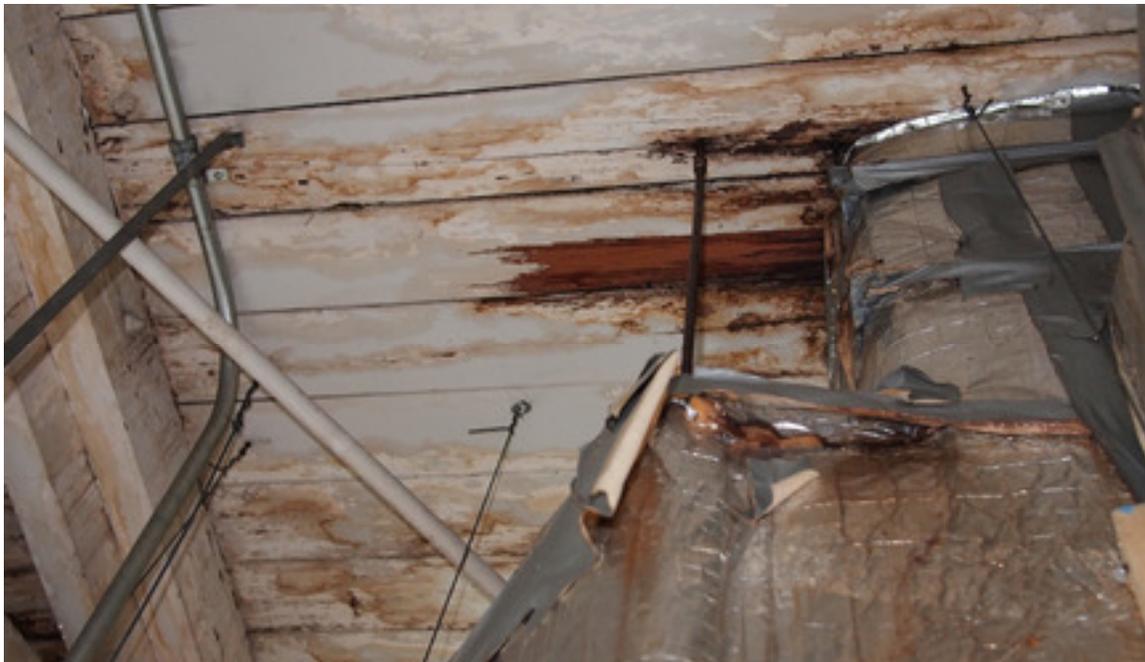
**Photo 9-Water-Stained and Deteriorated Roof Decking at Mechanical Penetration**

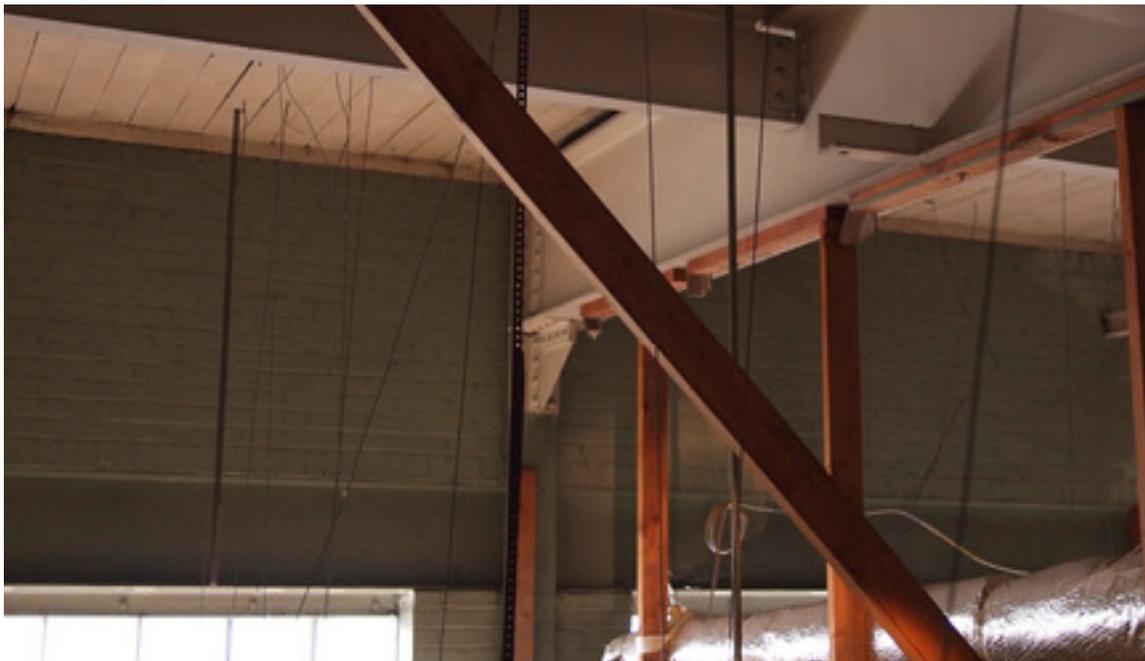
**Photo 10-Inside View of North Wing North Wall, Showing Framing System and Congestion**

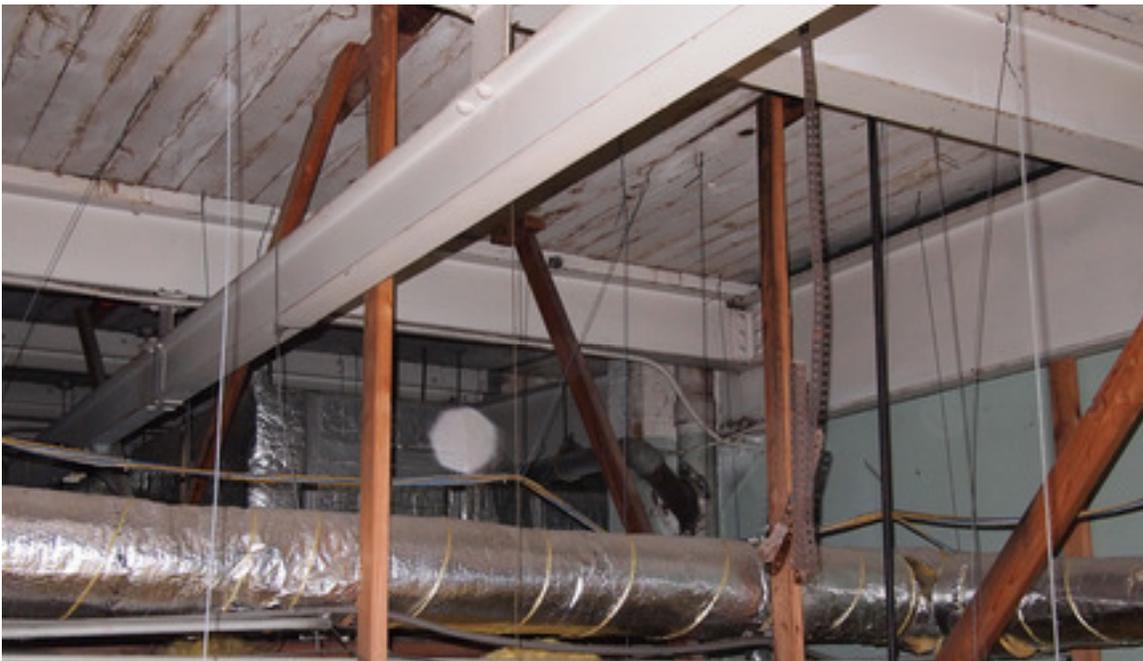
Photo 12-Above 2nd Floor of North Wing, Showing Congestion of Mechanical Equipment and Framing

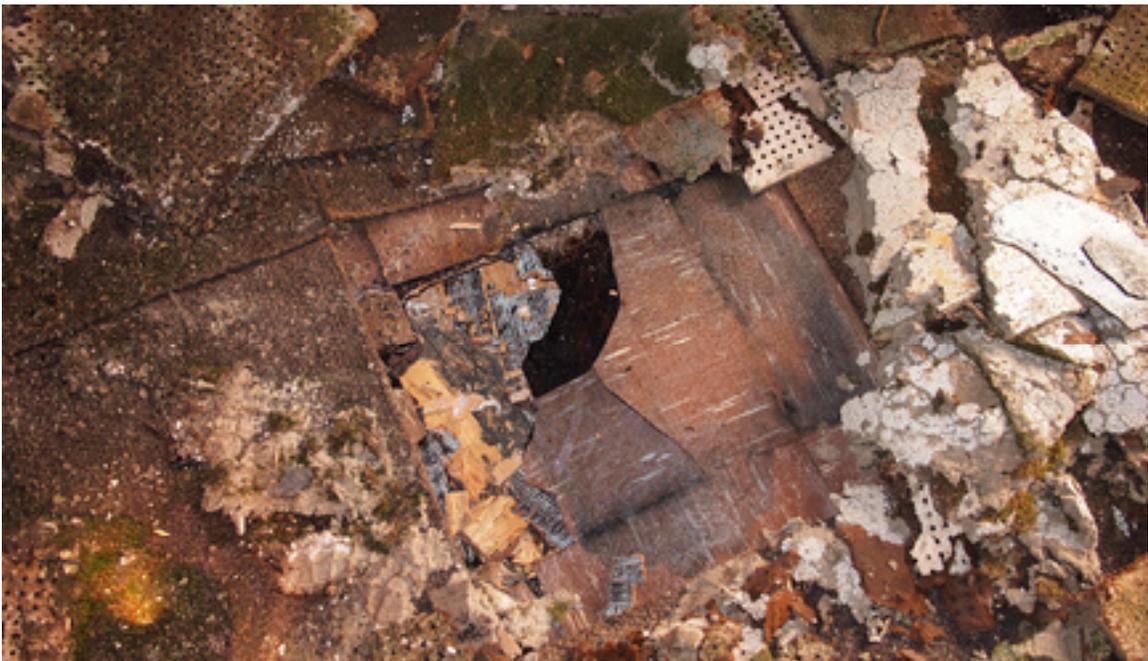
In several rooms (at the west end) the existing carpet is completely saturated with water. It is unlikely that the existing carpet can be salvaged.

Photo 14-Floor Damage from Water Intrusion at Northwest Rooms

1. All interior repairs should occur after roof has been replaced.
2. Replace floor finishes (carpet at rooms recently inundated from roof leaks)
3. Replace all existing ceiling tile.
4. Clean light fixture lenses.
5. Remove/replace all existing batt insulation. Suspend new insulation from the underneath side of roof deck. Install airtight membrane at underneath side of insulation (as commonly seen in pre-fabricated metal buildings).

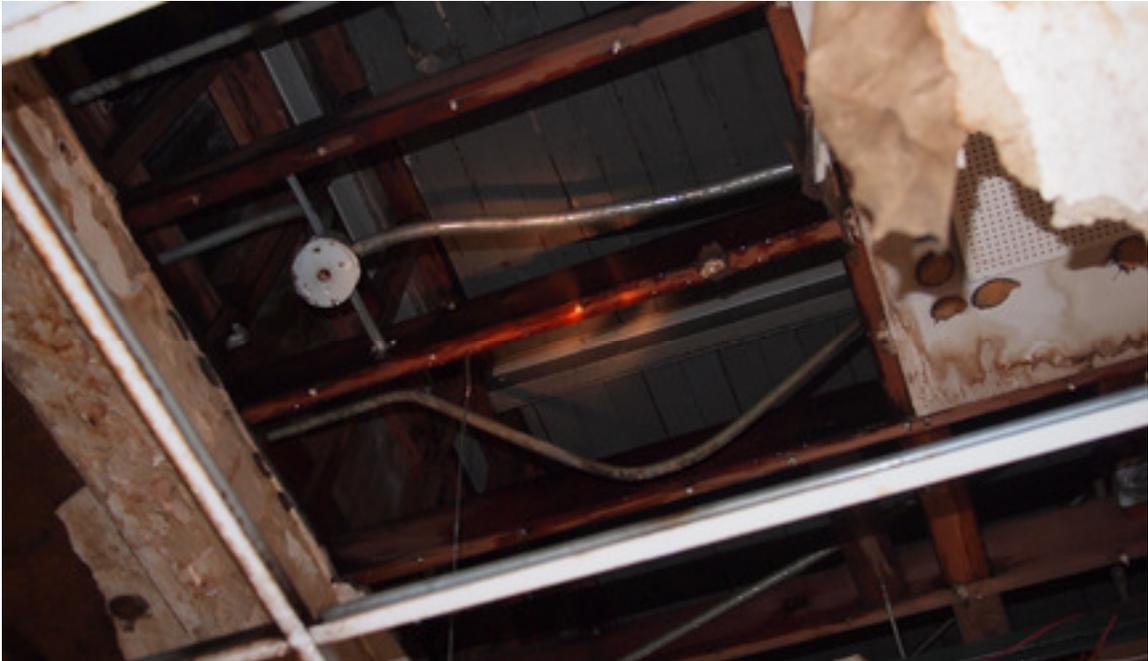
There is widespread water infiltration that is occurring for most of the north roof. Water infiltration is most pronounced at the west end of the north wing. Several of the second floor rooms at the west end were totally saturated and sections of the existing ceiling had collapsed or were near collapse. Carpets in these rooms were also saturated. Fortunately the walls observed were in good condition and the electrical systems remained functional.

Photo 15-Ceiling and Roof Damage at Northwest Corner from Water Intrusion

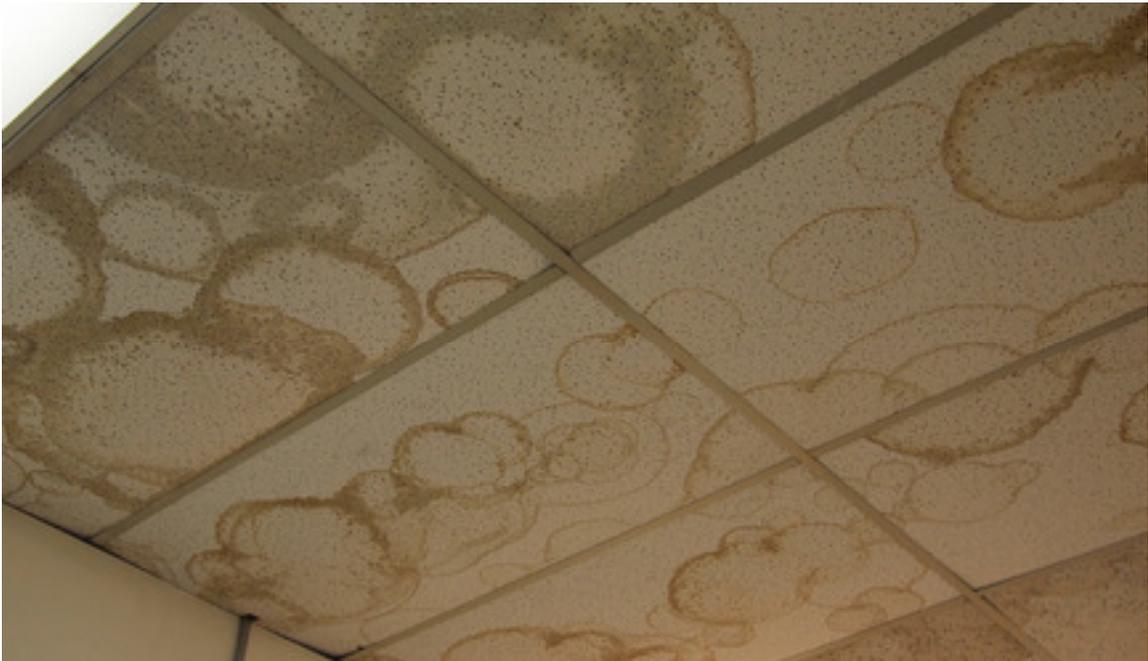
A telling observation for the entire second floor of the west wing is the number of stains that were observed in the ceiling tiles throughout the entire floor area:

Photo 16-Water-Stained Ceiling Tiles at North Office Wing

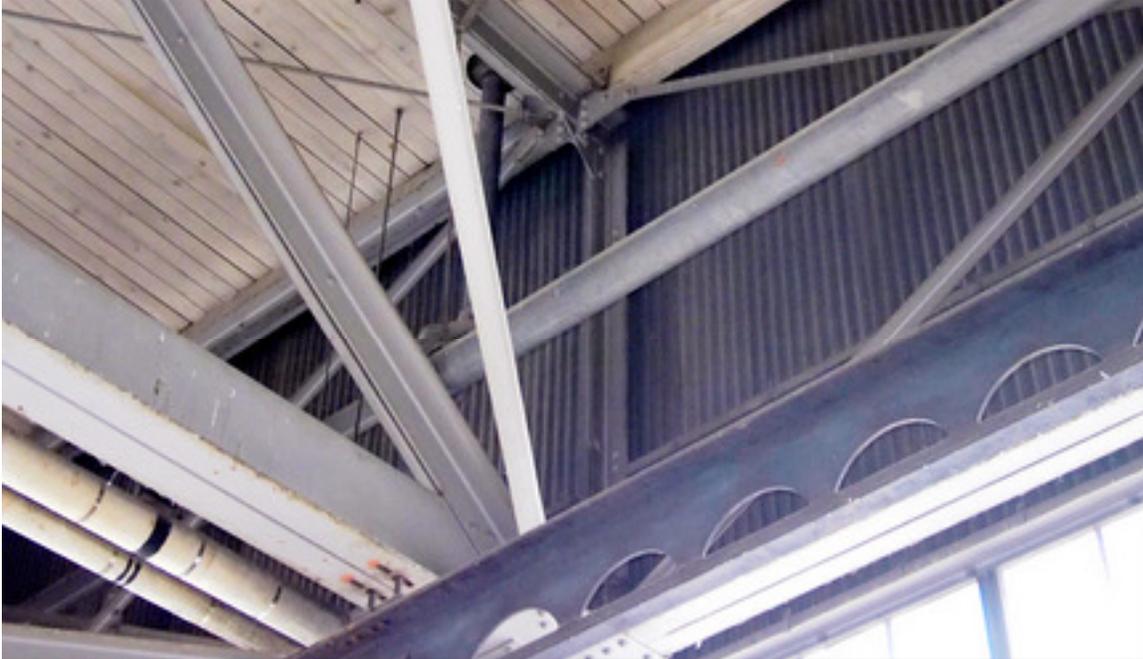
Photo 21 South Hangar Truss Bearing Condition
