# **SEATTLE PARKS AND RECREATION**

## **MAGNUSON BUILDING 2 STRUCTURAL/SEISMIC ANALYSIS (WC2362)**

### **Final Report**

**July 26, 2010**

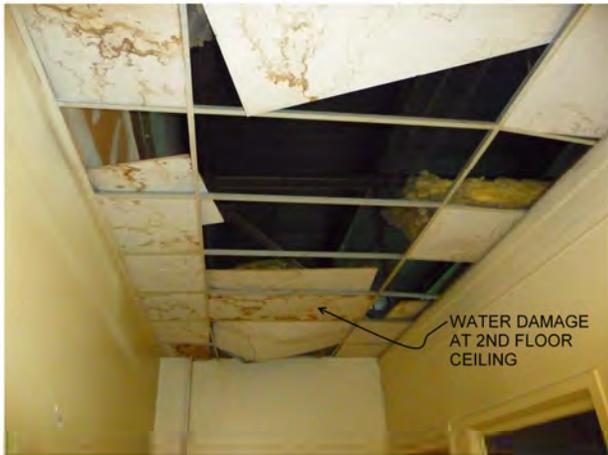
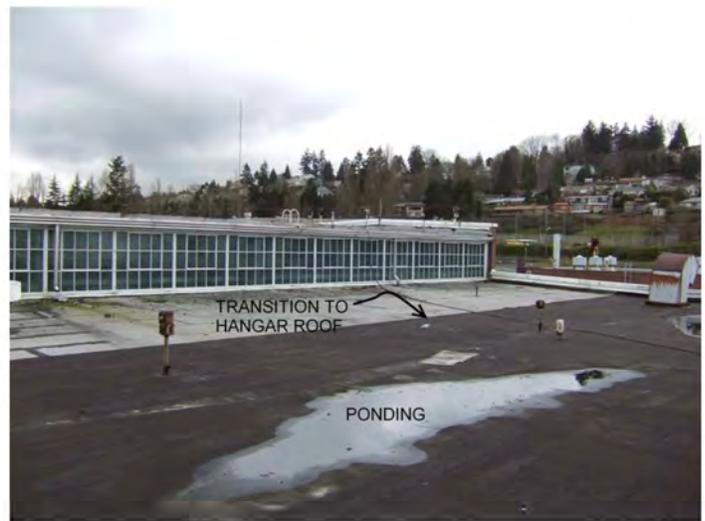
The roof membrane is past the end of its design life. Leakage has occurred in many areas, and particularly in the North Wing.

Investigation for the presence of mold in these areas is beyond the scope of this report, but mold is likely to occur in these situations.

Our building envelope consultant, Jerry Osborn of S.M. Stemper, says that this building should be reroofed.

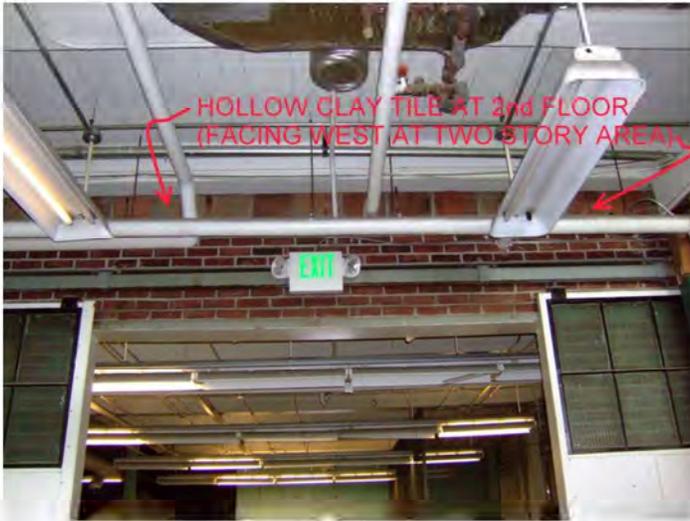
HOLLOW CLAY TILE AT 2nd FLOOR (FACING WEST AT TWO STORY AREA)

The west 80 feet of the north hangar includes a mezzanine. Lateral resistance may rely partially on unreinforced masonry walls in this area, at the east and west side of the mezzanine.

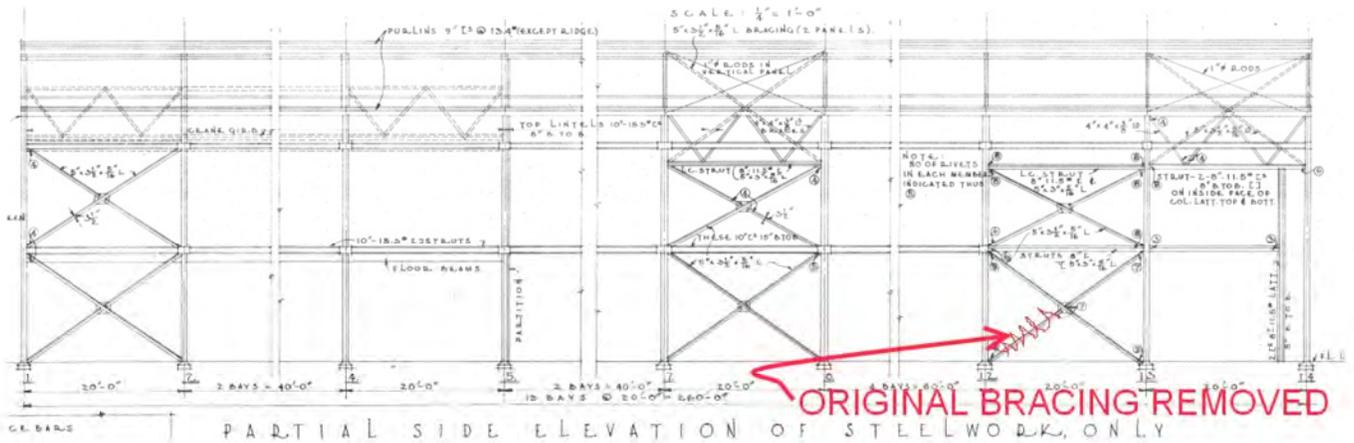
In the east-west direction, the original steel construction of the north hangar high bay had a deliberate bracing scheme on both sides for lateral forces:

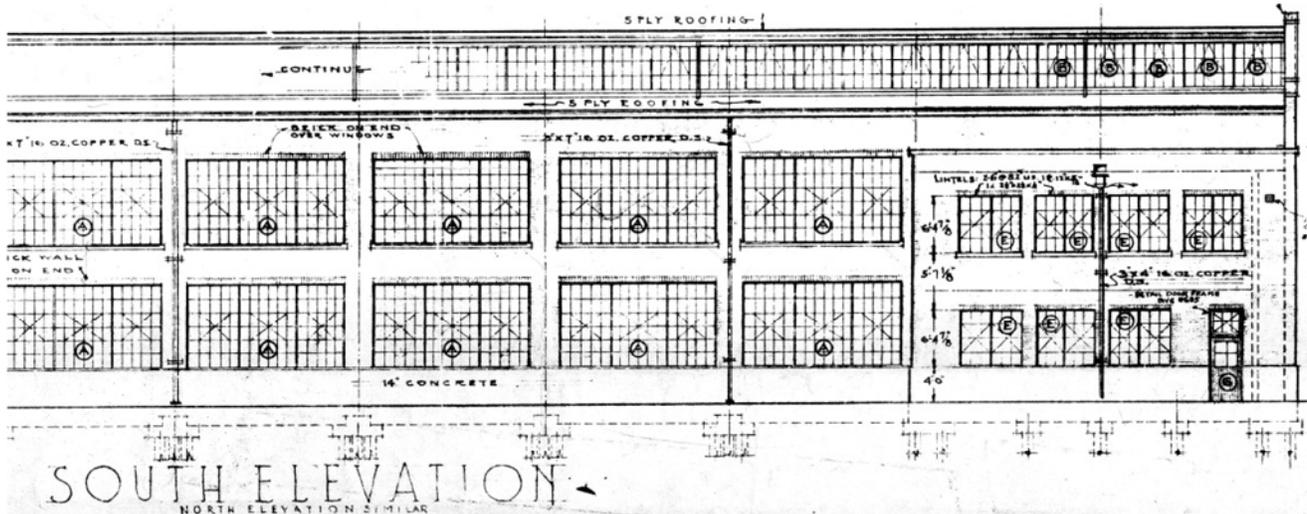
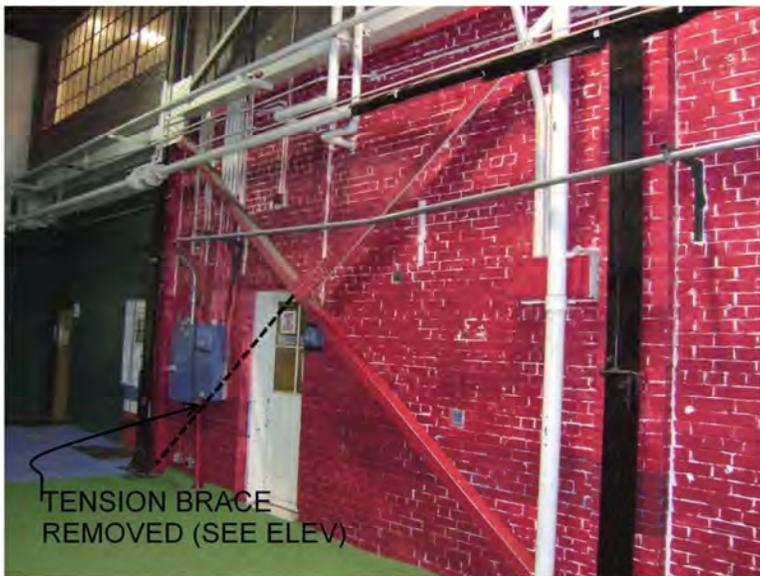
Built integrally with the steel frames are brick walls, which were originally the exterior walls of the building:

Some of the openings in these walls have been enlarged, and the walls completely removed. Other openings are infilled with wood or plaster partitions. It appears that the steel bracing originally designed has been removed in some cases for convenience. (See photo.)

The high bay stability of the north hangar thus relies on an incomplete and deleteriously modified steel bracing scheme.

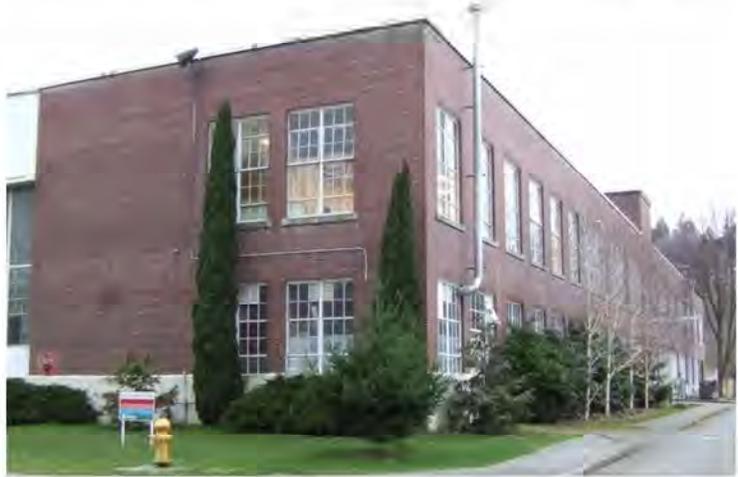
The north wing shown in the photo is a two story area, and will, by the end of 2010, house the building's only tenant. The floor framing in this area is concrete slab over steel beams, while the roof is framed with steel and wood decking. The walls are unreinforced brick masonry.

Our ASCE 31 quick check for east-west lateral forces at the north wing reveals a lack of adequate in-plane strength in the unreinforced masonry piers to resist anticipated seismic loads. Additionally, steel girders in some locations may bear directly on the north wall unreinforced masonry piers, and have minimal or no positive attachment for out-of-plane loads. Additionally, the braced frames at the hangar bay, which provide stability for this north block as well, lack adequate strength, and one brace has been removed, as described above.

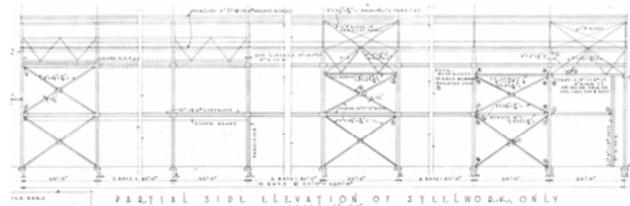
The north bay lacks seismic resistance in the east-west direction. The original high bay bracing is modified or missing in some cases. This bracing supports both the high bay roof and the two story occupied tenant space. Reestablishing this bracing, with new members and connections for current forces, is one option for increasing resistance at these lines. Another option is to provide concrete shear walls in some of the bays.

At the north wall, the narrow URM piers lack capacity for seismic loads. Multiple windows may have to be infilled with concrete or steel braced frames to reinforce this wall for in-plane loads. These infill walls or braced frames will need to be coordinated with the State DAHP regarding any changes to architectural character defining features.

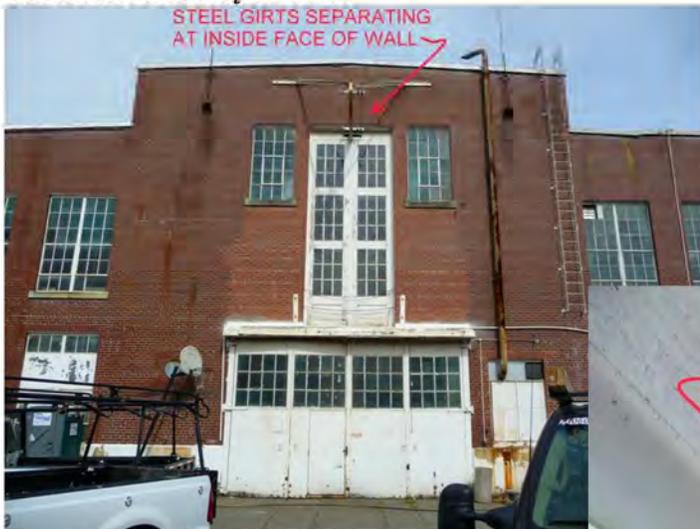
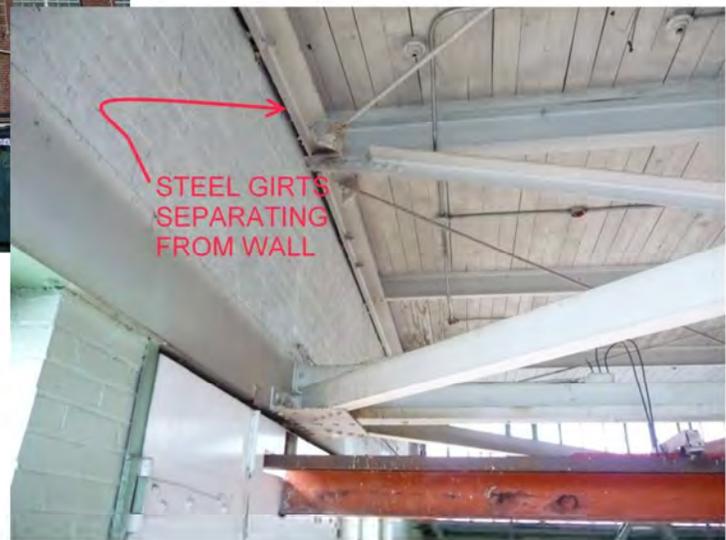
On the west side of the north hangar, the brick masonry appears to be pulling away from the supporting steel frame. Solutions to this apparent failure include rebolting the masonry to the steel angle at the top of the wall, or providing a light gage steel stud strongback wall to support the URM.

| Item | Category | Location | Budget | Pros | Cons | Comments |
|---|---|--|---|---|---|--|
| <b>Repair West Side Masonry</b> | Building Condition, Non-structural Seismic Mitigation | Center of North Side West wall<br> | \$15,000 | Preserves building stability. | | <i>Use light gage steel stud backup, or reconnect steel framing to walls with new bolts.</i> |

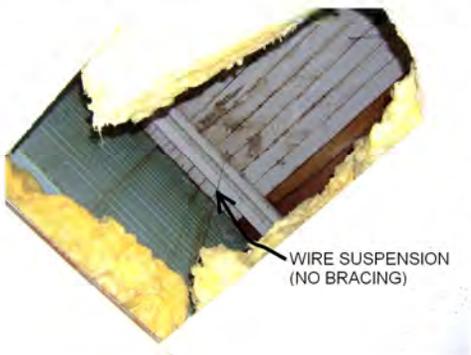
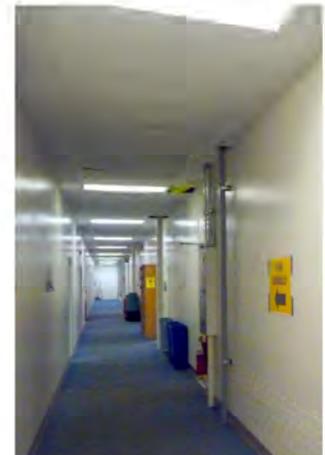
Suspended ceiling systems, especially in the 2<sup>nd</sup> floor area (see photo), most likely lack adequate seismic bracing, and could drop during an earthquake. Suspended mechanical equipment may be inadequately braced as well.

| Item | Category | Location | Budget | Pros | Cons | Comments |
|---|---|--|---|---|---|--|
| <b>Brace Ceiling and Mechanical Equipment</b> | Non-structural Seismic Mitigation | Especially at 2 <sup>nd</sup> floor Corridor.<br> | \$80,000 | Increased exiting safety. | Costly. Construction is disruptive. | <i>Damaged ceilings may block exit path.</i> |

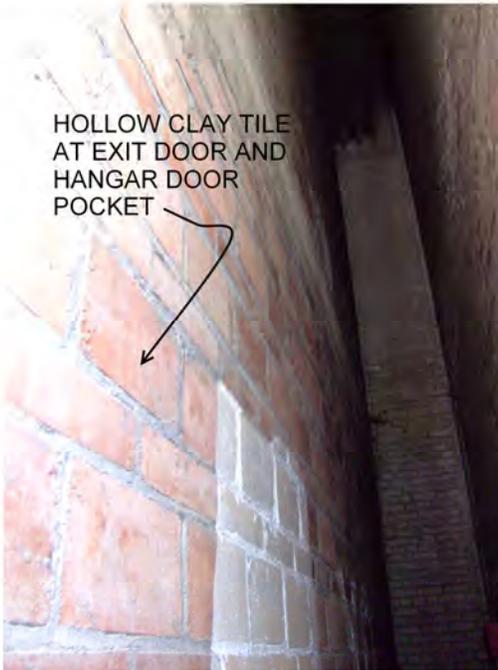
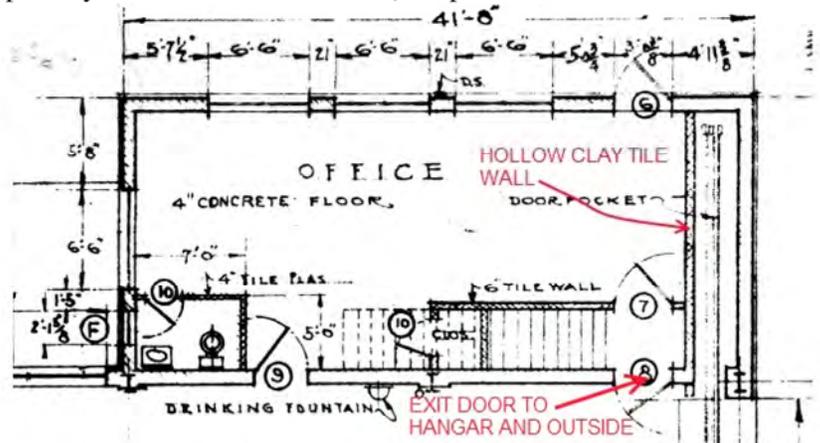
Hollow Clay Tile walls exist near exit paths, especially at the northeast corner. (The photo shows an HCT wall at the hangar door pocket directly adjacent to the exit stairs.) These walls are extremely

vulnerable to collapse in an earthquake. The walls should be strengthened, or the exit path changed.

Strengthening could be accomplished with carbon fiber reinforcement, or steel strongbacks.

| Item | Category | Location | Budget | Pros | Cons | Comments |
|--|---|---|---|---|---|---|
| <b>Strengthen Hollow Clay Tile Walls Near Exit Paths</b> | Non-structural Seismic Mitigation | Especially at the NE Corner in the north wing.<br> | \$25,000 | Increased exiting safety. | Cost. | Damaged walls may block exit paths. Consider carbon fiber wrap reinforcing. |

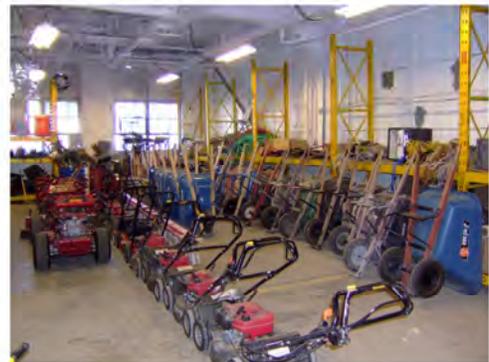
Gasoline in yard maintenance equipment may be stored in the first floor area of the north wing. This may be an unintended hazard.
