November 7, 2014

**RE: Preliminary Geotechnical Evaluation**  
Proposed Trail Expansion – Cheasty Greenspace  
28<sup>th</sup> Avenue South & South Columbian Way  
Seattle, Washington

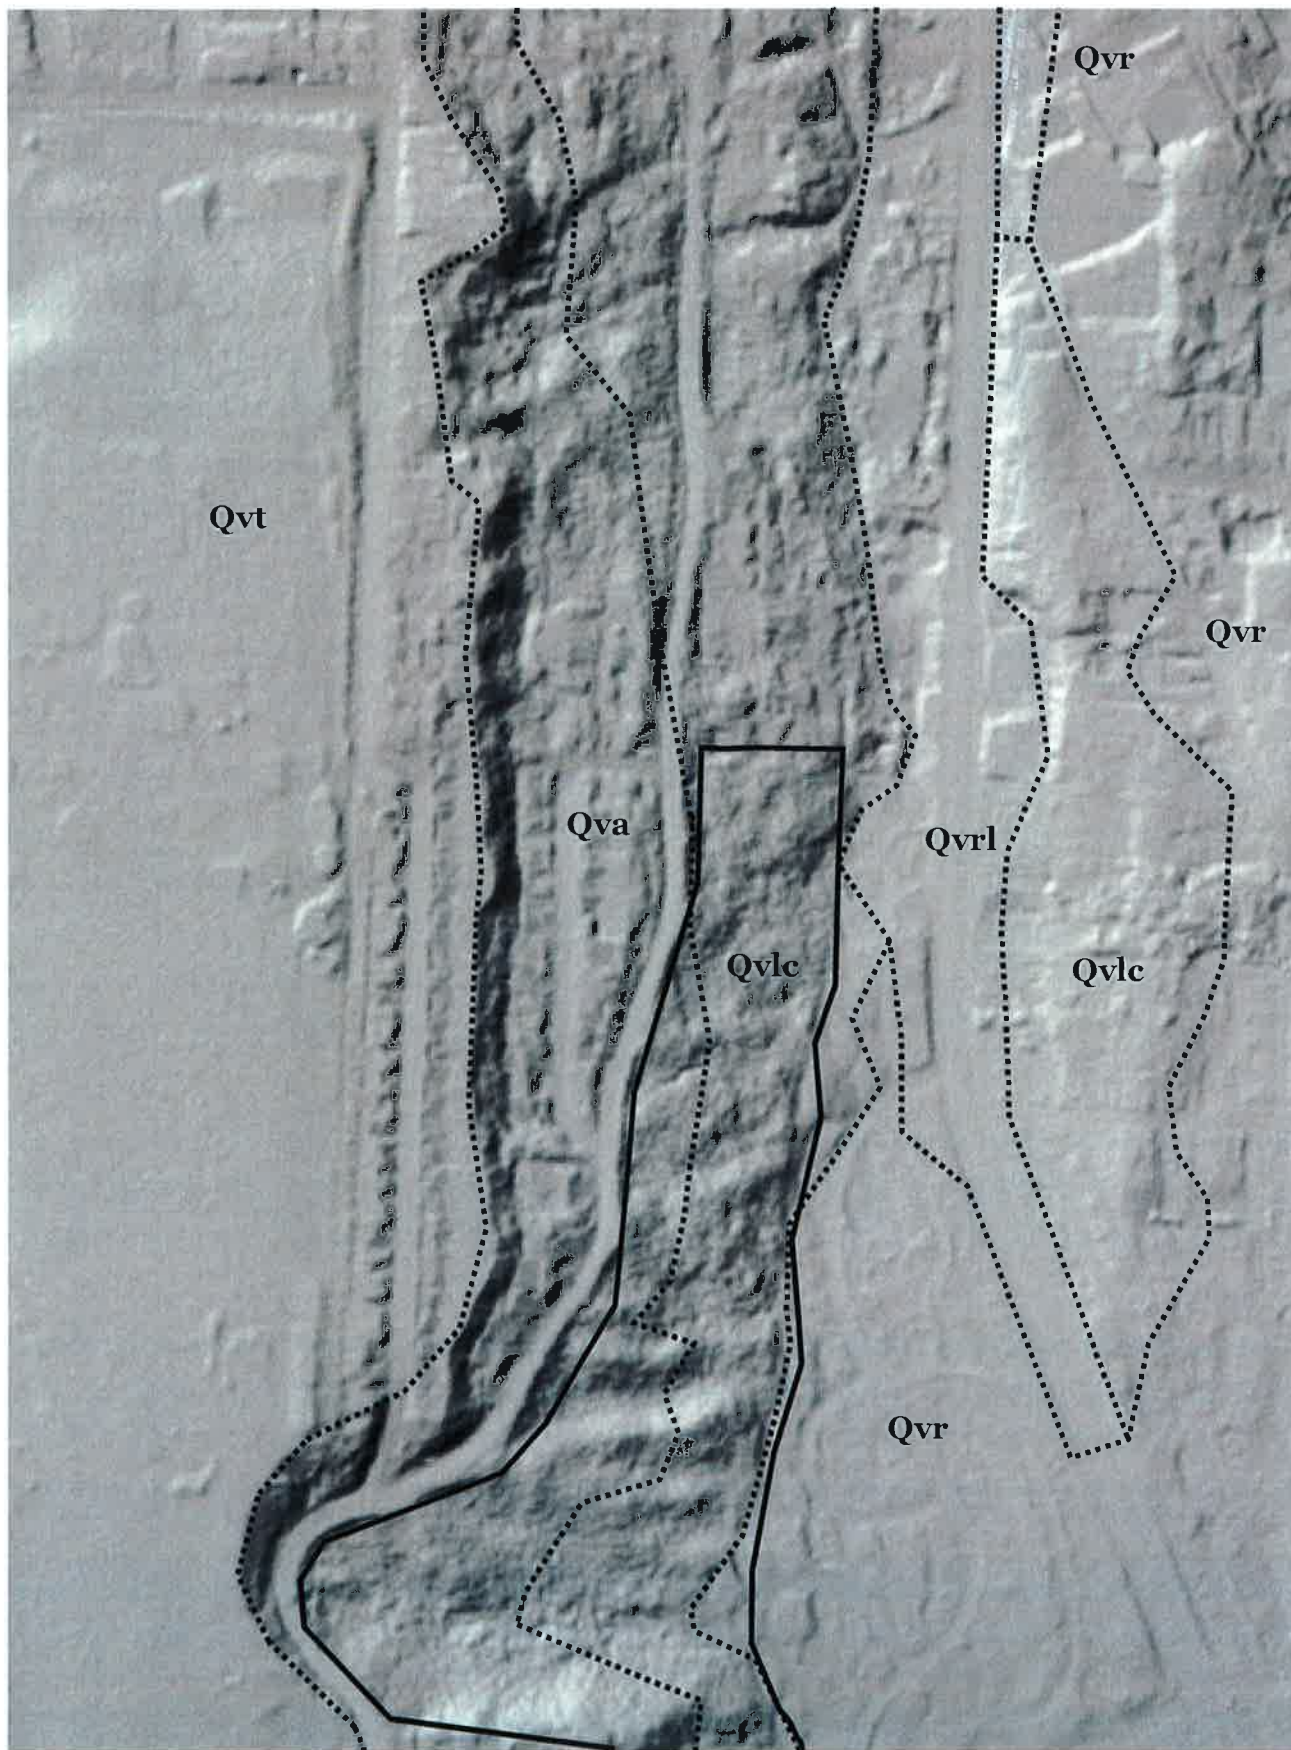
**FIGURE 2**

We also conducted a preliminary review of available LIDAR maps of the site area. The LIDAR images confirm the landslide scarp locations, indicate other localized scarp/landslide areas (dark shading), the existing hummocky terrain within the greenspace, and approximate outlines of severe landslide hazard areas. Figure 2 shows the LIDAR image along with area geology and greenspace limits. Further evaluation of aerial photographs and LIDAR images from multiple years could aid in delineating landslide areas further.

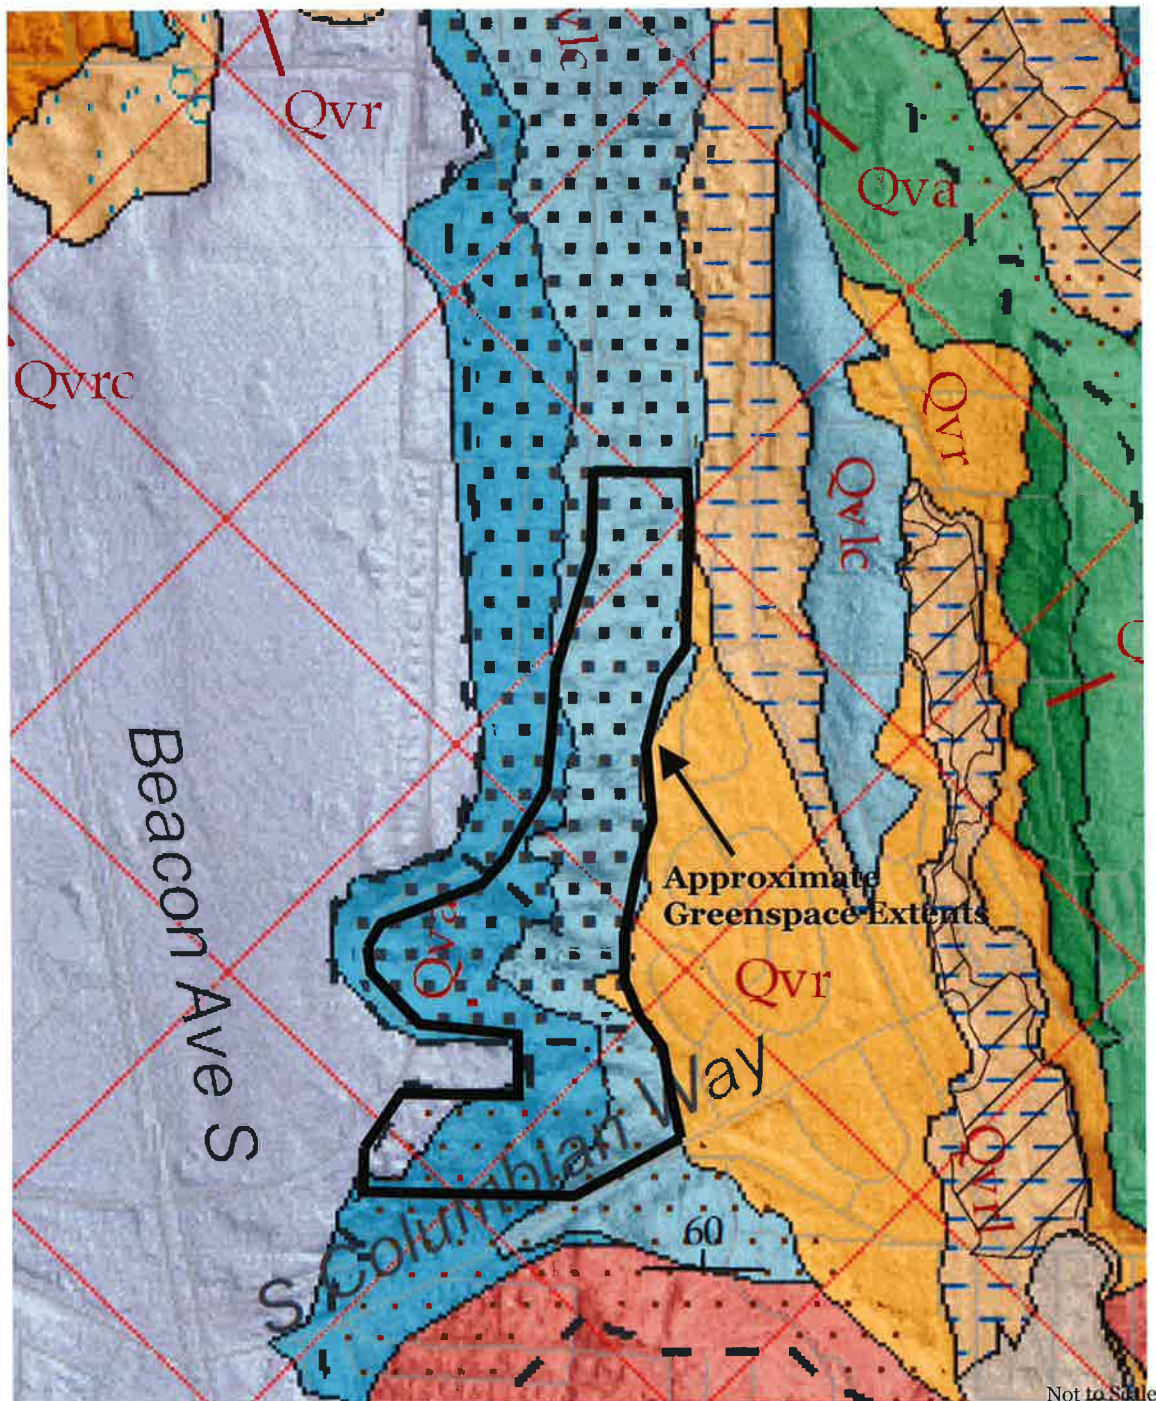
**GEOLOGIC  
 MAP  
 FIGURE 1**

The geologic map shows landslide scarps extending along the west margin of the greenspace, generally along the top of the overall slope system. The map also indicates that the greenspace is underlain by landslide debris and mass wastage deposits. An area excerpt of the geologic map is shown in Figure 1.

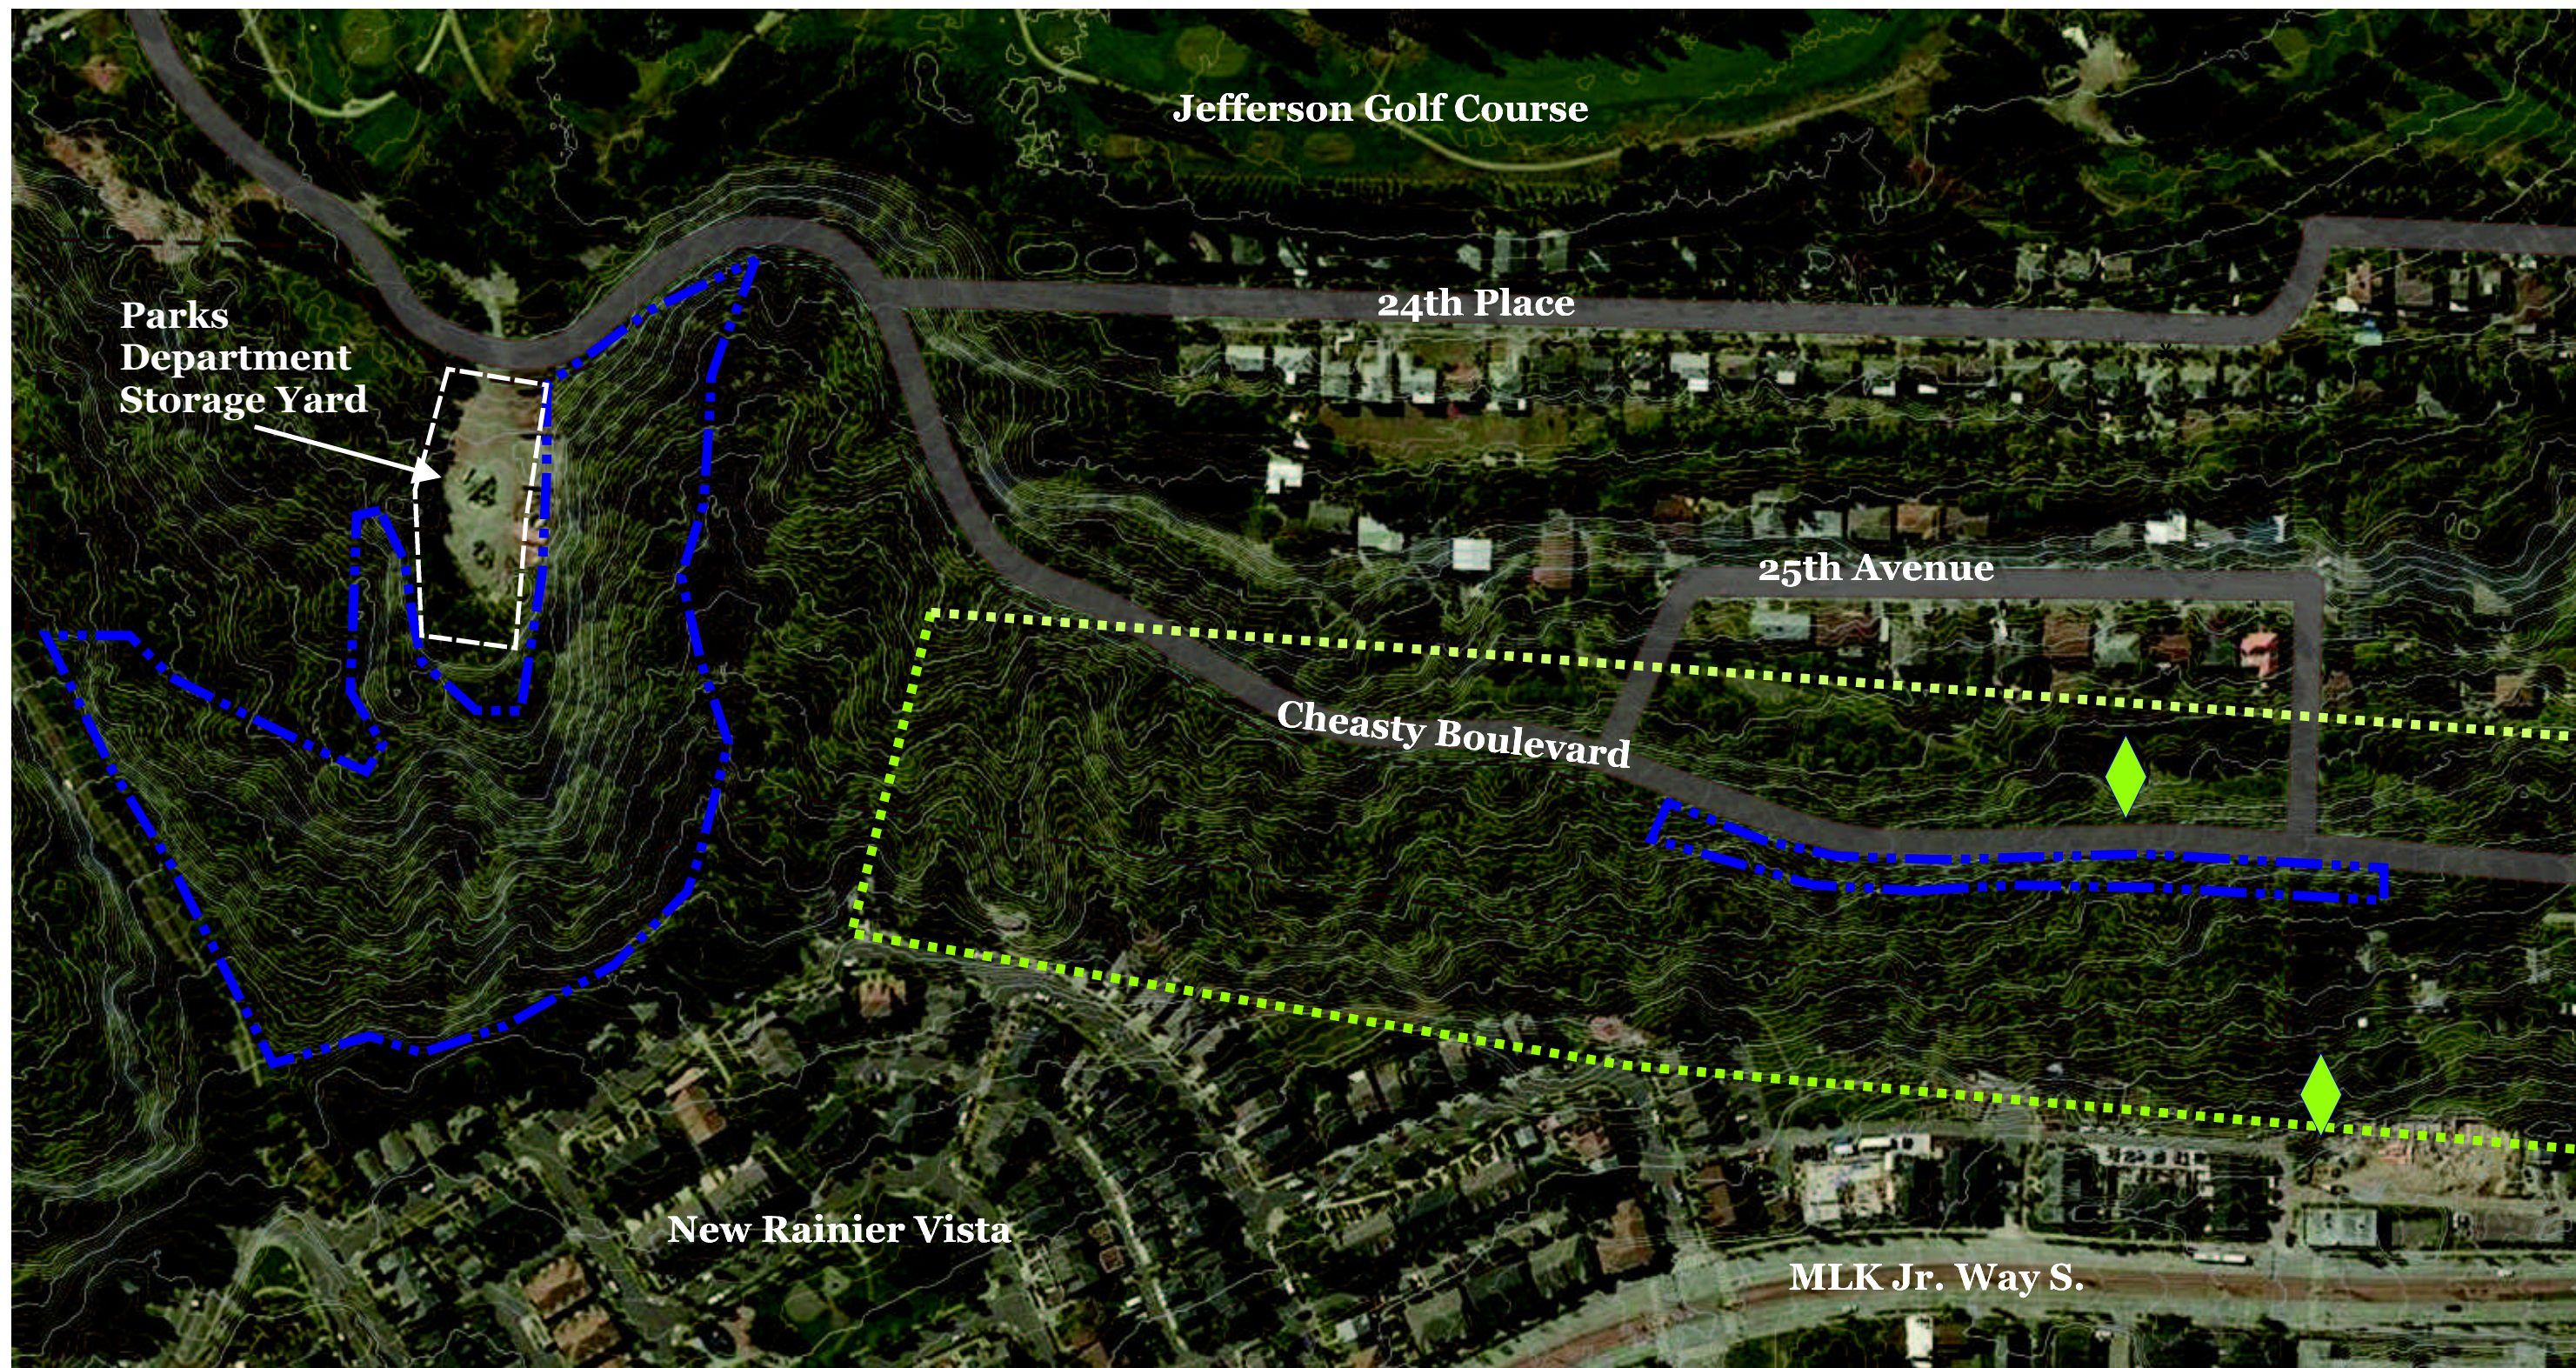
**FIGURE 3**

The greenspace site is located within an older landslide complex located along a geologic contact well known for landslide activity in the City of Seattle. Several relatively recent slides have been documented north of, or in the north portion of the site. Figure 3 shows the approximate location of the most significant and severe geologic hazard areas. As shown on the figure, there are two significant erosion/steep slope hazard areas. Also, a majority of the north end of the greenspace is within a landslide hazard area.

It should be noted that this is a preliminary map based on our site reconnaissance, geologic map review, LIDAR image review, and historical information review only. Once a schematic trail plan has been developed and the proposed route flagged on site, we recommend that the geologist or geotechnical engineer walk the proposed alignment to evaluate specific hazards along the route and determine which geologic and geotechnical analyses are required in these locations.
