January 25, 2014
HWA Project No. 2014-177-21

Subject: **GEOTECHNICAL ENGINEERING INVESTIGATION**
Cheasty Trail Pilot Project
City of Seattle Parks and Recreation
King County, Washington

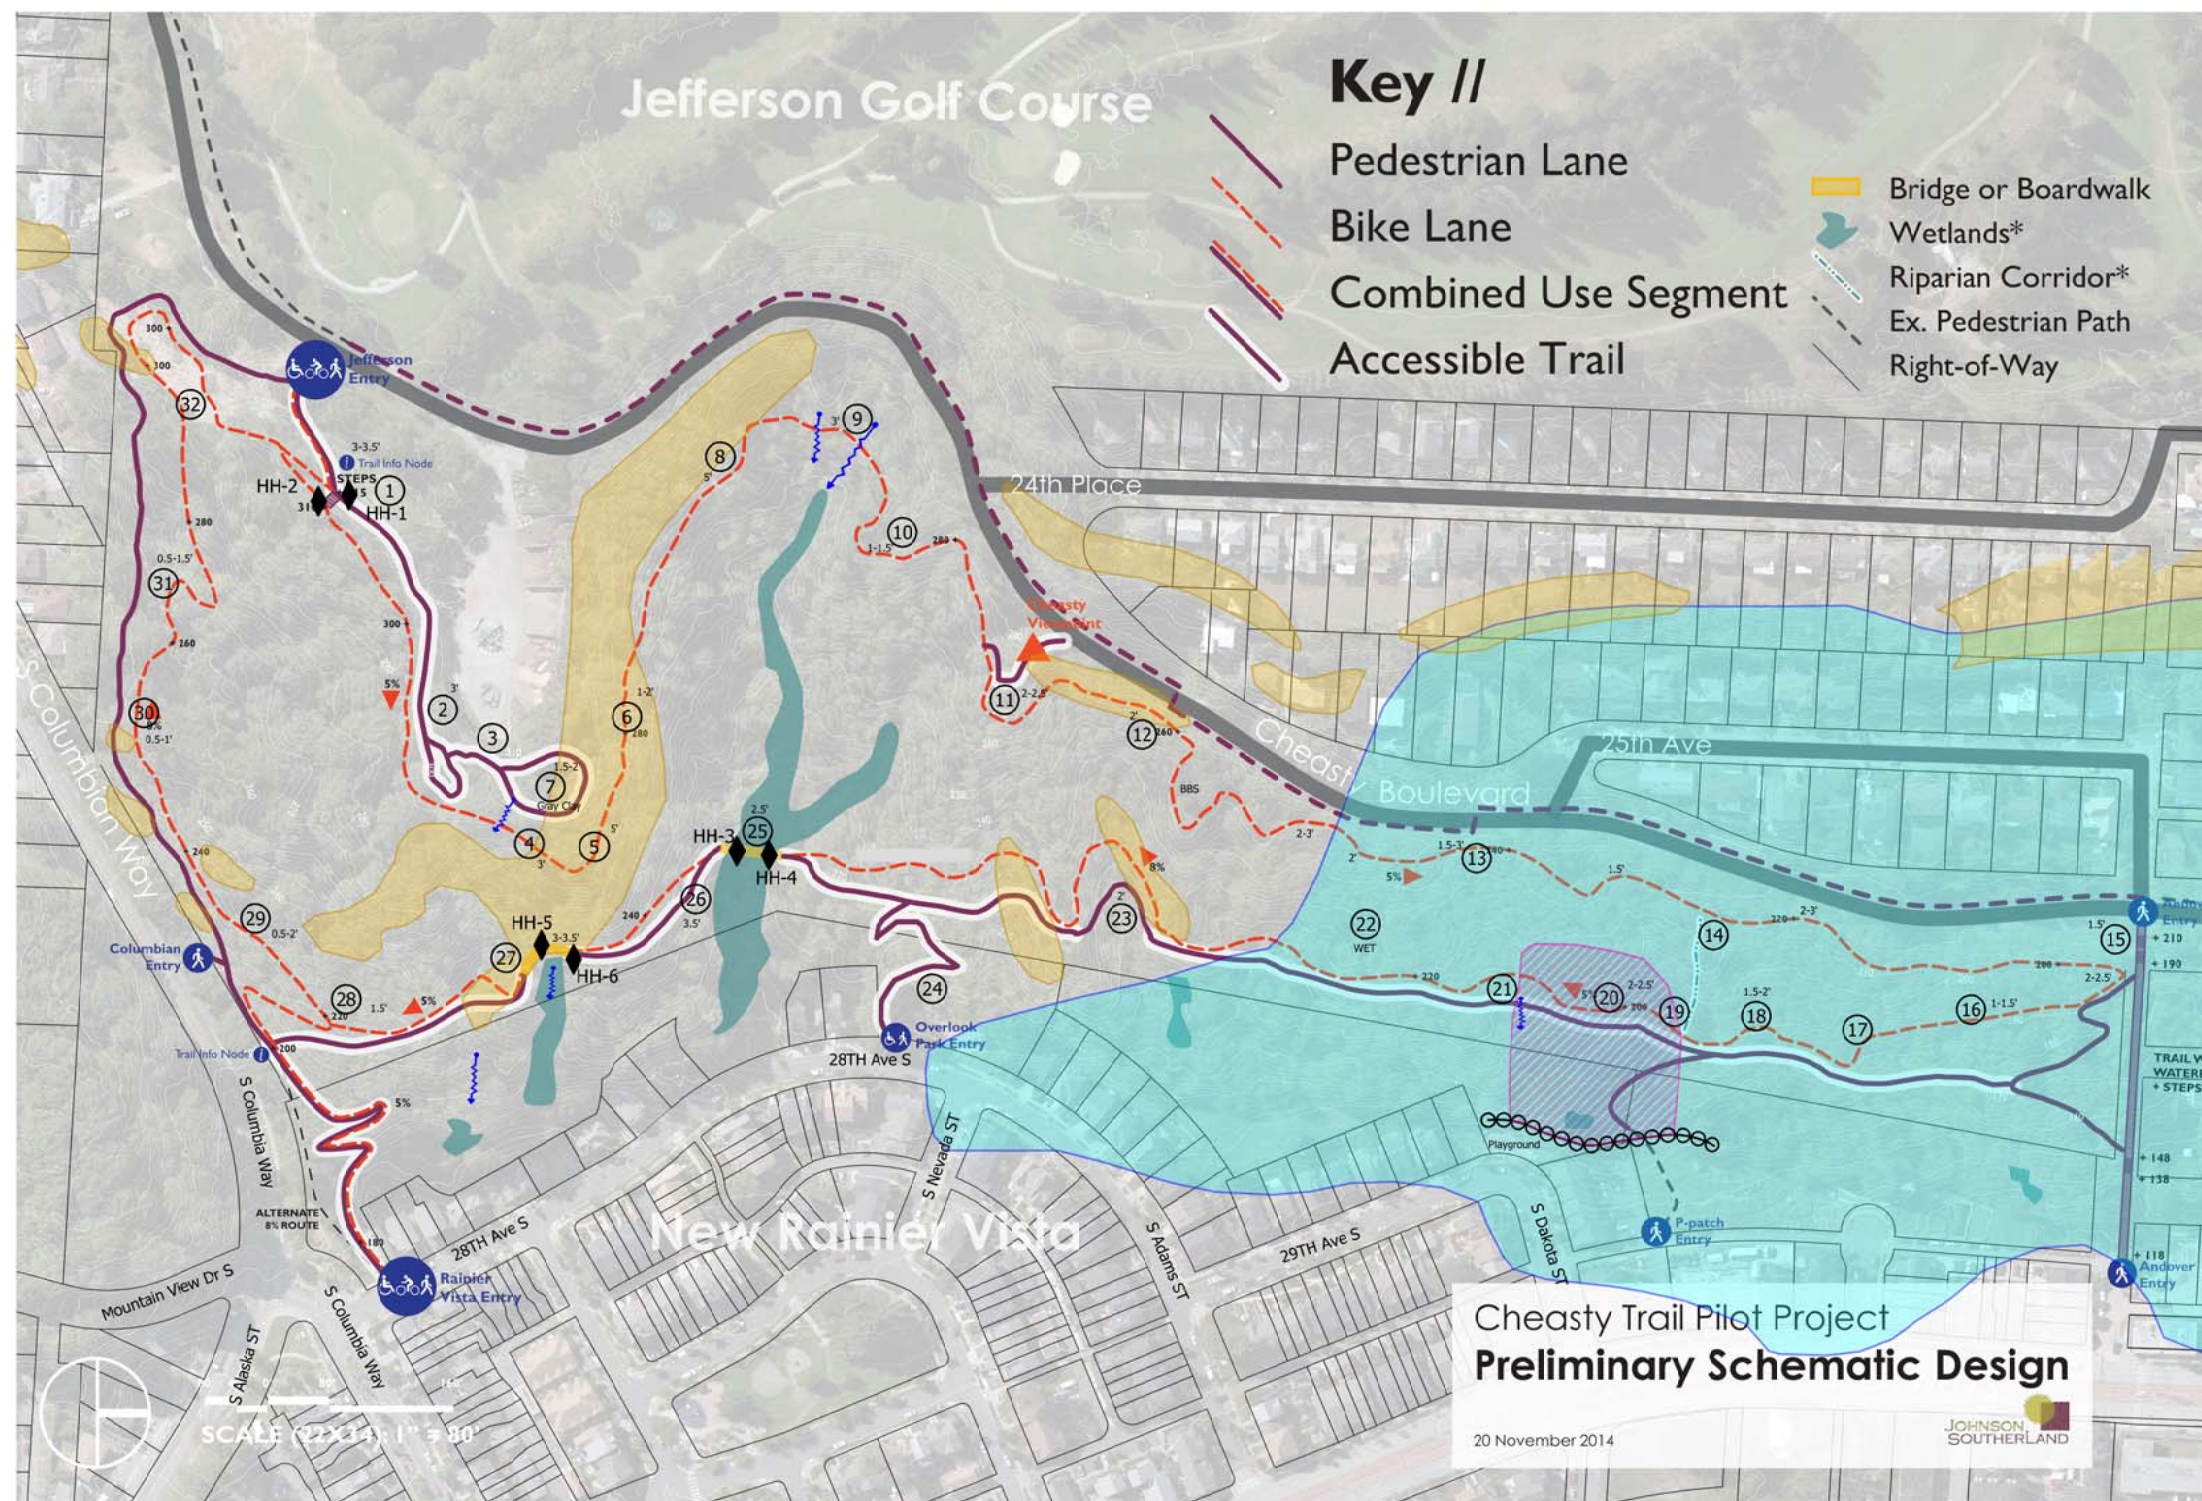
Slopes exceeding 40 percent were mapped by City of Seattle along portions of the southern half of the site (see [Figure 2](#), yellow hatching). The main portion of this is along the northern slope below the materials yard and above the main stream.

An HWA engineering geologist and a geotechnical engineer evaluated site and surficial soil conditions on January 12, 2015 by performing a geologic reconnaissance of the site on foot along the general alignment of the proposed mountain bike trail. The alignment was traversed clockwise starting at the top of the slope just south of the existing Parks materials yard on Cheasty Blvd. Slope geomorphology, vegetation patterns, tree growth, and surficial soils were observed during the traverse for signs of slope instability. At intervals the ground surface was probed with a ½-inch diameter T-handled steel rod to observe density or cohesiveness of surficial soils. General observations and locations of note are discussed below, with specific ground observations made at waypoints (numbered on [Figure 2](#)) included in [Appendix B](#).

Three areas of recent slope instability were observed:

- 1) **Along the fill slope around the Parks materials yard:** The fill historically spread over the crest of the slope showed signs of sliding this winter near the easternmost point. Fresh soil exposures near the top and deposits of sloughed and eroded soil down the 15- to 25-foot high slope were present.

- 2) **Above an existing soldier pile wall just west of Dakota St and 24th Ave S.:** This curving wall retains the toe of the forested slope within Rainier Vista common space, above a playground and the P-patch. The wall is from approximately 6 to 10 feet high and 300 feet long, with tiebacks along the eastern portion, as well as multiple clean outs in front of the wall, presumably for slope drainage piping. Two irregular slide scarps were observed at approximately 100 and 150 feet upslope from the wall. The scarps were on the order of 1 to 2 feet high and did not appear recent, being sloughed and moss-covered. Horizontal separation appeared to be less than 1½ feet at each scarp. The age of the scarps, based on appearance, is likely older than the relatively new soldier pile wall, which seems to have been built as part of the recent Rainier Vista redevelopment project. There were fewer and smaller trees in this area, likely due to past instability. However, the current trees were not tipped as would occur from deep, rotational sliding, such that in our opinion the most recent slide activity, before the wall was constructed, was relatively shallow and translational. The extent and exact locations of these scarps should be determined during project surveying.

- 3) **The head end of the western riparian area, below hand hole HH-5:** Ground water seepage was observed emanating in a bowl-shaped headwater area extending approximately 40 to 50 feet across. The bowl was gently sloping at the top, and increasing in slope as it transitions to a stream valley. Along the upper edge of the bowl, the slope was over-steepened to approximately 1H:1V to 1½H:1V over a height of 3 to 6 feet, with shallower slopes above. The localized over-steepening of this type is due to sloughing induced by ground water seepage. The slope progressively retreats headward

Ground water seepage was observed in several locations, most of which were closer to the bottom of slope than the top. The approximate locations in which ground water seepage was observed during our site visits are indicated in [Figure 2](#). The exception was ground water seepage below Cheasty Blvd at the head of the large stream valley. These seepages formed the head ends of surface drainages. Based on the geologic mapping, it is likely that most of the seepage emanates from granular soils just above their contact over hard silts and clays. The presence, specific locations, and flow quantity of ground water seepage should be expected to vary seasonally.

Ground water seepage zones and the resulting surface runoff were observed at a number of places along the trail corridor. Specifically these were observed near waypoints 4, 9, 14 (surface

pipeline for stormwater), 21 (in or adjacent to deep-seated slide area), 25 (north riparian zone), and 27 (south riparian zone). Other areas of seepage could become apparent during and after trail construction. The trail should not be constructed with wet crossings of seepage or runoff, as bicycle and foot traffic will cause disturbance of wet soils that will result in rutting and erosion of the trail (requiring higher maintenance) and silty runoff (impacting wetlands and streams down gradient).

- Routing the trail outside of the three noted areas of instability,
- Avoiding steep slopes (greater than 40 percent, or 2.5H:1V) where possible,
- Avoiding ground water seepage zones where possible,
- Minimizing cut heights where the trails must traverse steep slopes,
- Minimizing steepness of trail grades, and
- Installing and maintaining suitable drainage features.

In general, the proposed mountain bike trail alignment is appropriate. However, specific modifications to the trail alignment should be considered during final design. We recommend that the trail alignment be modified to avoid locations of identified groundwater seepage and observed slope instability.

The fill slope below the materials yard shows evidence of sloughing. Drainage facilities from the yard are discharged out over the proposed accessible trail loop. We recommend dispersing the drainage from the yard in an area below the trails. Further we recommend moving the trail as far from toe of slope as practicable. Alternatively, the slope up to the materials yard could be laid back to greater than 2.5H:1V.
