First Hill Yellowwood Inspections

Christopher Rippey, OOC Arboriculturist
Seattle Department of Parks and Recreation

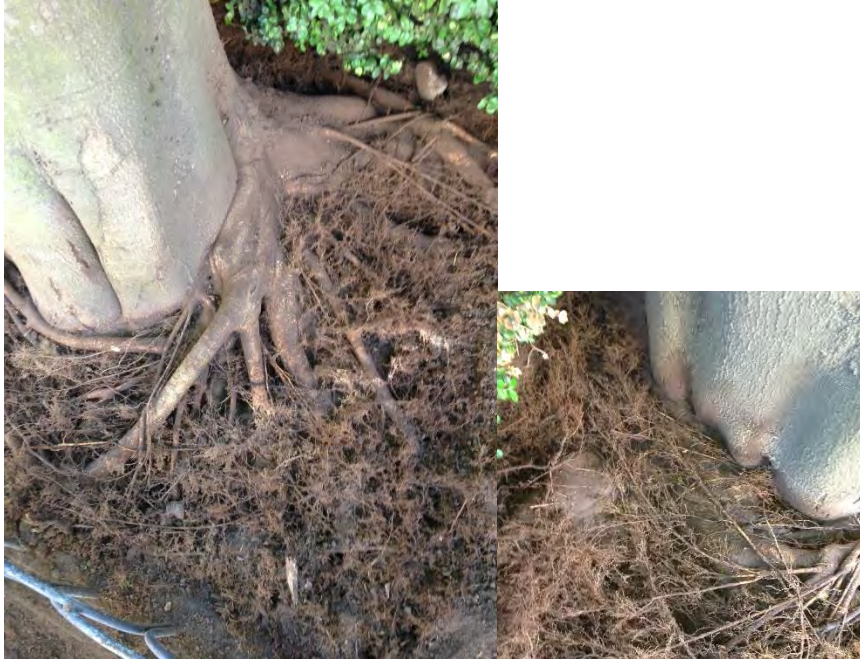
TREE A:

Tree has extensive girdling roots. Roots girdle almost all of the trees stem. The tree appears to be in very good health but so did the tree immediately to its south which failed on September 17th. It is my determination that the tree that failed on the 17th failed as a result of a root system comprised almost entirely of girdling roots. I think this tree could be pruned and remain after construction but the pruning would be extensive. I believe at least 1/3 of the crown would have to be removed and chances of surviving the pruning and root loss due to construction impact would not be great.

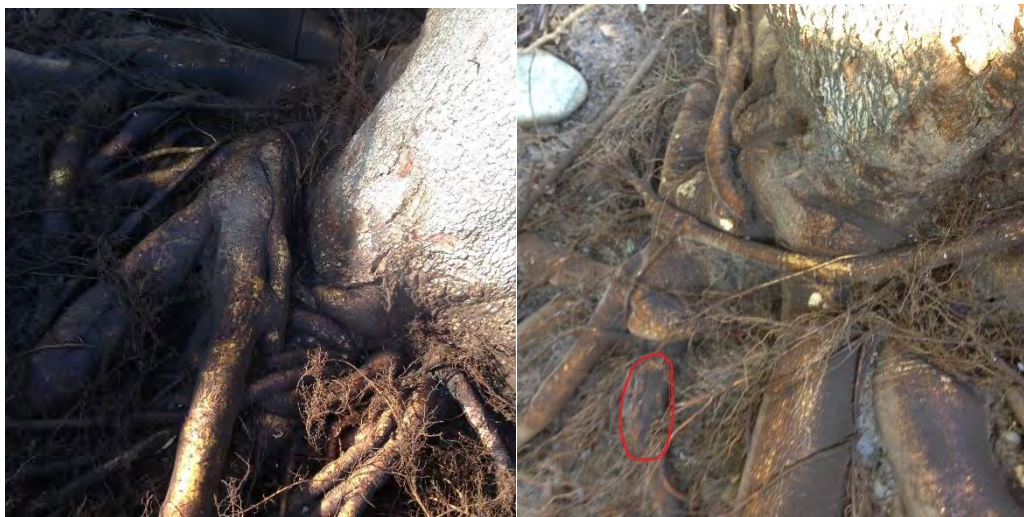
Tree B:

Extensive amount of girdled roots and presence of decay indicated with red circle. This tree is the smallest and presumably the youngest of the group. This tree does not have a large crown and wind throw forces are probably not excessive but it does already lean opposite of the prevailing wind. It is my determination that with some reduction pruning this tree could be left to stay but I cannot guarantee that it will not fail in a large wind storm.

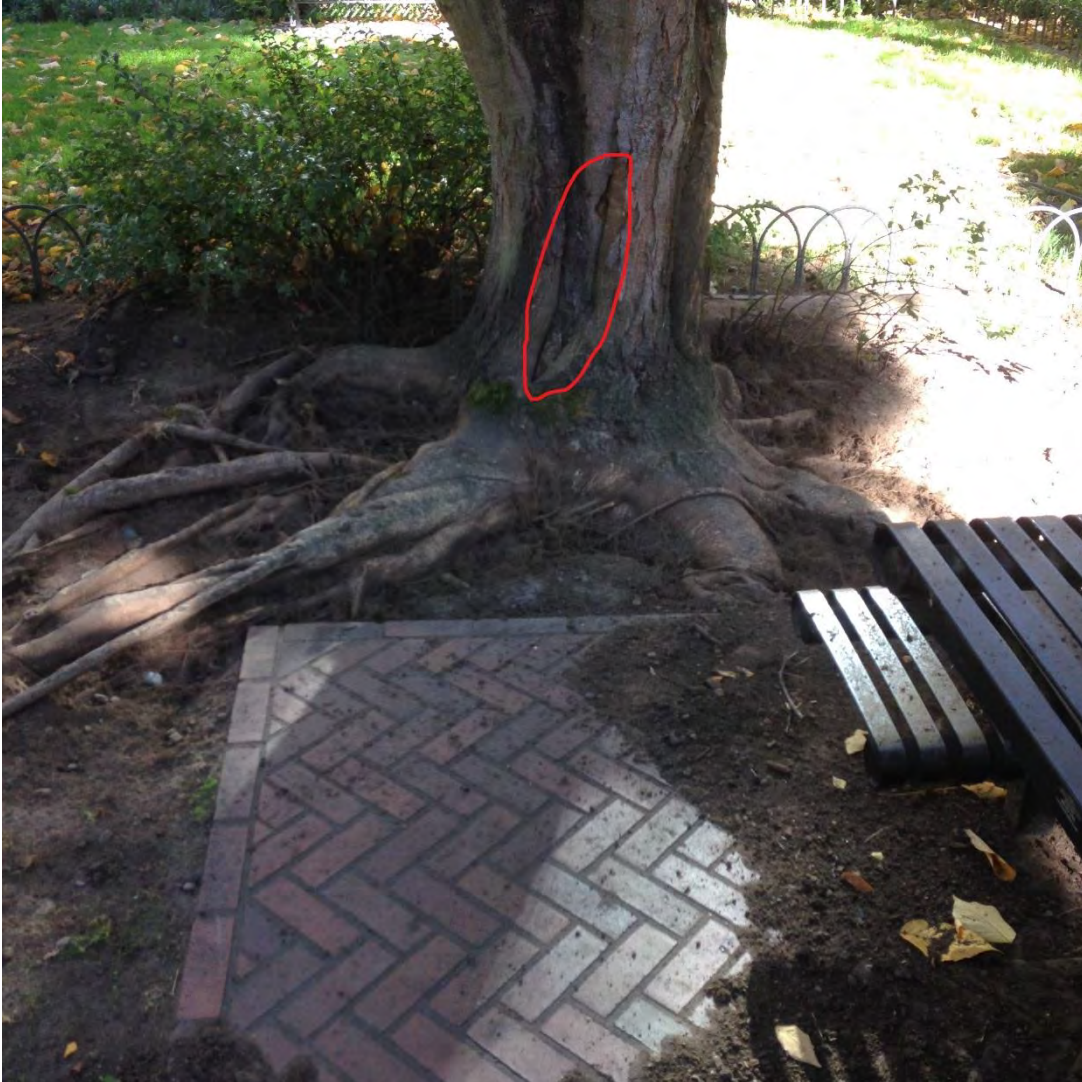
TREE C:

Tree C has the best root system and looks to be in the worst condition. This Tree has many areas on the root system where decay can be seen. Some of these pockets of decay are most likely due to the interactions of mowers or string trimmers and some are probably due to old construction wounds. This tree had a large dead limb removed from it a few weeks back and has a large co-dominate stem that is in decline and will probably die soon. That being said this tree could be cabled and left in place though I am not sure how long it will live as it is in some stage of decline and root loss due to construction could dramatically advance this decline.

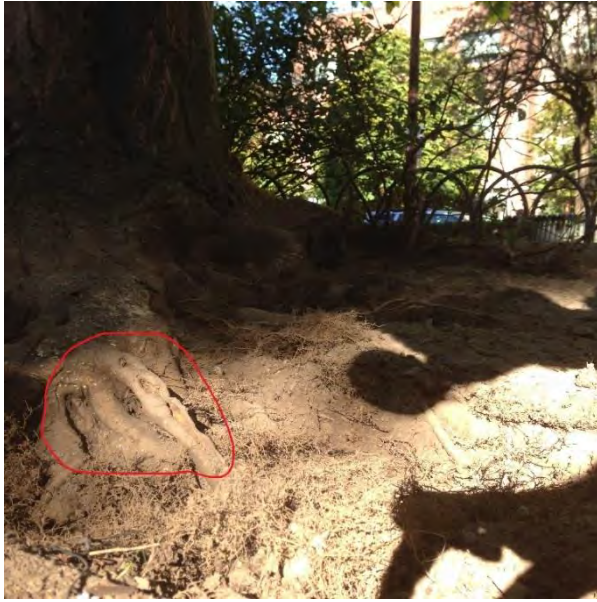
Figure 1 Tree C root decay

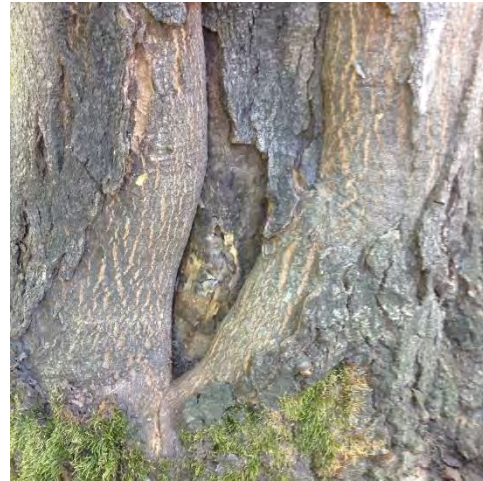
Figure 2 Tree C trunk decay

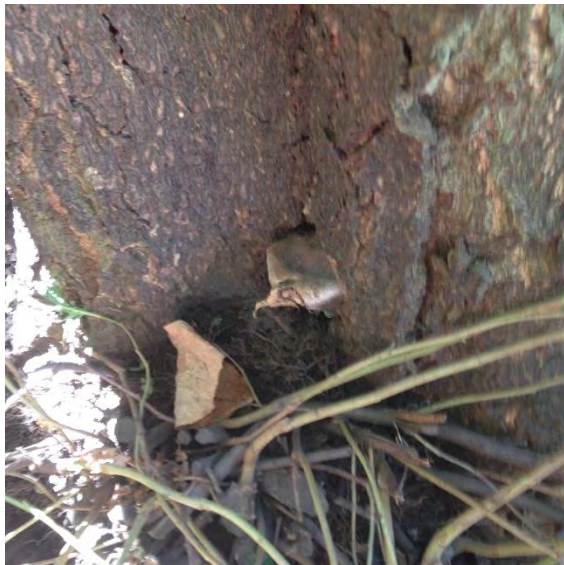
Figure 3 Tree D fungal conk

Tree D has a full canopy and looks very healthy but has an extensive decay issue and the appearance of two different fungal conks. One of the fungal conks is possibly *Kretzschmaria deusta* which indicates extensive root decay. This tree has several small root decay areas and one massive decayed and hollow root area. This tree is going to have to be removed as its failure is likely.

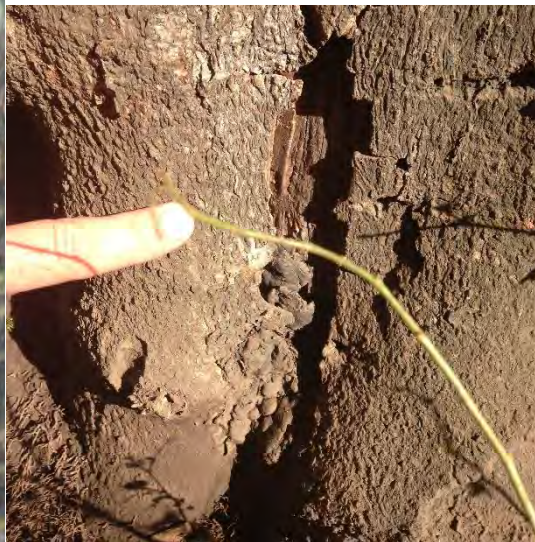
Figure 4 Tree D with possible Kretzschmaria deusta

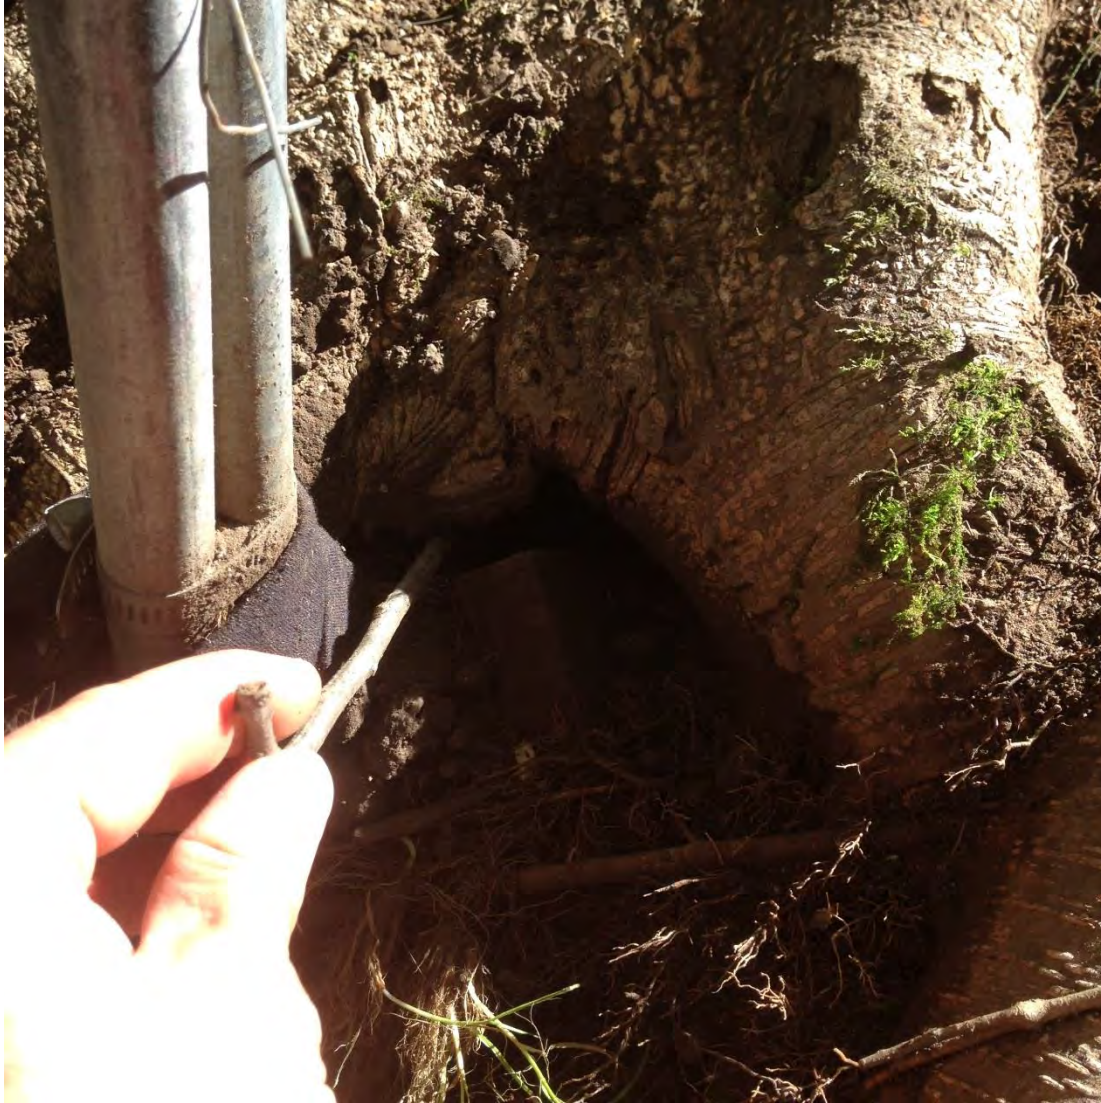
Figure 5: Tree D hollow root

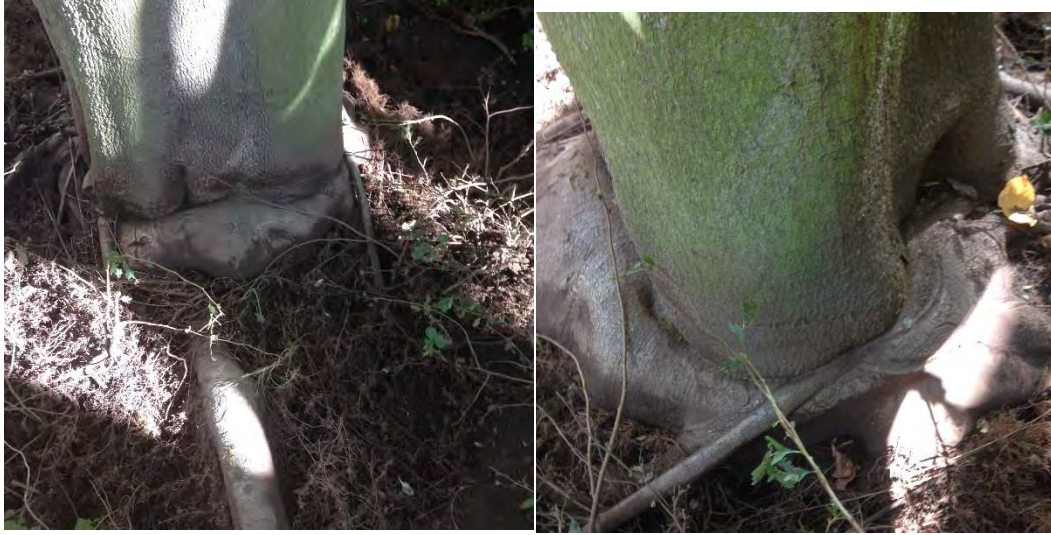
Tree E has the largest and most extensively girdled root system. This root system is as bad if not worse than the girdled root system on the tree that failed on the 17th. It is my determination that in order to allow this tree to remain standing it would have to be reduce significantly to give it less of a sail in wind storms which would most likely be the cause of its eventual failure. I do not think this tree would survive the necessary pruning with the expected root lose due to construction and stress related to construction so I am recommending its removal.

Girdled root on Tree E.

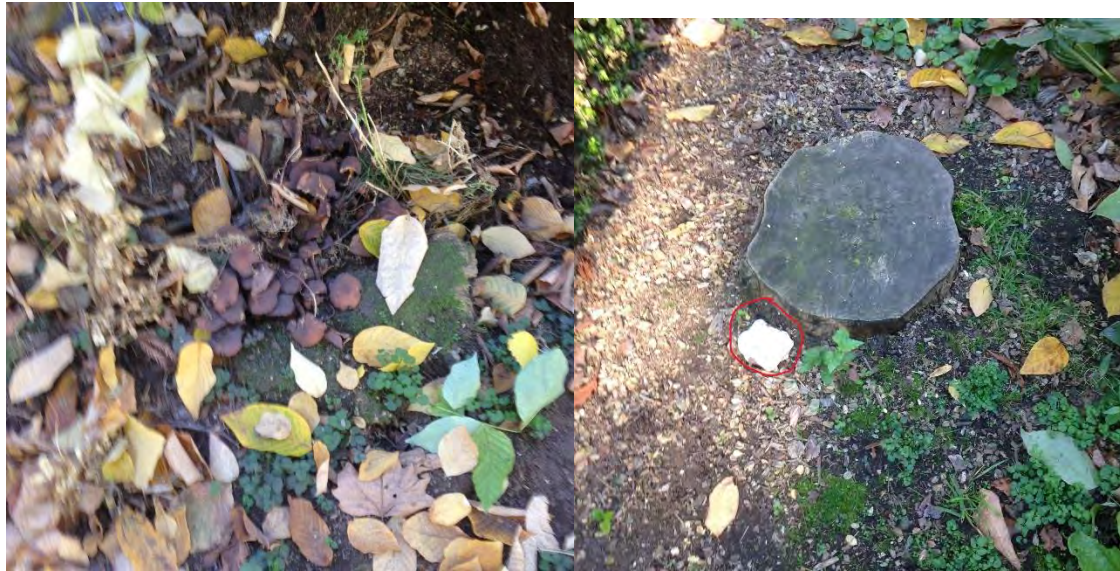
Failed or dead stumps with fungal conks indicated with red circle

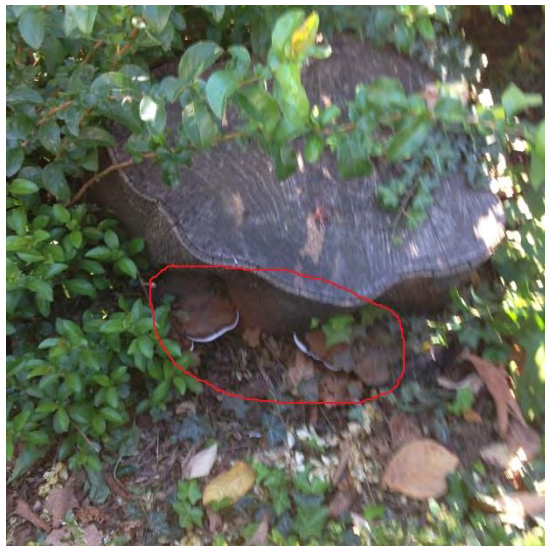
Figure 6 Ganoderma applanatum (very aggressive decay organism) on old Yellowwood stump.

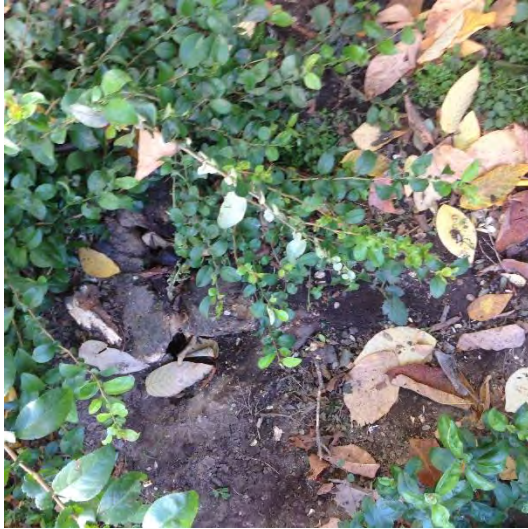
Figure 7 evidence of old root failure

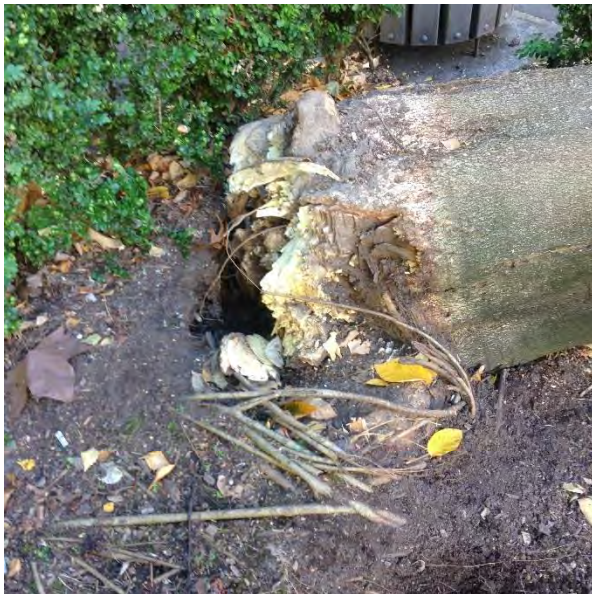
This is a classic example of a failure caused by a girdled root system. This was the Yellowwood tree that failed from storm forces being applied to a girdled root system on September 17th 2016.
