LOWMAN BEACH PARK

Feasibility Study Report

Prepared for
Seattle Parks & Recreation Department

LOWMAN BEACH PARK SEAWALL CONDITION ASSESSMENT

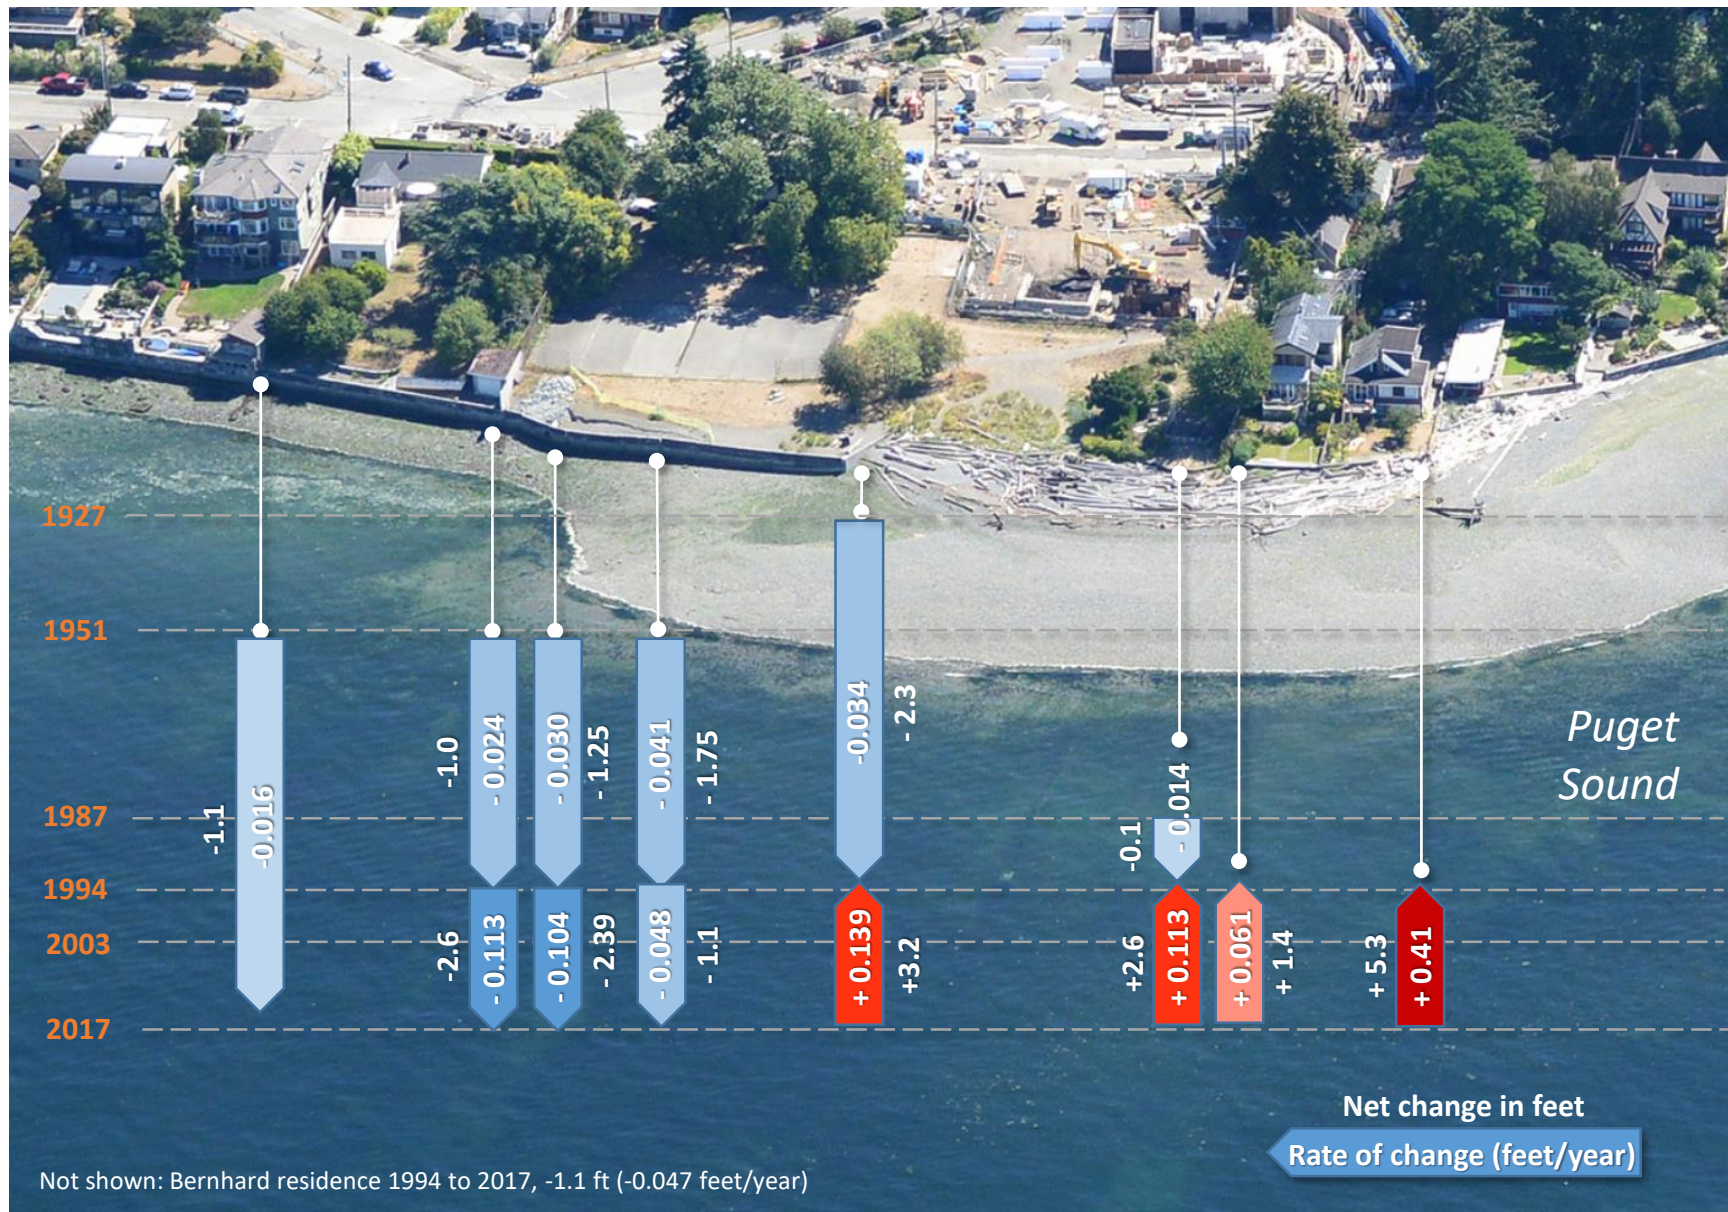
Notes: 1. Positive values (red) indicate accretion, negative values (blue) indicate erosion
2. Beach restoration occurred in 1995.

Figure 19
Beach Elevation Change Summary

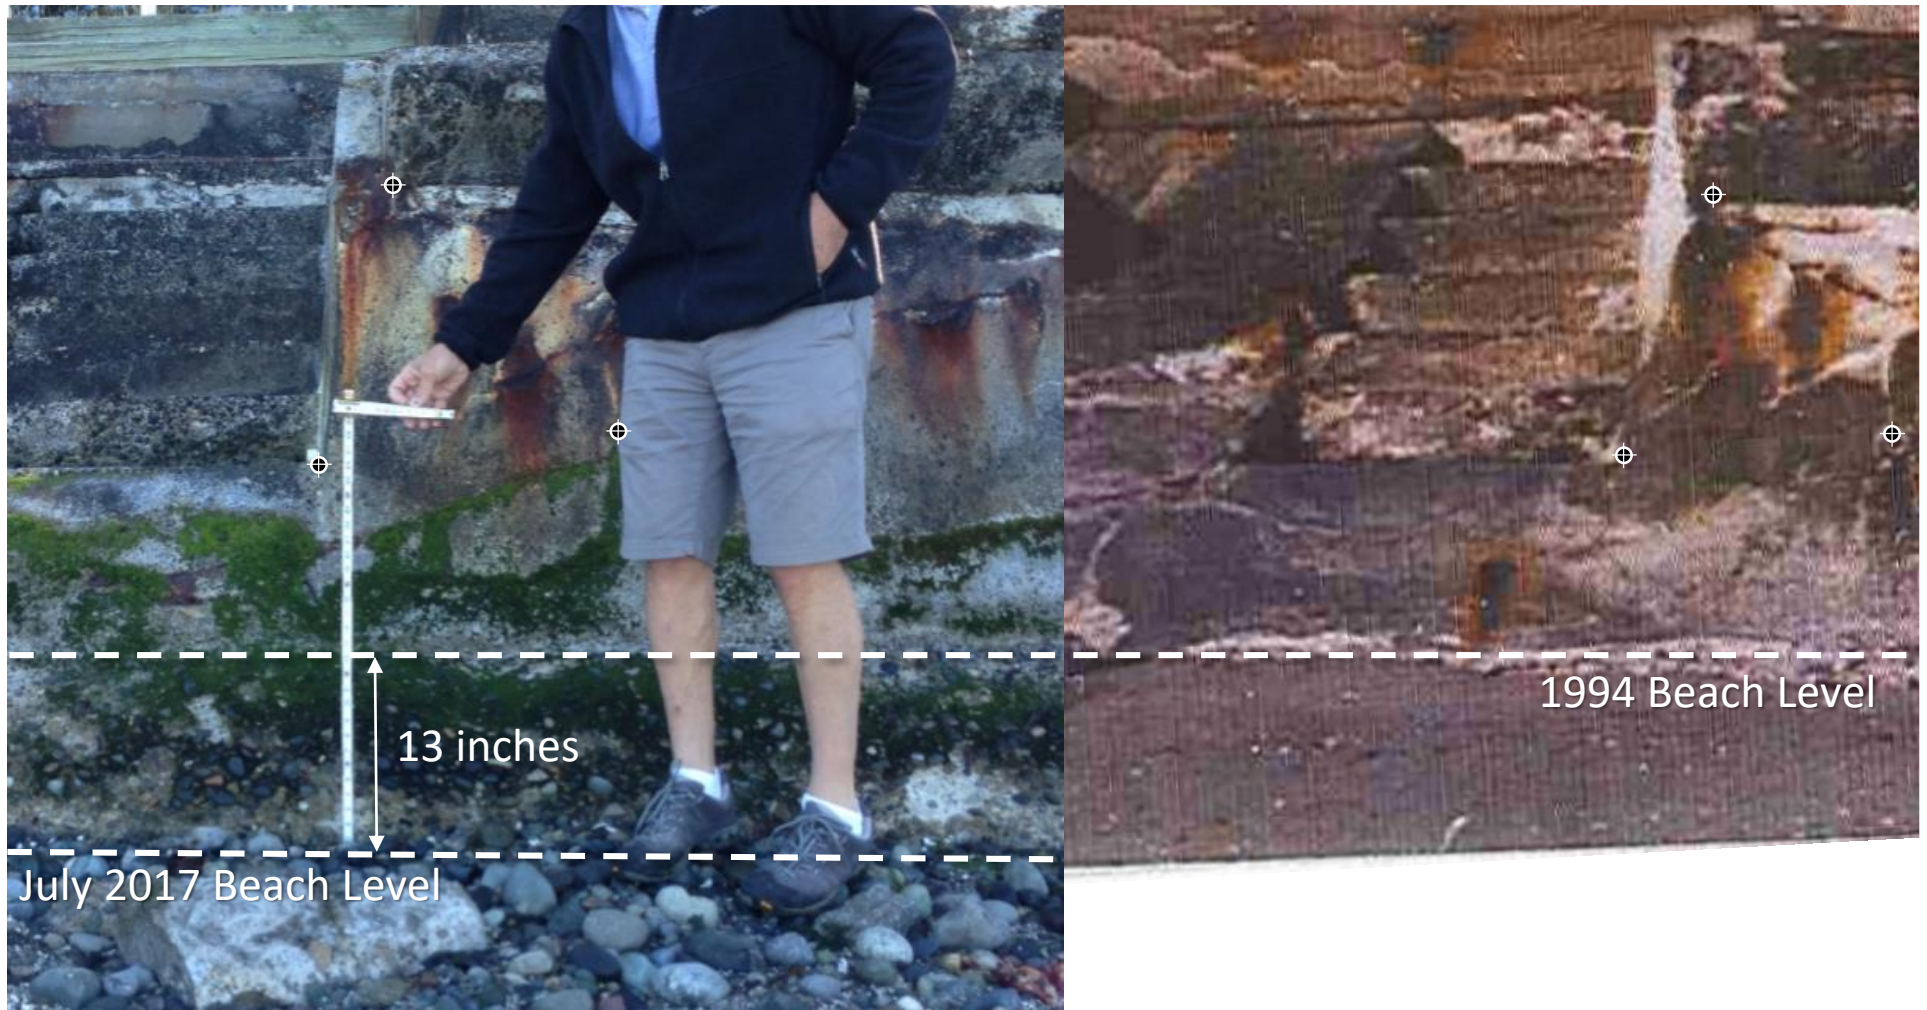
2017	City survey indicates murphy residence north property boundary of EL. 5.0 feet. At the north park property boundary, grades are approximately EL. 5.34 feet on top of spalls but actual beach grade about 1 foot lower, 85 feet south of north park boundary EL. 5.4 feet, south property boundary EL. 11.3 feet. Bernhard residence beach elevation dropped by approximately 13 inches from 1994 to 2017 based on photo comparisons.

Lowman Beach Park Feasibility Study. D160292.00
Figure 20
 Comparison of Ground Photos of Beach
 Level at 6751 Beach Dr. SW

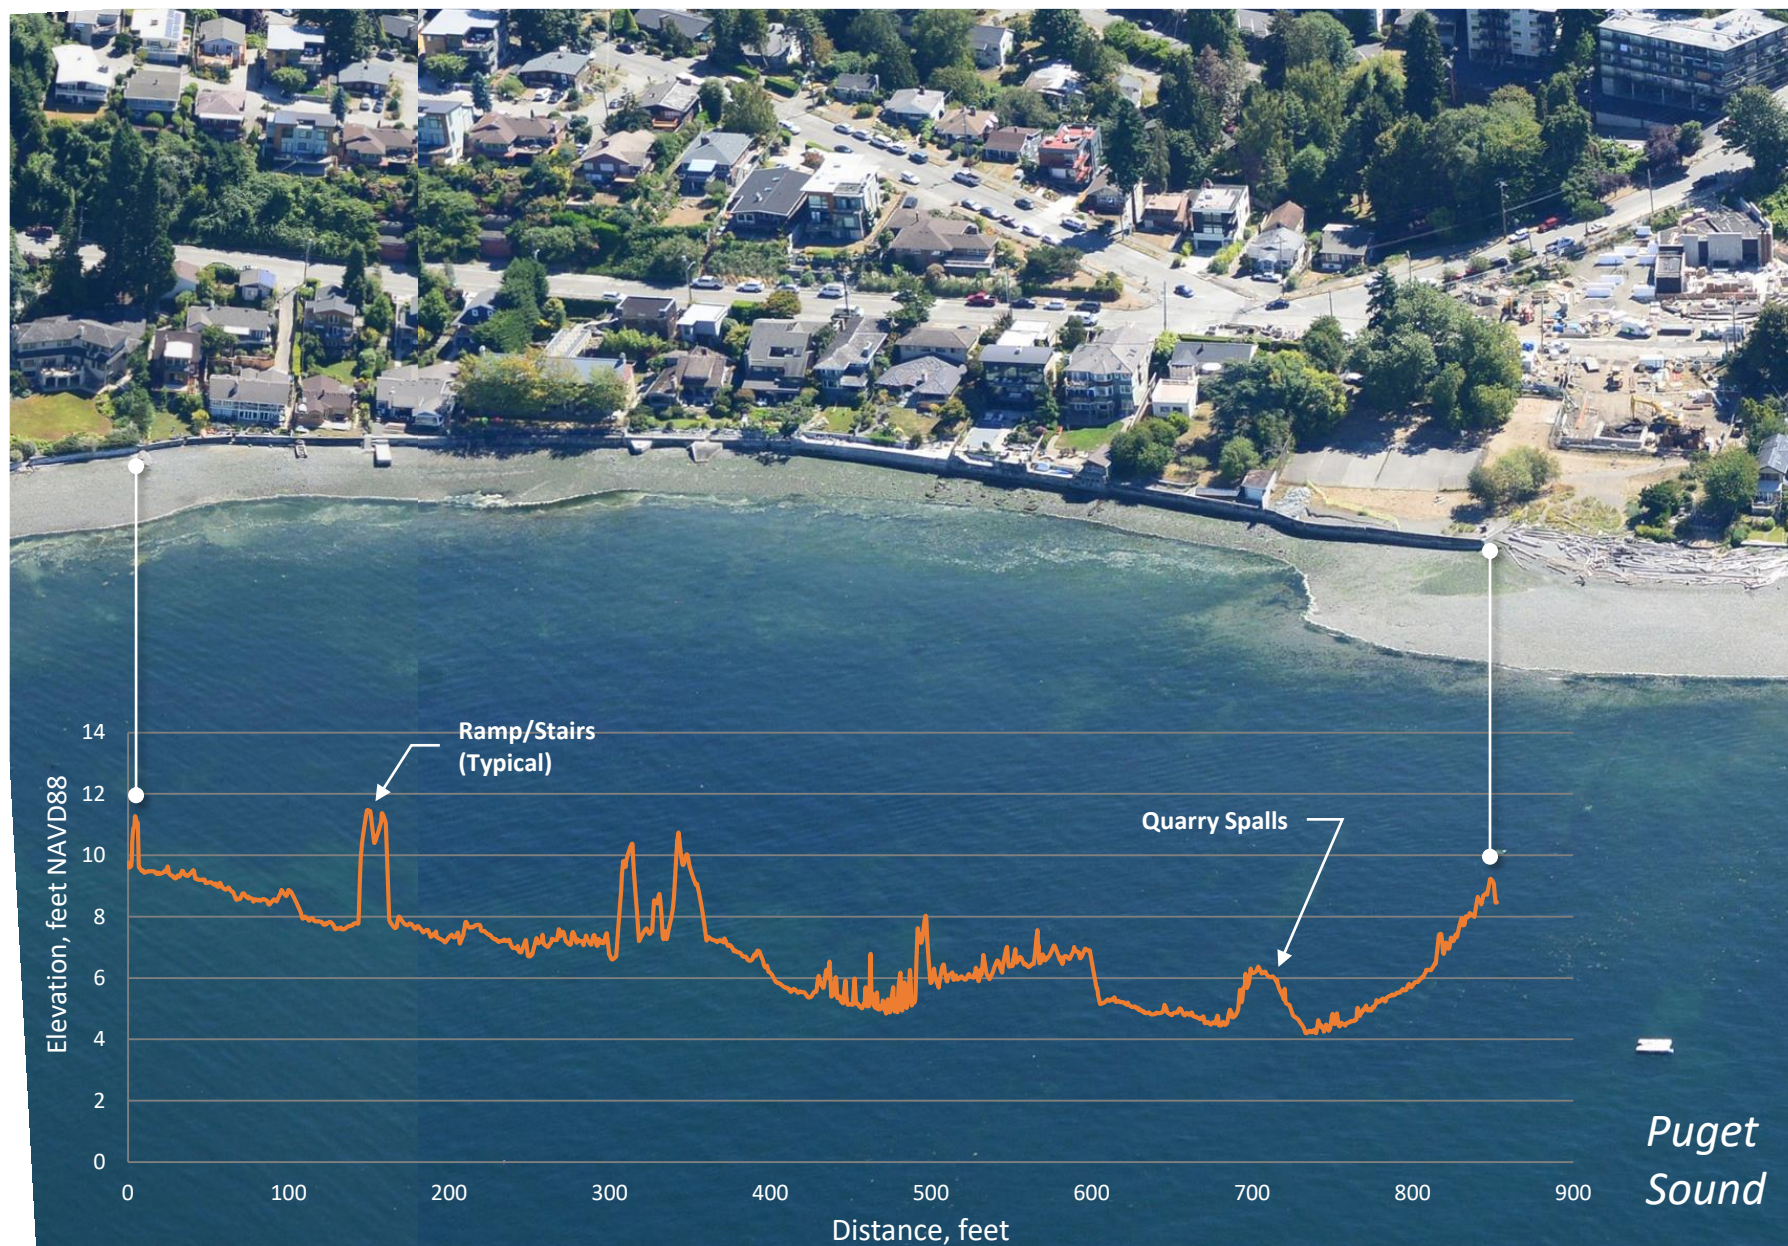
From 1994 to 2017 the beach grades at the north end of park lowered by almost 3 feet. At the middle point of the existing seawall, beaches grade lowered by about 1.5 feet. In the restored beach area, accretion (rising elevations) has occurred near the existing return wall and restored beach to the south of the seawall. Beaches immediately to the north of the park have continued to experience erosion from 1994 to 2017. Based on limited data, beach elevations at the toe of seawalls north of the park are estimated to have lowered by 1.0 to 2.5 feet during this period, with the most pronounced erosion occurring immediately north of the park and diminishing further to the north. Beaches to the north of the park have also lost the veneer of sand that was present near the toe of bulkheads in historical photos from 1993 and ground-level photos from 1994. Areas of grey clay are exposed at the surface, making fine sediment and small gravel deposition unlikely. Approximate beach elevation derived from LiDAR survey data near structure toes north of the park is depicted in Figure 21.

Figure 21
Beach Elevation Near Structure Toe
from 2016 King County LiDAR

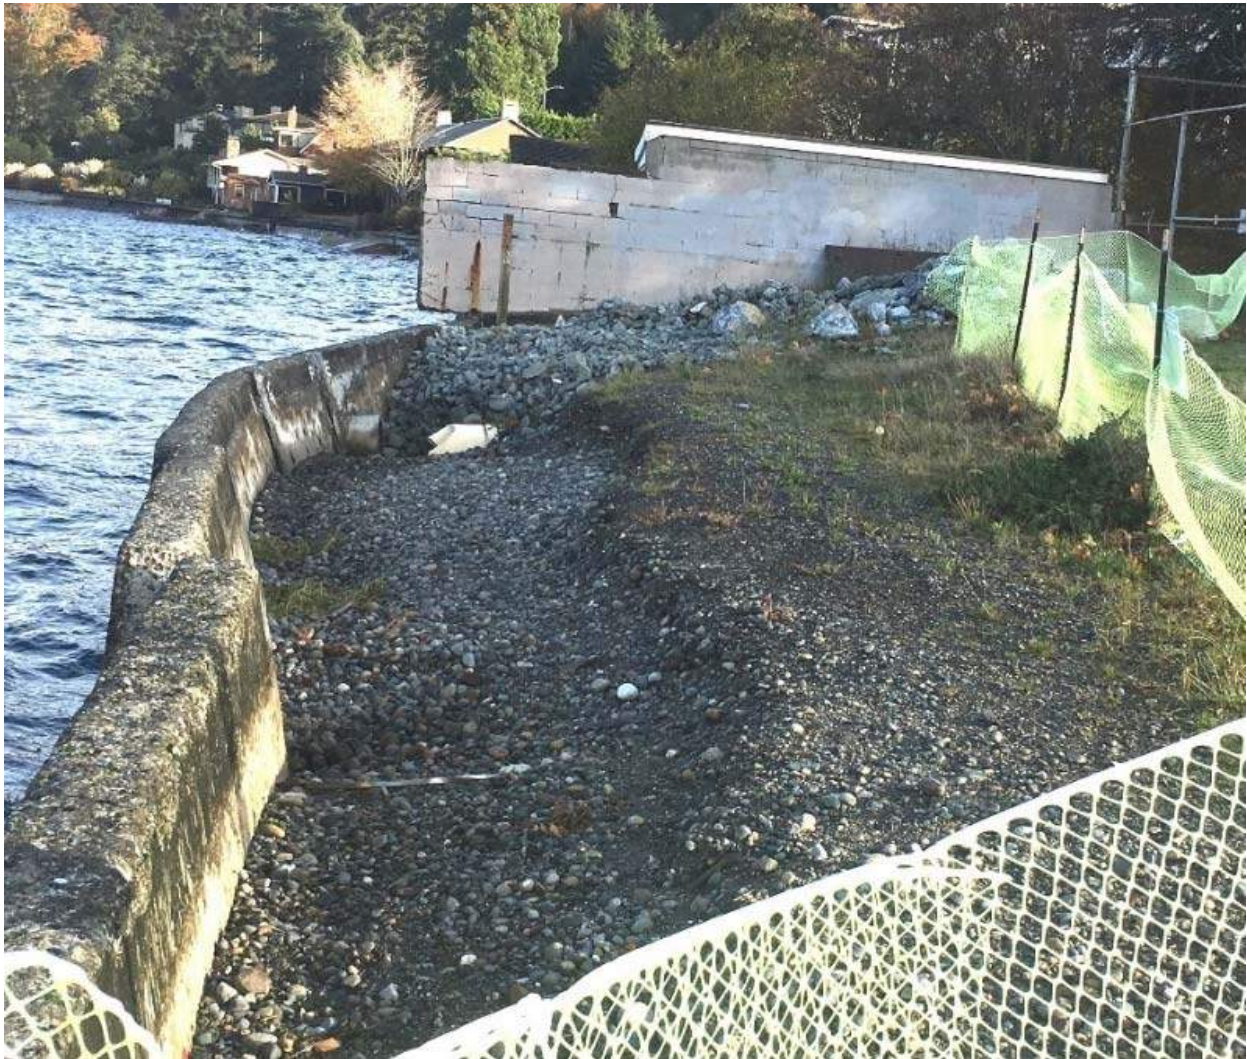
Figure 1. Failed Seawall (Photo taken on 10/18/2016).

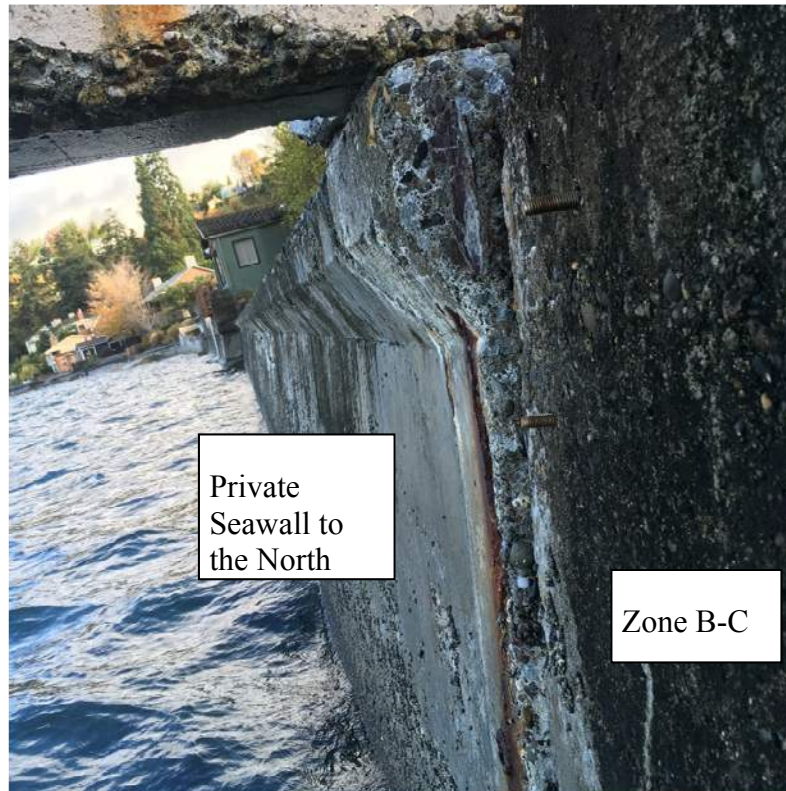
Photo 9. Private Seawall to the North.
 Source: Reid Middleton Site Visit 10/18/2016

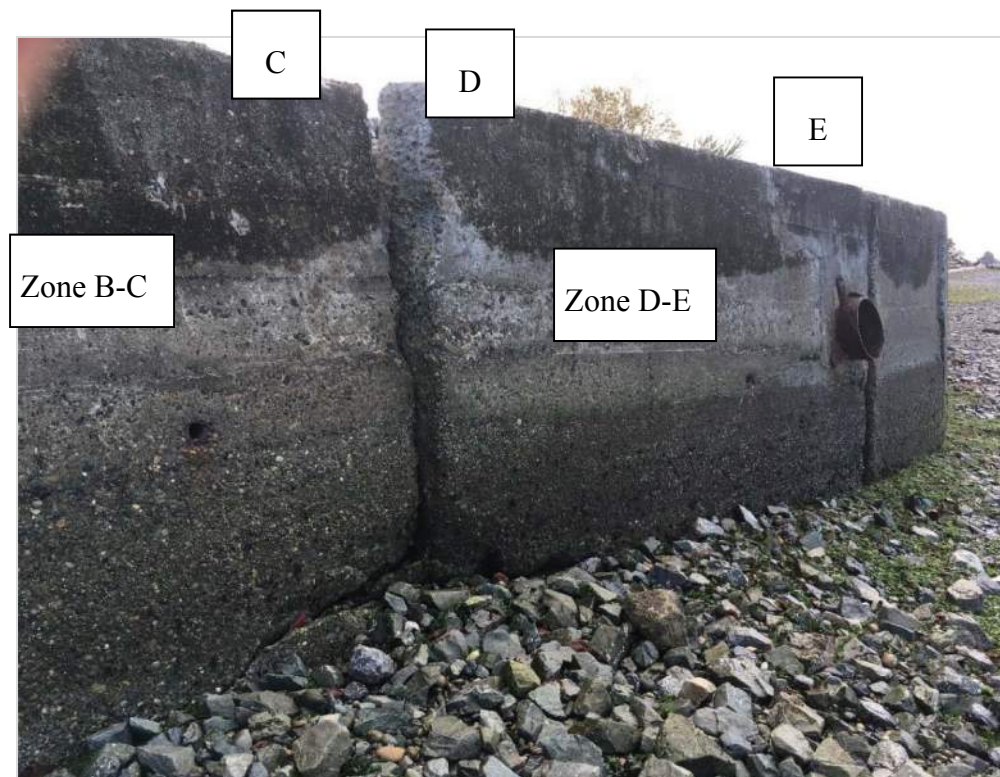
Photo 11. Zones B-C & D-E, Outfall.
Source: Reid Middleton Site Visit 10/18/2016

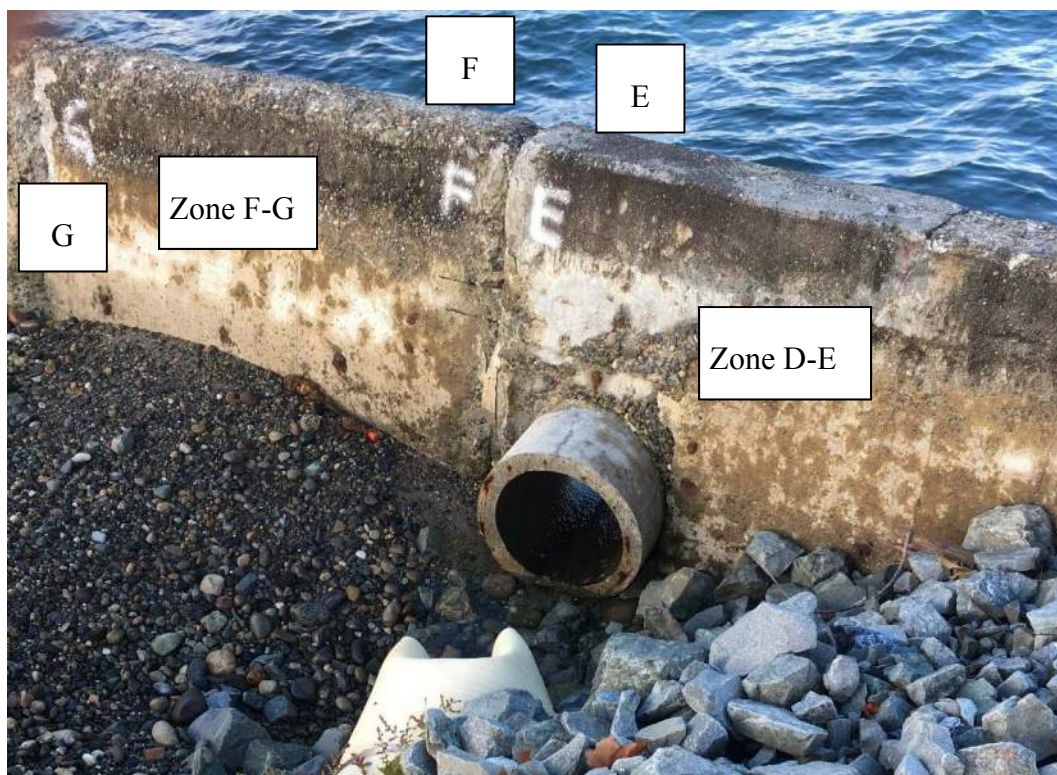
Photo 16. Zones D-E & F-G, Broken Outfall.
 Source: Reid Middleton Site Visit 10/18/2016
