# MONITORING & VERIFICATION (M&V) REPORT

**City of Seattle Tune-Up Accelerator**

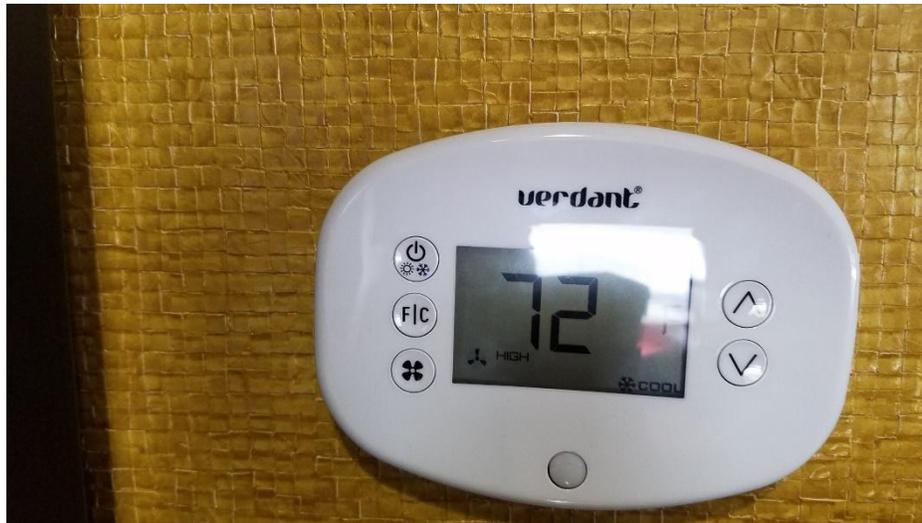
- **G7:** Two heat pumps in the lobby, one near the retail coffee vending stand (a heat-producing area) and one closer to the entry (an area prone to heat loss), were controlled separately via on-unit controls. Guests had access to change temperature settings, resulting in instances of simultaneous heating and cooling. Set points observed were 60° F on one and 70° F on the other.

**Requirement:** Install one thermostat to control both units; restrict guest access to control.  
**M&V:** A single wireless thermostat controlling both heat pumps in the lobby was observed (see picture below). Its location is more challenging for guests to access, resulting in a more consistent temperature range. Hobo U12 Temperature data loggers and UX90 motor runtime loggers were deployed for over 5 weeks to verify heat pump operation. The data shows minimal instances of simultaneous heating and cooling, though occasionally this still occurs, which can be explained by the varying microclimates that exist in the lobby. (See graph in Figure 1 below). When it becomes necessary to replace either of the heat pumps, a suggested strategy would be to replace both with one unit that can serve the whole area.

Photo 1. G7: Single wireless thermostat to control both lobby heat pumps.

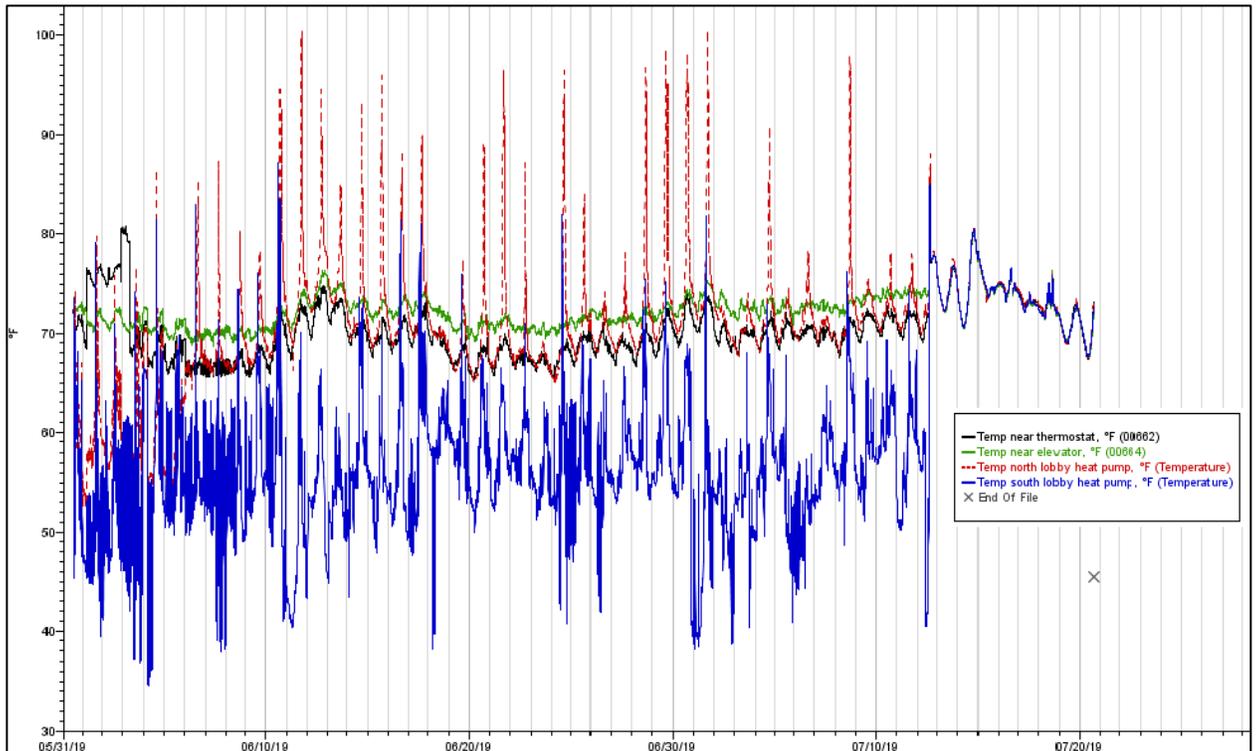
Figure 1. Graph of temps in lobby show minimal instances of simultaneous heating and cooling.

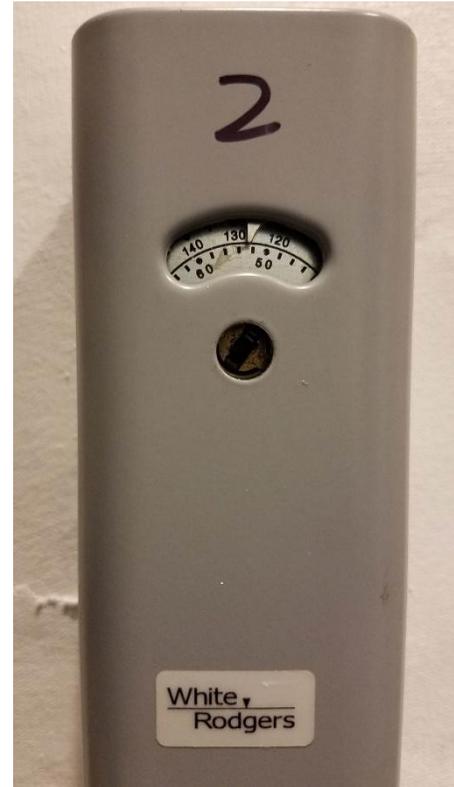
- **L1:** Hot water tank temperature set point was observed at 138 ° F.  
**Required action:** Reduce set point to 130 ° F.  
**M&V:** As per visual observation, tank temperature was set to approx. 128 ° F, verified at inlet with infrared thermometer. The recommendation to lower the temperature was followed, but this may be too low. In order to prevent bacteria growth, the tank temperature should be maintained at 135 ° F, as recommended in the Tune Up Specialist's assessment report. Water temperatures in two guest rooms, as tested with Hobo TMC-HD water temperature sensor were between 105-112 ° F.

Photo 2. DHW boiler thermostat showing tank temperature.

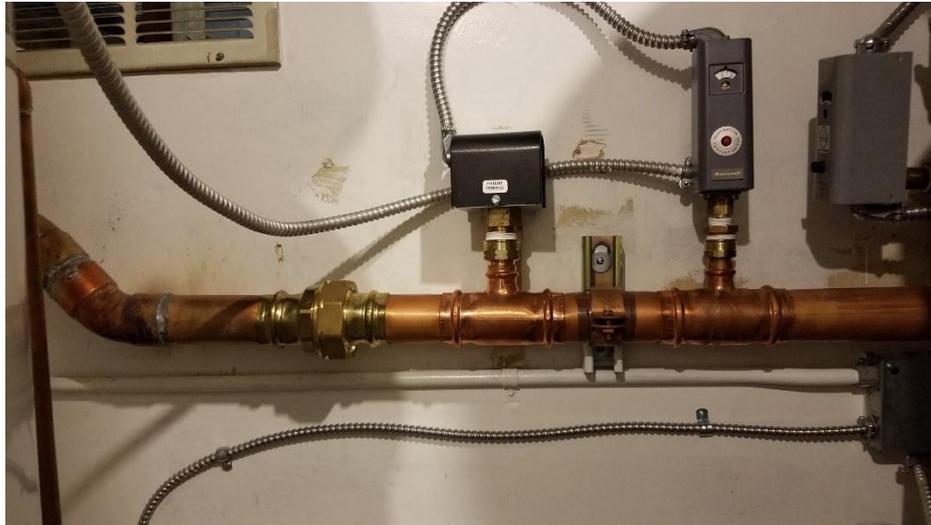
**M&V:** New wiring and plumbing indicated that water heater controls had been recently changed to prevent circulation pump operation when boilers are not firing. Boilers were not firing during M&V visit, nor were the circulation pumps operating, meeting the intention of the retrofit.

Photo 3. New wiring and plumbing to prevent circulation pump operation when boilers are not firing.

**Recommendation:** Change control wiring to prevent circulation pump operation when boilers are not firing. When future replacement of either boiler is required, replace it with a heat pump water heater to perform the base load of heating, re-piping the system so that the gas heater only operates to supplement when there is a high demand for heat.

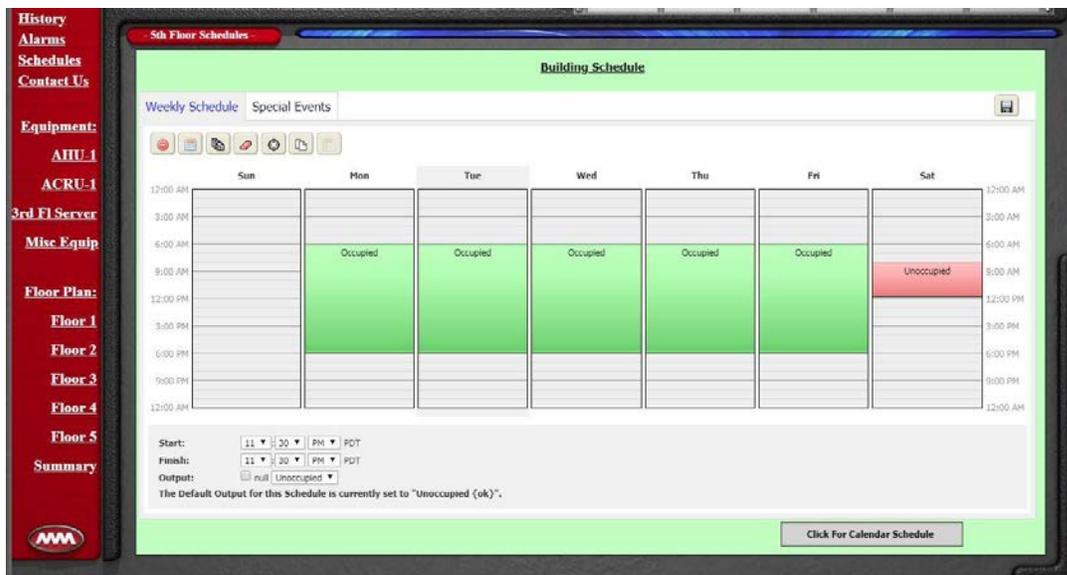
- **G1:** Sunday operating schedule was in place for upper office floors (2-5), even though these spaces are not typically occupied on this day.  
**Requirement:** Change operating schedule to reduce or eliminate Sunday runtime.  
**M&V:** Runtime schedule as observed in BAS interface was set for 12-hour operation M-F, reduced to 4-hour schedule on Saturday, and not operating on Sunday.

Photo 4. Screenshot from Bldg. 2 BAS showing operation Mon-Sat and no operation on Sunday.

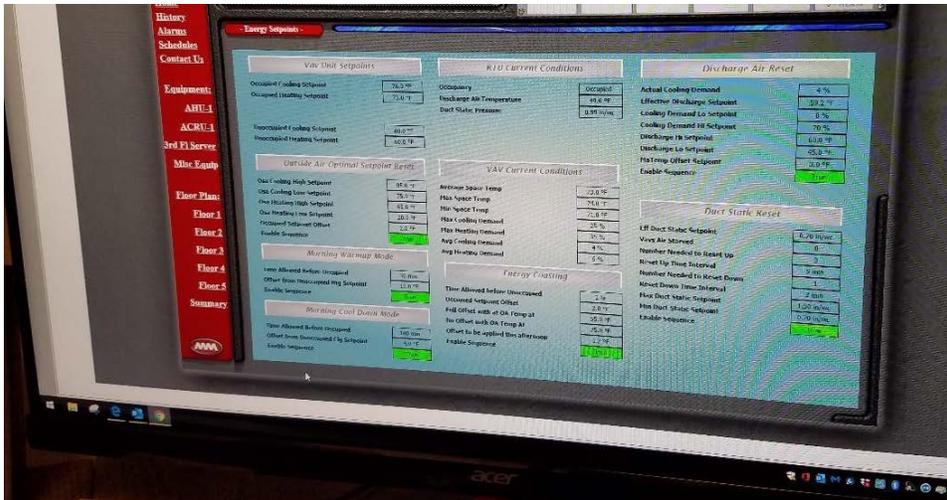
- **Recommendation:** Upgrade legacy building automation system to enhance efficiency.  
**M&V:** According to building management, a full upgrade to a Honeywell system with Spyder controllers was completed in Oct. 2018. BAS interface was observed, including reset functionality for duct static pressure and discharge air temperature.

Photo 6. Bldg. 2 BAS interface screenshot.

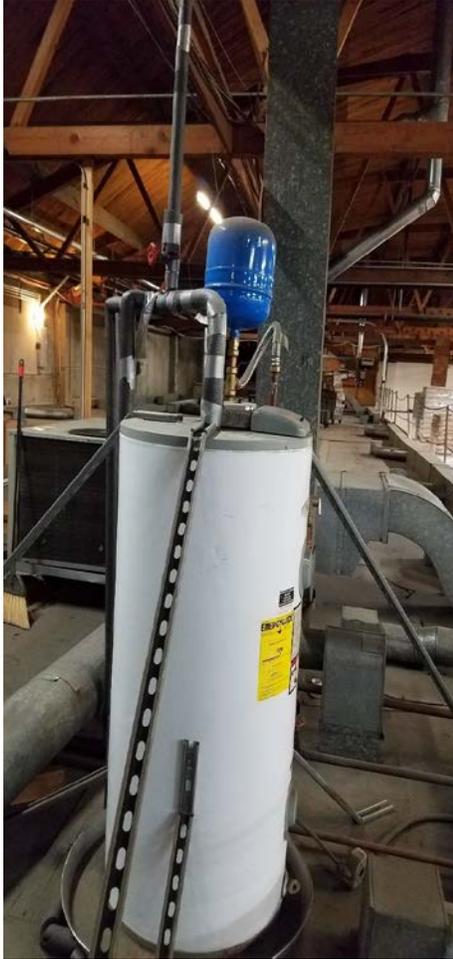
- DHW piping above offices in unconditioned warehouse space was uninsulated.  
**Recommendation:** Insulate DHW piping in unconditioned areas.  
**M&V:** Pipe insulation was observed on all hot water pipes leaving the water heaters.

*Photo 7. DHW pipe insulation installed March 2019.*

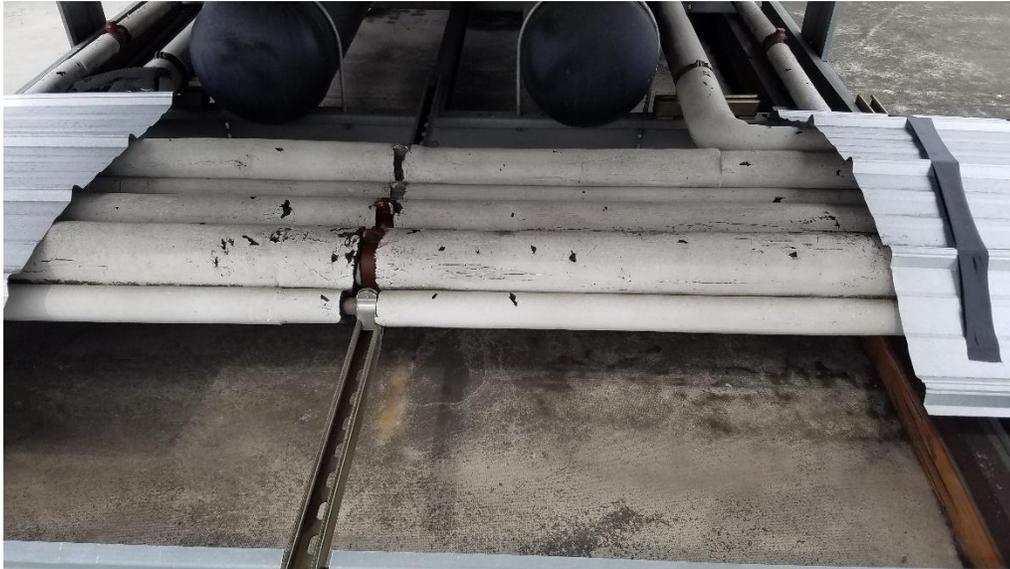
as had happened previously (a common problem with rooftop insulation). Areas not covered had sustained further damage.

*Photo 8. Refrigerant piping on roof was installed, with portions covered to prevent damage from birds.*

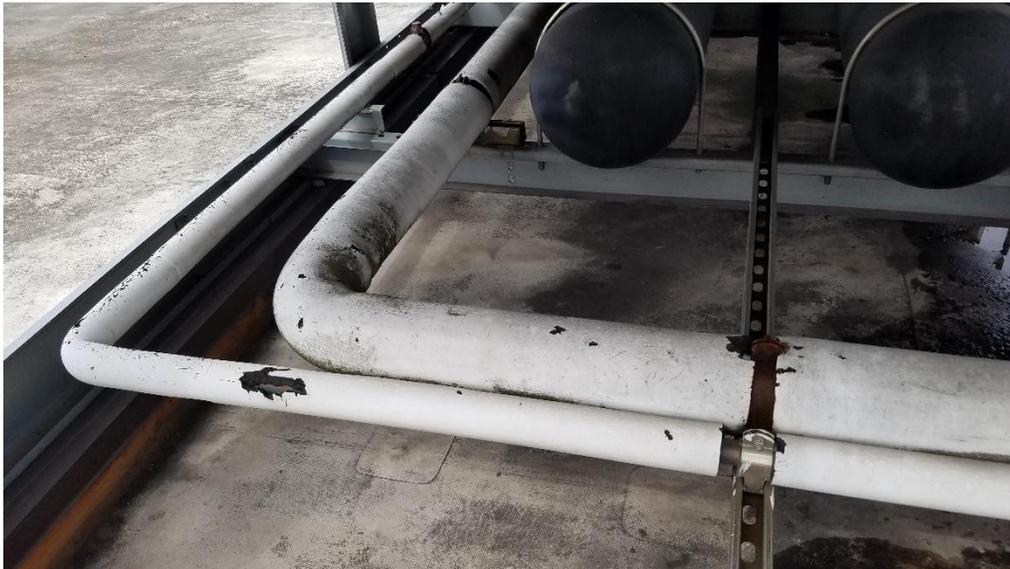
*Photo 9. Uncovered insulation had sustained more damage from birds.*

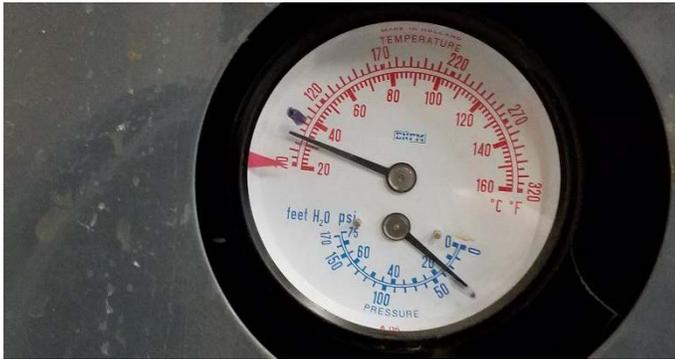
readings taken with infrared thermometer showed 76.5° F at the outlet and 74° F at the inlet, indicating that the gauge may be faulty.

Photo 10. Electric boiler temperature gauge may be faulty.

- **Recommendation:** Drop the floor freeze protection boiler set point for the walk-in freezer.  
**M&V:** According to building management, the set point for the frost heave prevention boiler had been reduced by 3° (to 76° F). As observed, boiler temperature on gauge read 90° F, but

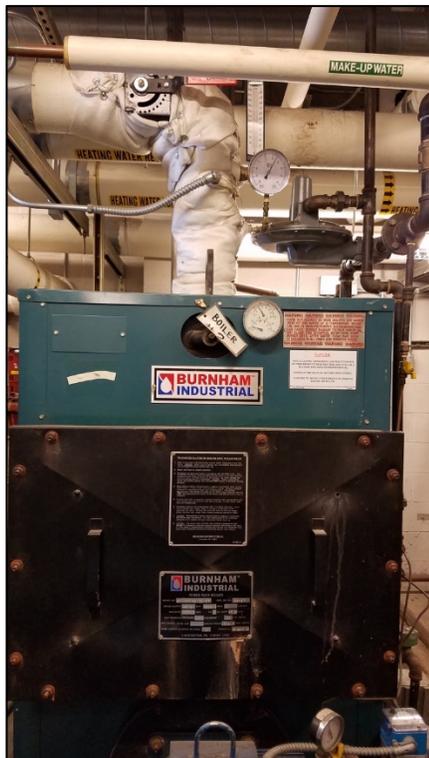
- **G3:** Boiler supply temperature reset was configured to respond to outside air temperature (OAT). Also, the less efficient fire-tube boiler was set as the primary boiler.  
**Requirement:** Modify the reset schedule to look at zone demand instead of OAT. Make the condensing boiler the lead boiler over the fire-tube one.  
**M&V:** The site visit occurred in the summer when the boilers were turned off. According to the Tune-Up Specialist, who is also a Retro-commissioning Specialist (RCx) for the school district, at the time of the assessment (autumn 2018) he changed the BAS configuration to make the condensing boiler the lead boiler over the fire-tube and modified the reset schedule to look at a sample of zone demand instead of OSA. He also lowered the HWS temp for the condensing boiler.

Photo 11. The less efficient non-condensing boiler was carrying the primary load.

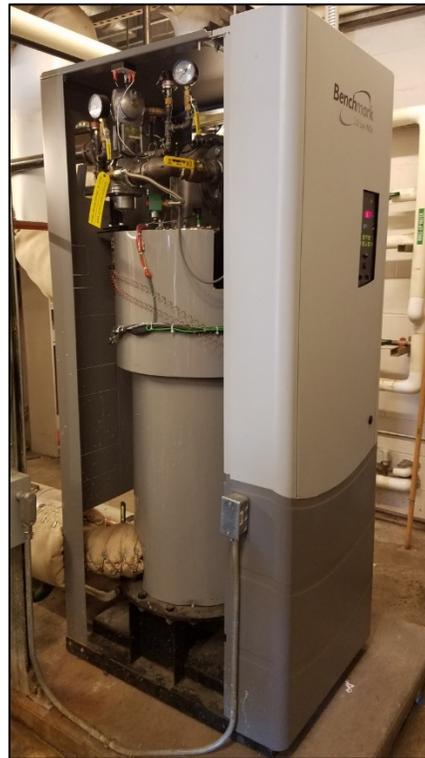
Photo 12. Settings were changed so that the more efficient condensing boiler carries the primary load.

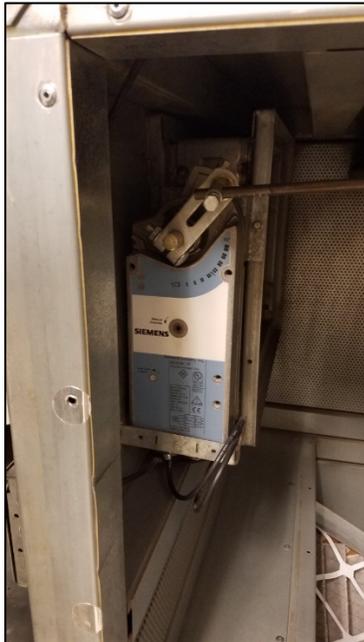
- **G17:** About a half-dozen non-functioning damper actuators and two faulty valve actuators were found.  
**Requirement:** Repair or replace non-functioning actuators.

**M&V:** According to the RCx, all non-functioning damper actuators and valve actuators were replaced. During a random spot check, new damper actuators were observed and functioning properly.

Photo 13. New damper actuator.

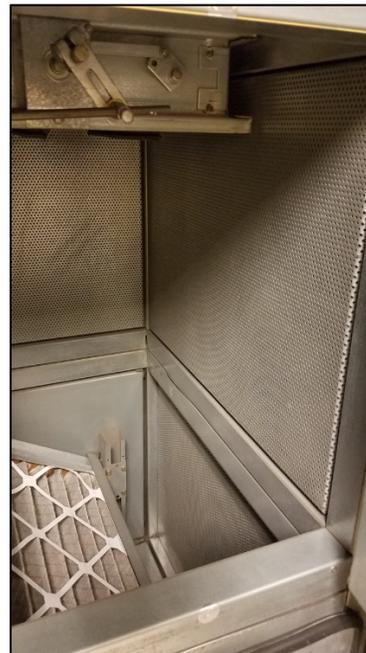
Photo 14. Random inspection of several units indicated filters had been replaced, and coils and plenums had been cleaned.

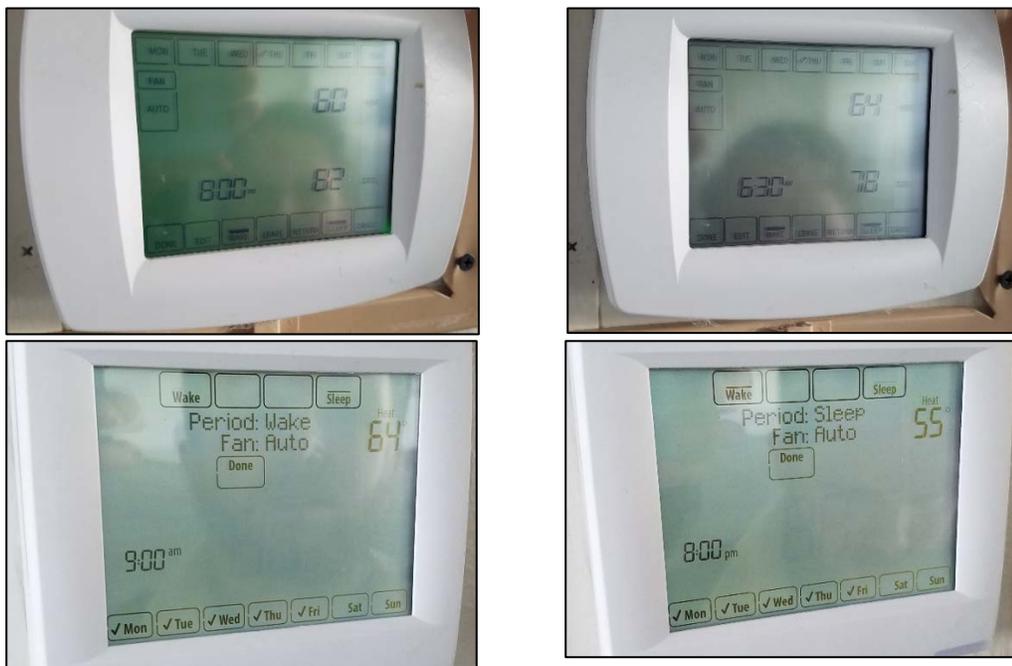
**M&V:** The BAS was inaccessible during site visit, but as per building management night set back functionality for the boiler temperature had been enabled. Temperature had previously been set to 160° F even in unoccupied times and is now set to 100° F during unoccupied periods, based on an occupancy schedule of 8am to 5pm M-F. Management provided a work order showing this included as a line item. All boilers and circulating pumps were disabled for the summer months, and they had recently been turned back on for winter. The two thermostats for the hangar space gas-fired units had been upgraded to include set back capability. Upon observation, they were each incorrectly set at different set points, and according to the manager at the time of the site visit, these had changed since they last had been observed. Though the requirement to enable unoccupied temperature set back was completed, the intended outcome did not show persistence. The manager then again changed both thermostats to 64° F for occupied periods and 55° F for unoccupied periods, on a schedule of 9am to 8pm. But because fluctuating nature of the event activity in the space and the public has access to these controls, maintaining consistent settings will continue to pose a challenge unless they are locked down.

*Photo 15. Top photos show that thermostats were set incorrectly. Bottom photos show corrected settings for occupied and unoccupied periods.*

**Requirement:** Set back boiler supply temperature at night in radiator zones and disable circulation pumps when there is no load. Set back hangar set points at night or during unoccupied periods. Disable boilers and boiler pumps seasonally.

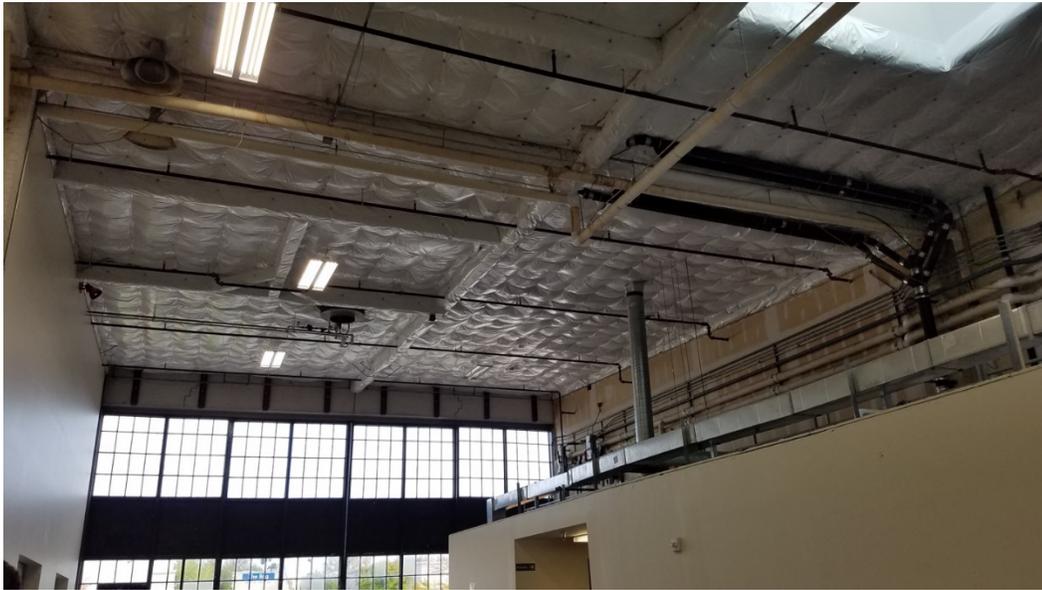
**M&V:** As visibly observed, some areas of the ceiling and walls had visible insulation that appeared to be recently installed. Some windows had been insulated and filled in with sheetrock. According to the RCM, upgraded walls were insulated to R-19 and the upgraded ceiling areas were insulated to R-38. Some windows still did not seal well when closed. The second floor of the northeast office space was inaccessible at the time of the site visit, but building management indicated that the hole in the ceiling had been sealed.

*Photo 16. Part of the ceiling was insulated. Note the ductwork to the right that has not been insulated.*

improve energy performance, as will repairing the windows so they close properly, insulating exterior walls and upgrading the windows throughout.

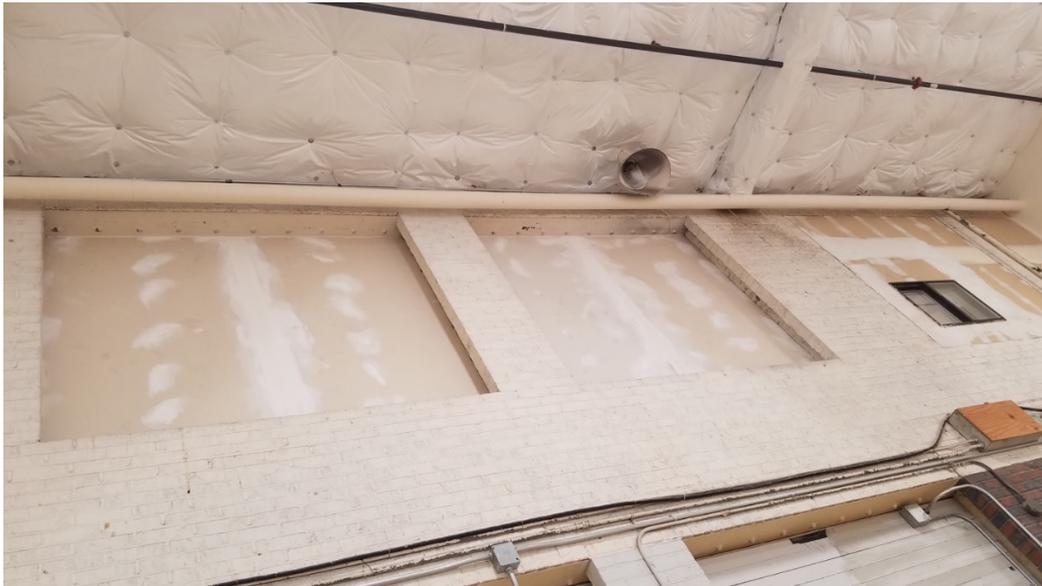
*Photo 17. Some windows were filled in and insulated.*

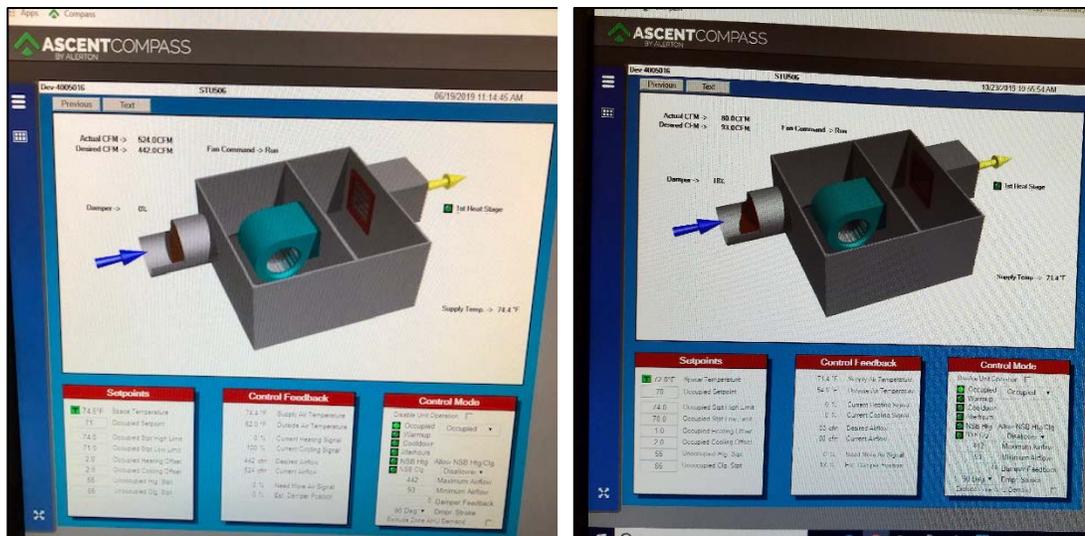
- **G6:** Several supply terminal units (STU) and exhaust terminal units (ETU) showed substantial flow variance from set points (either over-ventilating or under-ventilating).

**Requirement:** Investigate control settings and/or equipment and return to proper operation.  
**M&V:** According to building management, most of the suspect units had been set to manual override with dampers at 100%. The settings on these units were subsequently changed to remove the manual override and return them to intended operation. Two units had filters that were blown out. These filters were replaced, and the units were rebalanced. Several units had dampers that were mechanically stuck (open, shut, or somewhere in between); management physically corrected these. One unit was found to have a broken damper that was replaced. Visual observation of the BAS interface confirmed all units listed as suspect had been restored to intended operation.

Photo 18. Before and after BAS settings for VAV box.

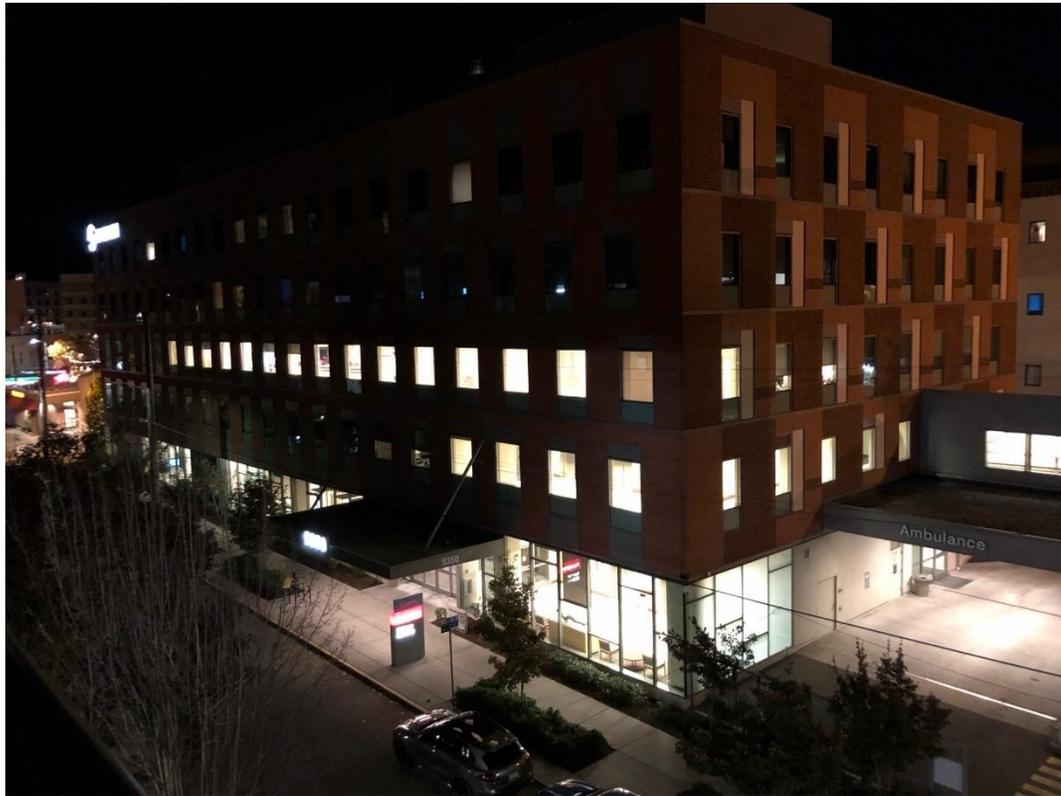
- **H3:** Custodial staff were overriding lighting control system and leaving all the lights on throughout the entire 3rd floor at night.  
**Requirement:** Change lighting control settings or occupant behavior to avoid leaving lights on during unoccupied hours.  
**M&V:** According to building management, custodial staff were educated about the importance of turning the lights off. Data from lighting loggers indicates that behavior has changed and the lights are being turned off after custodial work is completed (see graph below). Visual observation of the third floor from the exterior on 10/30/19 at 6am indicated common area with lights on but office lights off (see photo below).

Photo 19. Photo taken at 6am shows common space on third floor lights on, but office lights (right side) off.

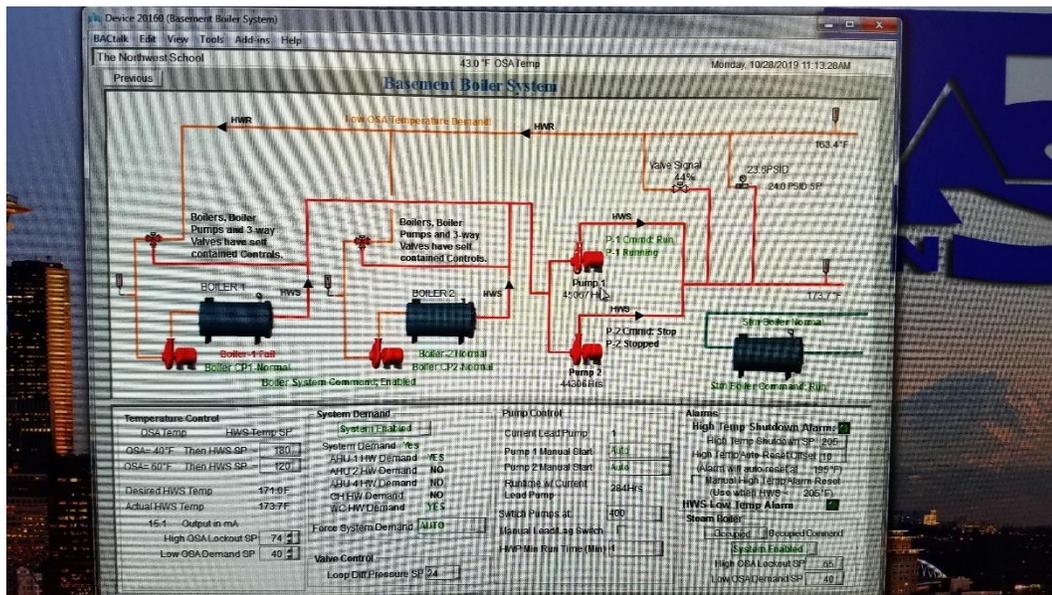
- **G3:** Penthouse boiler HWS loop reset was active (set point 120-140°F), but boiler system with package controls was maintaining ~170°F. Corrected control interface with package boilers and now running at lower setpoints.

Photo 20. Screenshot of BAS interface showing boiler reset functioning as intended.

**Requirement:** Correct control settings for boiler loop reset to maintain intended temperature.  
**M&V:** As per building management, control interface for boilers was corrected by changing a physical switch inside the unit itself that was overriding the reset functionality. Data loggers were deployed to monitor boiler supply temperature and OA temperature, and analysis of the data showed that the reset control was working as intended. See photo and graph below.

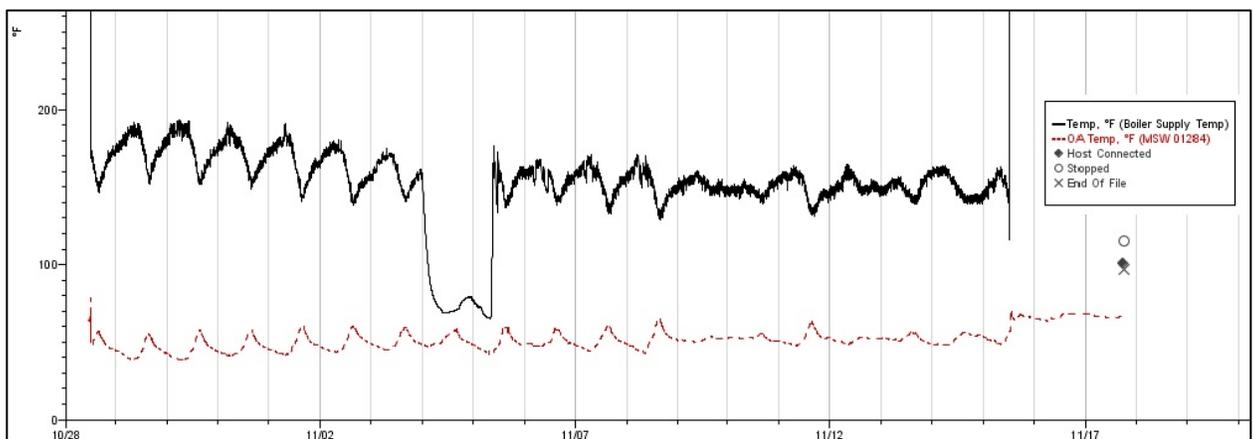
Figure 2. Graph shows boiler reset function working as intended, with higher outside temps corresponding with lower supply temps. Note: The big dip in supply temp was when the boiler was offline for a repair.

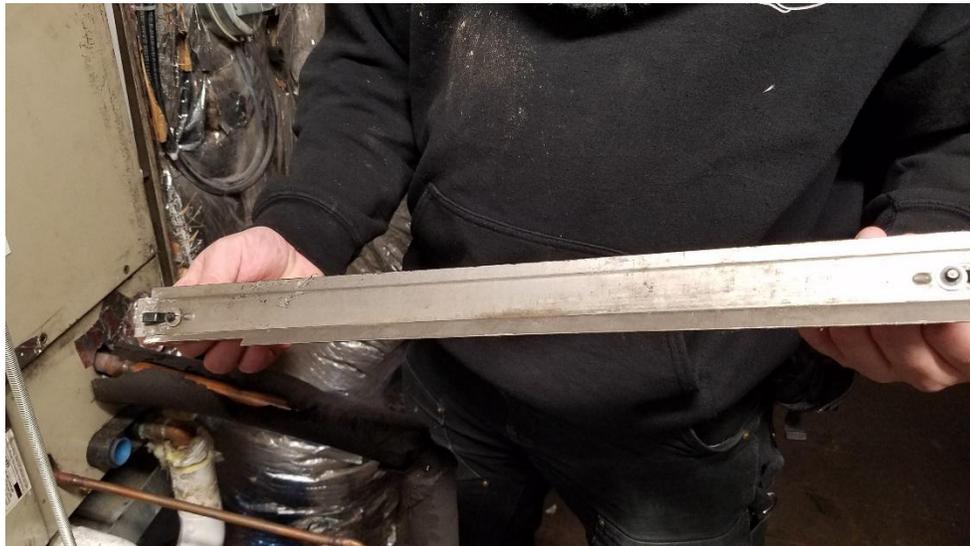
**M&V:** As per building management, the mechanical space is no longer used as a storage location, and visual inspection confirmed this.
- **G14:** AHU-4 filter frame is taped on and therefore ineffective.

*Photo 21. A bracket on the non-functioning filter frame was repaired.*

**Requirement:** Repair or replace filter frame.  
**M&V:** As per building management, a bracket on the filter frame was repaired to restore it to full functionality; visual inspection confirmed this (see photo below).

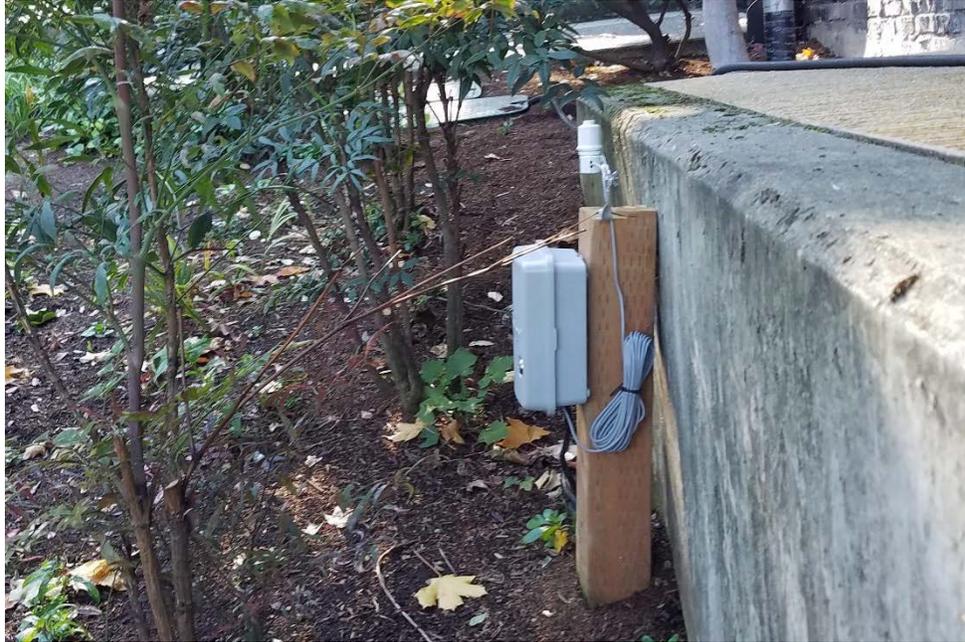
- **J5:** Irrigation system does not have rain sensors.  
**Requirement:** Install rain sensor for irrigation.  
**M&V:** As per building management and visual inspection, a rain sensor controlling the irrigation was installed (see photo below).

Photo 22. A rain sensor was added to the irrigation system.

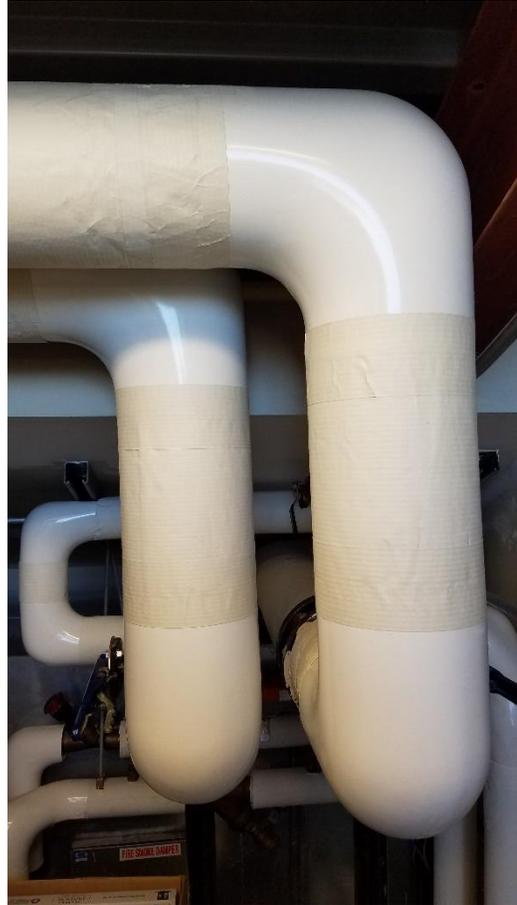
Photo 23. New insulation on piping in penthouse area.

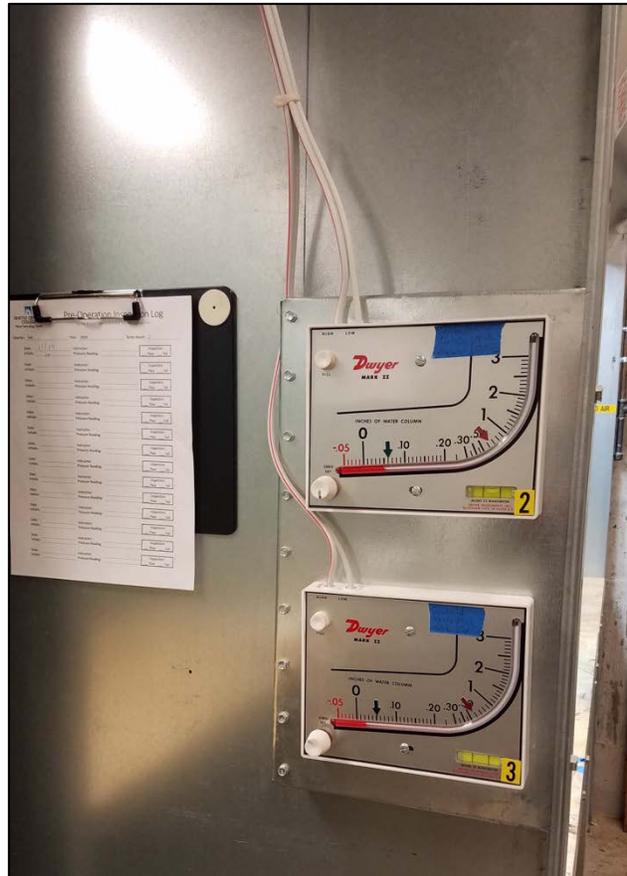
Photo25. Spray booth pressure is monitored and logged regularly.

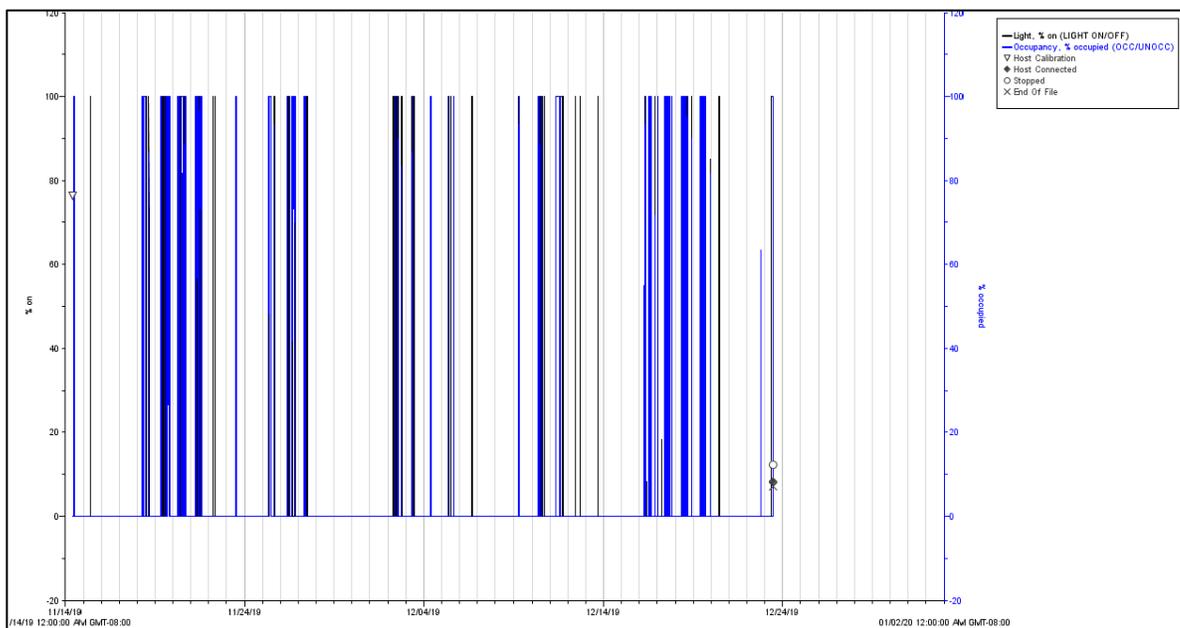
- **H3:** Lighting stays on past occupancy schedule.  
**Requirement:** Configure lighting to same schedule as HVAC.  
**M&V:** Building manager and Tune-Up Specialist confirmed that the lighting was set to follow HVAC schedule on 12/20/18. Lighting loggers were deployed, with data confirming these schedule settings (off at 21:00). See graph in Figure 4 below.

Figure 3. Lighting/occupancy logger data shows correct schedule.

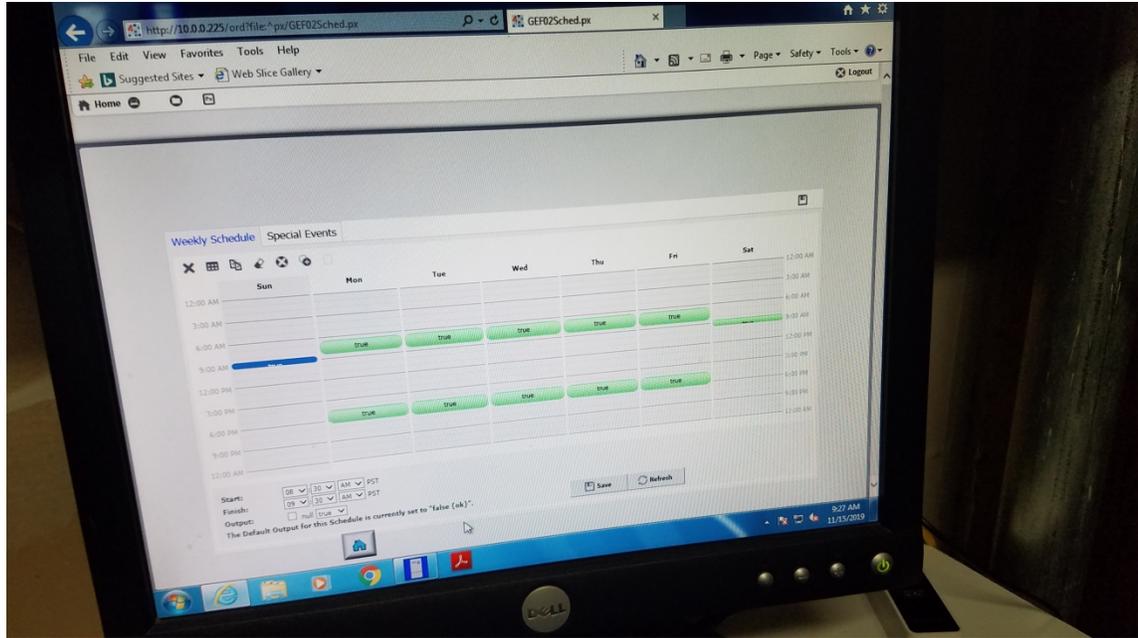
Photo 26. Reduced parking garage exhaust fan schedule.

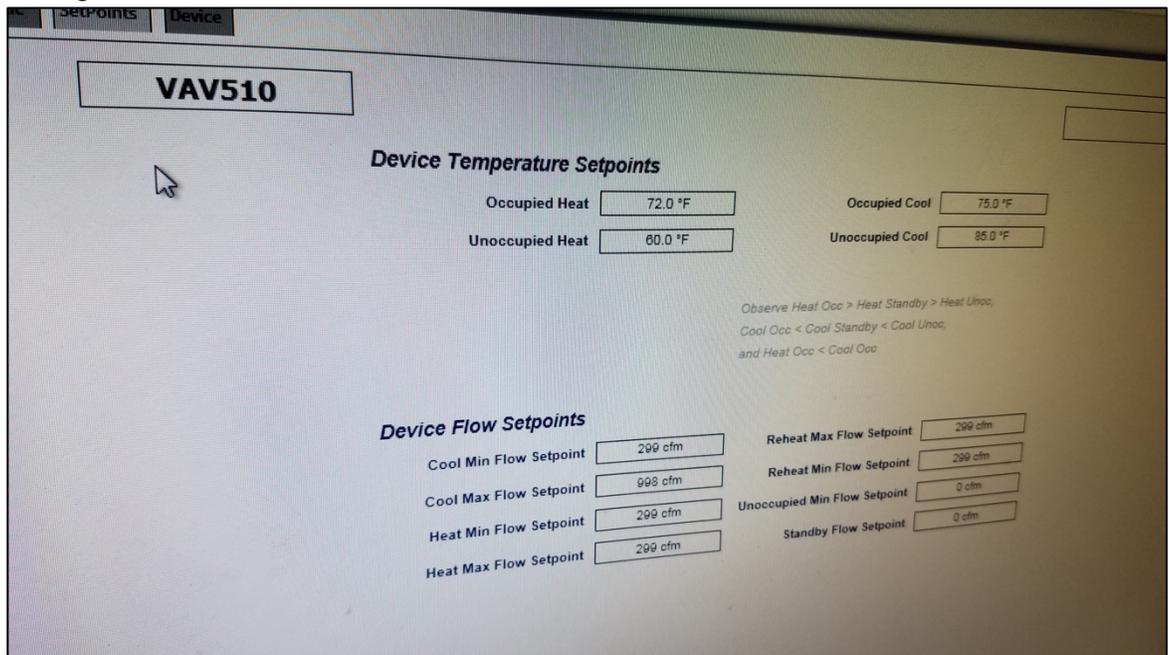
- **G2:** HVAC set-point and set-back temperatures could be lowered.  
**Requirement:** Review HVAC set-point and set-back temperatures and update as appropriate (e.g. 68°F /62°F in heating, and 75°F /80°F in cooling).  
**M&V:** VAV settings were observed through BAS interface, and occupied set points were 72°F for heating and 75°F for cooling. Night set backs were 60°F for heating and 75°F for cooling.

Photo 27. VAV set points and set backs.

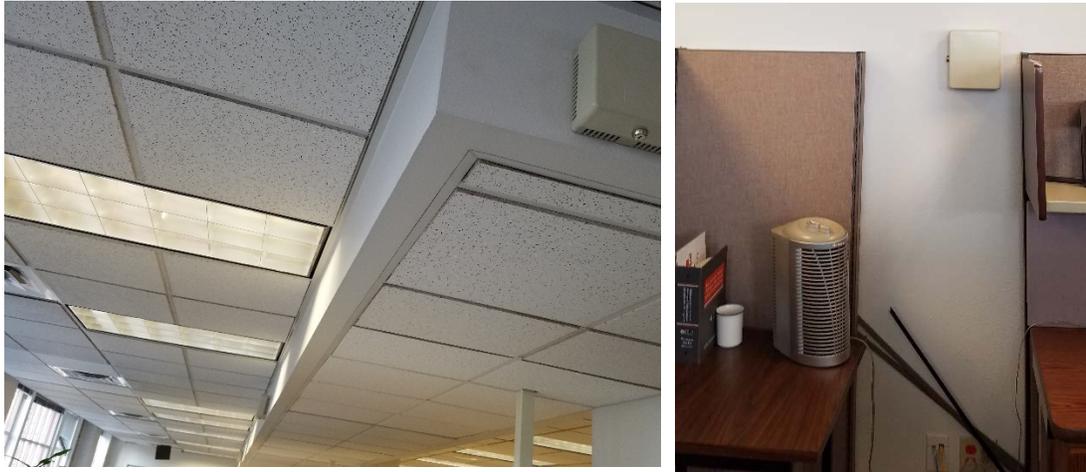
- **G5:** Thermostats in office spaces are located near the ceiling.

**M&V:** As per building management, this had been completed on 4 of 6 floors, with the other two floors scheduled to be completed as part of the remaining controls upgrade in early 2020. This was confirmed by visual observation.

*Photo 28. Thermostats were previously located near the ceiling (left) but have been moved to a more accurate location further down the wall (right).*

**Requirement:** Move thermostats from ceiling to wall according to ASHRAE guidelines where possible.
