# **Taylor Creek Sediment Study**

**Seattle, Washington**

**July 2007**

**Perkins Geosciences**

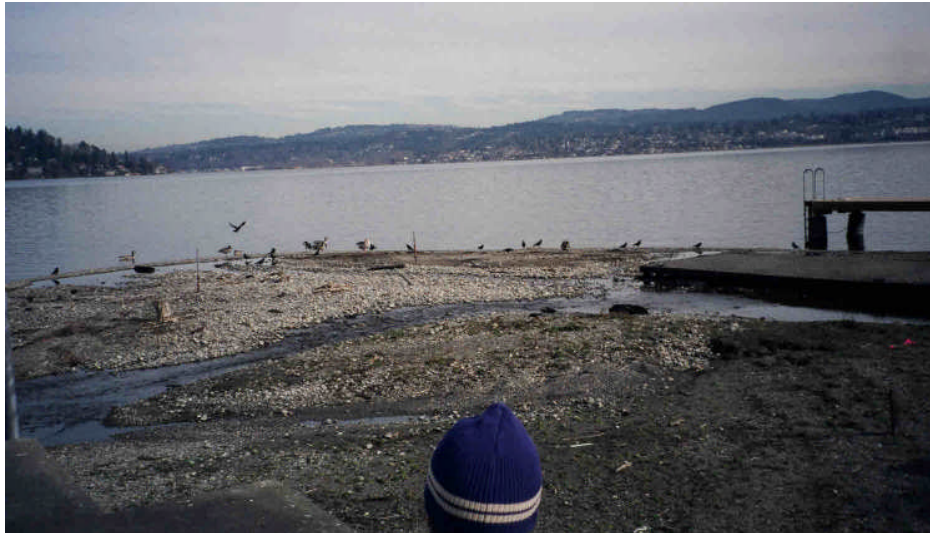
**Figure 9. Photograph showing Taylor Creek outlet on the left (west) side of the delta in February, 2007. The creek reportedly switched to this location during the storm of November 5-7, 2006. The low dock on the right side of the photo prevents the creek from flowing down the east side of the upper delta.**

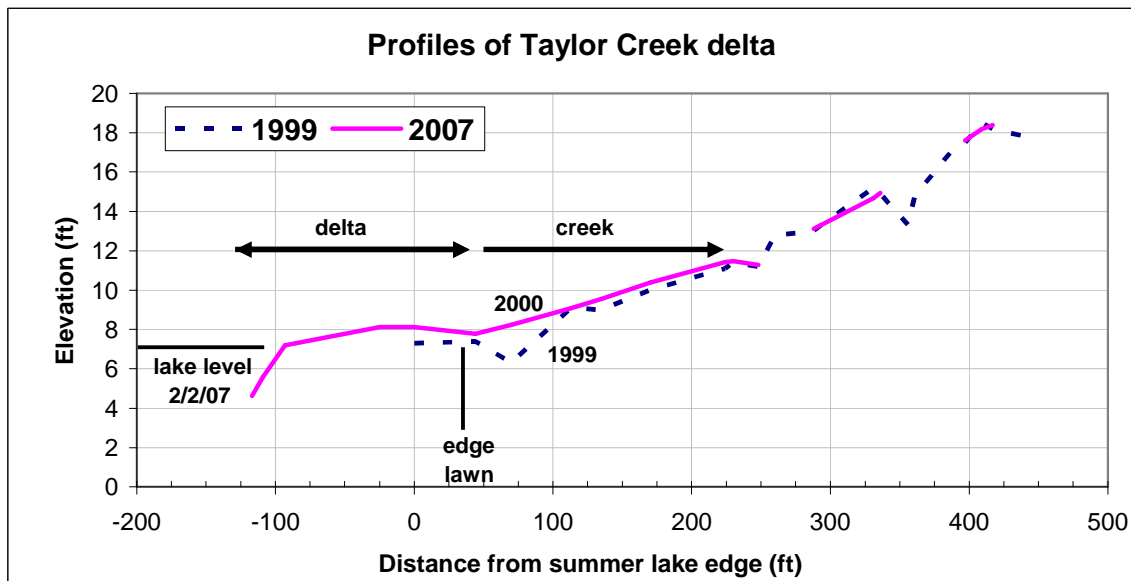
No estimates were made prior to 1999 due to lack of data, but up to 4 feet of sediment reportedly was deposited in the lower creek near the delta in 1990 and dredged the next year (Section 3.1.1.1). Deposition followed by dredging probably also occurred in the early 1980s.

**Figure 12. Profiles of Taylor Creek below Rainier Avenue showing about 1 foot of sediment deposition in the creek just upstream from the delta between 1999 and 2007. See Figure 4 for location of delta and creek profiles. The 1999 profile is from Thomas/Wright, Inc. (2000).**

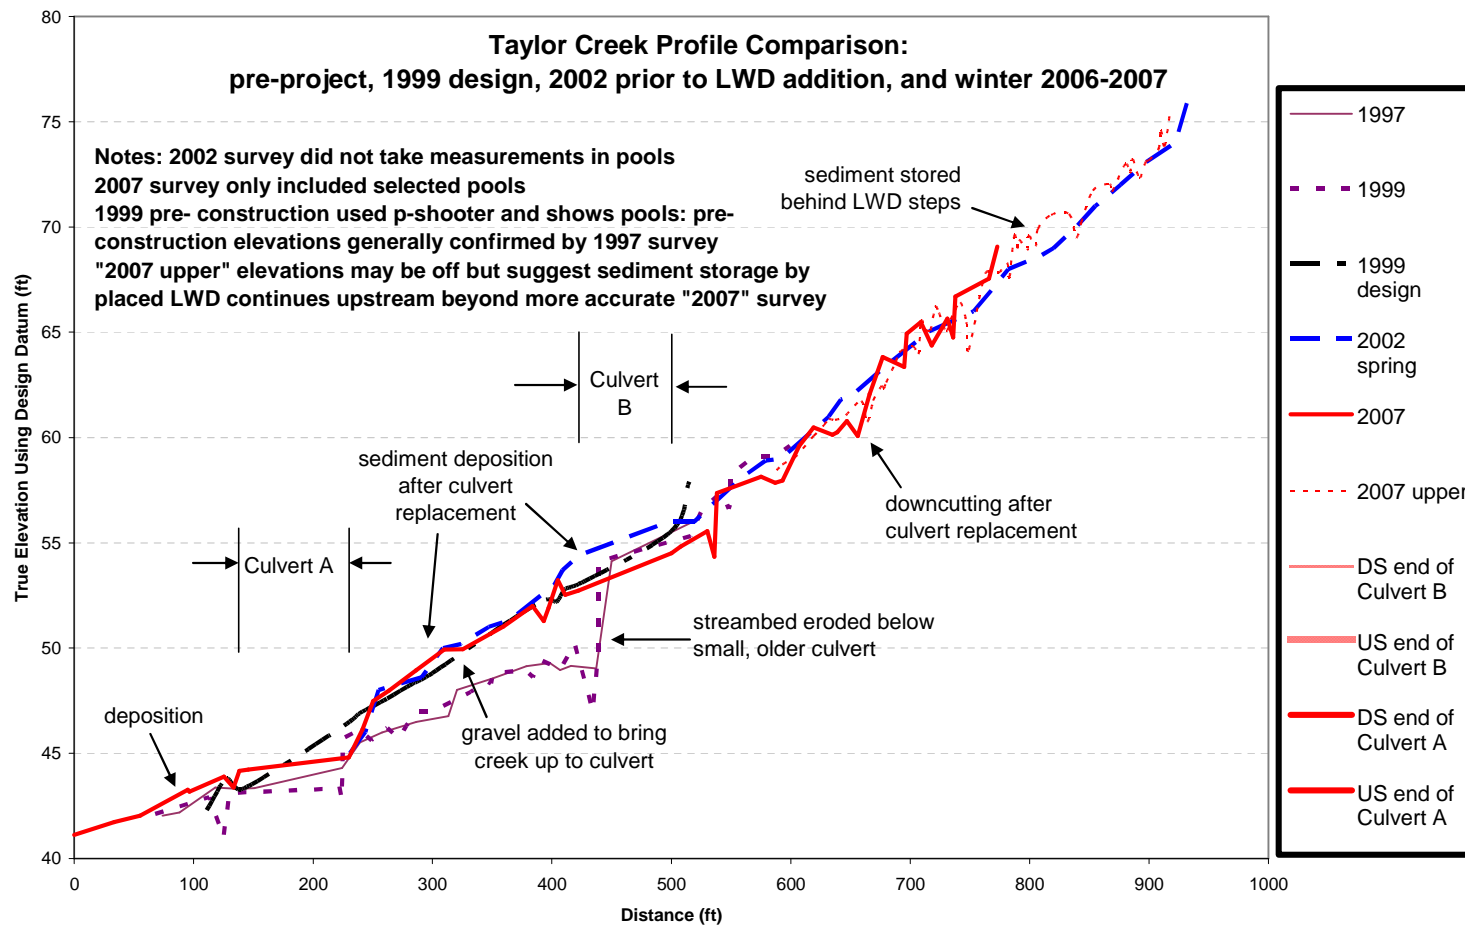
In 1999, the City of Seattle replaced undersized 3-foot culverts at the two road crossings with much larger, 14-foot wide culverts. The old culverts were too small to convey storm runoff from the urbanized basin, which was mostly built out by the end of the 1940s. By 1999, Culvert B could only pass the 2-year flood and the road embankment served as a dam for an unintended storm water detention basin (TWI and Taylor, 1999). Over the years, about 500 yd<sup>3</sup> of gravel deposited in the backwater zone upstream from Culvert B, raising the valley floor and creating a broad depositional zone that extended about 160 feet upstream. The channel downstream from Culvert B was starved for sediment and eroded about 200 yd<sup>3</sup> from its bed, cutting down to form a 7-foot high hanging culvert as shown in Figure 14. There was a drop of over 4 feet from the

**Figure 14. Profiles showing the streambed of Taylor Creek prior to construction (1997 and 1999), the designed new channel (1999 design), and post-construction (2002 and 2007). Although not shown on the profile, the design included eight log weirs with associated pools. No as-built survey was performed. Station 0 is shown on Figure 13. Cross-section 17 is located at about Station 640.**

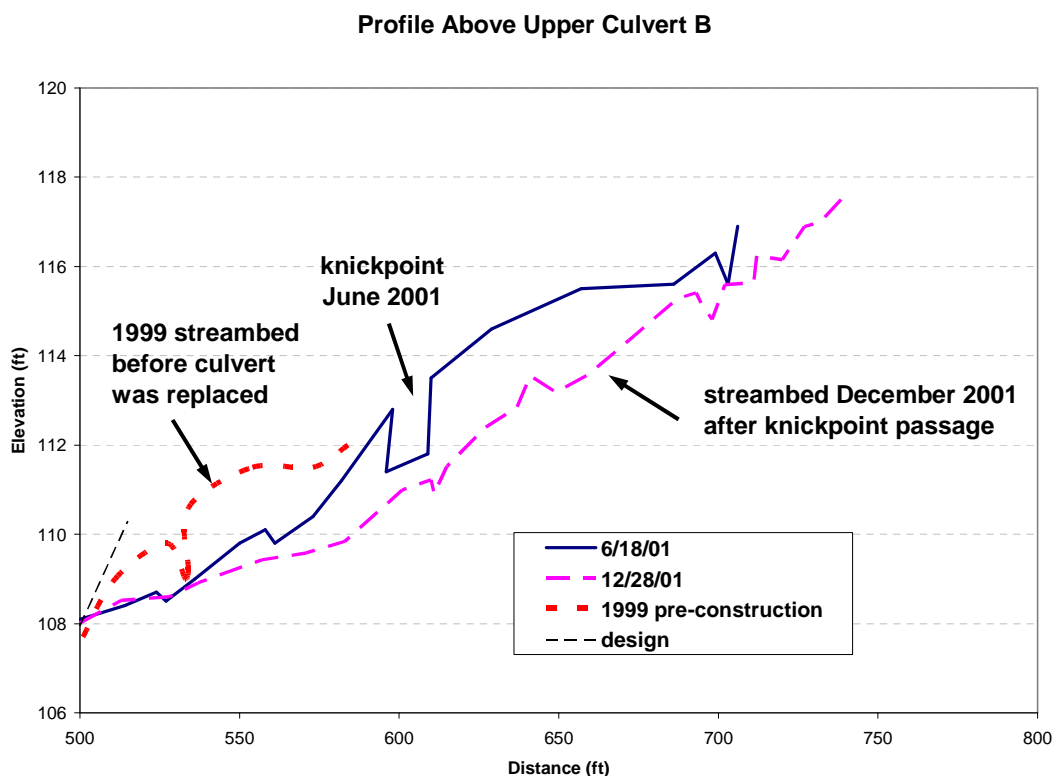
The sandy gravel that had accumulated upstream of the old, undersized culvert was a smaller caliber sediment than the bedload from the canyon. By early 2002, the former backwater deposits had been eroded away and the streambed had coarsened. Downcutting reexposed some large boulders in the streambed at the upstream end of the former depositional zone. The new surface texture was about half gravel and half cobbles, with a median diameter of 58 mm (Appendix A, XS 15&16). Gravel-cobble bedload from the canyon upstream was now being transported all the way through the former depositional zone.

**Figure 15. Stream monitoring profiles starting at the upstream of Culvert B (Station 500), showing upstream knickpoint migration after culvert replacement in 1999.**

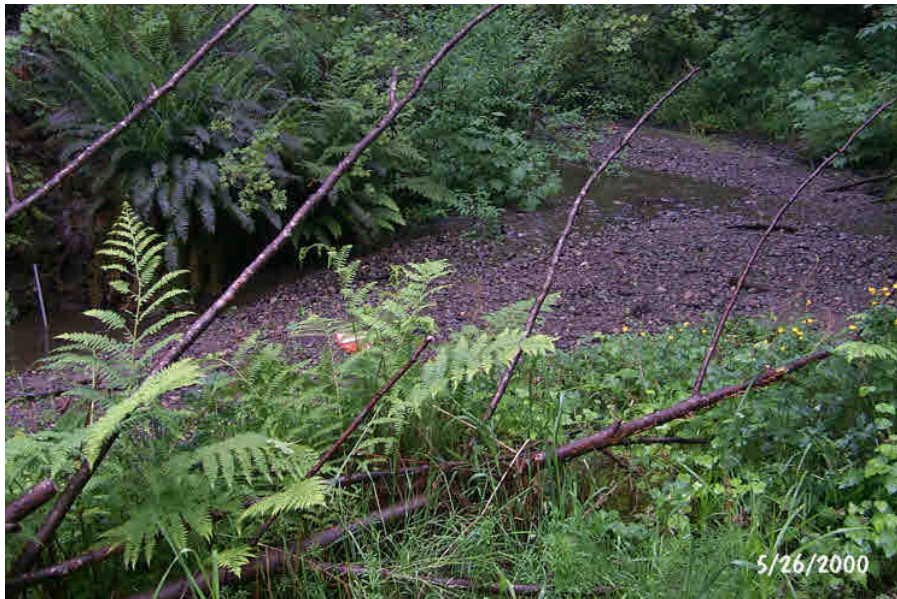
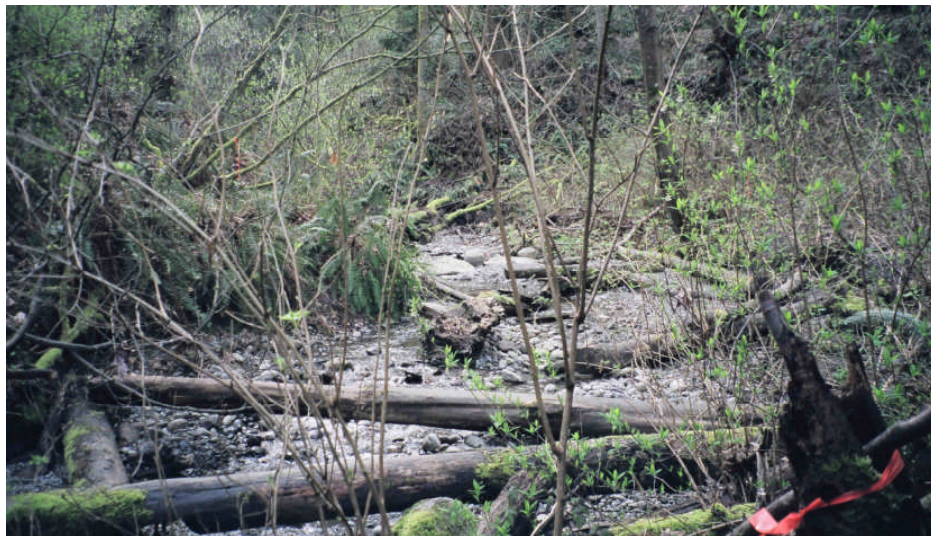
**Figure 16. 2000 and 2007 photographs taken from the same location above Culvert B, looking upstream through cross sections 16 and 17. The broad gravel deposits have been eroded away, replaced by a deeper channel with cobbles and some boulders on the streambed.**

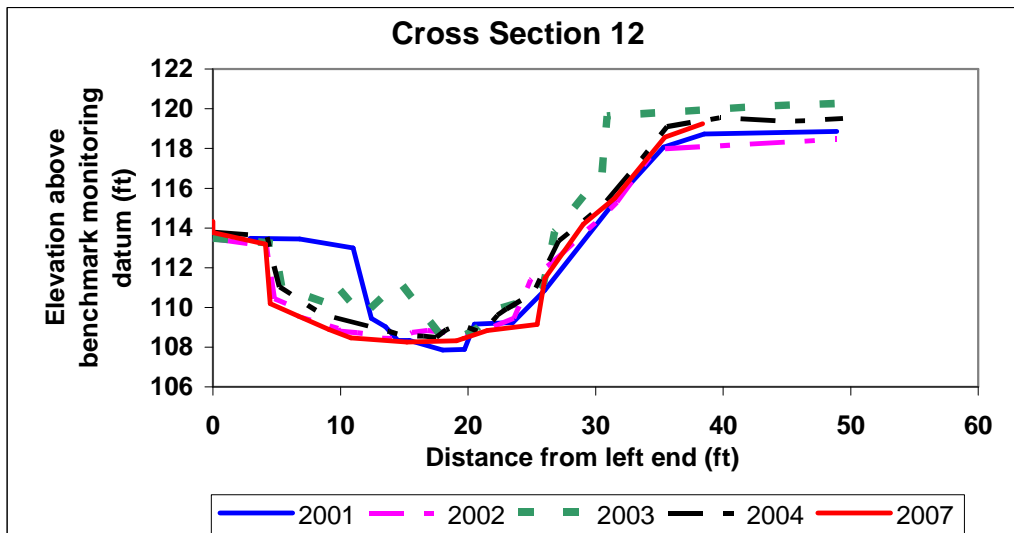
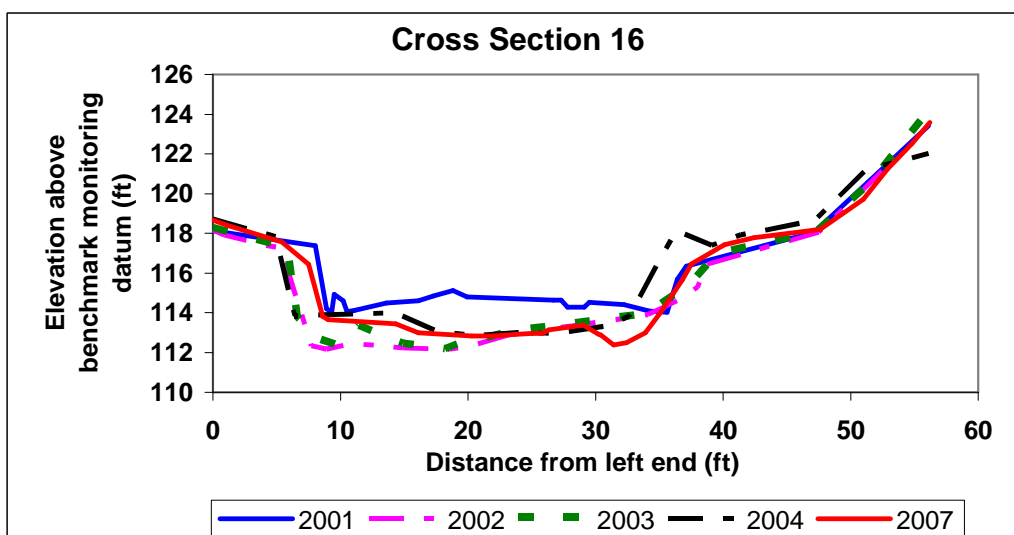
**Figure 17. Cross-section surveys showing widening and channel incision after upstream passage of the knickpoint. Cross-sections 12 and 16 are 32 and 125 feet upstream of Culvert B, respectively (see Figure 13).**

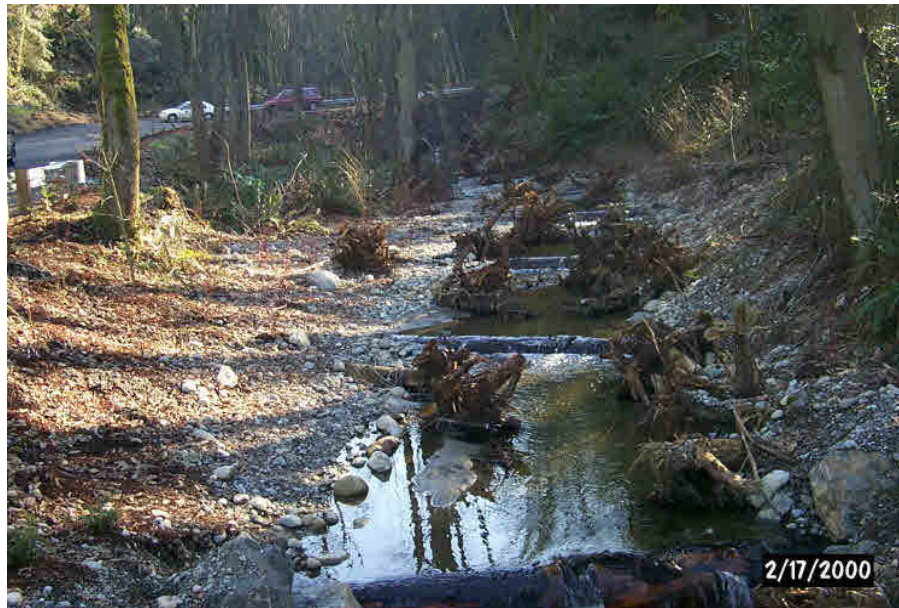
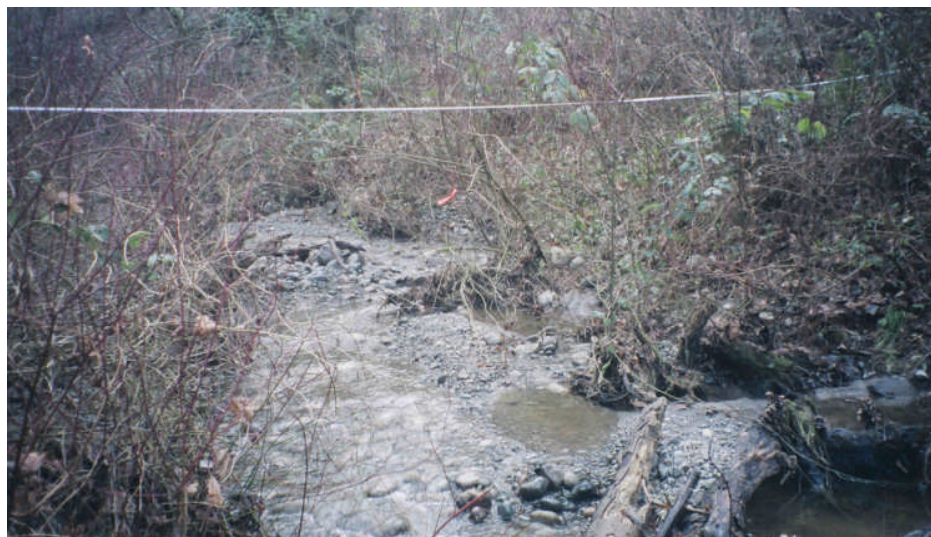
Taylor Creek between the culverts became very wide and braided when the initial sediment deposits buried the constructed channel. The creek had shallow, poorly-defined channel threads with a median sediment diameter ( $D_{50}$ ) of 20 mm and a  $D_{84}$  of 55 mm (Appendix A, "below XS 10" sample). By 2007, the creek had developed a single, deeper channel with some mild bends and had coarsened with a  $D_{50}$  of 34 mm and  $D_{84}$  of 81 mm. Some of the former gravel bars had become vegetated floodplain. These changes are consistent with a declining coarse sediment load compared to earlier when the accumulated fill above Culvert B was eroding.

**Figure 18. Paired photographs looking upstream from Culvert A towards Culvert B, showing the channel the first winter after construction (above), and the same location in 2007 after the log weirs were buried with sediment (below).**

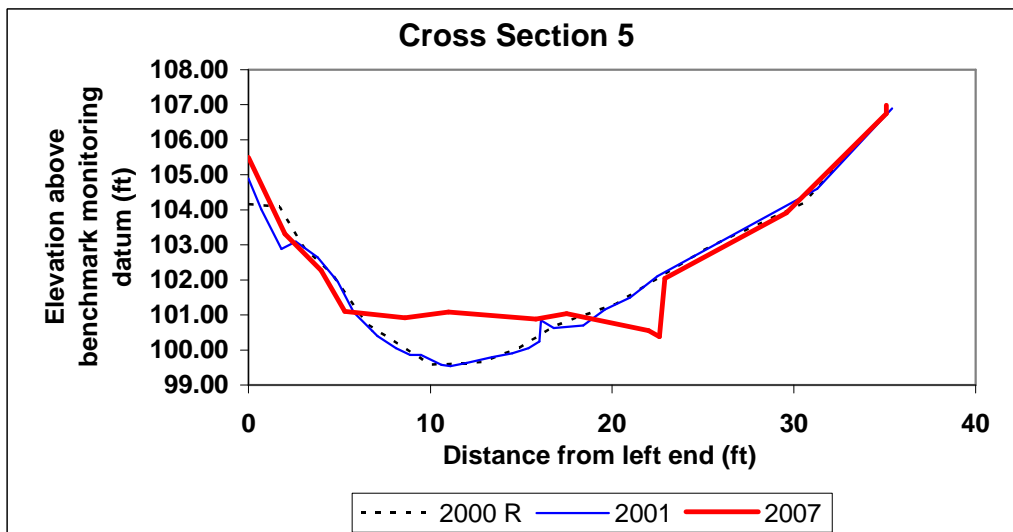
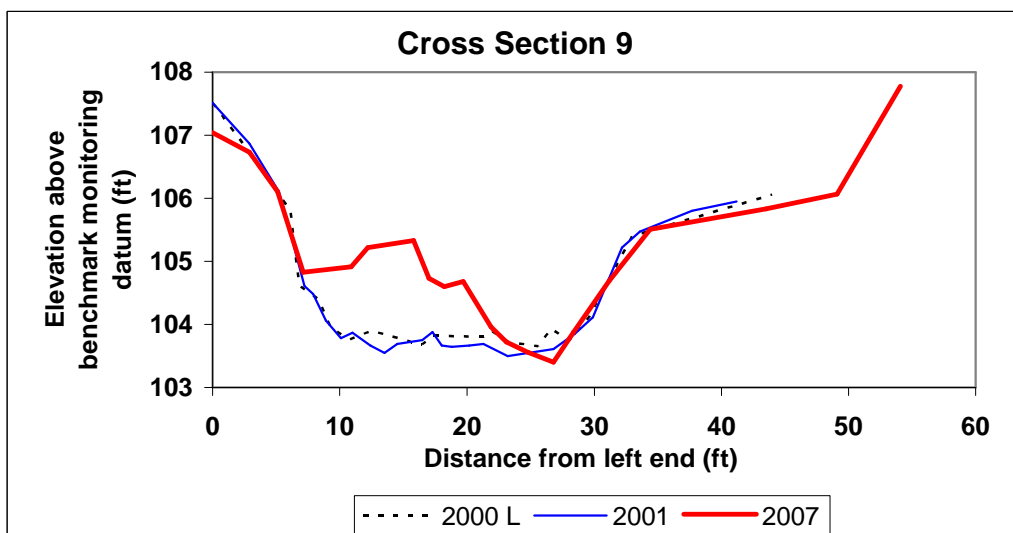
About 80 yd<sup>3</sup> of sediment were deposited between the two culverts between 2001 and 2007. Figure 19 shows sediment deposition at two of the cross sections. Only a few cross sections below Culvert B were surveyed in 2002, so there was insufficient survey data to determine whether some of the 130 yd<sup>3</sup> pulse of sediment from above Culvert B in 2001-2002 moved beyond the culvert-replacement zone that same year. At least 50 yd<sup>3</sup> of it was deposited a short distance downstream from Culvert B (Table 6).

**Figure 19. Cross-section surveys showing accumulation of sediment between the two culverts since the year 2000. Cross-sections 5 and 9 are 161 feet and 63 feet downstream of Culvert B, respectively (see Figure 13). The 2000 and 2001 surveys were done in summer. The "2007" surveys were done in Dec. 2006 (XS 5) and Jan. 2007 (XS 9).**

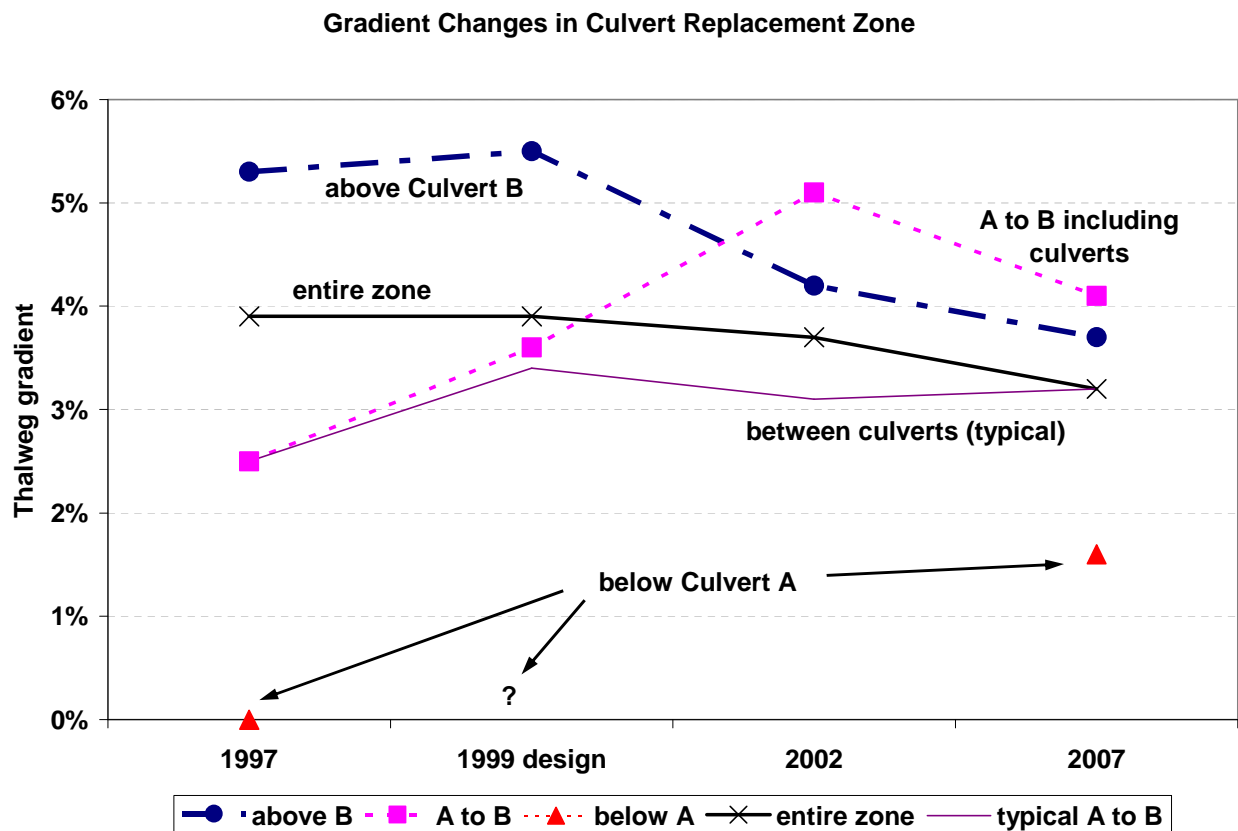
Although steeper than before, after construction the channel between the two culverts was flatter, wider and rougher than upstream. This caused sediment to drop out as soon as it exited culvert B. The length of channel between and including the two culverts steepened rapidly from 3.6% after construction to 5.1% in 2002. The initial steepening resulted from deposition at the upstream end and scour at the downstream end. The scour problem was repaired which brought the downstream bed up. Deposition at the upstream end was worsened by an

**Figure 20. Gradient changes in the culvert replacement zone.**

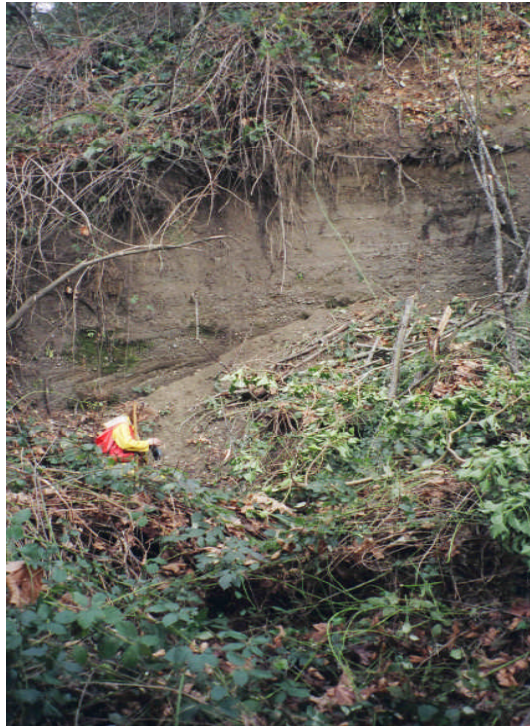
**Figure 22. Photograph of a 30-foot-high landslide in Vashon advance outwash gravel, East Fork Valley reach.**

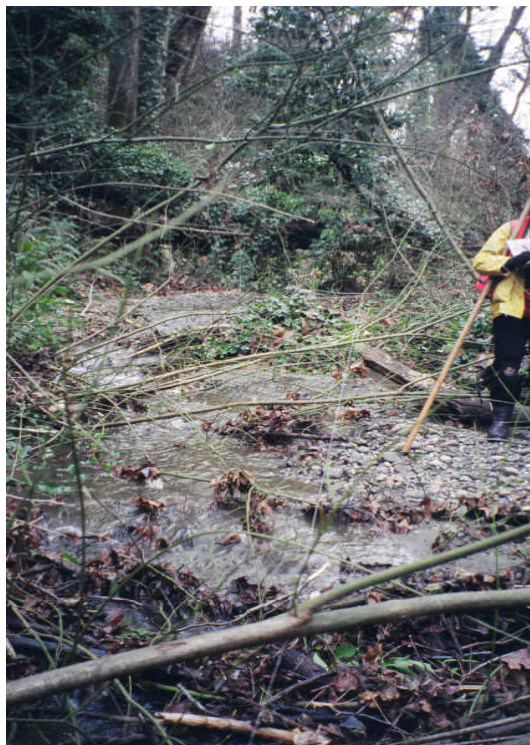
**Figure 23. Photograph of gravel deposits on East Fork Taylor Creek upstream of a valley-spanning LWD jam that raises the creek 4 feet.**

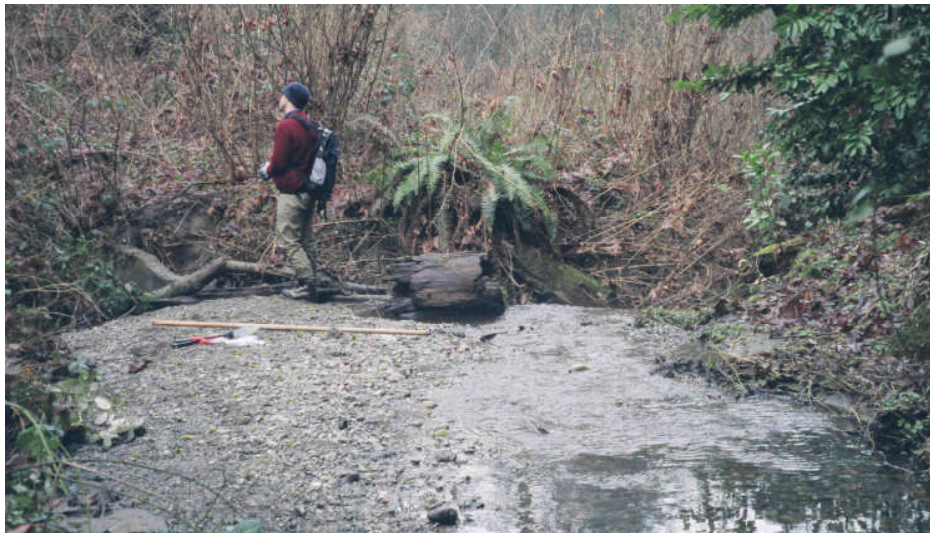
The third notable area of erosion on the East Fork is the bypass channel around the plugged culvert near the mouth of the East Fork. The bypass channel has enlarged dramatically since 2001, but since nearly all the eroded sediment was silt or clay it did not contribute to delta growth. Continued erosion at the inlet to the bypass channel could lead to failure of a concrete wall that steps up the channel 4 feet and stores gravel behind it. Should this occur, it would trigger downcutting further upstream. A small, groundwater-fed channel delivers a minor amount of sand to the bypass channel from a slowly-eroding, till landslide known as the Grotto.

**Figure 24. Photograph of gravel deposit upstream from plugged culvert near the mouth of the East Fork. The plugged culvert is to the left of the person. The creek currently drops off a 4-foot-high concrete wall into the bypass channel to the right.**

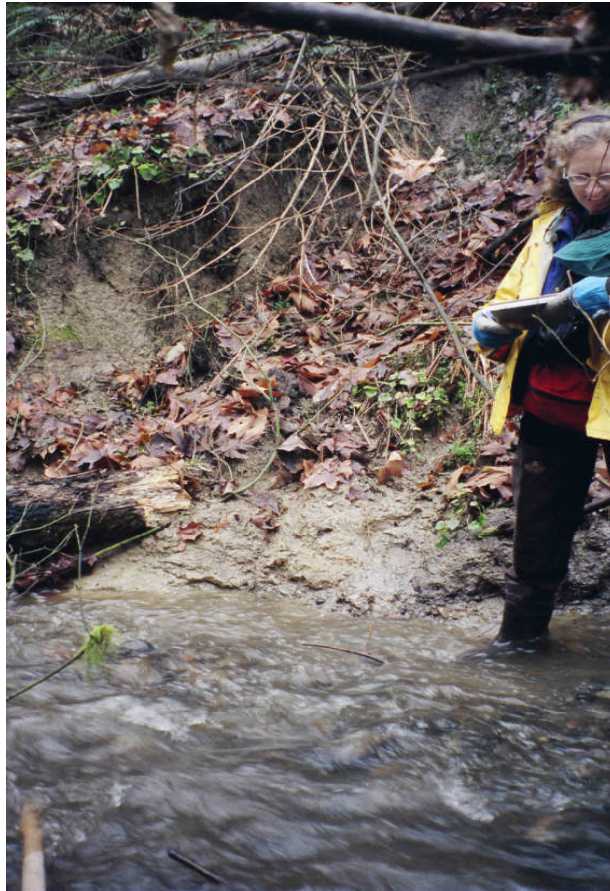
**Figure 25. Photograph of fresh bank erosion in glaciolacustrine silt in the lower West Fork Canyon reach.**

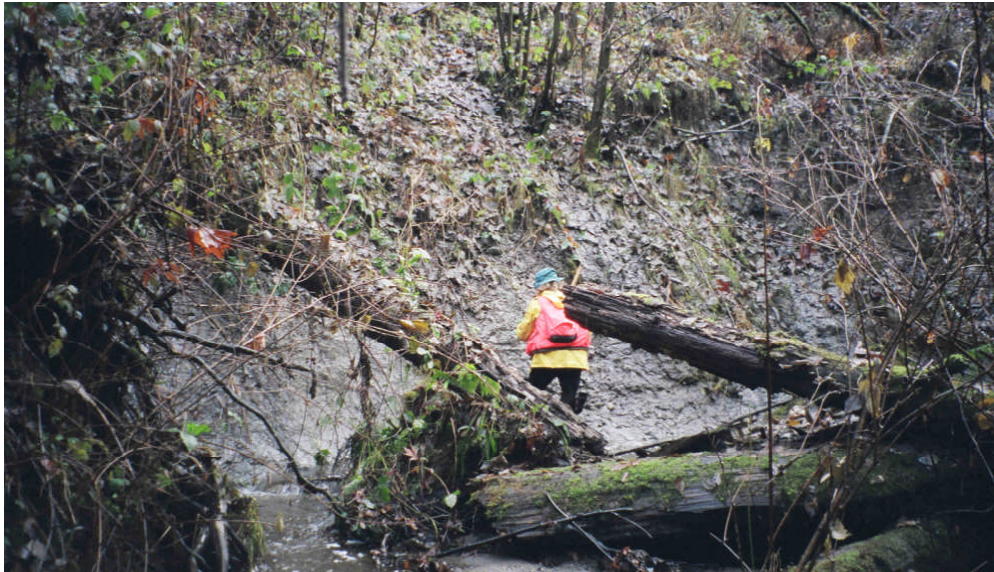
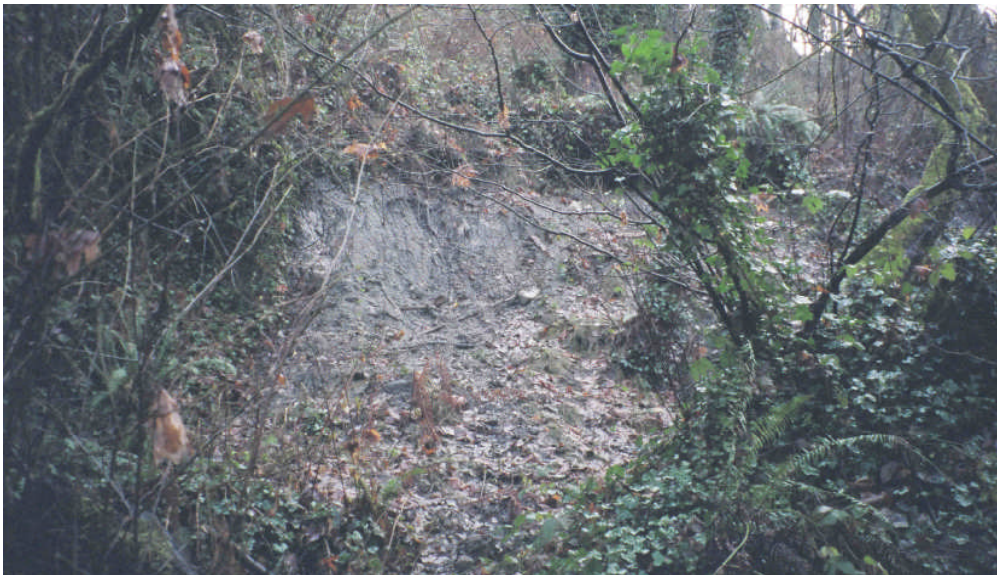
**Figure 26. Photographs of streamside landslide (above) and mid-slope landslide (below) in Deadhorse Canyon, mainstem Taylor Creek.**

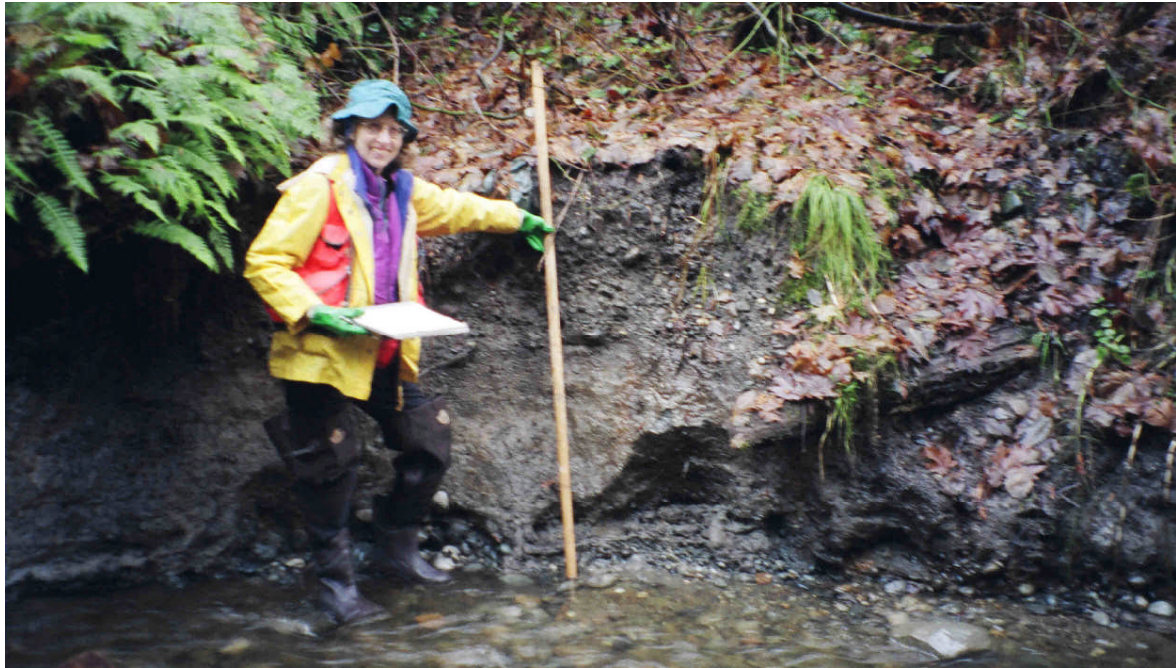
**Figure 27. Photograph of bank erosion in Deadhorse Canyon, showing clay-rich soil overlain by colluvium that contains some gravel.**
