Subject: 614 Maynard Avenue South – Existing Masonry Façade – Project Comparisons

Re: Seismic Assessment and Rehabilitation Recommendations for 614 Maynard Avenue South, located in Seattle, Washington

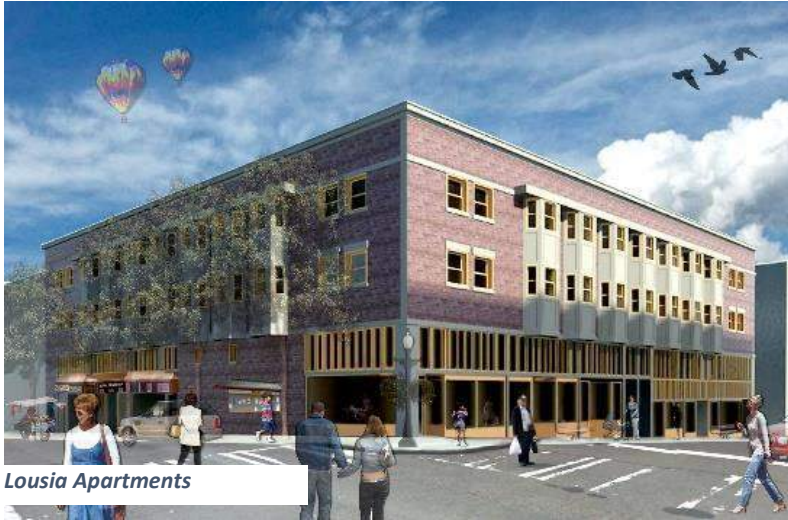
Louisa Apartments

In contrast, the Louisa Hotel Apartments did not require any major effort to retain the existing façade since the remaining interior structure was in good condition. There were few similarities with the 614 Maynard Avenue project, except for water intrusion issues and a partial unsupported below grade foundation. The Louisa Hotel Building structure was reported to be in good condition. The masonry was in good condition. However, portions of the roof had been

compromised and temporarily covered by tarps, exposing the building to water infiltration. In the retail area, due to the buildup of the flooring materials over time, unsafe conditions were uncovered during construction. Rotting wood required that the floor structure be rebuilt. The most notable safety hazard was the unsupported below grade walls. After a section of the Louisa Hotel burned down, a portion of the damaged structure was removed leaving below grade concrete walls exposed and unsupported. Even though the Louisa Hotel was generally in good condition and deemed safe by licensed engineers for construction to occur, during construction the project experienced a catastrophic failure when the southern wall unexpectedly collapsed. There was no injury because it occurred after hours; however, if the site would have been occupied, there would have been a significant safety risk. This indicates the inherently uncertain and dangerous nature of retention of existing masonry façade structures and helps inform the conservative recommendations that GC will make to ensure site and worker safety as required by law.

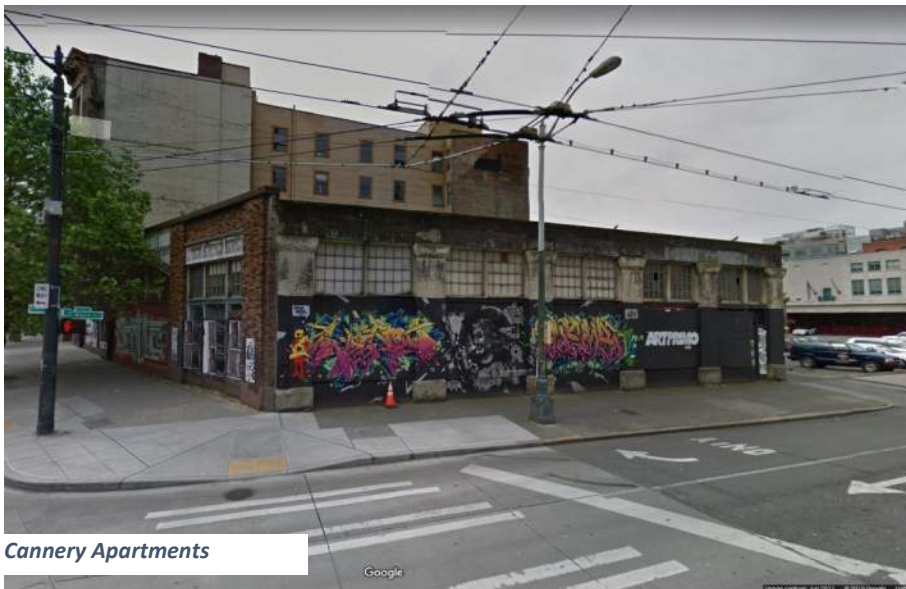
The Cannery Apartments has most similarities to the 614 Maynard project. Portions of the masonry walls were built at different times, the roof and building envelope had been compromised, the structure had been compromised, bearing soil was at a significant depth, and a basement existed in the structure. Note that an existing basement in these conditions poses a unique extreme challenge

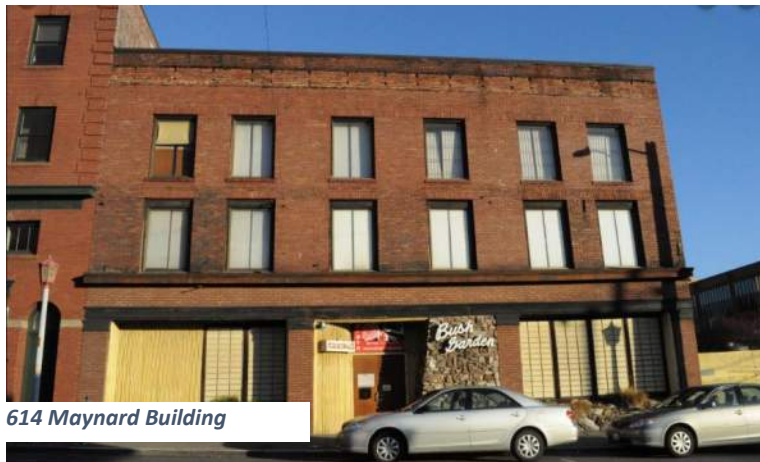
614 Maynard Building

The 614 Maynard project has many similarities to the Cannery project. Although the Cannery building is more advanced in its dilapidated condition, the 614 Maynard project poses similar safety concerns and challenges as noted in DCI’s Seismic Assessment report. DCI specifically references the compromised state of the below grade basement and structural elements supporting those basement walls. Most notably “the columns and basement walls and footing were originally designed for a one-story building” (See page 6 of DCI’s report) and “there is no obvious footing under the basement concrete walls.” (See page 5 of DCI’s report). There has been no work done to-date to upgrade the walls, columns or footing to accommodate the addition of the second and third floor. As mentioned in the Louisa Hotel project, basement walls do collapse if they are unsupported. Like the Cannery project there is no safe way to get a construction worker in the basement in its current condition. After reviewing this project with multiple Structural Engineers, a Shoring Engineer, a Geotech, General Contractor and Shoring Contractor, collectively we have come to the conclusion that extreme measures will need to be taken to create a safe working environment to salvage the existing masonry façade, very similar to the Cannery Project. Outlined below are steps associated with salvaging this masonry façade. The basement poses the biggest challenge, unfortunately like the Cannery project, soil freezing will most likely not be an option with the below grade utilities near the property line at 614 Maynard. Alternatively, the only safe way to support the below grade walls is to fill the basement with a lightweight concrete (CDF) (See Step 1 Below). CDF would be filled up to 2/3rd the height of the basement walls. Per the Geotech recommendations, we would be required to place the lightweight concrete in one-foot increments,

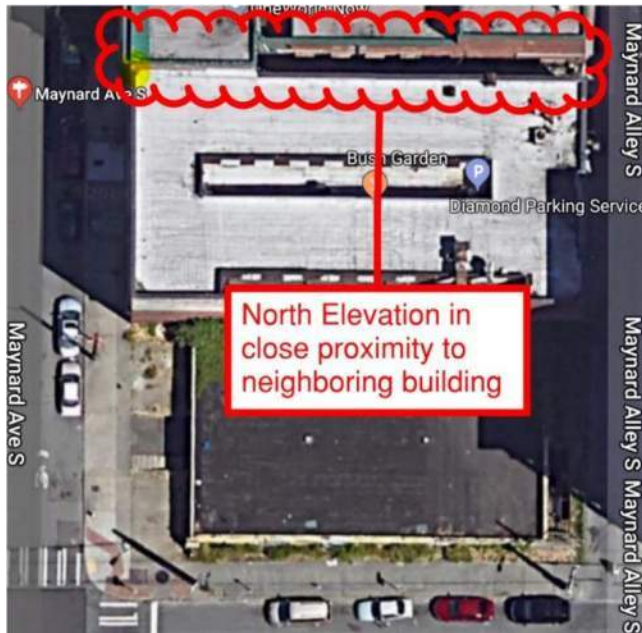
Exterior Bracing Scenario Challenges – A typical exterior structural steel bracing scenario was explored, however there are real challenges with this approach which would limit the amount of façade that could be salvaged. The east walls would require permission from Seattle Department of Transportation and

the building owner across the alley to place structural steel elements in the alley to temporarily support the masonry façade. Considering the location of the neighbors parking garage, any such bracing would block access to their building, which you can see in the picture to the left. This will make it highly unlikely that such a technique could be utilized (even if it were permissible by SDOT). Accordingly, such a technique is not viable for retention of the Existing Structure east façade.
