# ALASKAN COPPER WORKS BUILDING ANACONDA WIRE & CABLE CO. BUILDING

902 & 904 FIRST AVENUE SOUTH

## HISTORIC RESOURCES REPORT

OCTOBER 2019

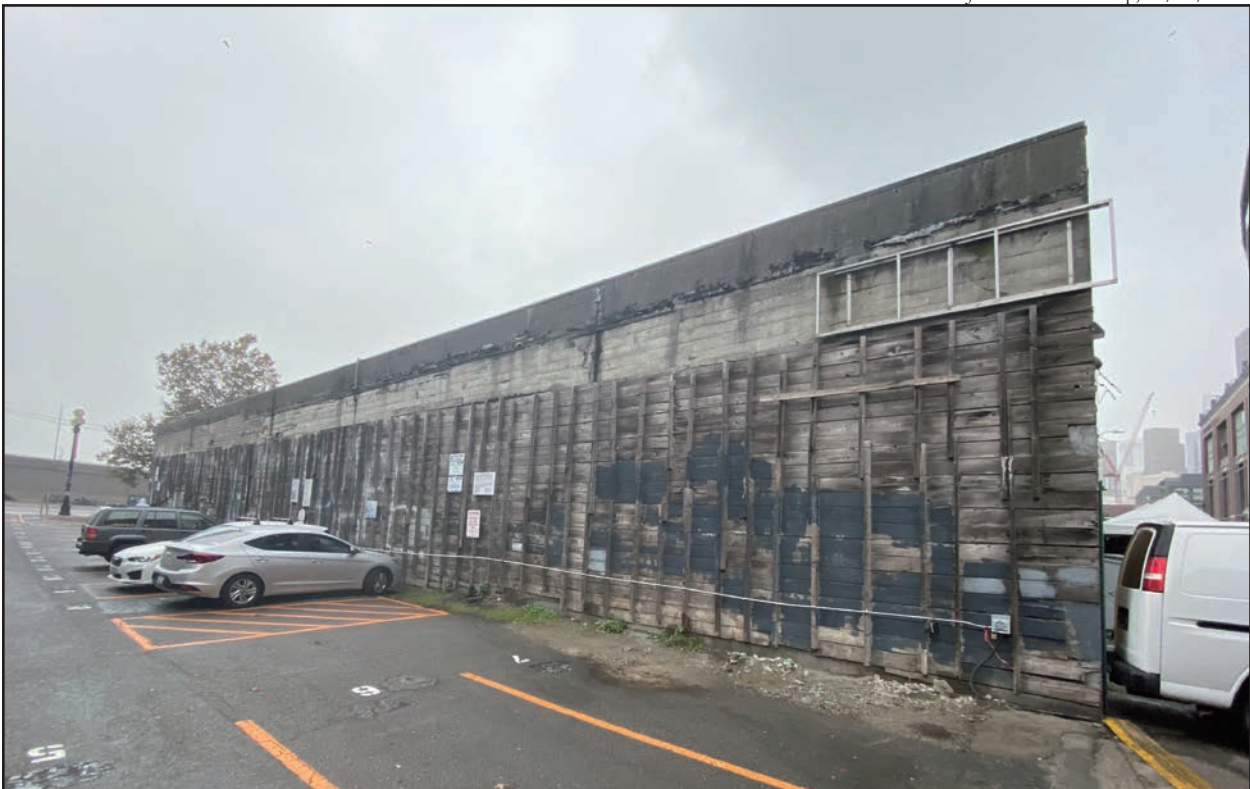
Figure 14 • 904 First Avenue S, southern façade

The southern façade stretches 150'-0" along the adjacent southern parking lot. This façade contains the remnants of the original wooden formwork used for casting the exterior concrete wall. (At the time the building was constructed, a one-story wood framed building at 924 First Avenue S was in place with a zero lot line development. The remaining formwork on the southern façade of the subject building may be a legacy of being cast up against an existing building which has since been demolished.) The upper portion of the wall, the parapet, has been repaired or replaced and painted with waterproof elastomeric coating, and has a metal flashing capping the parapet. The wooden formwork and exposed concrete at the western end are in poor condition. The wooden formwork has decayed and water has intruded into the concrete, causing rust to form on the steel reinforcing and spalling of the concrete at the exposed areas. *See figure 14.*

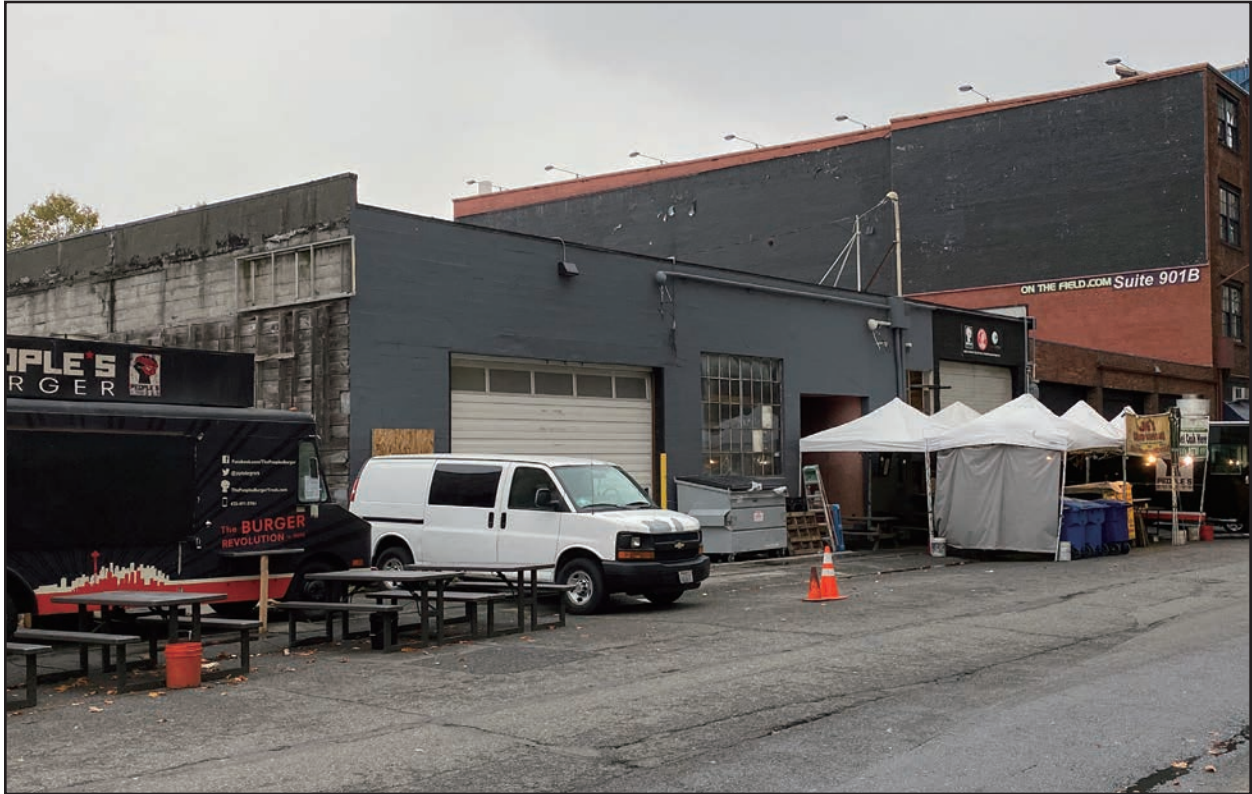
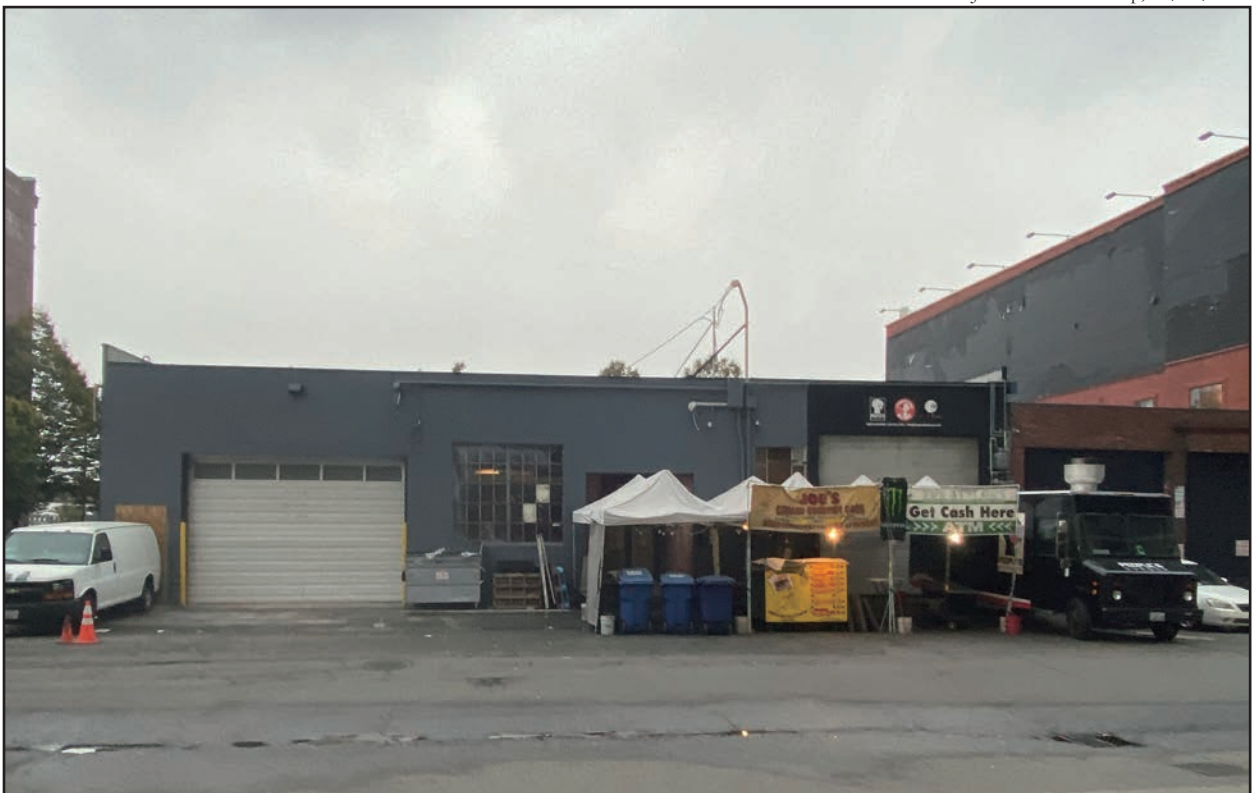
The eastern façade is made of painted board-formed concrete. At the southern end, this façade contains an access door and a steel roll-up door. These are contained within an original opening that has since been filled in with concrete masonry units (CMU) above the access door and on either side of the roll-up door. The center of the façade contains an opening with a recessed entry and two different-sized steel sash windows on either side. To the south is a large window containing two twenty-light sashes separated by a steel mullion. The glazing in this window has been damaged. To the north of the central entry is a smaller, 12-light steel sash window. The sash and glazing in this window have been extensively damaged. The non-original recessed entry itself consists of fixed glazed double doors flanked by radiused pink stucco cheeks. A large swinging stucco-panel door is located on the northern side of the recess. There is visual and documented evidence that this opening has been altered; namely, the concrete has been saw-cut to provide a step up to finish floor level. On the northern end of the façade is another steel roll-up door. *See figures 15-16.*
