**GEOTECHNICAL REPORT – AMENDMENT 1
DEADHORSE CANYON LANDSLIDE
STABILIZATION ALTERNATIVES
SEATTLE, WASHINGTON**

**Work Authorization No.: E314059 MG2
July 2017**

**Seattle Public Utilities
Geotechnical Engineering**

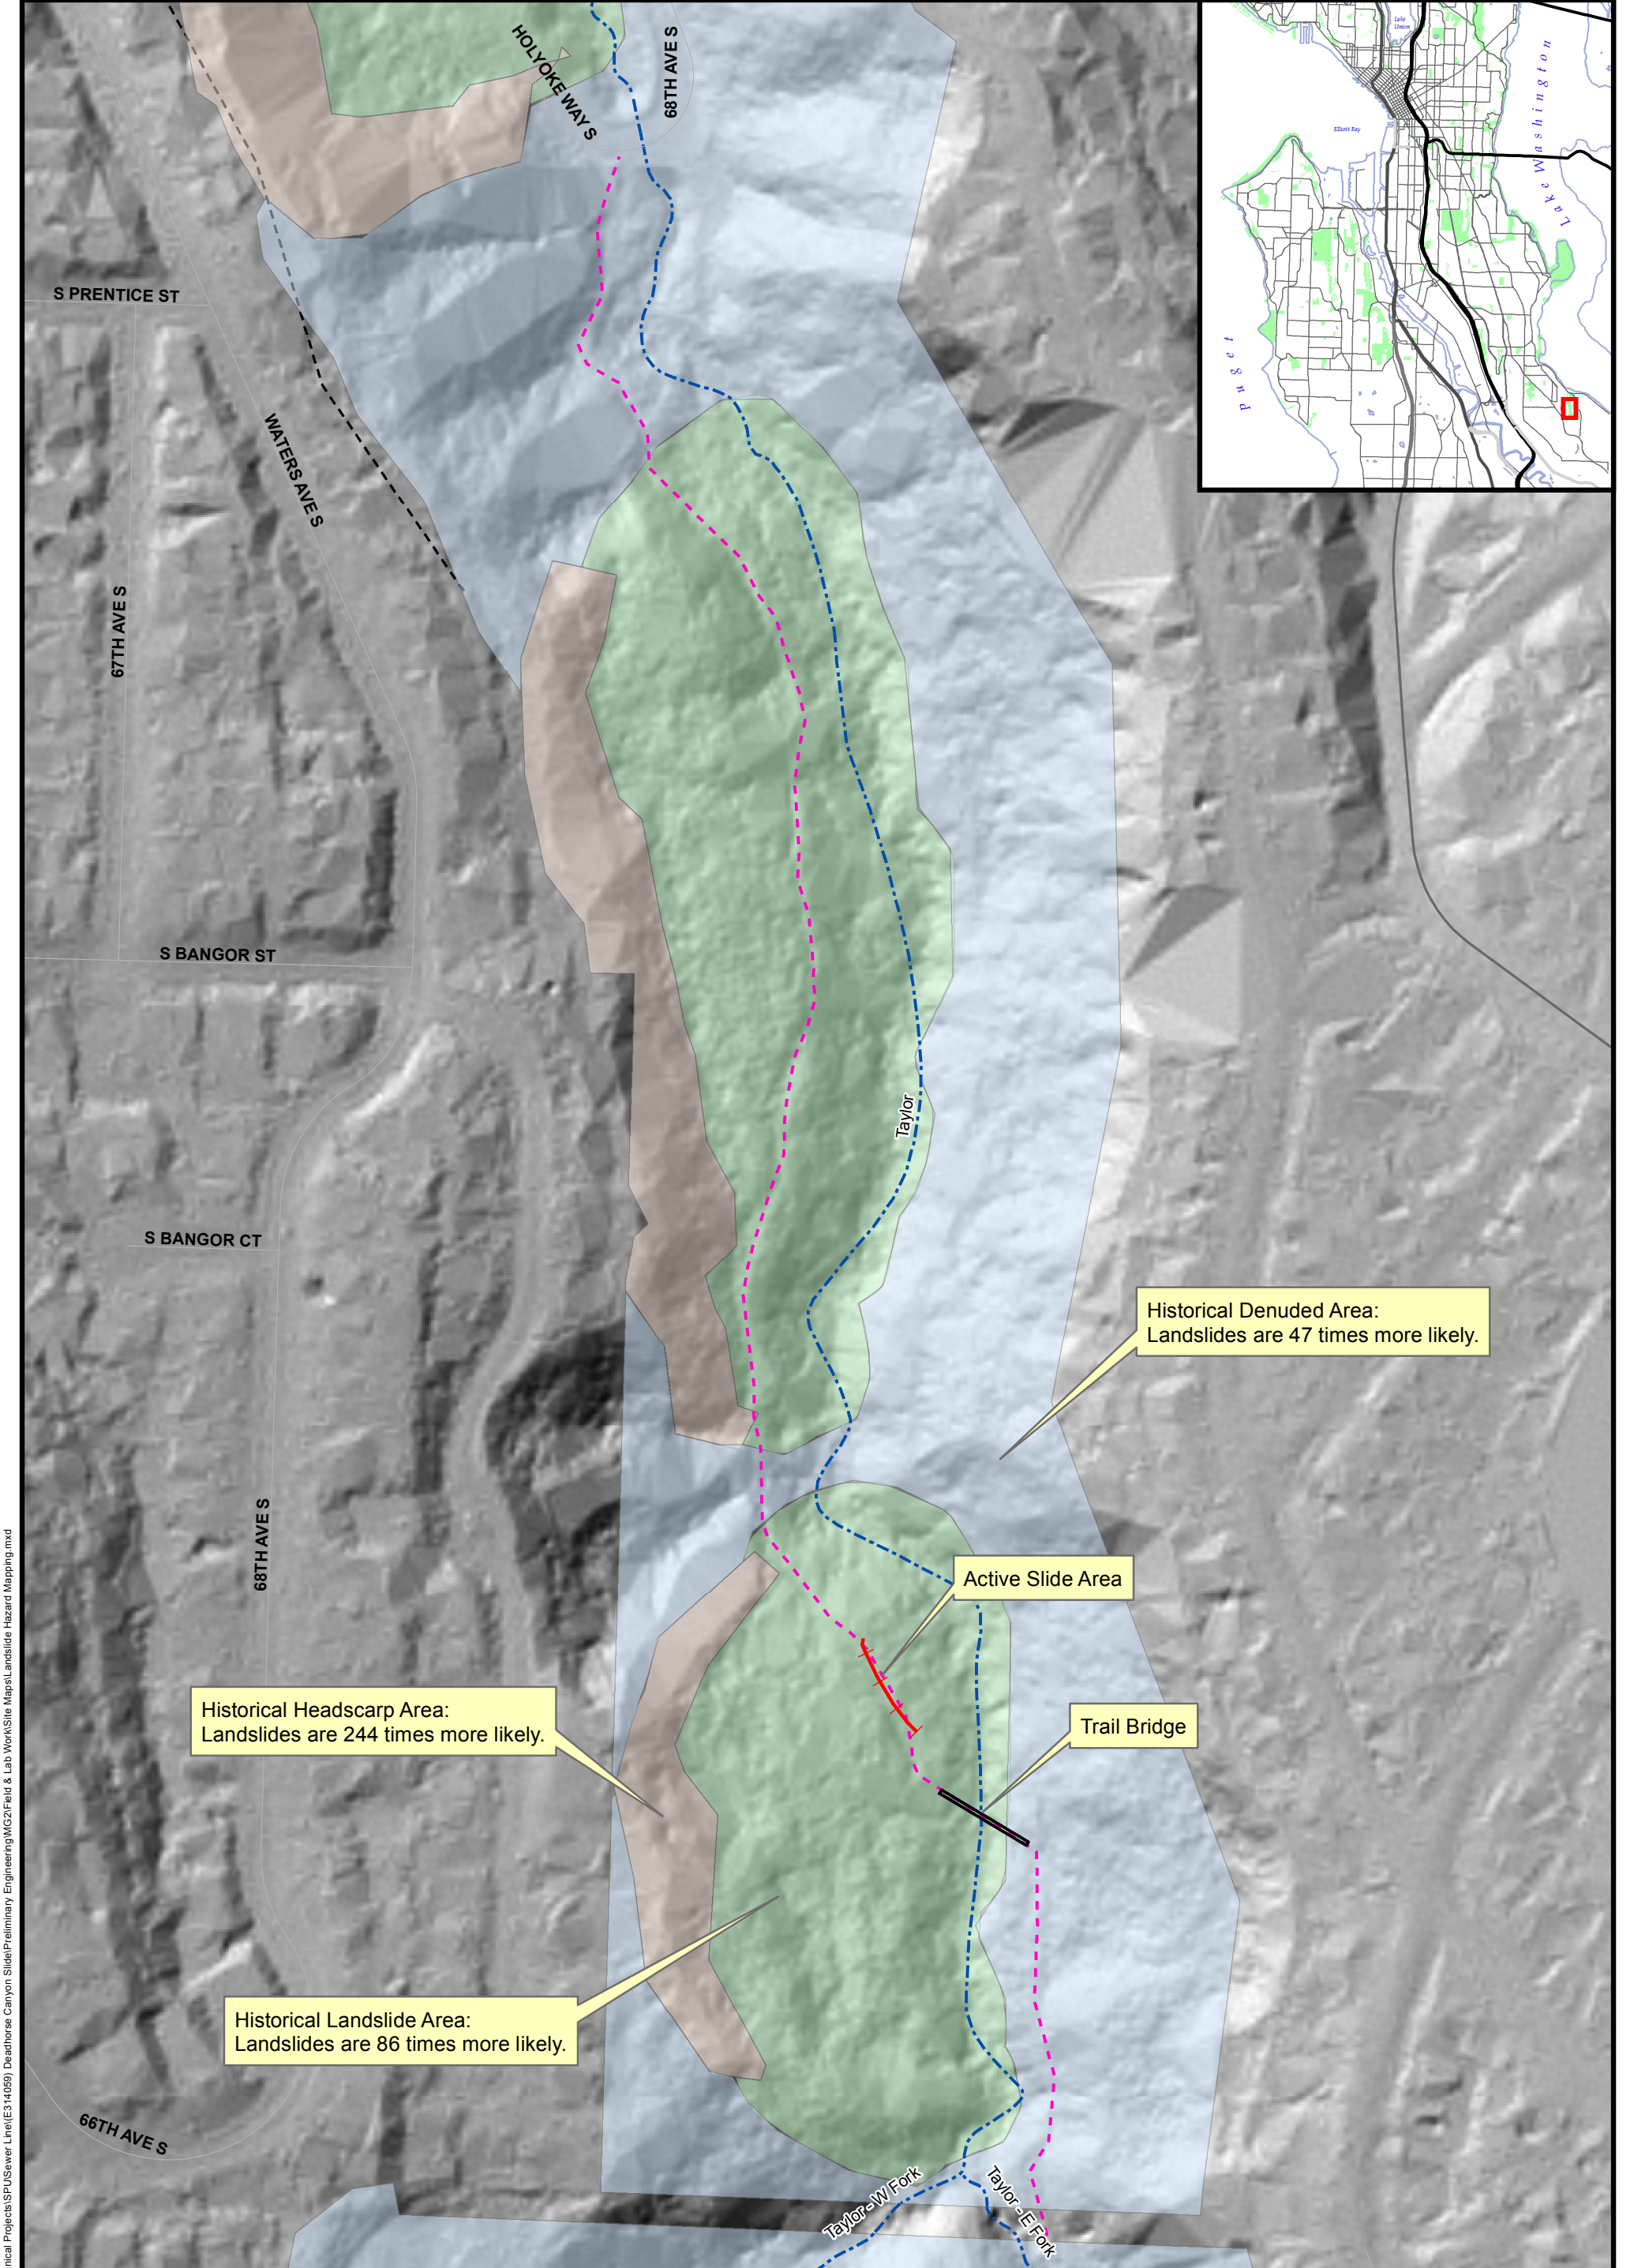
Historical Landslide Map with Reoccurrence Potential
Seattle, Washington

In 2005, the United States Geological Survey (USGS) (Schulz, 2005) used LIDAR imagery to create a landslide inventory map for Seattle. Based on landforms visible in the LIDAR imagery, possible headscarps, landslide deposits, and denuded slopes were identified. The historical landslides identified using LIDAR were compared to data from a landslide inventory based on historical records (Shannon and Wilson, Inc., 2003) to develop a relationship between landslide potential and the three identified landform types plus an additional landform representing the areas within Seattle where no landslide-related landforms were observed.

Schulz proposes that because future landslide activity in Seattle is expected to be similar in type and location to recent activity, projections can be made about the relative likelihood of landslides within a given area. The results of the study indicate that compared to areas where no landslide-related landforms have been observed, the likelihood of future landslides is 244, 86, and 47 times greater within areas mapped as headscarps, landslide deposits, and denuded slopes, respectively. Figure 2 shows the landslide-related landforms identified by the USGS draped over LIDAR based digital elevation model of Deadhorse Canyon. The majority of the west slope is within three of the mapped historical landslides, indicating that landslides are 86 to 244 times more likely to occur within Deadhorse Canyon than areas where no landslide-related landforms have been observed.

Historical Headscarp Area:
Landslides are 244 times more likely.

Historical Denuded Area:
Landslides are 47 times more likely.

Historical Landslide Area:
Landslides are 86 times more likely.

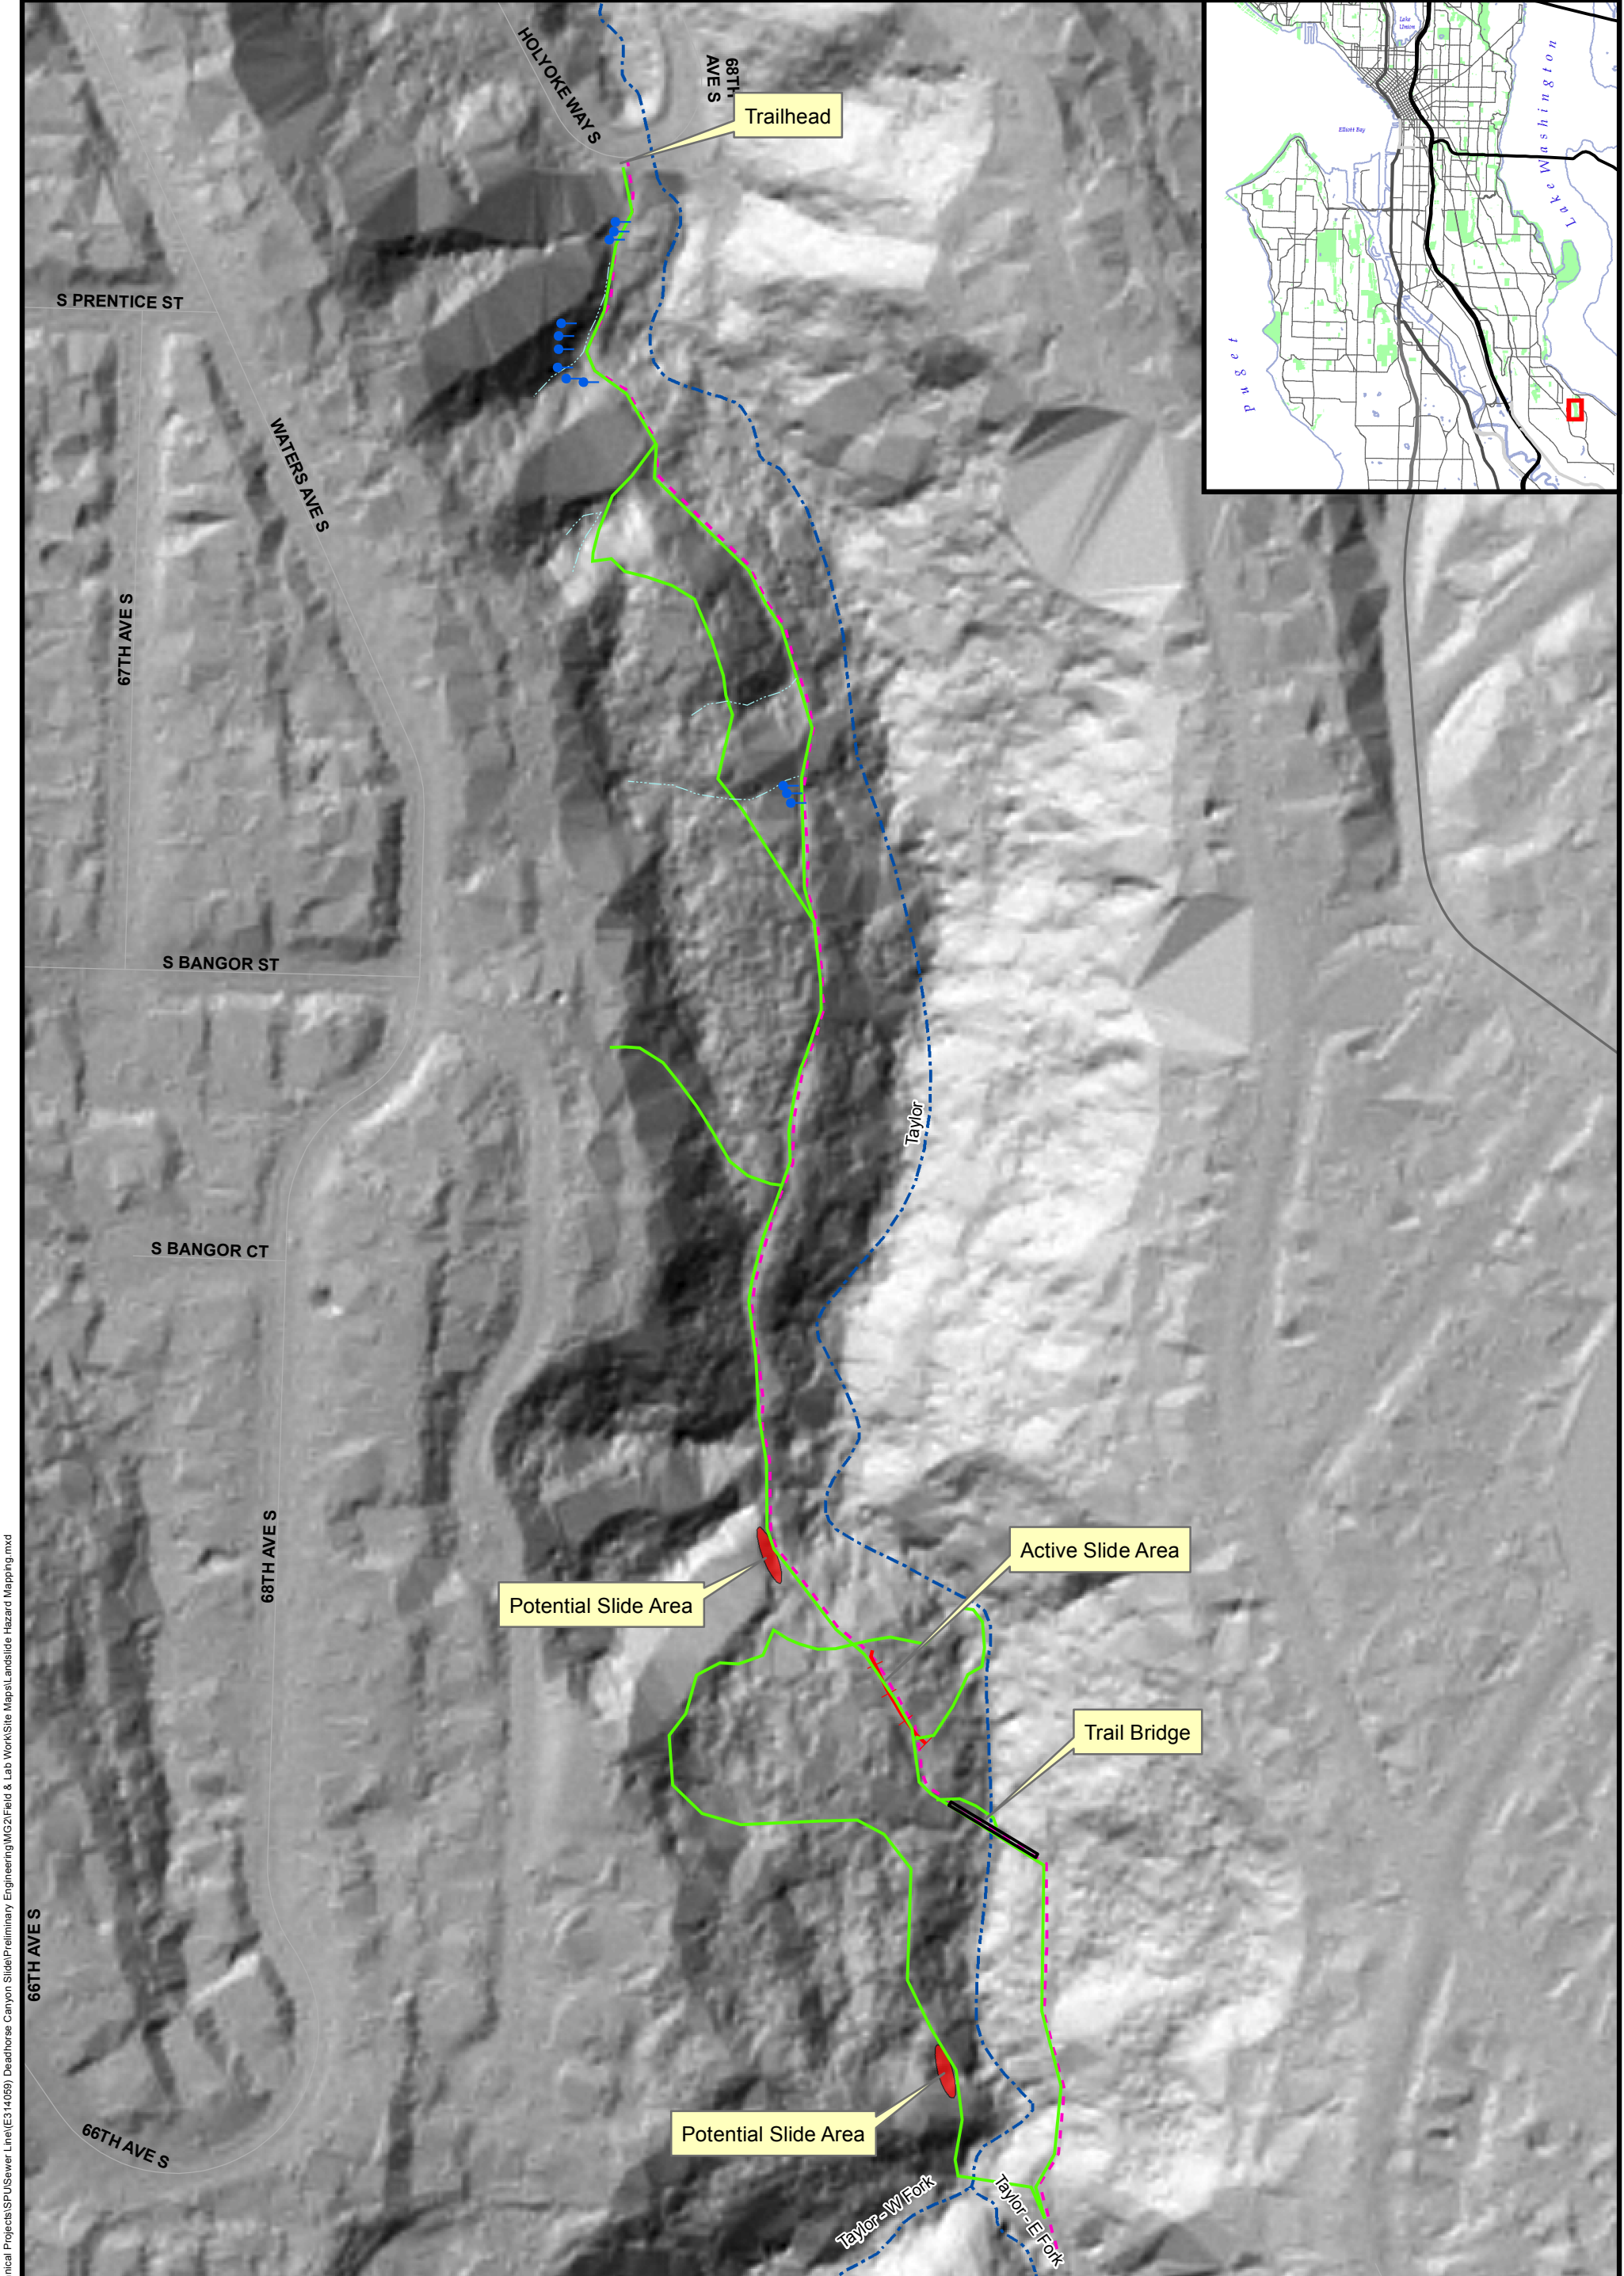
**Field Reconnaissance
 Observations**

On June 18, 2015 an SPU field geologist and geotechnical engineer completed a field reconnaissance that consisted of walking the slopes looking for signs of active movement (e.g., tension cracks, scarps, and leaning trees). Particular attention was paid to areas indicated on Figure 2 as being within previous scarp and landslide deposit areas. The route that was followed and items observed during the reconnaissance are indicated on Figure 3.

Several seeps and some ponded water were observed in the northern half of the study area west of the trail and between approximately elevation 130 and 140 feet.

Two areas that exhibit potential signs of movement were observed, however, one of the areas is located outside of an area likely to affect the sewer. The other area is located approximately 100 feet north of the active slide. At this location, the surface of the trail is uneven and there are several discontinuous cracks located along the uphill side of the trail. It appears that surface water flows down the trail to this location, then discharges over the downhill slope, as a result, it is difficult to determine if the uneven ground is caused by surface erosion or by larger scale movement. The two areas that exhibit potential signs of movement are shown on Figure 3. No other signs of slope instability were observed.

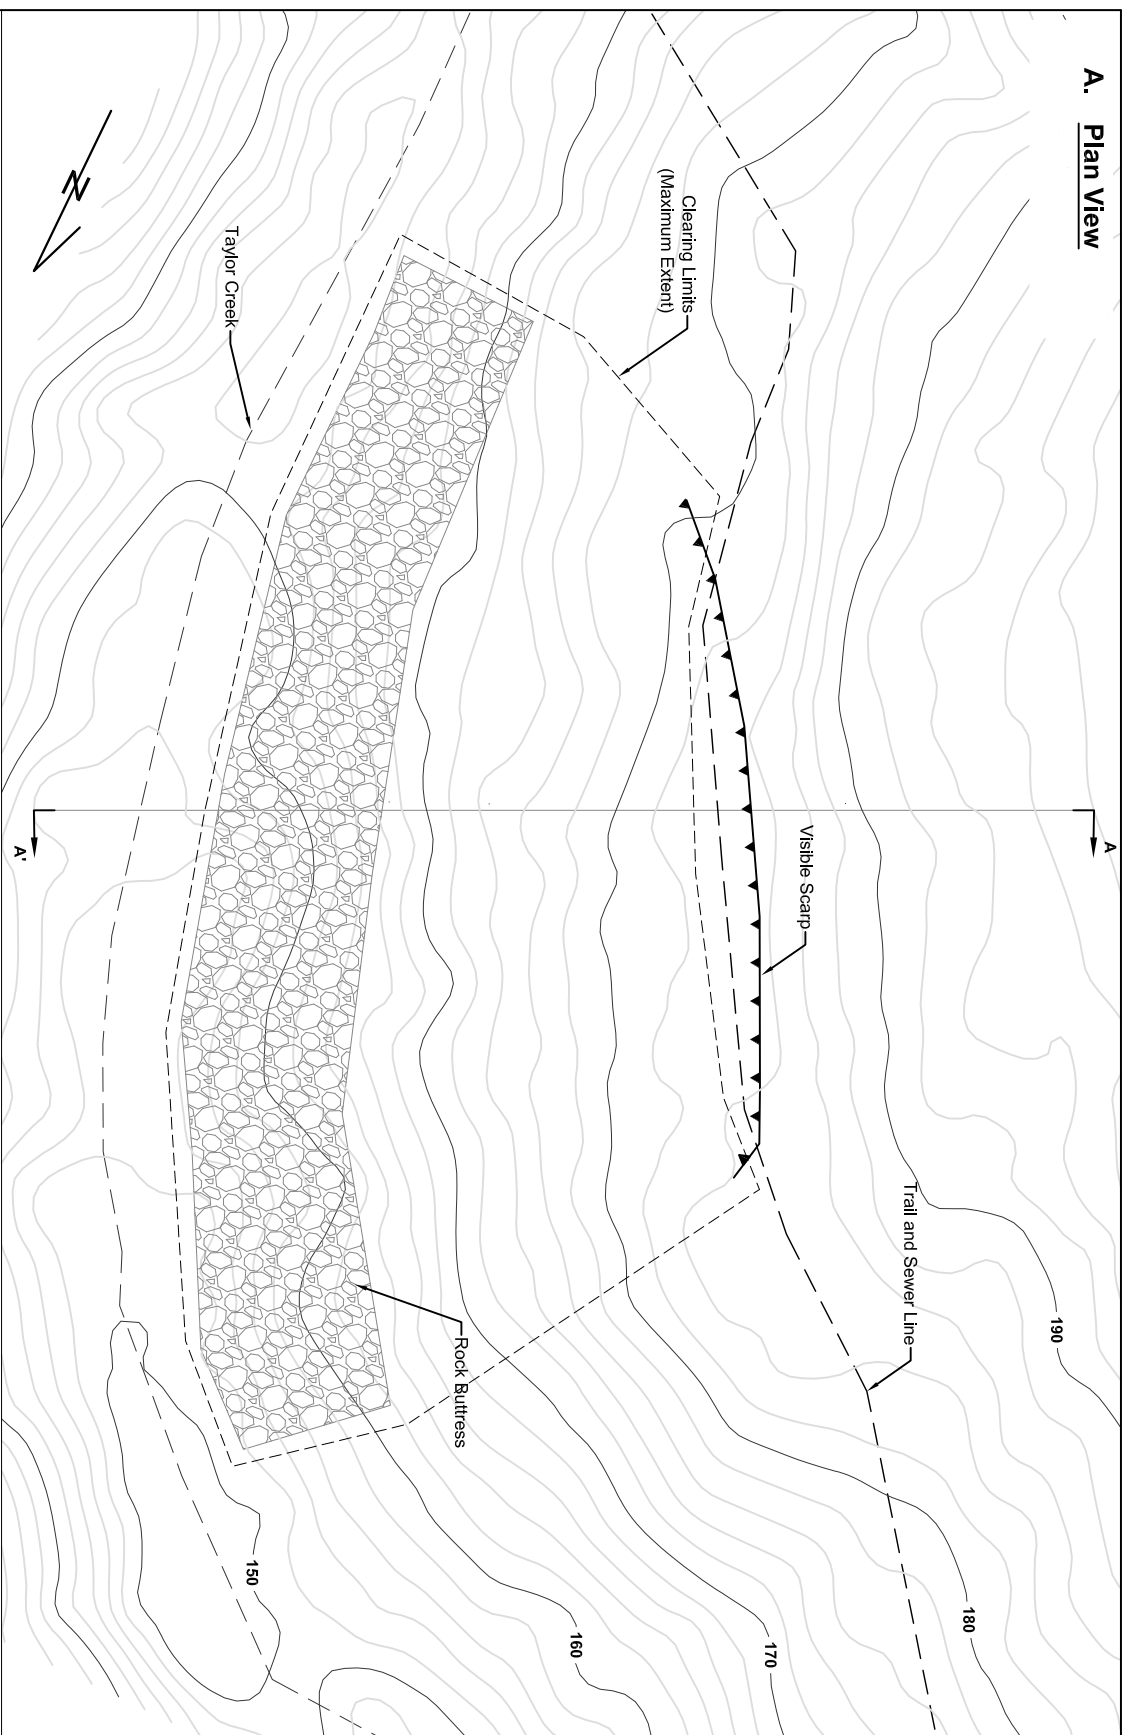
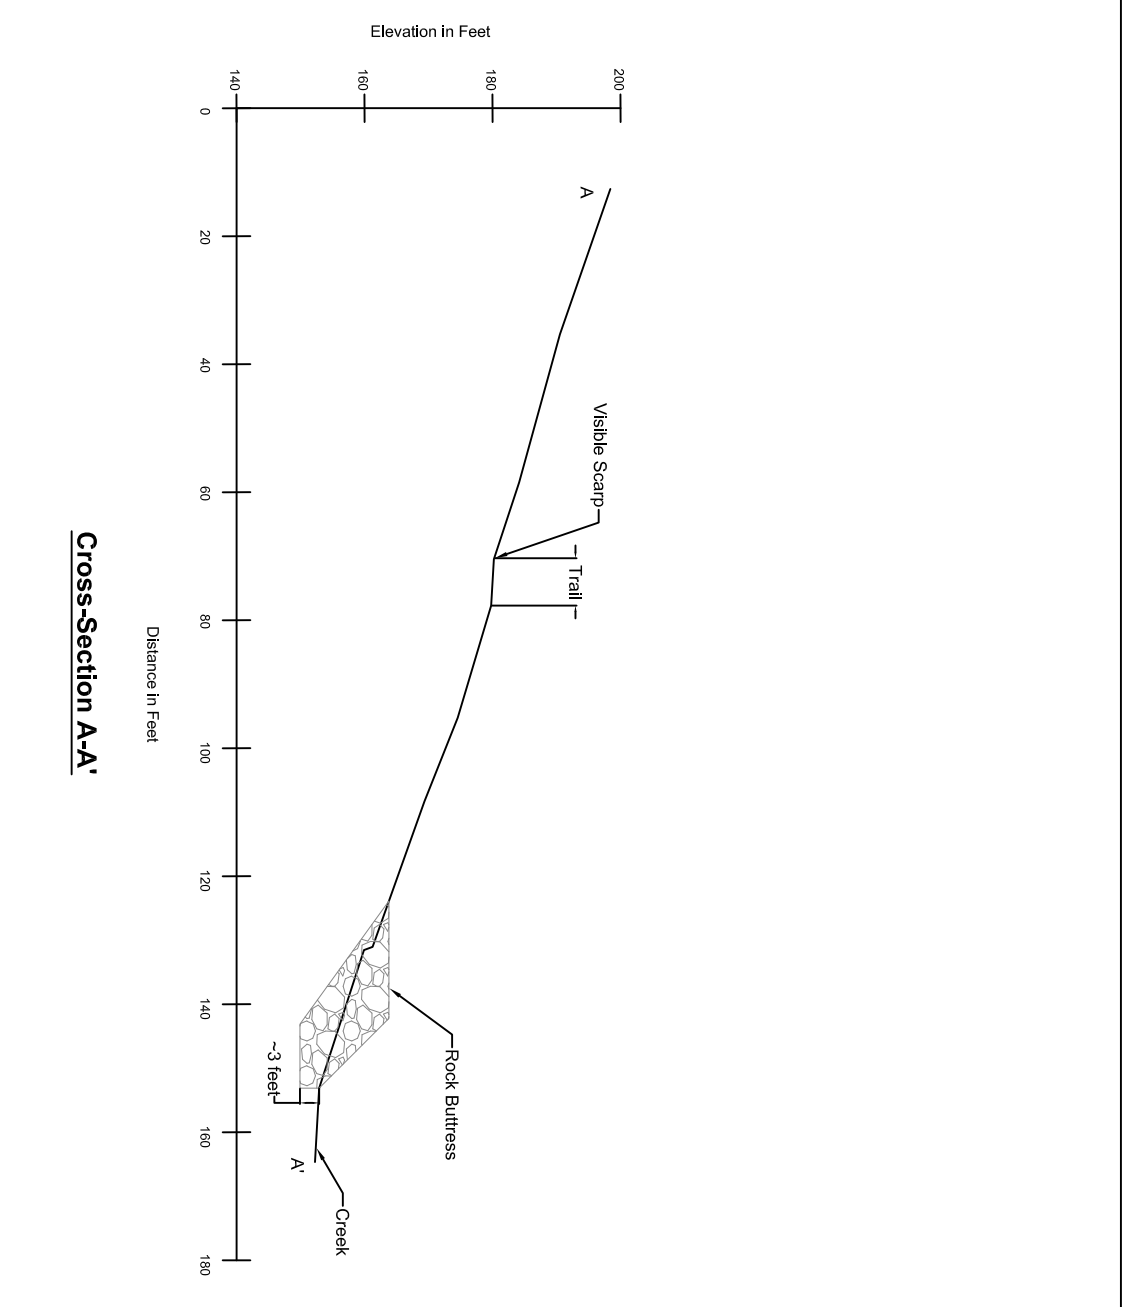
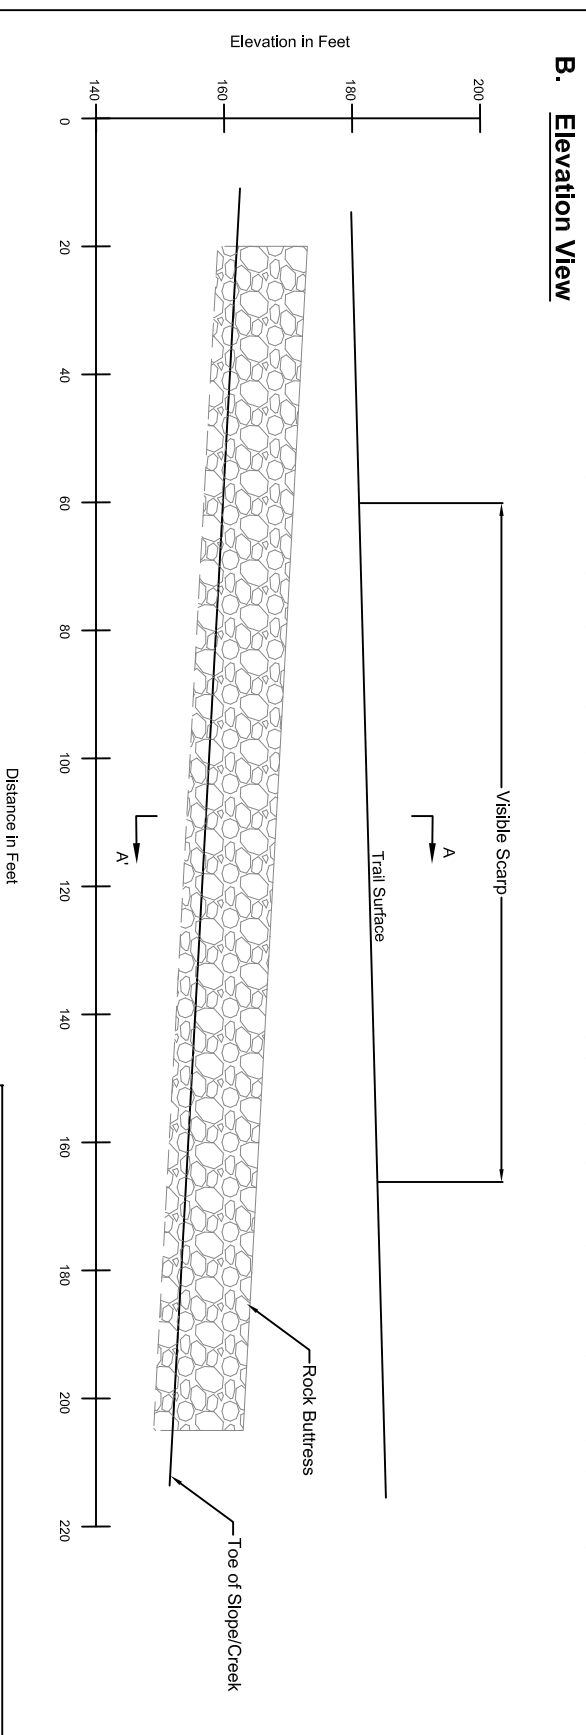
**RIP RAP BUTTRESS SLOPE STABILIZATION
CONCEPTUAL PLAN, PROFILE, AND CROSS-SECTION**

Rock buttresses typically consist of rip rap placed along the toe of a landslide. The increased weight of material at the toe acts as a counterforce that resists movement. We estimate that a minimum of 1,200 and 1,470 cubic yards (CY) of rip rap would be needed to provide sufficient counterforce to resist static and seismic loading, respectively. The rock buttress would be approximately 10 to 15 feet tall, an average of 12 to 15 feet thick, and extend 185 feet along the toe of the slope. The static design would be at the lower end of this range and the seismic design would be at the upper end. Conceptual cross-section, elevation and plan views of a rock buttress are shown on Figure 4.

The rock buttress will create a hard surface along the creek bank. During high flows, the creek will reflect off of this hard surface and could cause increased scour and erosion along the opposite bank. This is of particular concern because there is an existing problem with excessive stream bed loading downstream of the site that would be worsened by an increase in streambed erosion.

Construction would require vegetation removal and excavation within the buttress footprint shown on Figure 4. The area between the trail and the buttress will also need to be cleared to allow track mounted excavators to access the buttress area. All of the clearing and excavation would occur within the Taylor Creek riparian area which extends from the creek up to the trail. We estimate that approximately 700 to 800 CY of excavation will be required within the buttress footprint. This includes approximately 3 feet of excavation below the creek bed elevation. The excavation below the creek bed would likely require diversion of the creek and localized dewatering. All excavated material would need to be removed from the site using dump trucks and the temporary access road.

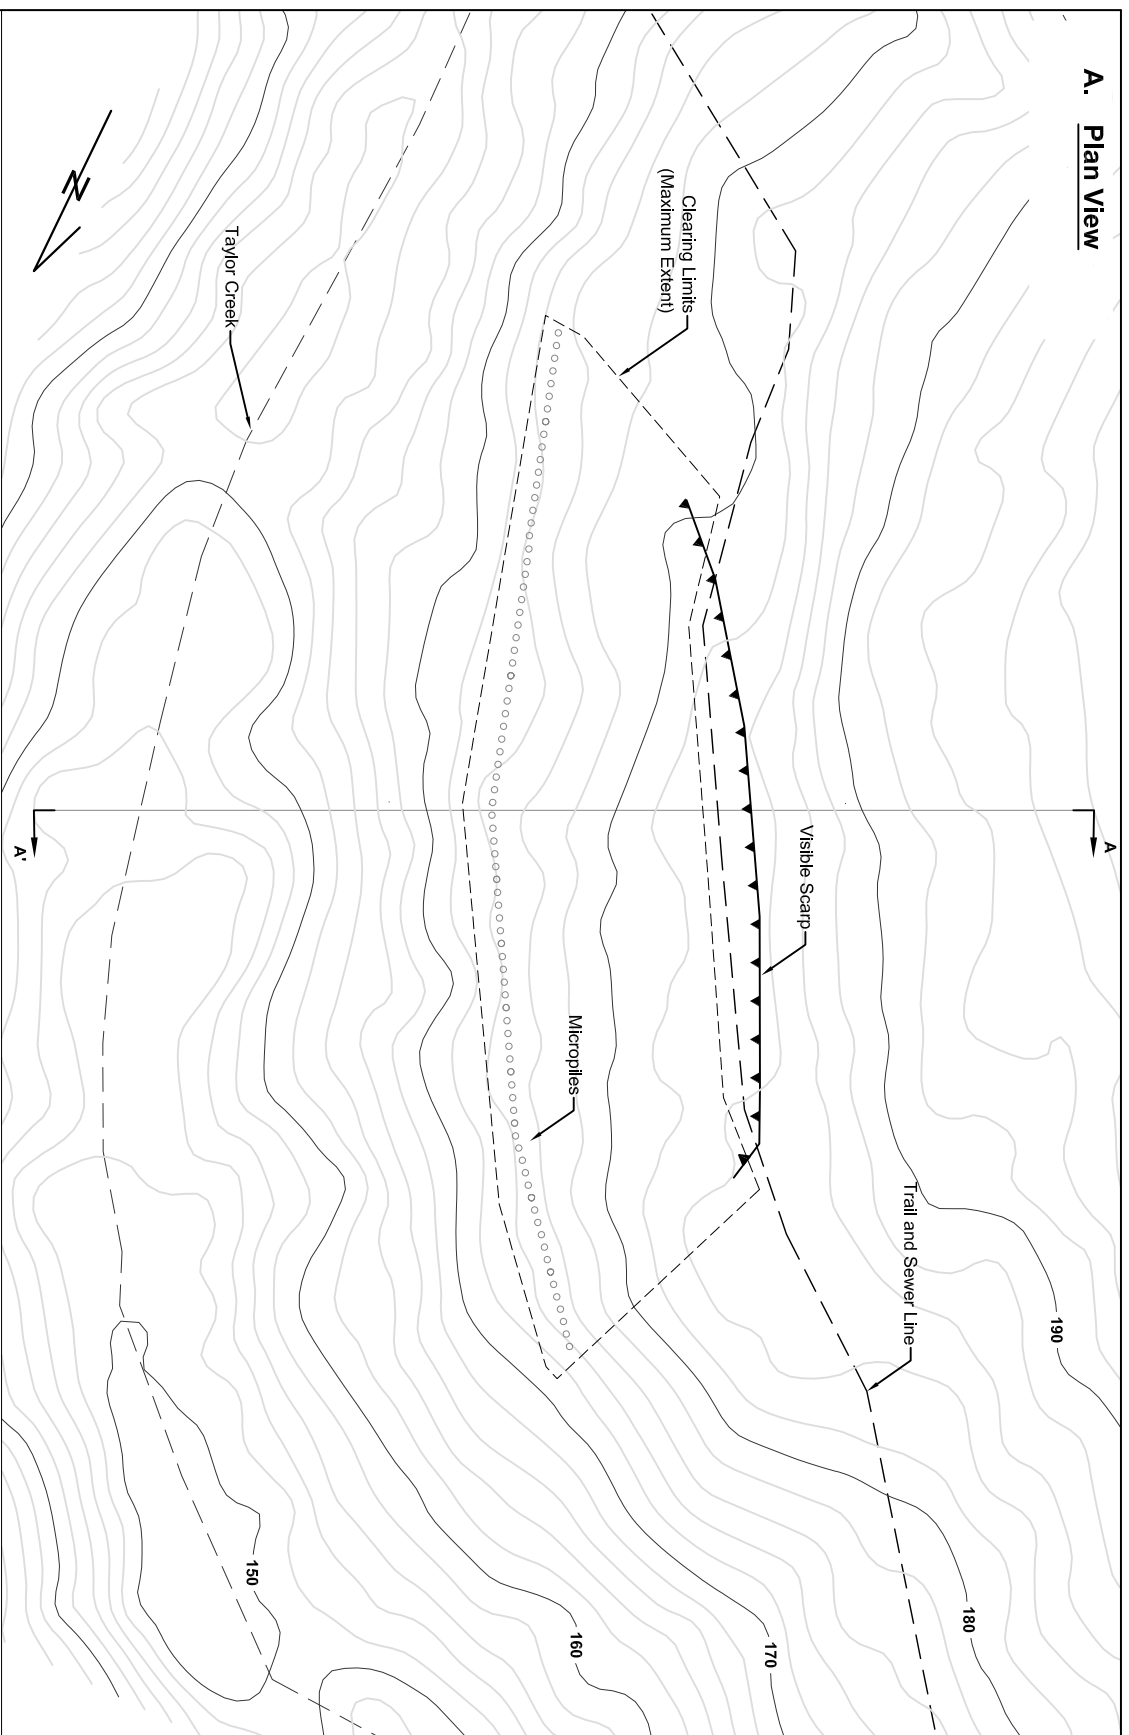
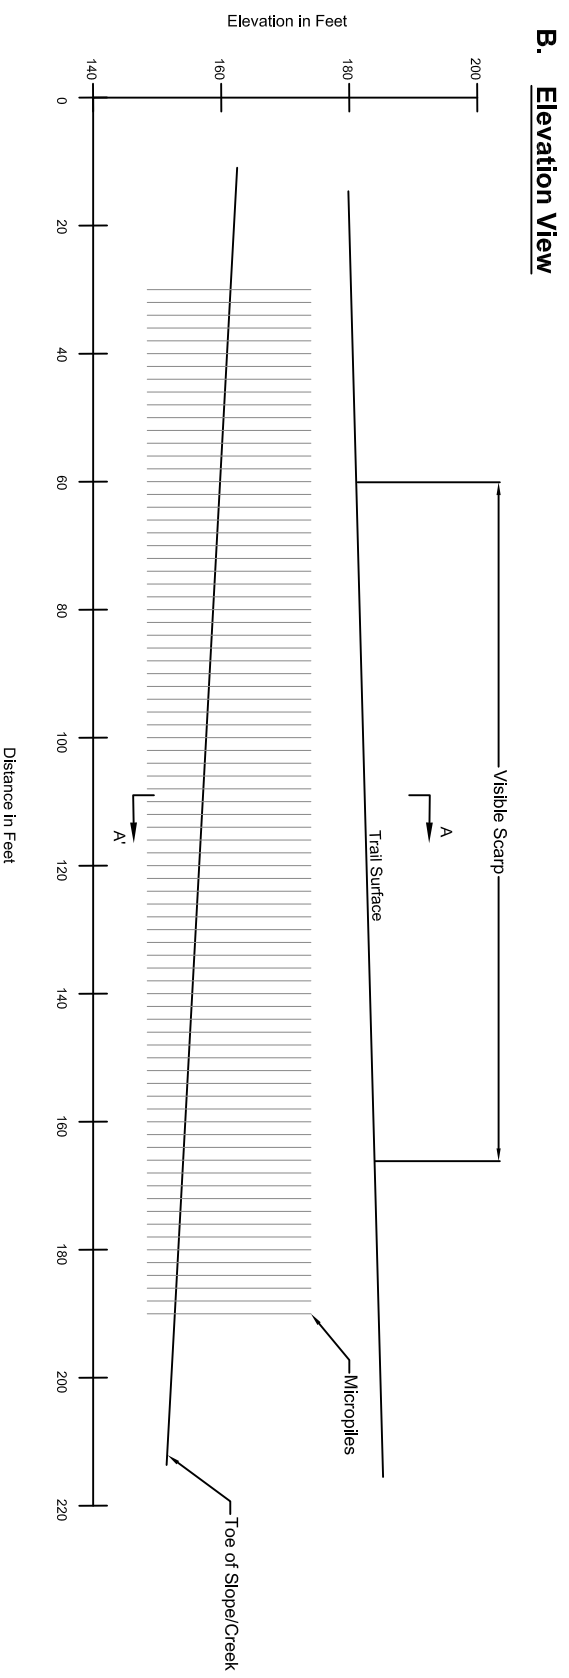
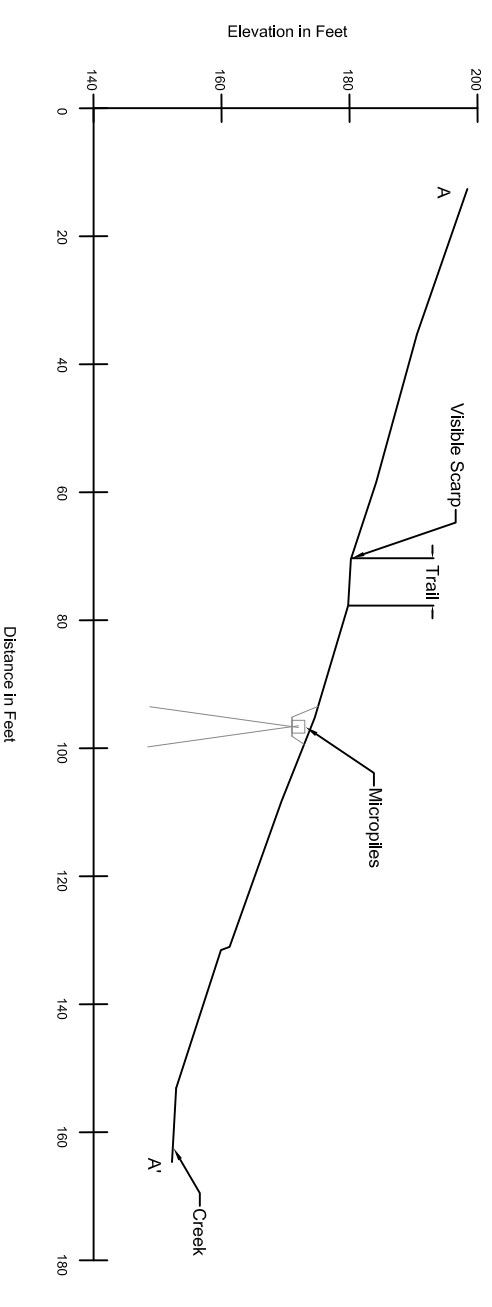
**MICROPILE SLOPE REPAIR
CONCEPTUAL PLAN, PROFILE, AND CROSS-SECTION**

A preliminary design chart (Armour, 1997) indicates that battered 6-inch-diameter micropiles spaced approximately 2-foot on-center should provide the required shear resistance for the seismic case. We anticipate that the micropiles would extend approximately 25 feet below ground surface. An approximately 2-foot-wide reinforced concrete cap beam would be installed along the length of the micropiles to structurally tie the piles together. We assume that SPU and Parks would prefer to minimize visual impacts within the park and as a result the top of the piles and cap beam would be buried below the existing ground surface. Conceptual cross-section, elevation and plan views of the micropile slope stabilization are shown on Figure 5.

The structural reinforcement would stabilize the slope above the reinforcing elements, but the slope below the reinforcing elements could still fail. Failure of the lower slope should not adversely affect stability of the upper slope and sewer. However, additional work

Construction would require vegetation removal and excavation within the micropile footprint shown on Figure 5. The area between the trail and the micropiles will most likely need selective clearing to allow access for the drill rig and materials. It may be possible to work around some of the larger trees that are located in this area; however, at this time we do not have surveyed locations for the trees so it is impossible to determine which trees would need to be removed.
