**GEOTECHNICAL REPORT
DEADHORSE CANYON SEWER
SEATTLE, WASHINGTON**

**Work Authorization No.: E314059
December 2014**

**Seattle Public Utilities
Geotechnical Engineering**

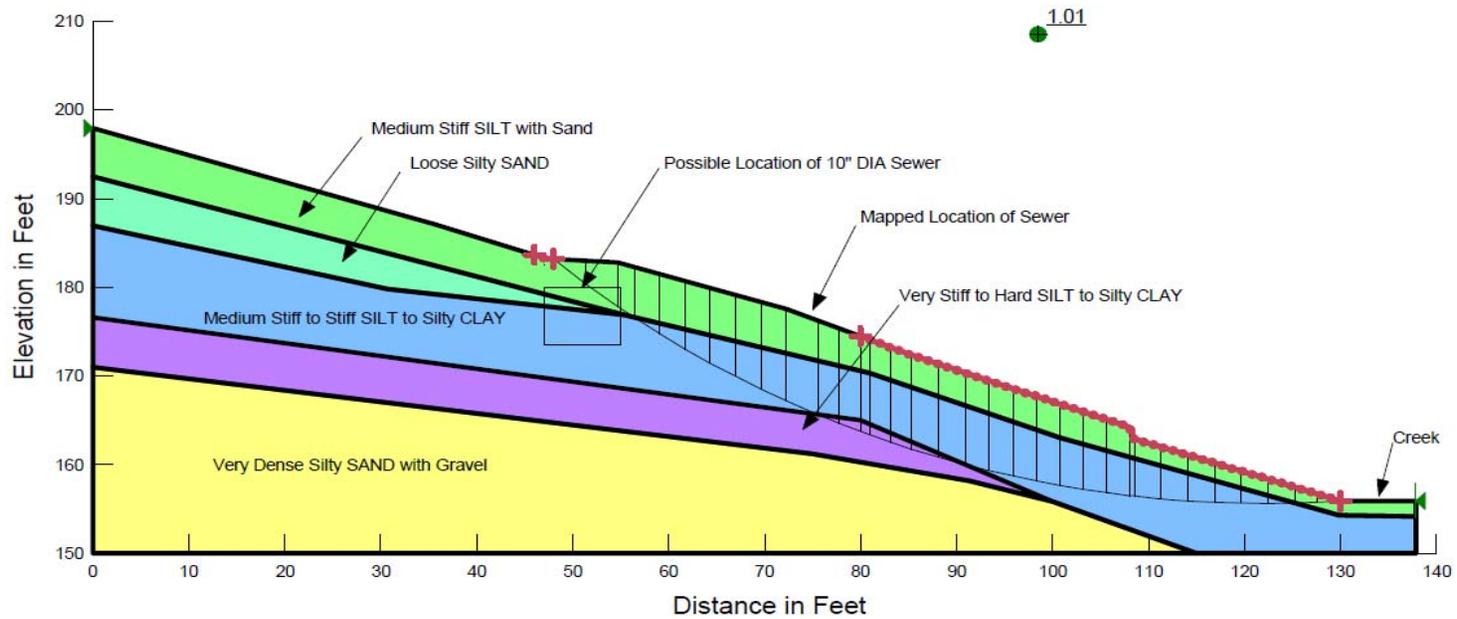
Name: Static Drained Residual Shear Strength
 Method: Morgenstern-Price
 FOS: 1.01

The tabulated FS reflect the most critical slip surfaces (i.e., the minimum FS) found by the computer model for each mode of failure and the loading conditions described above. The critical slip surfaces identified during the analysis are shown graphically on Figures 3 through 7.

The slope is presently in a “just-stable” condition. The site history suggests that the slope has been moving primarily during the rainy winter seasons for at least the past five years. We anticipate that this pattern of slope movement will continue. The magnitude of slope movement is likely tied to the amount of rainfall, i.e., a wetter year will yield greater slope movement. In addition, an extended period of heavy rainfall may lead to catastrophic failure of the slope, which may or may not affect the sewer.

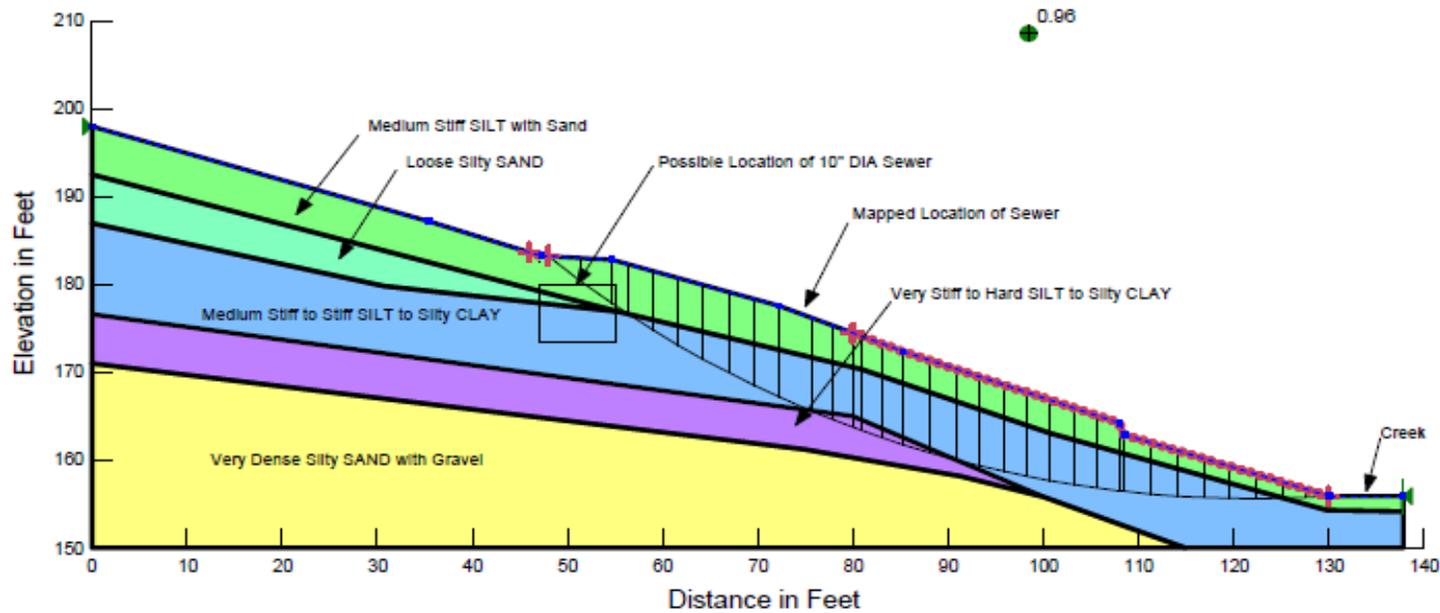
Name: Static Drained Residual Shear Strength GW
 Method: Morgenstern-Price
 FOS: 0.96

Although we did not observe seeps in our site reconnaissance or encounter groundwater in our subsurface explorations, the history of the slide suggests that movement coincides with rainfall events. The lack of groundwater during our explorations may be explained by the time of year the explorations were completed and may not reflect typical wet season conditions. As a result, we completed an analysis that included groundwater perched above the silty clay and extending up to the ground surface.

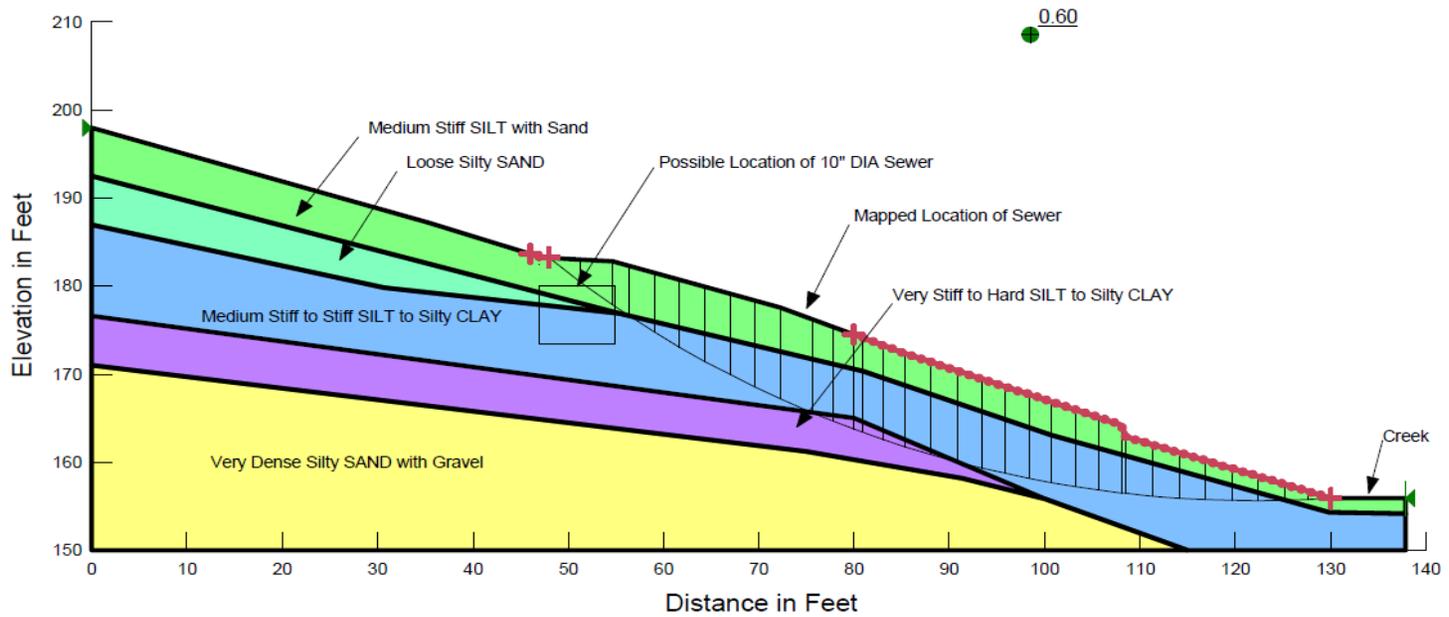
Name: Seismic Drained Residual Shear Strength
 Method: Morgenstern-Price
 FOS: 0.60

Analyses were completed for both static and dynamic (seismic) load cases. For the seismic case, a pseudostatic analysis was performed, using a seismic coefficient, k_h , equal to 0.21g, in accordance with Section 1803.5.11 of the Seattle Building Code (2012).

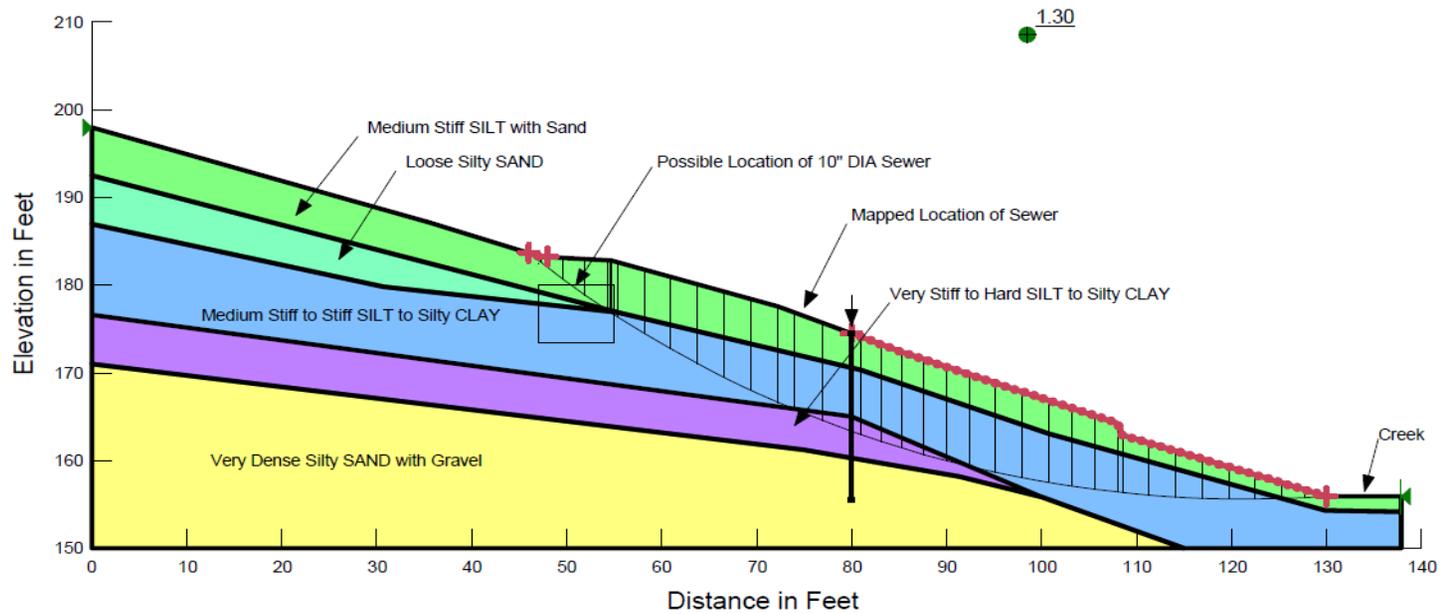
Name: Static Drained Residual Shear Strength Reinforced
 Method: Morgenstern-Price
 FOS: 1.30

For both the static and seismic loading conditions we analyzed the slope and estimated the existing FS. Then we included a vertical reinforcing element in the model that contributes additional shear resistance. The reinforcing element extended from the ground surface down to the glacial till layer. We iteratively increased the shear resistance of the reinforcing element until the FS exceeded 1.3 and 1.1 for the static and seismic loading conditions, respectively. Graphical representations of the results are presented on Figures 3 through 7. The results are summarized below.

- **Structural Reinforcement:** Install structural reinforcing elements along the length of the slope failure in a row approximately mid-way between the head and toe of the slide. The structural elements would be advanced across the failure plane into the stable glacial till material to provide passive shear capacity, disrupt the slide plane, and reinforce the soil mass. We determined that an increase in shear strength of 5.5 and 18 kips per lineal foot was required to provide the target FS for the static and seismic cases, respectively.

A preliminary design chart (Armour 1997) indicates that 6-inch-diameter micropiles spaced approximately 2-foot on-center should provide the required shear resistance.
