INTRODUCTION

City Light completed its annual contact voltage testing on November 4, 2015. Utilizing a mobile detection system for the sixth year in a row, City Light tested all conductive assets in the right-of-way, regardless of ownership. If 30 volts or more was detected, the structure was immediately repaired or de-energized for public safety.

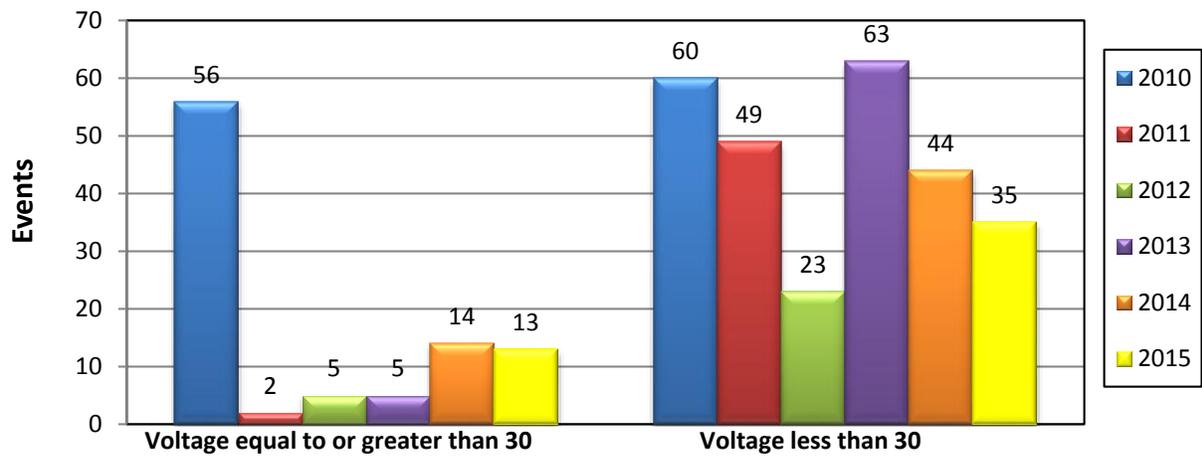
2010 to 2015 Contact Voltage Survey Results SCL Assets

In comparing the results of City Light assets surveyed in 2015, there was a decrease of one in the number of contact voltage events at 30 volts or greater on SCL owned equipment from the previous year. Nine events were determined to be the result of bad wiring and connections, one instance of failed equipment, and one in a long term active construction site where the actual cause has not been fully determined. The remaining two events were determined to be the result of pinched wires in the door of the luminaire during LED conversion. Retraining on proper luminaire installation was conducted with the contractor crews.

- City Light has touch potential testing in place for both its crews and contractors performing streetlight work
- City Light will continue to test its streetlight system annually and report the findings to the public
- Finally, City Light has taken responsibility for testing and inspecting all streetlight equipment before it is energized
