MEMORANDUM

TO	Lynn Sullivan, Project Manager	DATE	November 29, 2006
	Seattle Parks and Recreation	PROJECT No	200607
	800 Maynard Avenue South, 3 <sup>rd</sup> Floor	PROJECT	(WC2281)
	Seattle, Washington 98134		Lake Washington
CC			Boulevard South Drainage
SUBJECT	Drainage Assessment and Conceptual Design	FROM	Mike DeLilla, P.E.
	Vicinity: S Dose Terrace & 34 <sup>th</sup> Avenue S	PAGE	1 OF 3

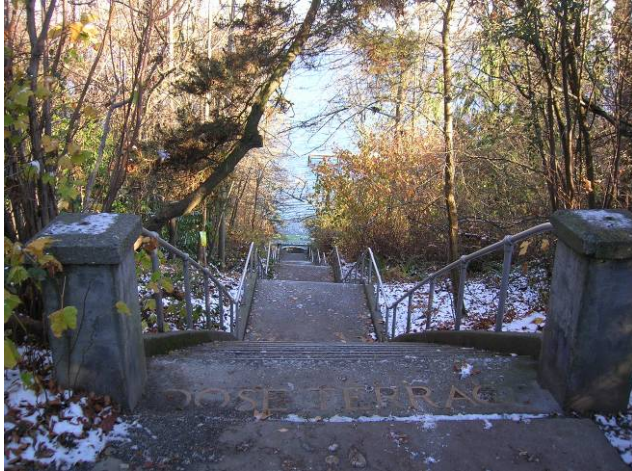
The project site is located approximately 200-feet east of the intersection of S. Dose Terrace and 34<sup>th</sup> Avenue S. At the end of the roadway (S. Dose Terrace), a stairway provides pedestrian access down to Lake Washington Boulevard South. See Figure 1. An existing 8 inch clay pipe conveys flows from this location and parallels the stairway alignment. Due to the age of the system, various breaks in the pipe were reported by the Seattle Parks Department. The largest break is located between the top of the stairway and the first landing down slope of the S. Dose Terrace intersection. This break has eroded the soil at that location and likely caused settlement in a portion of the stairway. See Figure 2 and 3.

Figure 1. S. Dose Stairway

The City of Seattle Parks Department would like bury this conveyance system so that it will not be subject to damage and vandalism. In order to address the current situation, a new tight lined system from the upstream storm manhole on S. Dose Terrace to a catch basin on the west side of Lake Washington Boulevard South is proposed.

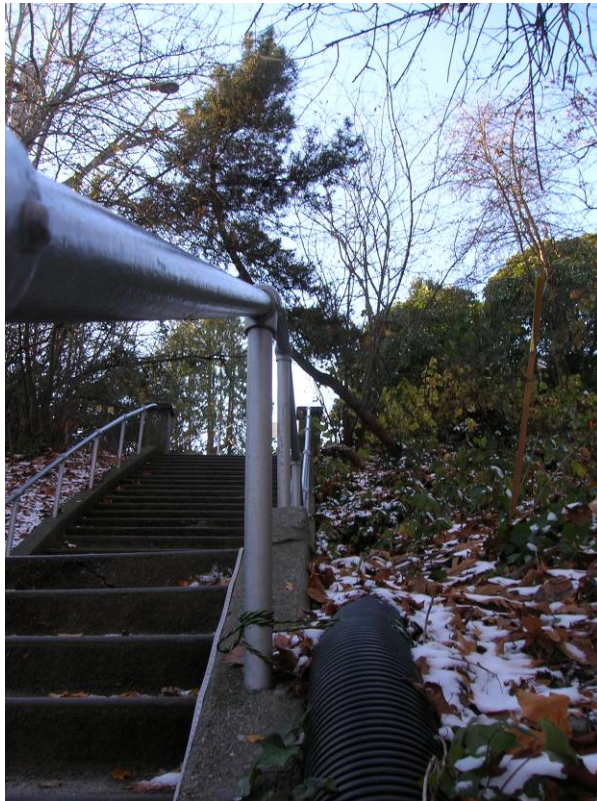
A temporary 8-inch flexible pipe system has been installed by the Seattle Parks Department on the north side of the stairway and connects to the existing pipe at the large break location. This temporary pipe currently acts as an at grade bypass for the existing system. The bypass discharges at the bottom of the stairway in a lawn area near the short retaining wall located on the west side of Lake Washington Boulevard South. Flows then continue overland flowing west to the west curb of Lake Washington Blvd and enter a storm drain inlet. See Figure 4.

Figure 2. Temporary pipe along the north side of the stairway

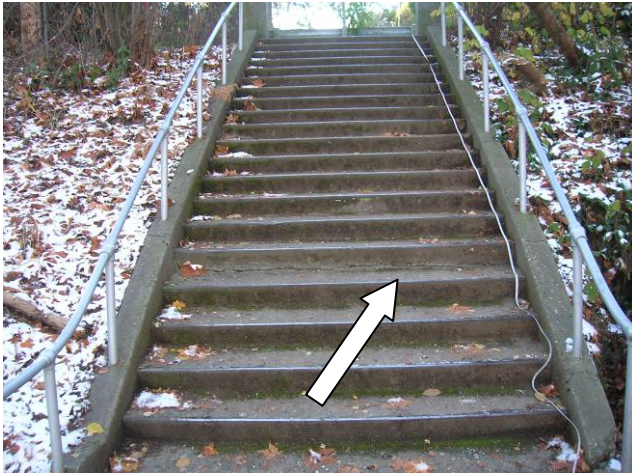
The structural design of the staircase is unknown. The soils should be inspected by a geotechnical engineer to further investigate the slope stability.

Figure 3. Cracking in the stairway

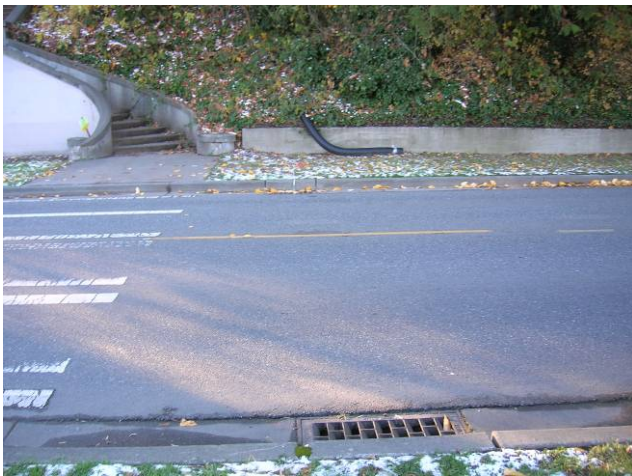
Figure 4. Outfall to temporary pipe on west side of roadway

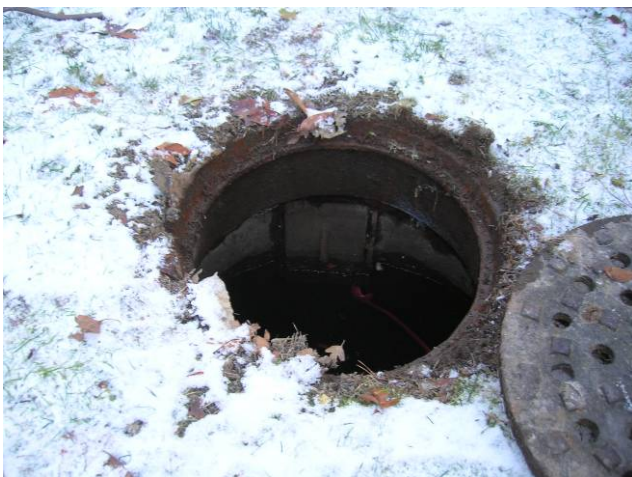
The existing upstream manhole is a brick structure that has three inlets and one outlet. The outlet is covered by a metal gate and the purpose for the gate is currently unknown. See Figure 5. This manhole should be cleaned and inspected prior to final design for cracks and overall condition. The structure may be related to the movement encountered in the stairway. Depending on the condition, the manhole will be either replaced or rebuilt.

Figure 5. Outlet to upstream manhole
