Phase 2B

Ornamental Plaster Repairs

September 30, 2012

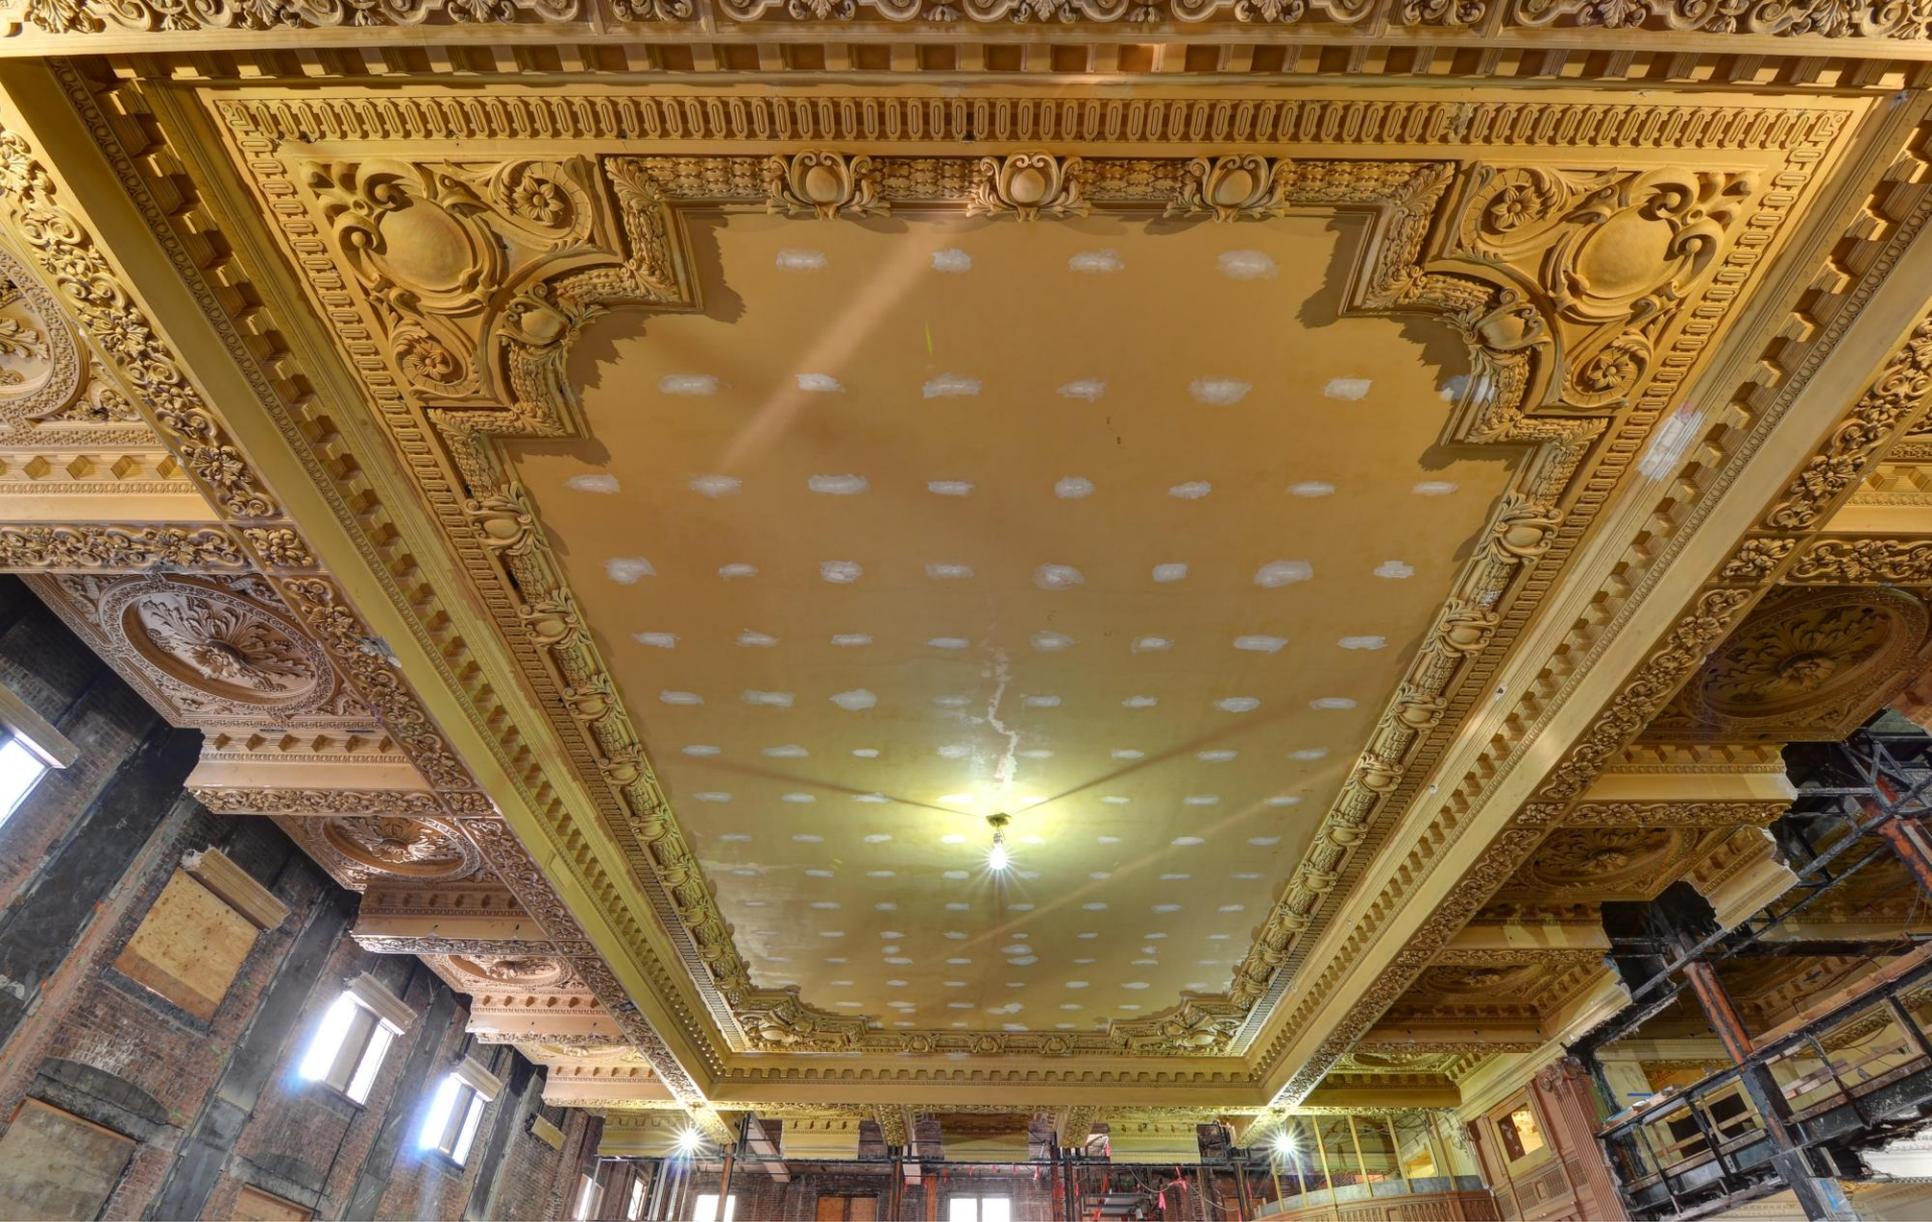
In the 1950s and 60s the King Street Station underwent some major “modernization” efforts. Marble panels on the walls were removed to make way for plastic laminate and gypsum wallboards. Chandeliers and wall sconces were replaced with fluorescent fixtures. The ornamental plaster ceiling was also covered up by the installation of an acoustical dropped ceiling. This photo showed all the puncture holes of the historic plaster ceiling being repaired.

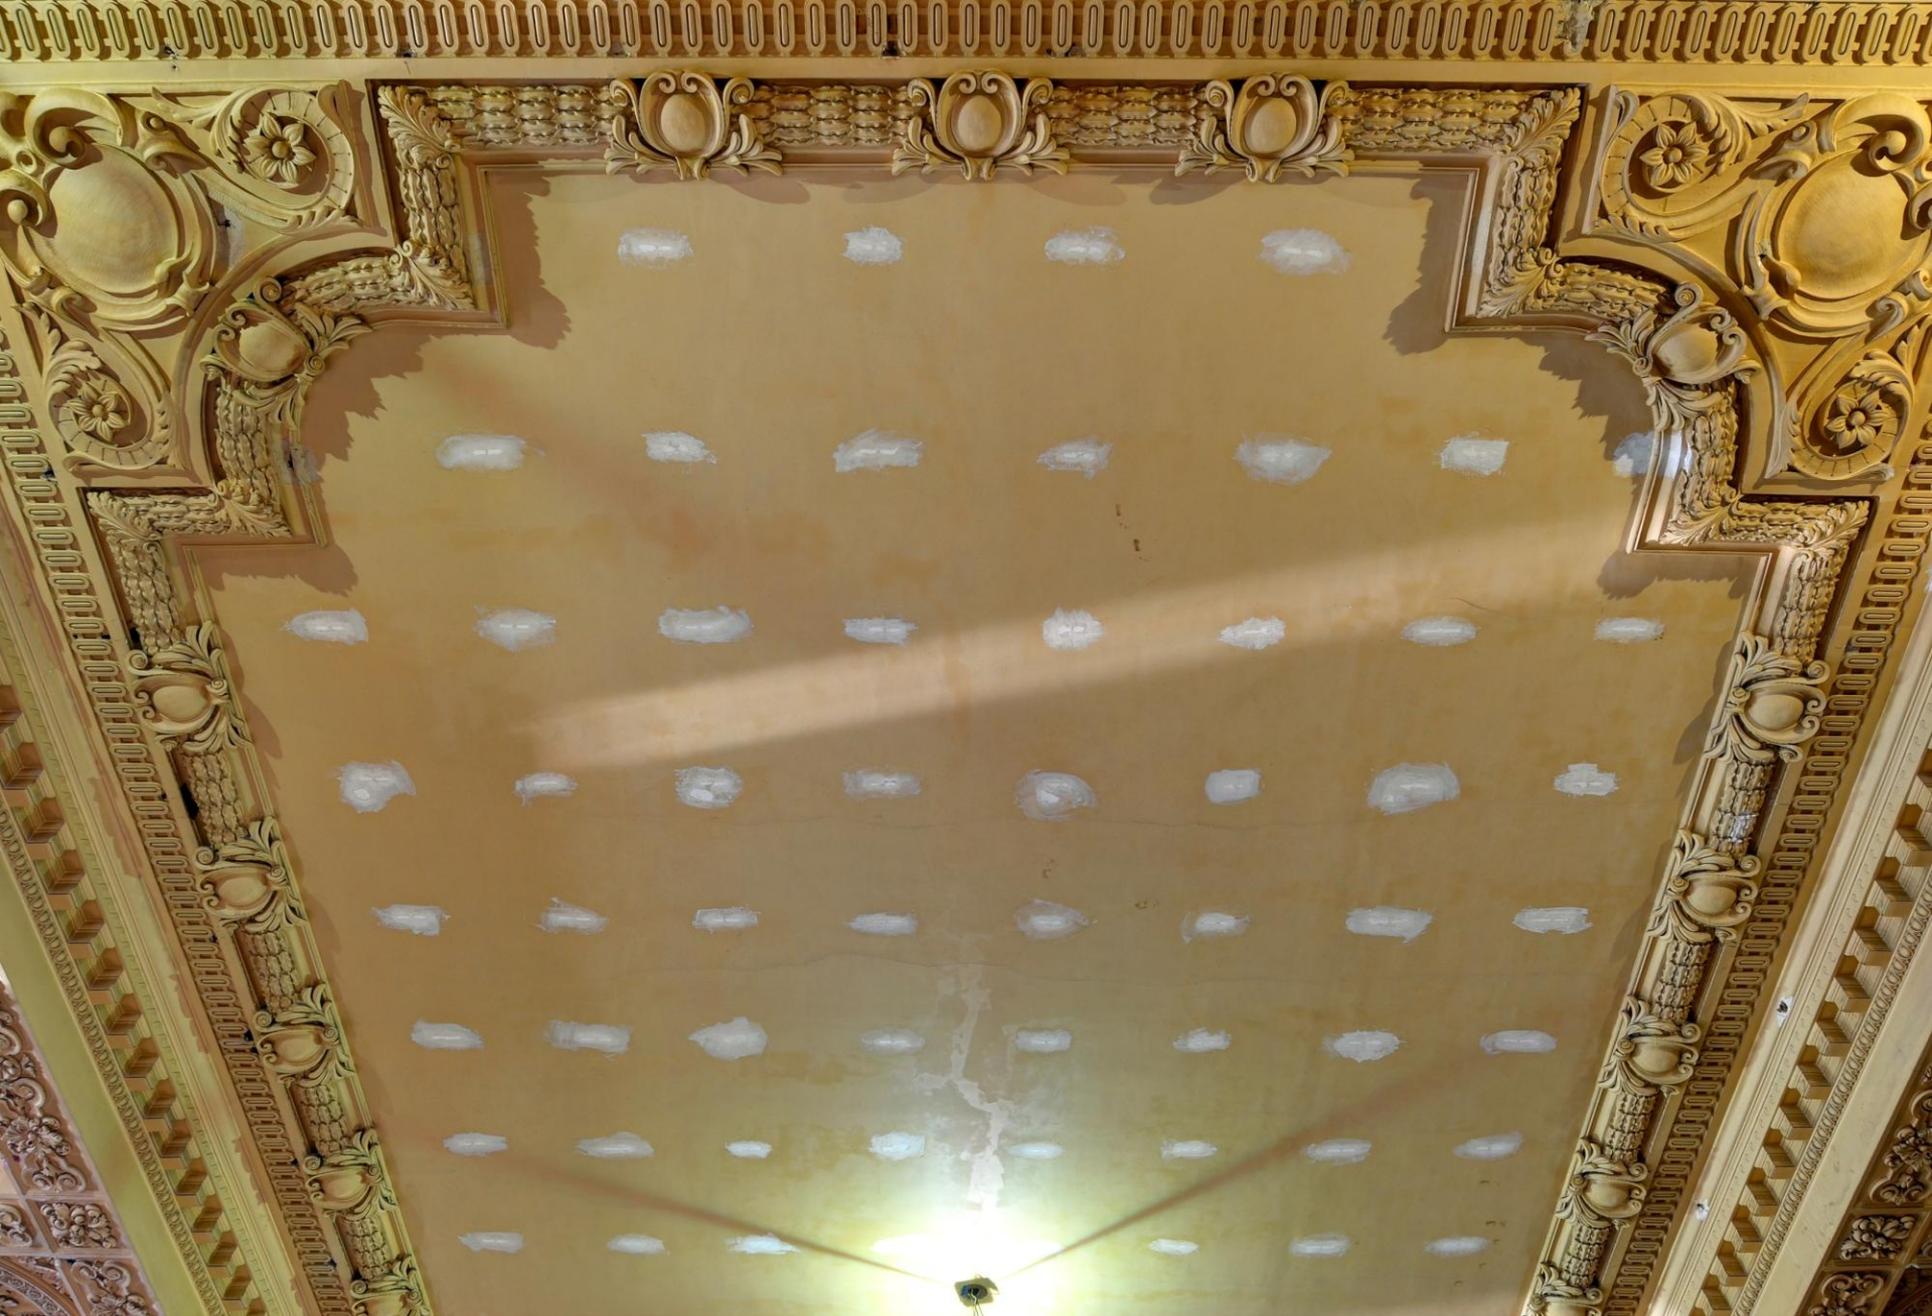
The idea of the lowered ceiling was to conserve heating and brighten up the space with cool white fluorescent light. In order to do so, much of the original plaster ceiling was drilled into for tension attachments.

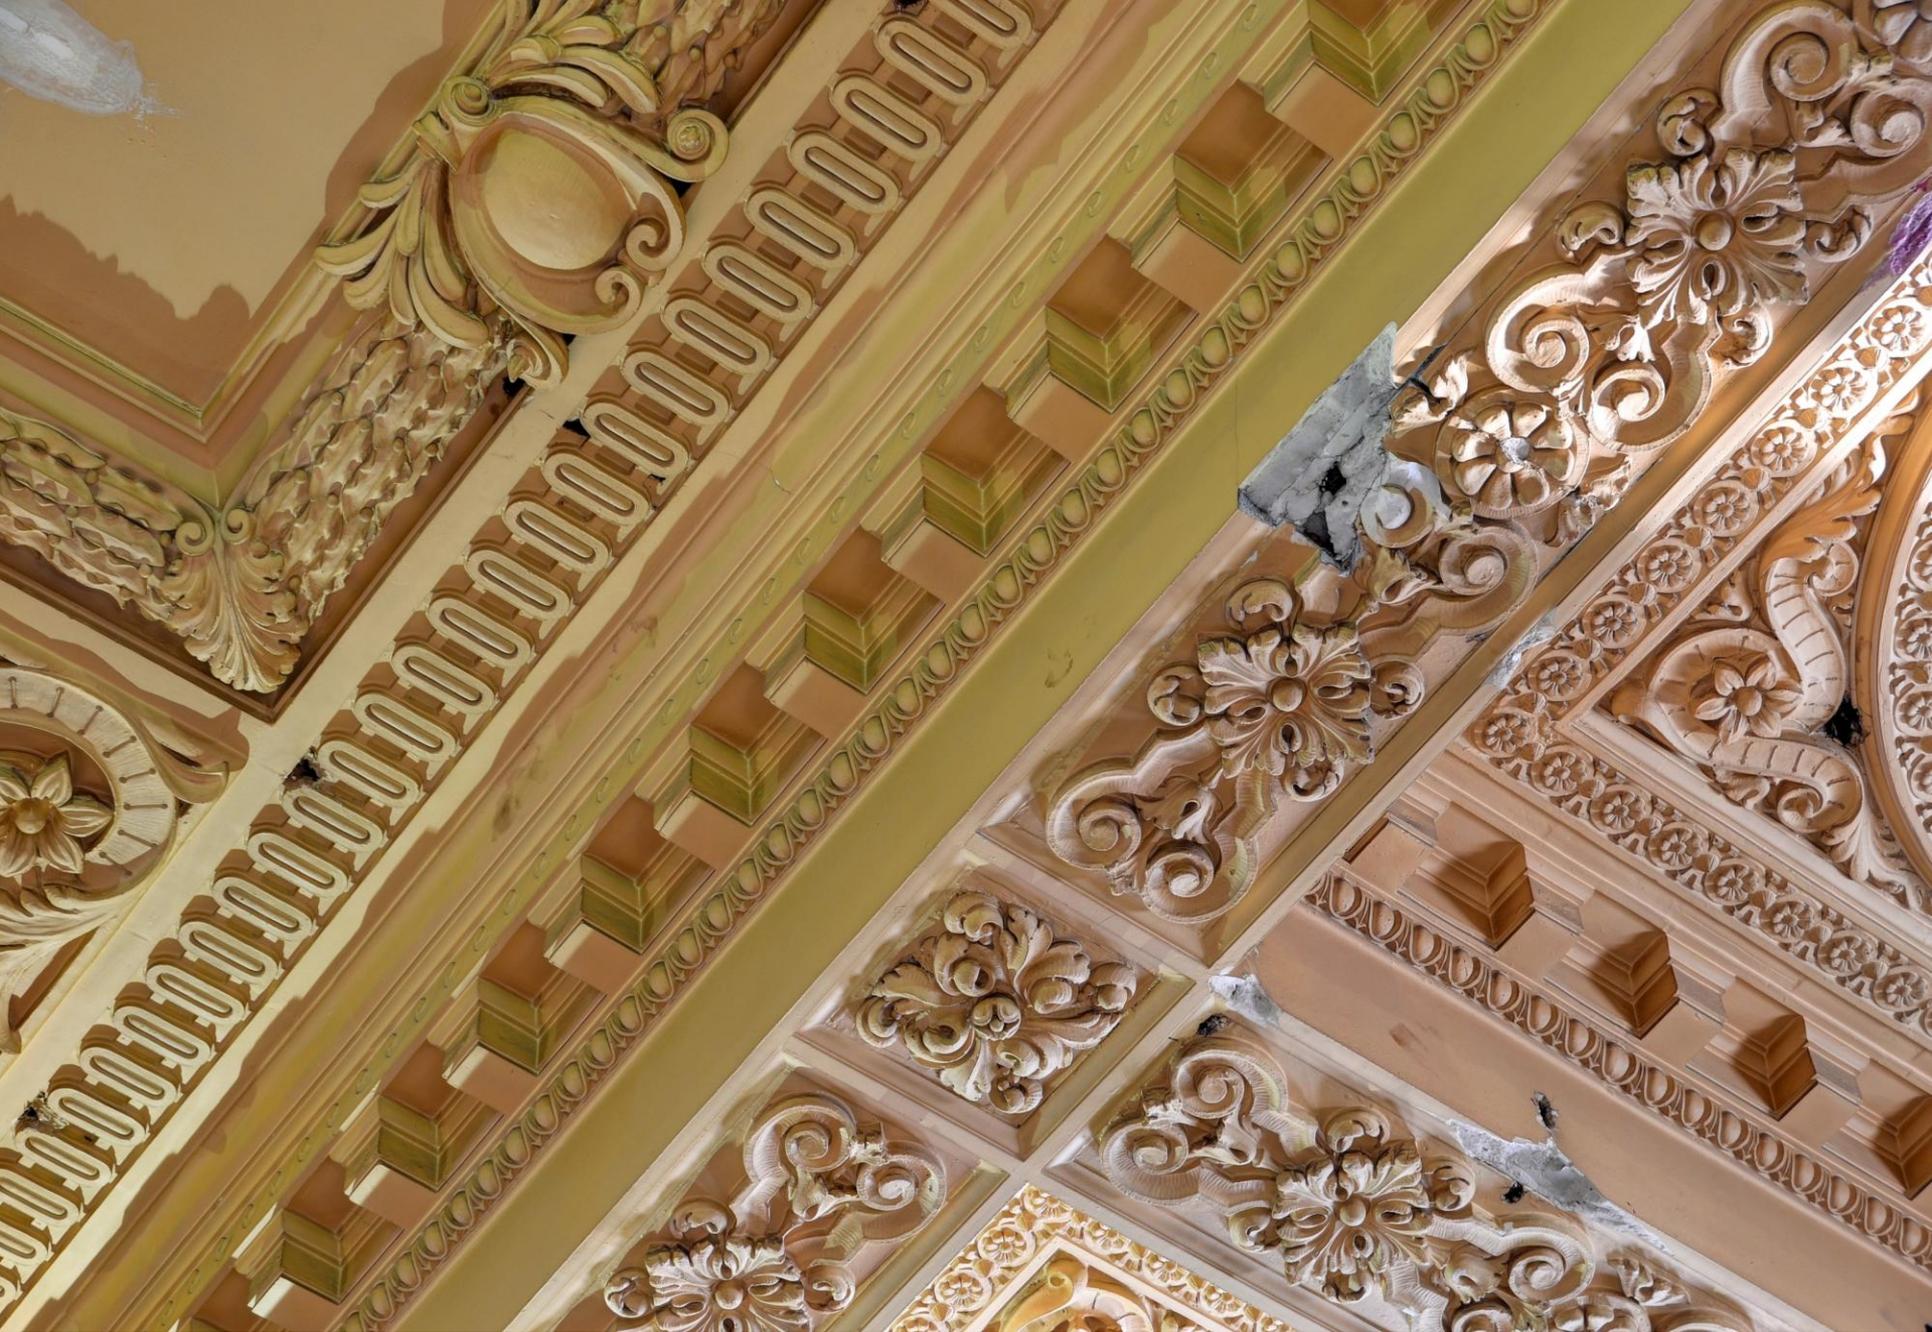
The intricate ornamental plaster work was forgotten and covered up for over 5 decades.
