Final Report

Alaskan Way Viaduct Independent Technical Review

Prepared for
Seattle Department of Transportation

April 10, 2015

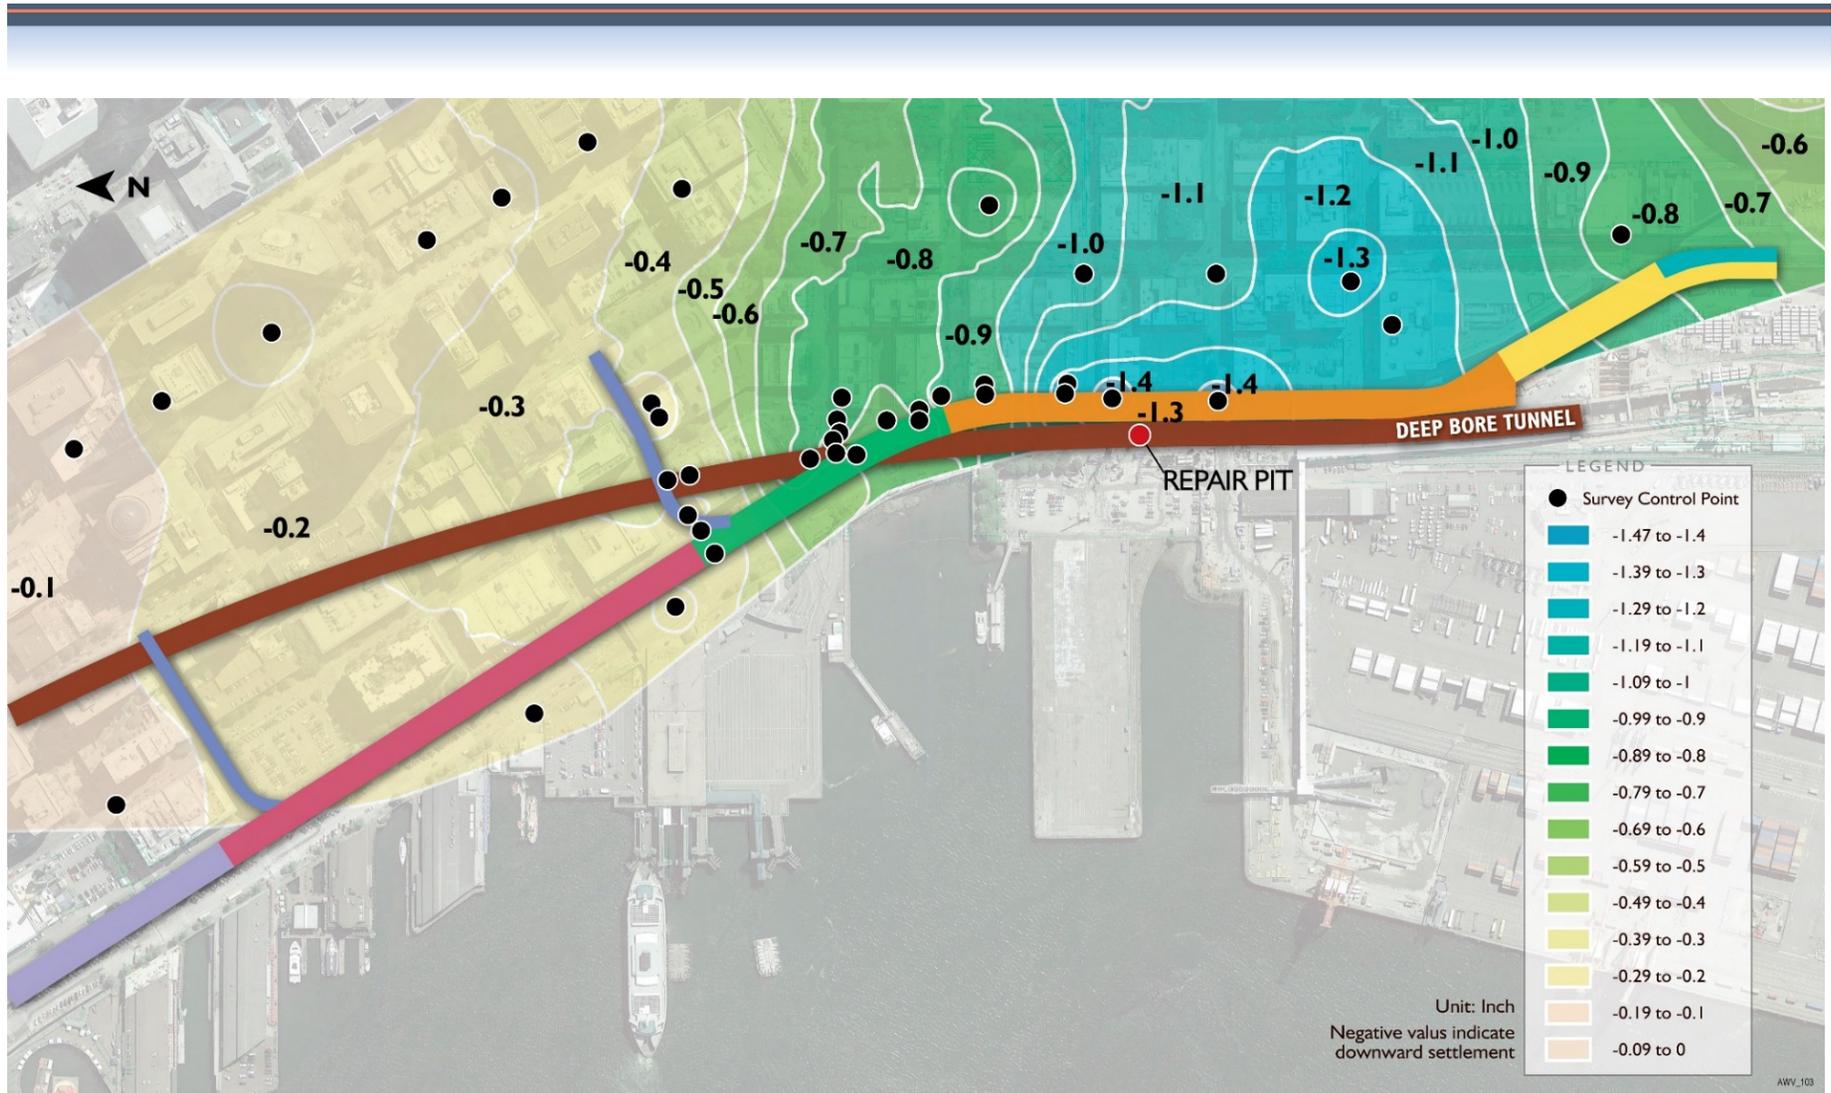
The dewatering that began in November 2014 to construct the tunnel repair pit has coincided with observed ground settlement measured by WSDOT that is shown in Figure 2-4. This figure includes ground settlement from 2010 to December 2014. It should be noted that ground settlements are measured at the ground surface, while structure settlements are measured at locations on the structure.

FIGURE 2-4
Ground Settlement from 2010 to Dec 2014
 (Source: WSDOT Media Release, Dec 11th, 2014)

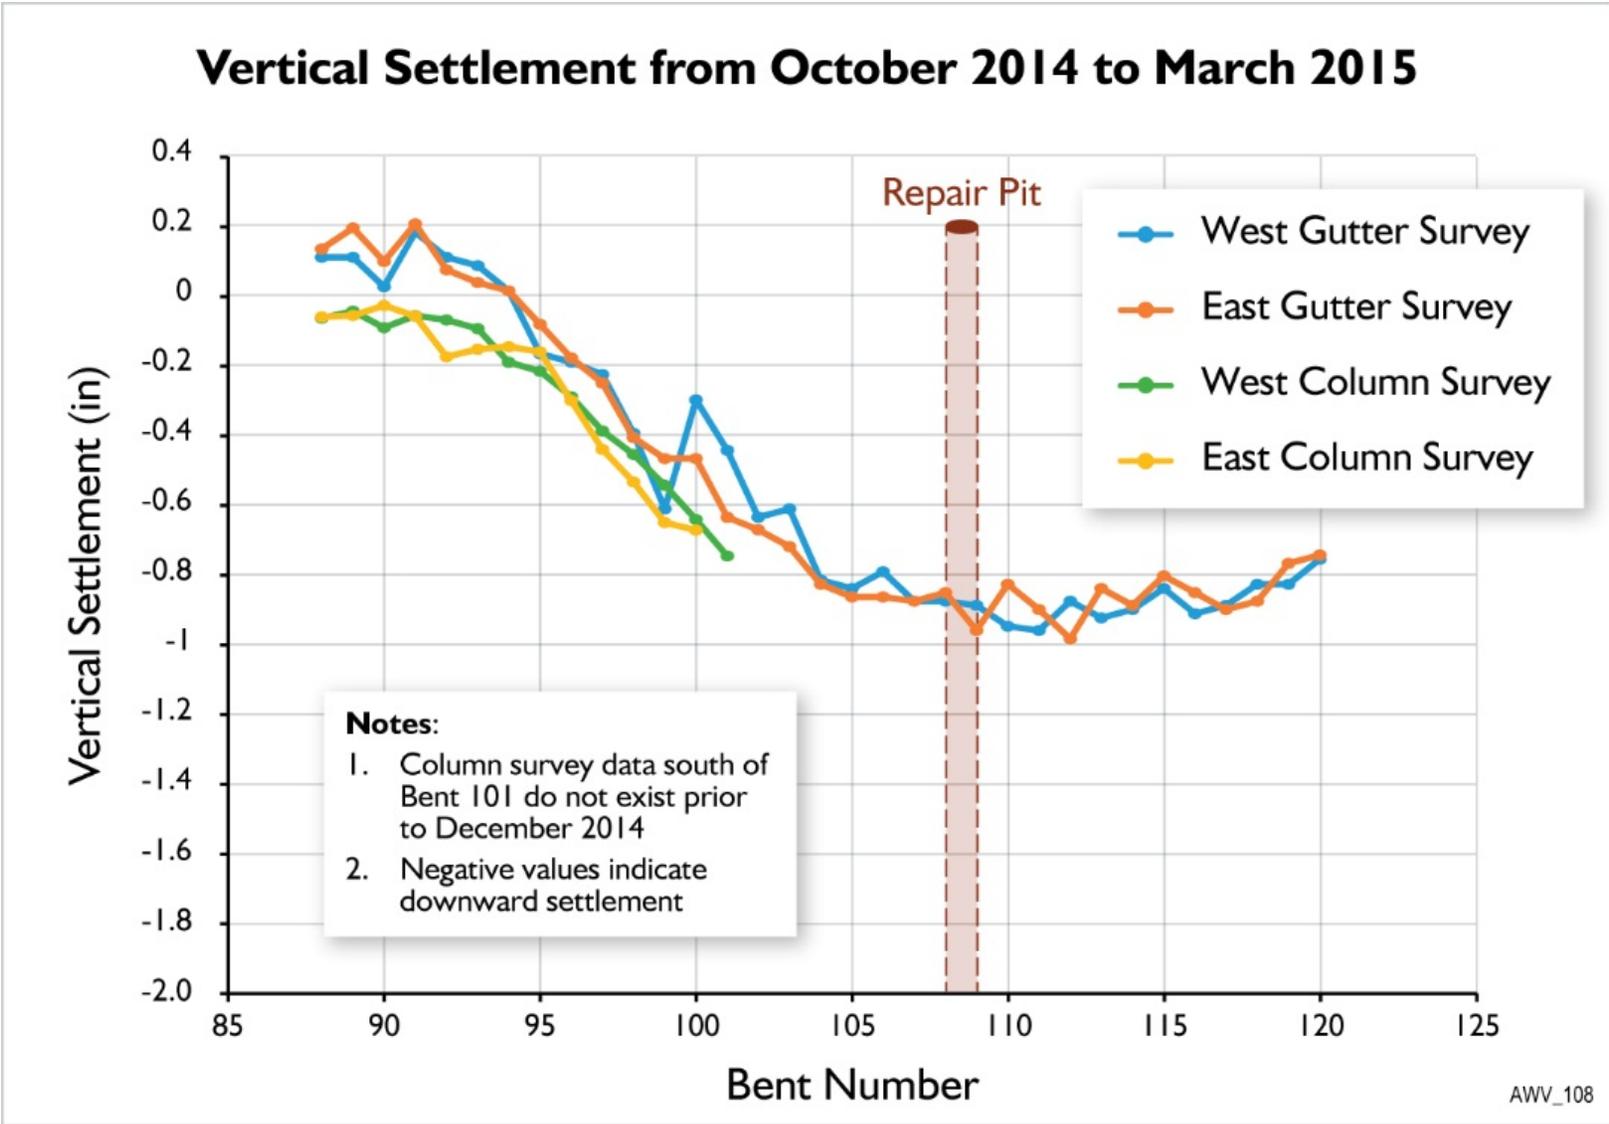
FIGURE 2-5
Structure Settlement – Bents 88 to 120 (From October 2014 to March 2015)

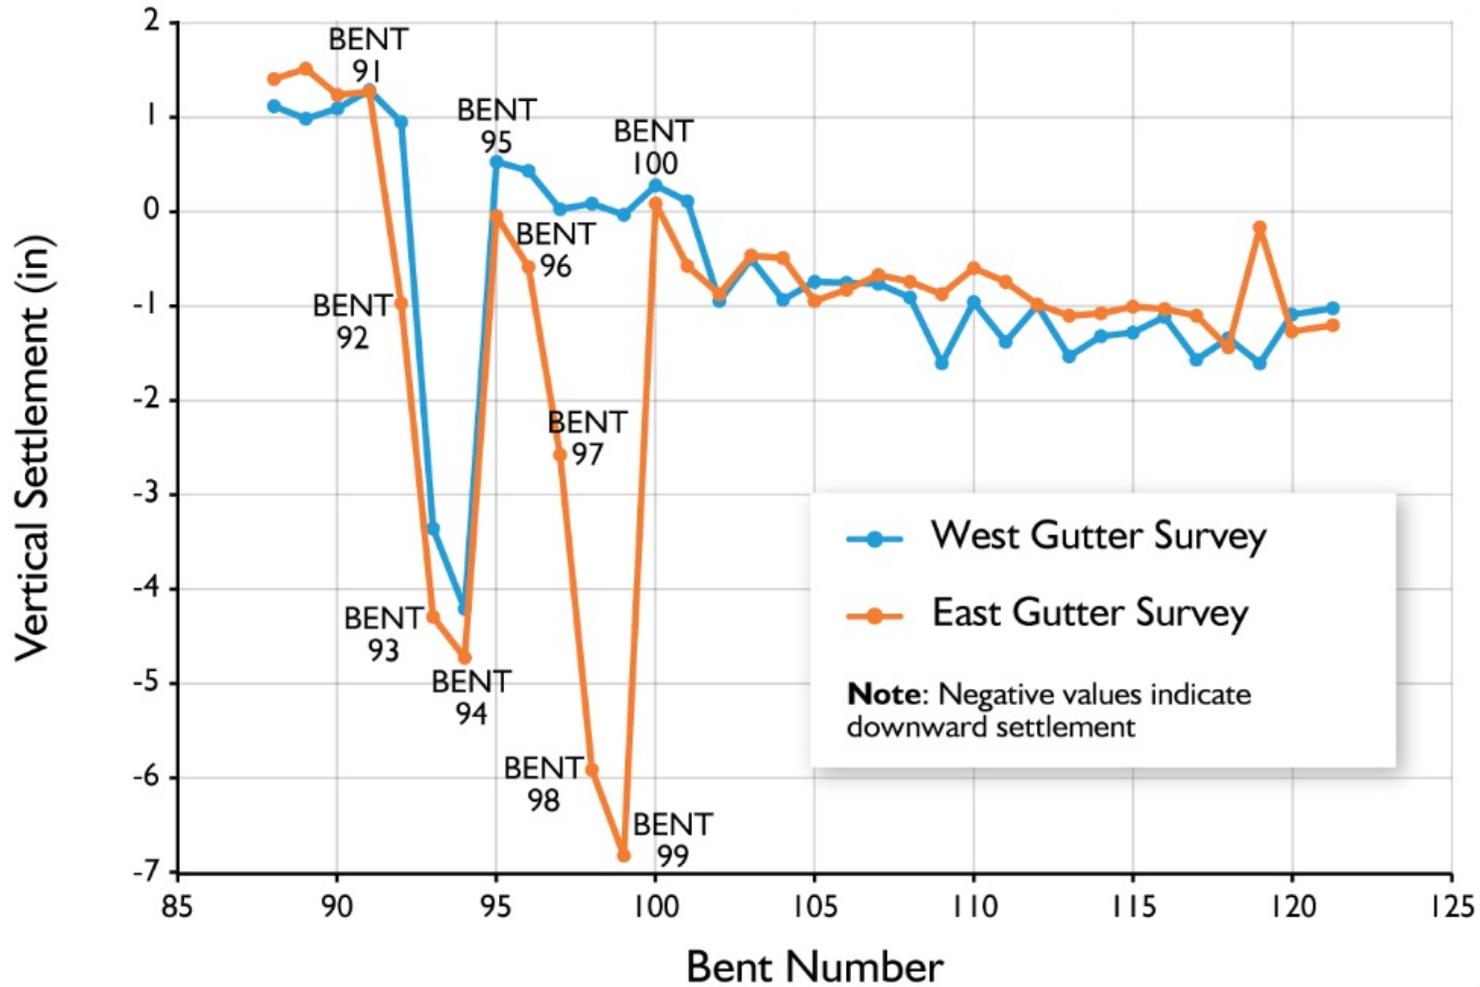
Figure 2-6 shows measured structure settlements from Bents 88 to 121 over the time frame from as-built conditions to March 2015. The values shown are the differences between the elevations reported on the as-built drawings and the elevation measured by survey along the East and West gutters of the viaduct on March 2015. The figure shows significant settlements at Bents 93-94 and Bents 98-99.

FIGURE 2-6
Structure Settlement – Bents 88 to 121 (From As-Built Elevation to March 2015)

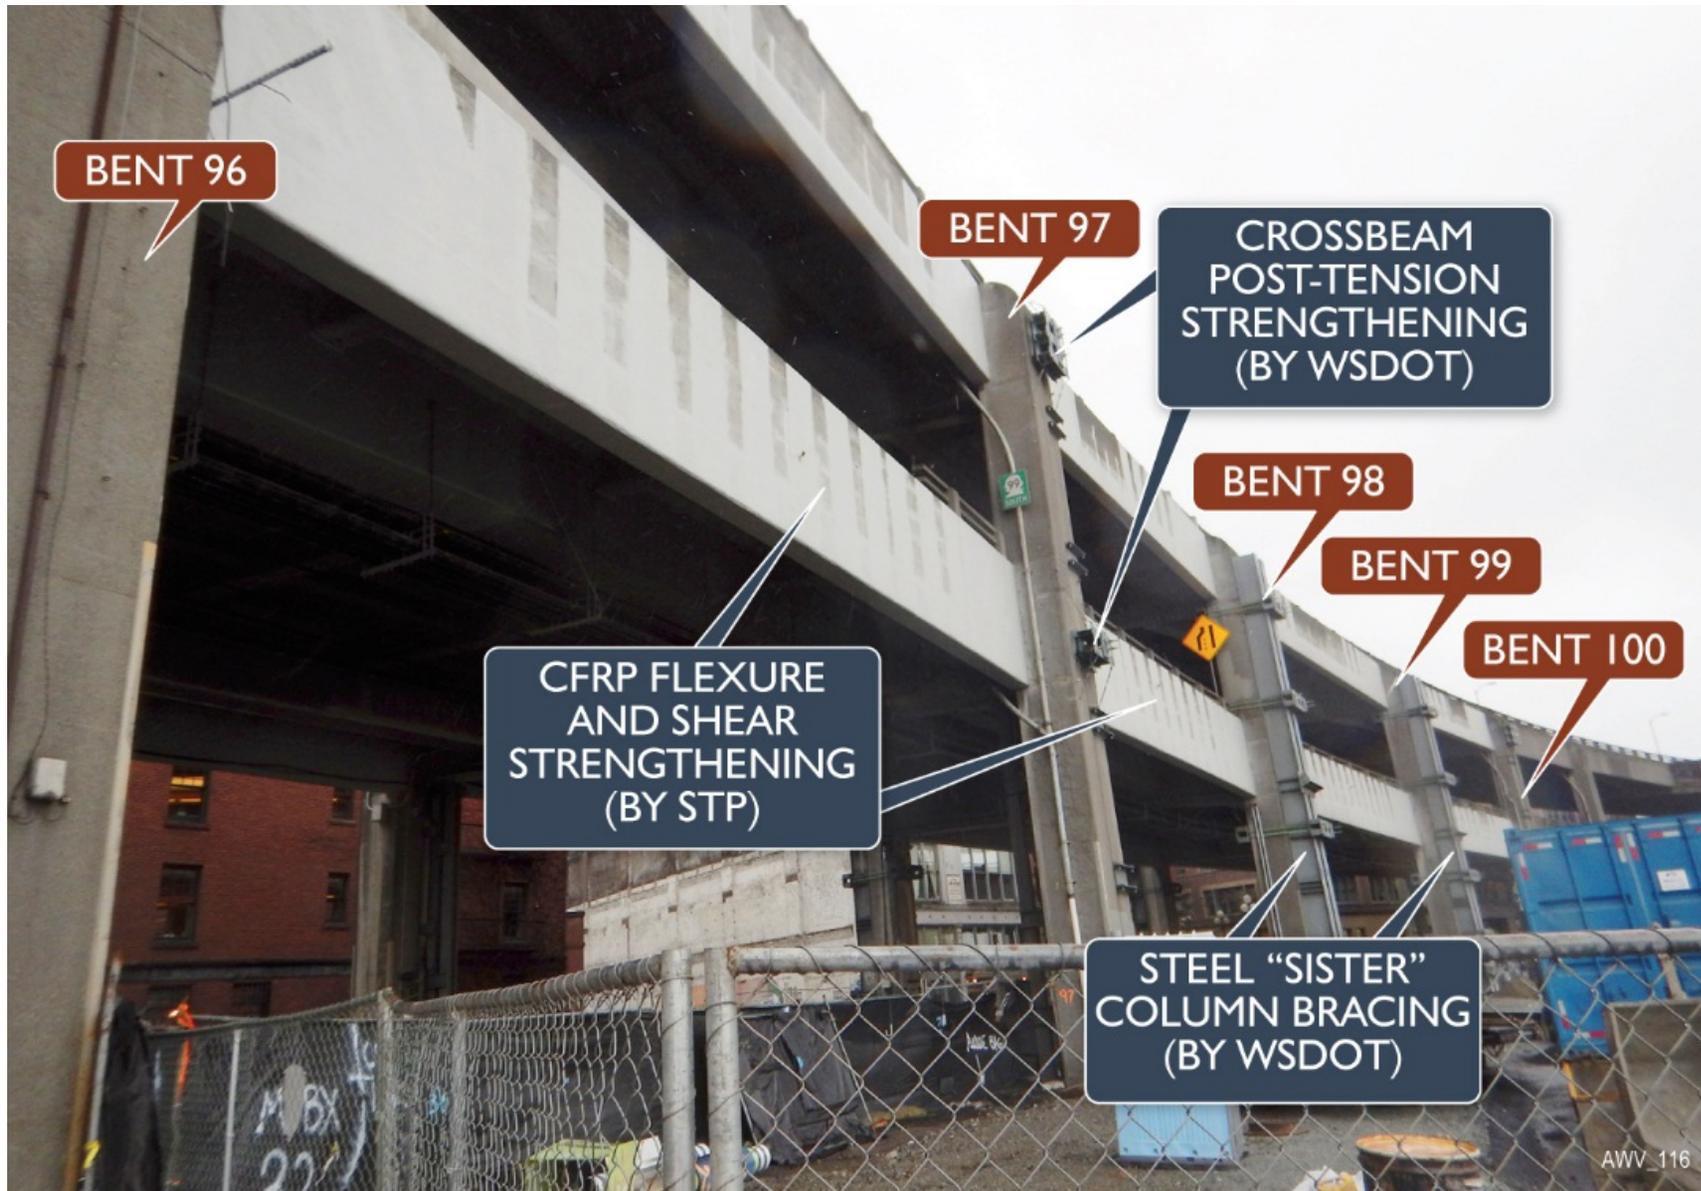
The three-span frame between Bents 97S-100N experienced significant damage during the 2001 Nisqually Earthquake. Immediately after the earthquake, WSDOT issued two emergency earthquake repair contracts to provide temporary repairs to the structure. These repairs included steel "sister" columns, shoring and transverse post-tensioning of the transverse crossbeams, and carbon fiber wrap flexural and shear strengthening of the crossbeams and longitudinal girders, as shown in the photograph in Figure 3-2.

FIGURE 3-2
Alaskan Way Viaduct Bents 91-100

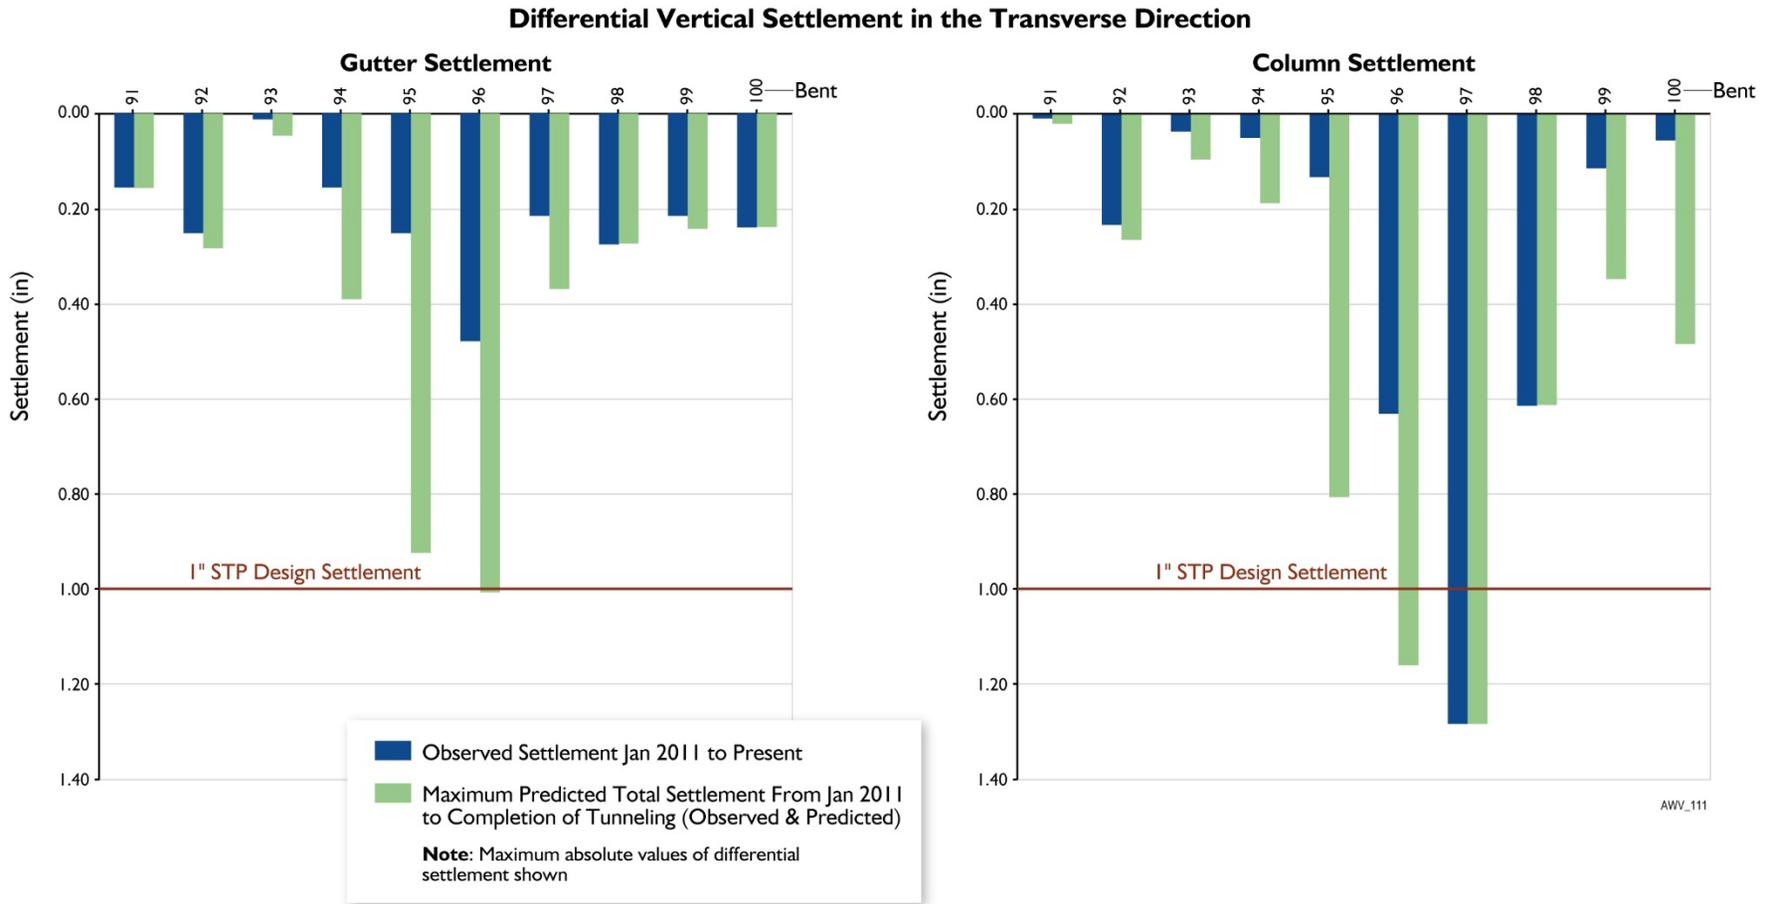
The review also identified a gap in the accounting of some of the historical and current structure settlement. Because STP performed its evaluation and strengthening design in 2012, differential structure settlements that have occurred since 2011 have not been included in the structural analysis. Figures 3-4 and 3-5 show bar charts of differential structure settlements in both the transverse and longitudinal directions from January 2011 to March 2015 for gutter line and column survey data. The dark blue bars represent the differential settlements that have occurred since STP's analysis was conducted. The green bars next to the dark blue bars show the total expected differential settlements when the expected tunneling settlements are added to the observed differential settlements since 2011. At some bent locations, tunneling is expected to induce differential structure settlement in the opposite direction from that measured since 2011. In these cases, the tunneling settlement offsets the differential settlement at these particular bents and the maximum expected differential settlement is not expected to increase from present condition. As Figures 3-4 and 3-5 show, the observed and predicted maximum differential settlements at some bent locations exceed the settlement limit of 1" that STP used in the strengthening design. In the transverse direction, the maximum observed and expected differential settlement is about 1.25". In the longitudinal direction, the maximum expected total differential settlement is approximately 1.28".

FIGURE 3-4
Differential Vertical Settlement in the Transverse Direction

STP's strengthening design of the longitudinal girders and transverse crossbeams included a safety allowance (or factor of safety). Exceeding the 1-inch design settlement has likely reduced this safety allowance, but may not necessarily pose a safety concern. It is recommended that this safety allowance be reevaluated. In addition, pending the successful resolution of the structure modeling issues discussed previously, it is recommended that this portion of the viaduct be actively monitored for both settlement and signs of structure distress. If the magnitude of the differential settlement continues to increase, or if certain signs of structure distress (such as increased cracking in the members) start to develop, remedial action may become necessary.

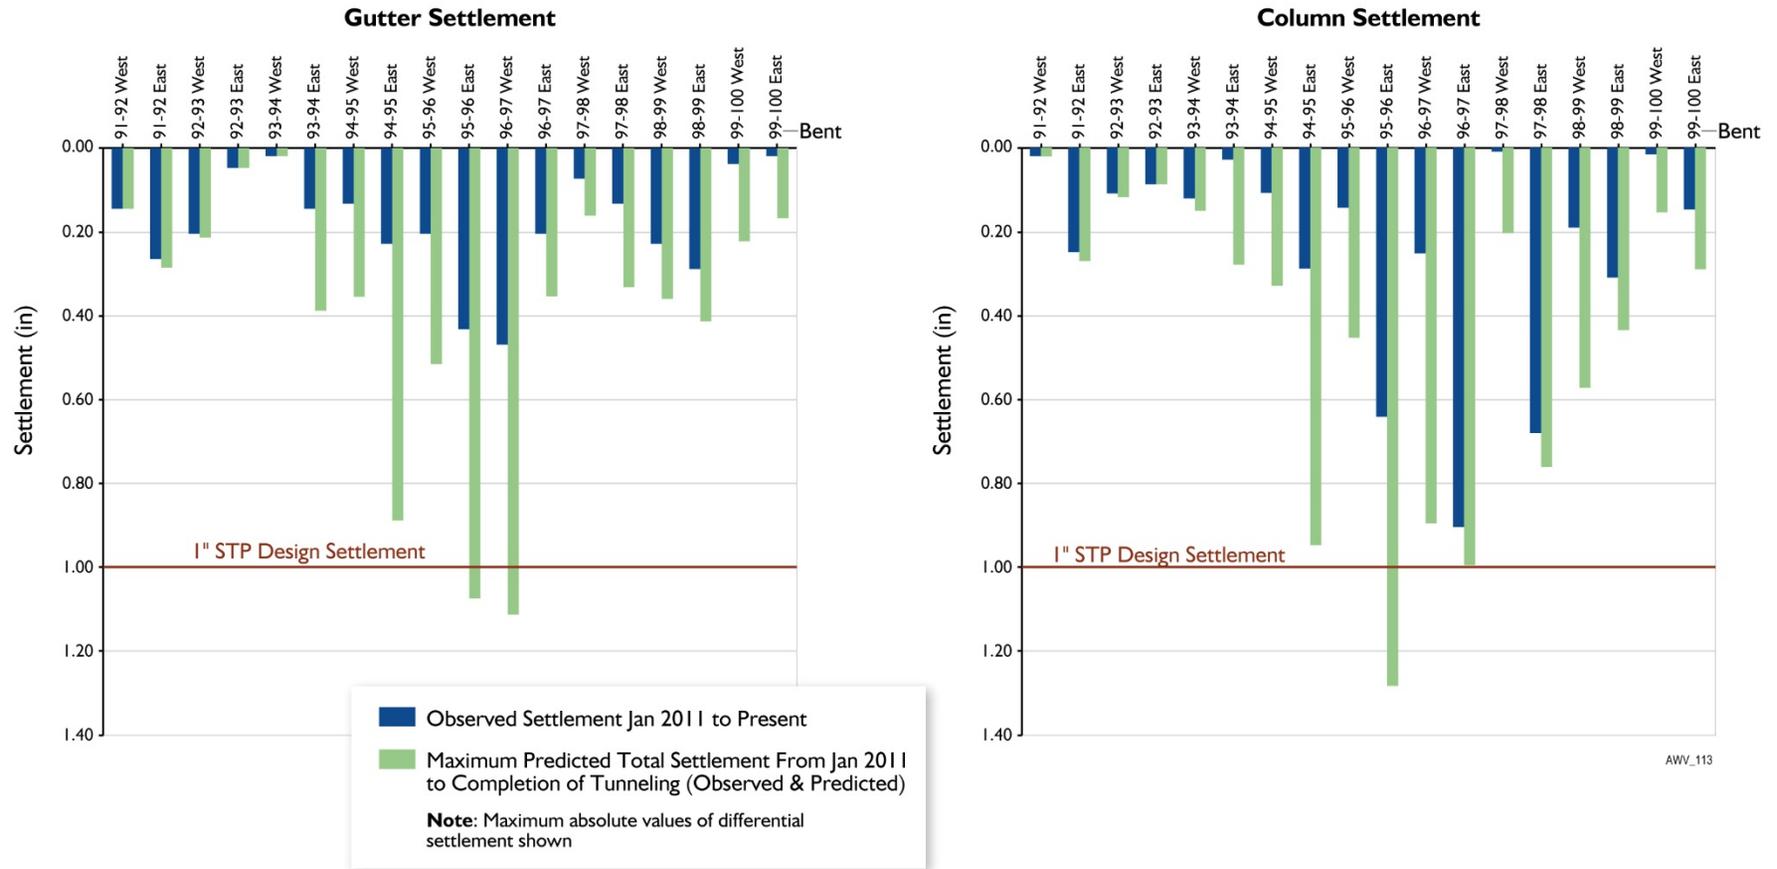
Review of available survey data found that the viaduct structure has experienced significant longitudinal and transverse differential settlement between Bents 91 and 100. The maximum magnitude of the vertical differential settlement appears to have exceeded 5 inches between Bents 94 and 95 and 6.5 inches between Bents 99 and 100 (Figure 2-6). Compared with vertical survey data, the availability of horizontal survey data is limited. Based on the horizontal survey data available, the magnitude of horizontal differential movement appears to be small.

FIGURE 3-5
Differential Vertical Settlement in the Longitudinal Direction

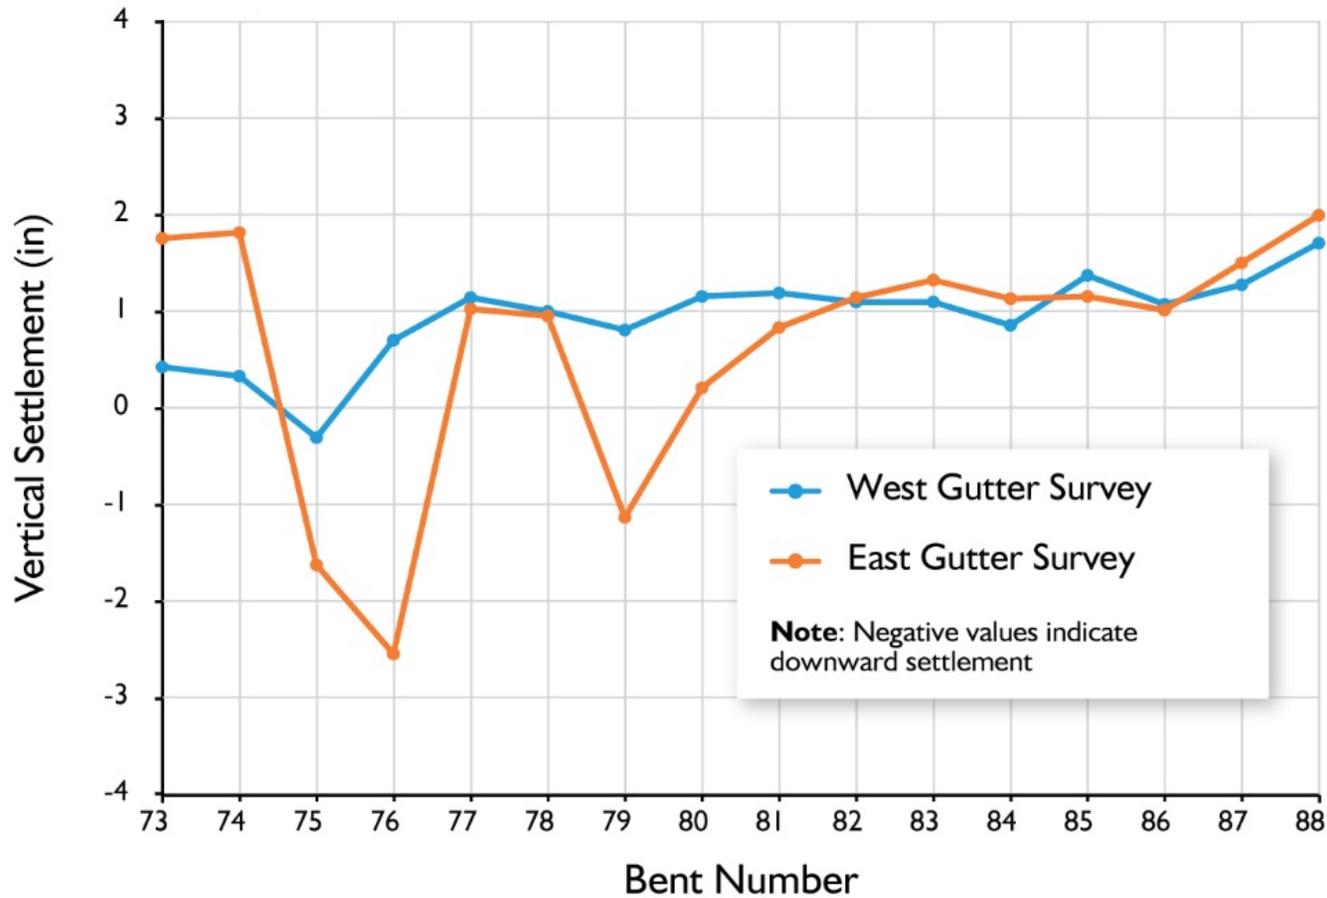
Significant historical settlement has been observed near Bents 75 and 76, as Figure 3-12 shows. Specifically, it was reported by WSDOT that the east footing of Bent 76 appeared to have settled 2.7 inches, while the east footing of Bent 75 appeared to have settled 1.8 inches. WSDOT also reported that the east footing of Bent 79 had settled 1.3 inches. It is understood that cracks were discovered in the upper west column of Bent 76 during a recent WSDOT inspection in March 2014. As a result, WSDOT performed a structural settlement analysis for the three span frame between Bents 73 and 76. Based on the results of the analysis, WSDOT repaired the upper west column of Bent 76 in 2014 using epoxy injection.

CH2M HILL's review of available survey data found that the viaduct structure experienced significant differential settlement in the area between Bents 74 and 76. The maximum magnitude of vertical differential settlement appears to be in excess of 3 inches according to gutter line survey. This magnitude matches relatively well with the settlement reported by WSDOT (2.7 inches). The magnitude of horizontal differential settlement could not be determined as no horizontal survey data were available.

FIGURE 3-12
Structural Settlement – Bents 73 to 88 (From As-Built Elevation to March 2015)

Considering the magnitude of observed differential settlement in this area, it is recommended that this portion of the viaduct be actively monitored. The settlement assessment should also be expanded to include structural members other than columns. At a minimum, exterior longitudinal girders and

crossbeams, which appear to be the most vulnerable members based on the analysis performed for similar frames between Bents 91-100, should be examined to establish their safety margin.
