CLOSED CASE SUMMARY

CASE NUMBER: 2024OPA-0241

EXECUTIVE SUMMARY:

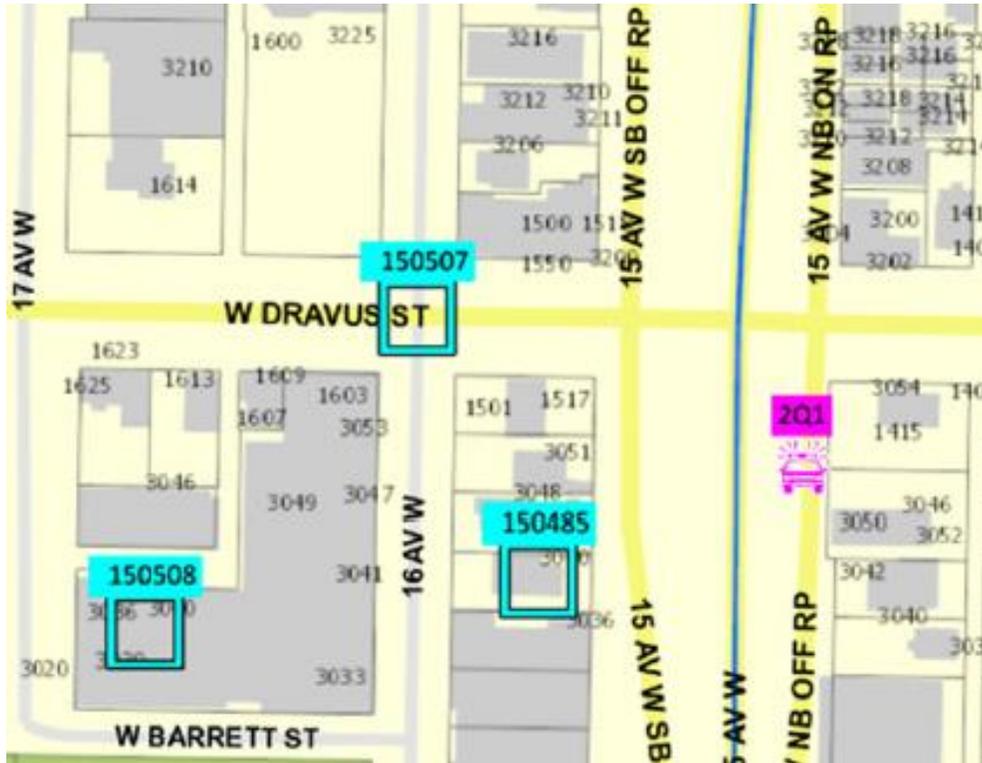
*NE#1, responding as "2Q1" shortly before collision.
Approximate call locations are indicated by light blue squares.*

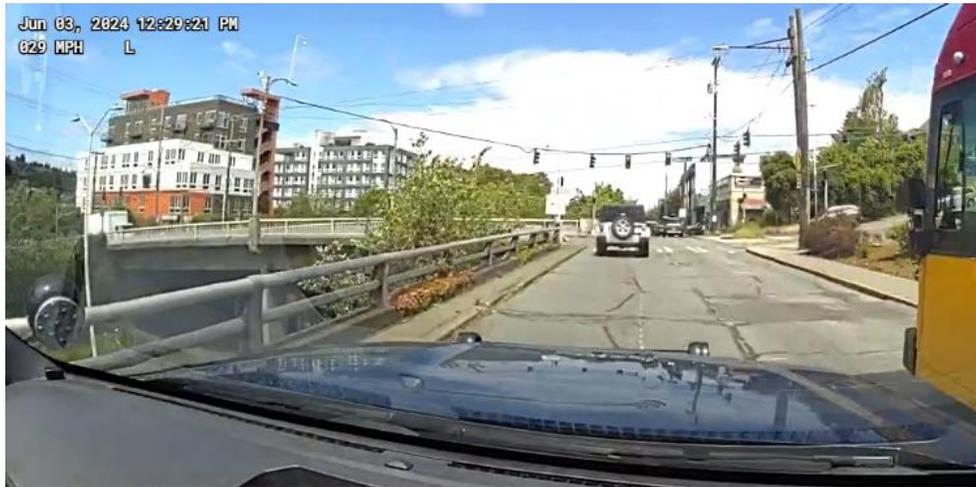
NE#1 had lights and a continuous siren activated as he drove northbound along the 15th Avenue West offramp, towards the intersection with West Dravus Street. NE#1 slowed from about 65 miles per hour entering the offramp to about 29 miles per hour as he approached the intersection. NE#1 had the redlight as he approached the intersection. A Jeep was ahead of NE#1, stopped in the left lane. NE#1 pulled into the right lane ahead of a Metrobus.

NE#1 approaching intersection.

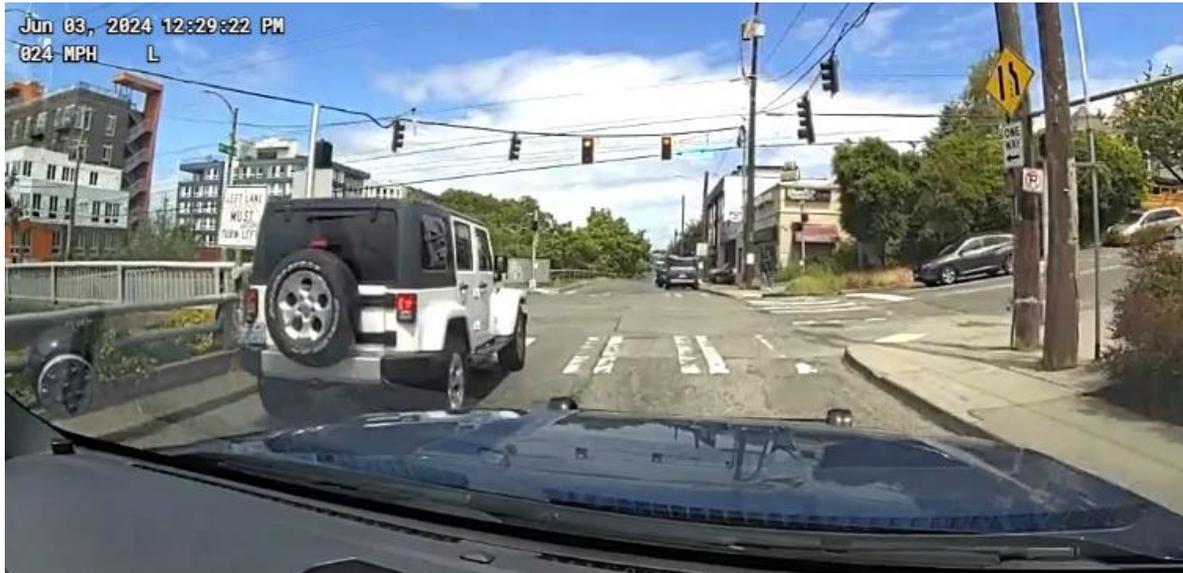
As NE#1 pulled to the right of the Jeep, no eastbound vehicles were visible along the fence line to NE#1's left. At right, a dark gray SUV has a green light but does not advance.

NE#1 pulling to the right of the Jeep. Dark gray SUV, at right, has green light but does not advance.

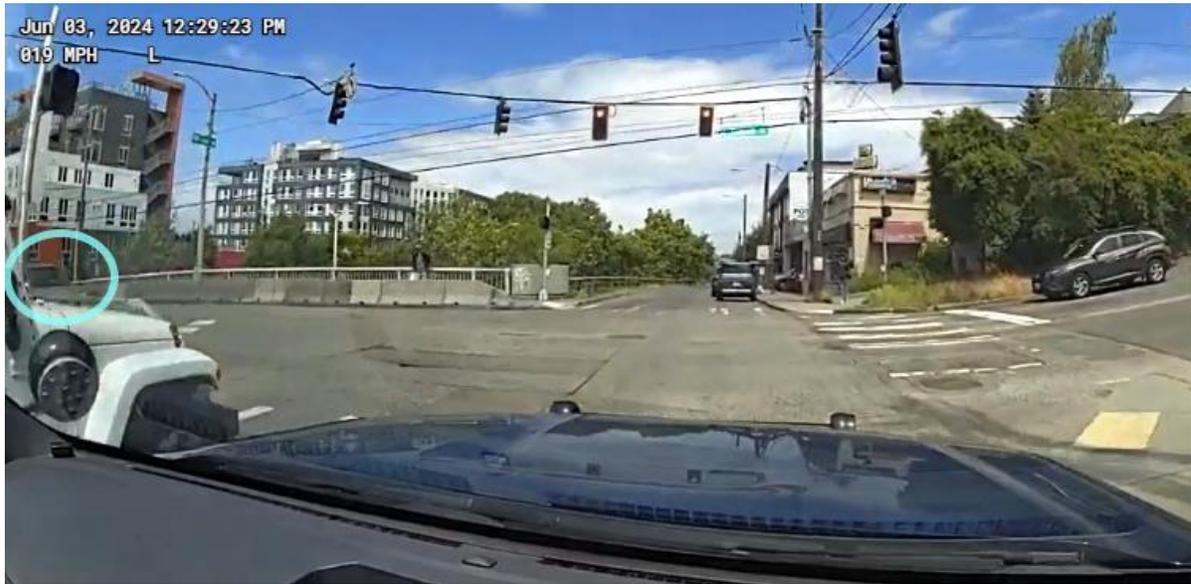
NE#1 slowed to about 19 miles per hour. As NE#1 pulled ahead of the Jeep, ICV recorded Vehicle #1 approaching from NE#1's left, heading eastbound.

Vehicle #1 circled in light blue, at left. Dark gray SUV still at light.

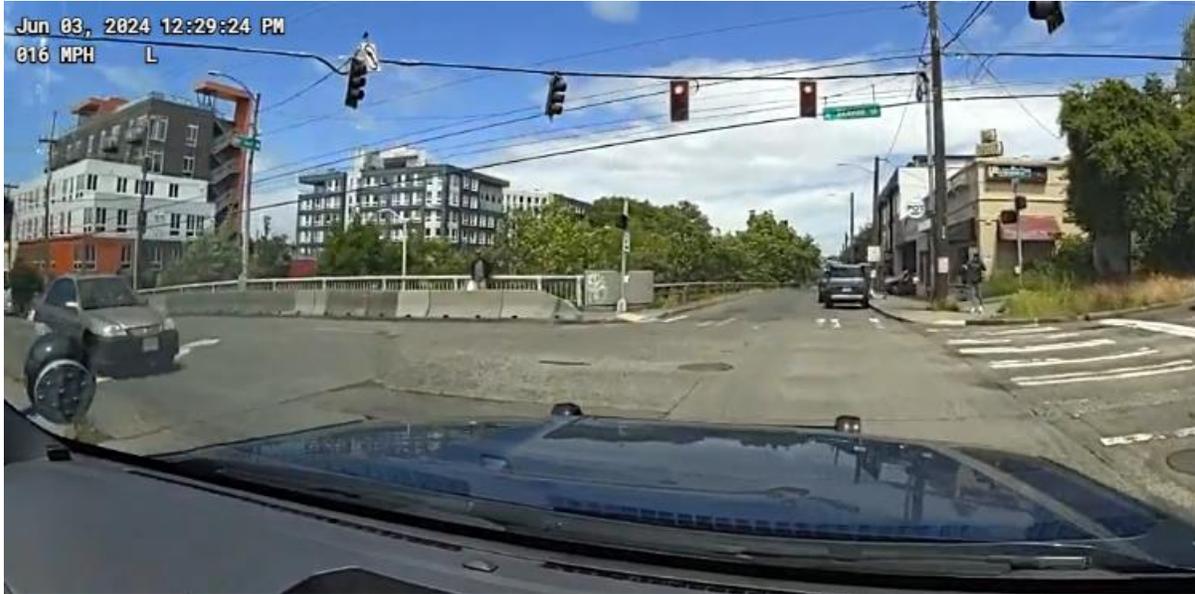
As both NE#1 and Vehicle #1 began to enter the intersection, NE#1 had slowed to about 16 miles per hour.

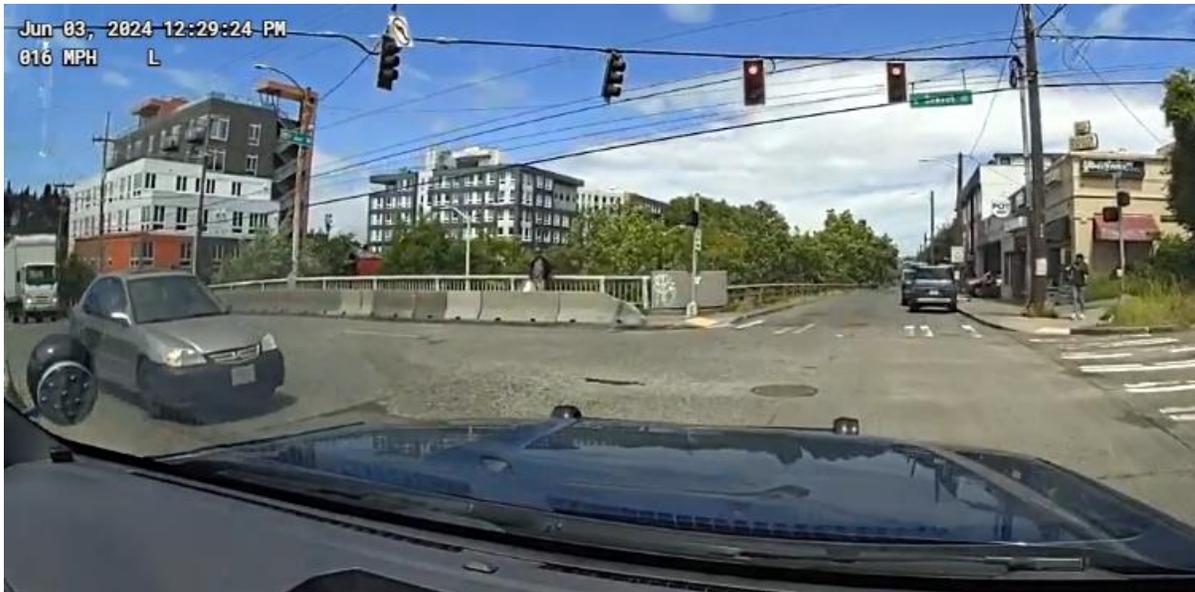
NE#1 continued at about 16 miles per hour as he began making a left turn onto West Dravus Street.

NE#1 beginning to make left turn.

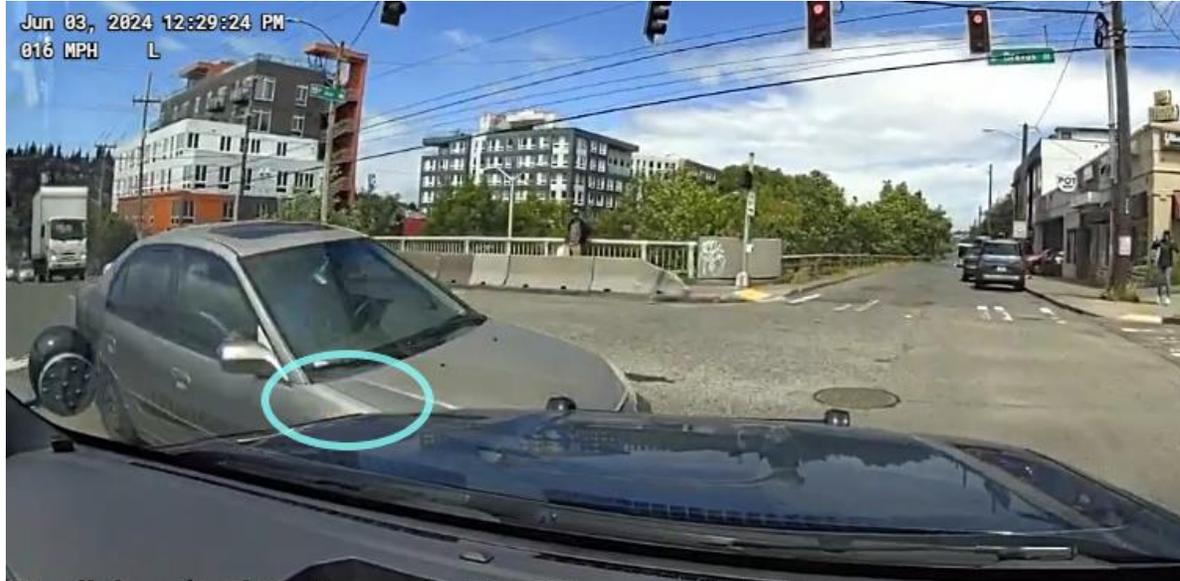
Immediately prior to the collision, ICV still showed NE#1 travelling about 16 miles per hour.

ICV image immediately prior to impact. Hood gap on Vehicle #1, circled in blue, is level.

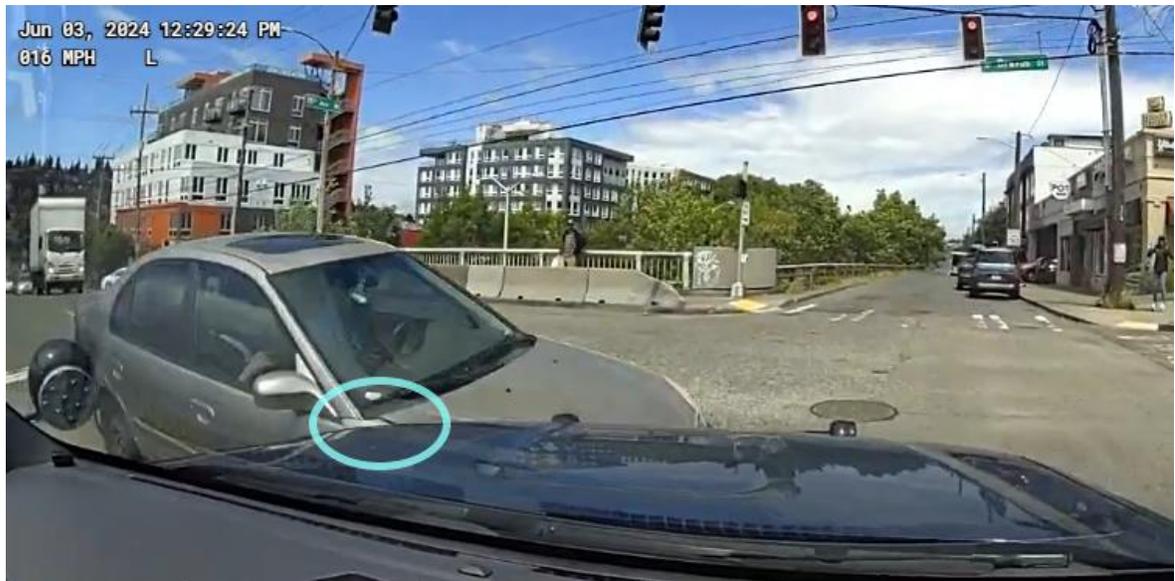
ICV image immediately after impact. Hood gap on Vehicle #1's is no longer level.

Momentum from Vehicle #1 pushed NE#1's vehicle to the right. NE#1's airbags did not inflate. Both front passenger airbags in Vehicle #1 inflated. Images of NE#1's front push bar showed it was impacted from the side.

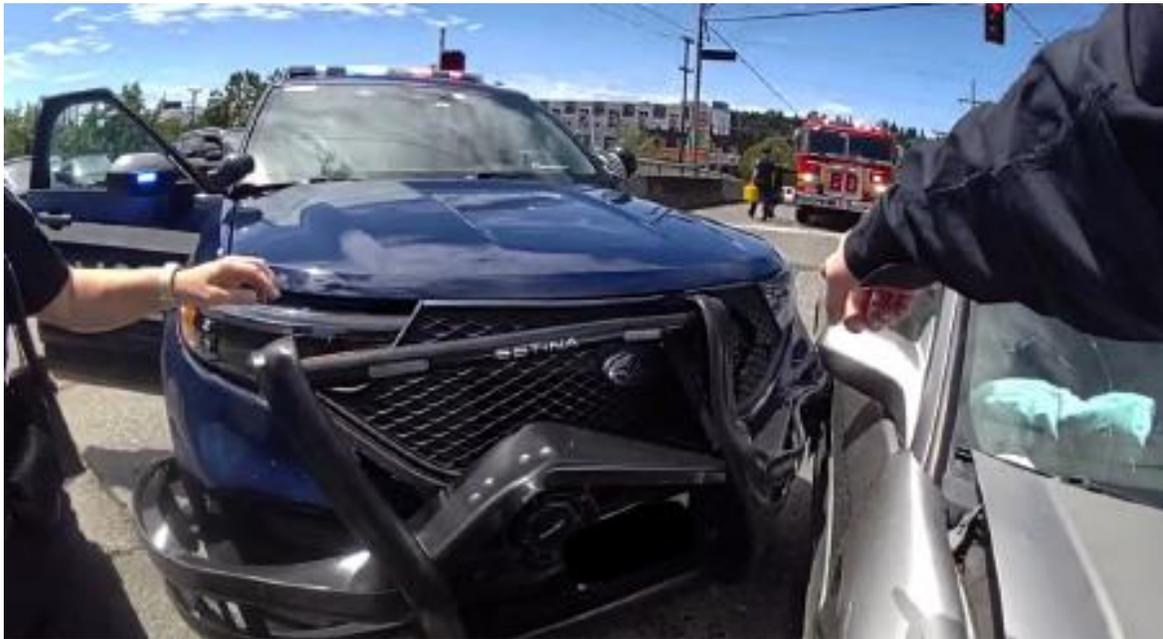
NE#1 pointing to the damage to his front push bar.
