DAYBREAK STAR INDIAN CULTURAL CENTER
SEATTLE PARKS AND RECREATION
ARCHITECTURAL AND ENGINEERING
MAINTENANCE EVALUATION STUDY
City of Seattle, Washington
September 2017

DAYBREAK STAR INDIAN CULTURAL CENTER EVALUATION

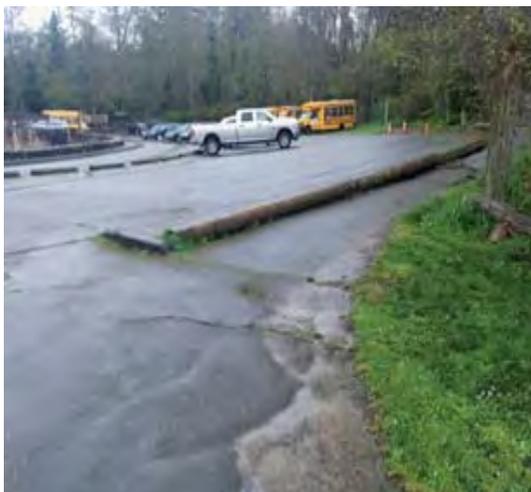
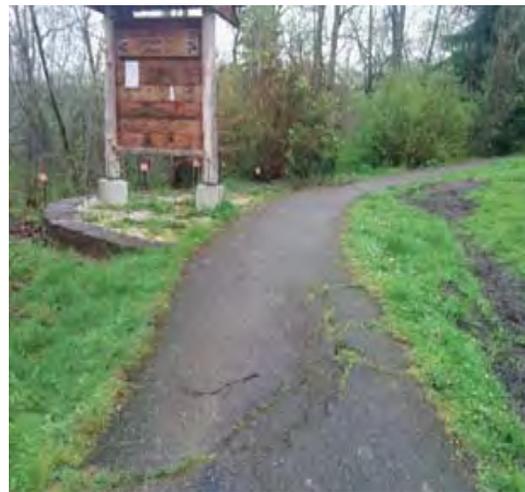
1. Clean out catch basins and TV existing drain lines to determine condition.
2. Grind the root heave areas and repave the cracked walkways that are surround the Daybreak Star Cultural Center.

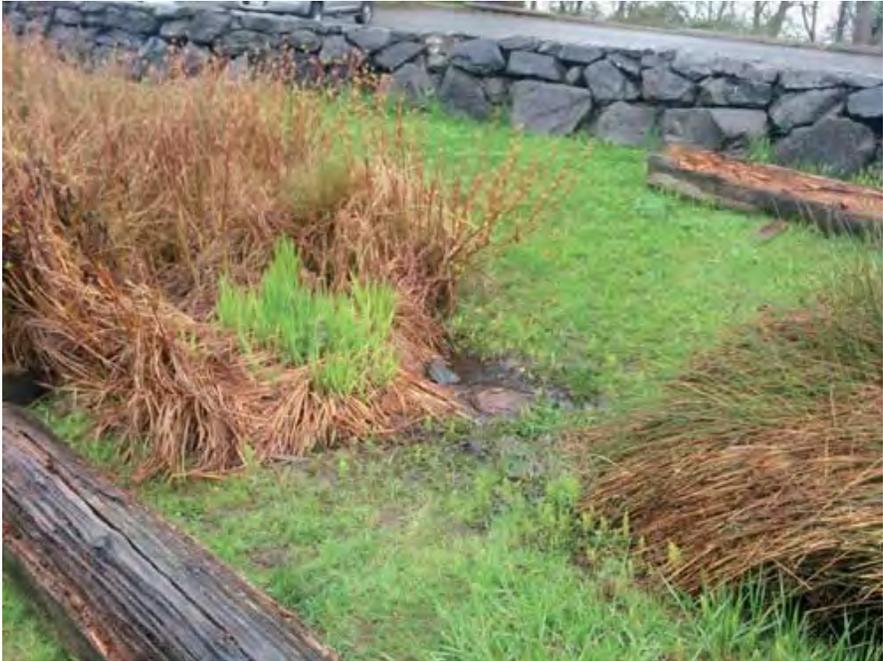
- 3. Clean and rechannel biofiltration swale located outside the northwest entrance.

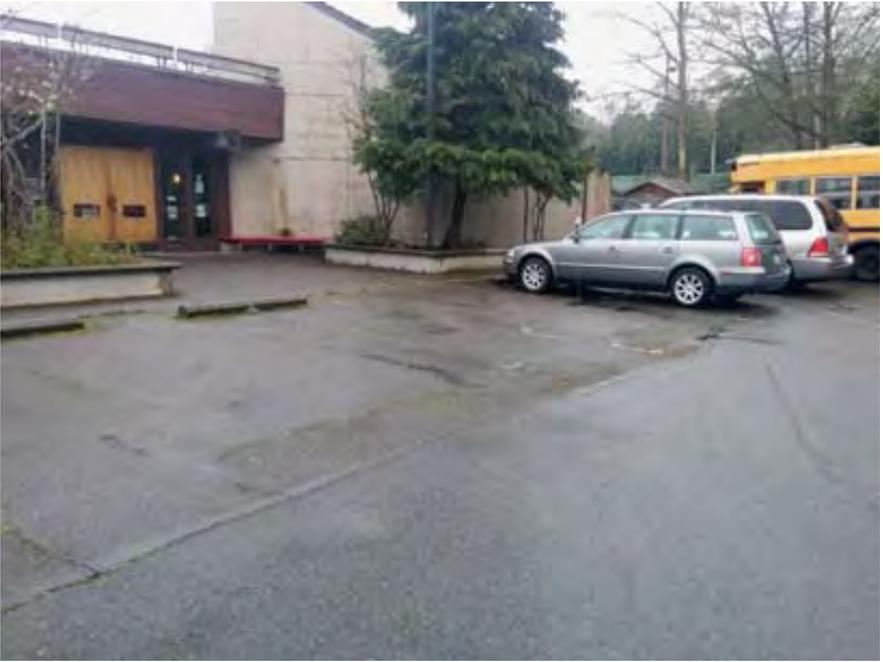
- 4. Restripe and paint parking lot and two handicapped parking stalls to meet ADA standards.

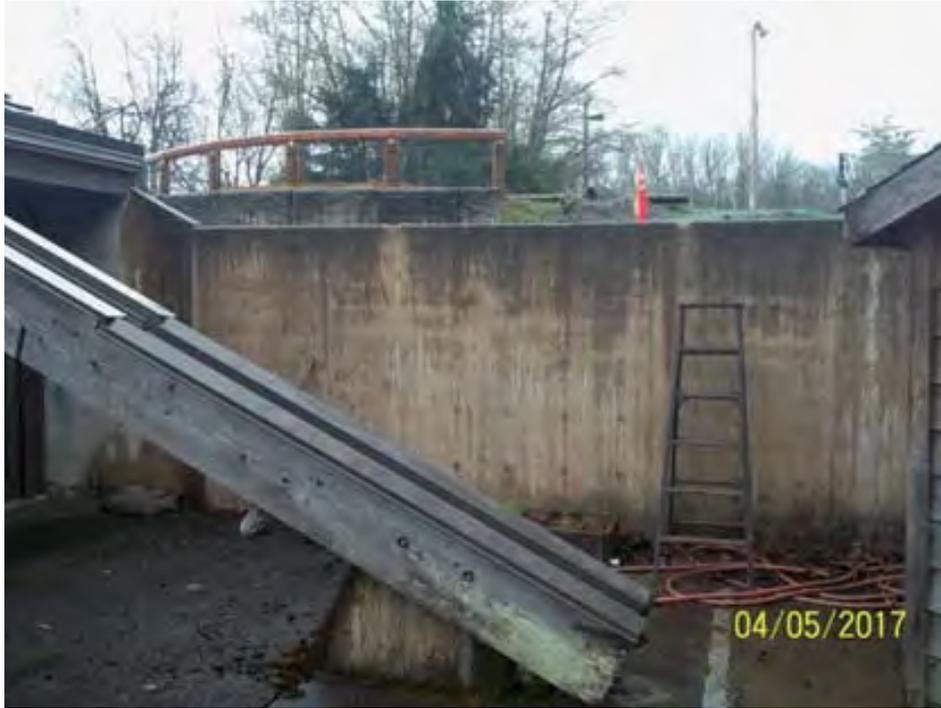
6. Provide fall protection from the existing 9' wall located outside of southwest entrance.

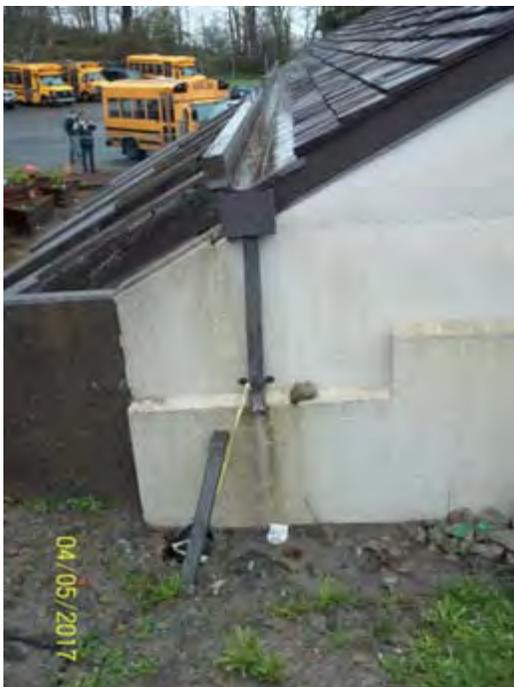
7. Fix and reconnect downspout to french drain on the north side of the facility.

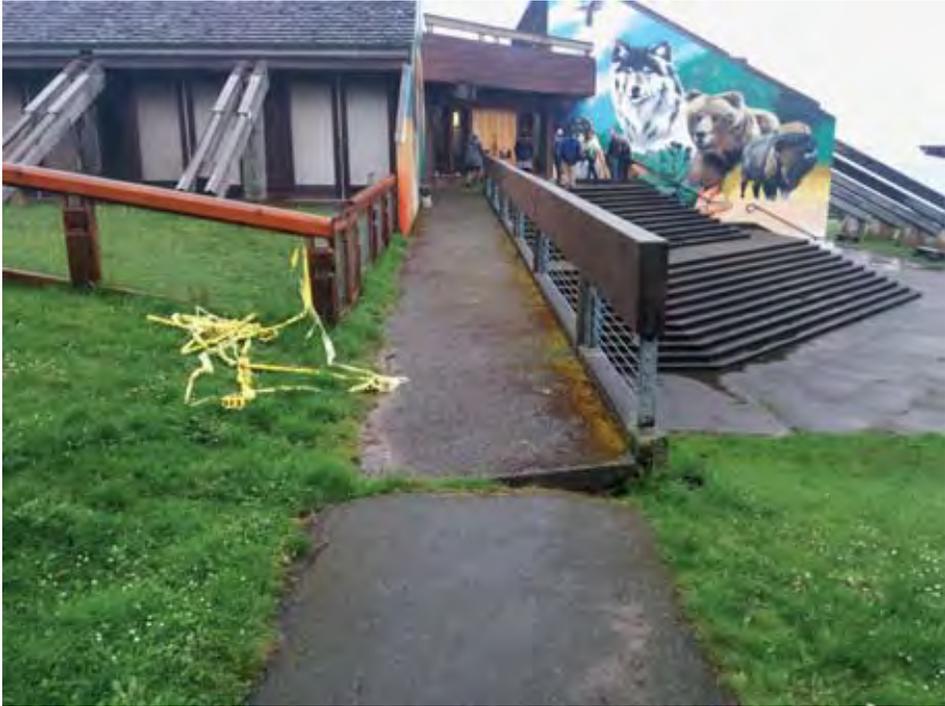
- 8. Subgrade beneath ramp to the east entrance is failing. Remove ramp and pedestrian walk, excavate 1' of unsuitable material, recompact and reconstruct concrete and asphalt pedestrian walk and ramp to ADA standards.

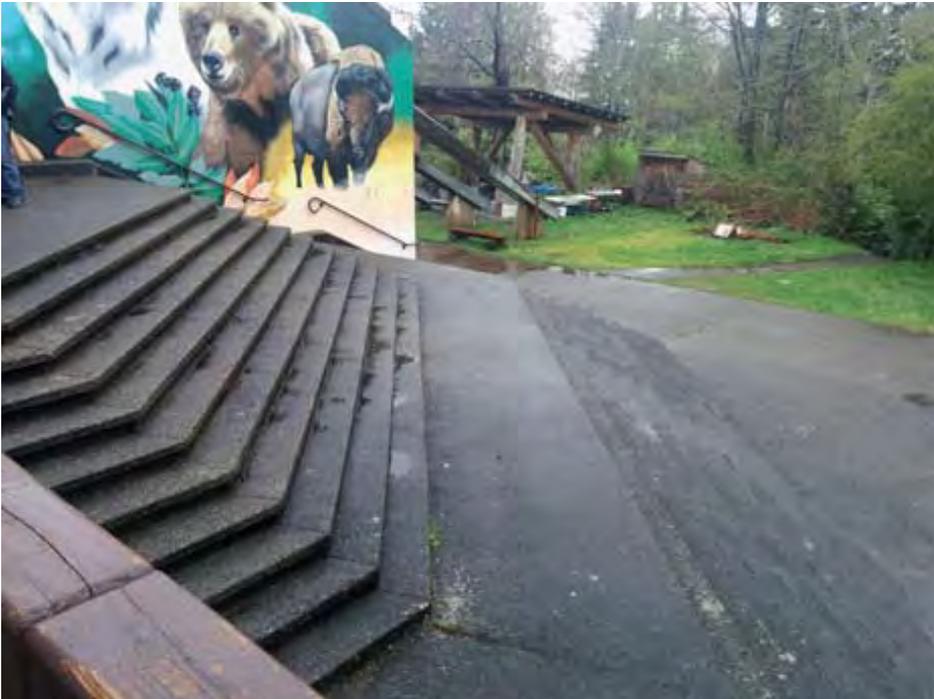
- 9. Install handrails for stairs outside of the east entrance.

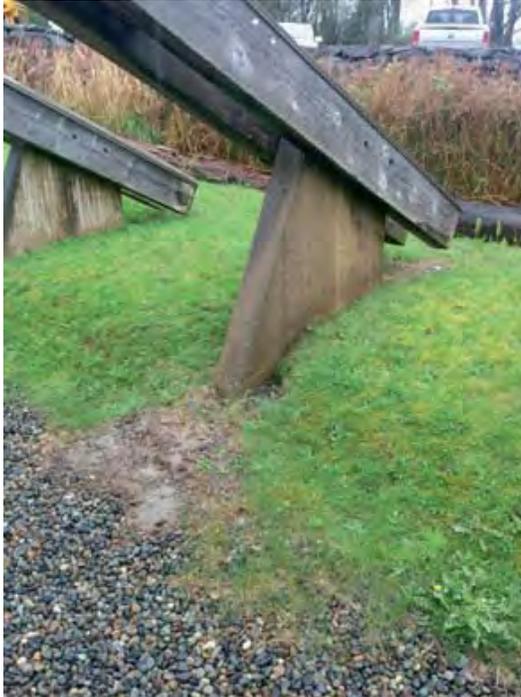
- Downspouts from roof discharge along external roof beam extensions and discharge to base of structure with no splashblock or storm connection causing erosion. Extend downspout and provide splashblock.

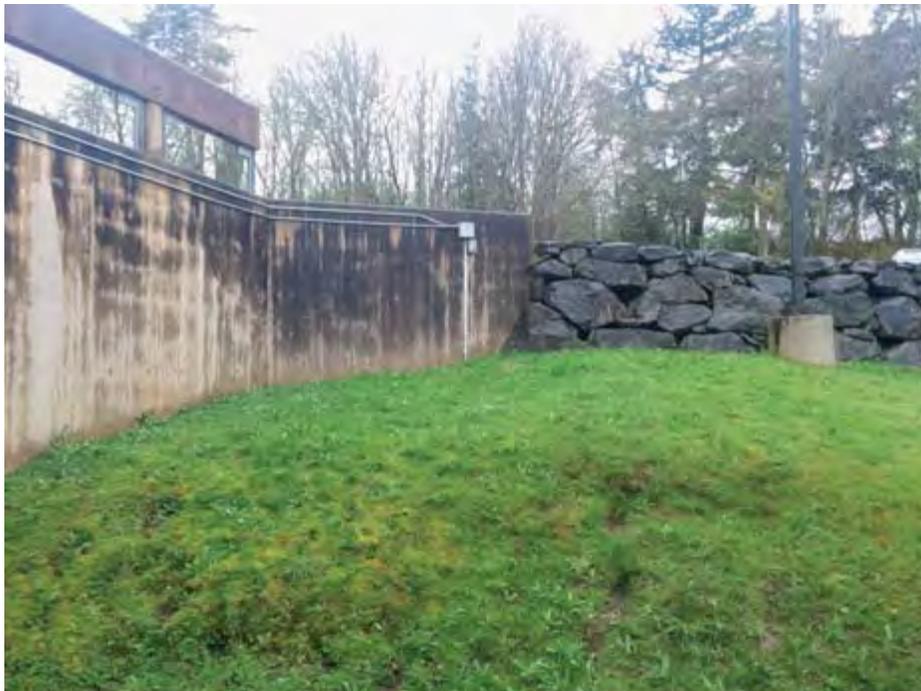
- Provide fall protection from the existing 6' wall located adjacent to northwest entrance.

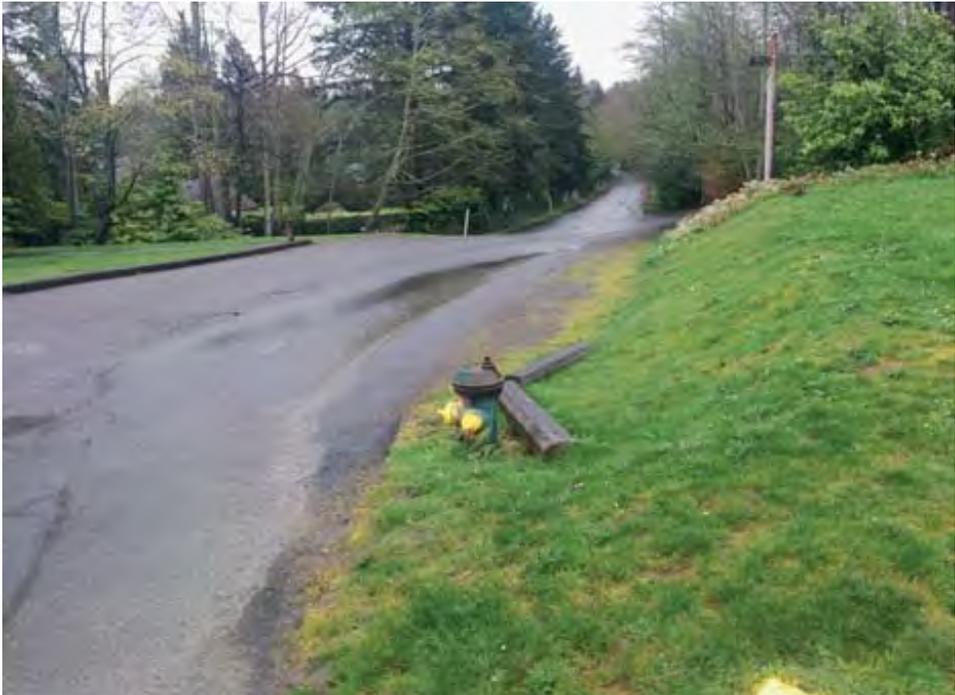
12. Excavate around fire hydrant to provide 2” minimum clearance from the hydrant’s flange connection to grade, remove curb stops and provide bollards to protect hydrant per City of Seattle details.

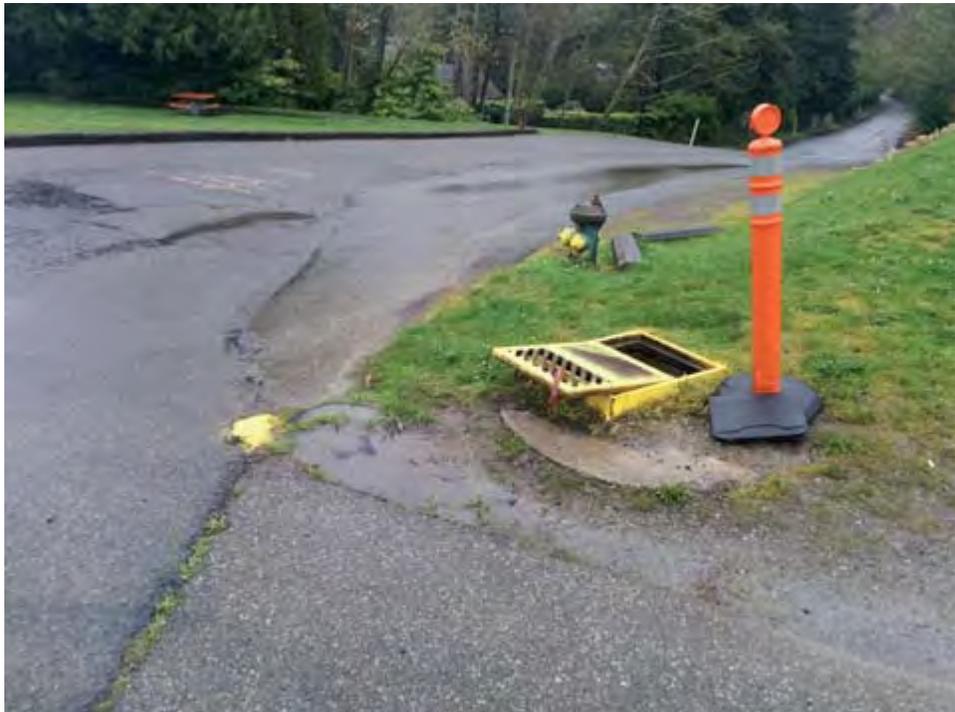
13. Exposed catch basin rim and structure needs to be lowered and/or landscaped so that the rim matches the surrounding grades.

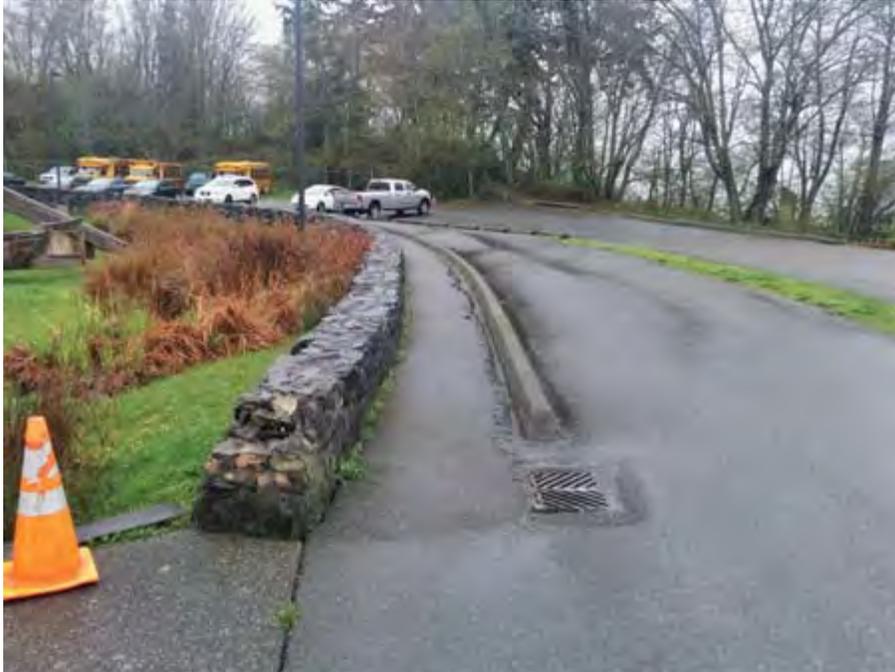
14. Demolish and reconstruct extruded curb approximately 1.5' to the north to allow the walkway that is adjacent to the parking area to meet the minimum 5' width requirement.

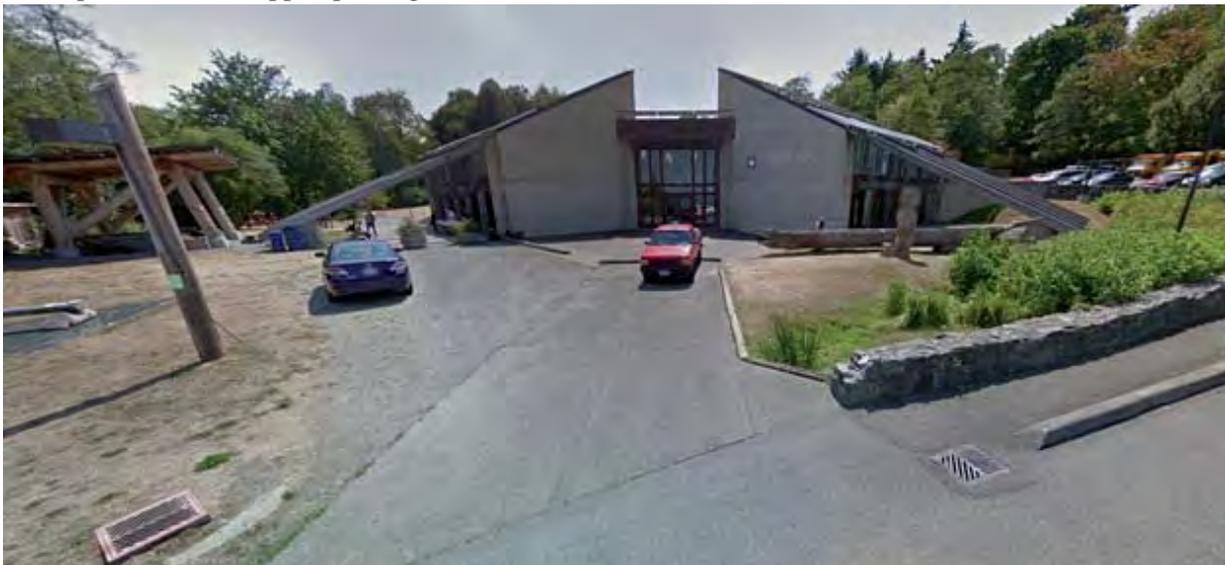
15. The walkway located outside the north entrance is currently being used as parking and/or ADA parking. Observing the site and plans, this area was not originally intended to be used as parking and was supposed to be used primarily as a pedestrian walkway. If the pedestrian access is going to be continued to be used as parking, the concrete should be removed and replaced with 6" of concrete and 4" of crushed surfacing to handle the vehicular loads. The new parking area should be marked and striped as a handicapped parking stall or stalls.

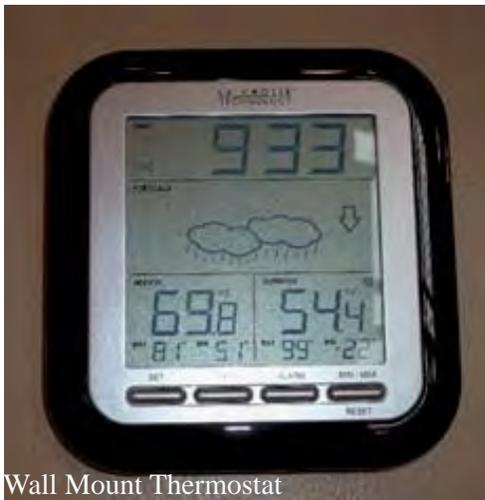
Wall Mount Thermostat

- The space temperature setpoint on the wall thermostat was 70F; the registered space temperature on thermostat was 69.8F.
- Deformed grilles were observed in some locations.

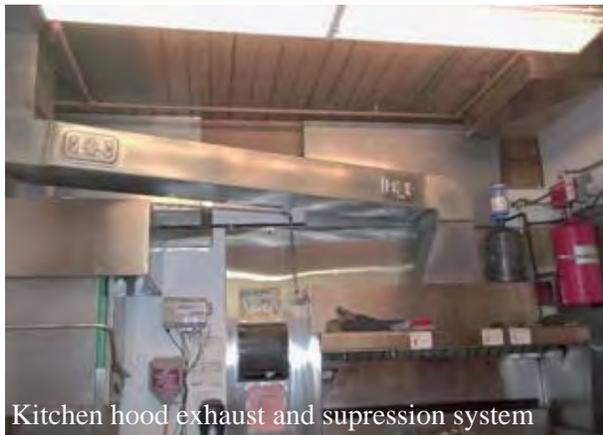
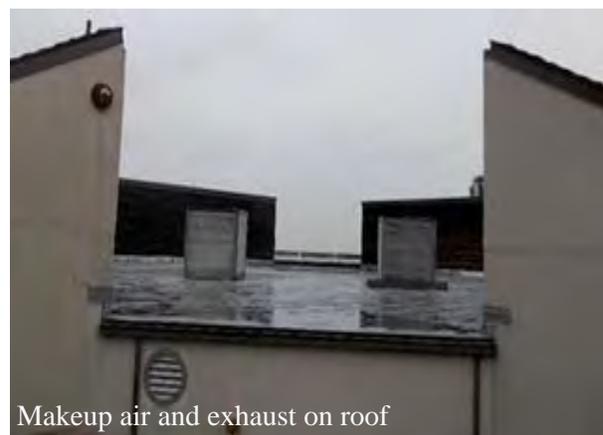
- The make-up air unit and hood exhaust fan were installed approximately 15 to 20 years ago and have reached their end of life, replacement should be considered.
- Electric stoves appear to be used for cooking.
- A fire suppression system appears to be installed for each kitchen hood.

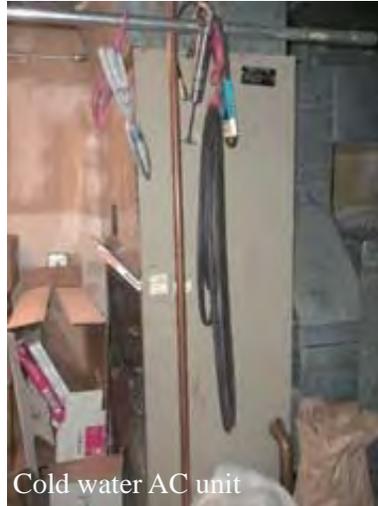
Cold water AC unit

- Apparently, this unit is seldom in operation.
- This Domestic cold water-cooled AC unit no longer complies with current Seattle Energy Code and the space which it serves is no longer used. Consider either removing or abandoning (decommissioning) this unit.

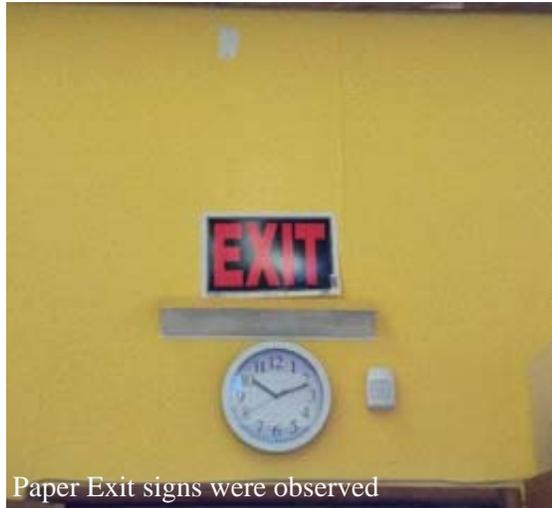
Battery backup bug-eye lighting fixtures are powered by integrated battery throughout the building and also feed the exit signs. Egress lighting and exit signs are observed in some rooms, but not all areas. We think the coverage is not sufficient to meet current code requirement. Also in some rooms, there are no illuminated exit signs, only temporary paper exit signs observed.

Paper Exit signs were observed
