MADRONA BATHHOUSE
SEATTLE PARKS AND RECREATION
ARCHITECTURAL AND ENGINEERING
MAINTENANCE EVALUATION STUDY

City of Seattle, Washington
September 2017

MADRONA BATH HOUSE EVALUATION

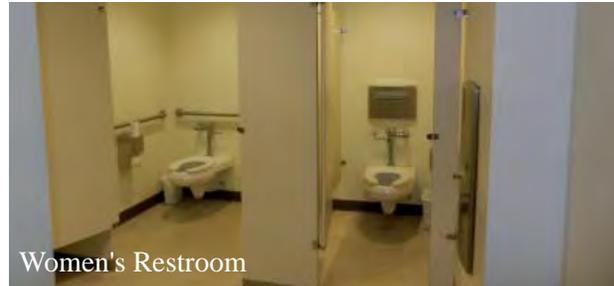
Damaged Countertop

Restrooms: The existing restrooms do not have enough fixtures to meet current code although they seem to meet the needs of the facility. Additionally, the changing rooms accessed from the exterior contain restroom facilities that primarily serve the adjacent public beach during the summer months. The grounds crew helps to operate these restrooms by keeping them open when the bathhouse is closed for those required usage times. This poses an operational difficulty for the parks department. The countertop in the Women's restroom was noted to have broken free from its mounts on one side, causing the laminate finish to delaminate.

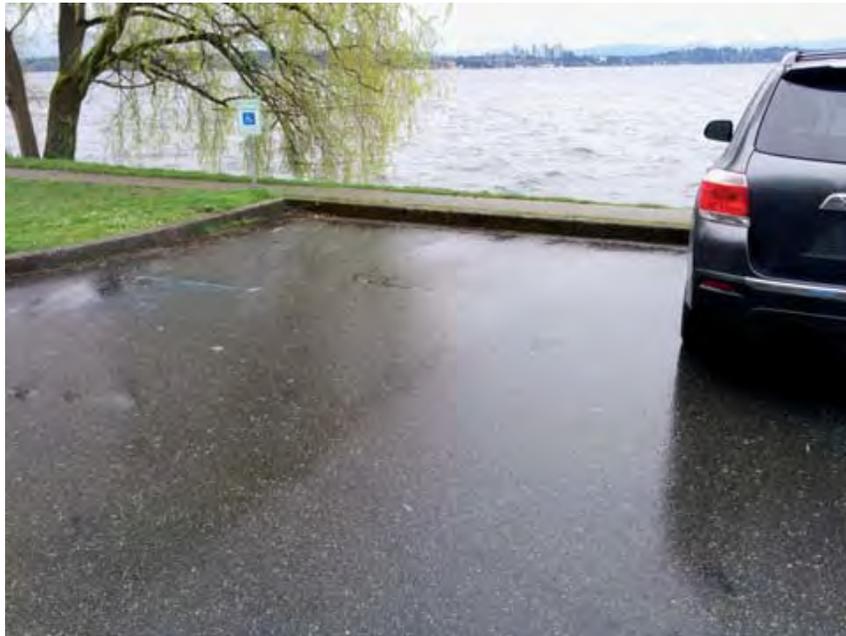
1. Clean out area drains and catch basins and TV existing drain lines to determine condition.
2. Restripe and paint the two handicapped parking stalls to meet ADA standards. Handicapped parking signs to be installed and/or relocated to in front of stalls.

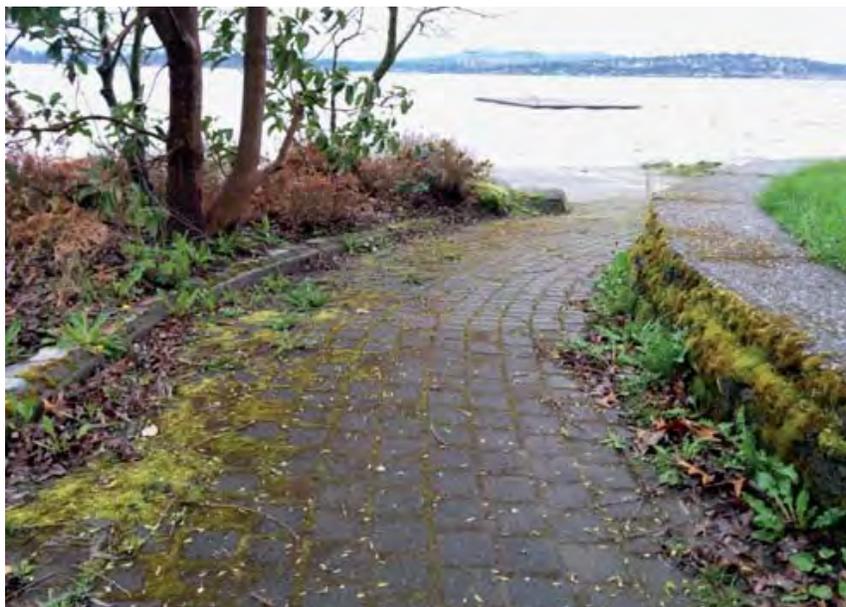
3. Remove and clean moss from walkways.

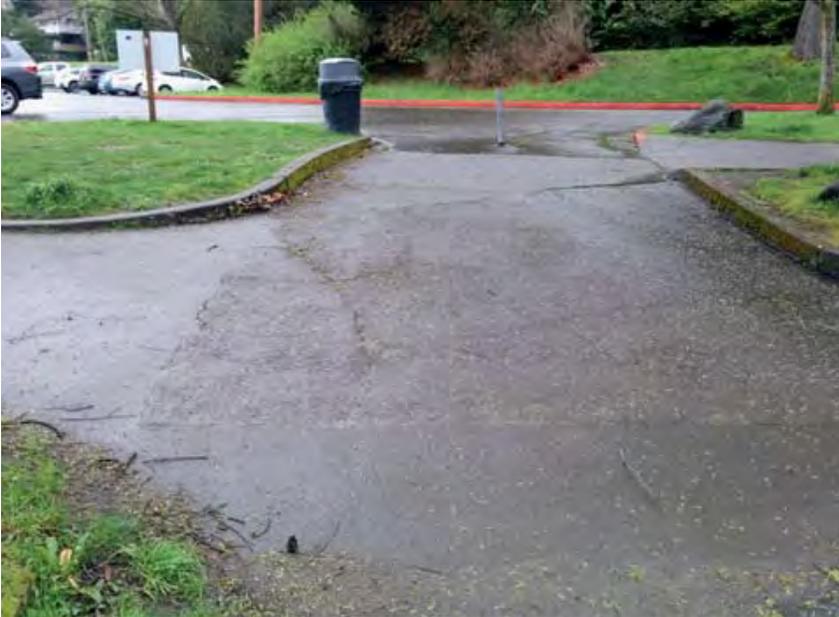
- 4. Demolish and relevel the beach vehicle access to have less than a 2.0% cross slope. Replace concrete vehicle access and provide a painted crosswalk.

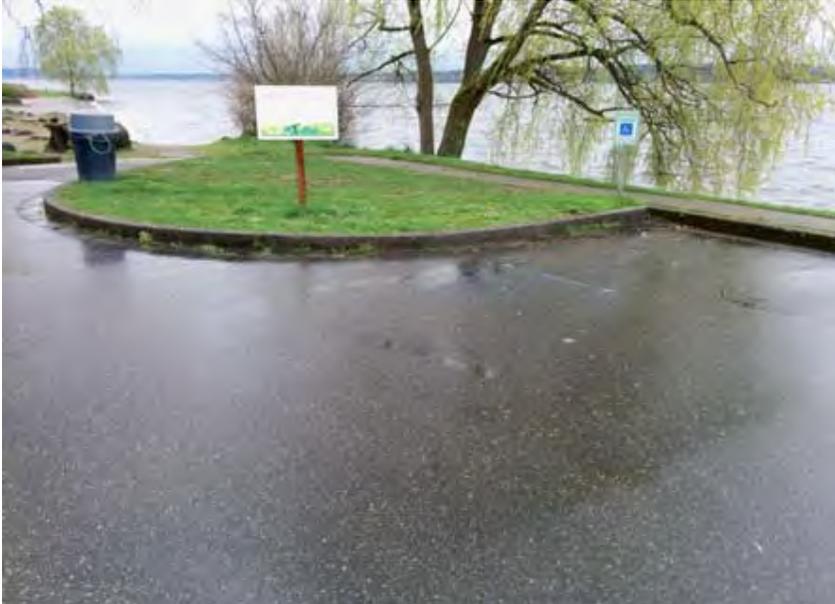
- 5. Construct curb ramp for ADA stalls and connect to sidewalk.

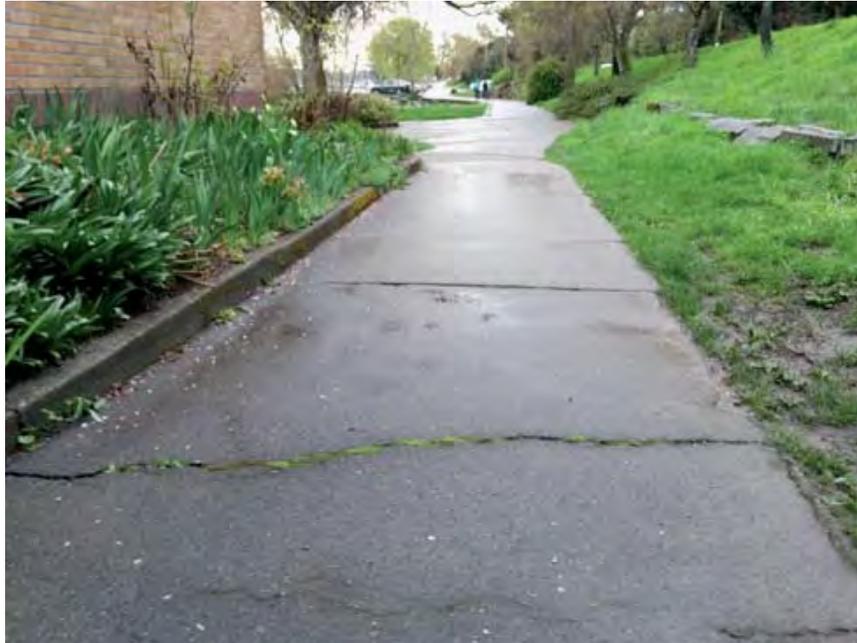
6. Clean and crack-seal the cracks in the asphalt path along the west face of the building.

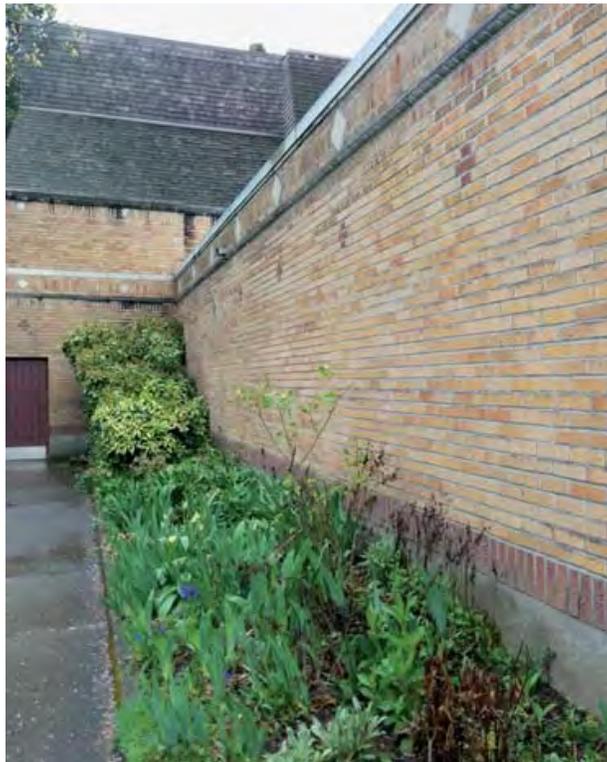
7. Install downspouts and splashblocks at all roof top scuppers.

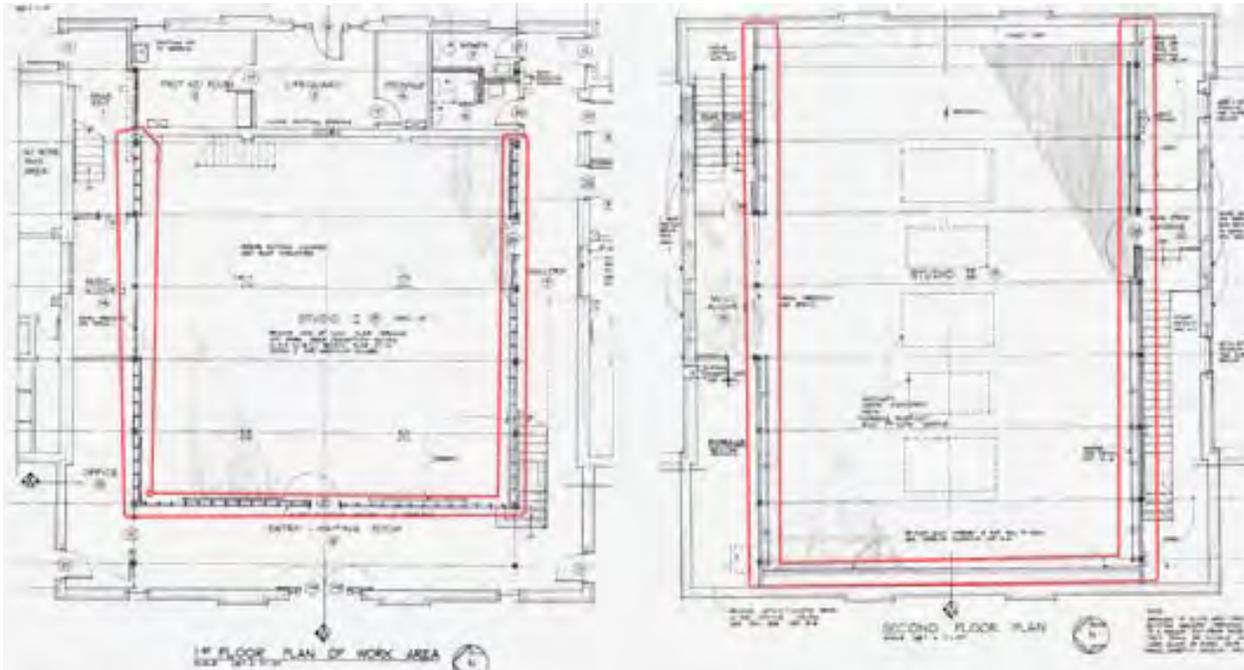
structural concept drawing

- Currently, the exterior URM walls are tied to the floor and roof framing with shallow embedded expansion anchors. These anchors are not rated for tension loads in Unreinforced Masonry (URM). We recommend new wall ties utilizing either 15 degree bent threaded rods embedded in the URM walls with screen tube and anchoring adhesive, or through-wall anchor rods with exterior rosettes, washers and nuts. These anchors would be located at 48" on center. Additional blocking may be required to tie these anchors into the floor and roof diaphragms.

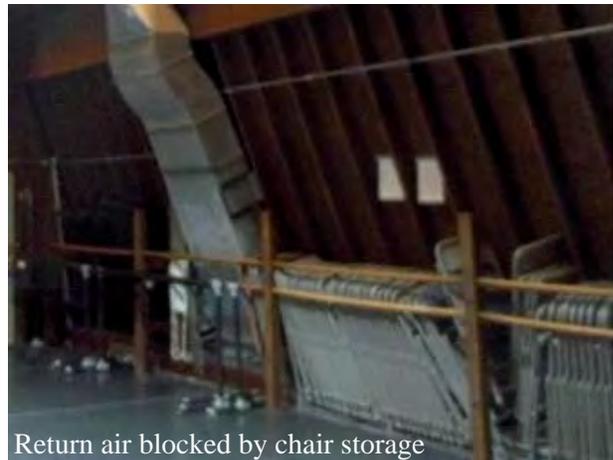
Return air blocked by chair storage

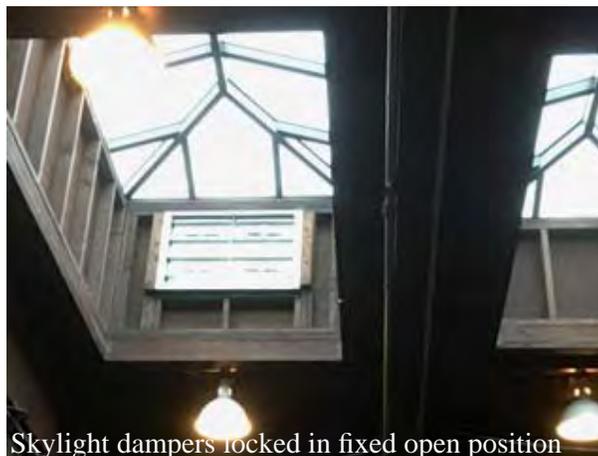
Skylight dampers locked in fixed open position

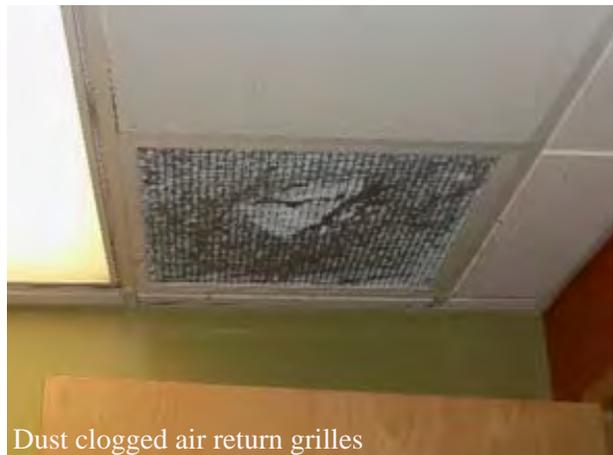
- The space temperature setpoint on the wall thermostat was 70F; the registered space temperature on thermostat was 70F.
- Most of the return grilles are clogged by dust, cleaning of these return grilles is recommended.

Dust clogged air return grilles

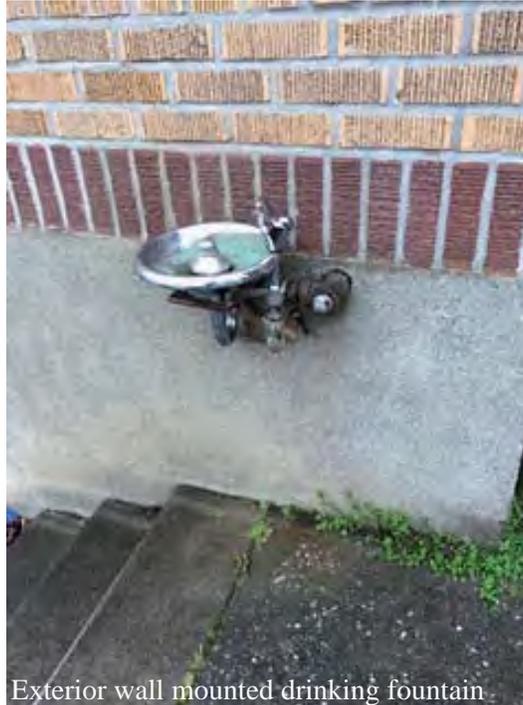
Older, very worn stainless steel drinking fountain. Water supply pipe is galvanized. Fixture and piping are corroded.

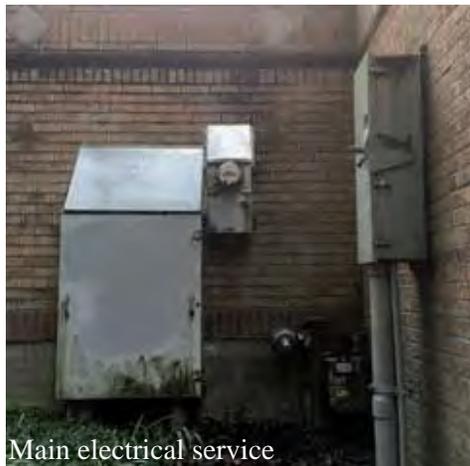
Main electrical service

Existing Distribution panel, now used as wiring junction box, is shown in the foreground of the photo below, and Main Distribution Panel 'DP', and Panels 'L' and 'P' in the background. This room is highly constrained – just marginally in compliance with code working space clearance requirements of 36” in front of the panels.

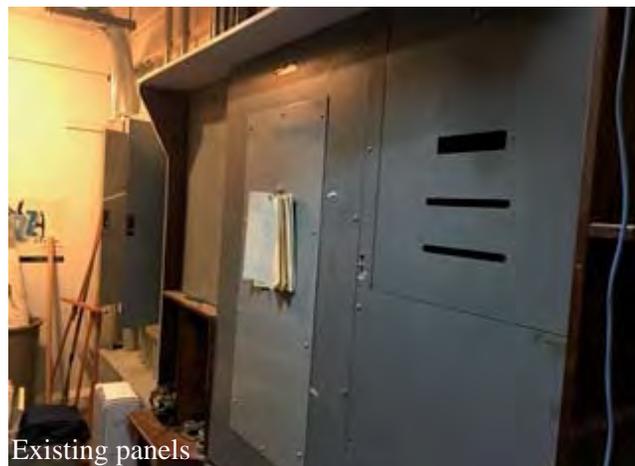
Existing panels

Panel DP is reasonably new and in good, serviceable condition, as are Panels 'P' and 'L'. There appears to be adequate power capacity for future renovations, however additional panel circuit breaker space will be required, and with the space being limited within the main electrical room, the recommendation is to provide a feeder from Panel 'DP' to a new branch circuit panel located in a convenient location on the main floor, to serve new lighting and power needs.

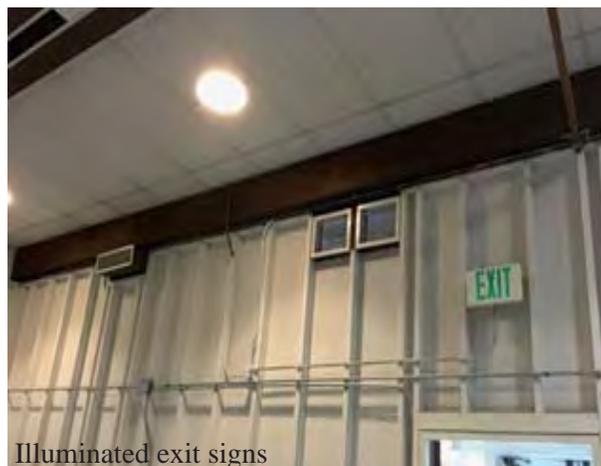
The means of egress from the spaces are marked with illuminated exit signs, however, with no discernible emergency power backup.

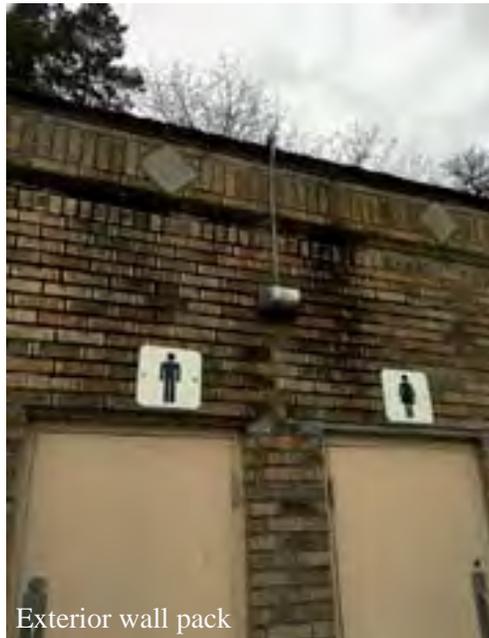
Exterior wall pack luminaires are located on the Beach (east) side of the building. There was no lighting control panel observed during our visit, and the exterior controls do not appear to be in calibration.
