**ASBESTOS SURVEY
AT
NAVAL STATION PUGET SOUND
SEATTLE, WASHINGTON**

N44255-93-C-4056

**BUILDING 18
FIRE STATION**

Subject: Transmittal of Asbestos Survey Report, Building 18, Fire Station, Naval Station Puget Sound, Seattle, Washington (N44255-93-C-4056)

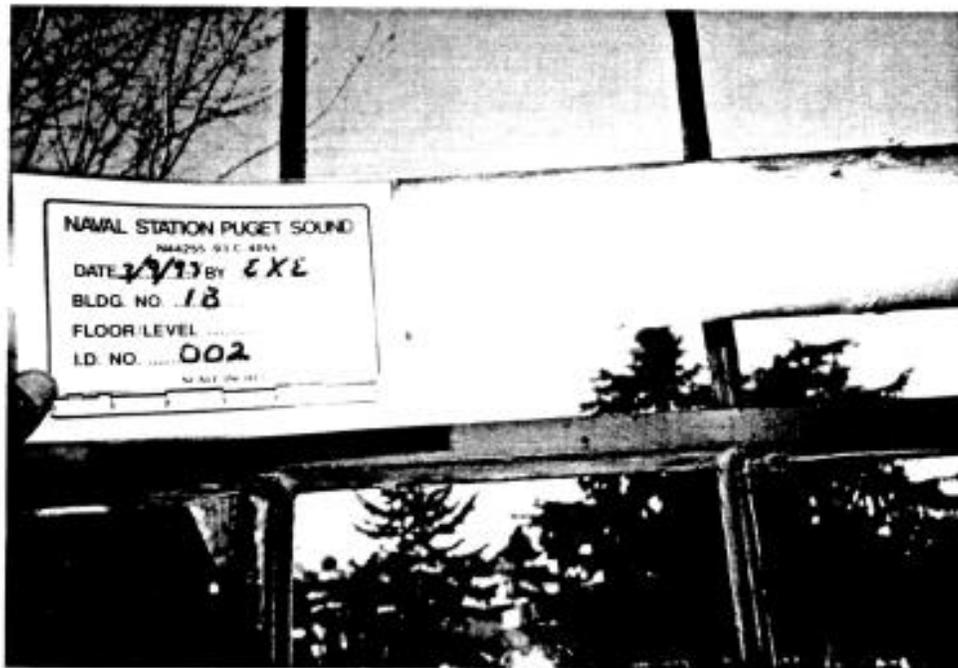
Building: #18 FIRE STATION	Date: 3/9/93 By: EXE-MKS	
Material: HMF	Sample No: 002	Location: S.W COR. BAY 101

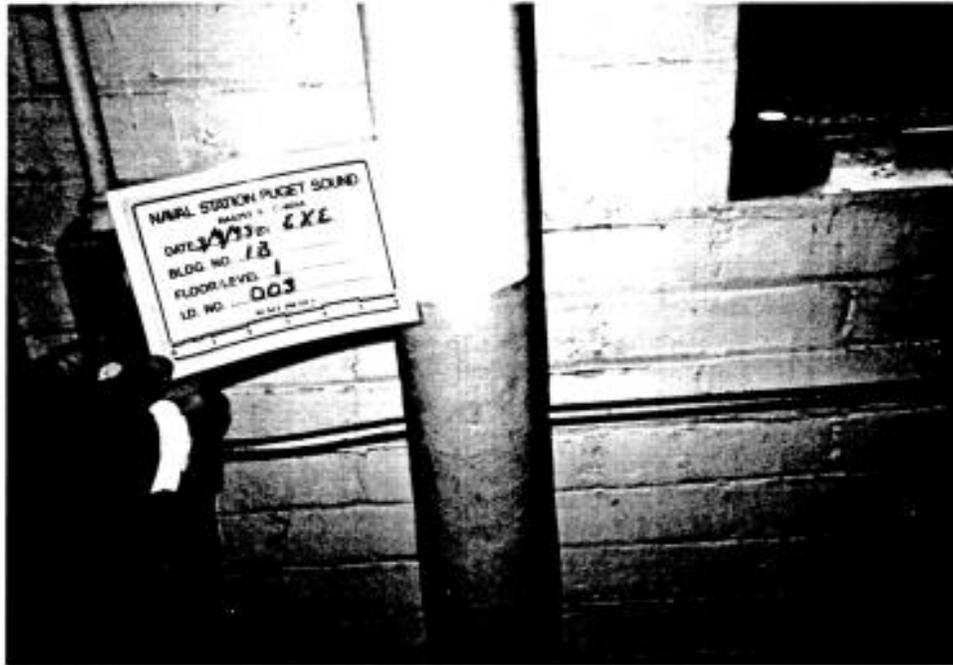
Location: W. SIDE BAY 101

Material: BLOCK PT Sample No: 003

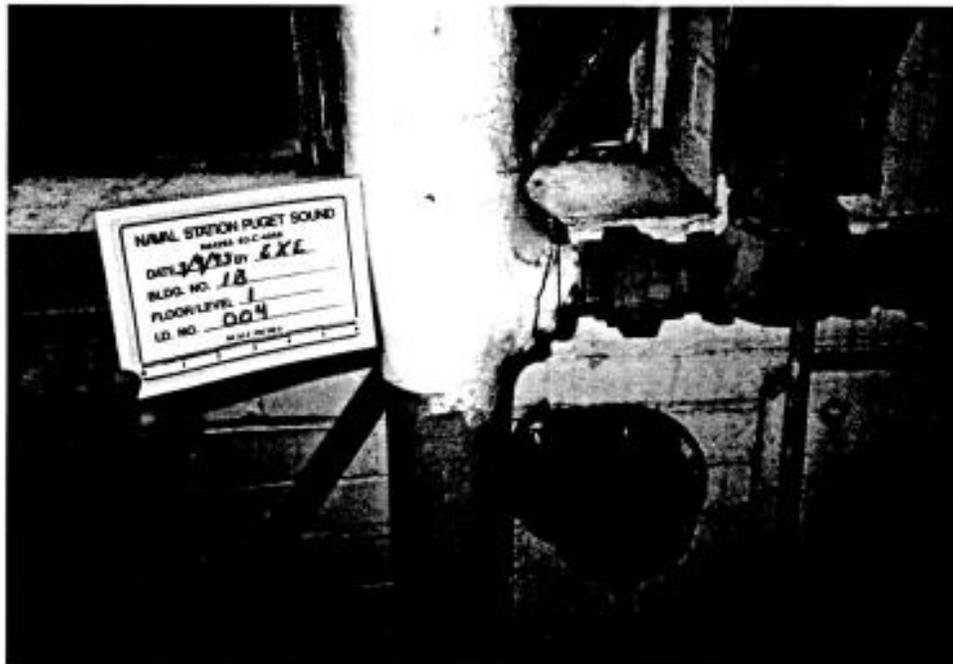
Location: W. SIDE BAY 101

Material: HMF Sample No: 004

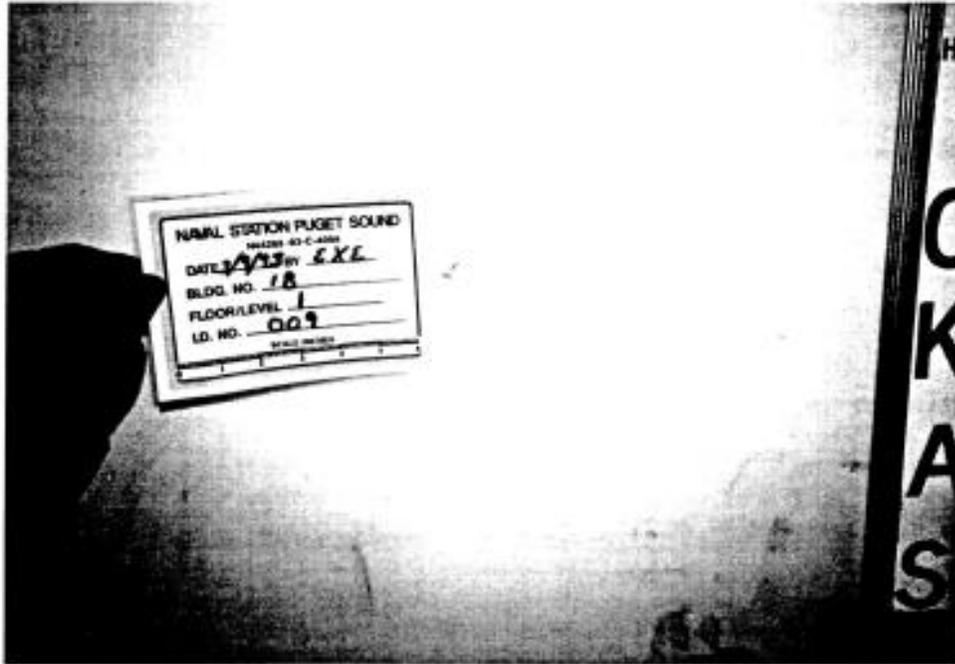
Building: #18 FIRE STATION	Date: 3/9/93 By: EXE-MKS
Material: GWB	Sample No: 009
	Location: E. SIDE BAY 101

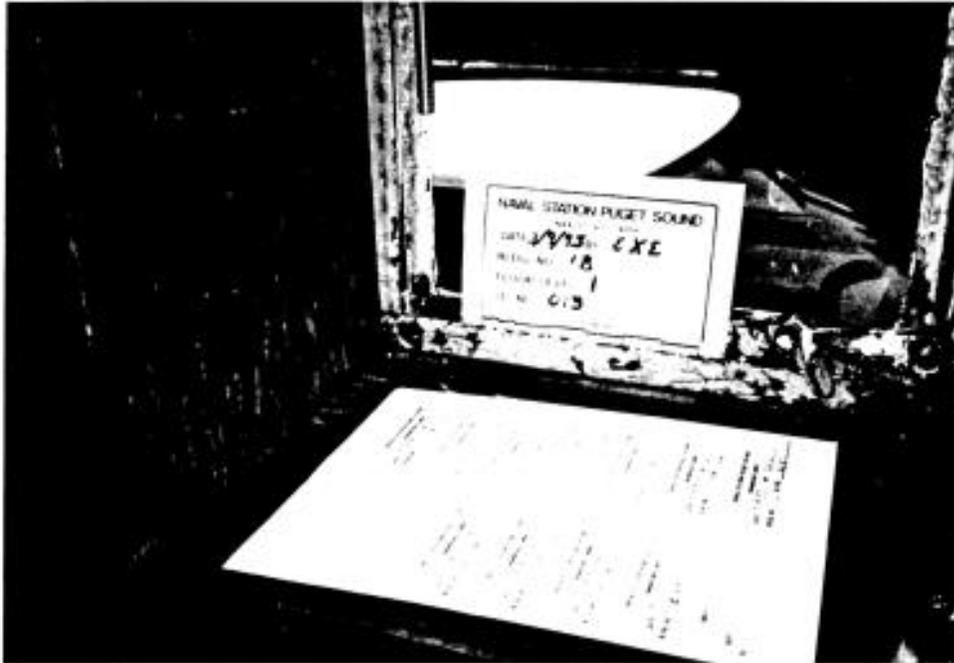
Location: S SIDE RM 113

Material: WINDOW PUTTY Sample No: 013

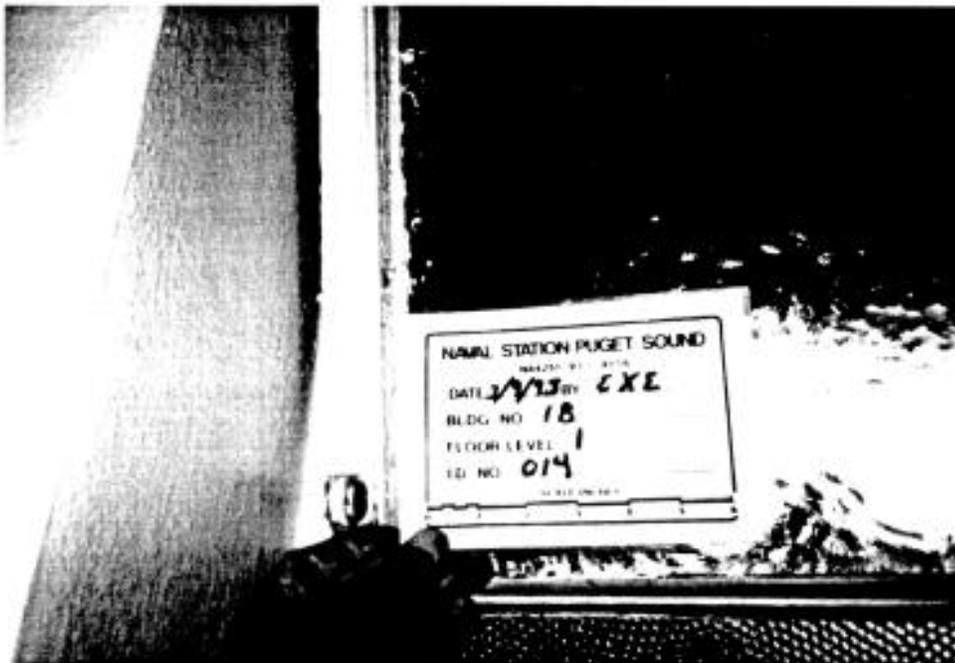
Location: S SIDE RM 113

Material: WINDOW PUTTY Sample No: 014

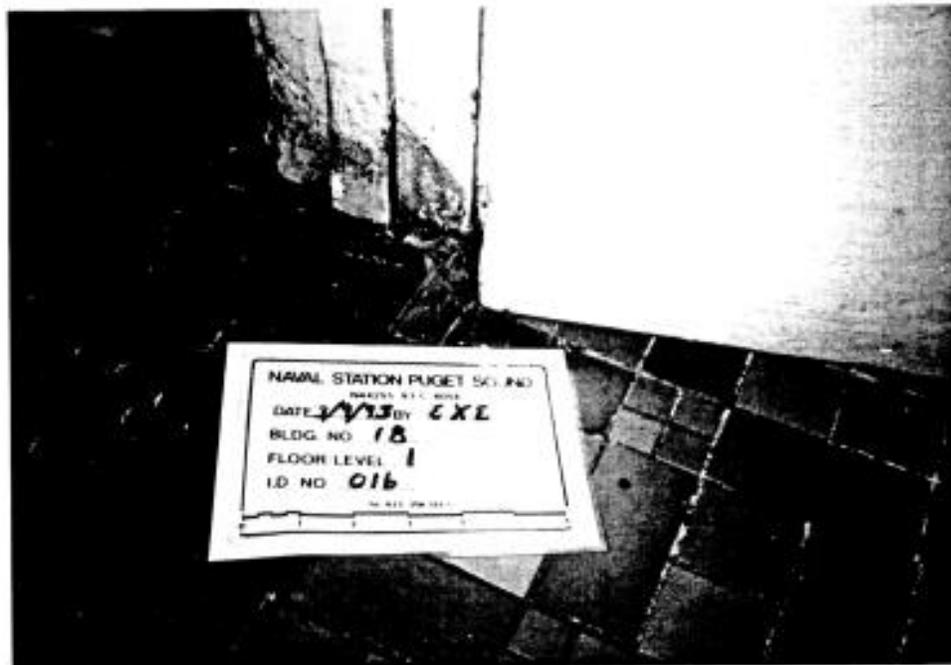
Building: #18 FIRE STATION	Date: 3/9/93 By: EXE-MKS	
Material: VFT	Sample No: 016	Location: N END HALL III

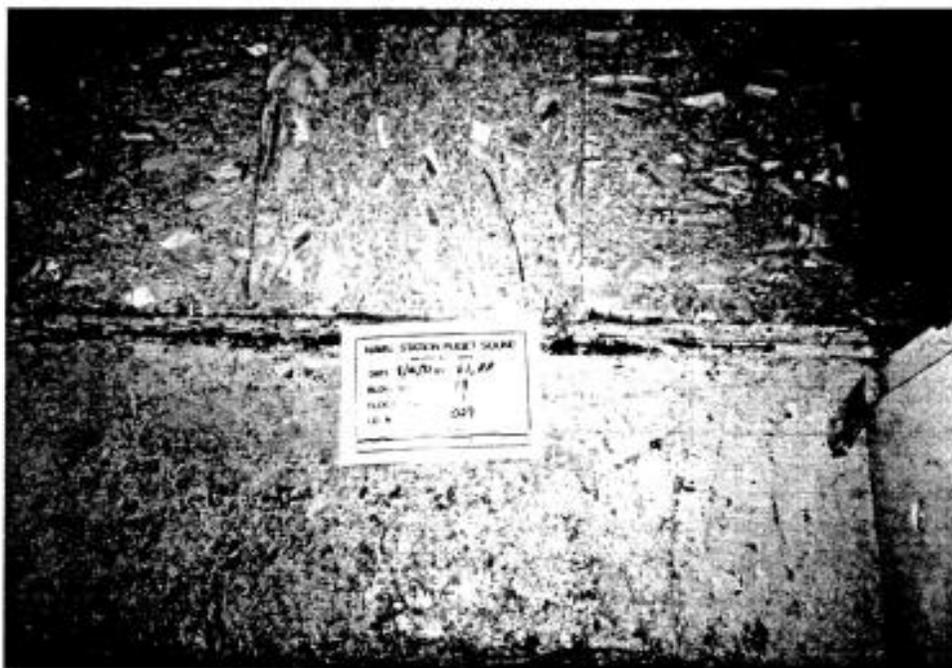
Building: #18 FIRE STATION		Date: 3/9/93 By: EXE-MKS
Material: VFT	Sample No: 029	Location: RM 115

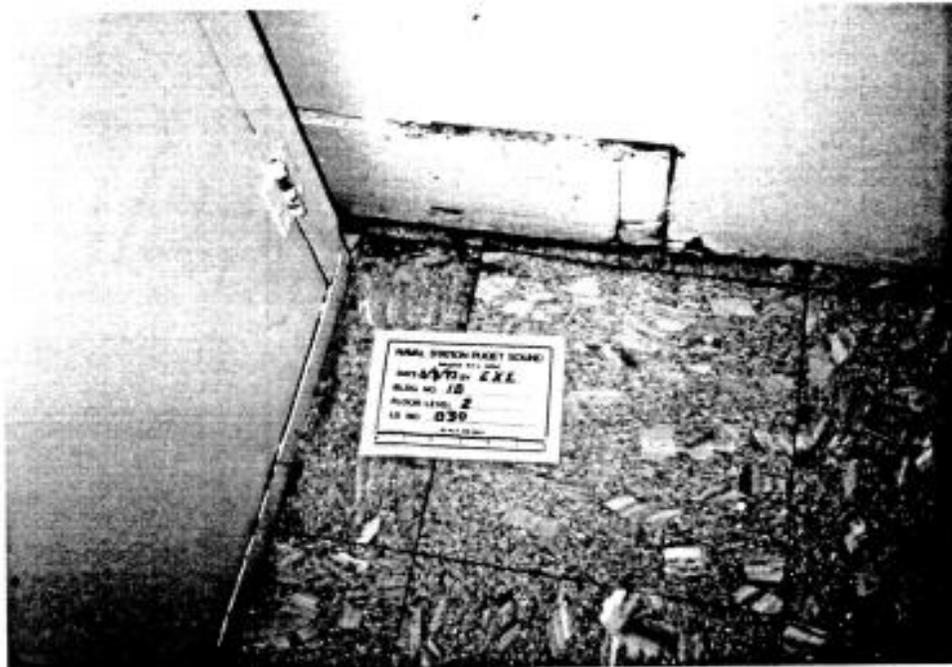
Building: #18 FIRE STATION		Date: 3/9/93 By: EXE-MKS
Material: VFT	Sample No: 030	Location: RM 115

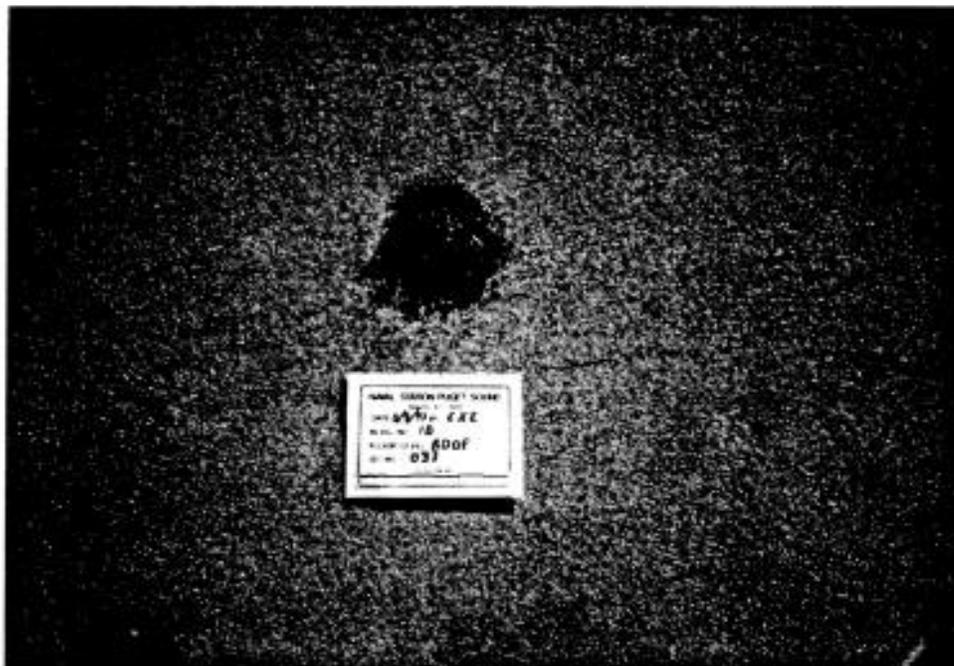
Building: #18 FIRE STATION		Date: 3/9/93 By: EXE - MRS
Material: ROOFING	Sample No: 033	Location: N W Roof

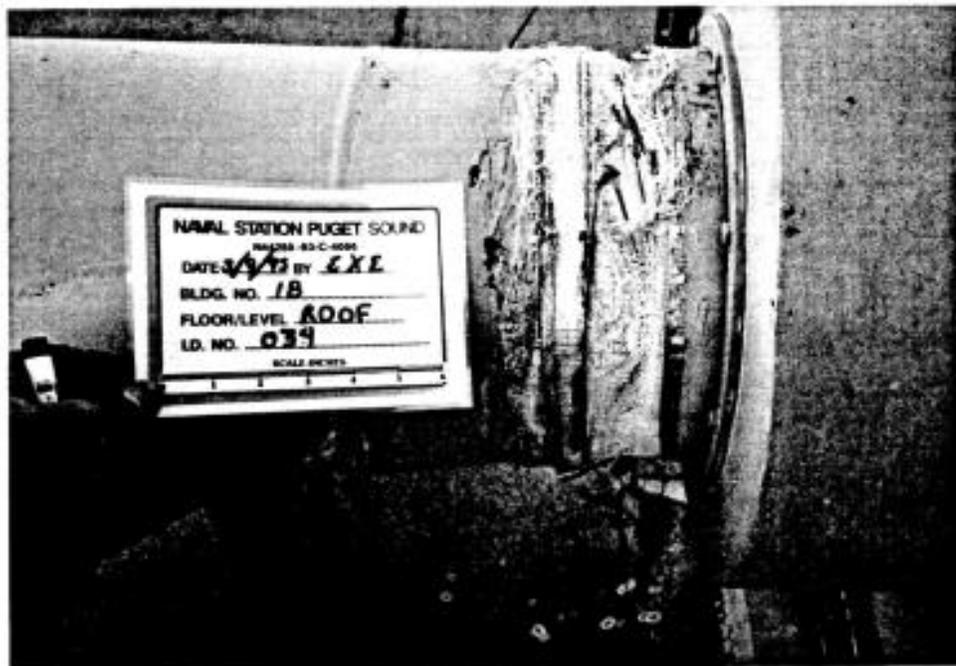
Building: #18 FIRE STATION		Date: 3/9/93 By: EXE - MRS
Material: SEALANT	Sample No: 034	Location: S SIDE ROOF ON DUCT

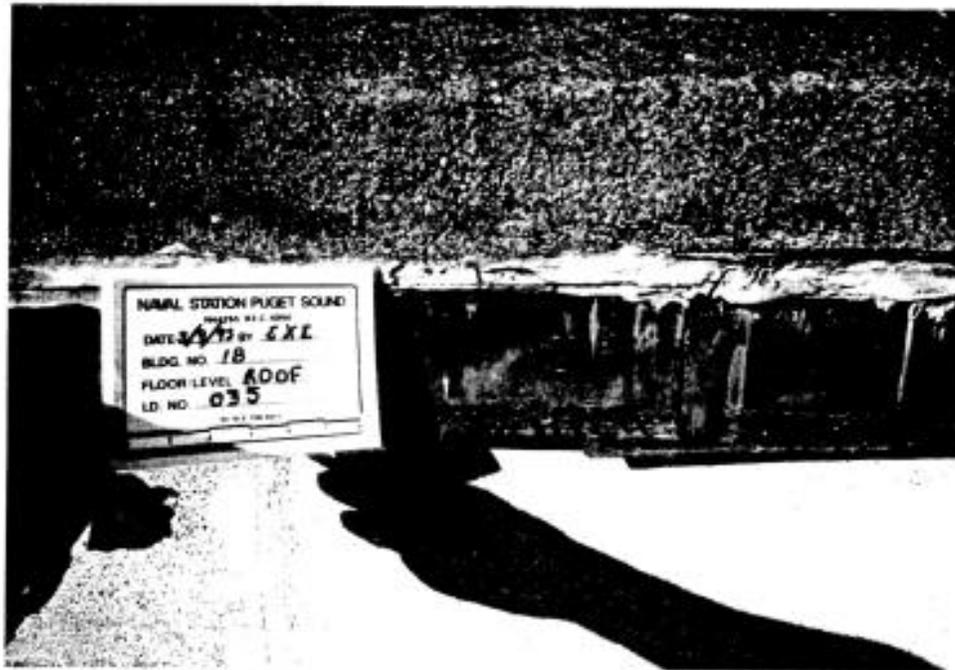
Location: N EDGE OF ROOF

Material: TAR PATCH Sample No: 035

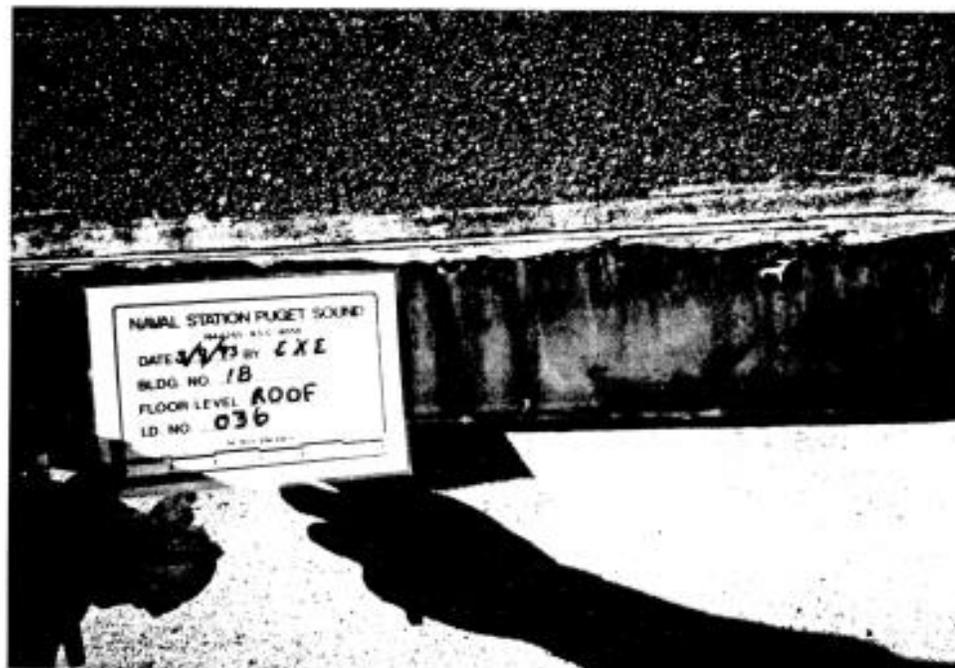
Location: N.W ROOF

Material: TAR PATCH Sample No: 036

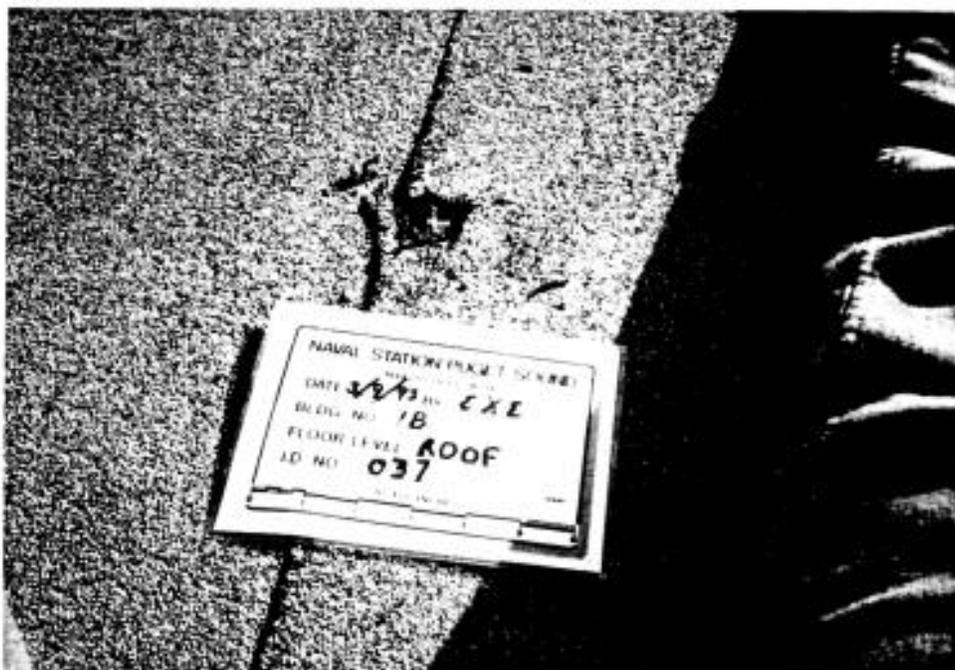
Building: #18 FIRE STATION		Date: 3/9/93 By: EXE-MKS
Material: ROOFING	Sample No: 037	Location: S. ROOF AREA

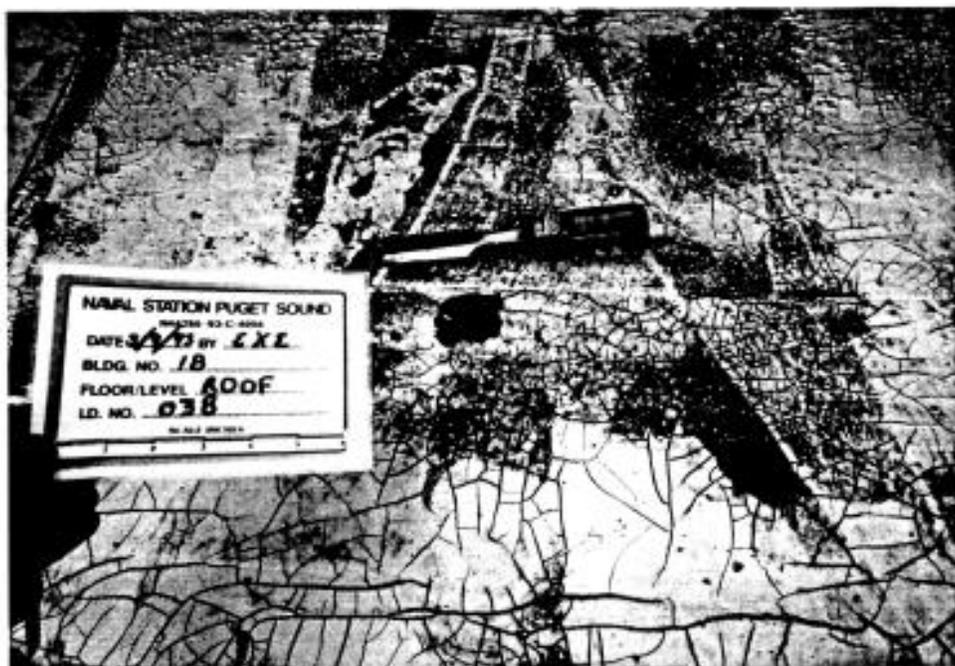
Building: #18 FIRE STATION		Date: 3/9/93 By: EXE-MKS
Material: ROOFING	Sample No: 038	Location: S ROOF / RM 115

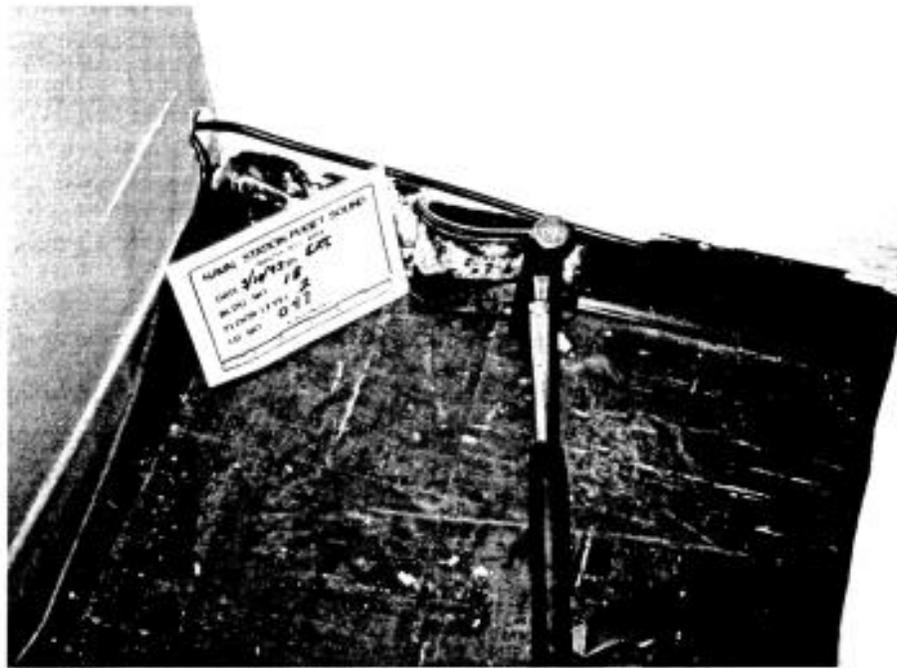
Location: W SIDE RM 202A

Material: COVE MASTIC Sample No: 047

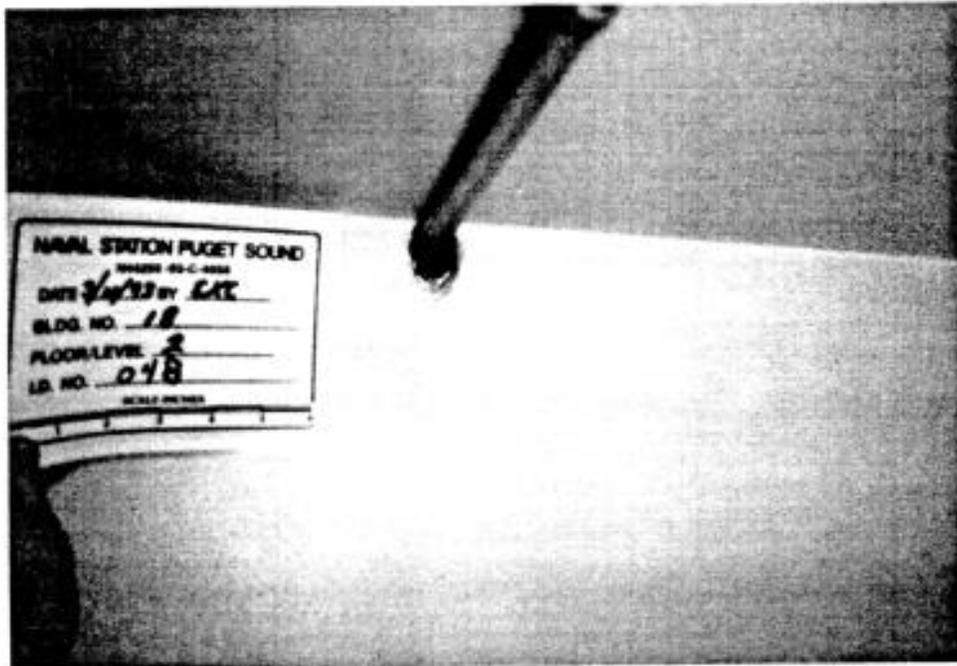
Location: W WALL 212

Material: PLASTER Sample No: 048
