## **Phase 2B**

**2<sup>nd</sup> Level Overview**

**September 24, 2012**

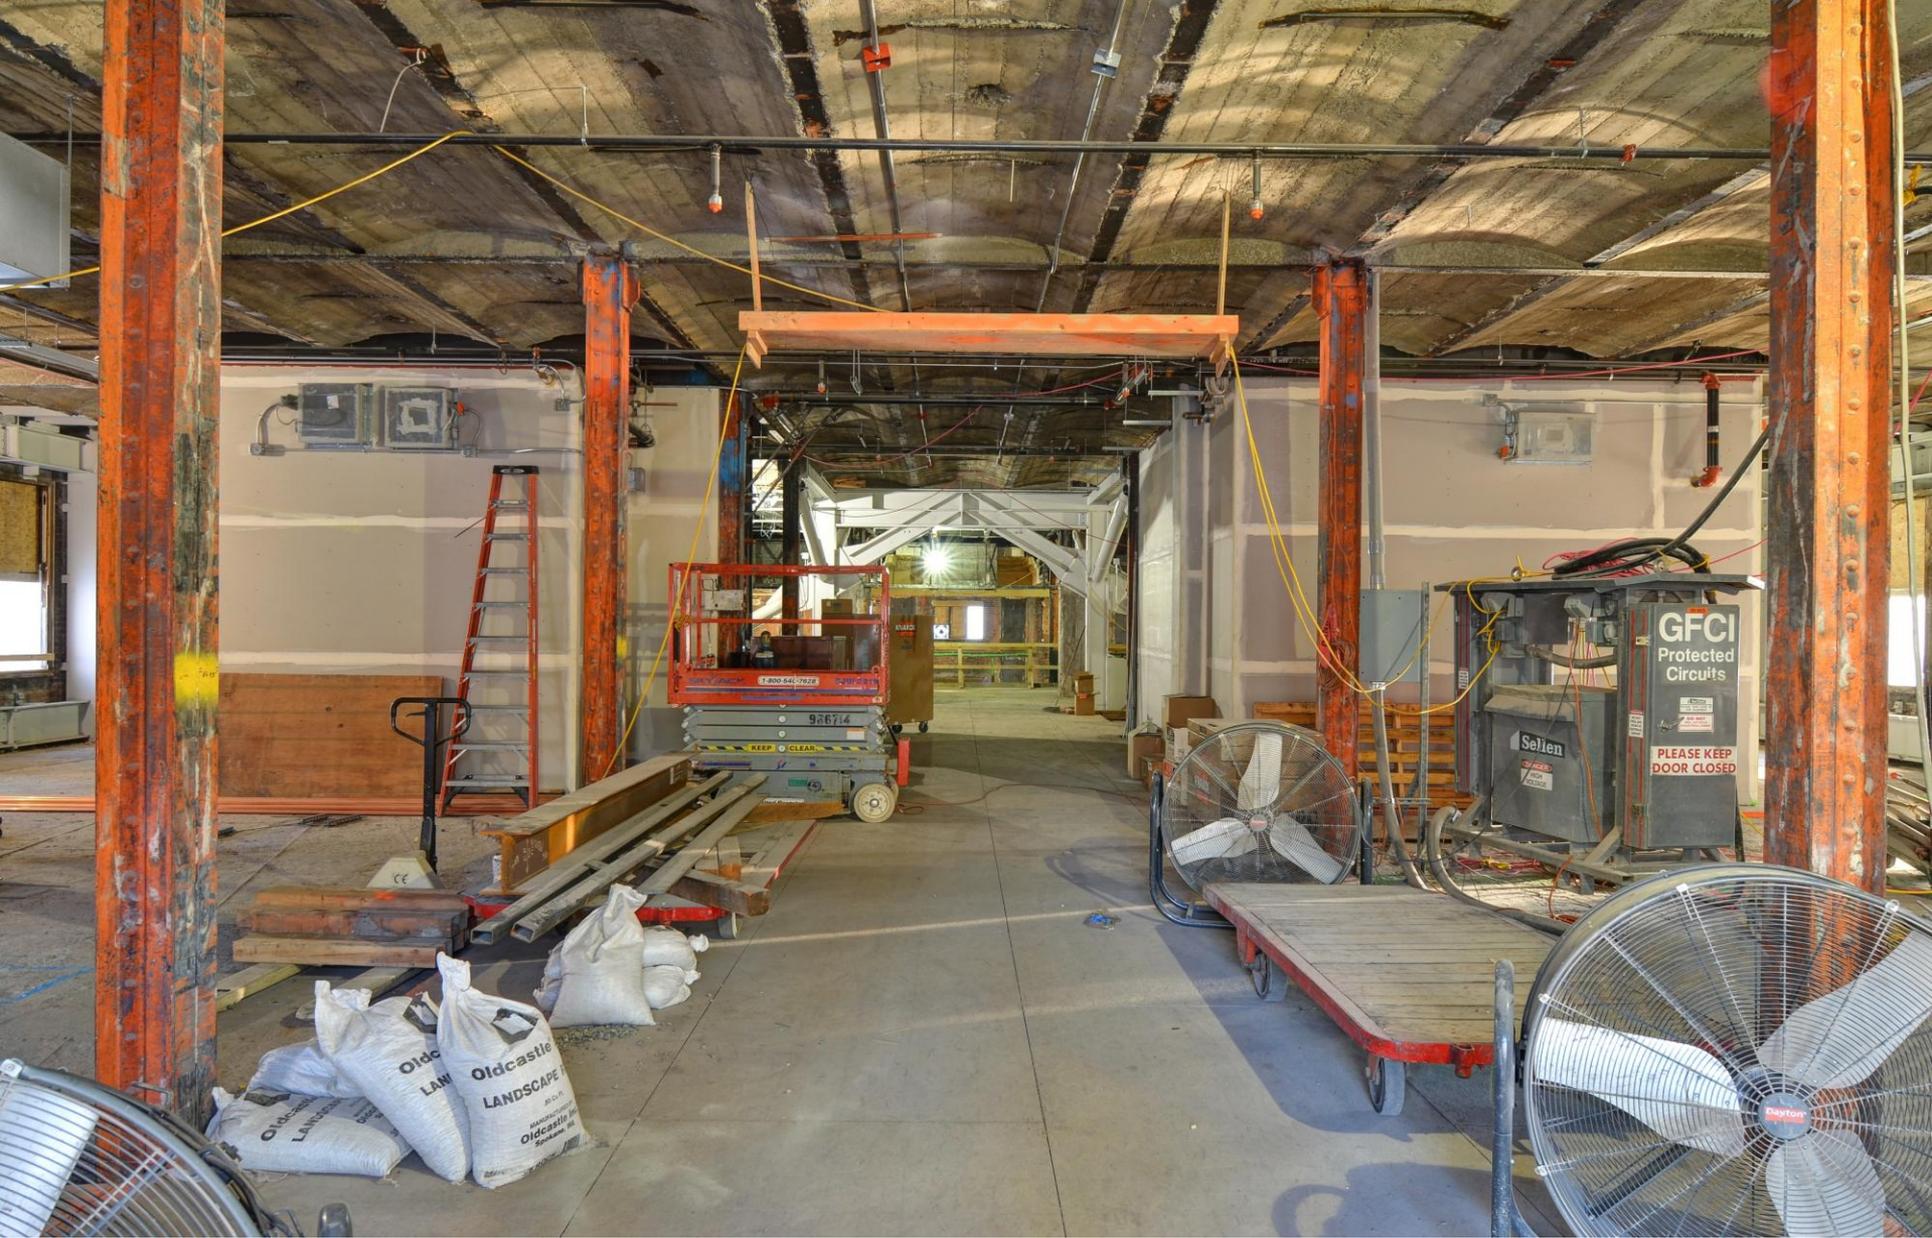
2<sup>nd</sup> level looking south at the new stair well(left) and elevator(right). The stair well will connect the 3<sup>rd</sup> floor to the 2<sup>nd</sup> floor, and the elevator connects the terminal level to both 2<sup>nd</sup> and 3<sup>rd</sup> floors. Elevator installation has been completed but the stair well is still under construction.

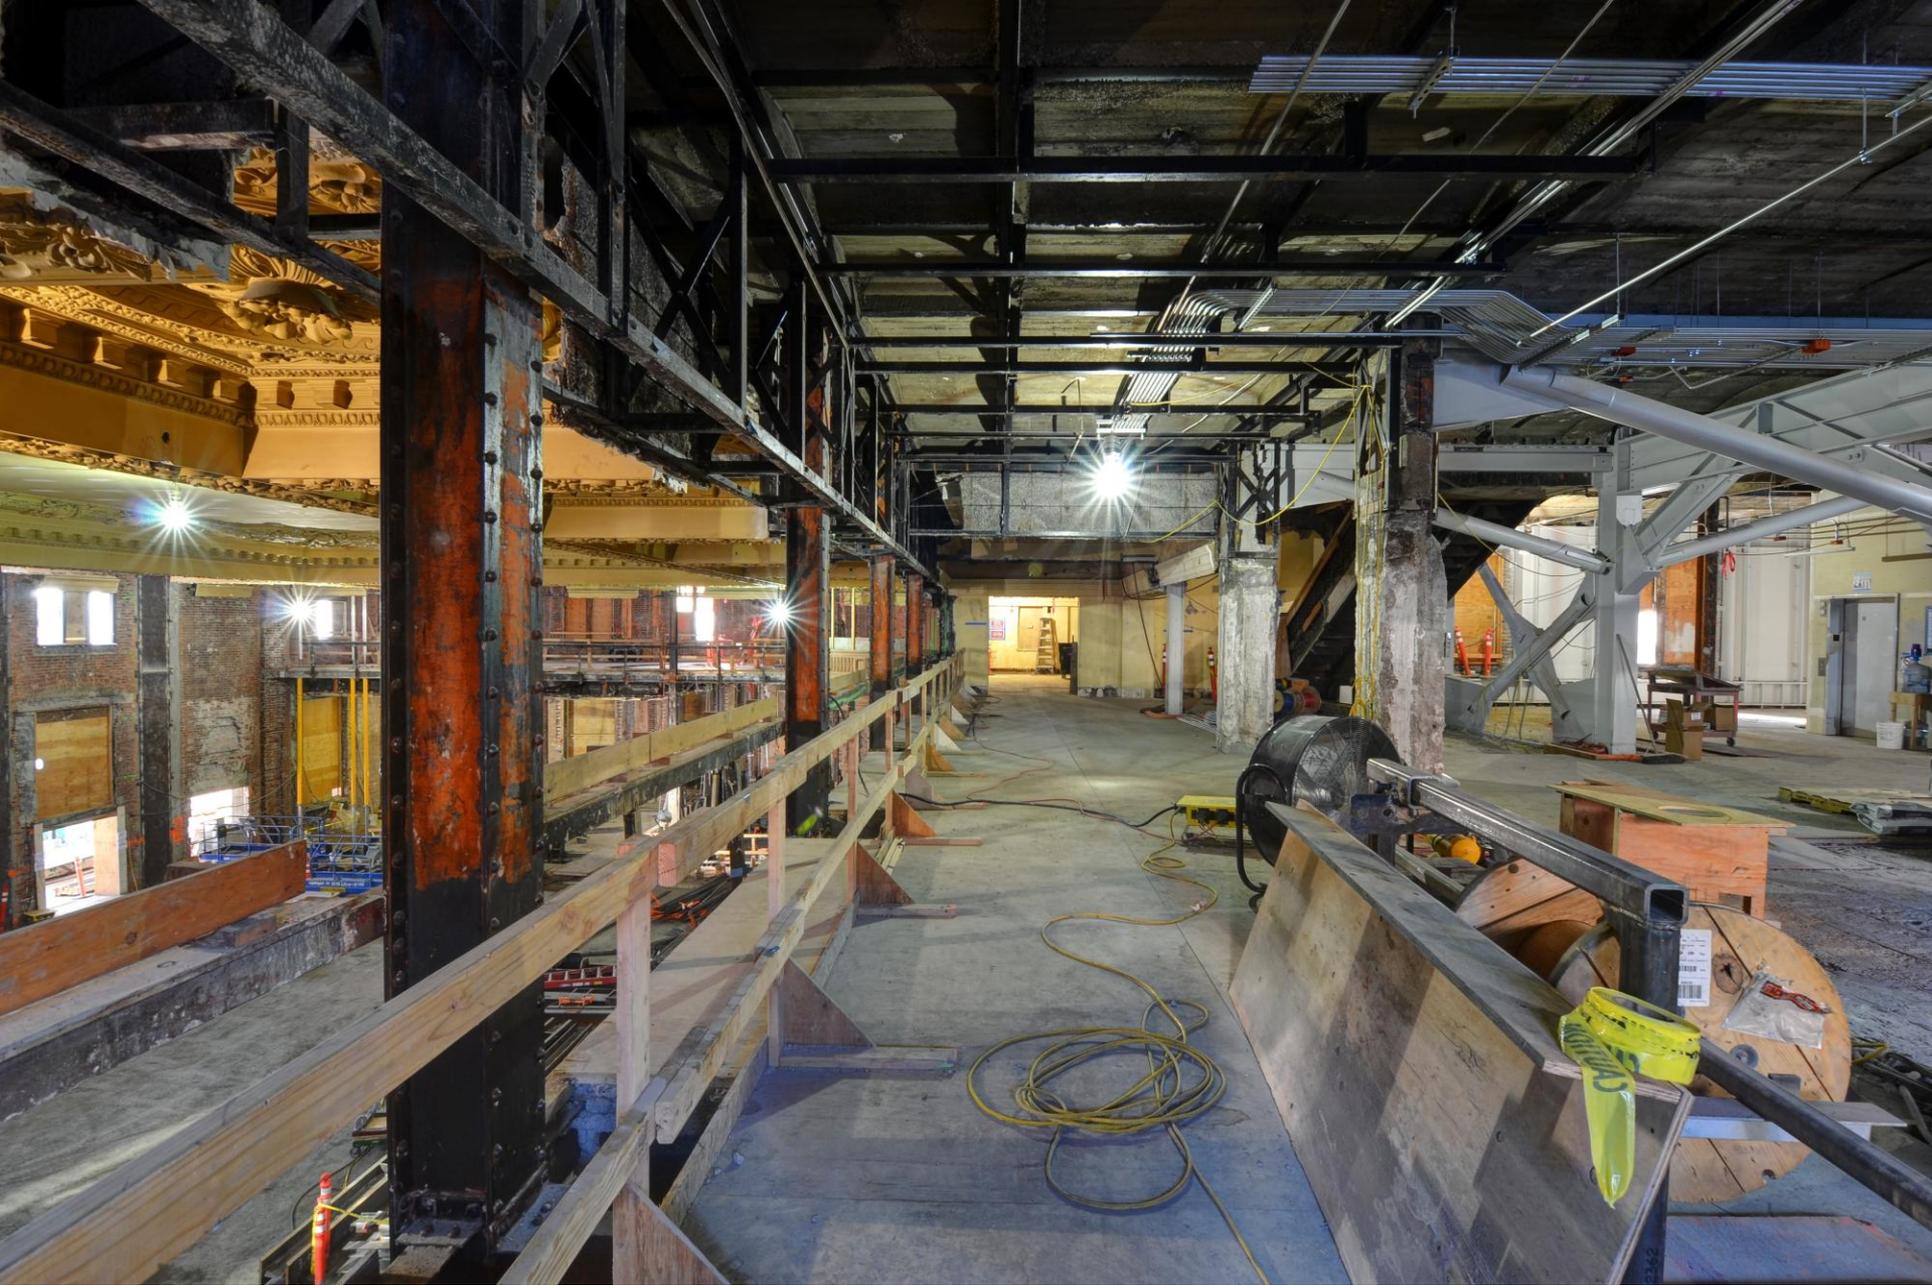
From the east wall looking west along the 2<sup>nd</sup> level balcony. Some plaster on this level has been removed for seismic upgrade.

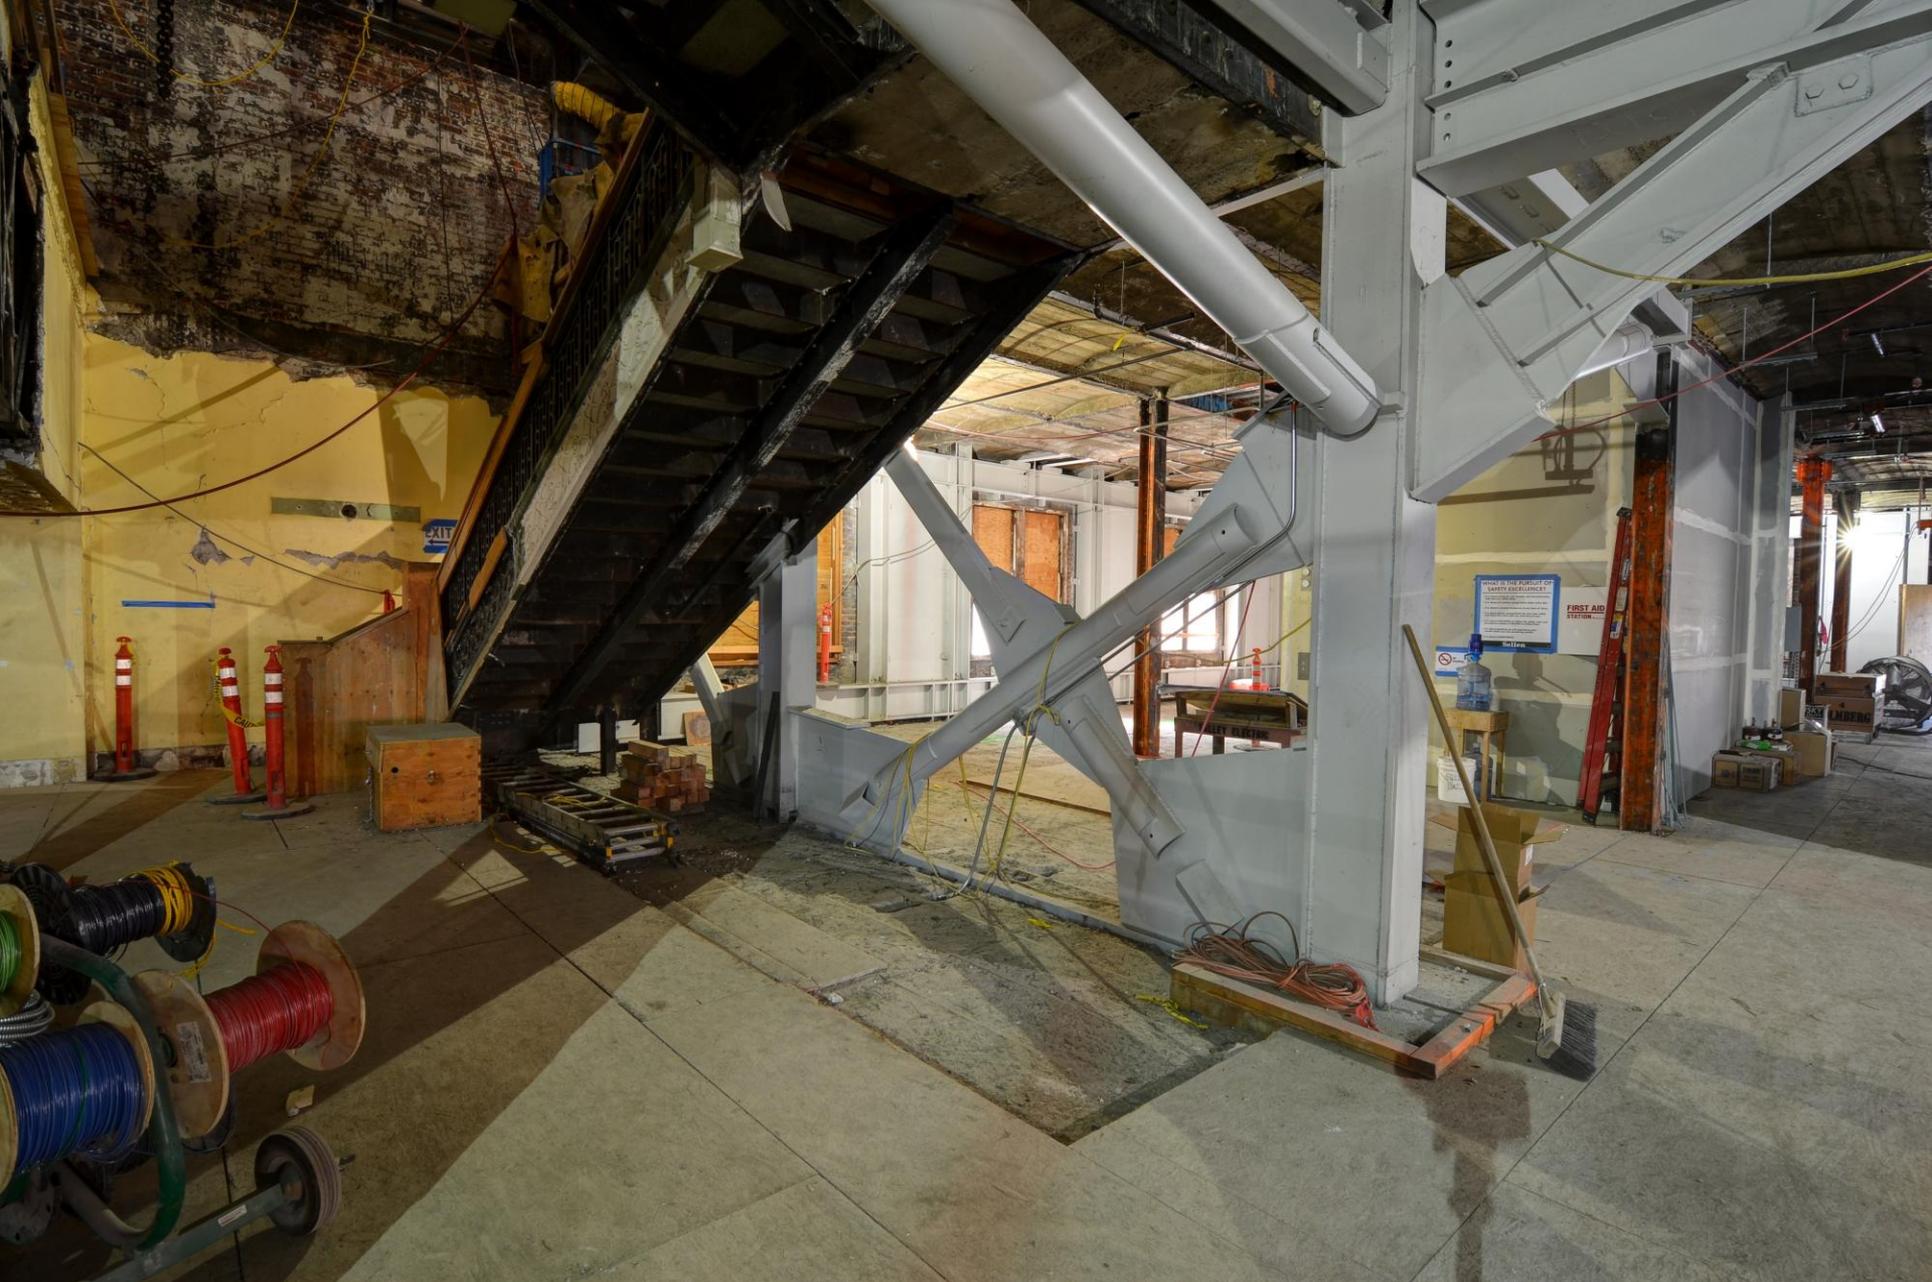
Massive new steel trusses have been installed as part of the seismic upgrade system to counter the weight of the tower.

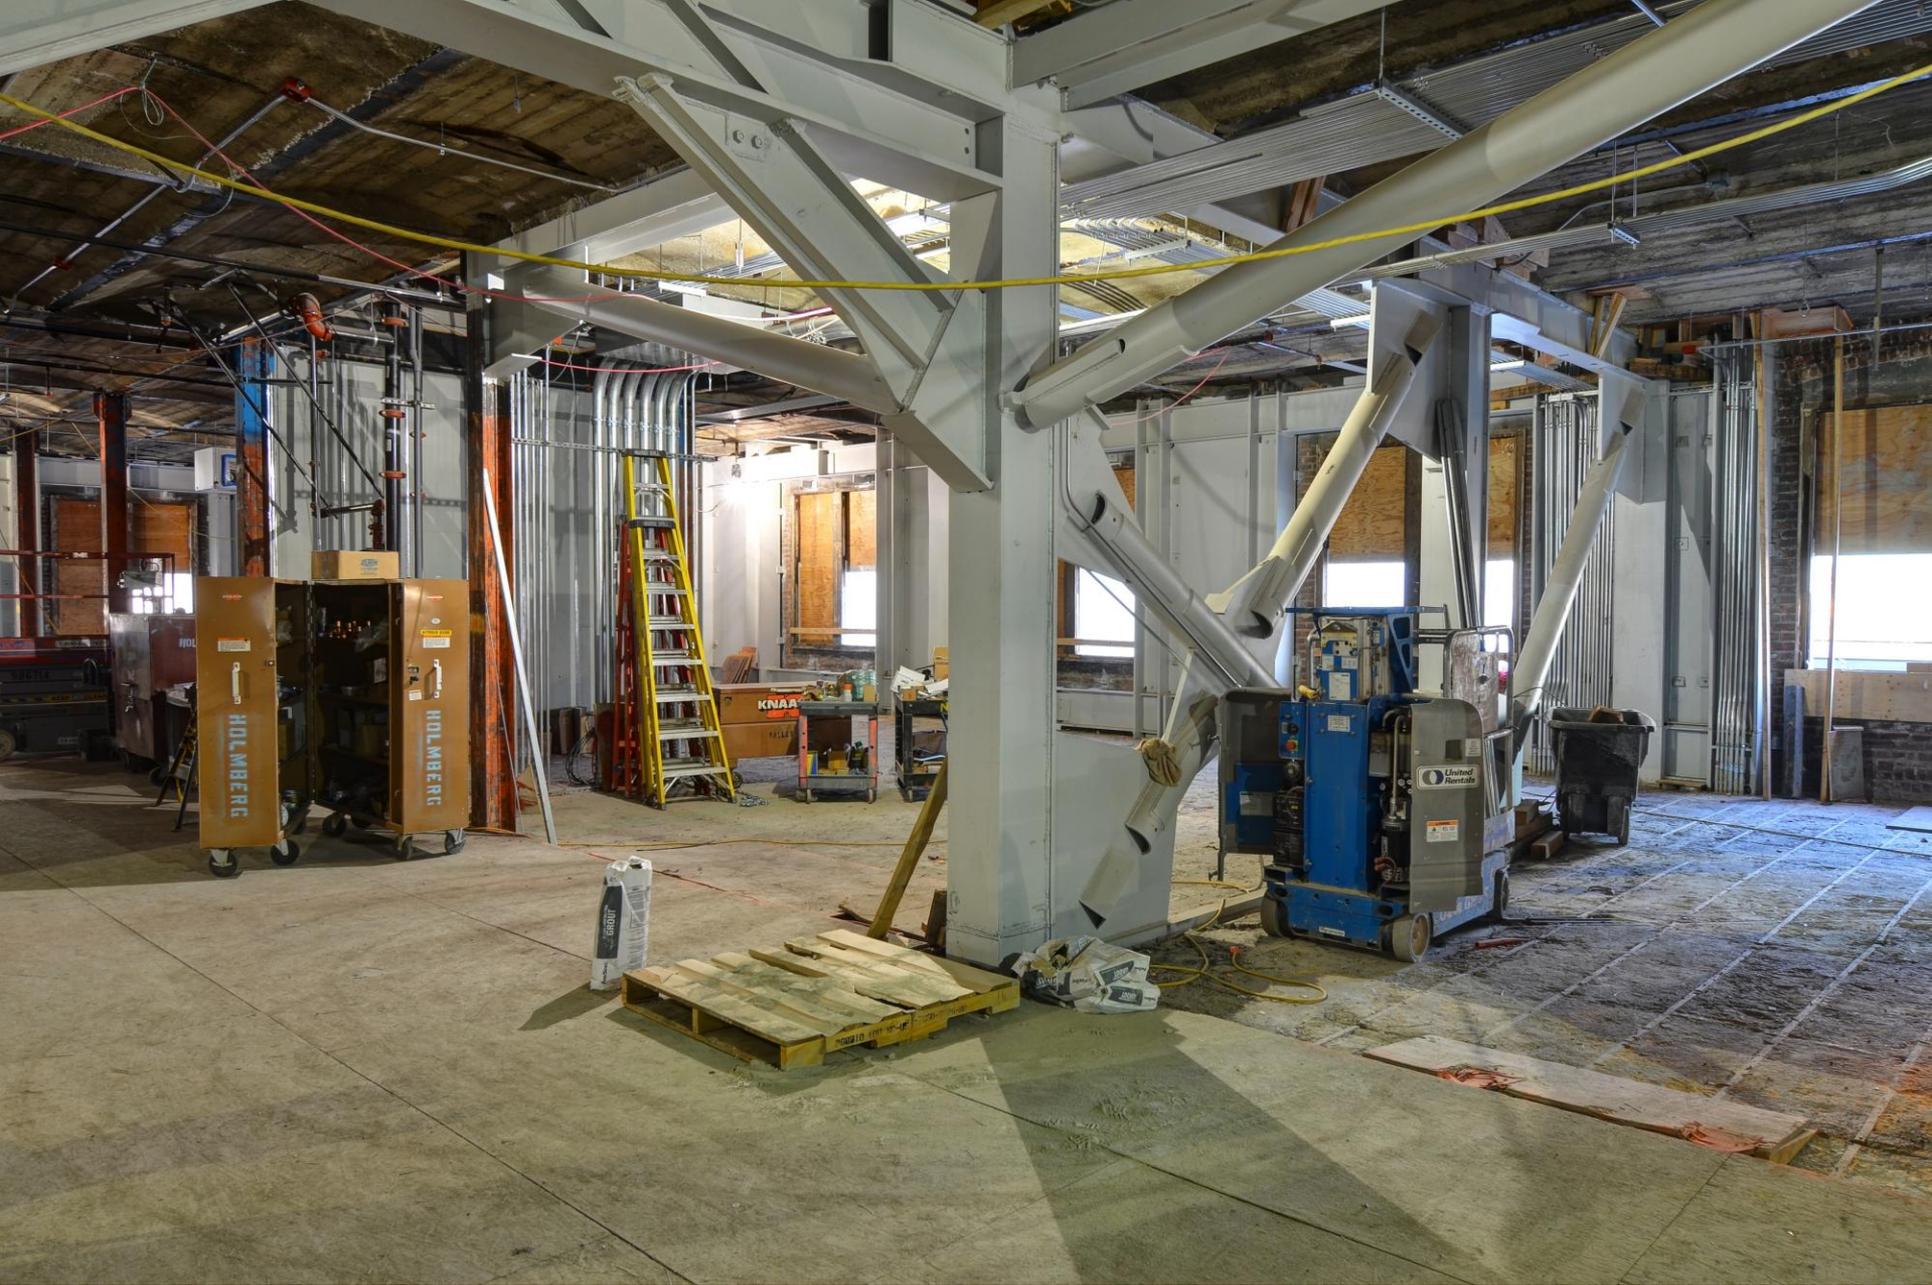
Location of a new stair well that connects the 2<sup>nd</sup> & 3<sup>rd</sup> floor beyond the new steel braces.

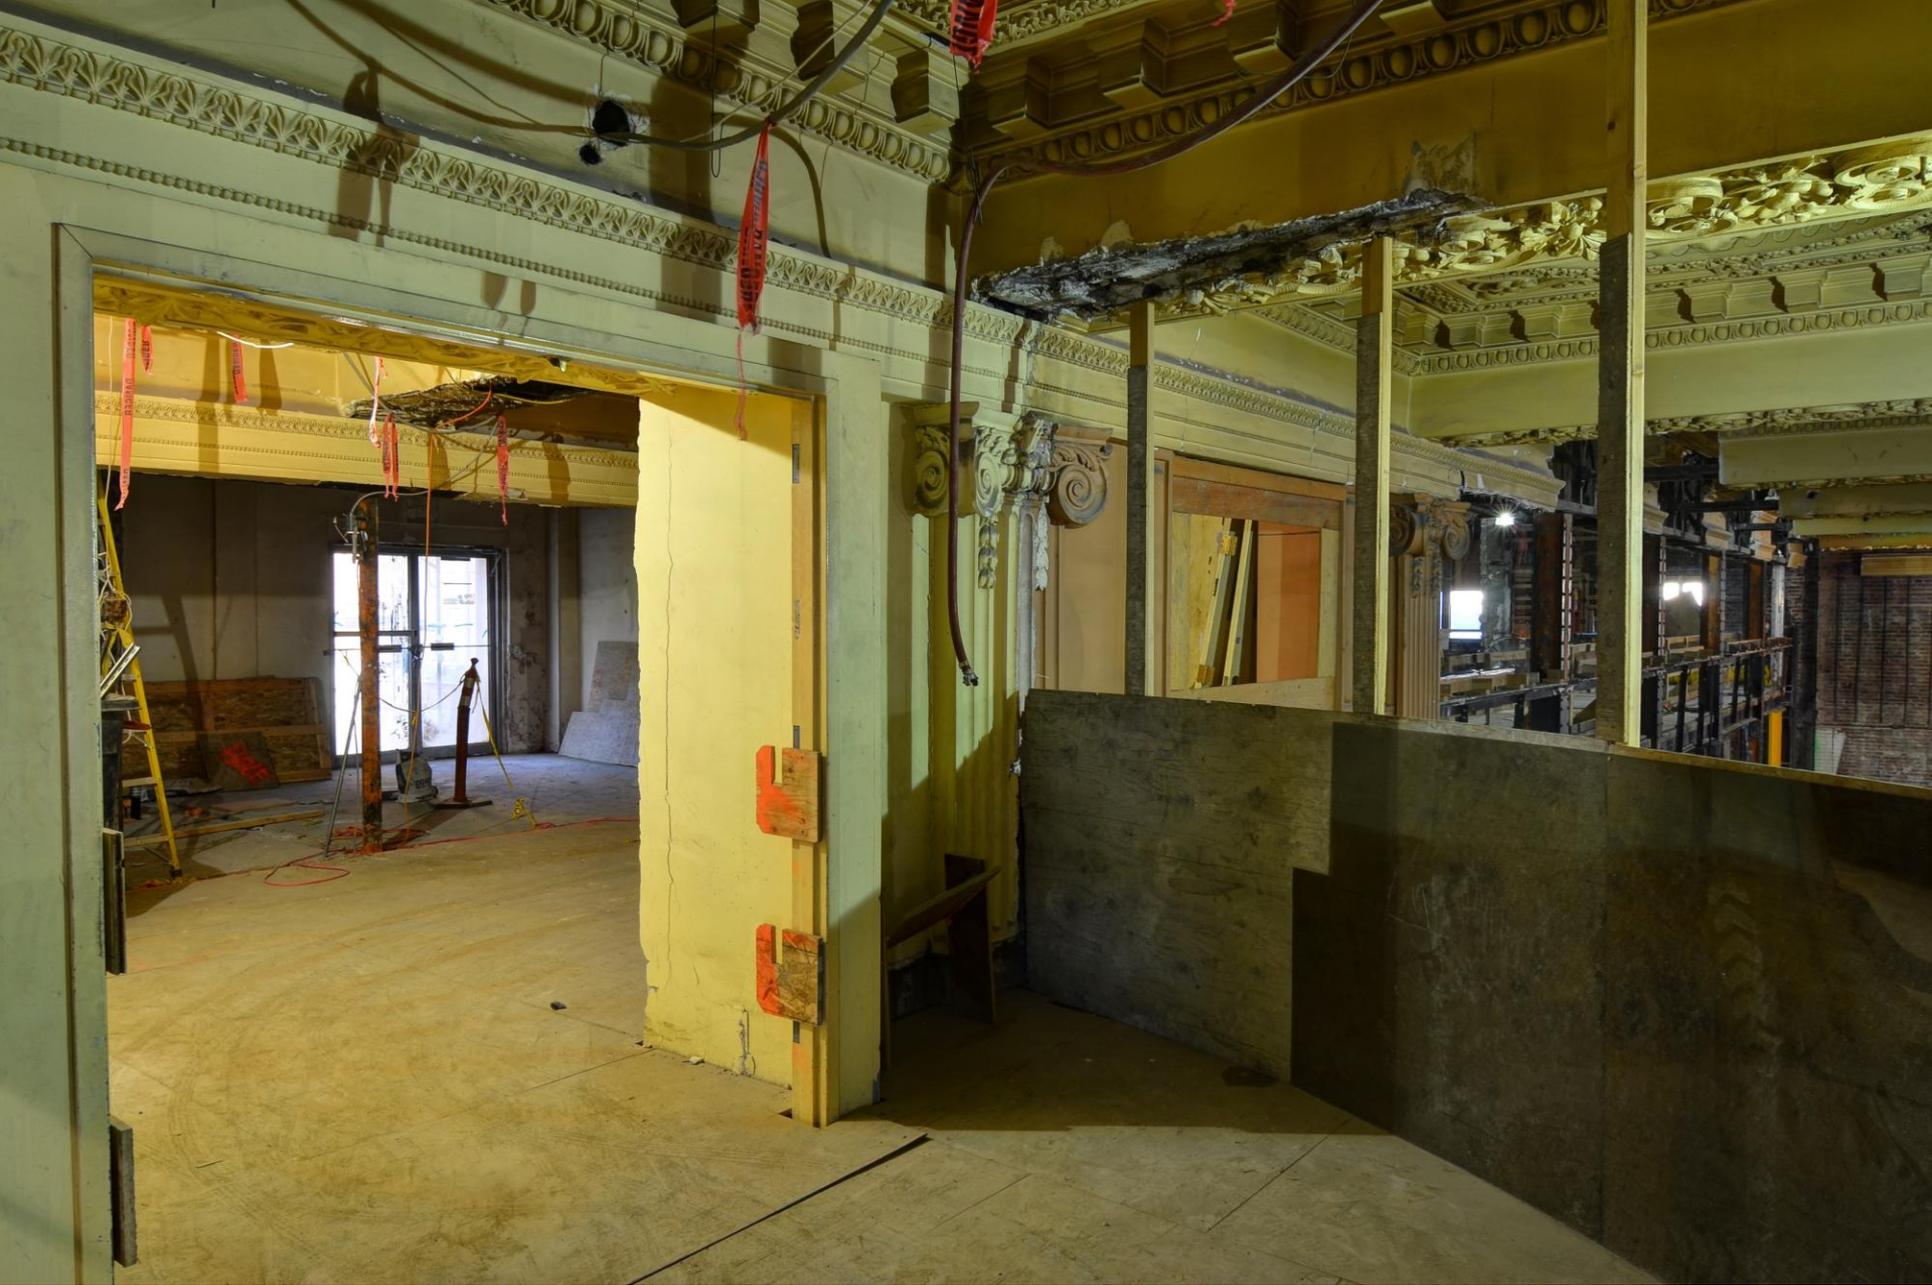
Quarter round balcony as seen from the 2<sup>nd</sup> level. All damaged ornamental plaster will be repaired or replaced.

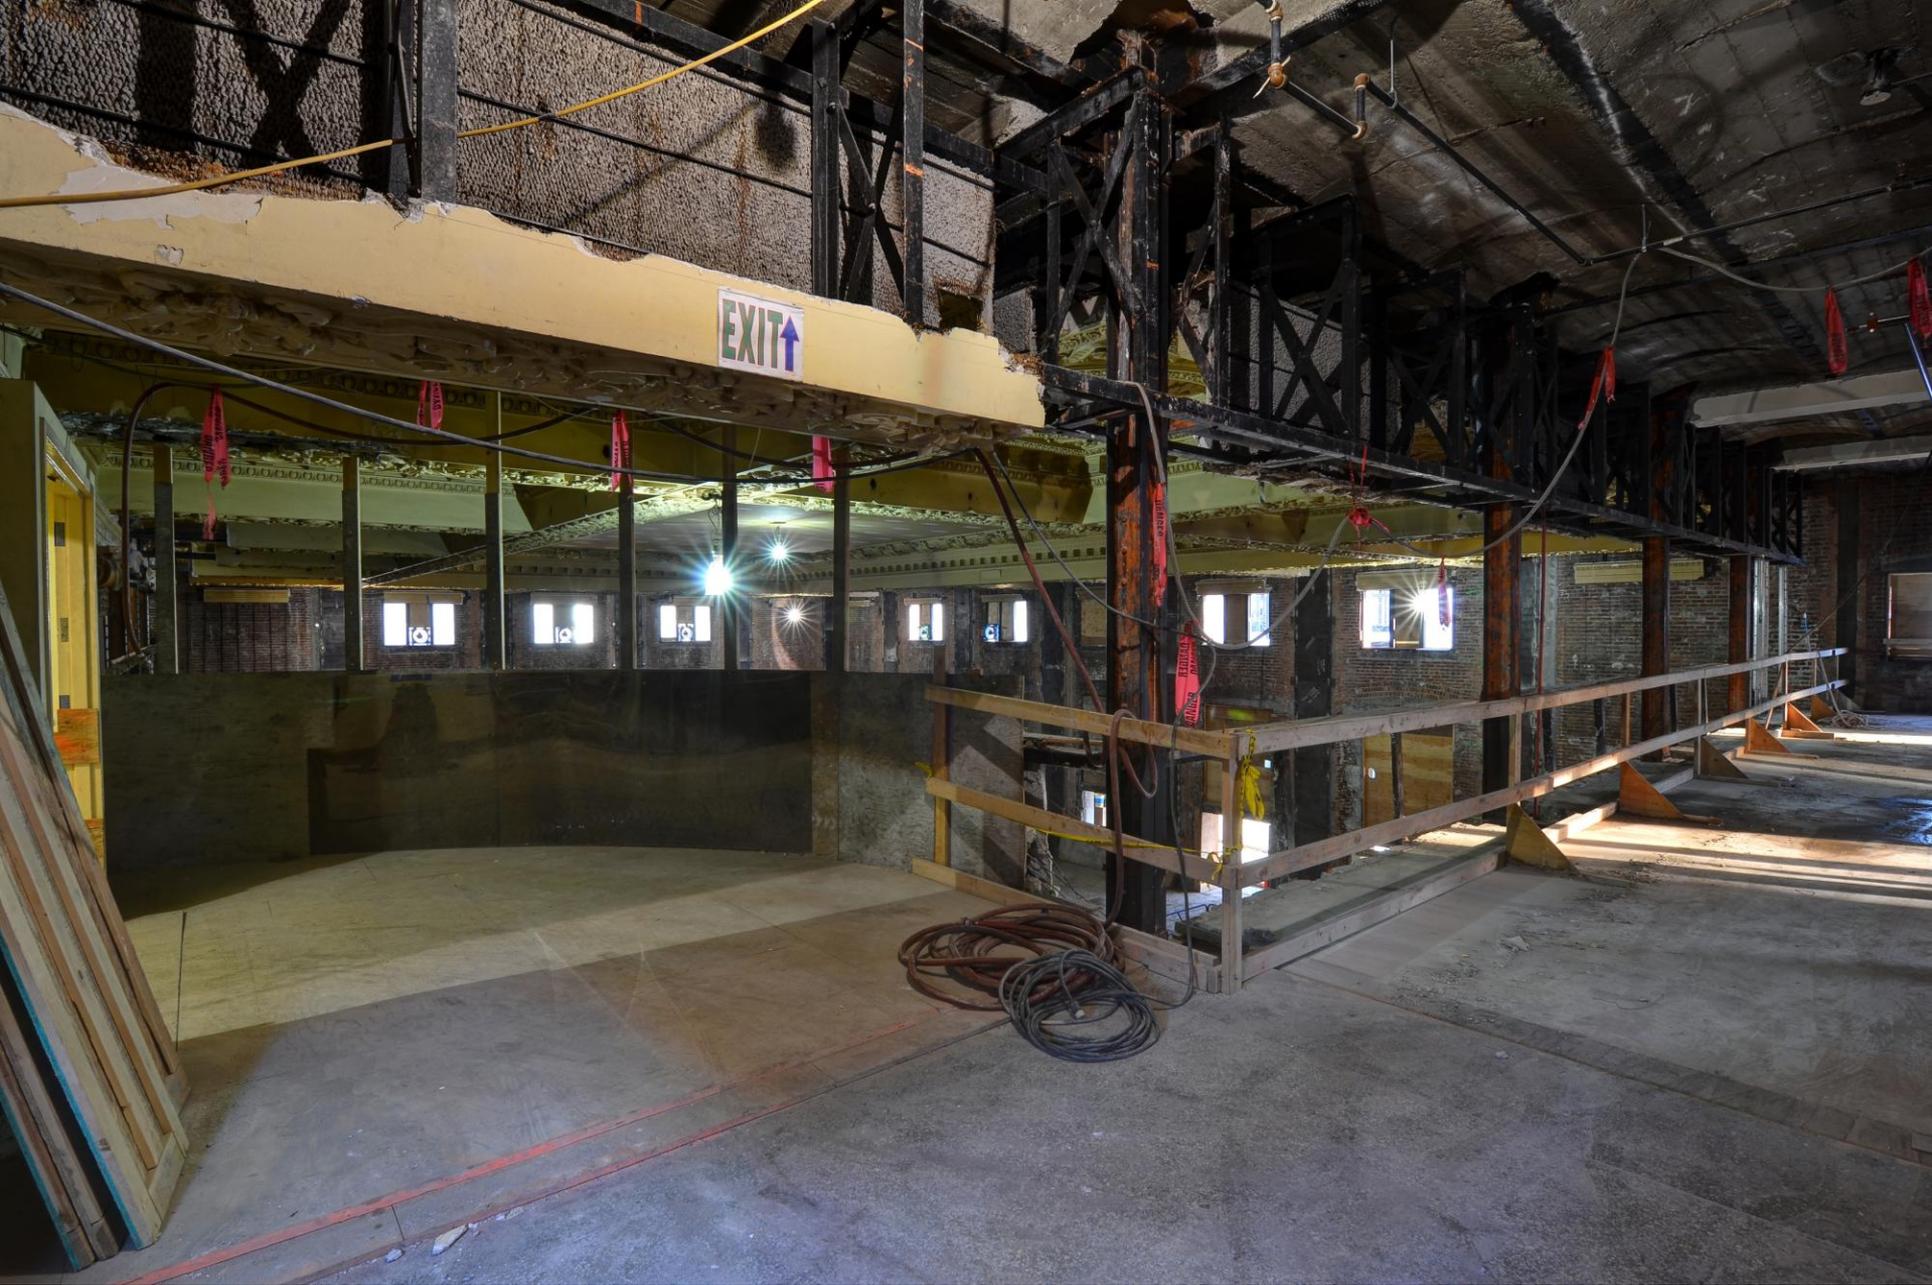
Part of the 2nd level corridor will be opened to the public to view of the waiting room below. Original steel trusses have been exposed for inspection prior to construction.

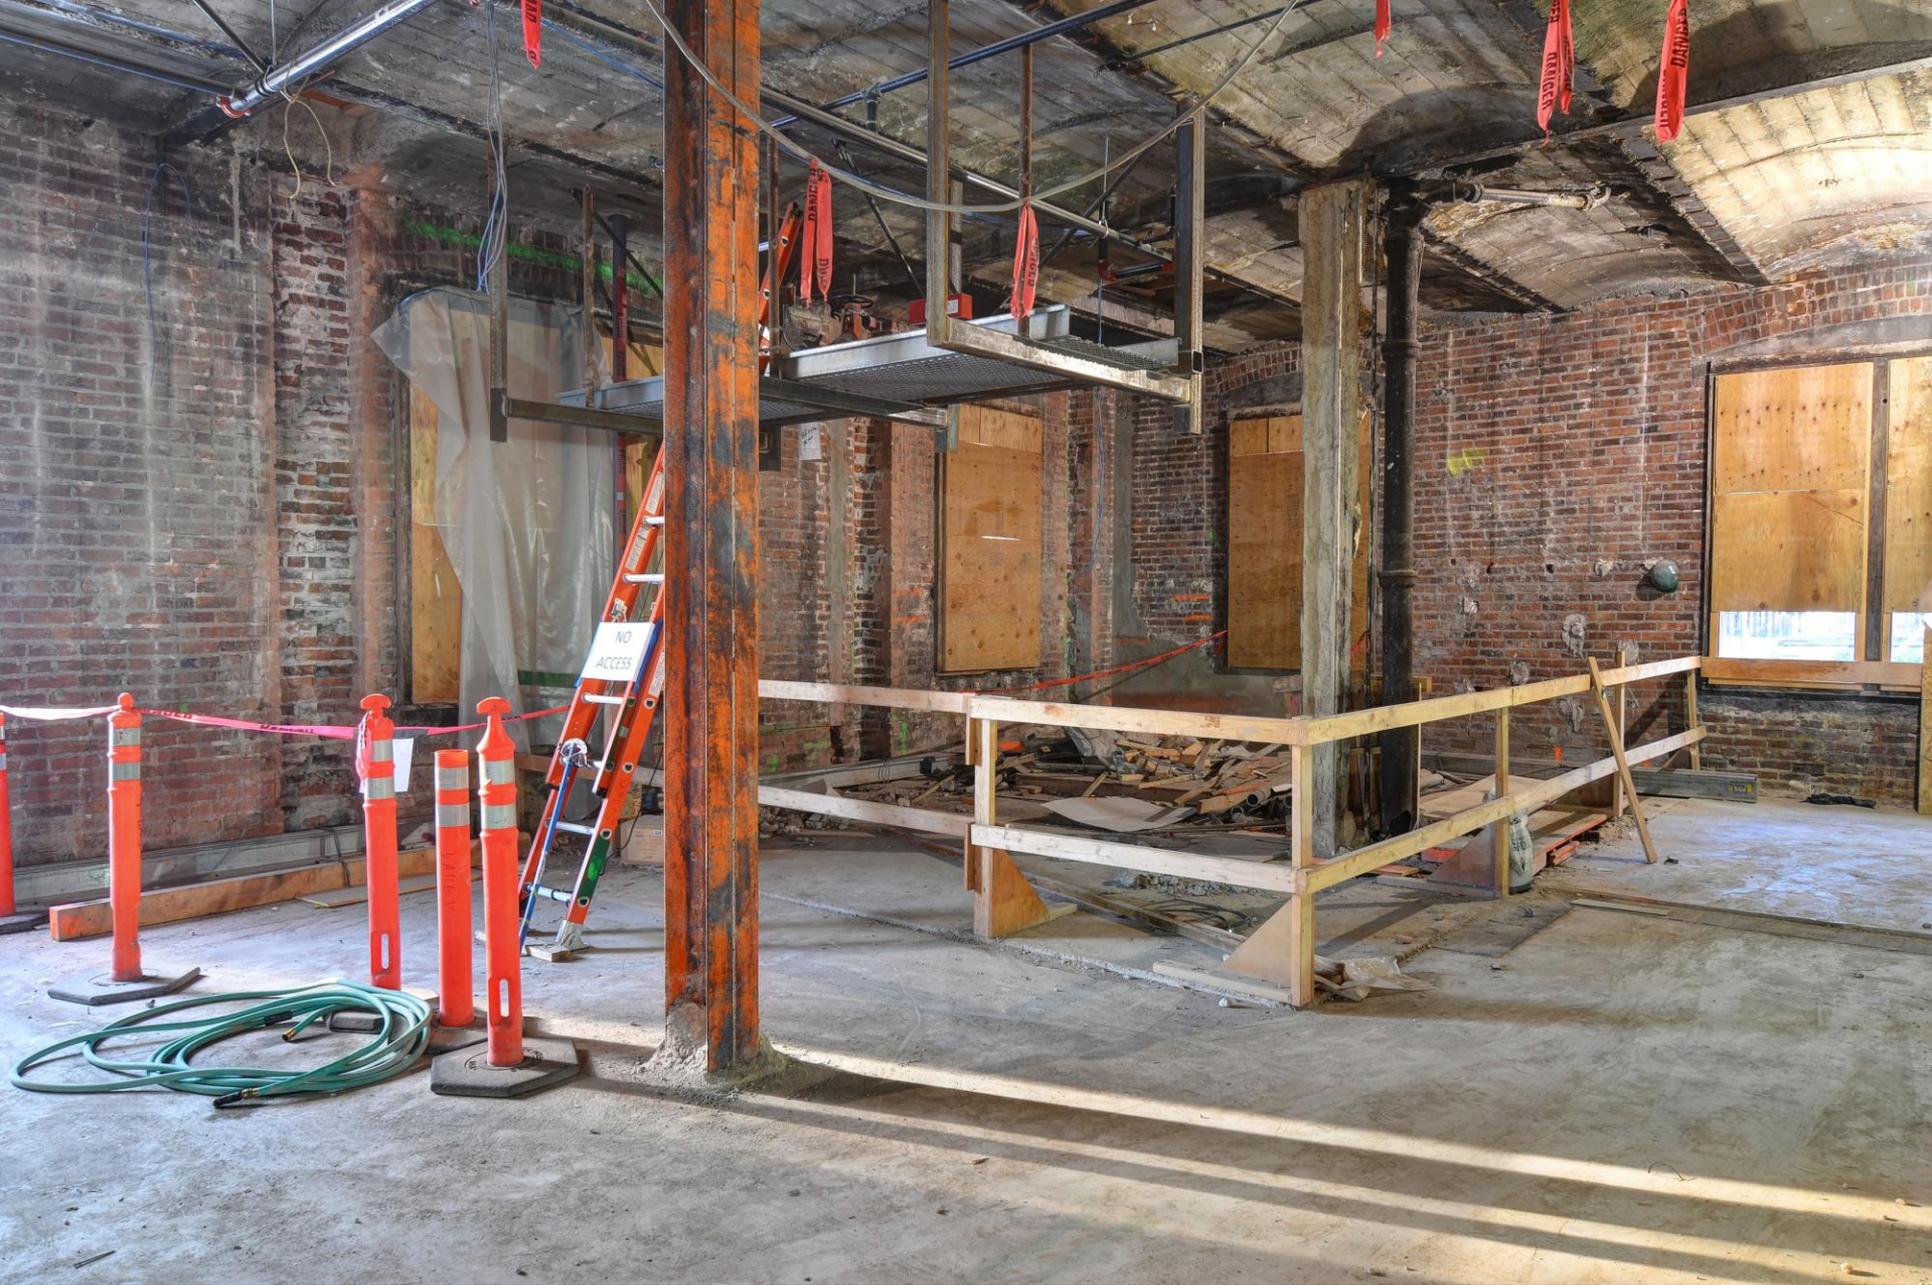
A view of the exposed brick walls of an upper floor. All windows have been removed for off site restoration.

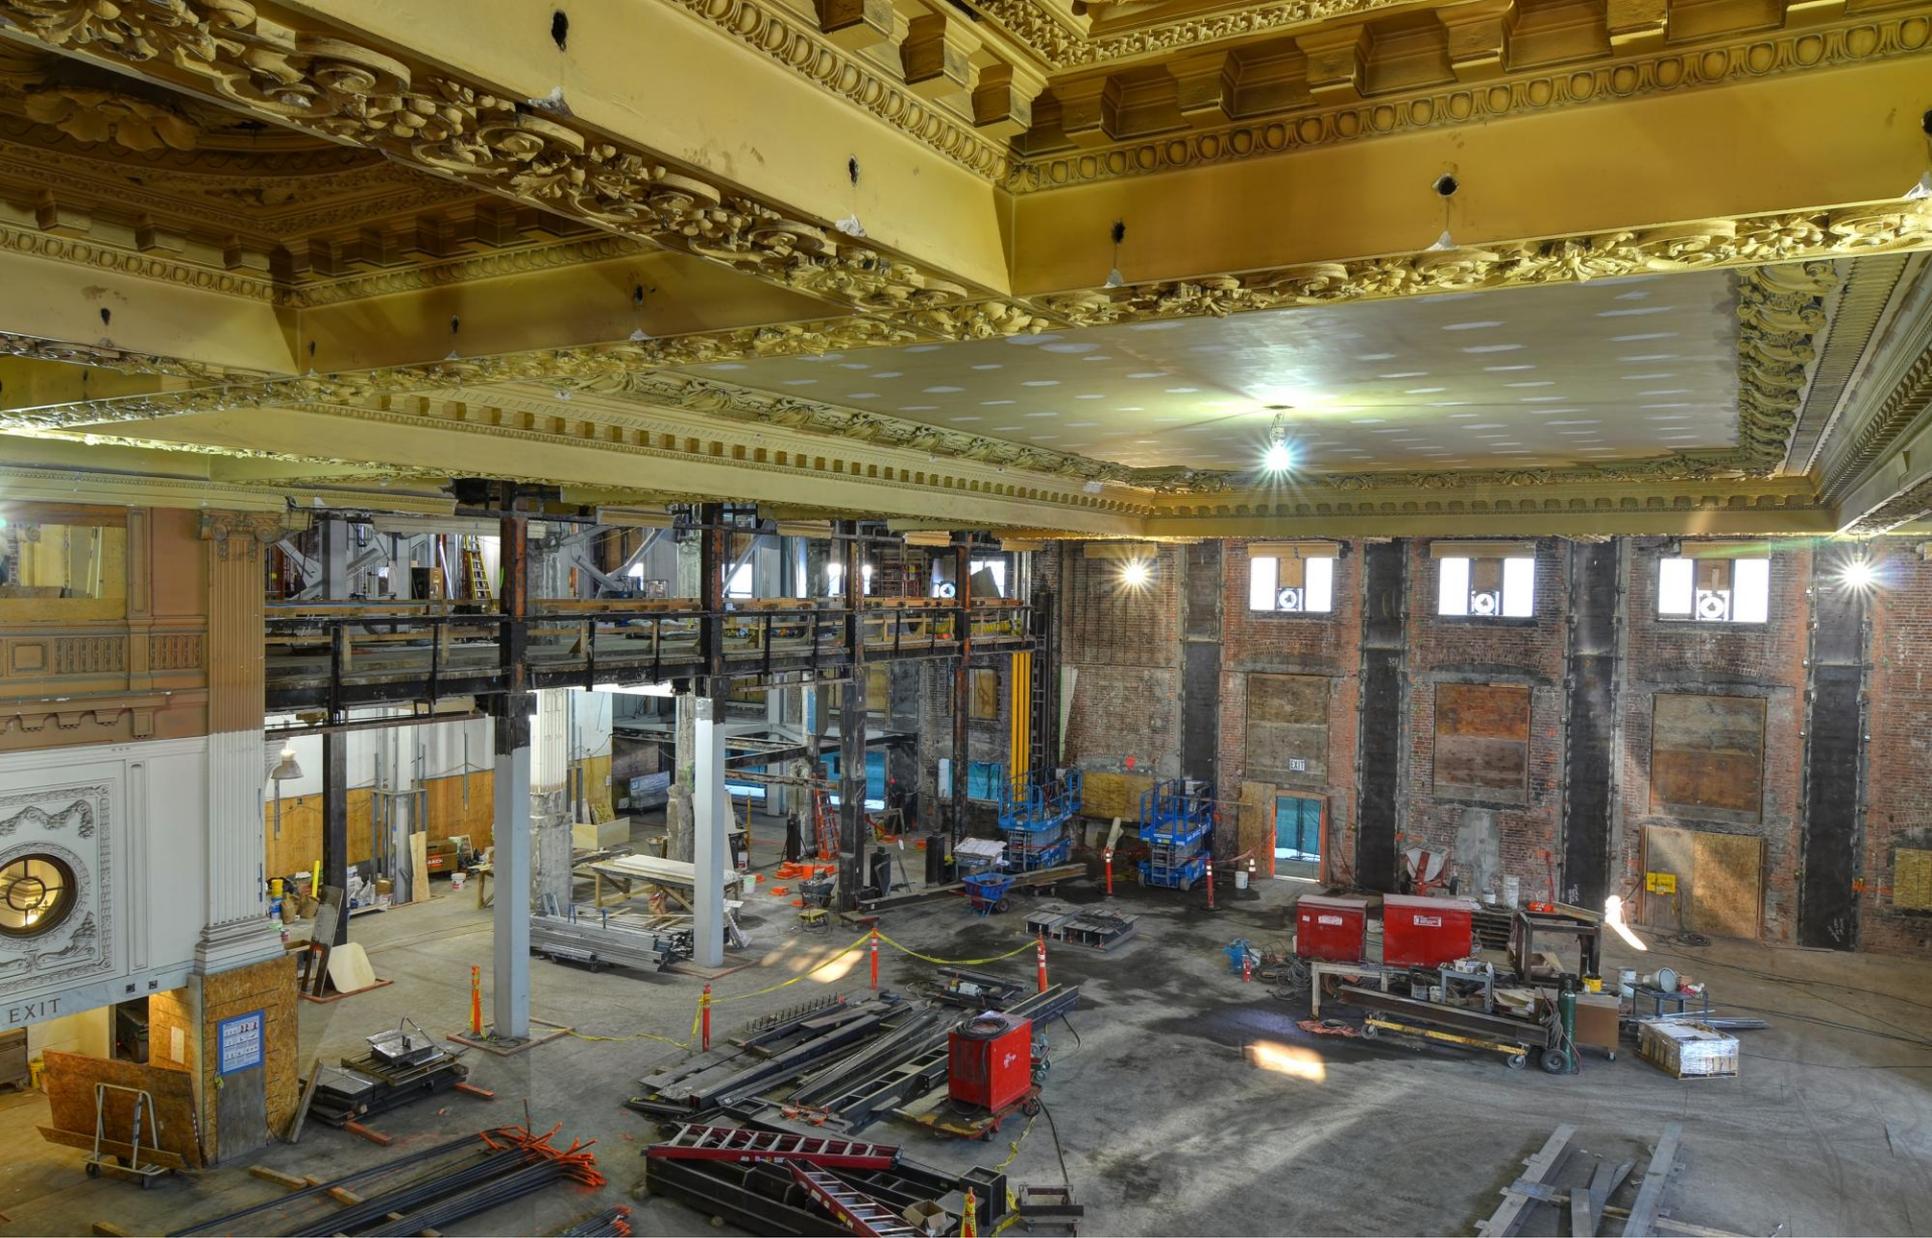
An acoustical ceiling that covered the 2<sup>nd</sup> floor windows as well as the balcony was installed at the station in the 1960s as part of a “modernization” effort. Holes in the ornamental plaster ceiling are results of this decision.

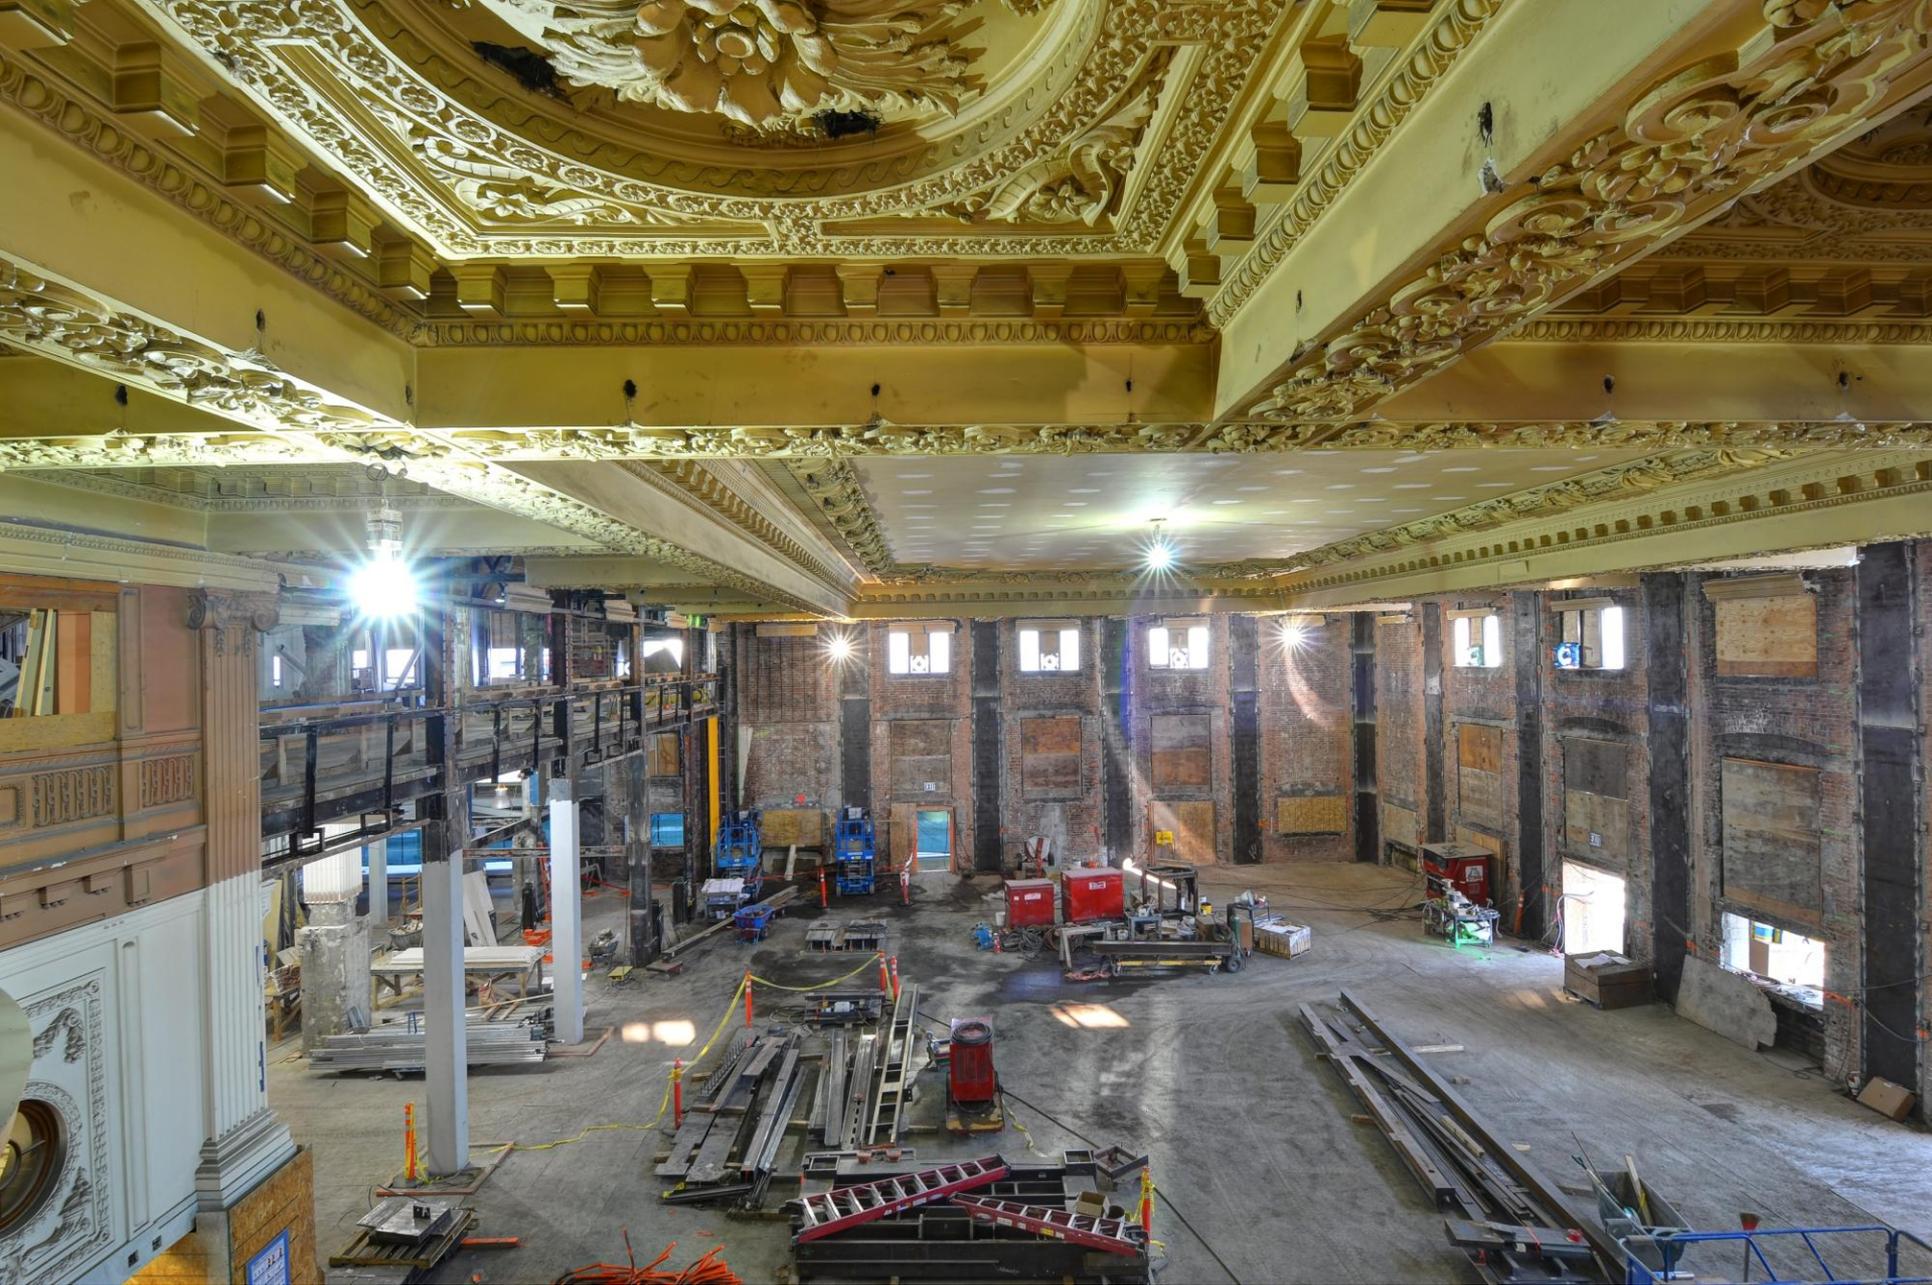
Holes and cracks in the ornamental plaster ceiling are currently being patched and repaired. Plaster molds are made and casted right on site.
