## **Phase 2B**

**2<sup>nd</sup> Level Overview**

**September 24, 2012**

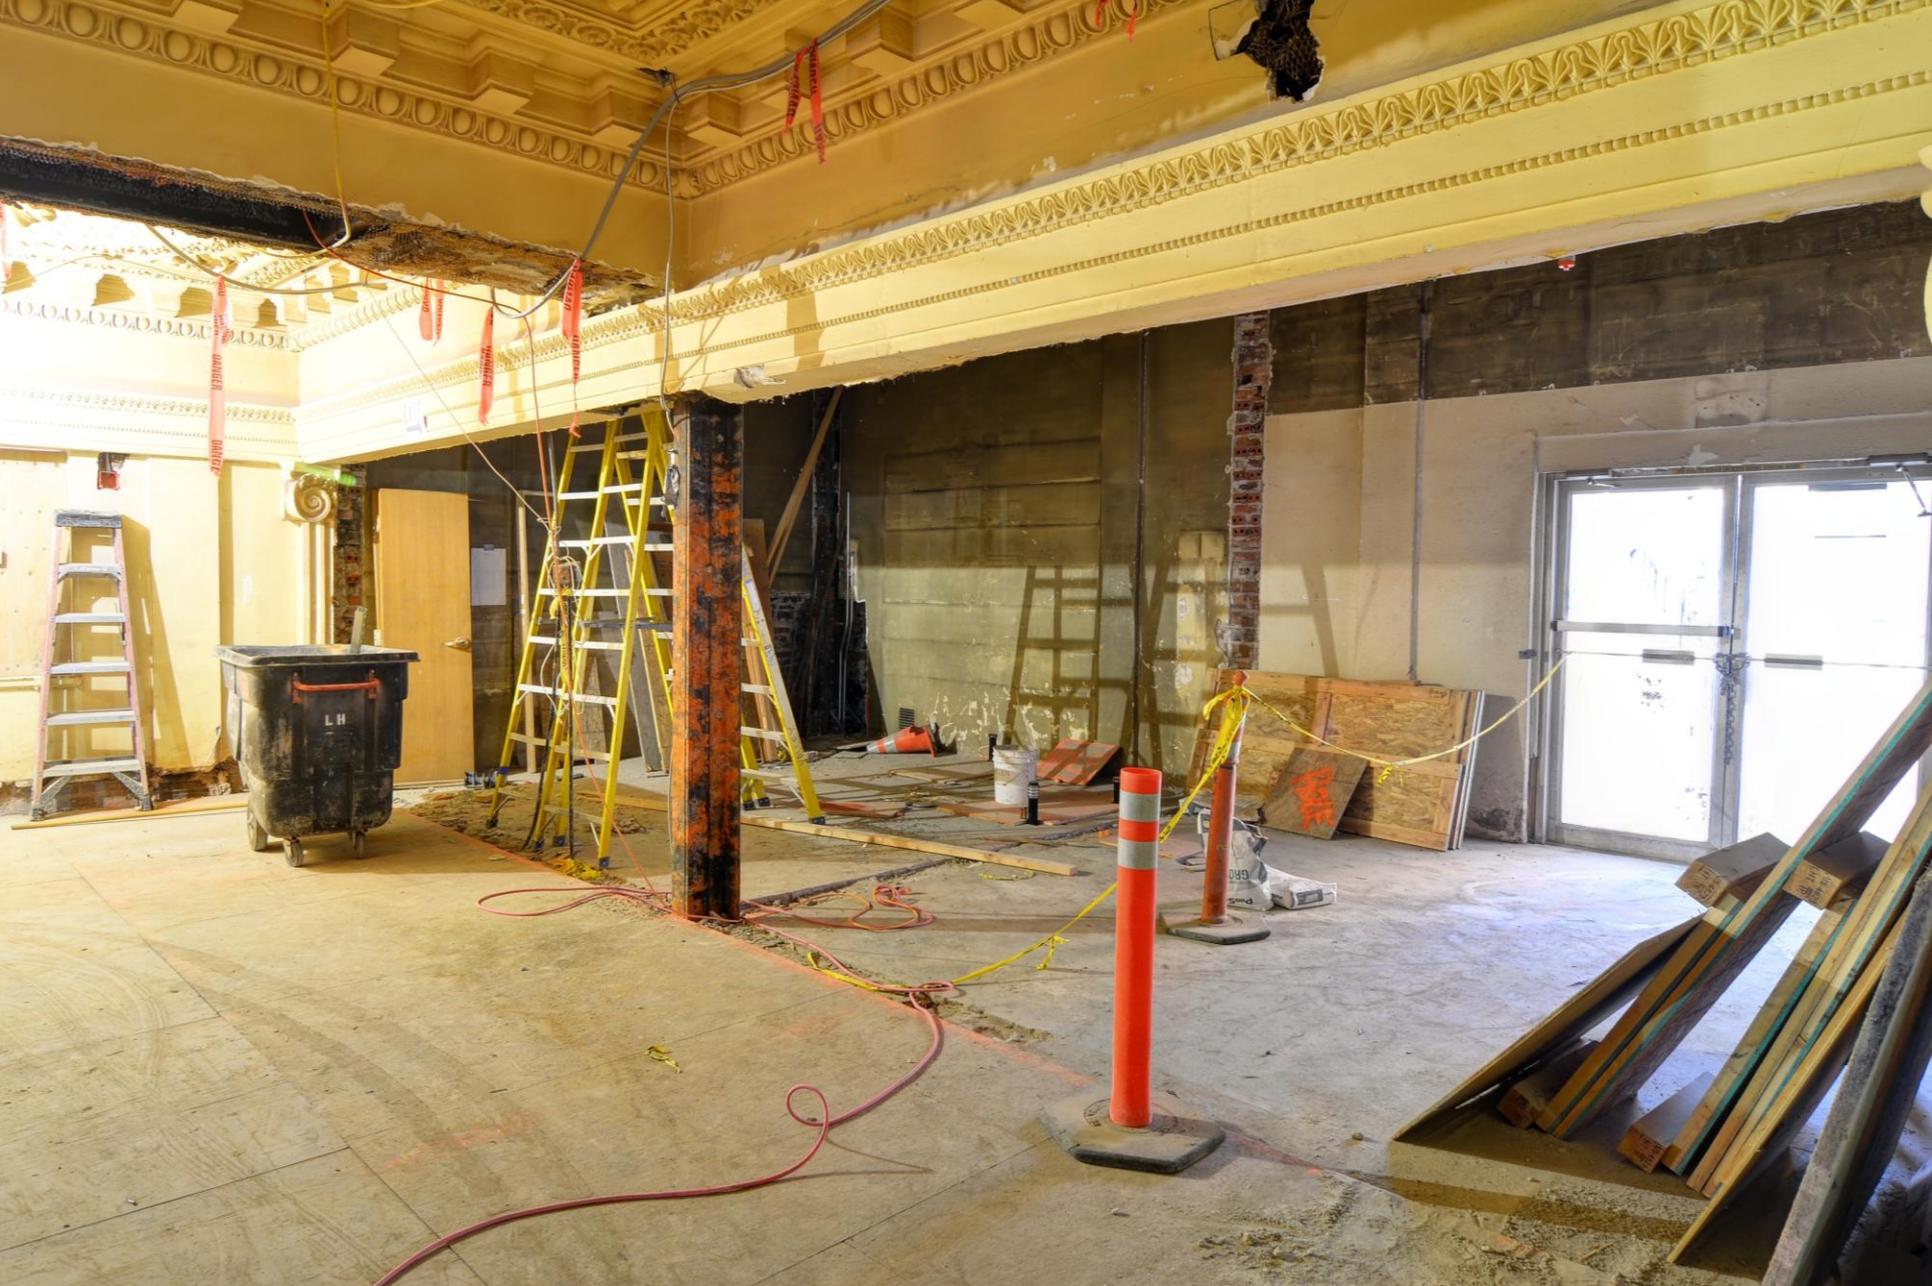
These exit doors used to connect a 2nd level entrance from the Jackson Plaza supported by a walkway and an addition that closed off part of the Grand Stairs. This work has been removed.

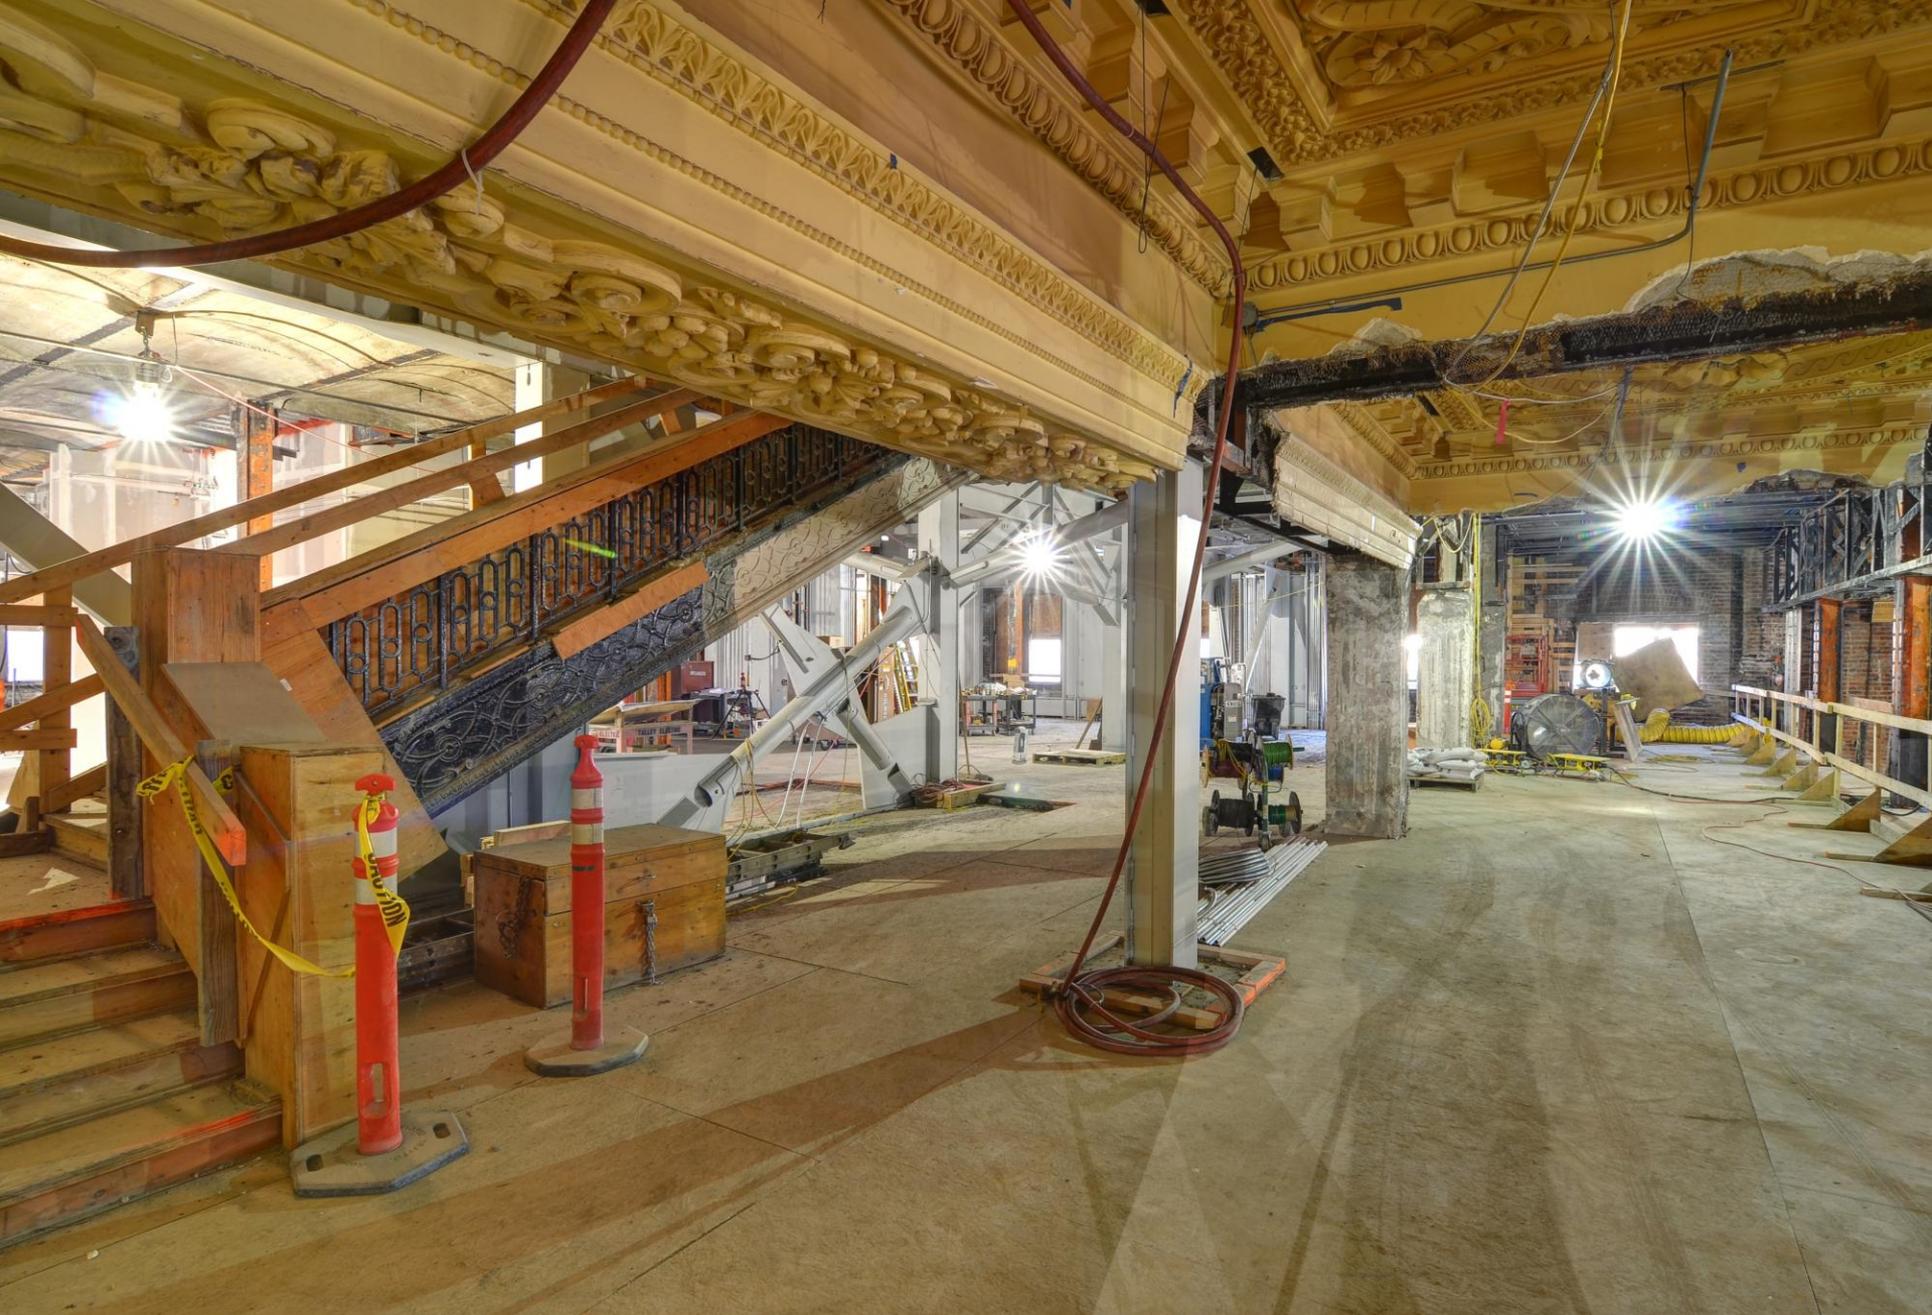
The terrazzo floor is protected by plywood sheathing. All interior partition have been removed.
