Arborist Report

To: Mill Creek Residential Trust LLC. c/o Matt Quigley
Site: 1032 S Jackson St., Seattle, WA 98104; Parcel# 8591900145
Re: Tree Inventory and Assessment
Date: April 27, 2022
Project Arborist: Sean Dugan, Registered Consulting Arborist # 457
ISA Board Certified Master Arborist #PN- 5459B
ISA Qualified Tree Risk Assessor
Referenced Documents: Site Plan A100 (Tiscareno Associates; plotted January 31, 2022)
Attached: Tree Inventory - Table of Trees
Aerial Photograph with Tree Locations

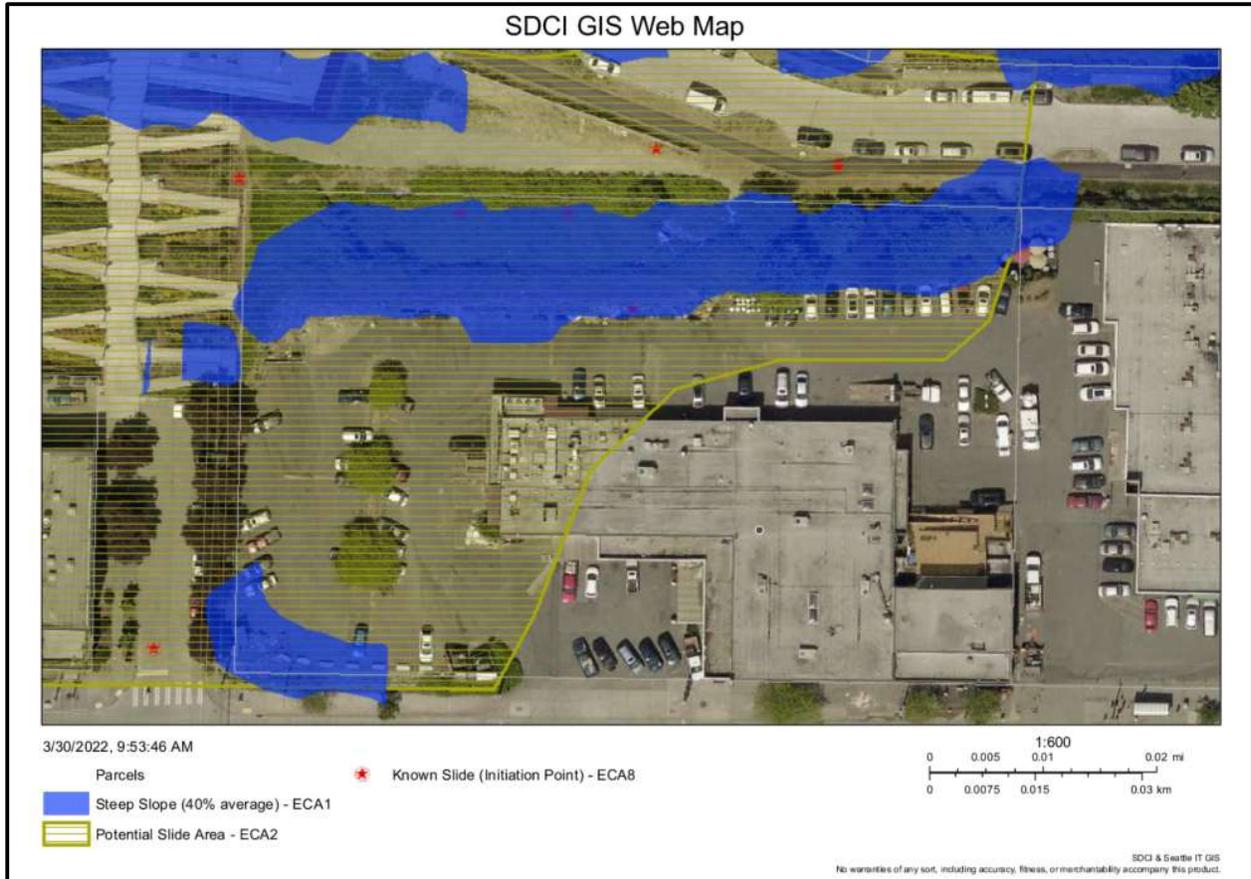
Figure 2. Aerial photograph with environmental critical areas. (Source: Seattle GIS Web Map accessed March 30, 2022)

A steep slope and potential slide environmental critical area (ECA) are located on the site (see Figure 2). An unmaintained landscape swath is located along the north portion of the property above a rockery retaining wall. Several trees on the slope show symptoms consistent with slope creep (soil movement down slope). Several trees have failed at the roots in the shallow soils in this area.

- Unless removal is approved by the Director, site planning around exceptional trees must follow the requirements outlined in SMC 25.11.050.²
- Site planning around trees in critical areas must follow the requirements outlined in SMC 25.09.070.³

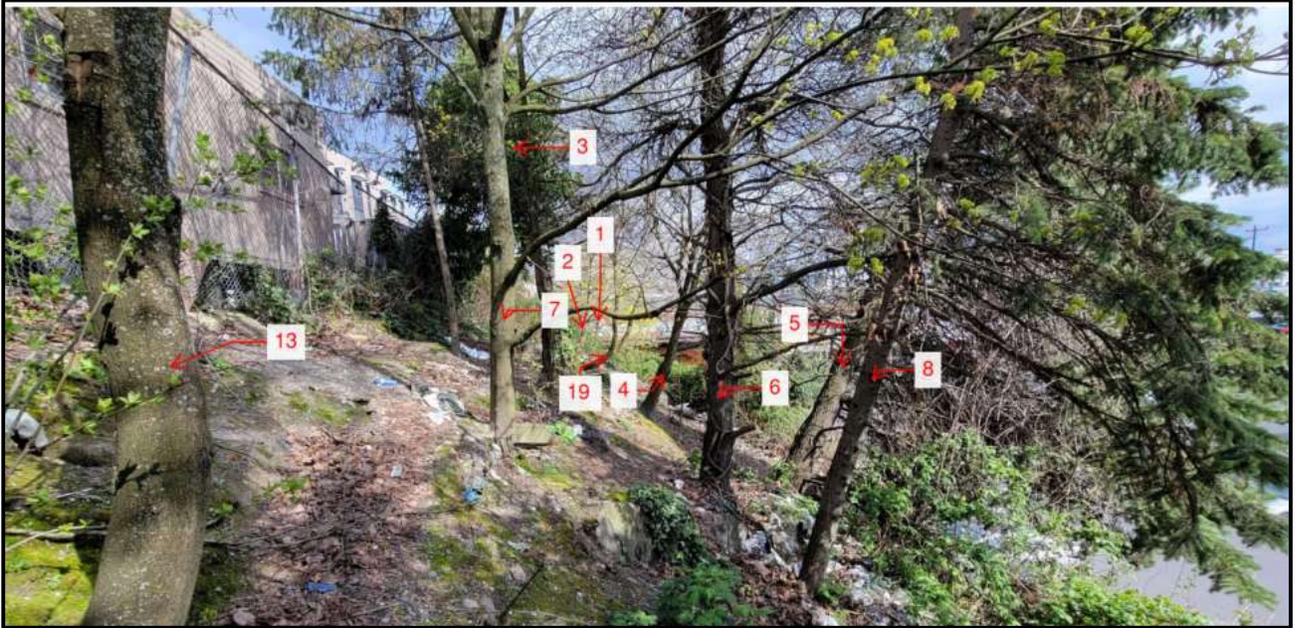
Photograph 1. View looking east on the north slope.

I inventoried 19 trees that meet the significant size threshold. Photographs 1 and 2 provides a ground level layout of the majority of the trees in the northeast stand. Trees are generally in fair to good health and structural condition. The trees are young and mature in age class. It is unclear if the trees are volunteer trees that established on their own or if they were planted. There are no exceptional groves on the property. Trees 5 and 17 meet the city of Seattle’s criteria of an exceptional tree.

Tree 5 is an exceptional Shore pine (*Pinus contorta*) tree that has a lean to the south (Photos 1, 2 and 5). The majority of the canopy is located over the parking lot. There is a slight correction at the top of the tree to vertical, indicating the tree is currently stable.

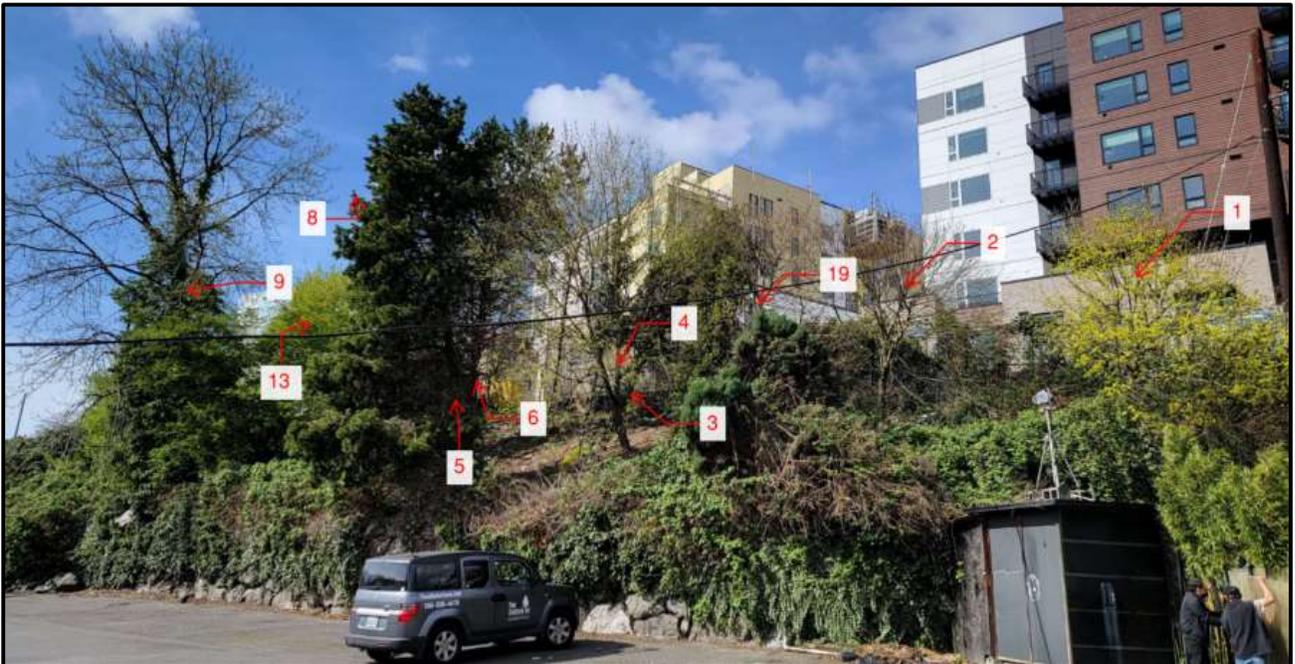
Photograph 2. View looking northwest from the parking lot.

The largest tree in the stand is a 23-inch diameter Black cottonwood (*Populus trichocarpa*) tree at the top of the rockery (Photos 2 and 6). This tree is not to be considered exceptional unless part of a grove, which does not exist.

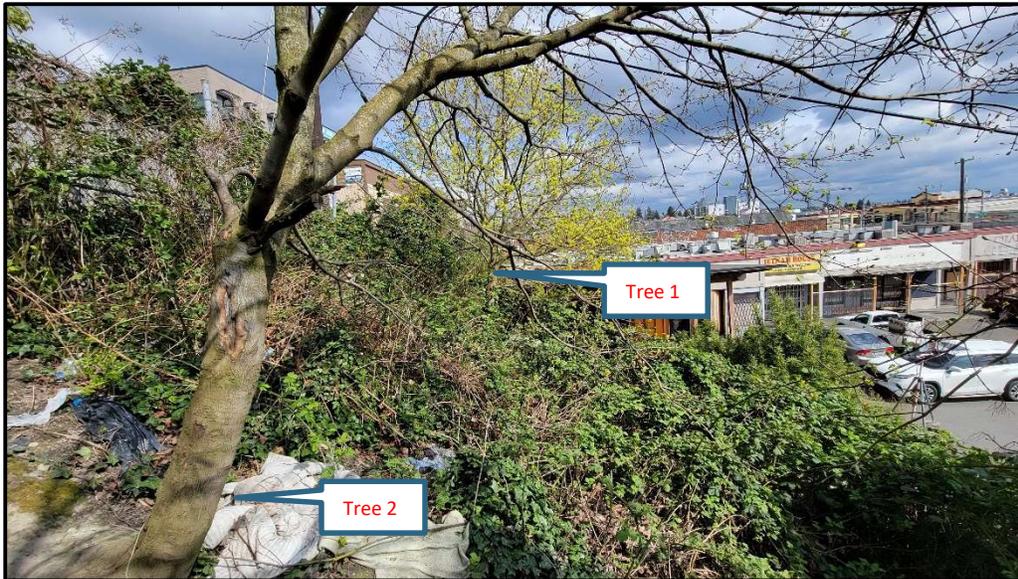
Photograph 3. View looking east at Trees 1 and 2.

Trees 1 and 2 are small diameter maple (*Acer spp*) trees (Photos 3 and 4). Tree 2 has a swept or “J-hook” base that indicates possible slope creep. The same structure can be seen in Tree 19 in Photo 5. Tree 3 is a Douglas-fir (*Pseudotsuga menziesii*) tree that has failed at the base in the shallow soils (Photo 5). The tree’s structure is considered to be poor.

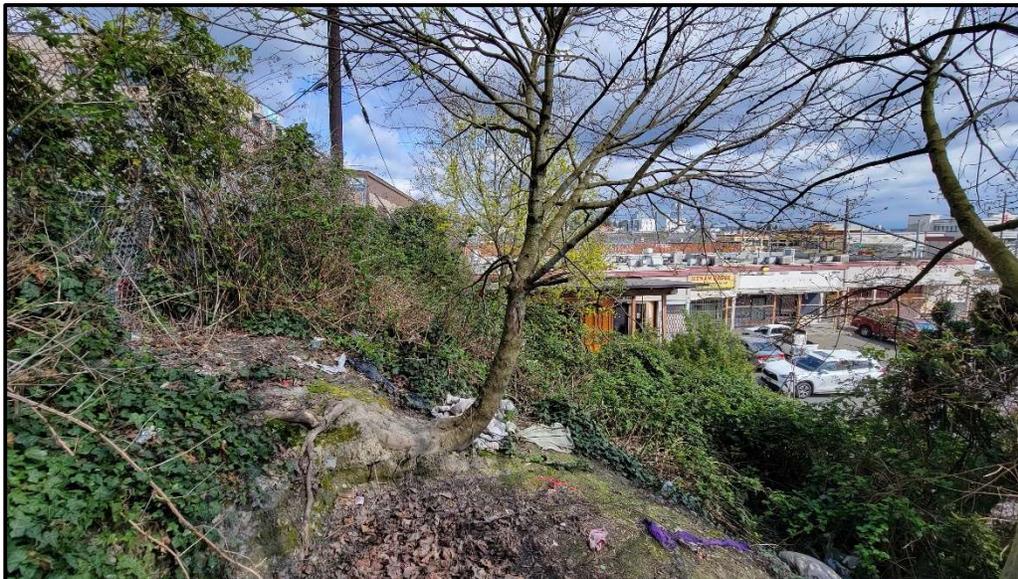
Photograph 4. View looking east at Tree 2. Tree 2 has a swept base, an indicator of slope creep.

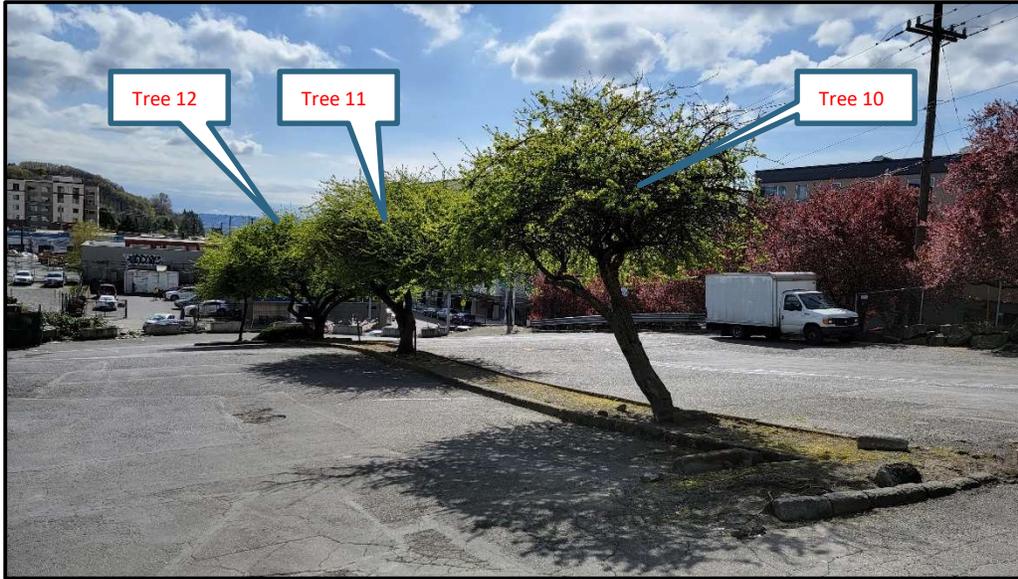
Photograph 7. View looking south at the parking lot Trees 10, 11, and 12.

There are three Pear (*Pyrus communis*) trees located in the parking lot west of the existing structure (Photo 7). These trees are in good condition but are damaging the surrounding infrastructure. Trees 14, 15 and 16 are pear trees located along the north property line (Photos 7 and 8).

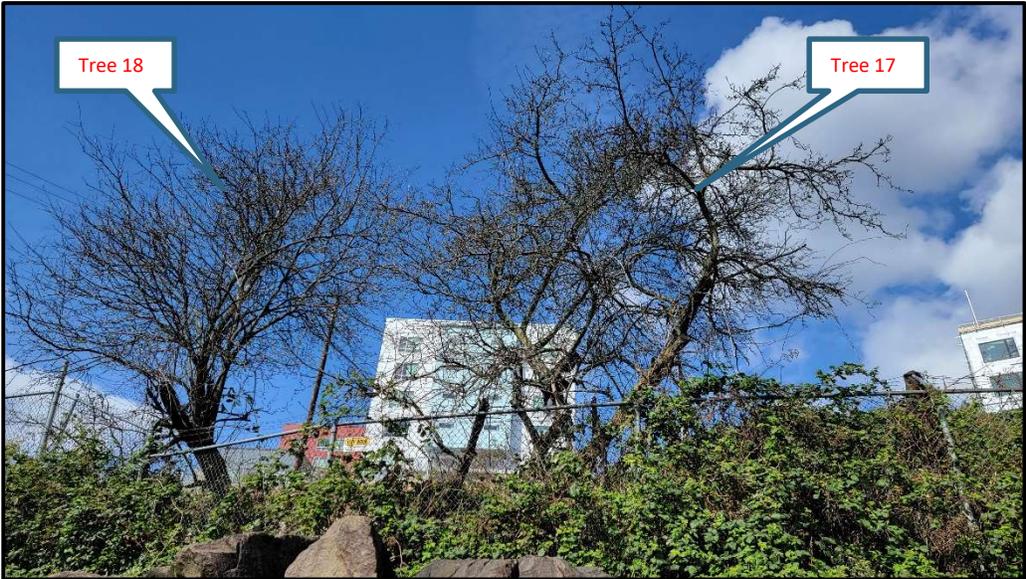
Tree 17 is an exceptional willow (*Salix spp*) tree located on the west portion of the site (Photos 10, 11, 12). The tree is in poor structural condition, having previously failed at the roots. A saprophytic fungus is growing along the trunk. It is unclear if the chain-link fence is acting as a support to keep the tree upright. The tree is a poor candidate for retention and is proposed for removal.

Photograph 10. View looking north at Trees 17 and 18. Tree 17 meets the exceptional species/size threshold.

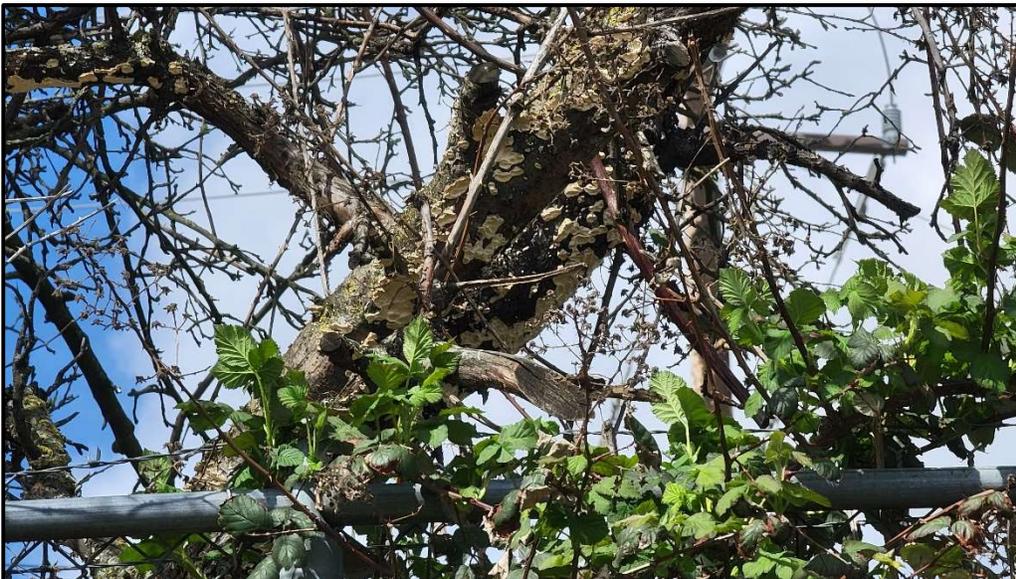
Photograph 12. Fruiting bodies on the trunk of Tree 17.
