NCH at Pike Market

Neighborcare Health Exterior Improvements

SCOPE OF WORK:

- 1st & 2nd Floor Door Replacment
- Replace 1st (003A)& 2nd floor(212B) exterior door with new hollow metal doors and hardware.
- Exterior Stairwell Security Improvement
- Provide enclosure over entire stairwell with gate for security control and safety.

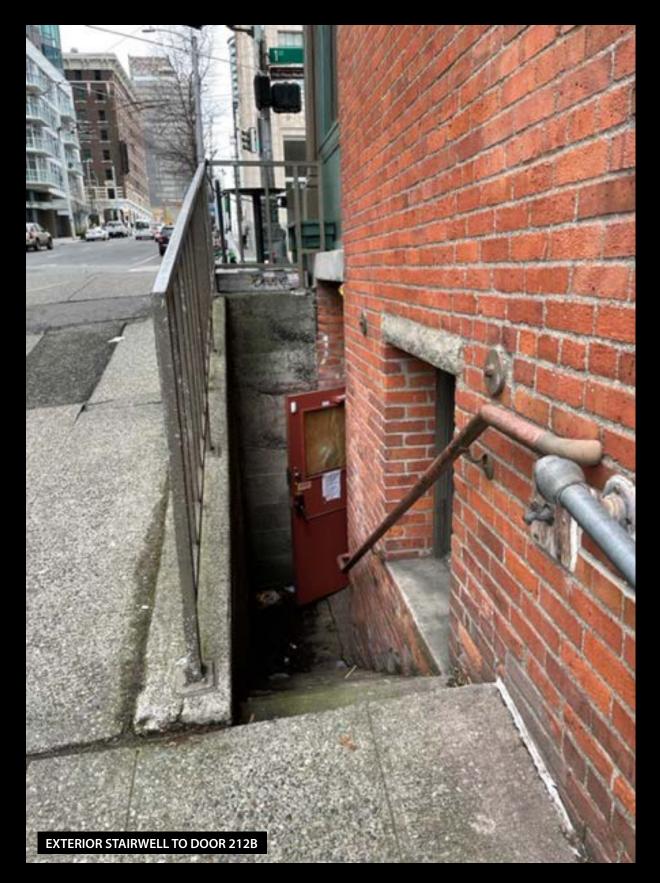
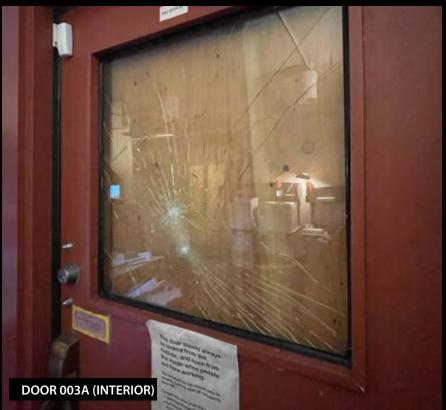
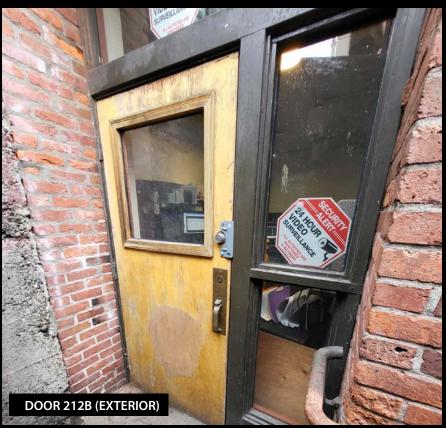
SITE OBSERVATION

LEVEL 2 DOOR 212B EXITS INTO BELOW GRADE STAIRWELL. ADJACENT TO VIRGINIA STREET RIGHT OF WAY, HANDRAIL AND **GUARD RAIL APPEAR IN DECENT** CONDITION.

BASEMENT EXIT CONCEALED BY STAIR RETAINING WALL WHICH MAKE IT SUBJECT TO VANDALISIM DUE TO CONCEALED CONDITION, AND A SAFETY ISSUE FOR STAFF **EXITING THIS DOOR**

PROVIDE PAINTED METAL **ENCLOSURE AND EGRESS ONLY** GATE FOR STAIRWELL TO IMPROVE SECURITY AND SAFETY. REPLACE DOOR 212B WITH HOLLOW METAL FOR DURABILITY.

RECOMMEND CLEANING DEBRIS FROM SURFACE DRAIN.

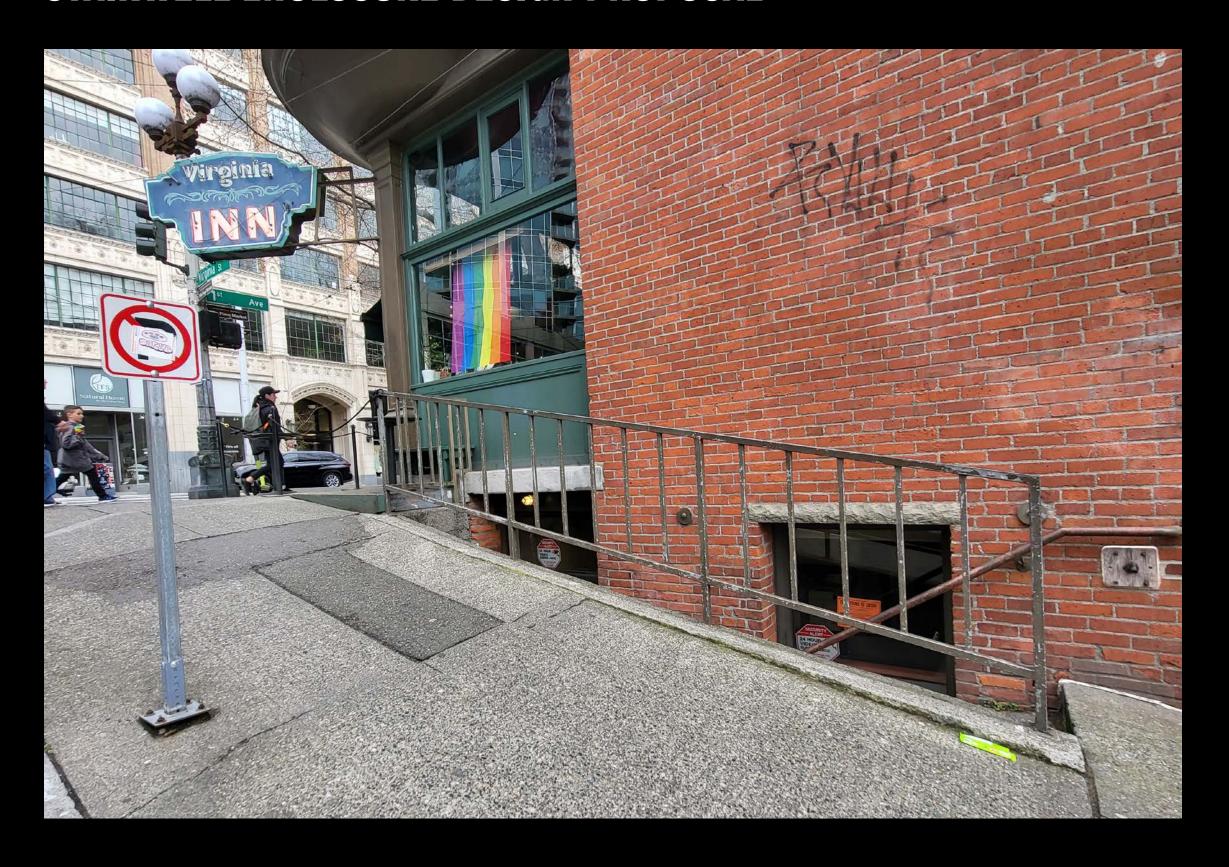
THERE IS A STAIRWELL ALONG VIRGINIA STREET IN THE NORTHWEST CORNER OF THE BUILDING, CONNECTING TO DOOR 212B, PARTIALLY BELOW GRADE

ADD ORNAMENTAL STAIRWELL ENCLOSURE FOR SECURITY AND SAFETY. PROPOSED ENCLOSURE TO ALIGN NEAR THE BOTTOM OF EXISTING CAFE WINDOW TO AVOID VIEW OBSTRUCTION, AND EXTEND TO 7'6" ABOVE GRADE AT STAIRWELL GATE.

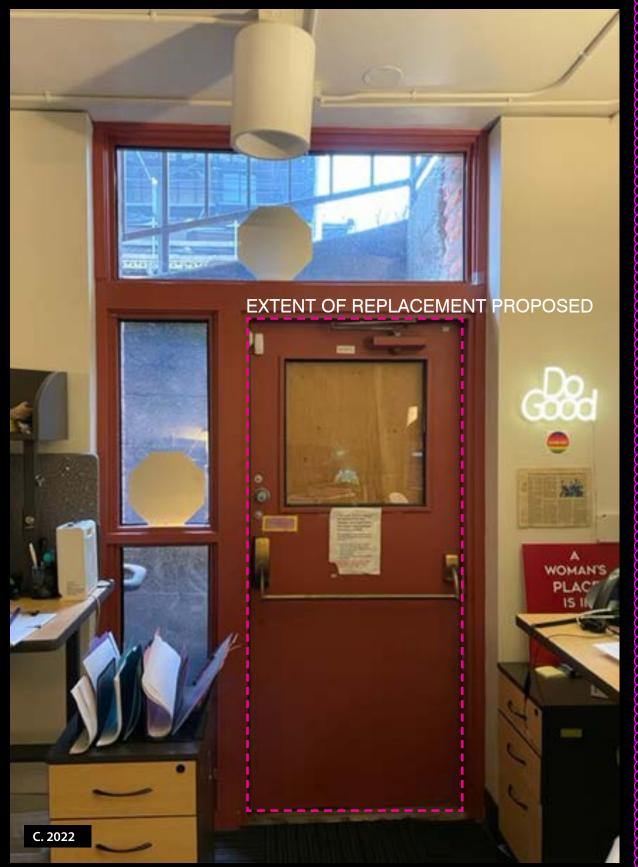
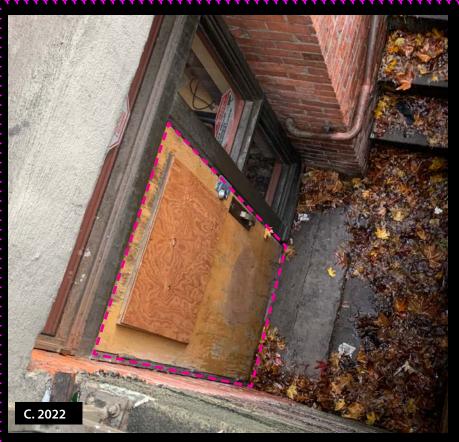
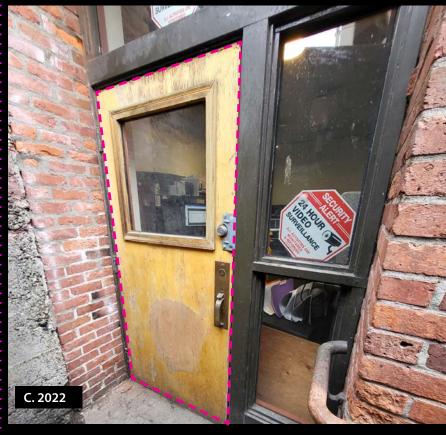
SITE OBSERVATIONS - EXIT 212B DOOR

EXISTING LITE AT EXTERIOR DOOR IS SHATTERED AND TEMPORARILY SECURED WITH PLYWOOD. ADJACENT LITES APPEAR NOT DAMAGED. EXISTING DOOR SWINGS OUT, WITH CLOSER INTO STAIRWELL.

REPLACE DOOR AND HARDWARE, PAINT TO MATCH EXISTING FINISH.

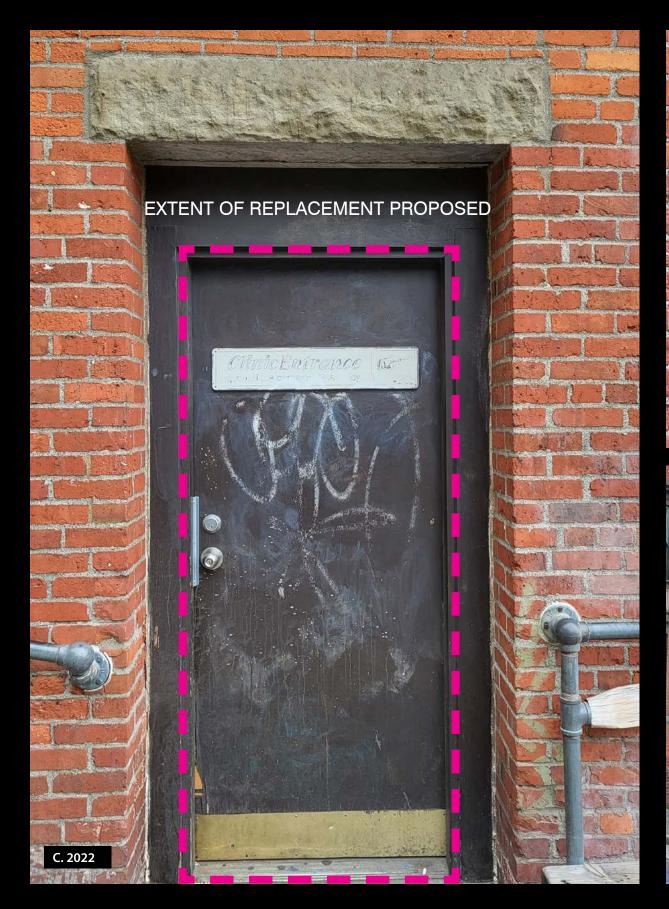
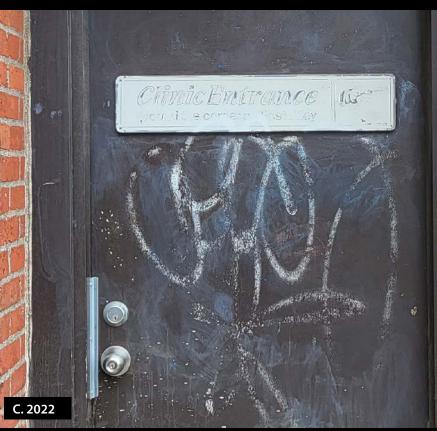
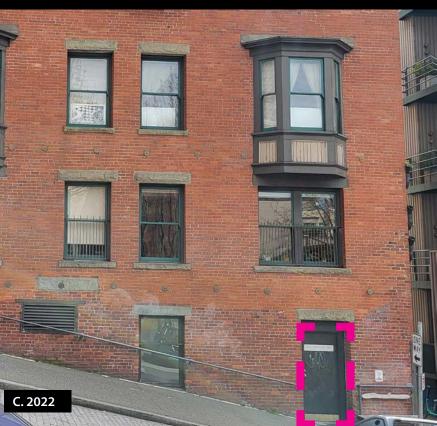
SITE OBSERVATIONS - EXIT 003A DOOR

EXISTING EXTERIOR DOOR IS CHIPPED AND FLAKING OF EXISTING PAINT AND MARKINGS OF GRAFFITI **REMAIN WHERE UNABLE TO** REMOVE.

REPLACE DOOR AND HARDWARE. PAINT TO MATCH EXISTING FINISH.
