Seattle Department of Transportation

Re: Areaway 190 (616 1st Ave.) – Repair Proposal – Correction Notice 2

AREAWAY 190 SKYLIGHT REPAIR (616 1ST AVE)

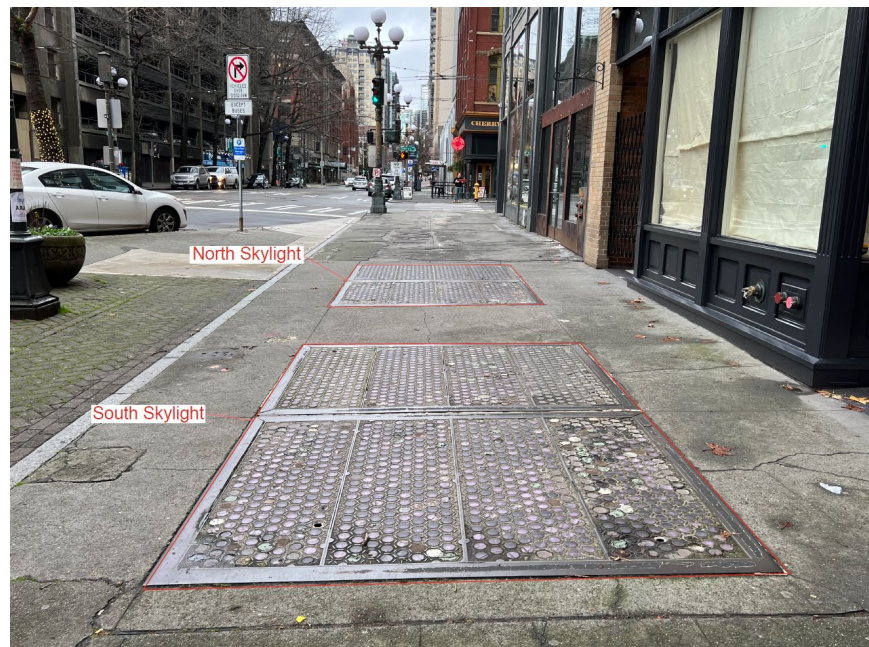
Figure 1: 4 frames, with 4 panels in each frame photo pre-accident condition

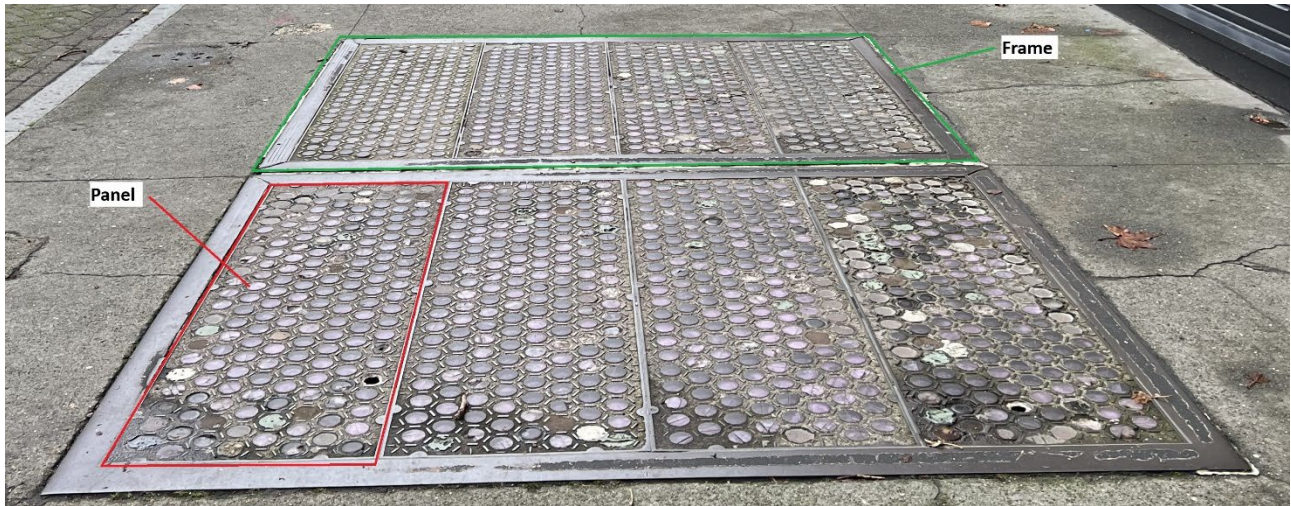
The areaway skylights are composed of two primary elements: the frame and the cast-iron panels. The frame is cast into and integrated with the surrounding concrete sidewalk. The cast-iron panels consists of three main components: cast-iron grate, embedded circular glass pucks and concrete infill. All these individual elements are integrated into what is referred to as the cast-iron panel. Each frame consists of four cast-iron panels. (Figure 1B)

Figure 1B: Definition of Frame and Panel

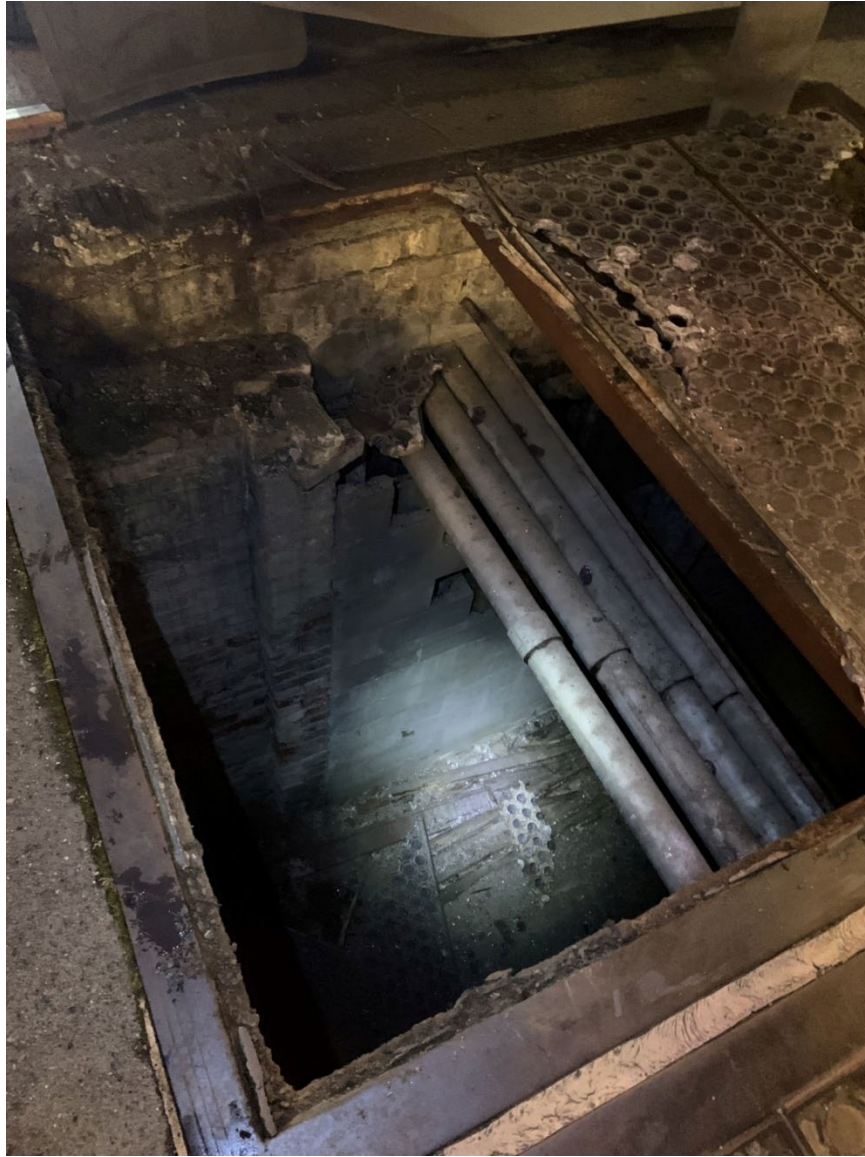
The extent of the damage caused by the accident to the north skylight assembly was quite apparent, see Figure 3. With the frame and the panels sustaining significant amount of damage some to extent that two of the panels had broken into multiple pieces and had fallen into the areaway; while the remaining panels of the north skylight did not fall into the areaway, the large cracks and deformation of the frame and panels were indicative that the structural integrity of these elements were compromised.

Figure 2: *Damage of north skylight right after vehicle was removed lifted from the opening*

Olympic Foundry, a local subject matter expert in cast-iron fabrication, was consulted to determine if the existing support frame and cast-iron panels can be repaired. Due to the extent of the damage consisting of crack frame members, section loss due to corrosion, multiple through cracks at various locations of the panels, repairs were deemed infeasible. Based upon this recommendation, shop drawing were developed for the fabrication of new frames and cast-iron panels.

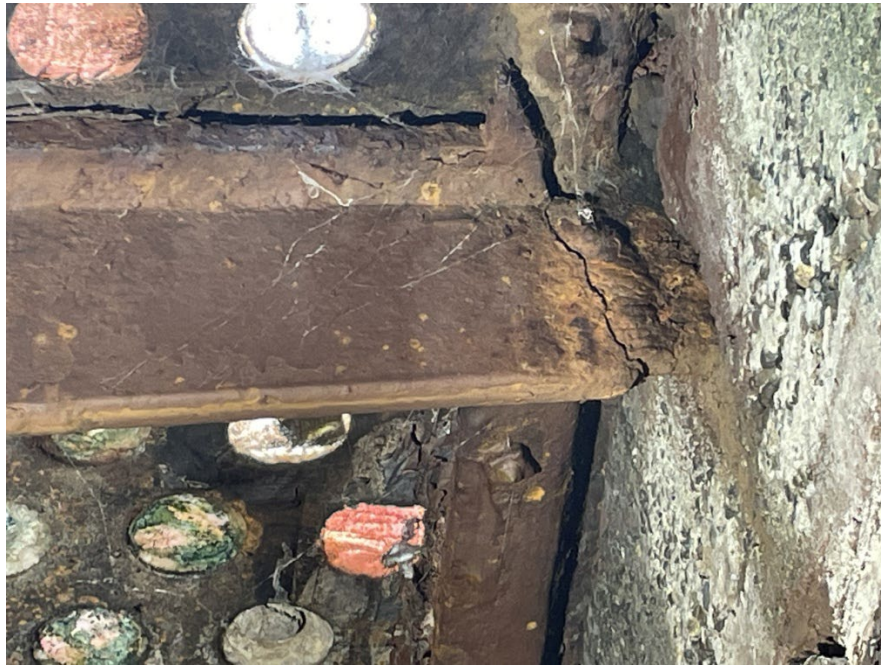
The severity of damage to the south skylight was not fully apparent until a more detailed evaluation of the areaways was conducted in the days following the incident. Closer inspection of the underside of the frame and panels revealed cracks of varying sizes, ranging from hairline fractures to large through-cracks extending the full depth of many of the structural members (Figures 3A and 3B). These findings indicate that the south skylight sustained significant damage, which was not immediately evident as the damage observed on the north skylight.

Photo 3A: Crack cast-iron frame (typ)

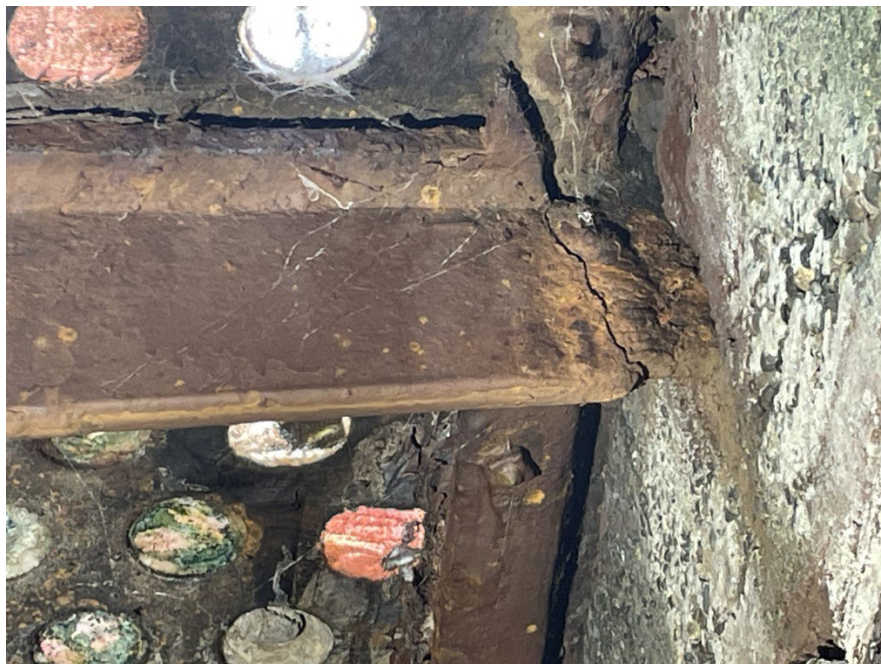
Photo 3B: Cracked cast-iron frame (typ)

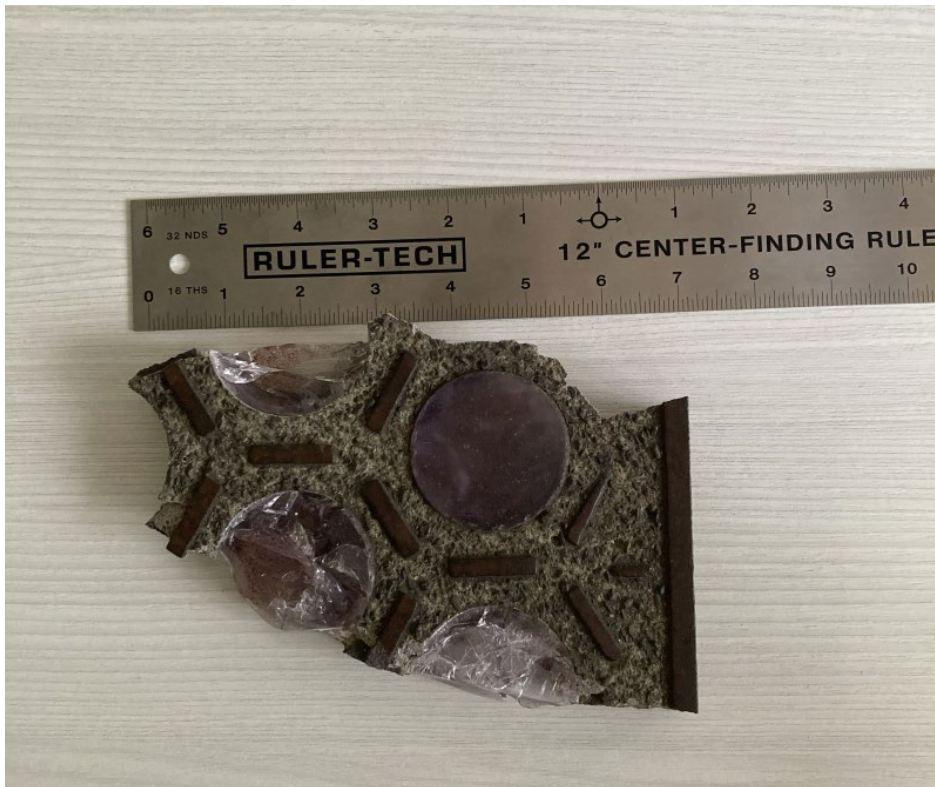
Figure 3: Fragment of existing panel

- The depth of the cast-iron panels was increased from 7/8" to 1.25"
- The depth of the frames changed from 4.5" to 5.75"
- The material of the frame was also changed from cast-iron to stainless steel to maintain dimensional sizes of the reveal due to the higher design loads and to ensure long term durability of the material that is in direct contact and imbedded to the surrounding concrete sidewalk
- use of an epoxy-infused concrete aggregate mixture as the concrete infill material for the cast-iron panels.

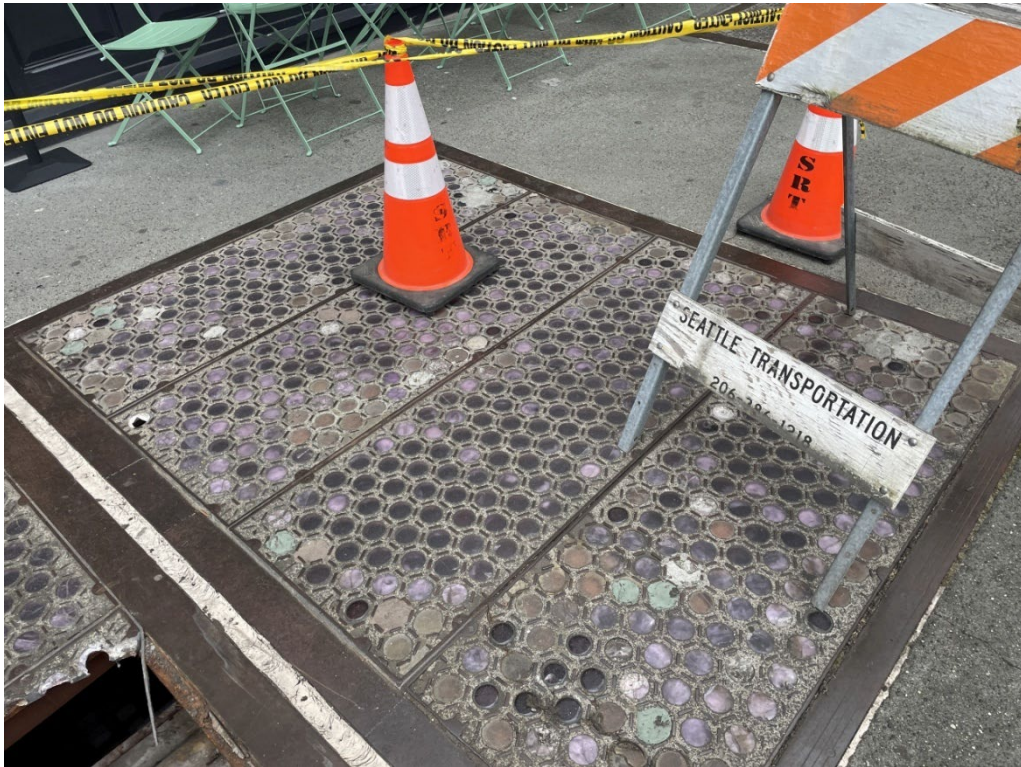
Photo 1: North frame and panel, post-accident condition

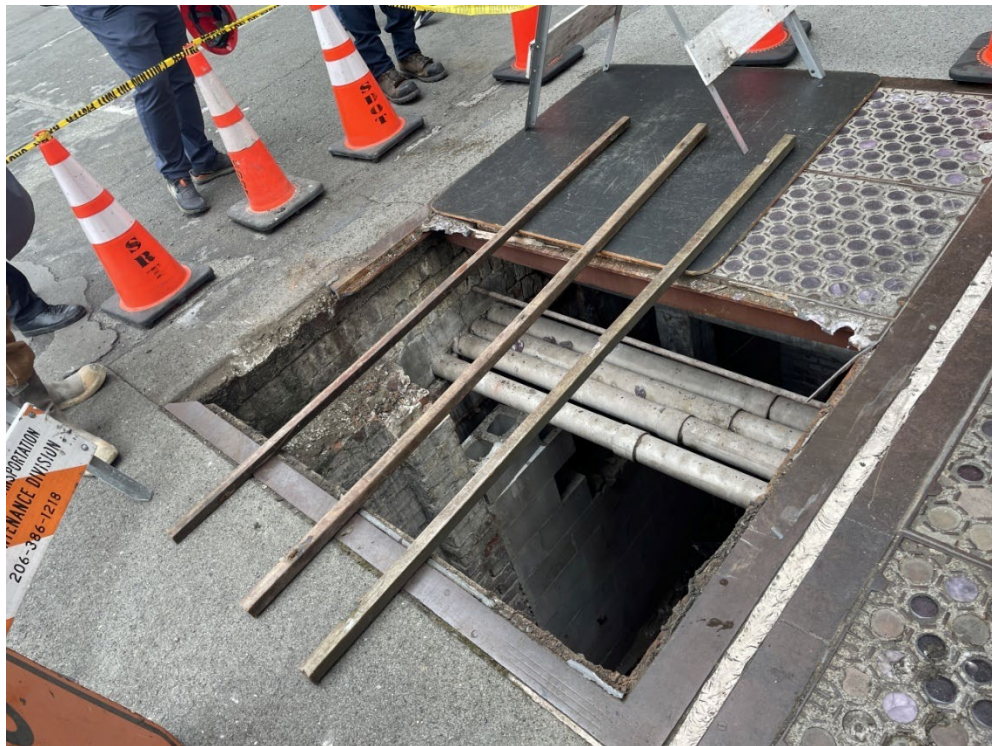
Photo 2: North frame and panel, post-accident condition

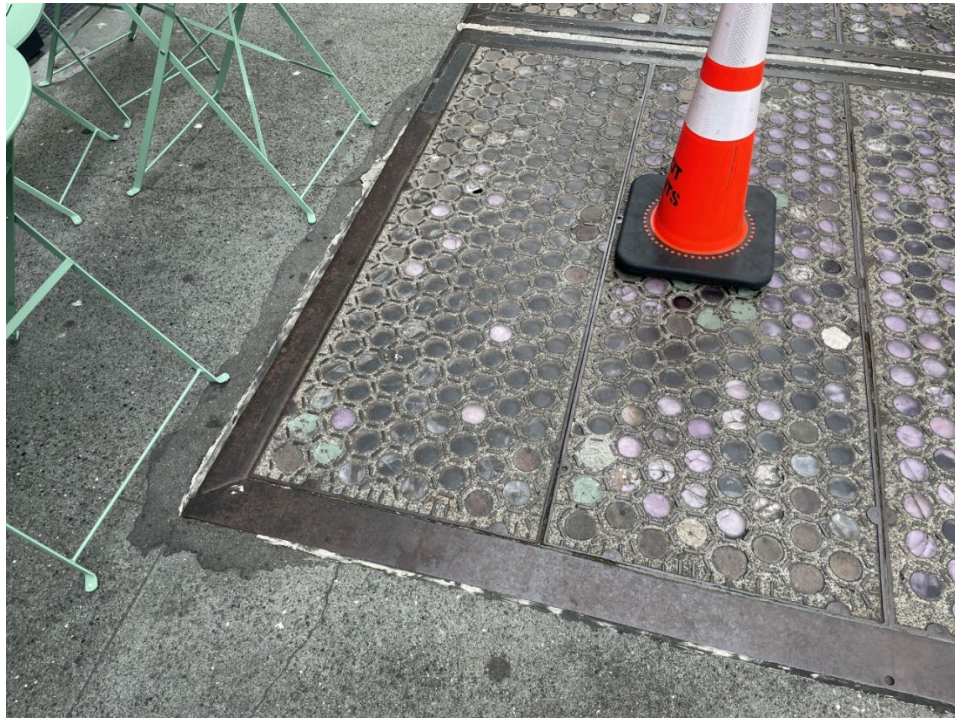
Photo 3: South frame and panel, post-accident condition

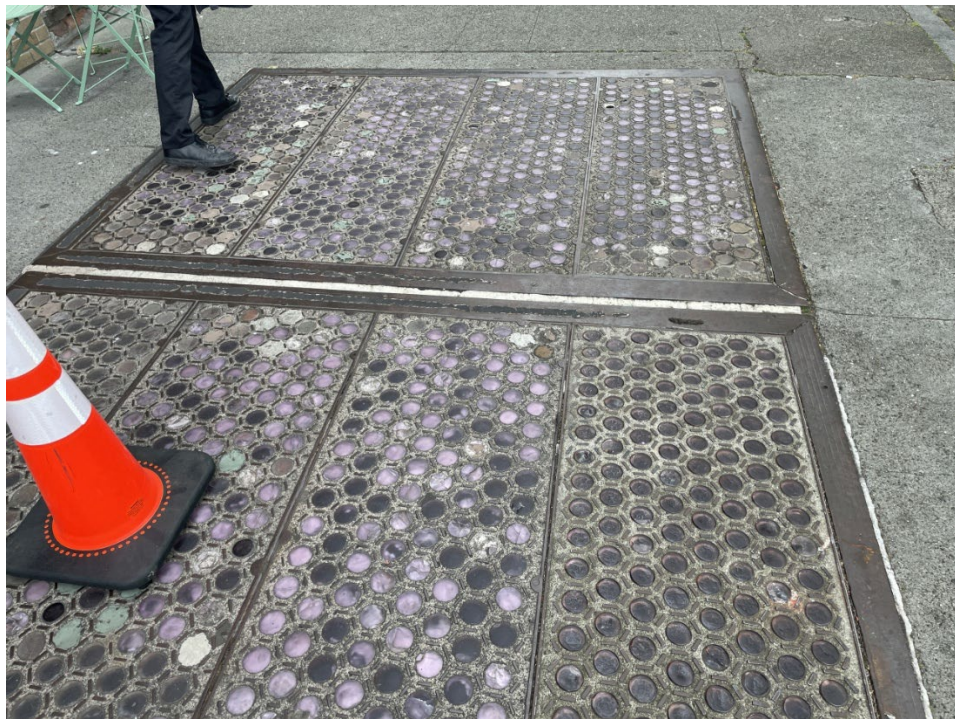
Photo 4: South frame and panel, post-accident condition

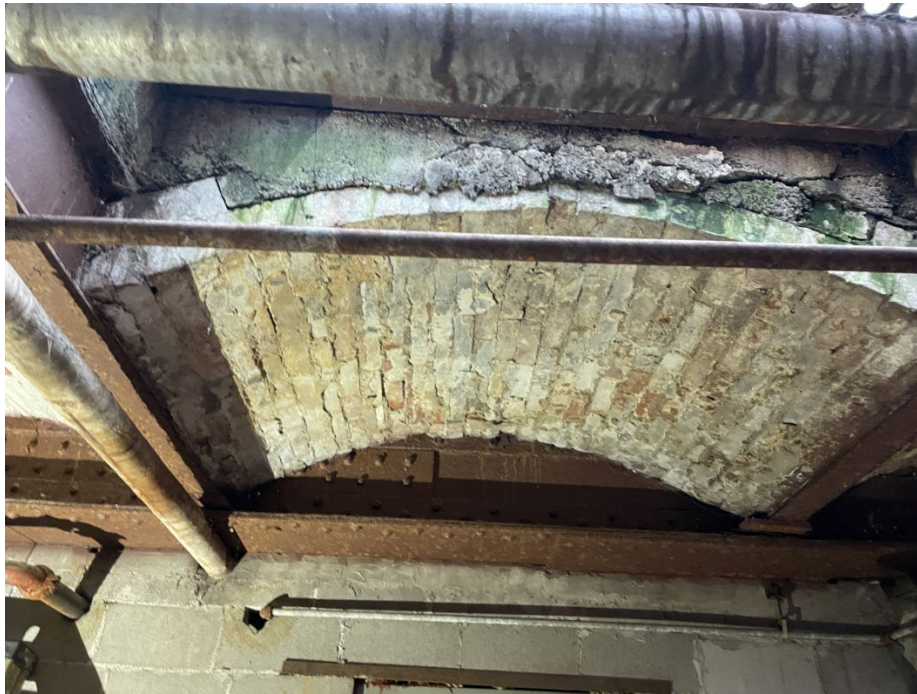
- **Restore loosed and displaced brick:** There were no observed impacts to the masonry walls and no wide spread impacts to most of the brick work. Areas impacted by the accident was limited to small, isolated areas near the brick barrel ceilings, where loose brick, deteriorated mortar, and minor displacement of bricks were observed. Proposed repair work includes tuckpointing damage mortar joints as needed as part of resetting and replacing loose brick.
- **Repair areas of open cut in the existing floor slab:** the accident did not damage the existing floor slab; however there were several existing open utility cuts associated with above ground utility connections were observed. As part of the areaway repairs, some of these areas will be cleaned and repaired

Photo 5: Masonry barrel ceiling looking towards building, post-accident

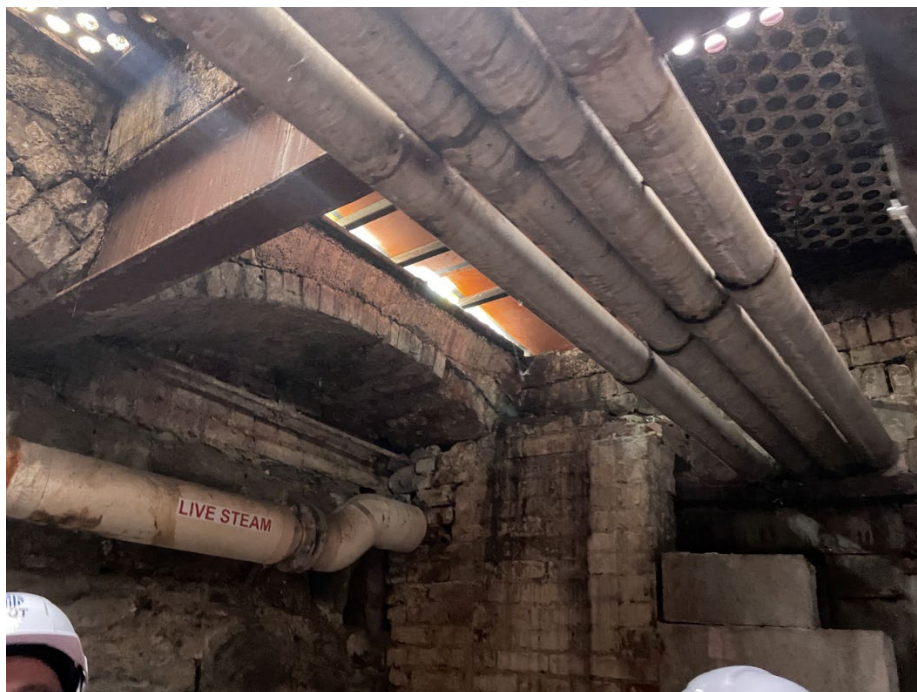
Photo 6: Masonry barrel ceiling looking towards street wall, post-accident

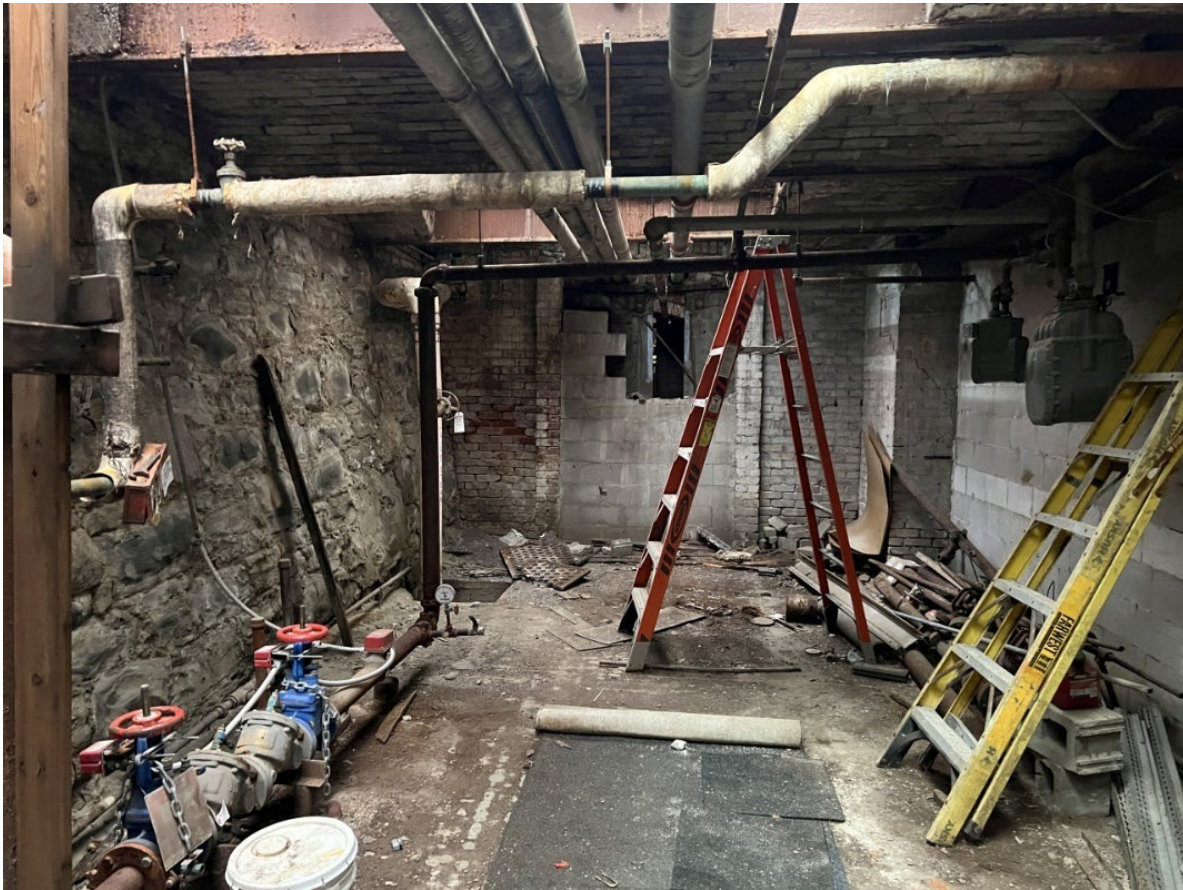
Photo 13: Looking north interior view of areaway – post accident

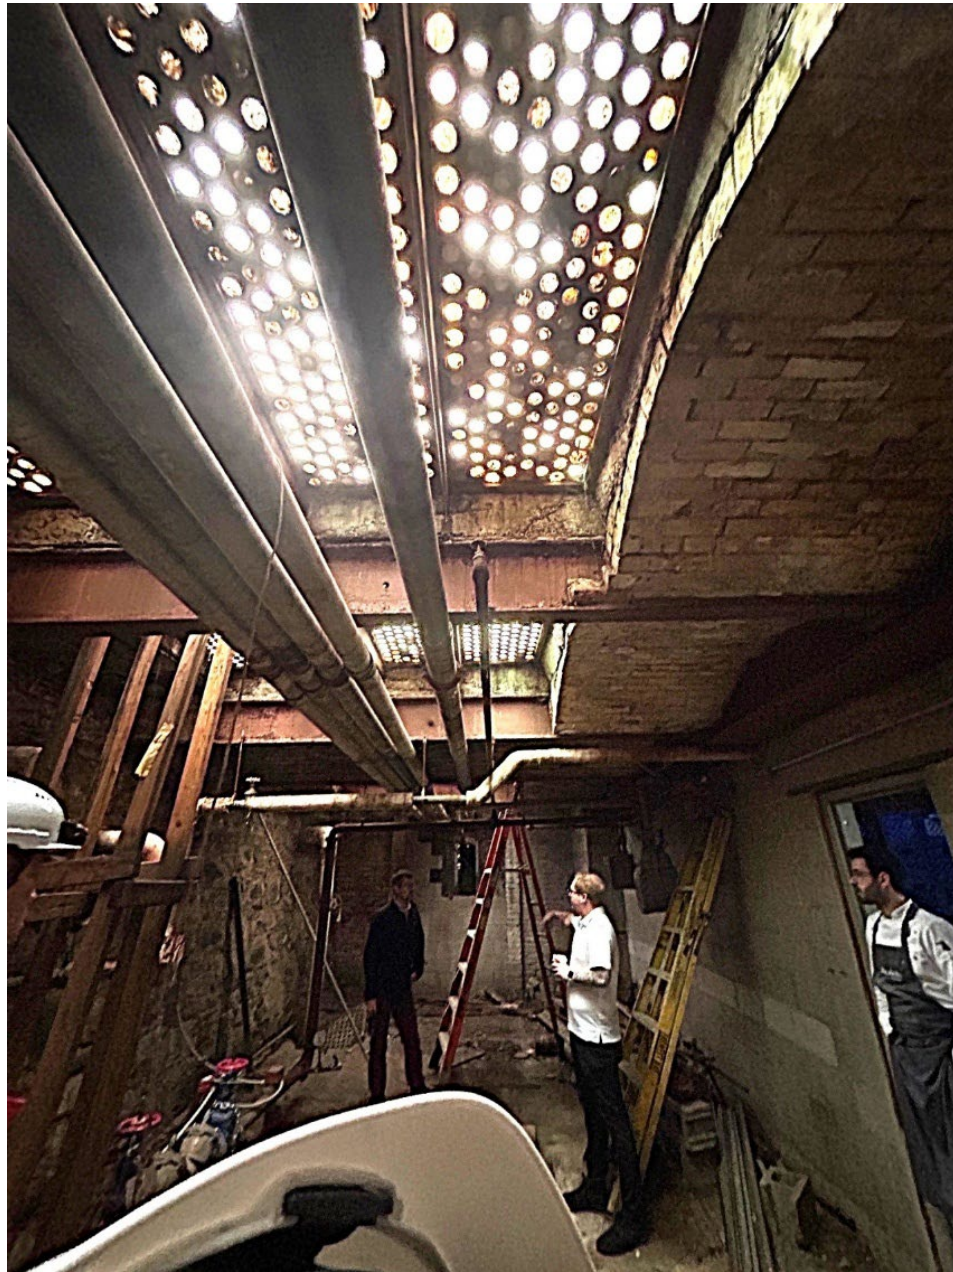
Photo 15: Looking north interior view of areaway – post accident

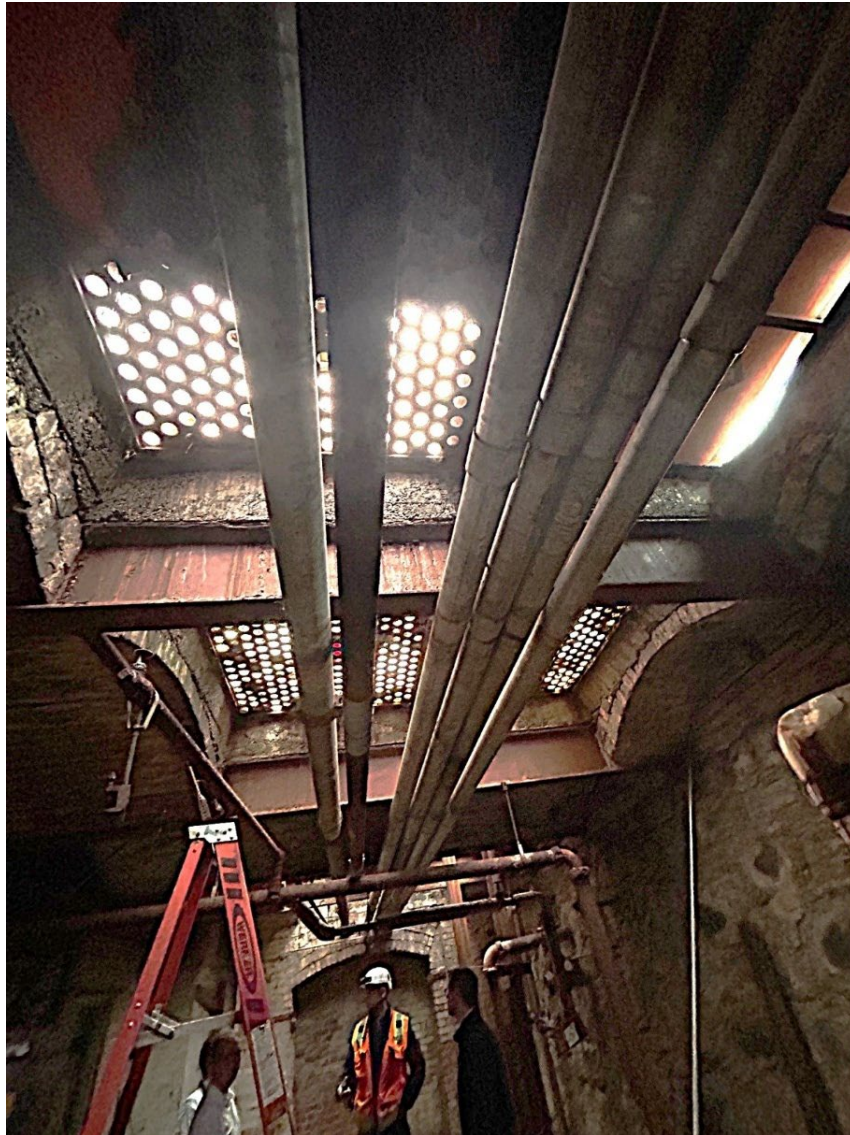
Photo 16: Looking south, interior view of areaway – post accident

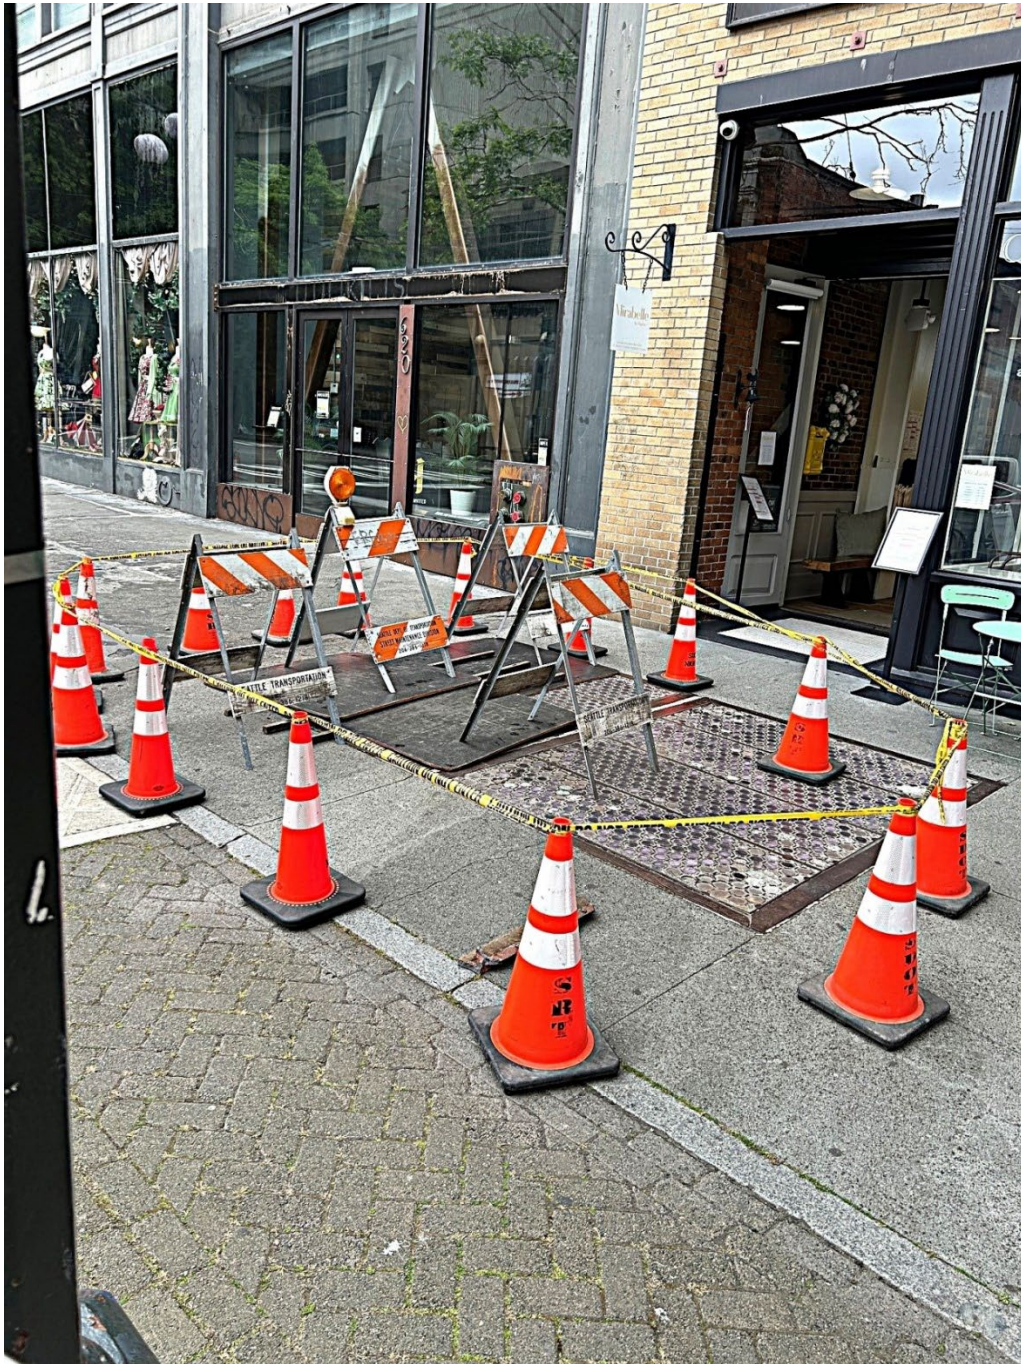
Photo 17: Post accident condition

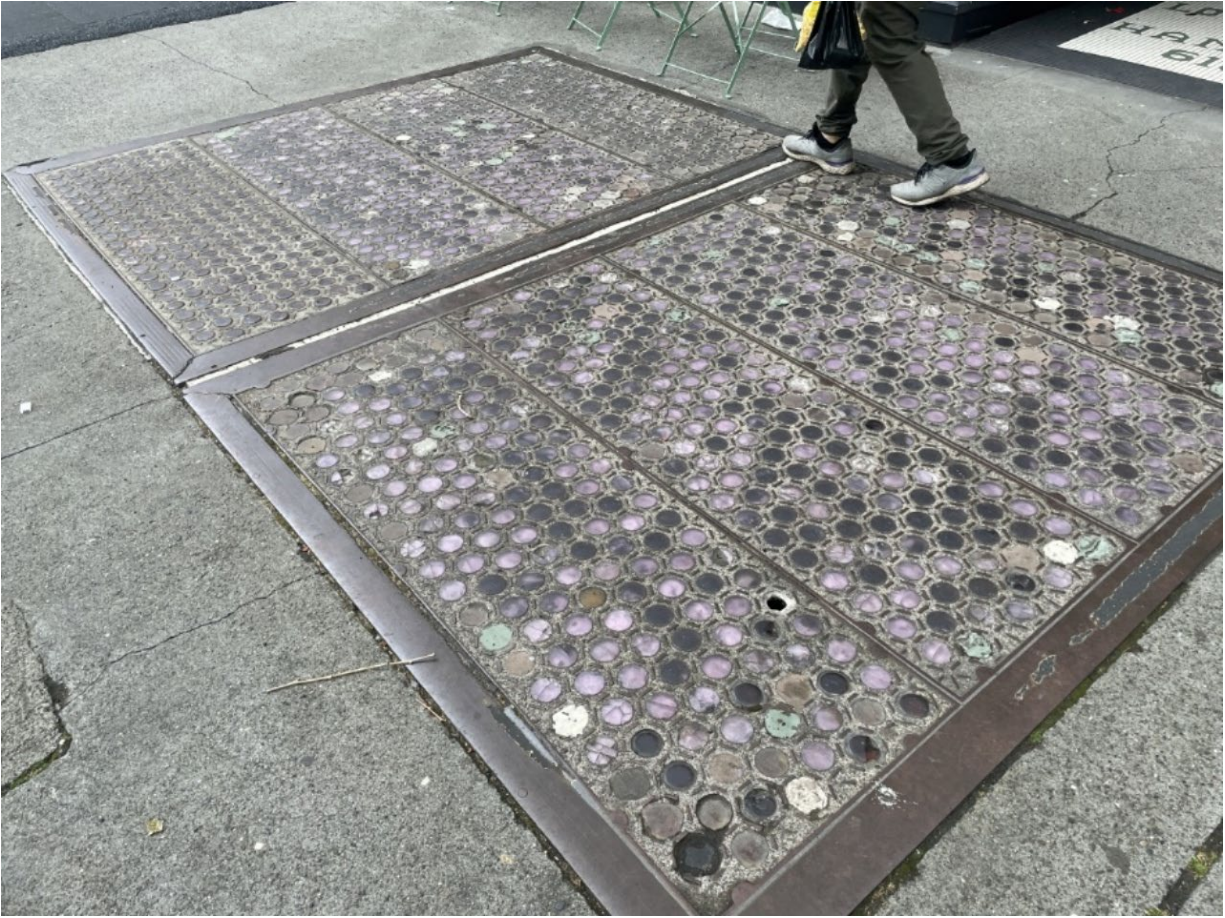
Photo 20: South frame and panel, outside, post accident condition

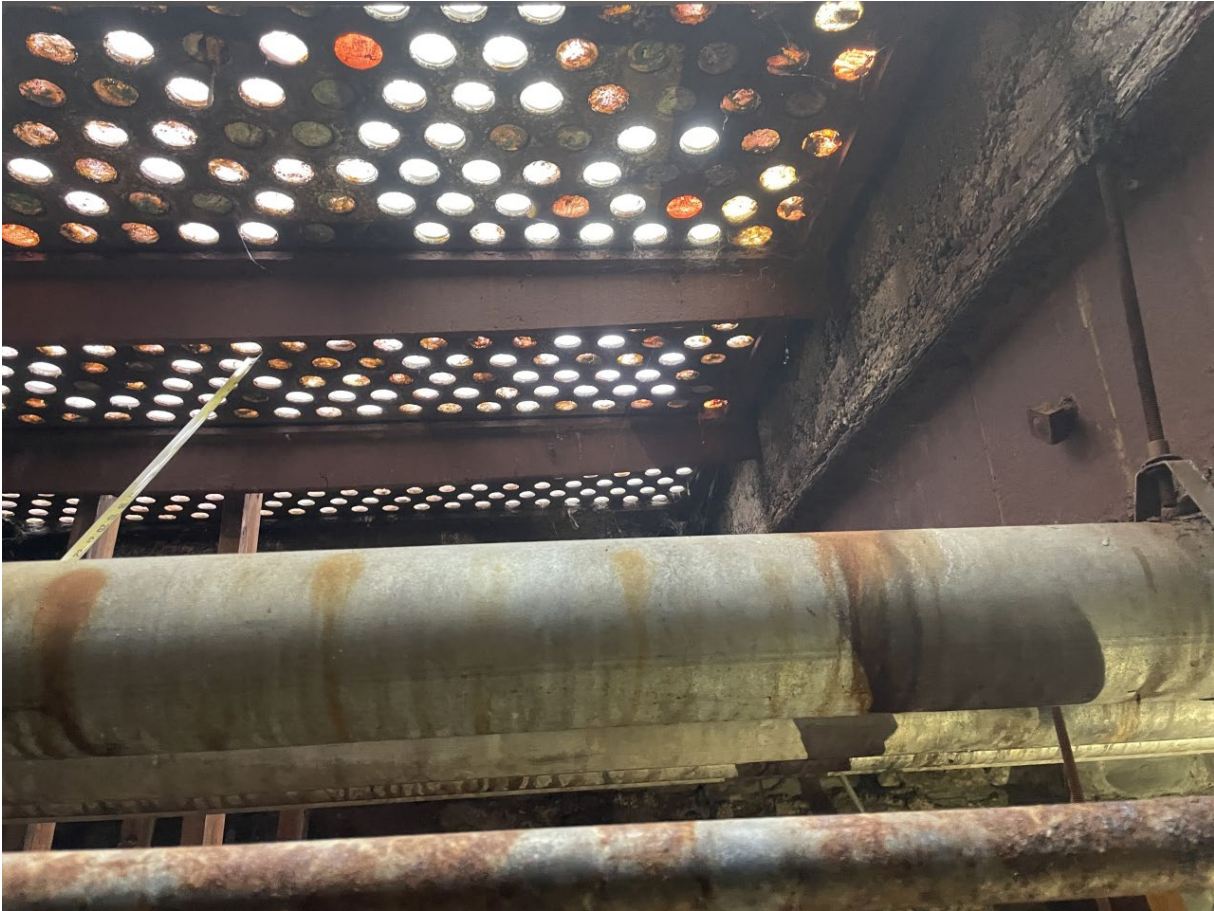
Photo 22: Underside of south frame and panel, post accident

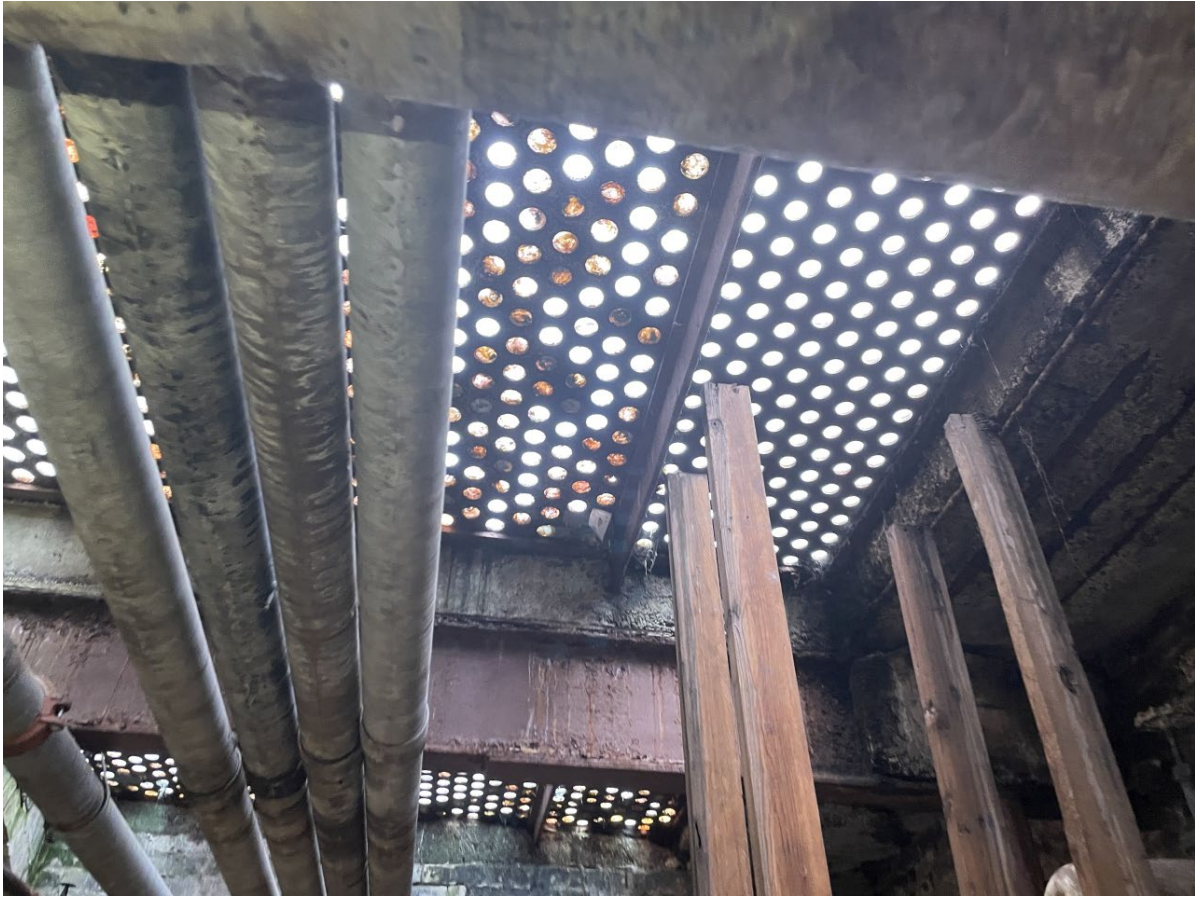
Photo 23: Underside of south frame and panel, post accident

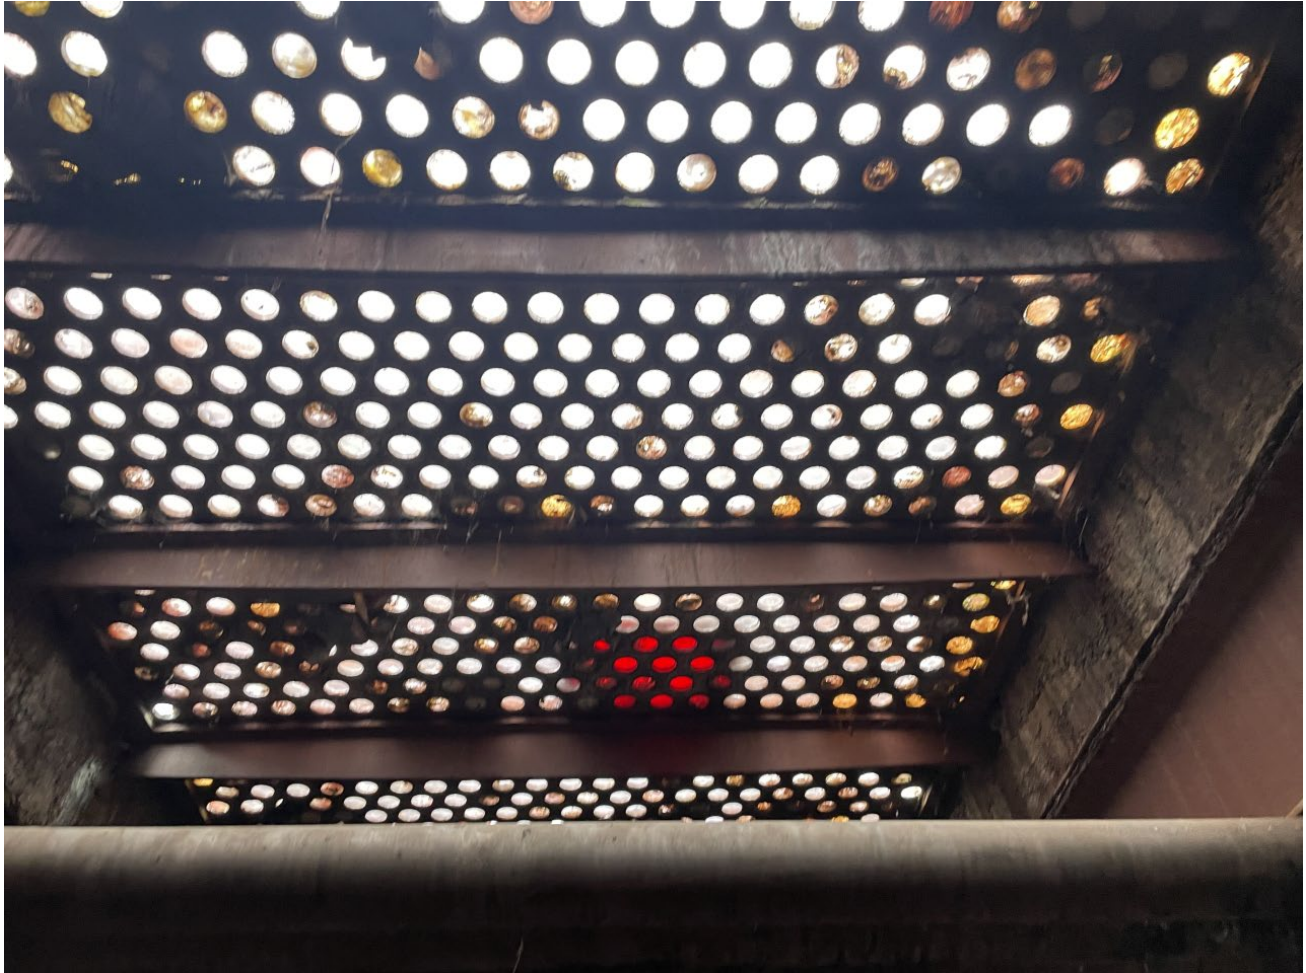
Photo 24: Underside of South frame and panel, post-accident condition
