Pioneer Square Preservation Board

Areaway Repair: 616 1st Ave S

May 20, 2026

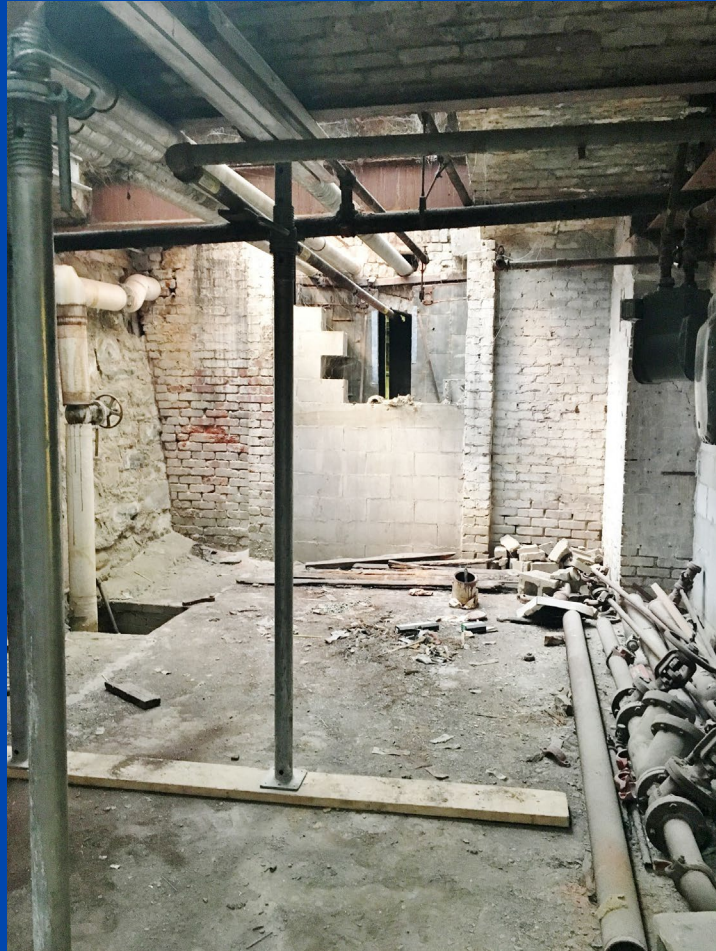
Post-accident Condition

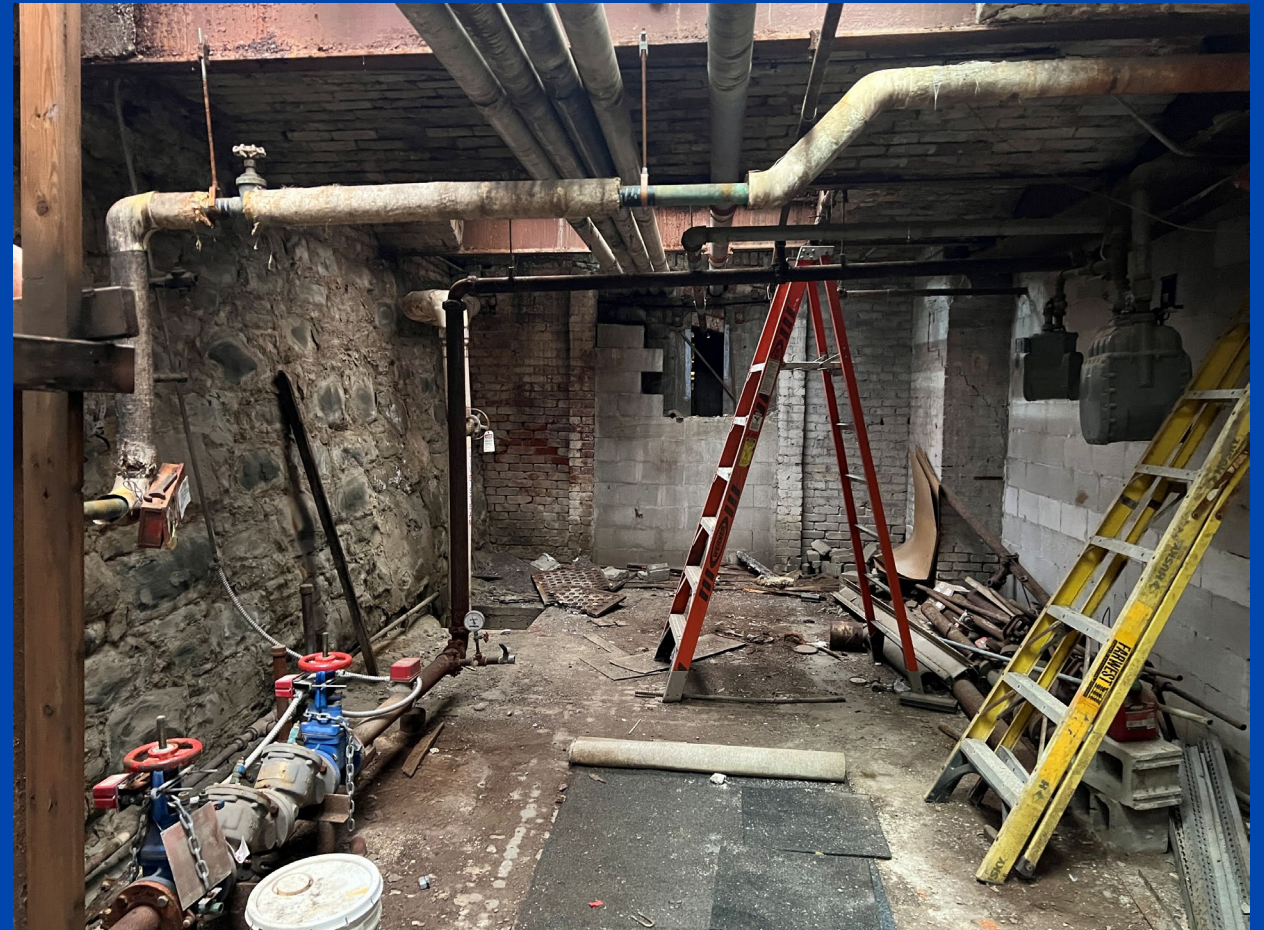
Interior of Areaway Looking North

Post-accident Condition

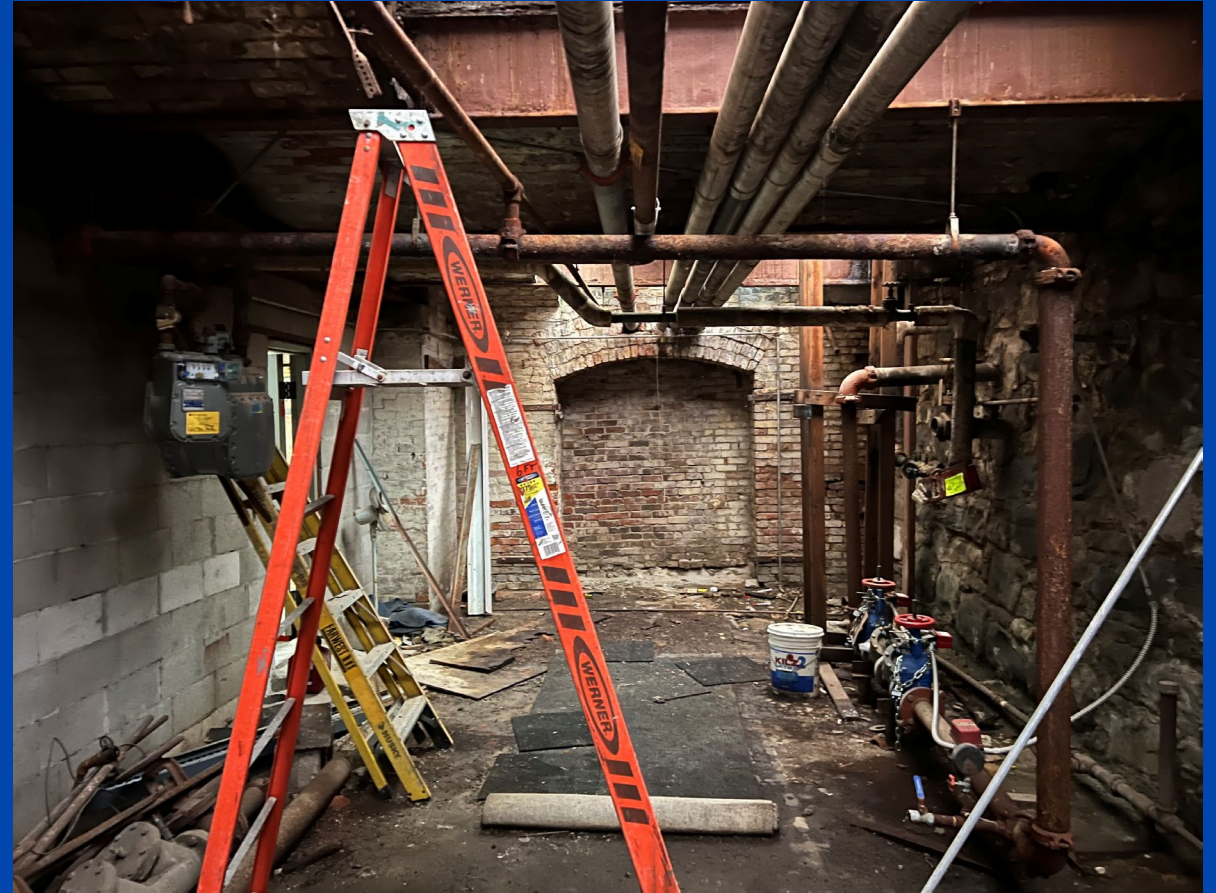
Interior of Areaway Looking South

Post-accident Condition

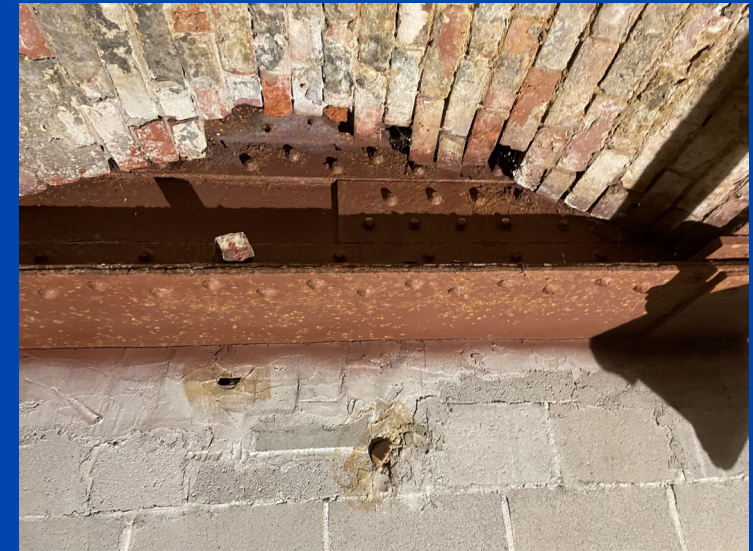
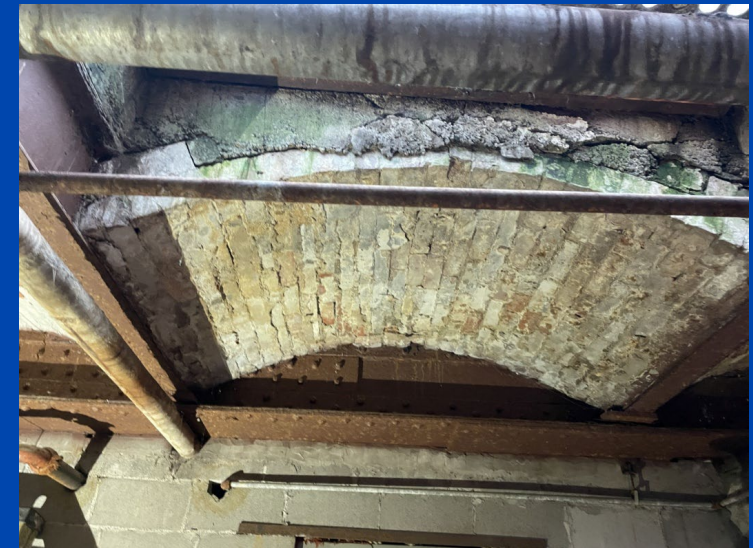
- Condition
 - Intact
 - Loose brick and mortar

Post-accident Condition

- Masonry Arch Ceiling
 - Re-secure dislodged bricks
 - Tuck point as needed

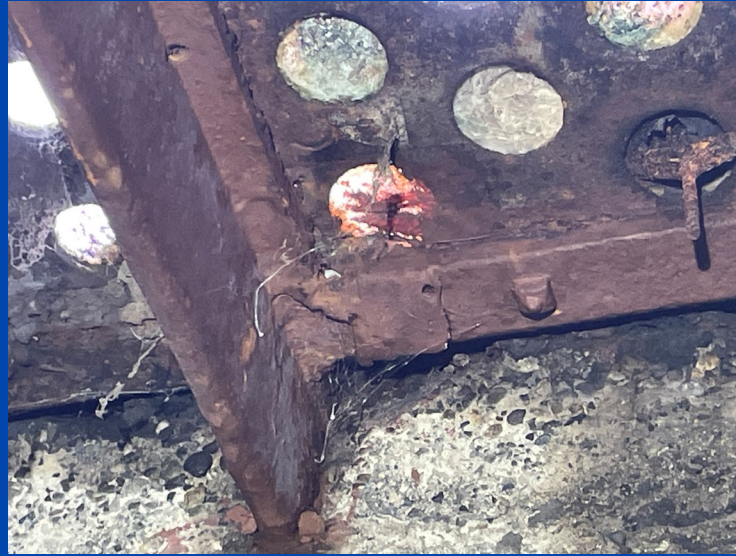
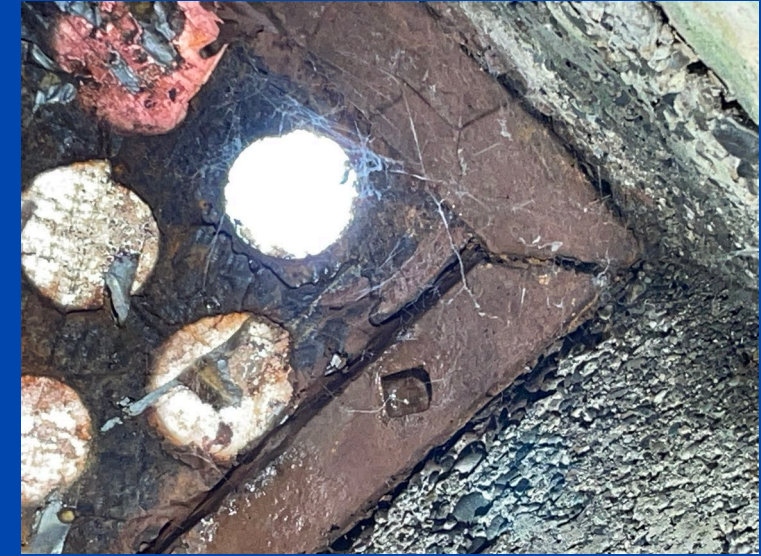
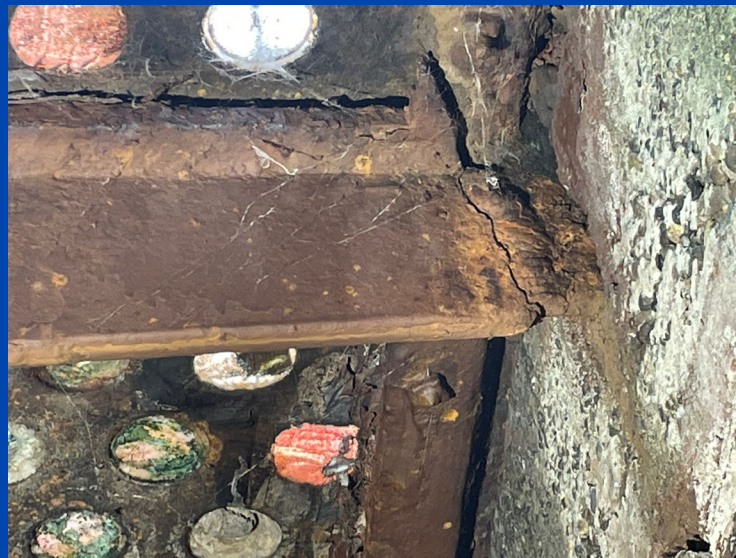
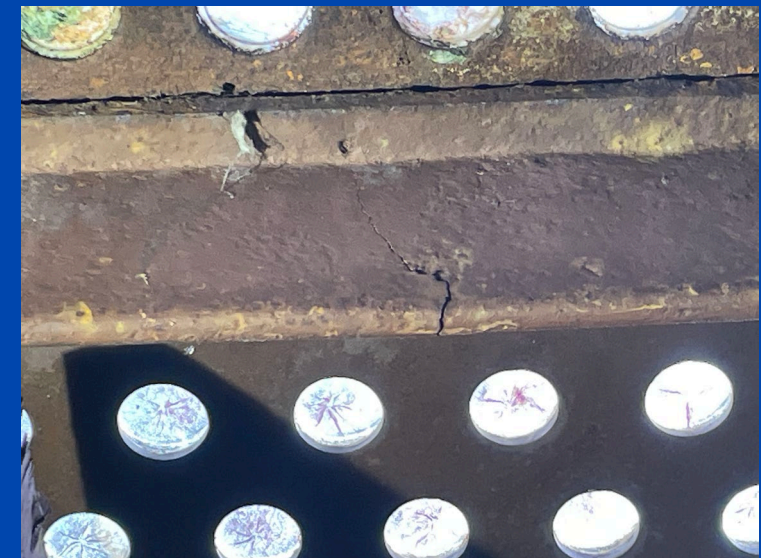
- North assembly
 - 4 of the 8 panels significant damage
 - Remaining panels have cracks at various locations
 - Frame broken or have cracks
- South assembly
 - Panels have cracks at various location
 - Cracks through frame elements

- Fabricate new skylight assembly
- Reconstruct concrete ledge supporting frame
- Remove and replace portion of sidewalk between joint lines of
