# SDOT Pioneer Square Areaway ARW-98 and ARW-99 Project Introduction

August, 2026

# Existing Conditions – ARW-098

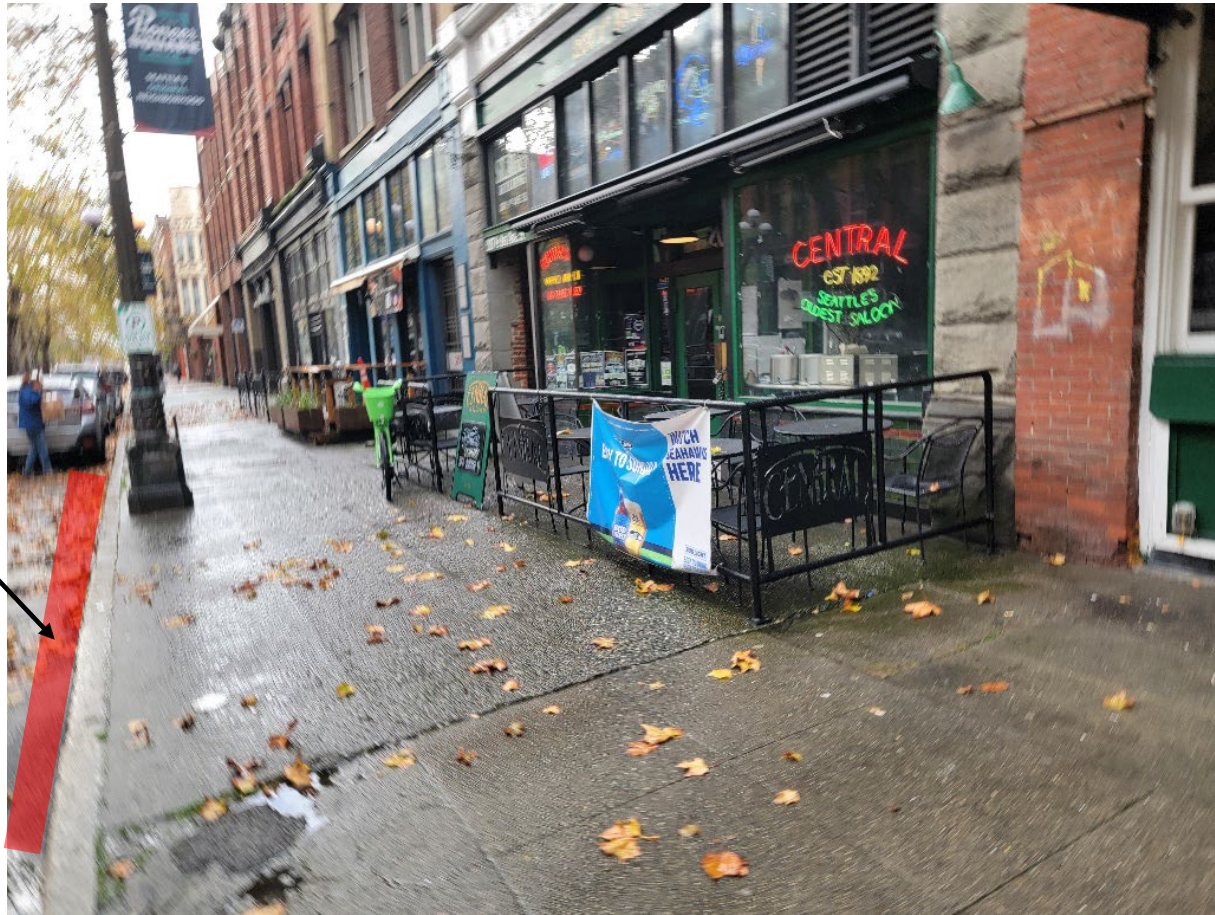
Sidewalk and frontage space looking south

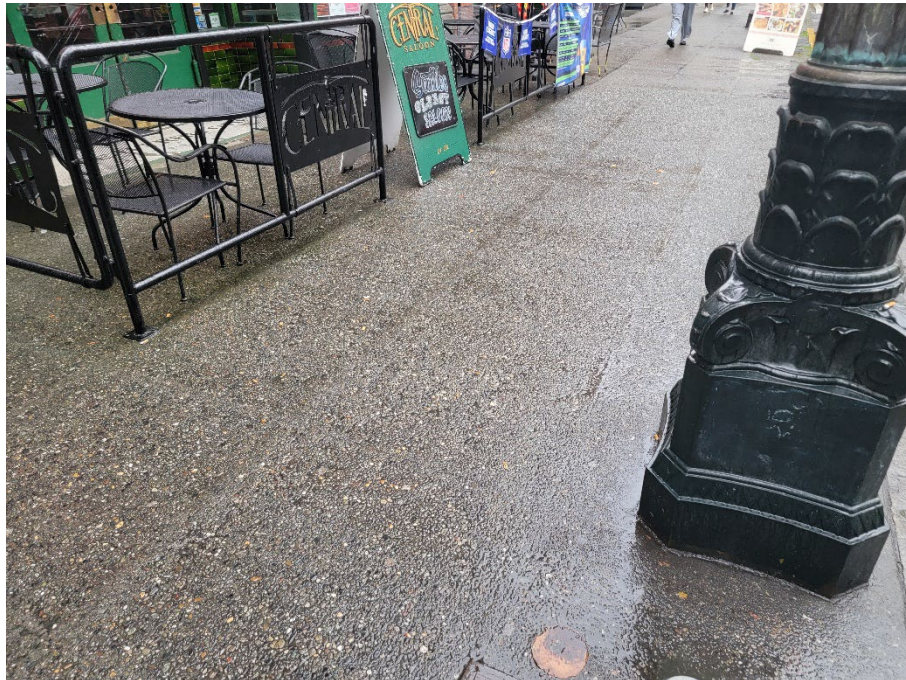
Fig1: Near south end of areaway,  
looking north at sidewalk

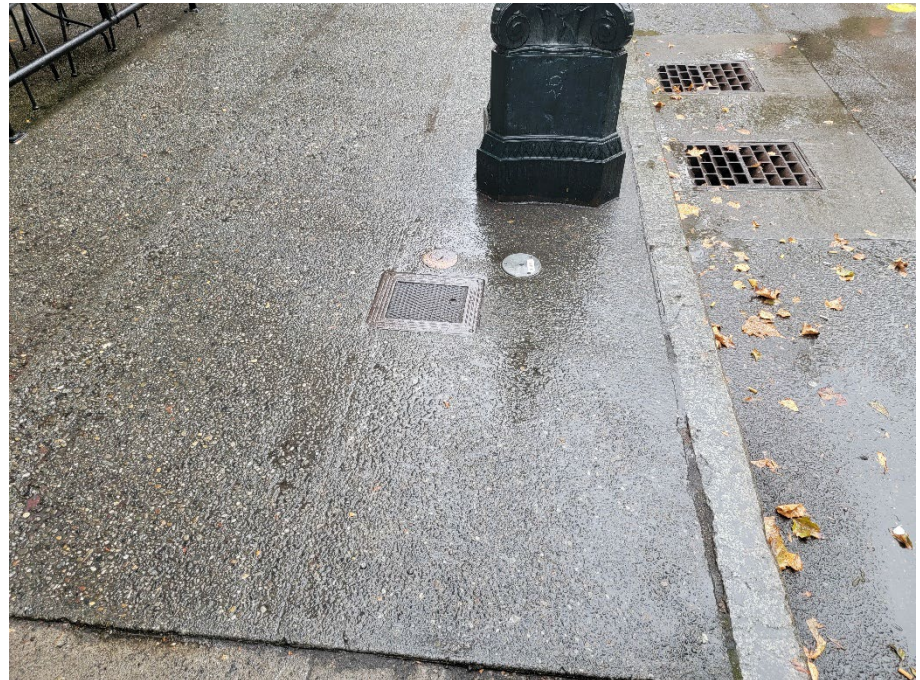
Fig 2: At south end limits of areaway,  
looking north at sidewalk

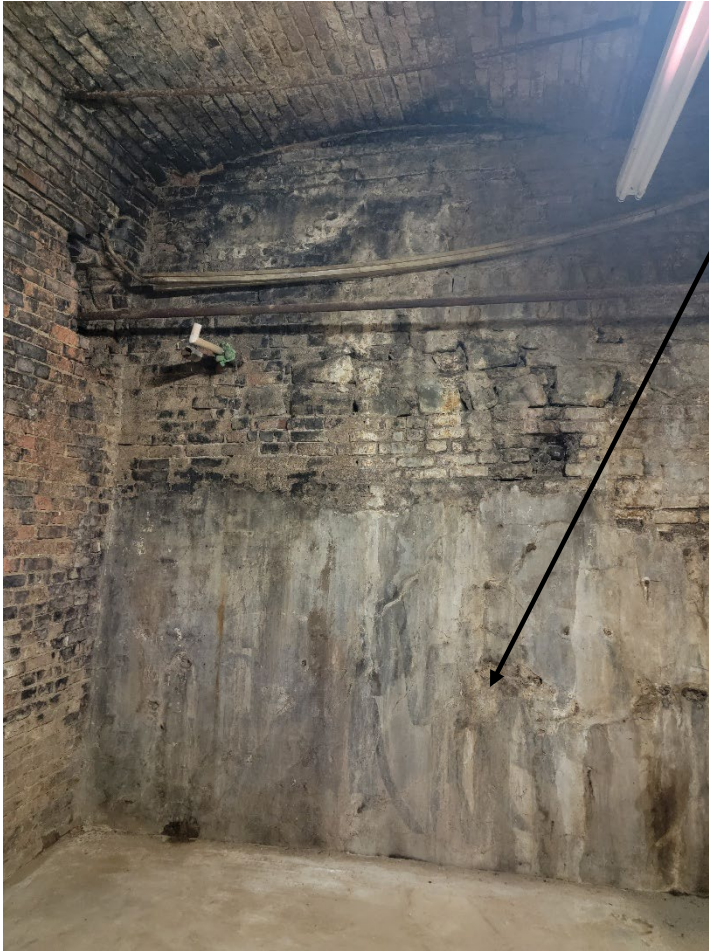
Past work on  
masonry wall

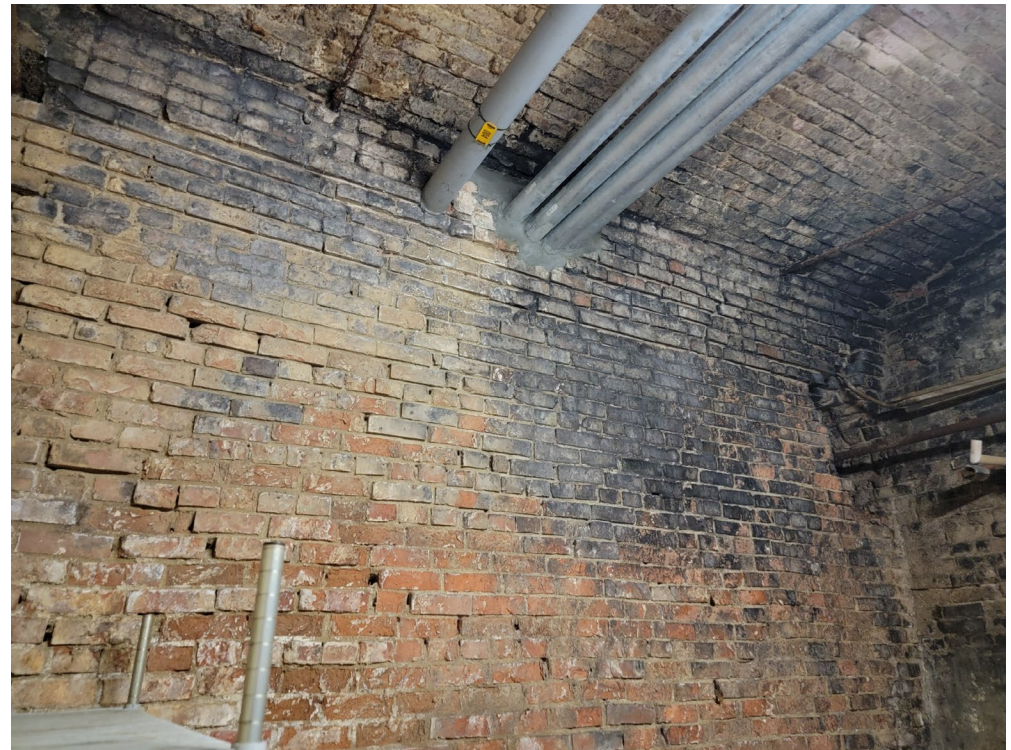
Fig 3: Looking at east at street wall at  
north end of areaway

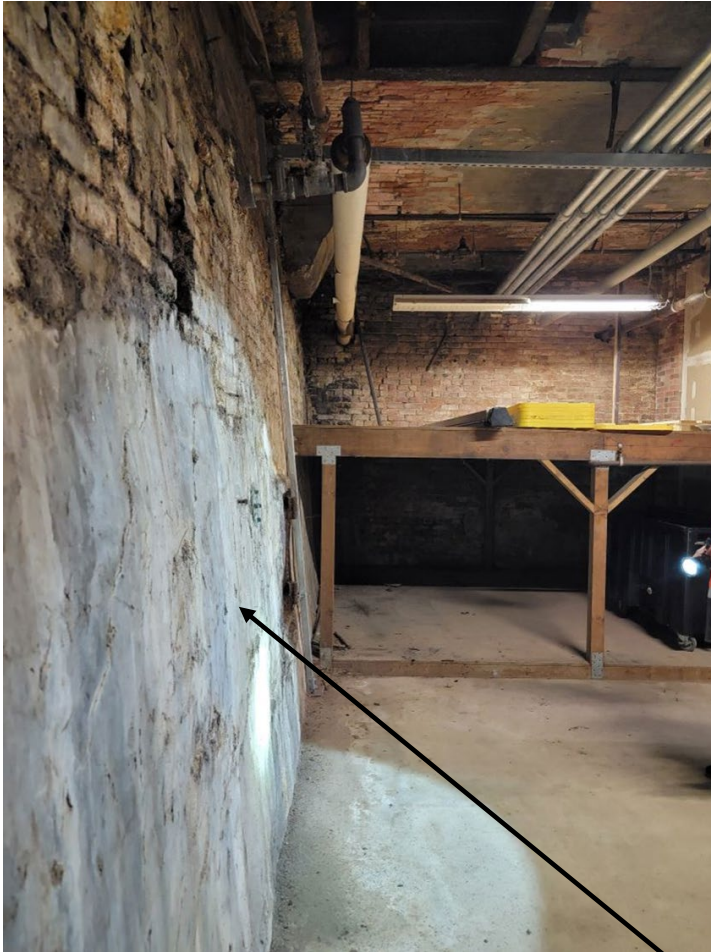
Fig 5: Looking at south end of areaway

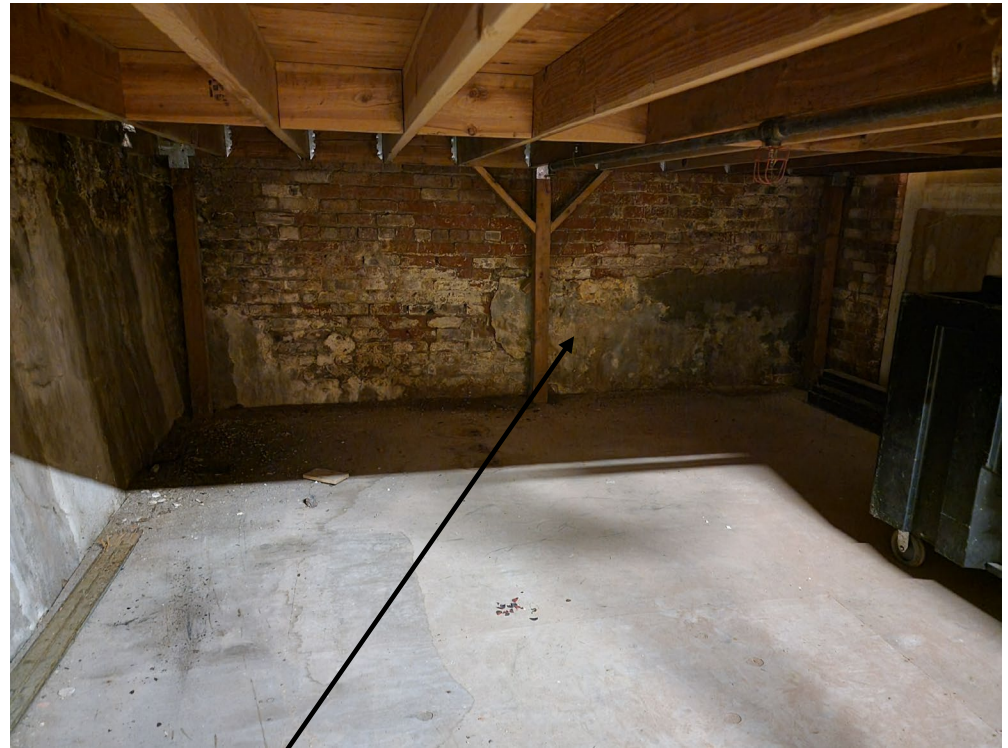
Fig 6: South end of areaway

Past repair work  
on masonry wall

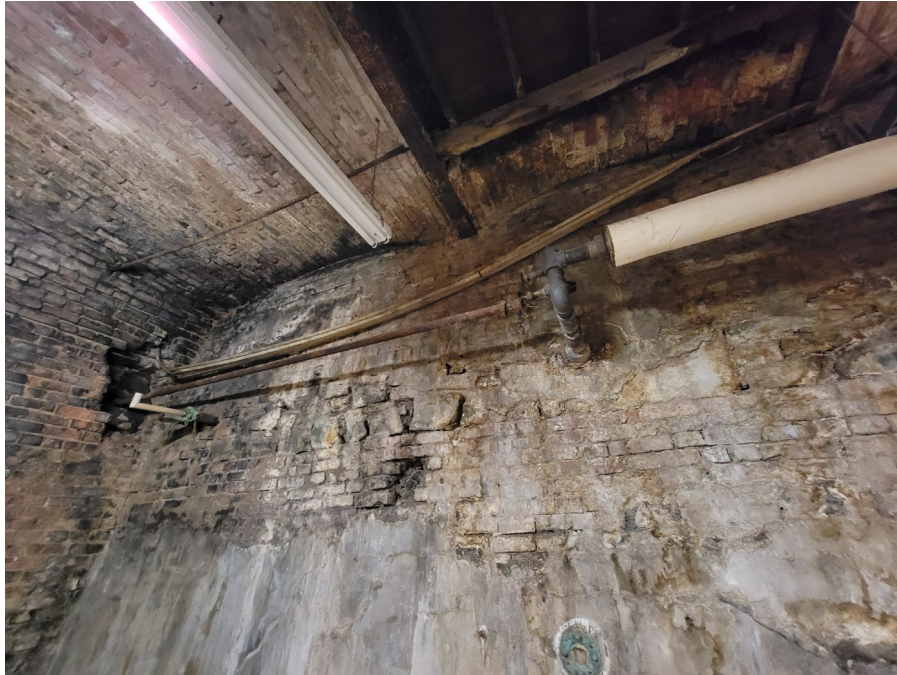
Fig 7: Near north end of areaway  
looking at street wall

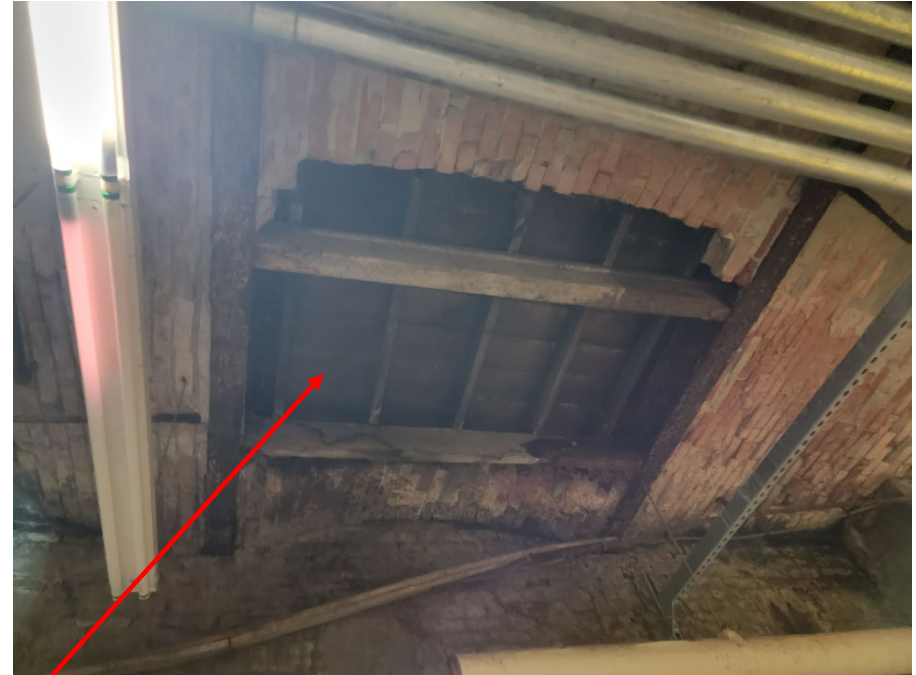
Fig 8: Looking at ceiling near north end

Sections of  
masonry barrel  
arch ceiling  
removed and  
replaced

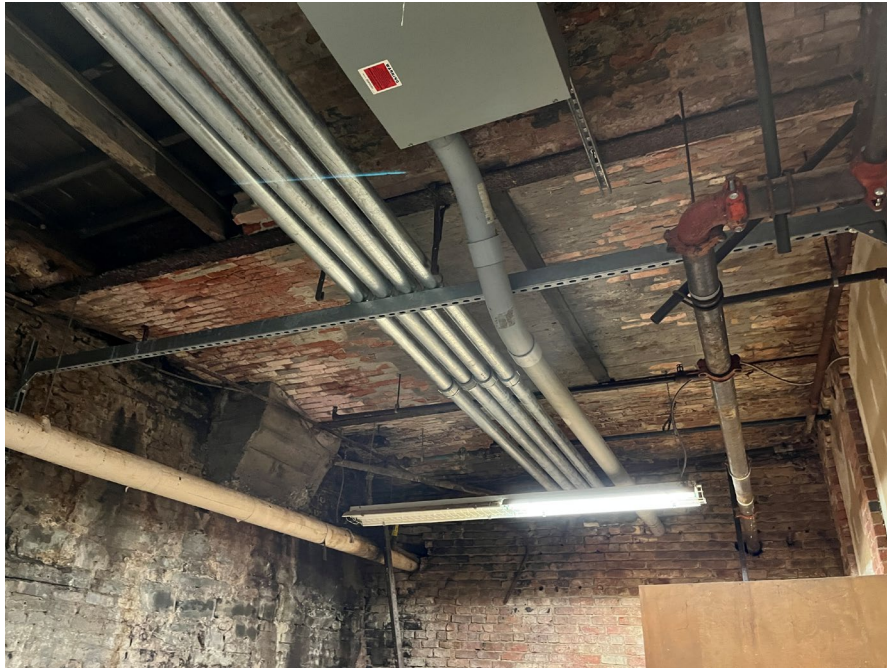
Fig 9: Barrel arch ceiling near south end

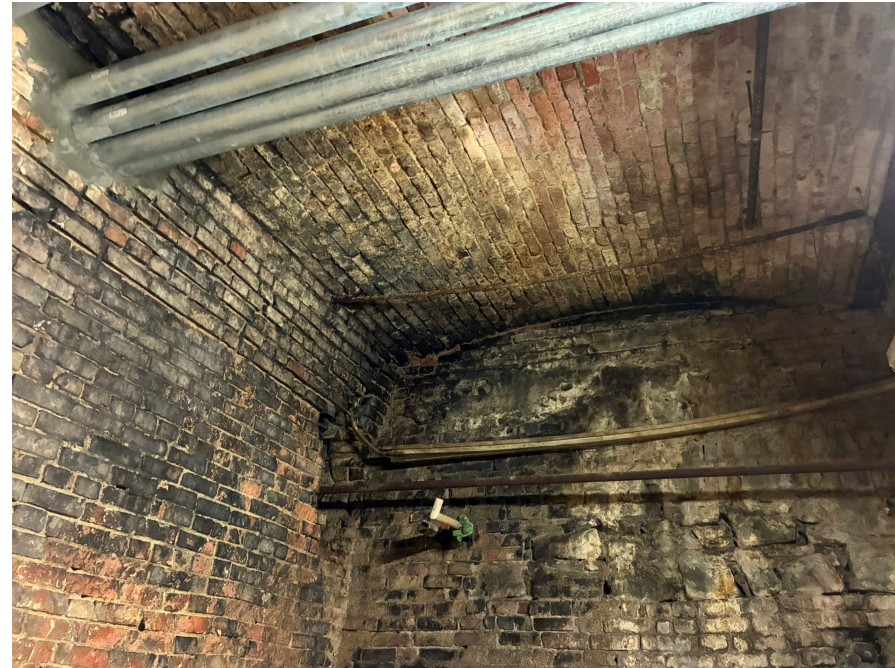
Fig 10: Barrel arch ceiling near north end

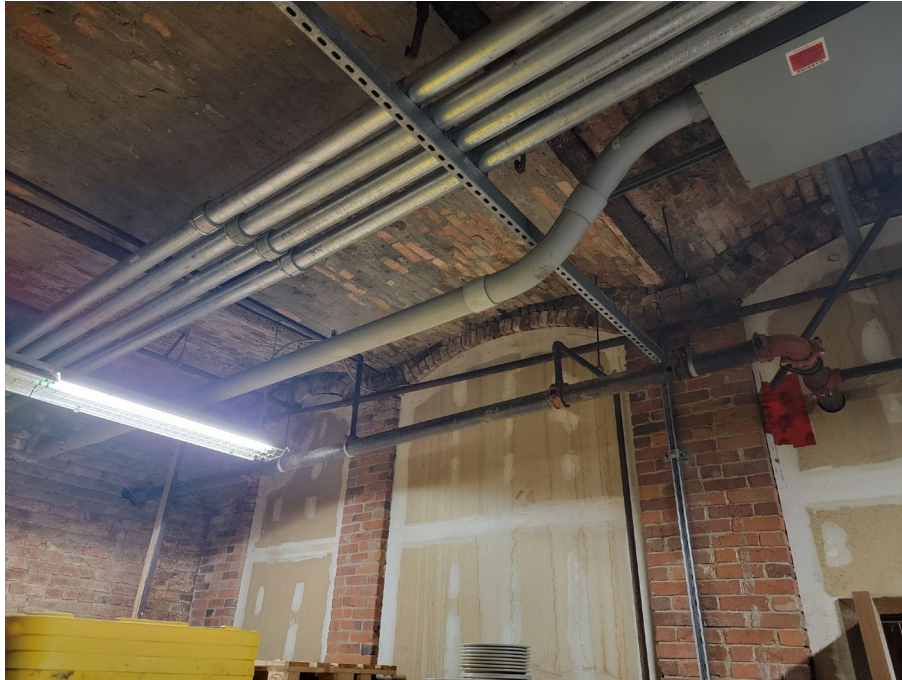
Fig 11: Openings building face from inside of areaway at south end

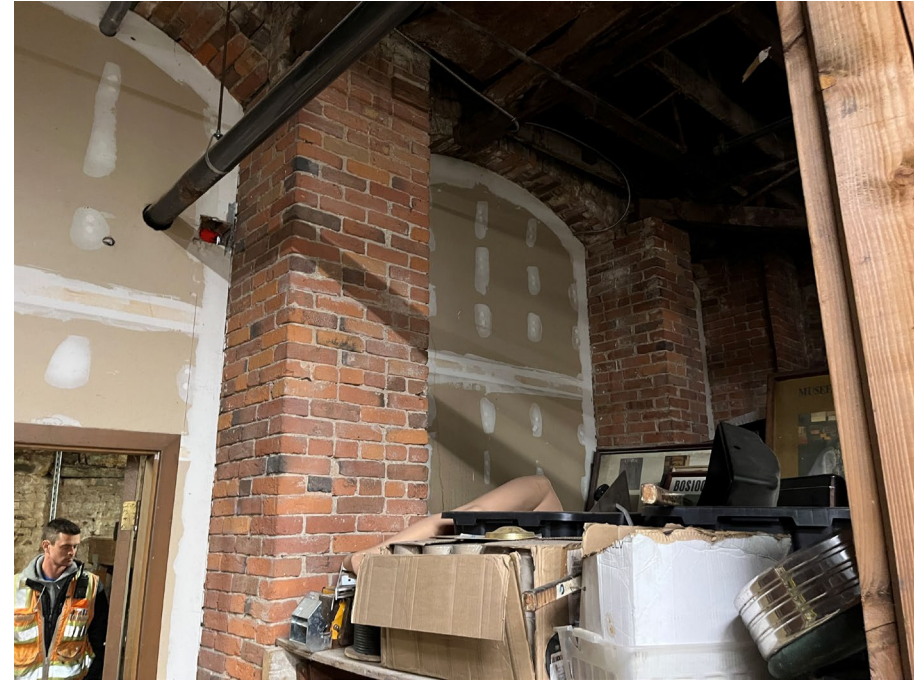
Fig 12: Openings looking towards areaway from building at south end

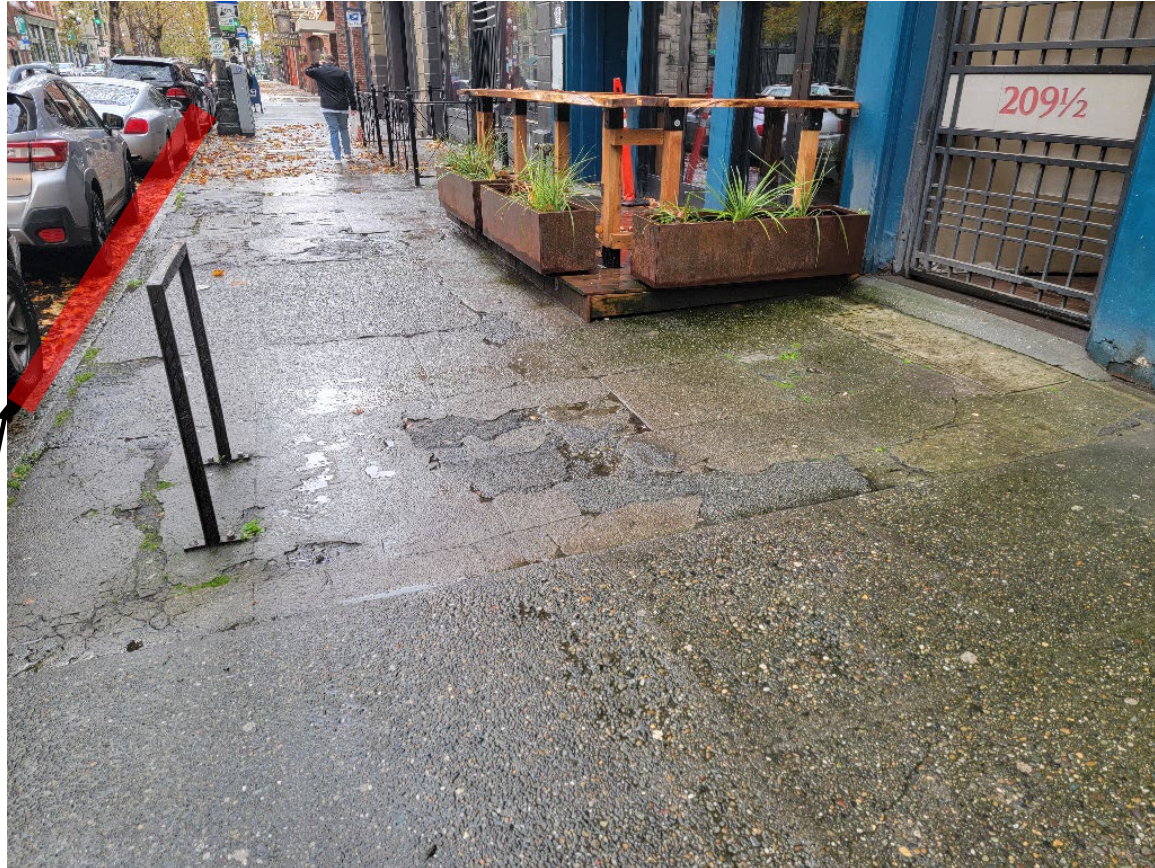
Wall Location  
(approximate)

Looking south, sidewalk and  
frontage space

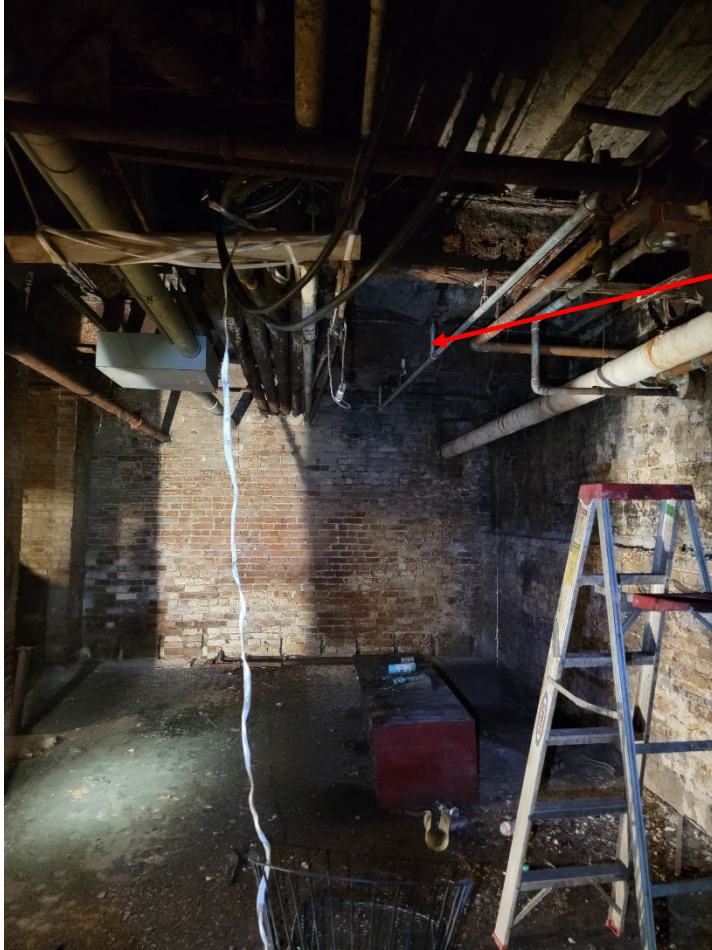
Fig 14: Looking at north at end of areaway with street wall to the right

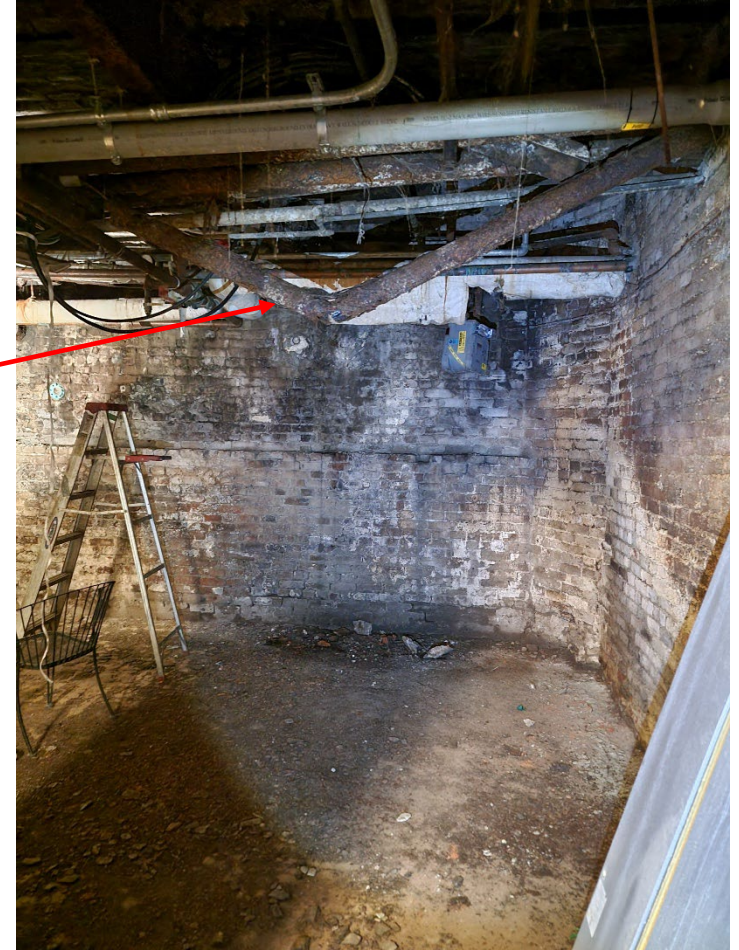
Fig 15: Looking at east at street near south end of areaway

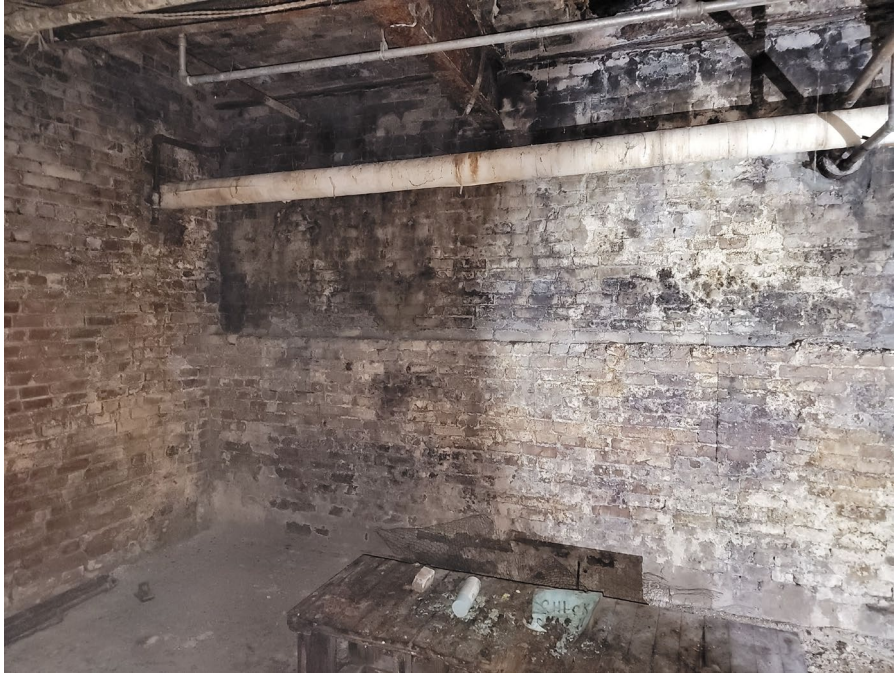
Fig 16: Near north end of areaway  
looking at street wall

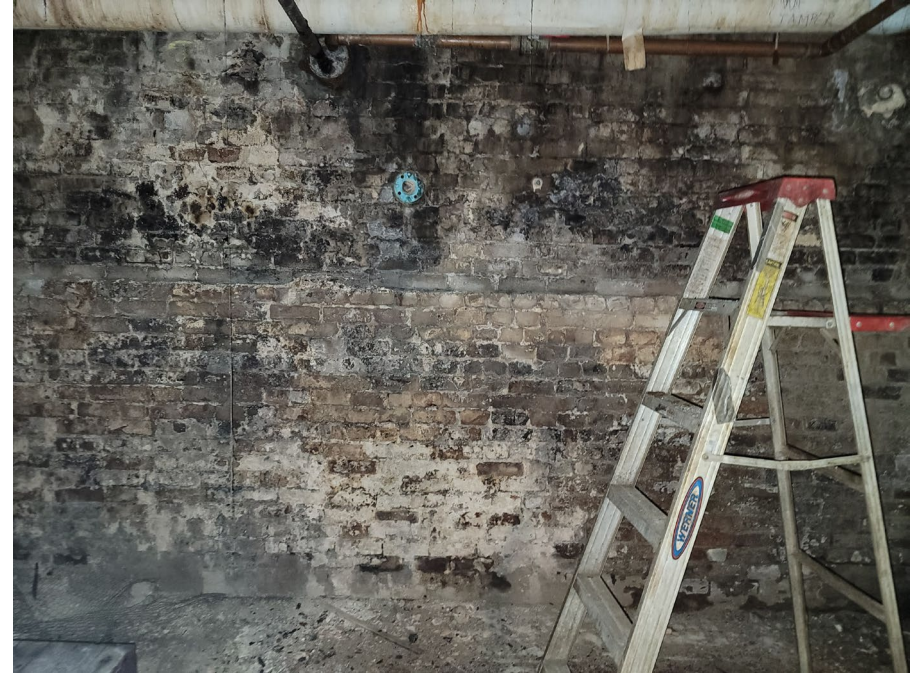
Fig 17: Looking at east at street wall  
near middle of areaway

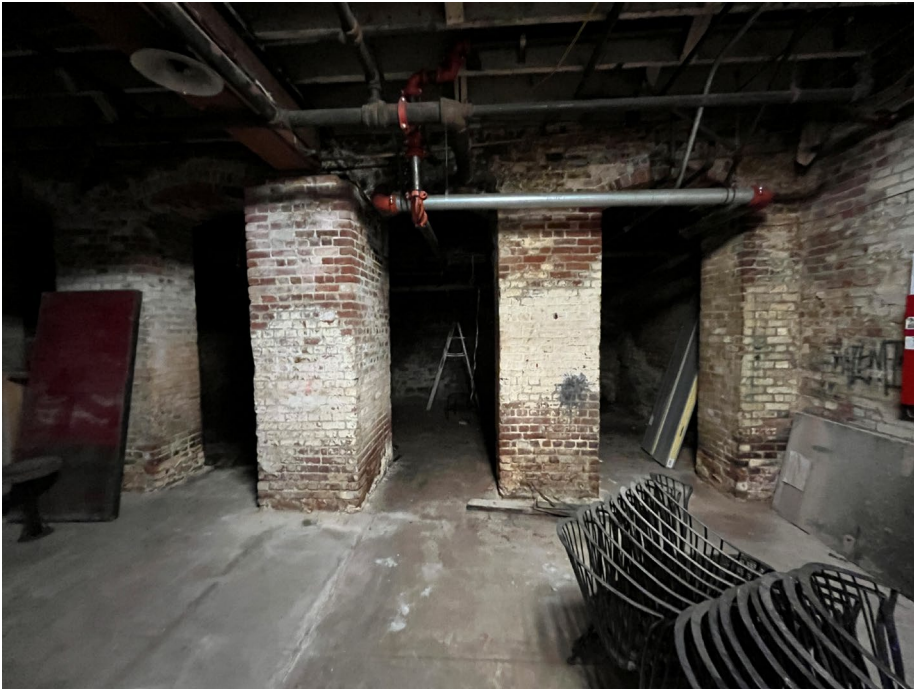
Fig 18: Looking east towards areaway from building

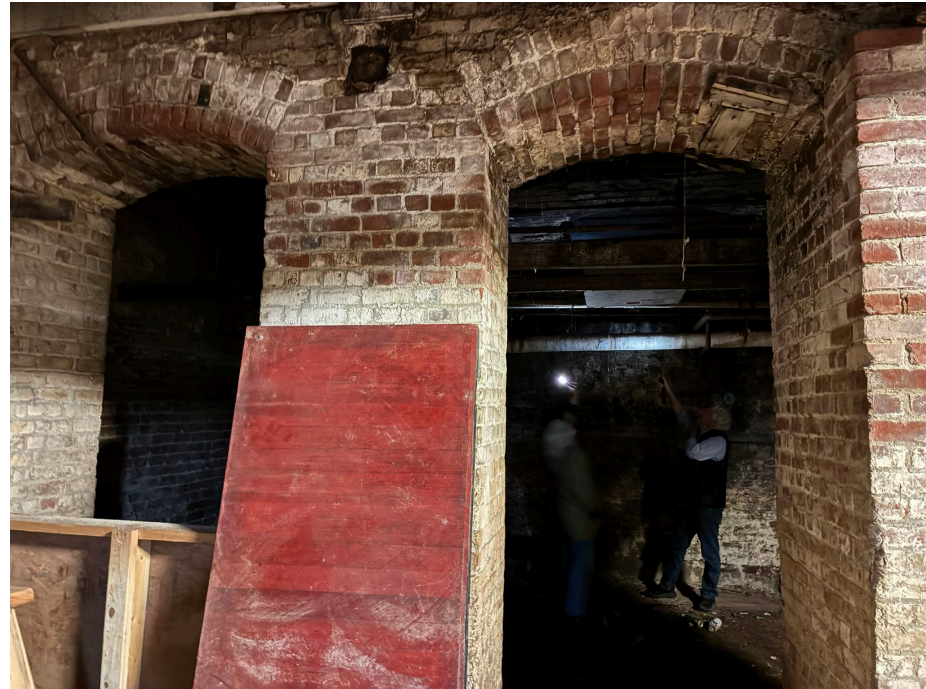
Fig 19: Looking east from building at north end of areaway

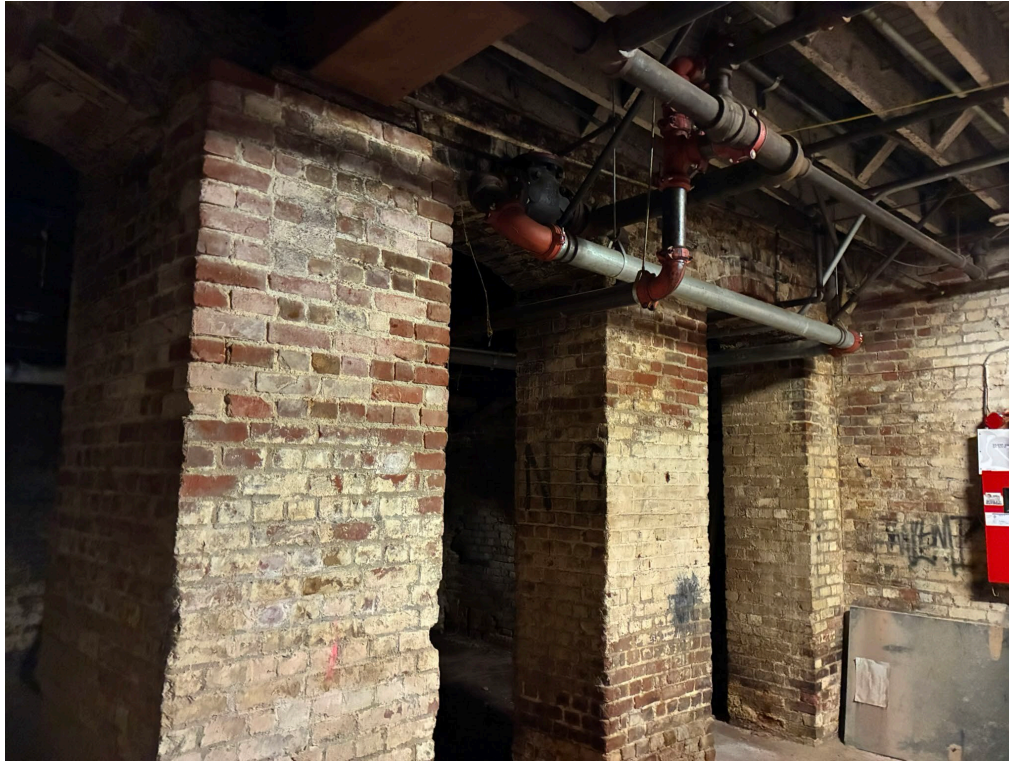
Fig 20: Looking towards the south end of areaway from building

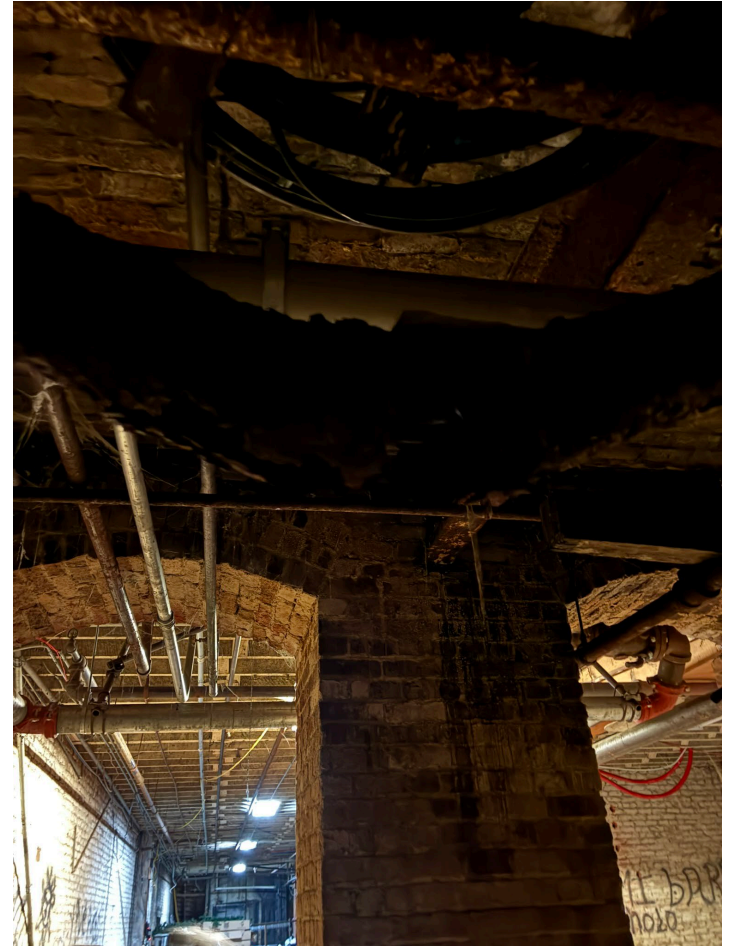
Fig 21: Looking west at building from areaway

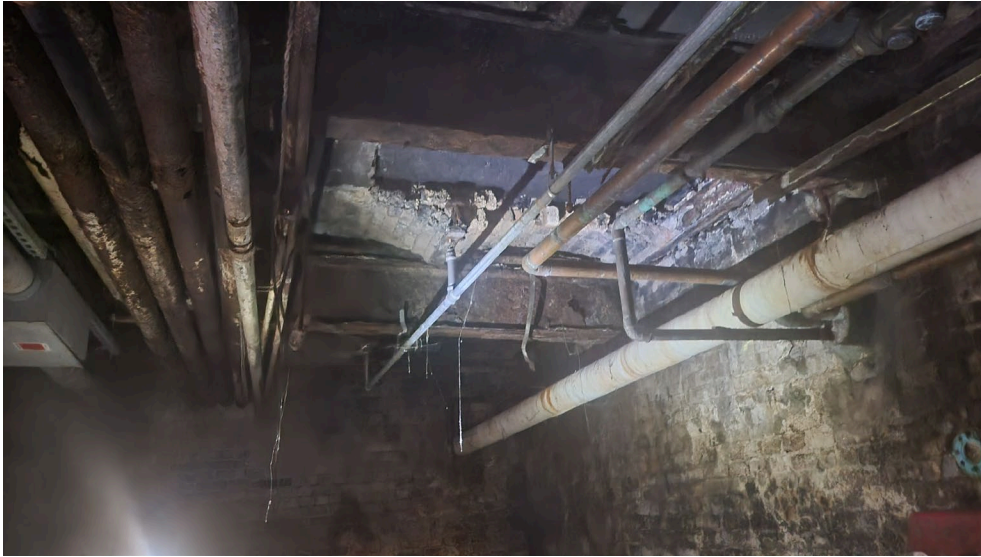
Fig 22: Northeast corner of areaway

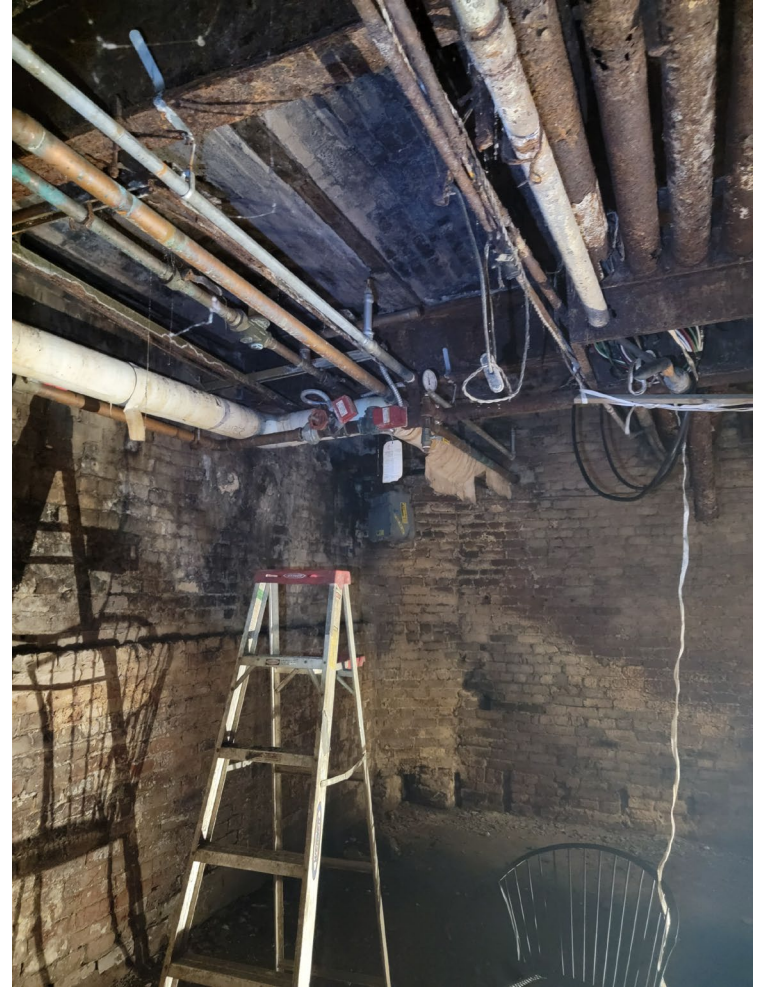
Fig 23: Looking at the south end

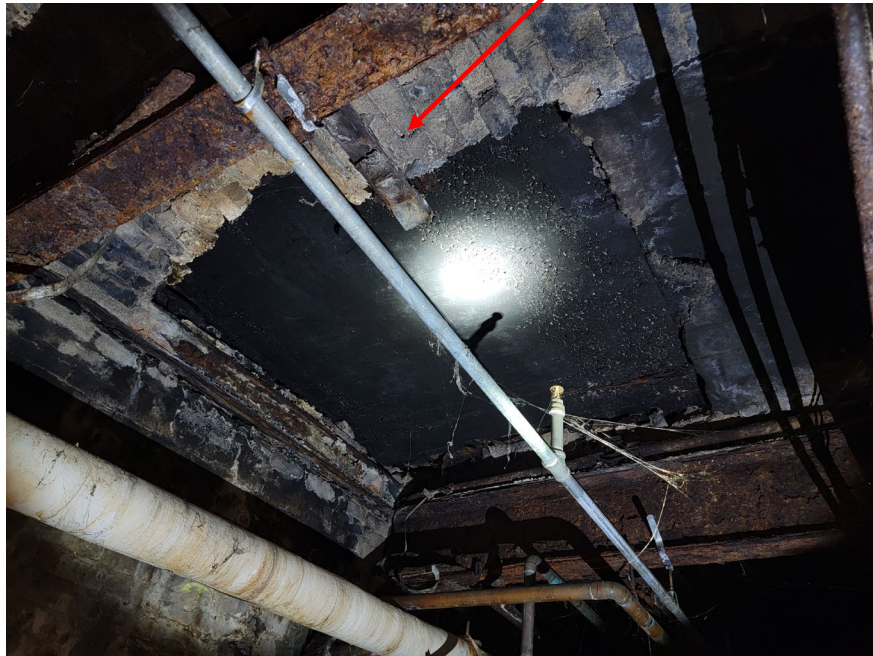
Portion of  
masonry arch  
ceiling removed

Fig 24: Ceiling near middle of areaway

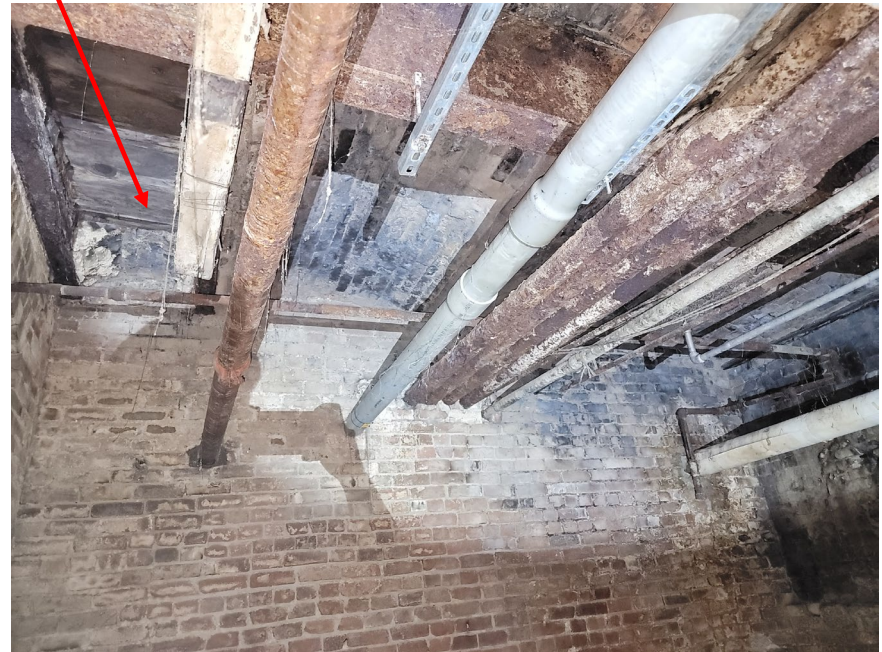
Fig 25: Ceiling near north end of  
areaway
