**To:** Pioneer Square Preservation Board

**Re:** (DONH-COA 02067) 617 1<sup>st</sup> Ave Areaway Repair: frame design and color

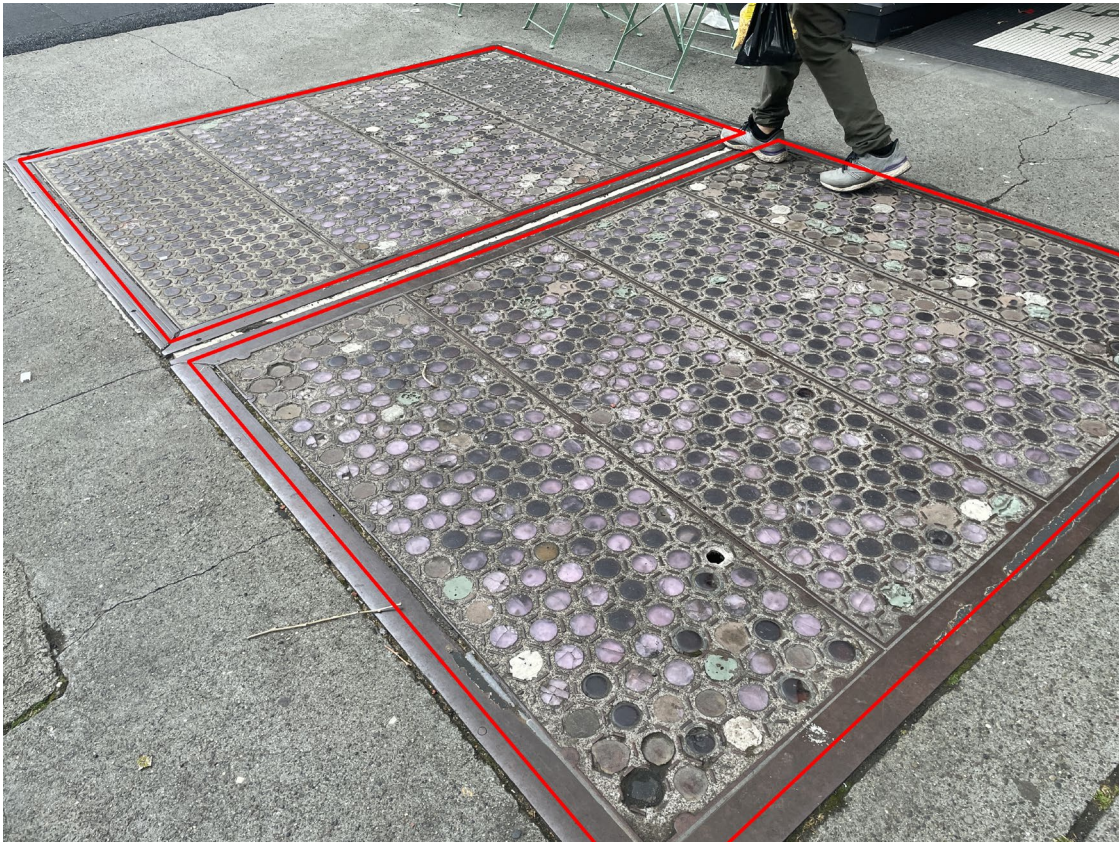
On May 20, 2026, the Pioneer Square Preservation Board issued the Certificate of Approval (COA) for the repair and reconstruction of the sidewalk and areaway that was damaged by a vehicle driving over the areaway on May 13, 2025. As part of the COA, final decision on the supporting frame for the new grating panels was postponed pending additional information on the material color and frame design, as depicted by the “red” lines on the following picture:

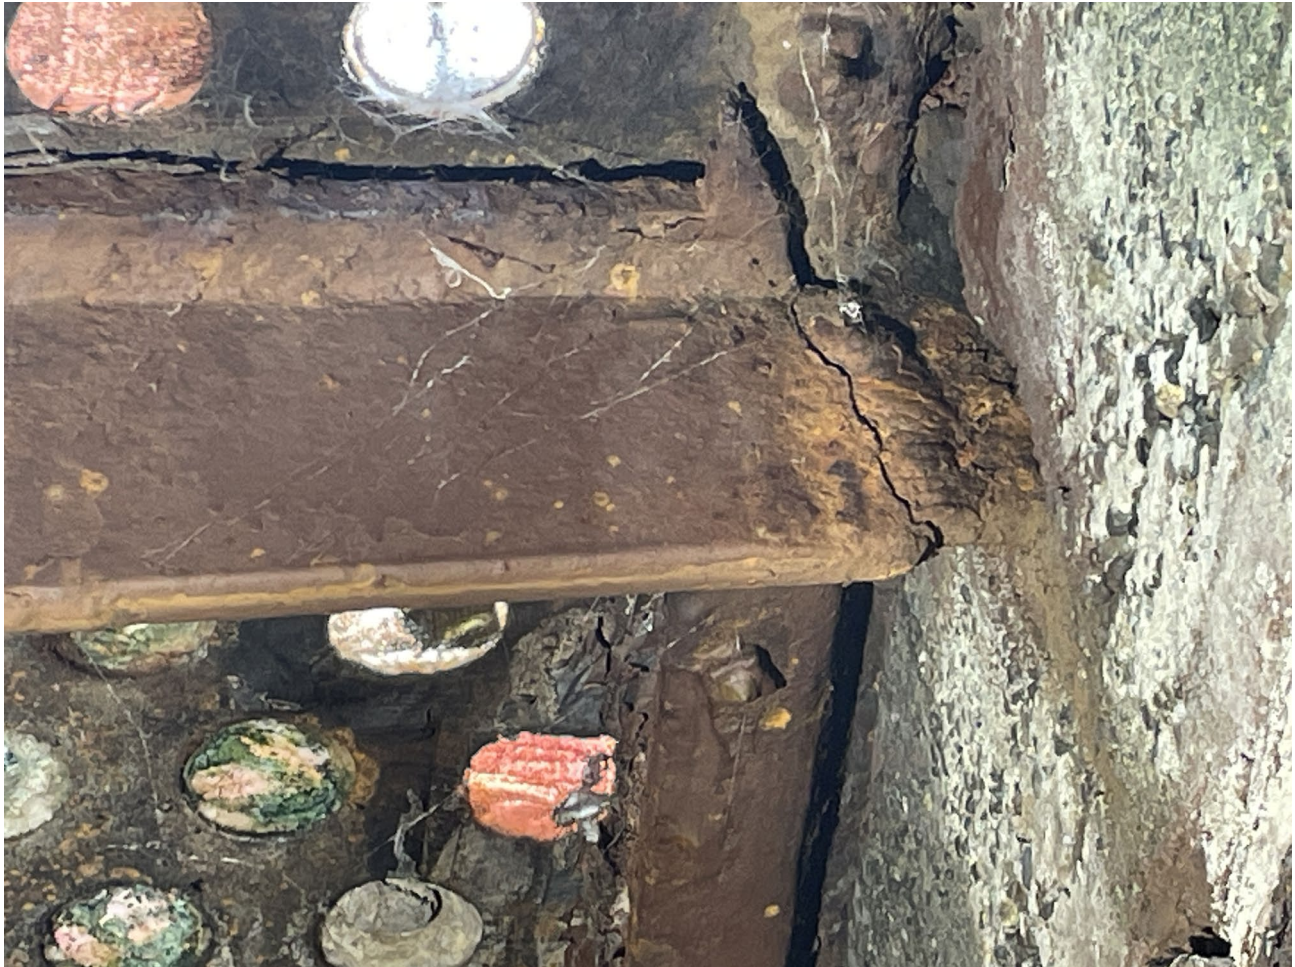
During the presentation, it was noted in discussion with the fabricator that the frame supporting the cast iron grating panels would be fabricated from stainless steel instead of cast iron to improve long term durability of the frame due to the frames contact with concrete and direct exposure to the weather. Pictures of the existing condition of the frame show that overtime contact with water and the concrete has caused significant section loss of the structural members due to corrosion.

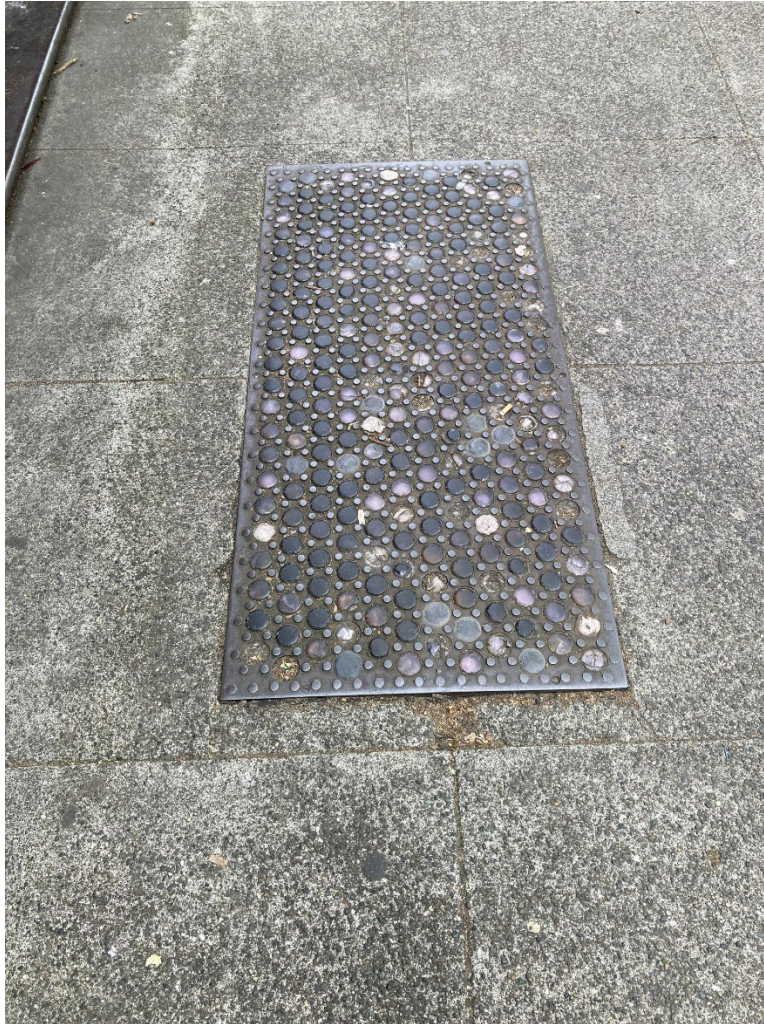
1. Can the top flange of the frame be reduced to a provide an almost edge-less appearance, similar to a cast iron panel located at 301 1<sup>st</sup> Ave S:

The project team evaluated the initial inquiry regarding whether the top flange of the frame could be reduced to create an almost edge-less appearance, in consultation with both the fabricator and the engineer. The engineer indicated that the top flange is essential for providing structural support to the skylight assembly. As these skylight assemblies constitute new construction, they are required to meet current load standards, necessitating an increase in assembly depth compared to the original design. To preserve the existing sidewalk elevation and avoid any alteration to the crown of the masonry arch

ceiling, the available space between these two constraints does not allow the frame to sit directly on top of the arch without altering either the ceiling or the sidewalk. Consequently, the top flange must serve as the structural support for the assembly, as no other feasible solution exists without major alterations.
