PIONEER SQUARE HISTORIC DISTRICT  
**AREAWAYS**  
HAZARD MITIGATION STUDY

MARCH 2003

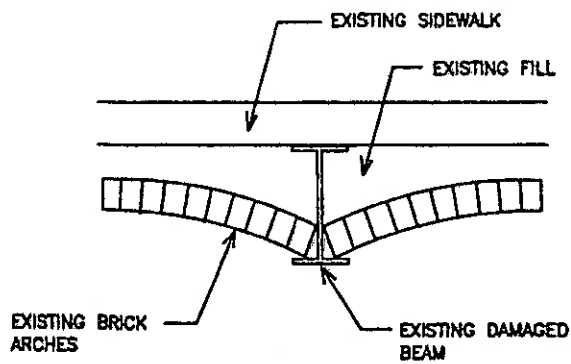
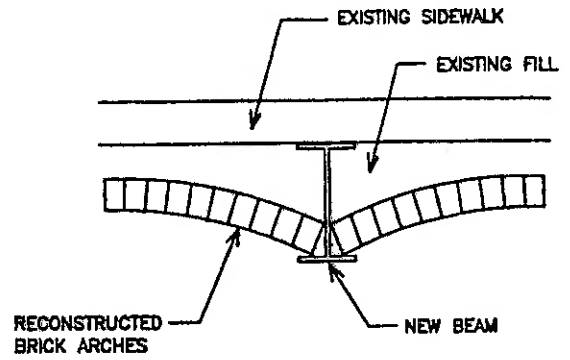
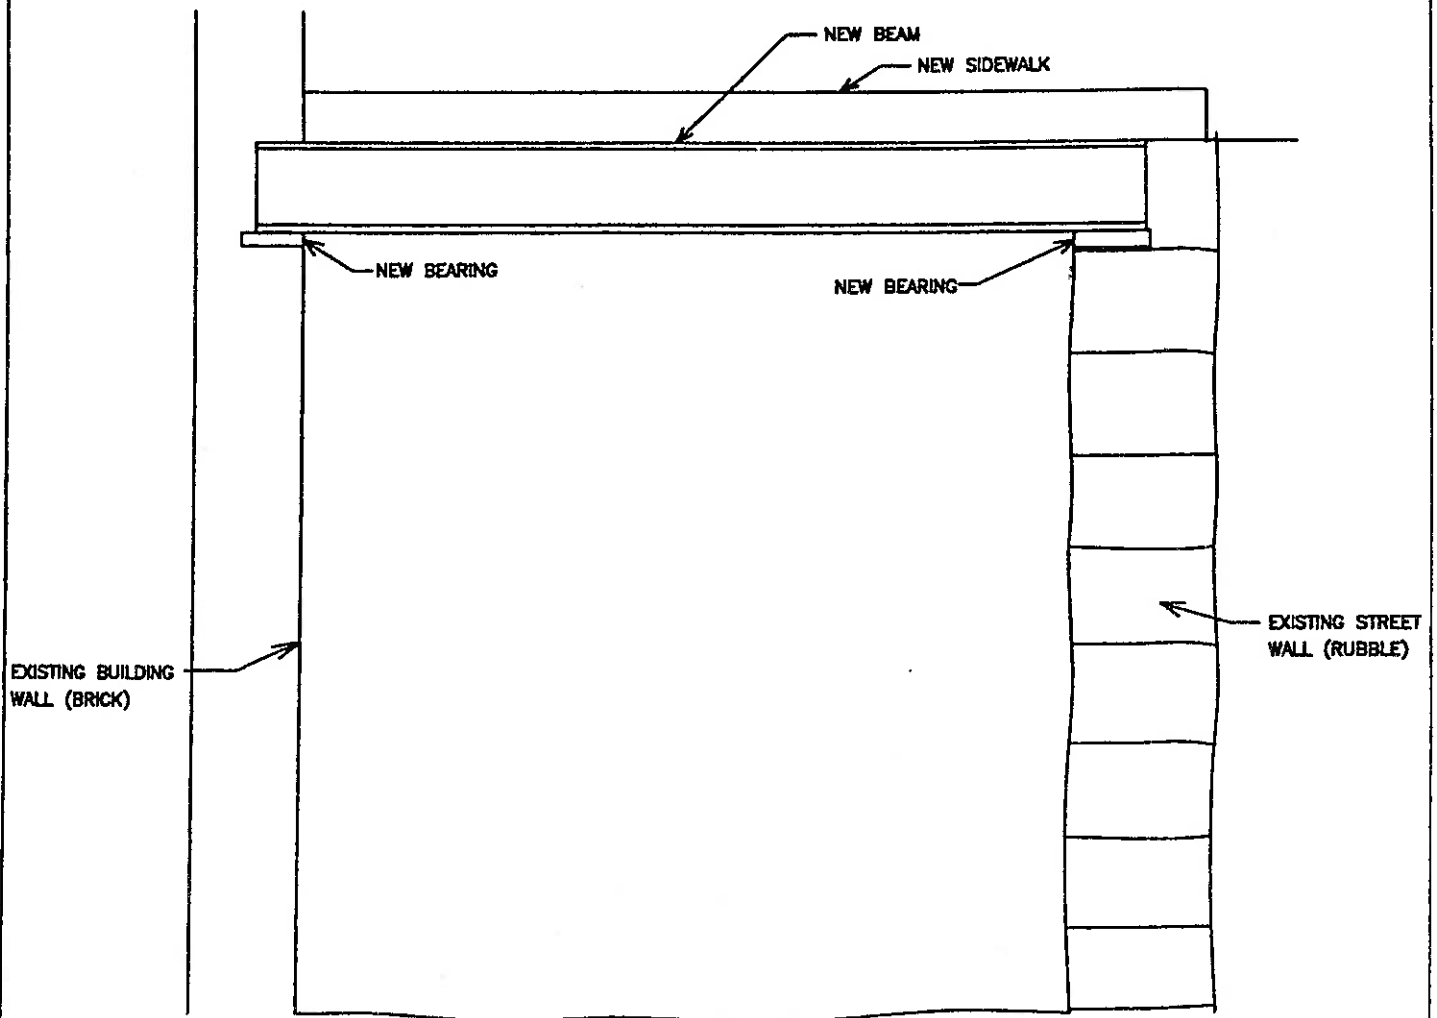
FIGURE 1

RECONSTRUCTION WITH BEAM REPLACEMENT

See Figure 1 for this type of repair.

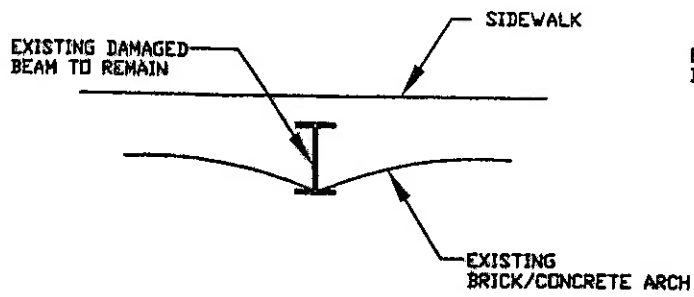
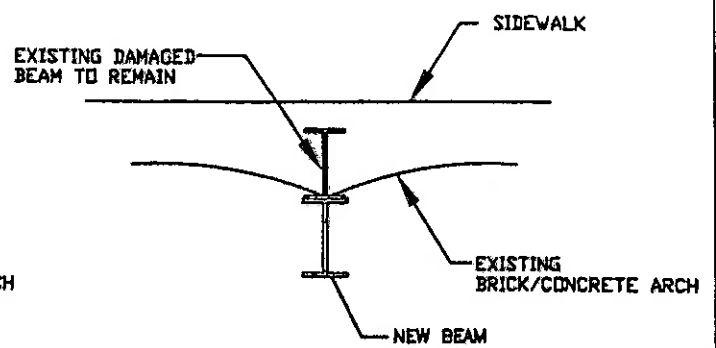
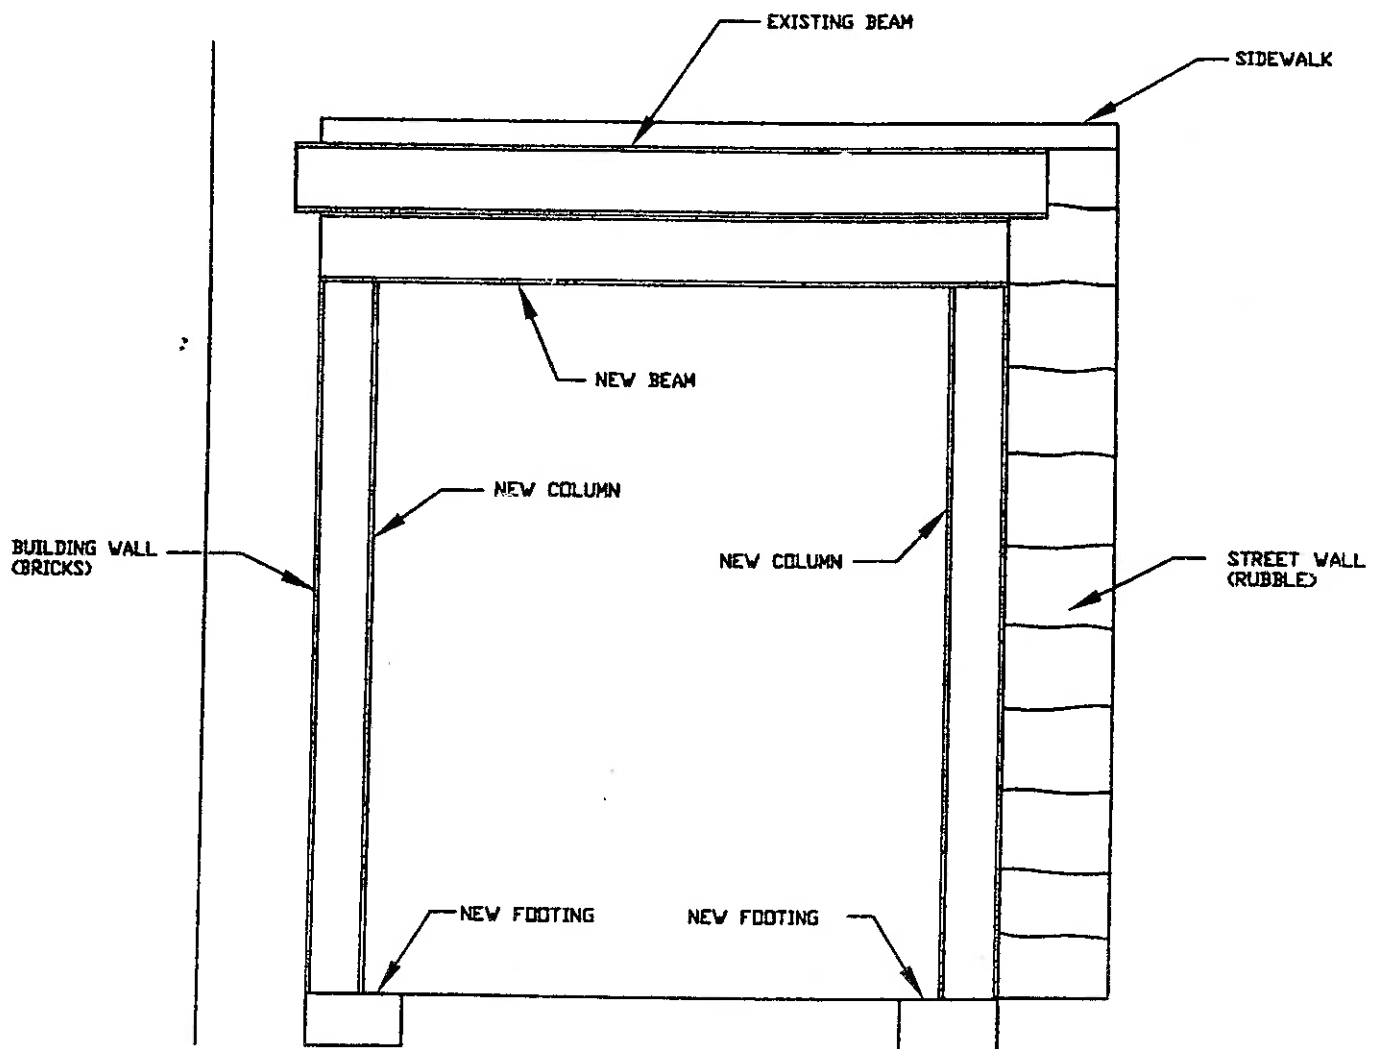
FIGURE 2

NEW SUPPORT BEAM/COLUMN

See Figure 2 for this type of repair.

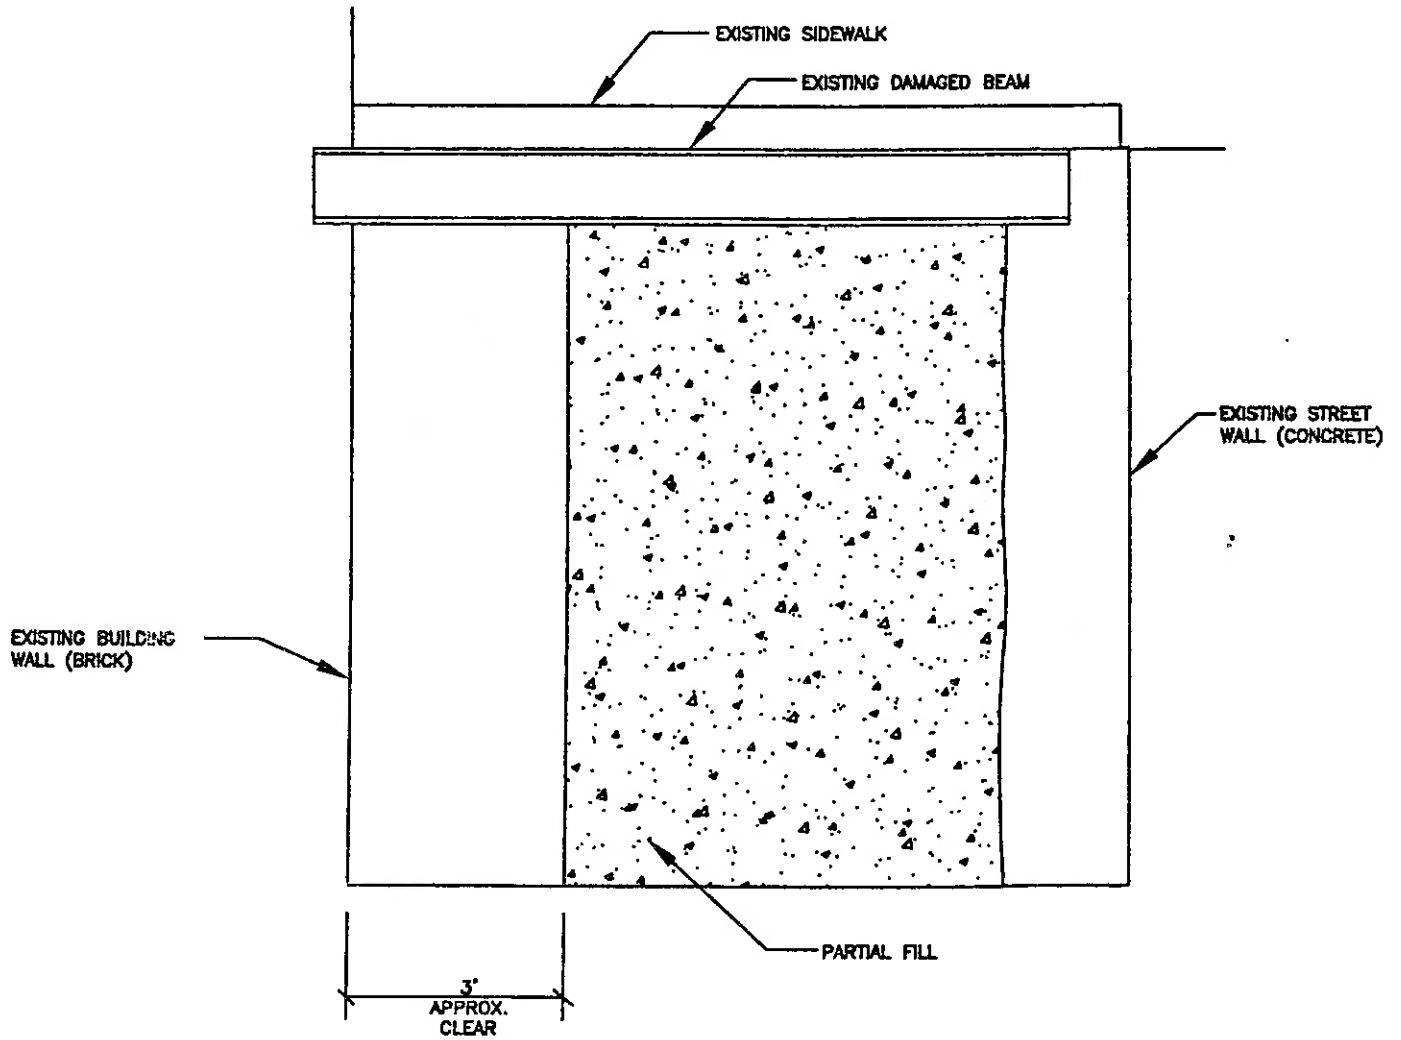
PARTIAL FILL  
FIGURE 3

See Figures 3 and 4 for this type of repair.

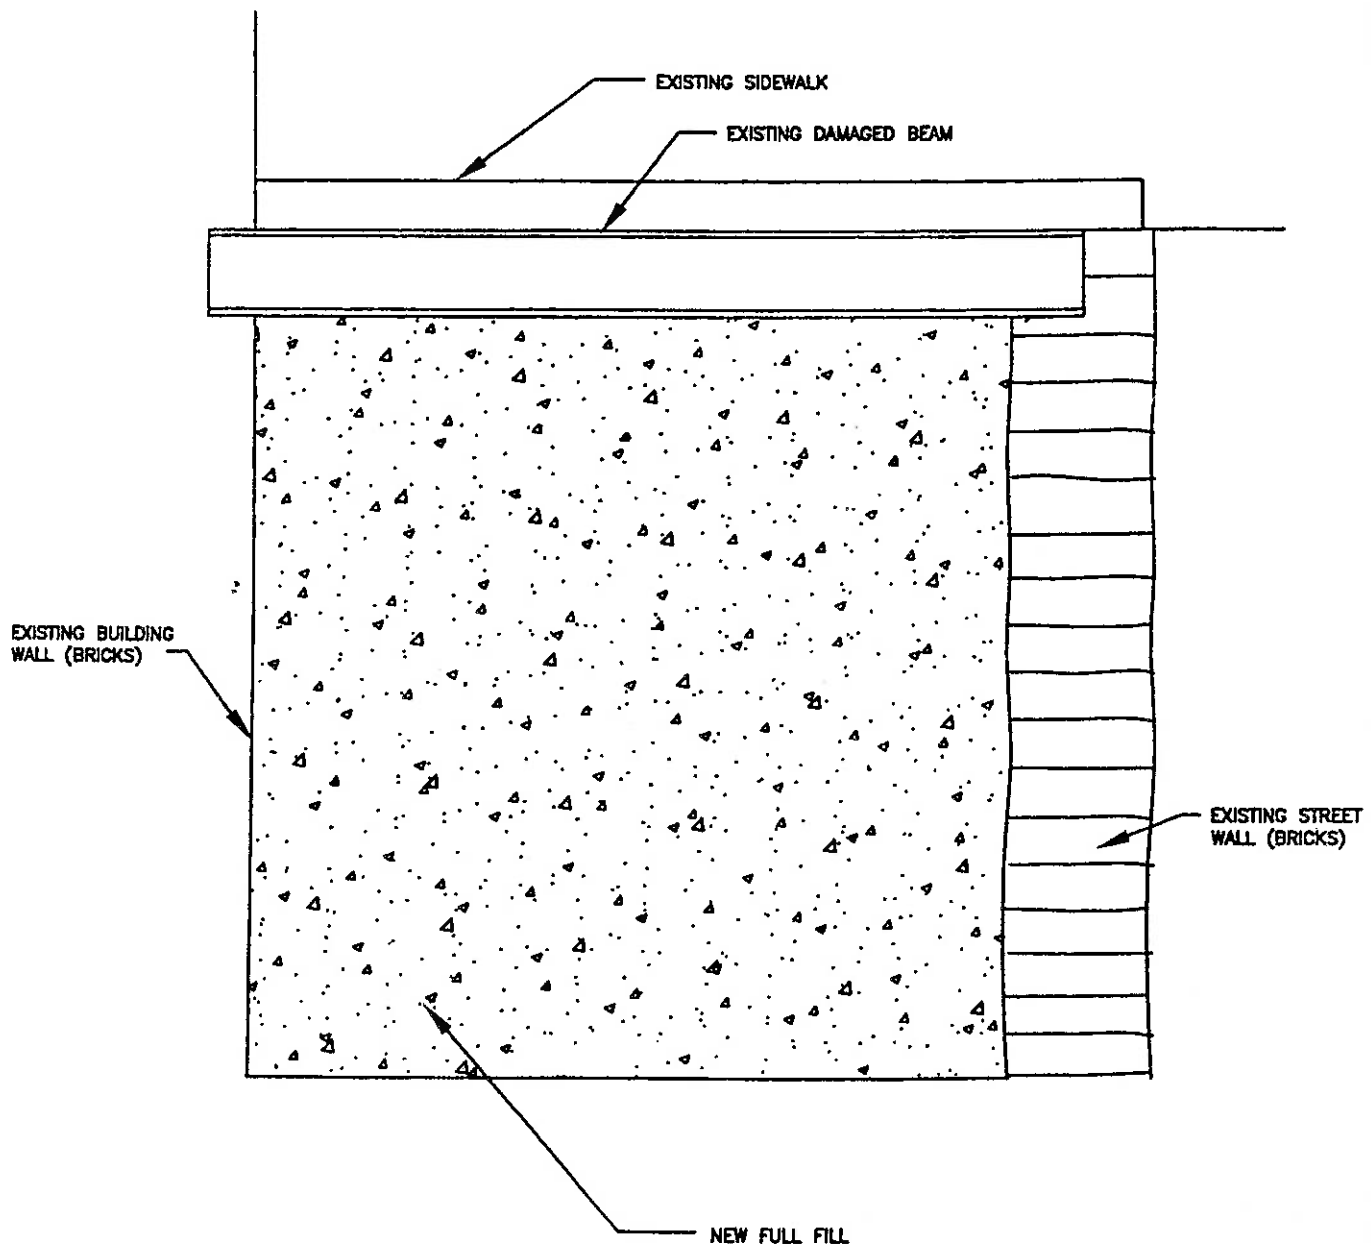
FULL FILL  
FIGURE 4
