Seattle City Light - Vault 22V-4 Repair and Transformer Installation 117 S. Main Street, Seattle

Existing Conditions for Vault 22V-4

Existing Vault Hatch Cover

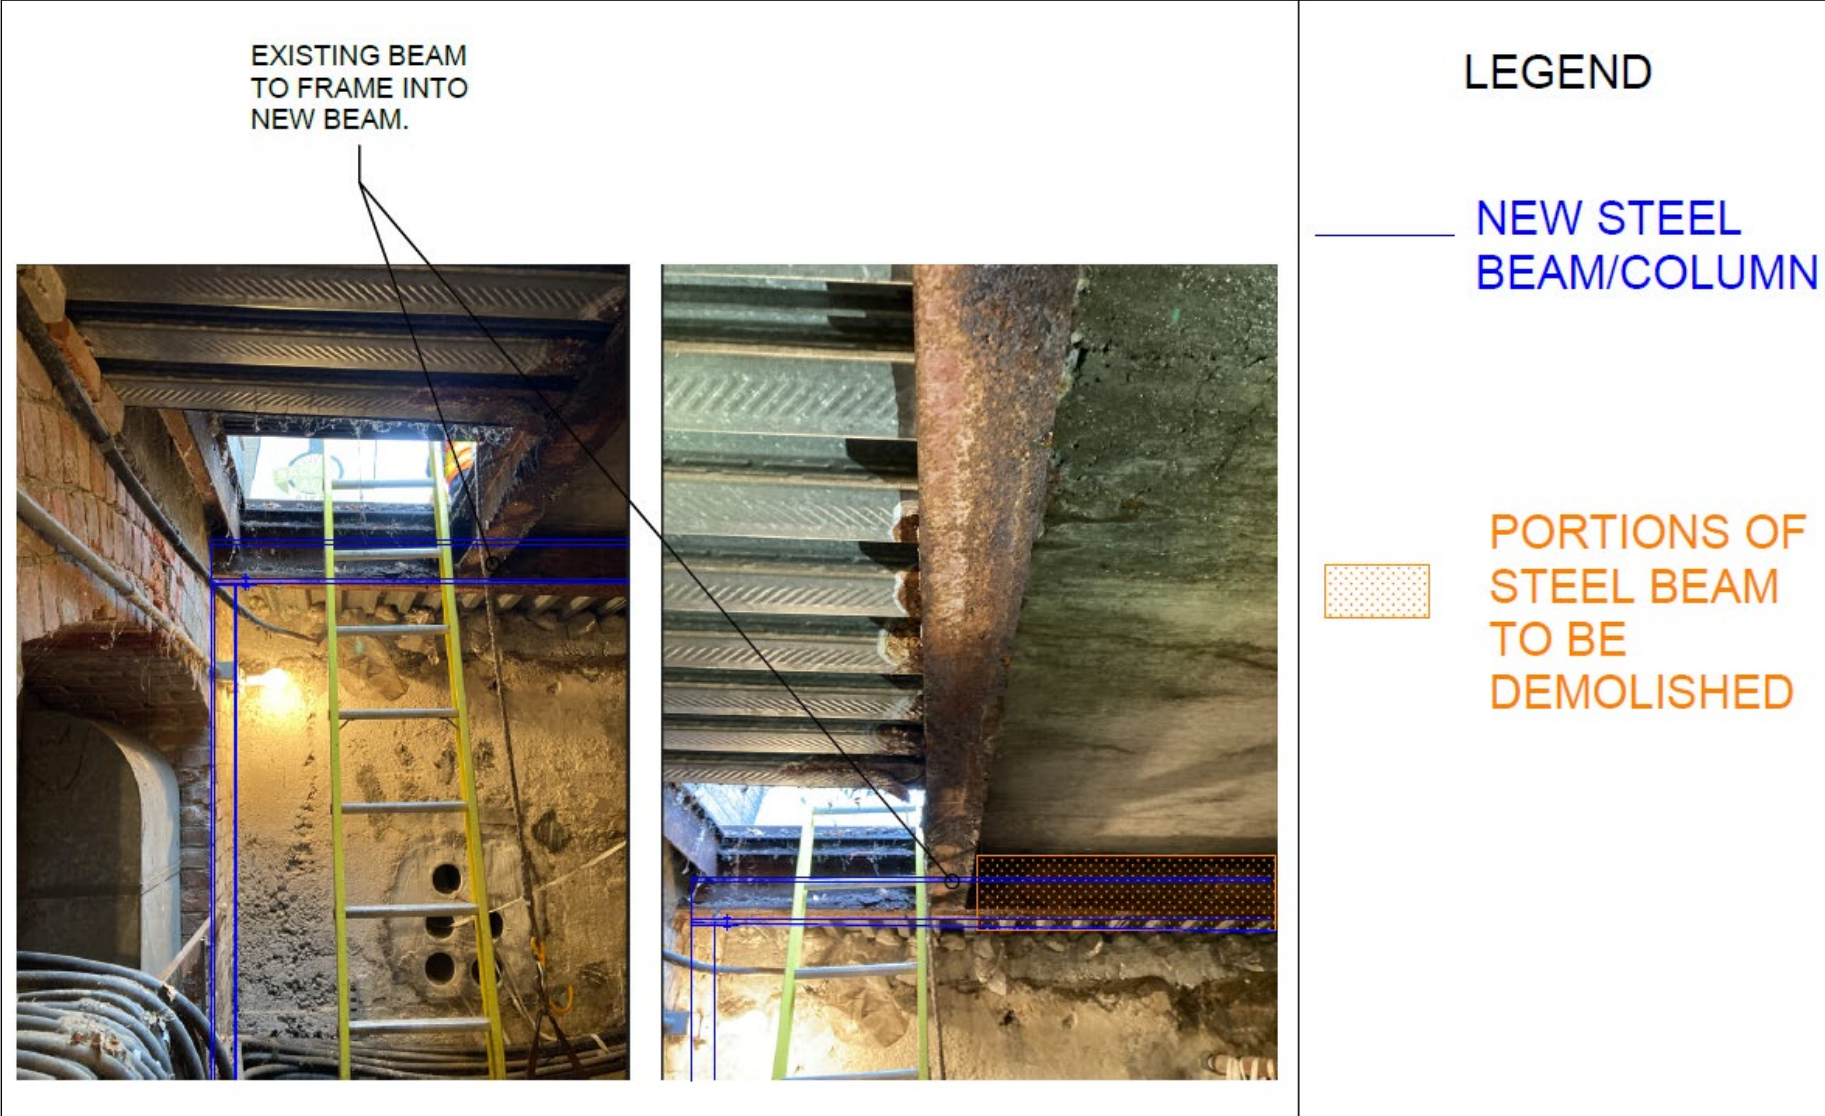
Figure 3 – Proposed placement of steel columns and beams within the vault using photos #5 and #6 as background. This is SK1 from figure 2. (Source: Seattle City Light, 2023.)

- Demolish the existing vault hatch cover on-site and remove debris.
- Remove portions of the steel beams within the vault.
- Install new steel beams where they have been removed, and new columns within the vault adjacent to the existing columns (e.g., to be left in place) and fasten the new into the concrete vault floor and wall surfaces.
- Install a transformer in the vault.
- Install a vault hatch cover composed of slip resistant steel grate panels (3) to provide ventilation and fire resistance.
- Avoid any work on or impacts to the brick arches in the southern side of the vault.
- Avoid any work on the sidewalk adjacent to the vault hatch opening and/or sidewalk curbs.

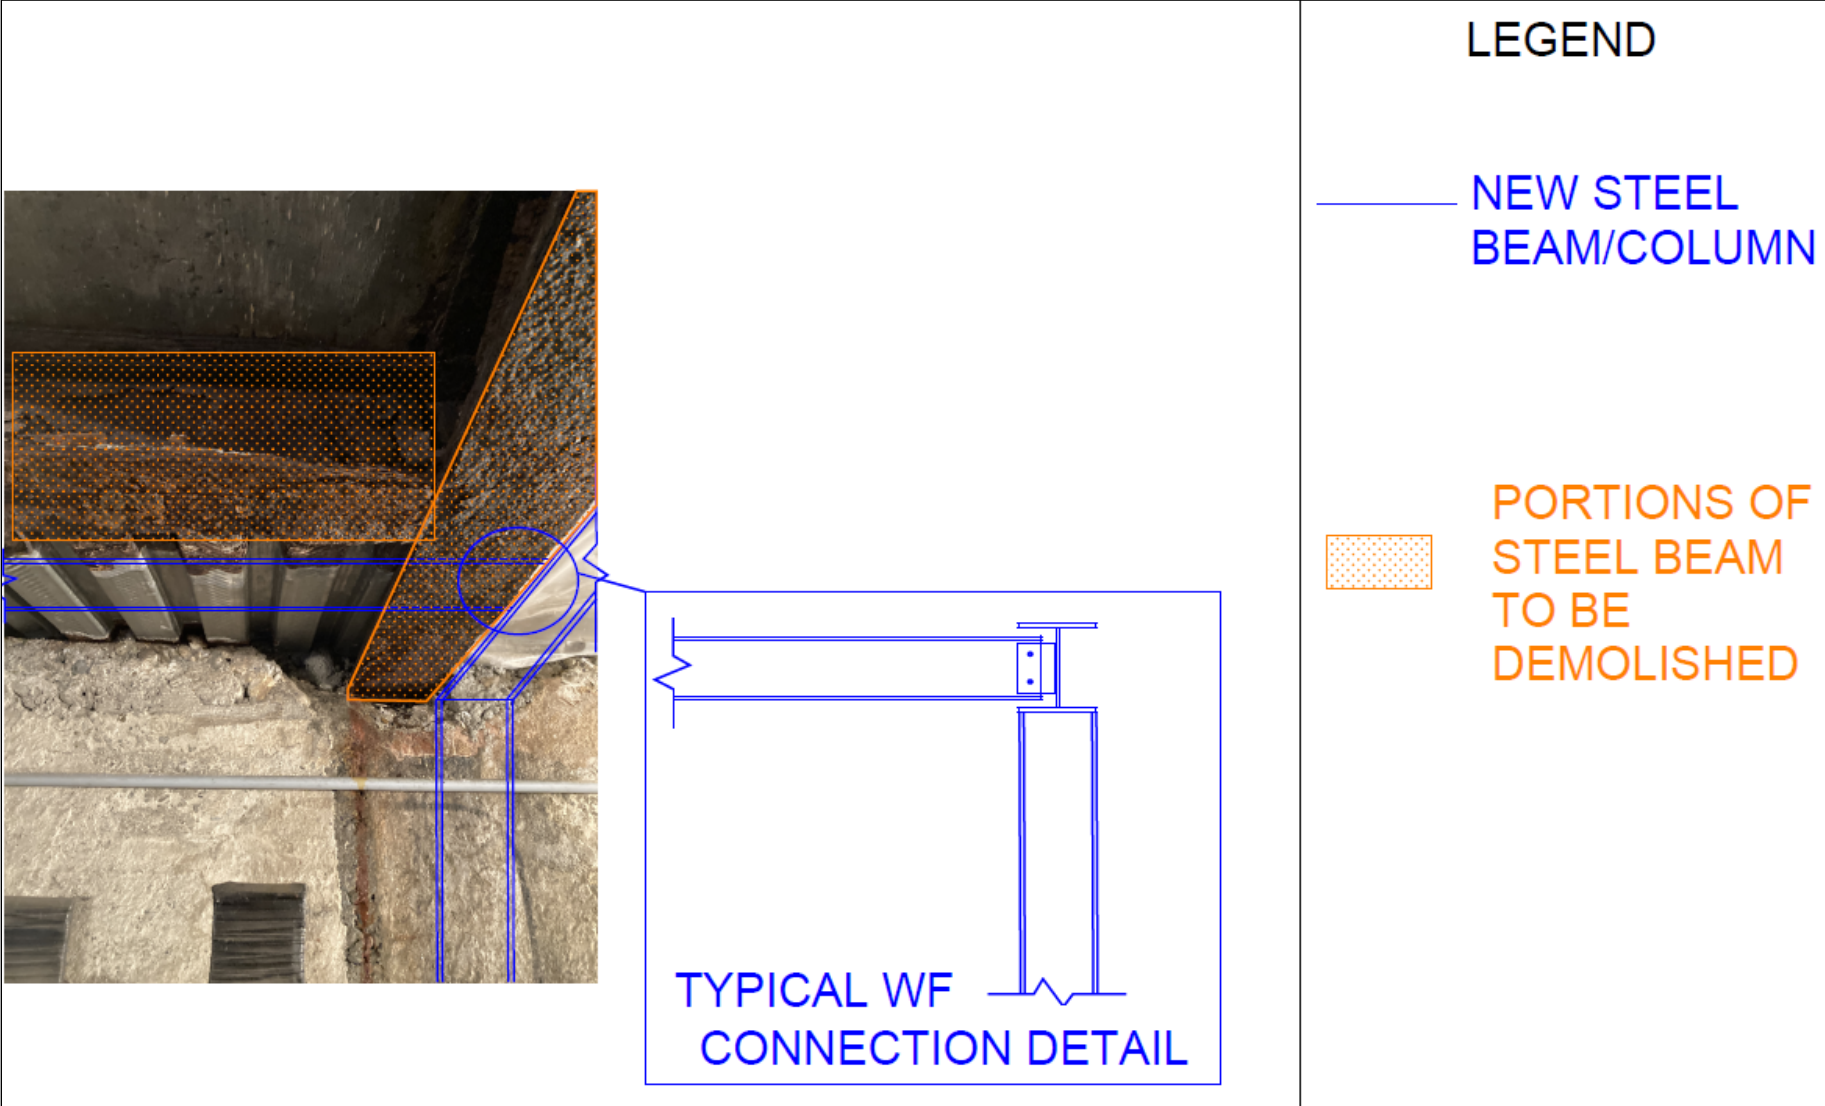
Figure 4 – Proposed installation using Photo #7 as background. This is SK2 from figure 2.
 (Source: Seattle City Light, 2023.)

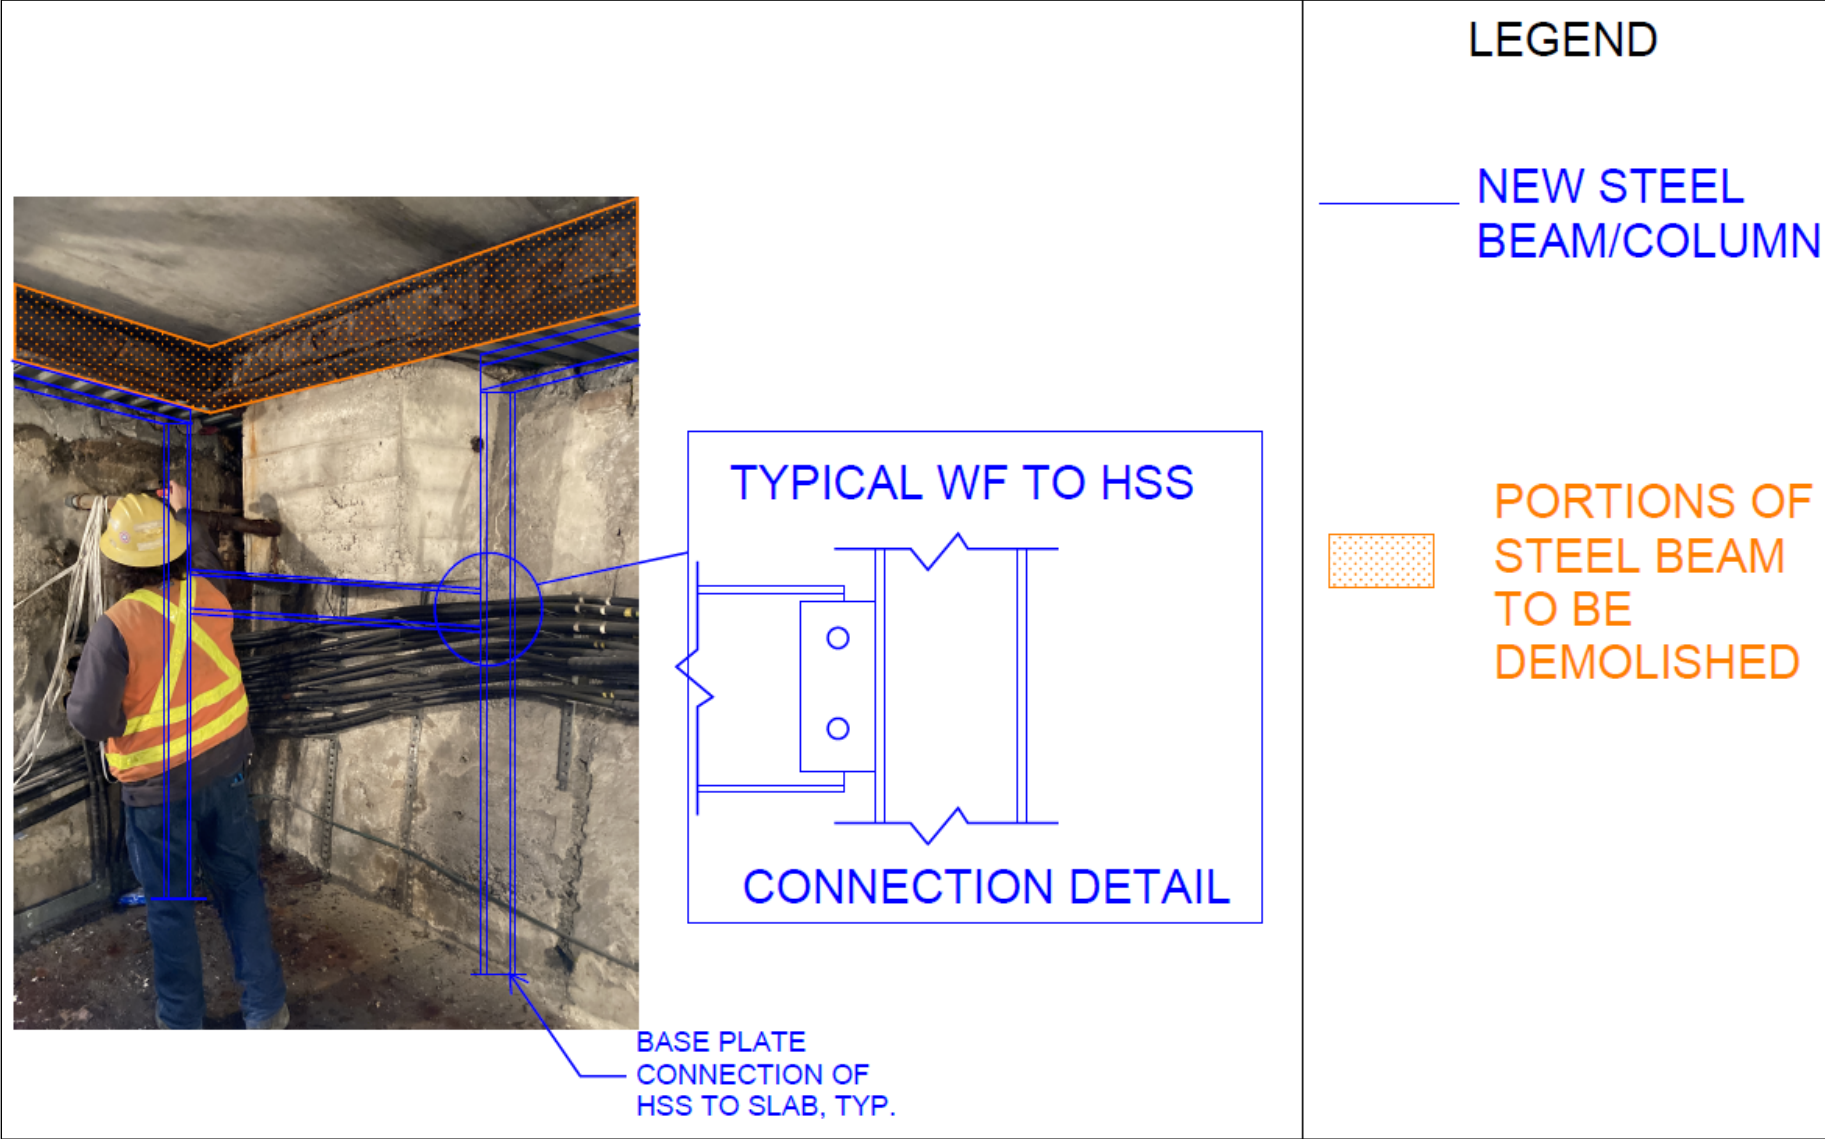
Figure 5 – Proposed installation using Photo #8 as background. This is SK3 from figure 2.
 (Source: Seattle City Light, 2023.)

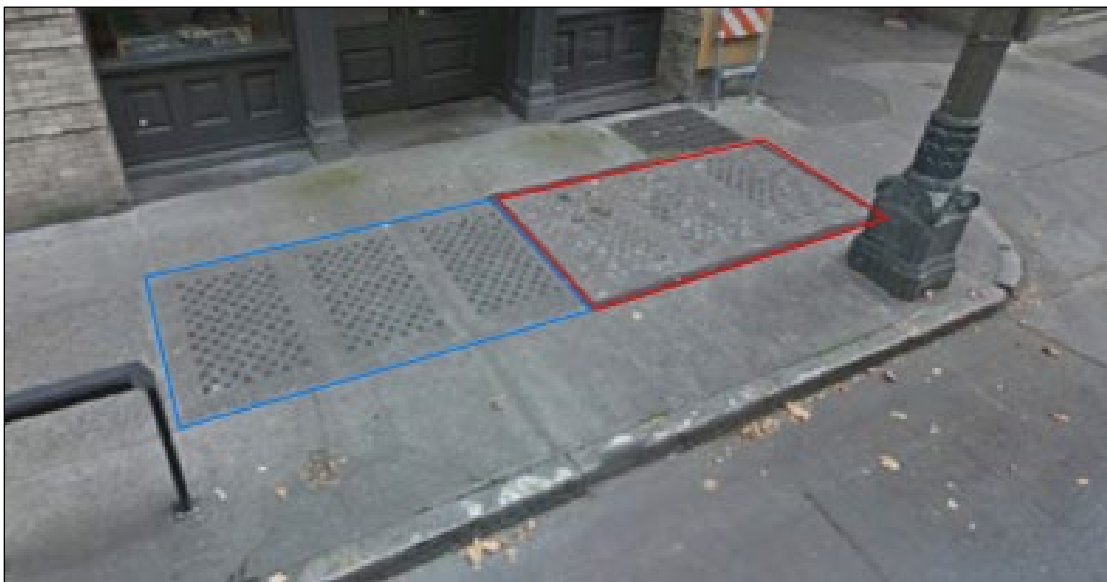
The existing cover as seen in figure 11 (outlined in red) and figure 13 (detail view of figure 11) has round glass pavers with a diameter of 2 inches. The east panel (outlined in blue in figure 11, detail view in figure 12) has round glass pavers that are 2-3/8 inches in diameter. Figure 14 is a partial view of the blue outlined area in figure 11, showing the dimensions of the panel, spacing between pavers and the existing pattern.

Figure 11 – Vault at 117 S. Main St. The blue outlined area shows the portion that will remain in place and will not be altered. The red outlined area shows the area we are proposing to change. (*) Note: The glass pavers here are not true prisms that allow light into the underground space. They are embedded in the upper portion of the concrete panel and do not extend through the depth (thickness) of the concrete panel. (Source: Seattle City Light, 2023.)

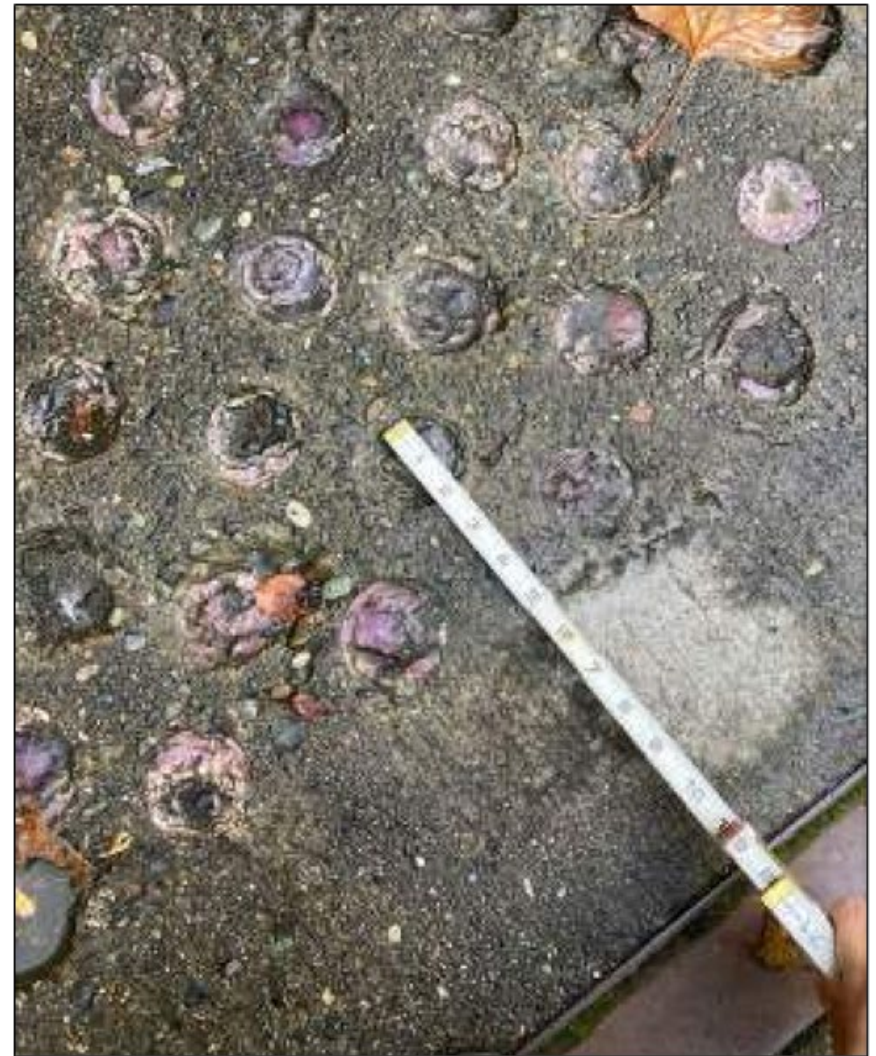
Figure 13 – Zoomed in view of the existing and deteriorated round glass pavers within the red outlined area in figure 11. The diameter is 2 inches. (Source: Seattle City Light, 2023.)

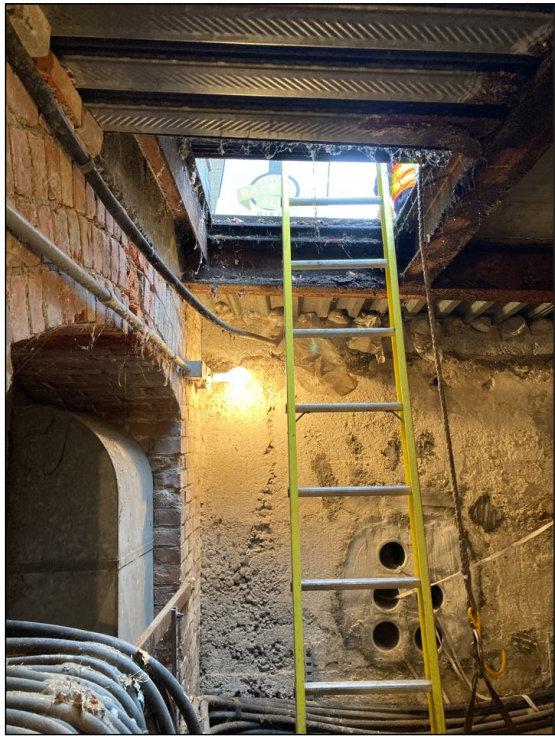
An inspection of Vault 22V-4 in 2022 observed that the exterior and interior steel framing and concrete hatch cover were showing signs of significant deterioration since their installation in 1977 (see photos 5-10). The outer surface of the cover (e.g., the "sidewalk" surface) is rusted, spalling, and missing pieces of concrete along with cracked and/or missing round glass pavers. Inside the vault, substantial rust was visible on the steel columns, beams, and ceiling decking. The conclusion was that emergency temporary wood supports would be needed in the vault; followed by new permanent steel structural framing, along with a new vault hatch cover before the transformer was installed. Further observation noted the lack of true prisms in the hatch cover and that the purple hued round glass pavers were 2-inches in diameter embedded on the surface and arranged in three rectangular groupings. Within each, the glass paver pattern consisted of 17 rows, alternating between 6 and 5 pavers per row. This treatment did not allow any light into the vault. Due to the clearances needed to install new steel beams and columns within the vault, the condition of the existing single concrete panel with pavers cover, and ventilation requirements for the new transformer, the existing vault hatch cover cannot be reused. A new vault hatch cover will be manufactured and designed as a three-panel hatch cover instead of a single panel due to the previously noted weight restrictions.

Photo 5 – Vault interior, view to the west showing existing conditions. Union Trust Annex brick arch to the left. (Source: SCL, 2022.)

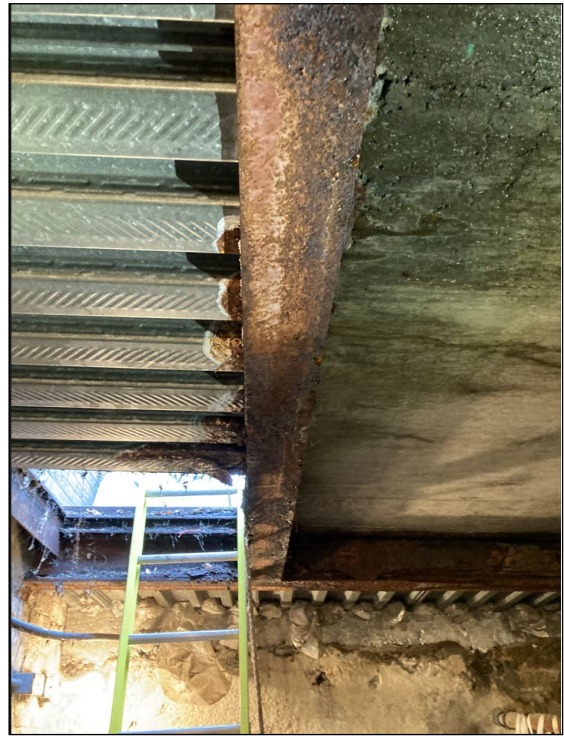
Photo 6 – Vault ceiling interior, west view showing rusted steel beams. Panel on right is sidewalk surface with glass pavers. (Source: SCL, 2022.)

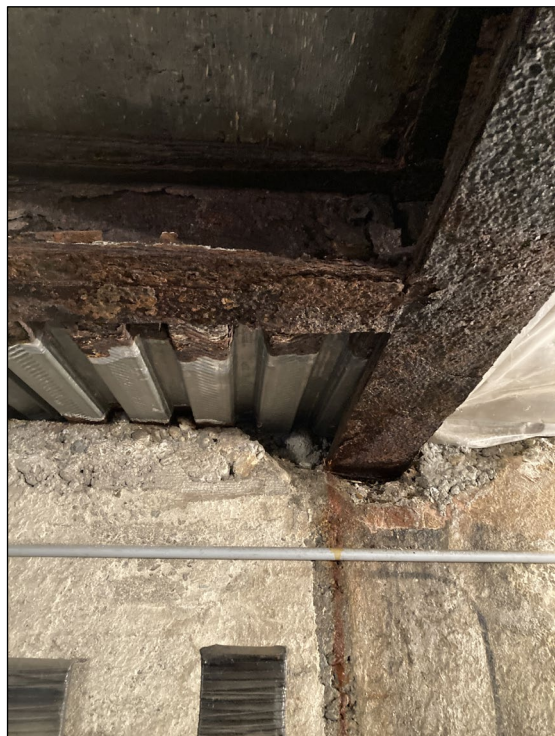
Photo 7 – Detail view showing general conditions of the steel beams and ceiling decking in the vault. (Source: SCL, 2022.)

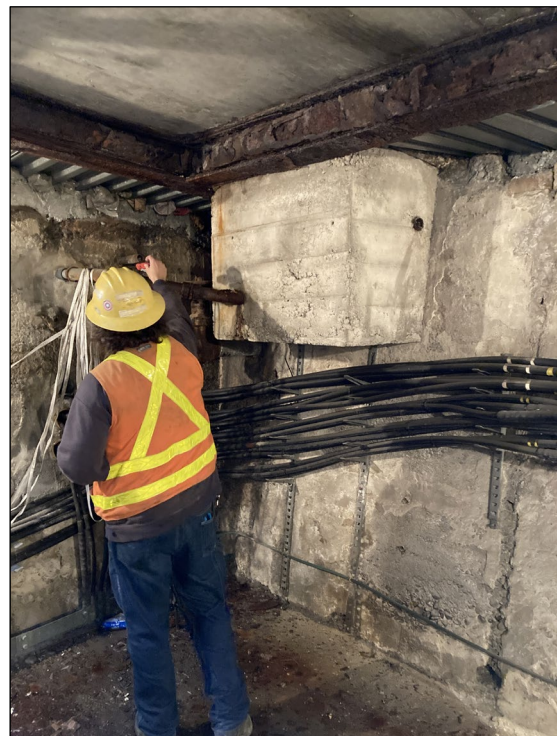
Photo 8 – Northwest corner detail. The ceiling concrete panel has on the exterior surface the small round glass pavers. (Source: SCL, 2022.)

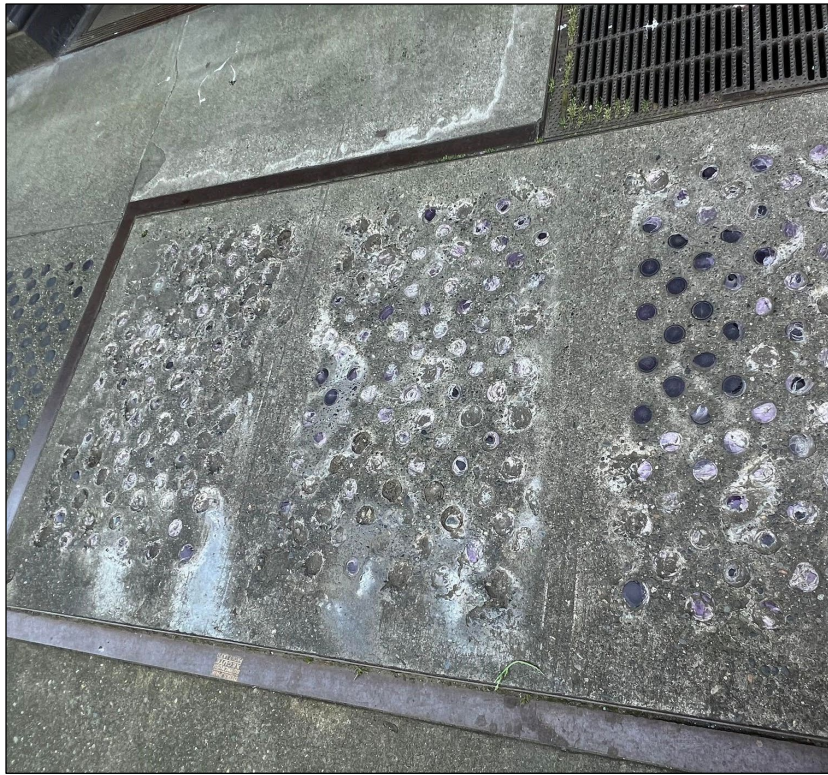
Photo 9 – Existing conditions on the exterior or sidewalk surface of the vault’s concrete hatch cover. Circular imprints are visible where glass pavers were once located in the concrete. (Source: Seattle City Light, 2022.)

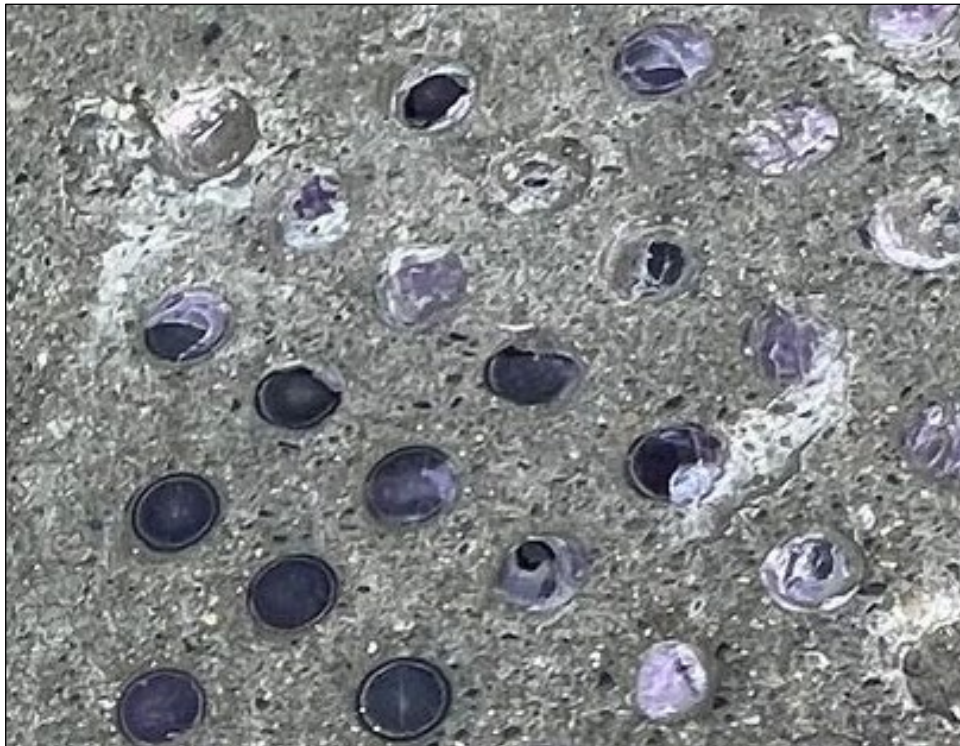
Photo 10 – Detail of upper right corner of photo #9. Glass pavers are embedded on the surface with many that are chipped, cracked, or missing. (Source: Seattle City Light, 2022.)
