LAKE COURT APARTMENTS

BRIEFING January 31, 2025

JANUARY 2025
WINDOW SURVEY, UNITS 1, 22, 109, AND 112

EMERGENCY WINDOW REPLACEMENT

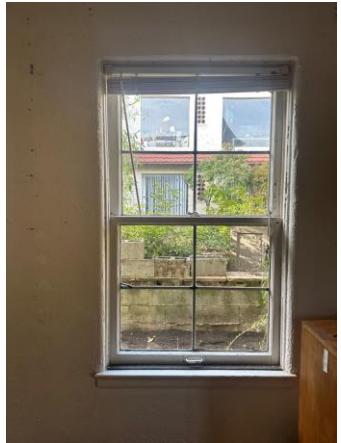
WINDOW 1_1

1_1	DESCRIPTION & CONDITION	SCORE
Window	Intact wood double hung four over four leaded glass. Poor condition	2
Frame	Wood frame inset into stucco	3
Sash	Wood double hung	1
Glass	leaded glass with 2 stained glass corners	3
Paint	many layers of cracking and flaking paint	1
Sill	Painted wood with evident rot	1
Casing	painted stool and apron, stucco returns to frame at jamb and head	3
Hardware	Painted metal	3

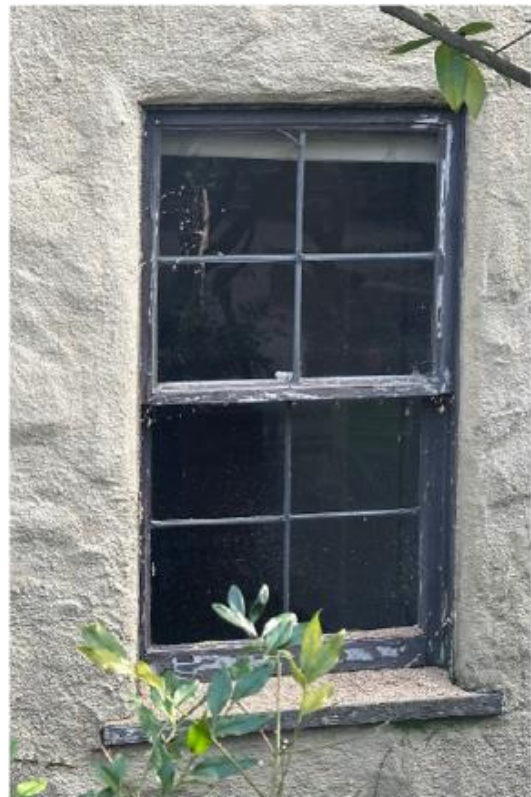
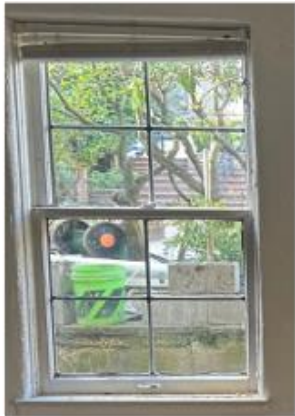
5.0 LIST OF WINDOWS & THEIR CONDITION
WINDOW 1_2

1_2	DESCRIPTION & CONDITION	SCORE
Window	Intact wood double hung four over four leaded glass. Poor condition	2
Frame	Wood frame inset into stucco	3
Sash	Wood double hung	1
Glass	leaded clear glass, single pane, with 2 stained glass corners	3
Paint	many layers of cracking and flaking paint	1
Sill	Painted wood with evident rot	1
Casing	painted stool and apron, stucco returns to frame at jamb and head	3
Hardware	Painted metal	3

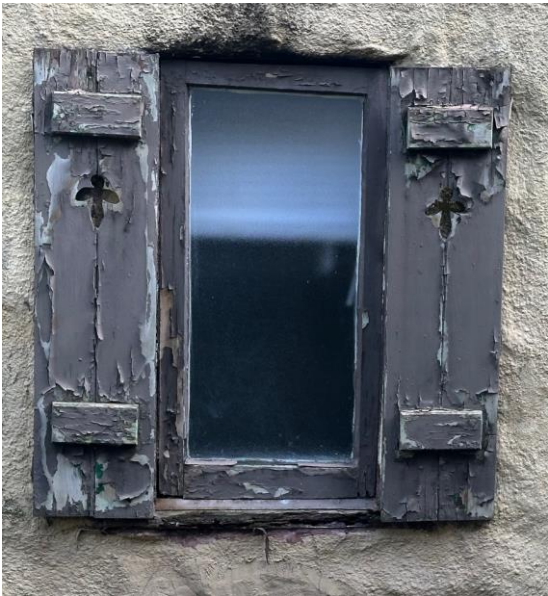
5.0 LIST OF WINDOWS & THEIR CONDITION
WINDOW 1_3

1_3	DESCRIPTION & CONDITION	SCORE
Window	Intact wood casement with frosted glass. Poor condition	2
Frame	Wood frame inset into stucco and decorative shutters	3/2
Sash	Casement	1
Glass	Obscure glass, probably replaced	0
Paint	many layers of cracking and flaking paint	1
Sill	Painted wood with major evident rot	1
Casing	painted stool and apron, stucco returns to frame at jamb and head	3
Hardware	NA	NA

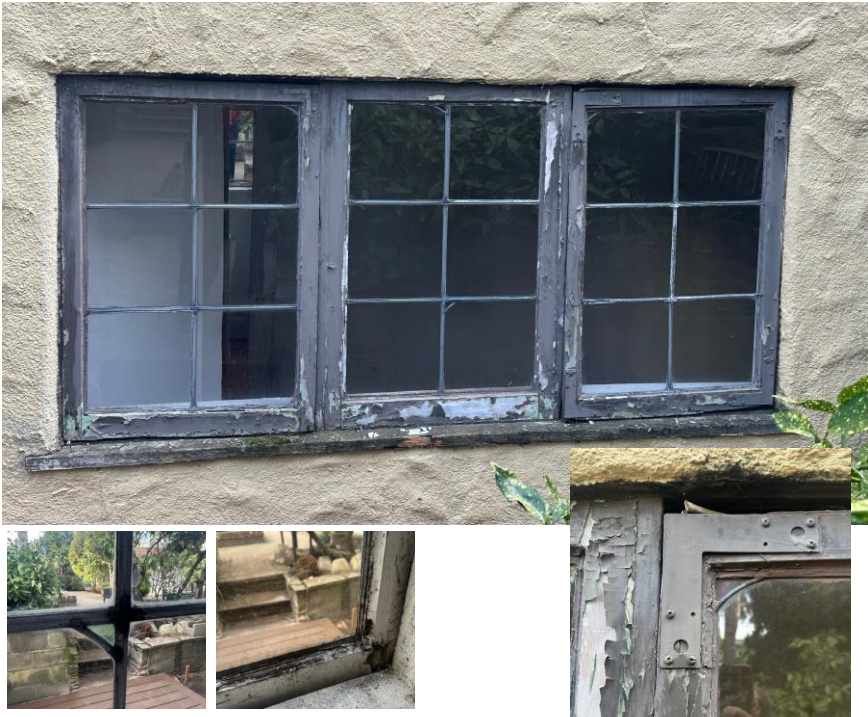
WINDOW 1_4

1_4	DESCRIPTION & CONDITION	SCORE
Window	3 intact wood casement each with two stained glass corners. Poor condition	2
Frame	Wood frame inset into stucco	2
Sash	3 casements in poor condition, with metal angle repairs and evident rot	1
Glass	6 light leaded clear glass single pane with 2 stained glass corners in each sash	3
Paint	many layers of cracking and flaking paint original green paint color observed	1
Sill	Painted wood with major evident rot	1
Casing	painted stool and apron, stucco returns to frame at jamb and head	2
Hardware	Painted metal	3

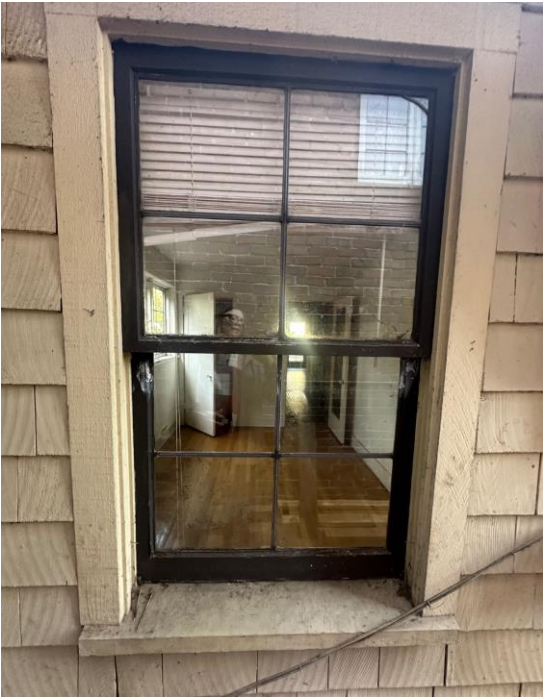
WINDOW 1_5

1_5	DESCRIPTION & CONDITION	SCORE
Window	Double hung 4-over-4 leaded glass with one stained glass corner. Poor condition	3
Frame	Wood frame	4
Sash	wood double hung with mold at interior bottom rail	3
Glass	4 light leaded clear glass in each sash, single pane with a stained glass corner in the upper sash	3
Paint	poor condition, peeling at glazing putty	2
Sill	Painted wood fair condition	3
Casing	painted stool and apron, with painted wood flange trim	3
Hardware	Painted metal	3

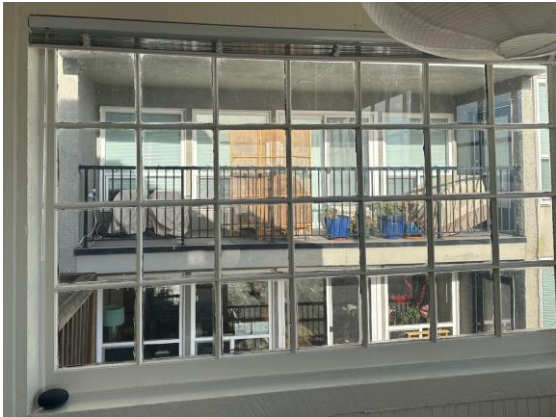
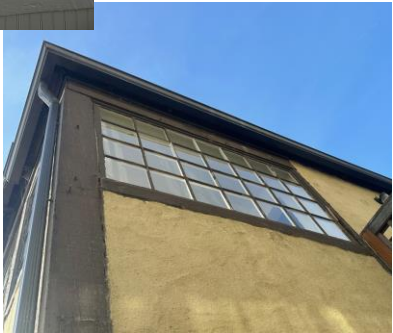
WINDOW 22_2

22_2	DESCRIPTION & CONDITION	SCORE
Window	Non-original 32 light fixed wood sash window with wood muntins	3
Frame	Painted wood frame not sealed allows water intrusion	2
Sash	Painted wood	3
Glass	32 true divided lights, single pane, clear glass	3
Paint	many layers of paint	1
Sill	Painted wood	NA
Casing	painted framing members with stops no casing	0
Hardware	None	NA

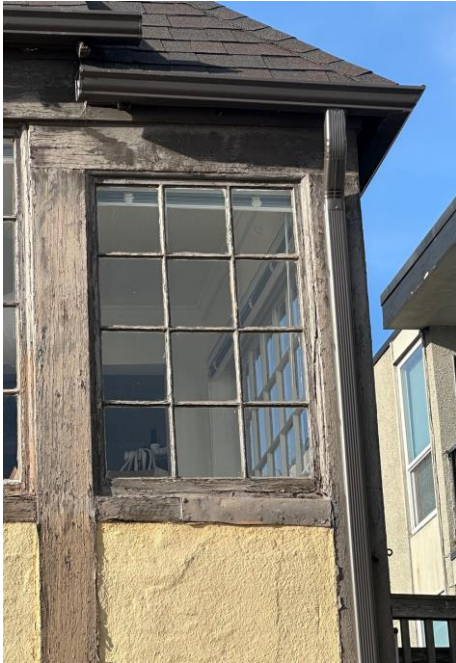
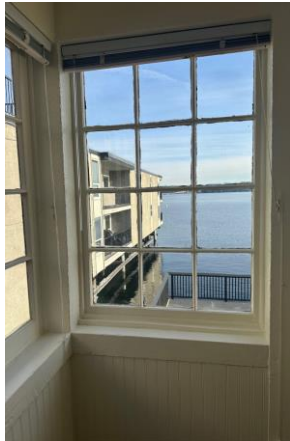
WINDOW 22_3

22_3	DESCRIPTION & CONDITION	SCORE
Window	Non-original 12 light fixed wood sash window with wood muntins	1
Frame	Painted wood frame not sealed allows water intrusion & not square	1
Sash	Painted wood in poor condition	1
Glass	12 true divided lights, single pane, clear glass	3
Paint	many layers of flaking paint	1
Sill	Painted wood with painted metal patch and evident rot	NA
Casing	painted framing members with stops no casing	0
Hardware	None	NA

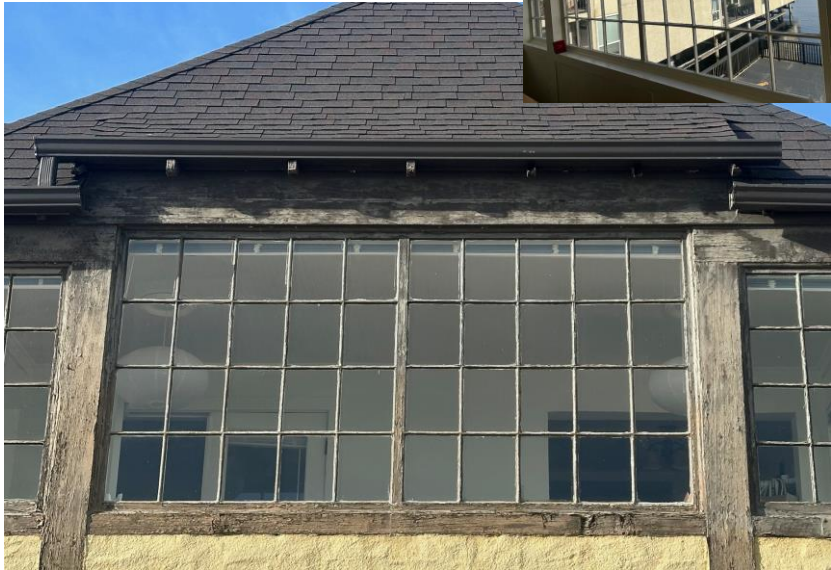
WINDOW 22_4

22_4	DESCRIPTION & CONDITION	SCORE
Window	Non-original 40 light fixed wood sash window divided with a central larger rail	1
Frame	Painted wood frame not sealed allows water intrusion	1
Sash	Painted wood in poor condition	1
Glass	40 true divided lights, single pane, clear glass, deteriorating putty	3
Paint	many layers of flaking paint	1
Sill	Painted wood with evident rot	NA
Casing	painted framing members with stops no casing	0
Hardware	None	NA

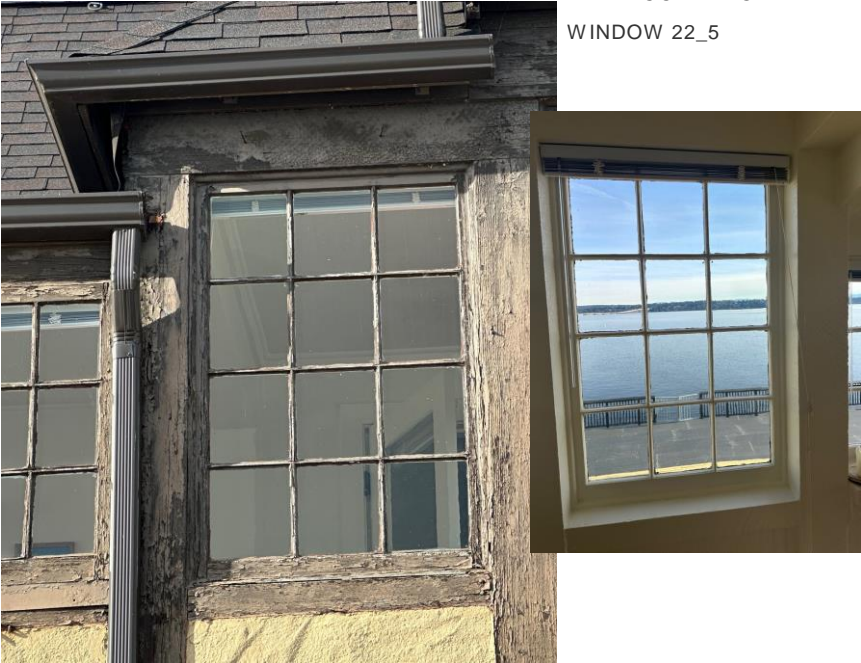
WINDOW 22_5

22_5	DESCRIPTION & CONDITION	SCORE
Window	Non-original 12 light fixed wood sash window with wood muntins	1
Frame	Painted wood frame not sealed allows water intrusion	1
Sash	Painted wood in poor condition	1
Glass	12 true divided single pane clear glass lights	3
Paint	many layers of flaking paint	1
Sill	Painted wood with evident rot	1
Casing	painted framing members with stops no casing	0
Hardware	None	NA

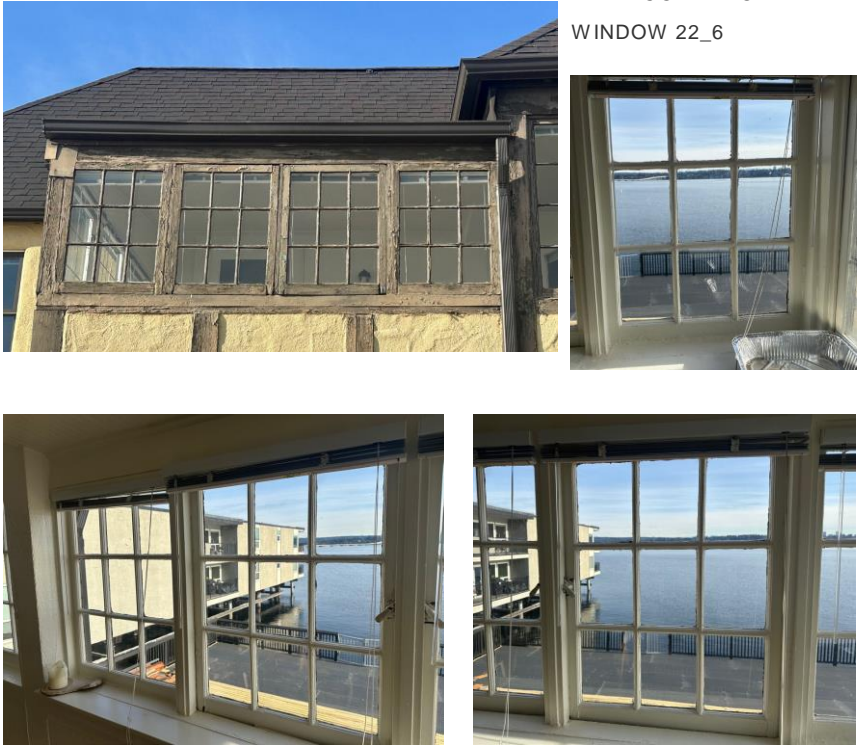
WINDOW 22_6

22_6	DESCRIPTION & CONDITION	SCORE
Window	Four 9-light casement wood sash windows with wood muntins & mullions, with two operable casements flanked by fixed sash.	1
Frame	Painted wood frame not sealed allows water intrusion	1
Sash	Painted wood in poor condition, casements do not close all the way	1
Glass	In each sash are 9 true divided single pane clear glass lights	3
Paint	many layers of flaking paint	1
Sill	painted metal flaking over wood with evident rot	1
Casing	painted framing members with stops no casing	0
Hardware	Push out casement latches and hinges	2

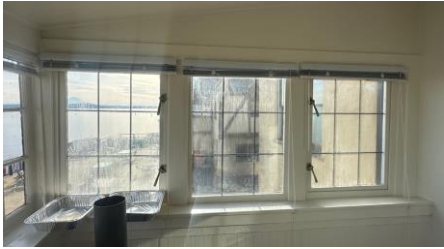
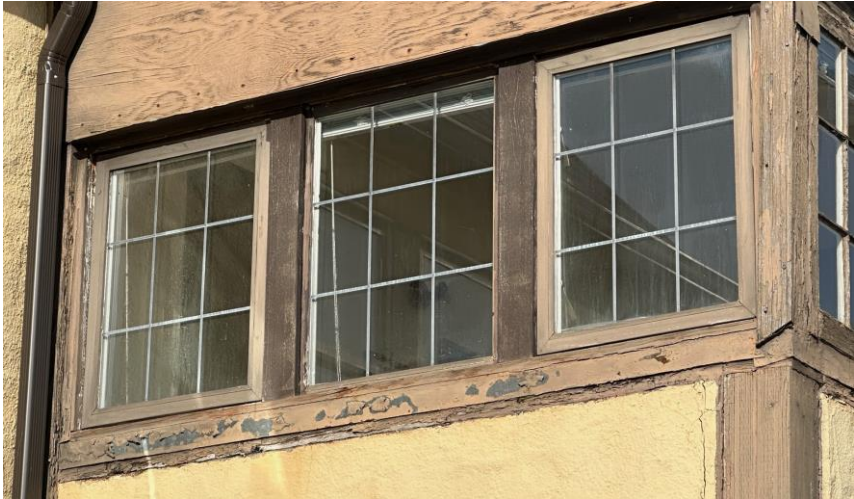
WINDOW 22_7

22_7	DESCRIPTION & CONDITION	SCORE
Window	three casement wood sash windows with exterior lead tape mimicing 9 lights for each window probably no more than 10 years old	3
Frame	Painted wood frame	3
Sash	Painted wood in good condition	4
Glass	One double glazed insulated unit in each sash	3
Paint	deteriorating brown paint at exterior, white paint at interior	1
Sill	painted metal flashing over wood with evident rot	1
Casing	White painted flt stock casing	4
Hardware	Push out casement latches and hinges	2

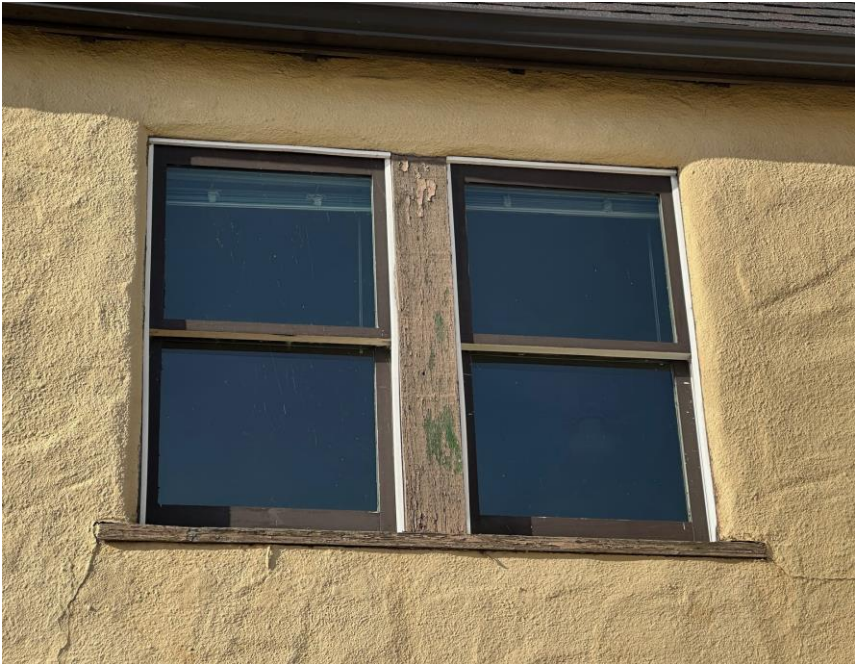
WINDOW 22_8

22_8	DESCRIPTION & CONDITION	SCORE
Window	Two single hung vinyl sash replacement windows probably no more than 10 years old	3
Frame	Vinyl frame inserted into painted wood frame, deteriorating wood at mullion	4
Sash	Painted vinyl	4
Glass	One double glazed insulated unit in each sash	3
Paint	deteriorating brown paint at exterior, white paint at interior	1
Sill	painted wood with evident rot	1
Casing	White painted jamb liners with stool and apron	4
Hardware	NA	NA

REPLACE 22_8 & 22_9
SINGLE HUNG W/
4-OVER-4 LIGHT

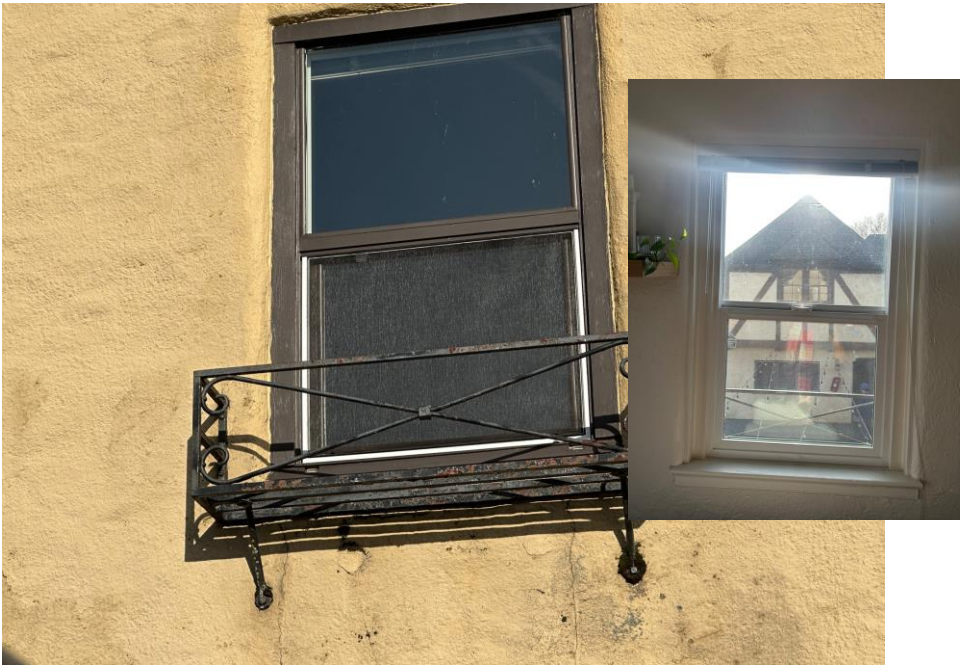
WINDOW 22_9

22_9	DESCRIPTION & CONDITION	SCORE
Window	Single hung vinyl sash replacement window probably no more than 10 years old	4
Frame	Vinyl frame inserted into painted wood frame	4
Sash	Painted vinyl	4
Glass	One double glazed insulated unit in each sash	3
Paint	brown paint at exterior, white paint at interior	4
Sill	NA	NA
Casing	White painted jamb liners with stool and apron	4
Hardware	NA	NA

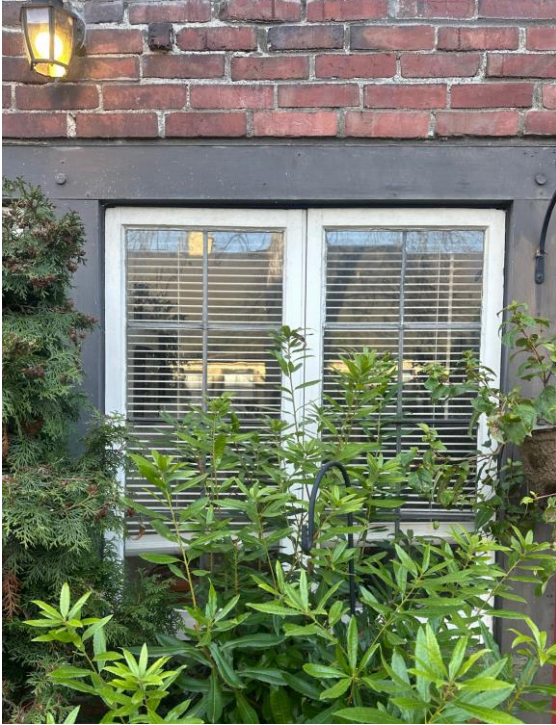
WINDOW 109_1

109_1	DESCRIPTION & CONDITION	SCORE
Window	French Casement with leaded 8-light glass doesn't close properly, allows moisture into unit	3
Frame	Painted wood frame	3
Sash	Two painted wood french casement sash	3
Glass	8-light leaded with a horizontal saddlebar, putty is deteriorated	3
Paint	brown paint at frame, white paint at sash	4
Sill	NA	NA
Casing	NA	NA
Hardware	NA	NA

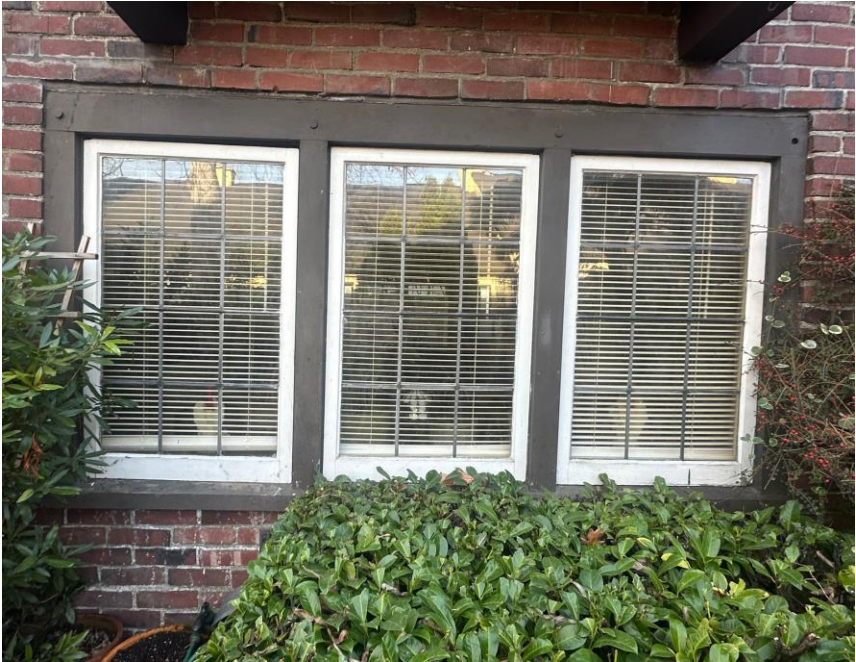
WINDOW 109_2

109_2	DESCRIPTION & CONDITION	SCORE
Window	Three casement with leaded 12-light glass. doesn't close properly, allows moisture into unit	3
Frame	Painted wood frame with two mullions. One decorative peg missing	3/4
Sash	three painted wood casement sash	3
Glass	12-light leaded with a horizontal saddlebar. putty is deteriorating	3
Paint	brown paint at exterior frame, white paint at sash	4
Sill	NA	NA
Casing	NA	NA
Hardware	NA	NA

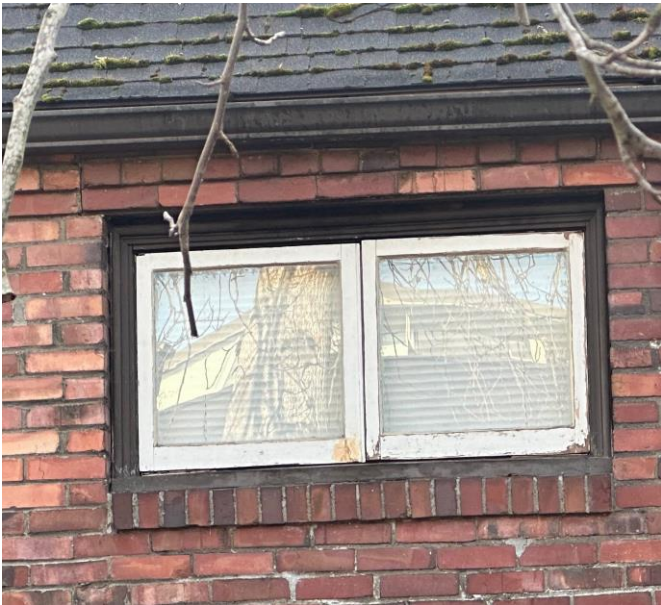
WINDOW 109_3

109_3	DESCRIPTION & CONDITION	SCORE
Window	French casement. doesn't close properly, allows moisture into unit	2
Frame	Painted wood brickmold frame	3
Sash	two painted wood casement sash, poor condition with rot and deteriorating joints	1
Glass	single pane. putty is deteriorating	2
Paint	brown paint at exterior frame, poor condition white paint at sash	1
Sill	NA	NA
Casing	NA	NA
Hardware	NA	NA

REPLACE CASEMENTS W/
LIGHT CONFIGURATIONS
REPLACE 109_3 WW/
(2) 4 LIGHT SASH
REPLACE DOORS 109_4
W/ MATCHING 10-LIGHT

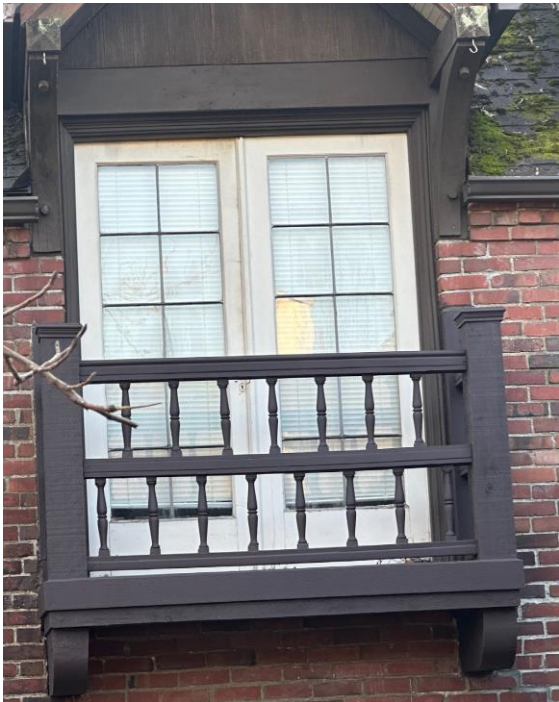
WINDOW 109_4

109_4	DESCRIPTION & CONDITION	SCORE
Window	French casement door □ doesn't close properly, allows moisture into unit	3
Frame	Painted wood brickmold frame □	4
Sash	two painted wood door leaves, rot and mold at bottom rail	2
Glass	each leaf has 10 light clear single pane with horizontal saddle bars	3
Paint	brown paint at exterior frame, poor condition white paint at door leaves	1
Sill	NA	NA
Casing	NA	NA
Hardware	NA	NA

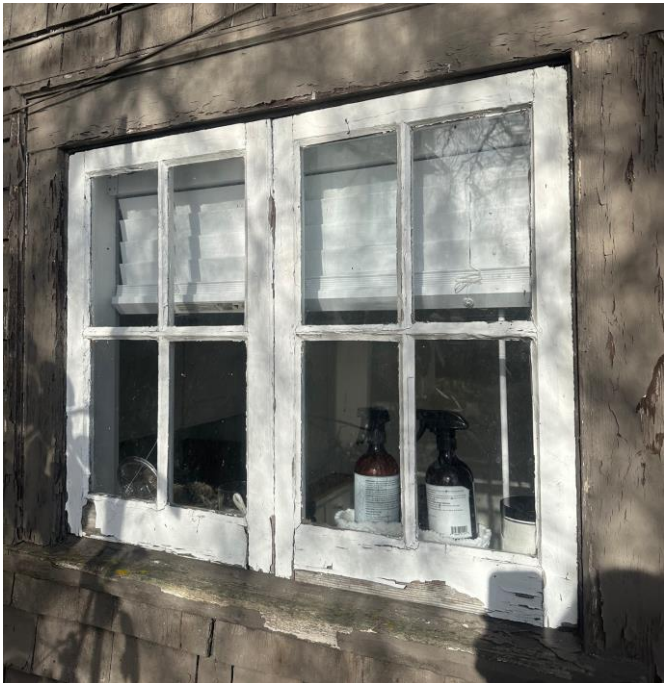
WINDOW 109_5

109_5	DESCRIPTION & CONDITION	SCORE
Window	French casement □ doesn't close properly, allows moisture into unit	1
Frame	Painted wood frame with evident rot	1
Sash	two casements with four true divided lights with wood muntins, evident rot	1
Glass	each sash has 4 clear single panes □ putty has deteriorated	3
Paint	poor condition brown paint at exterior frame, poor condition white paint at sash	1
Sill	wood sill with evident rot	1
Casing	NA	NA
Hardware	NA	NA

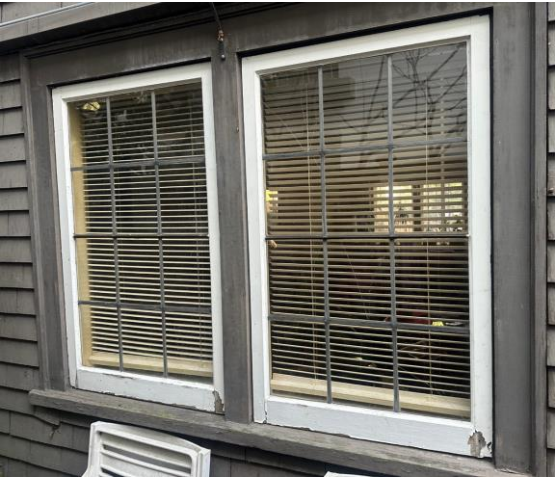
WINDOW 109_6

109_6	DESCRIPTION & CONDITION	SCORE
Window	Double casement with central mullion - doesn't close properly, allows moisture into unit	3
Frame	Painted wood frame	4
Sash	two casements with 12 true divided lights, evident rot at lower joints	2
Glass	each sash has 12 clear single panes with leading and a horizontal saddlebar	2
Paint	brown paint at exterior frame, poor condition white paint at sash	1
Sill	Painted wood sill, softening wood due to rot	2
Casing	NA	NA
Hardware	NA	NA

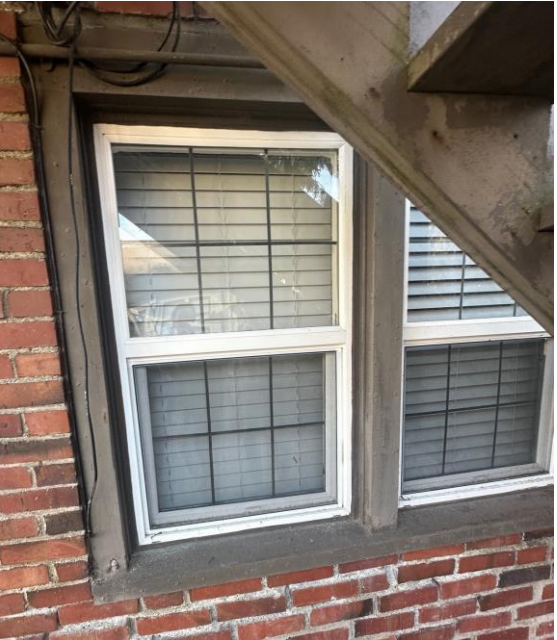
WINDOW 112_1

112_1	DESCRIPTION & CONDITION	SCORE
Window	Double replacement vinyl single hungs with interior grids and central mullion	4
Frame	Painted wood frame	4
Sash	two non-original vinyl single hung	4
Glass	insulated double pane units with interior grids	2
Paint	brown paint at exterior frame, sash are unpainted	3
Sill	Painted wood sill	4
Casing	NA	NA
Hardware	NA	NA

REPLACE 112_1 W/
4-OVER-4
REPLACE 112_5 W/
6 LIGHT REPLACE
ALL OTHERS W/ MATCHING
PANE CONFIGURATIONS

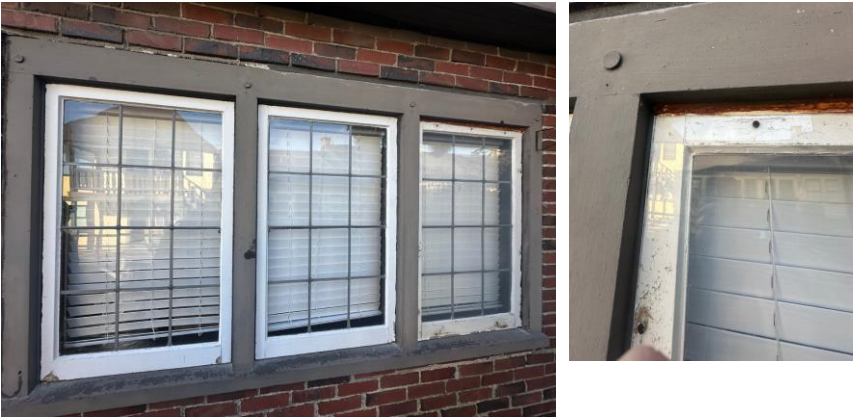
WINDOW 112_2

112_2	DESCRIPTION & CONDITION	SCORE
Window	Triple casement with two mullions. doesn't close properly, allows moisture into unit. note foam at westernmost window head	2
Frame	Painted wood frame	4
Sash	three casements with 12 true divided lights, separation at lower joints	1
Glass	each sash has 12 clear single panes with leading, a horizontal saddlebar, and deteriorating putty. Westernmost window has exterior plexiglass	2
Paint	brown paint at exterior frame, poor condition white paint at sash	2
Sill	Painted wood sill, softening wood due to rot	3
Casing	NA	NA
Hardware	NA	NA

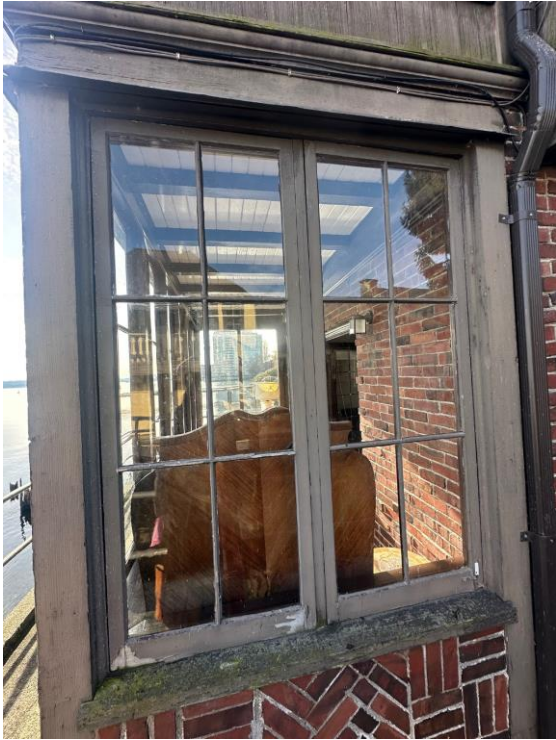
WINDOW 112_3

112_3	DESCRIPTION & CONDITION	SCORE
Window	Double casement with center mullion. now inoperable, allows moisture into unit	2
Frame	Painted wood frame, metal head flashing	2
Sash	two casements with wood muntins, each with 6 true divided lights and separation at lower joints	2
Glass	each sash has 6 clear single panes with deteriorating putty.	2
Paint	poor condition brown paint	1
Sill	Painted wood sill, softening wood due to rot and biological growth	1
Casing	NA	NA
Hardware	NA	NA

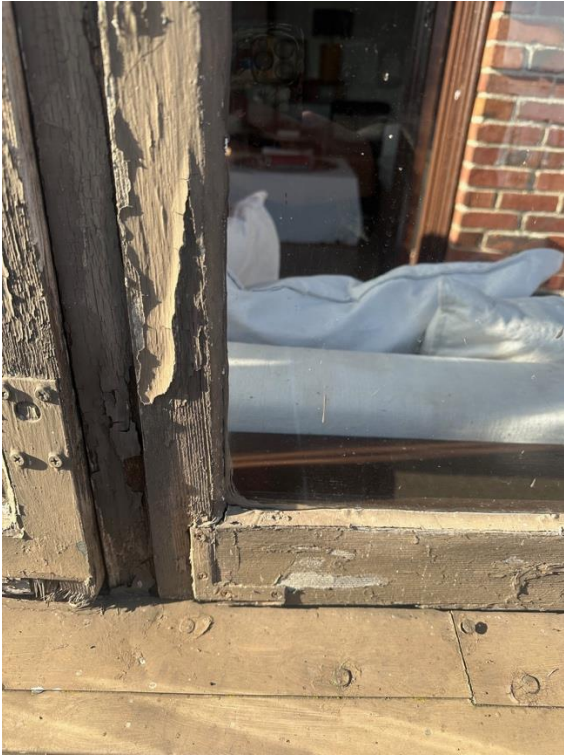
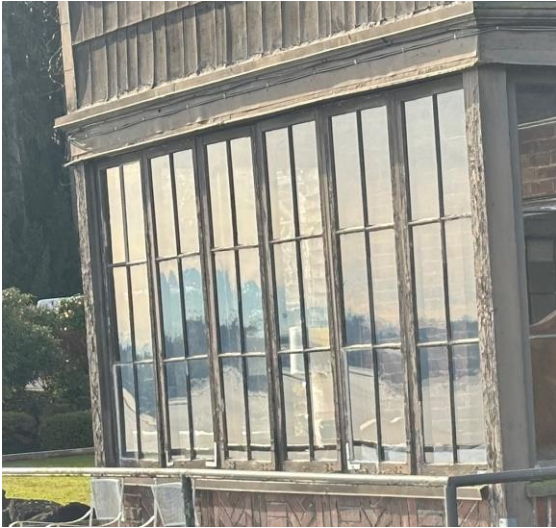
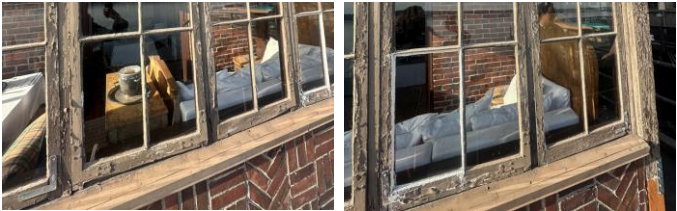
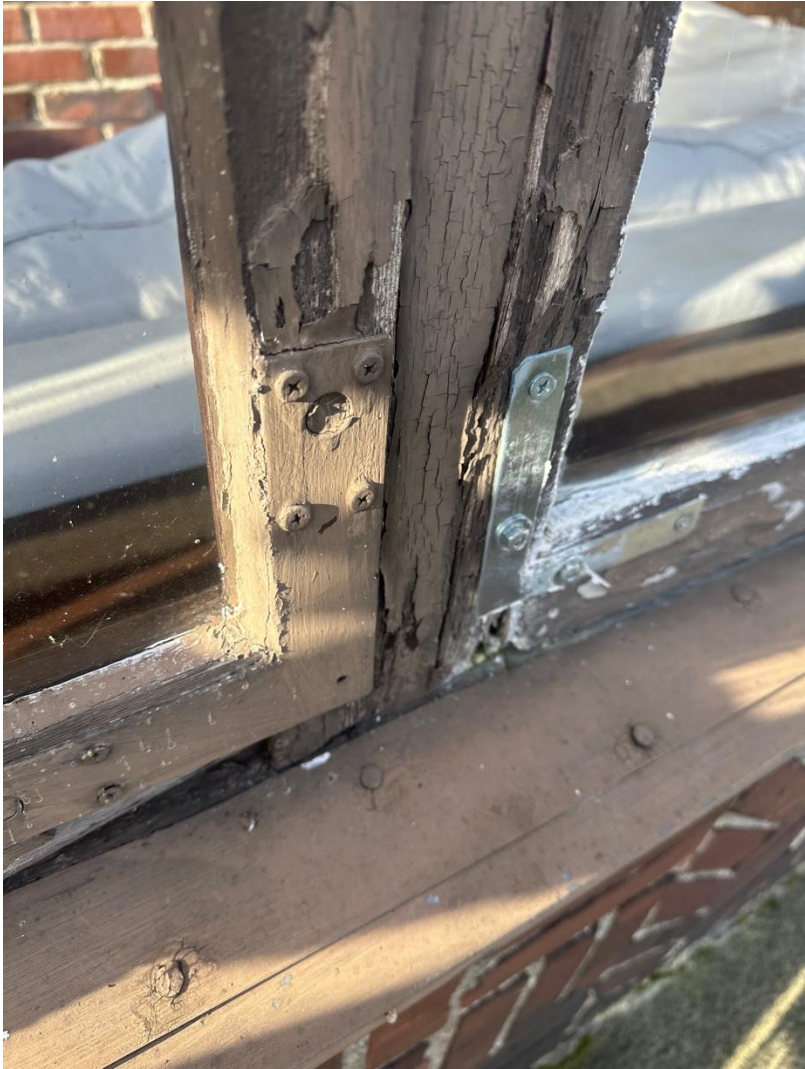
WINDOW 112_4

112_3	DESCRIPTION & CONDITION	SCORE
Window	Six casements with mullions. Now inoperable, allows moisture into unit	1
Frame	Painted wood frame with softening wood due to rot, metal head flashing	1
Sash	Each sash has wood muntins separating 6 true divided lights, separation at lower joints has been reinforced with metal angles	1
Glass	each sash has 6 clear single panes with deteriorating putty .	2
Paint	poor condition brown paint flaking to bare wood	0/1
Sill	Painted metal flashing on wood sill	1
Casing	NA	NA
Hardware	NA	NA

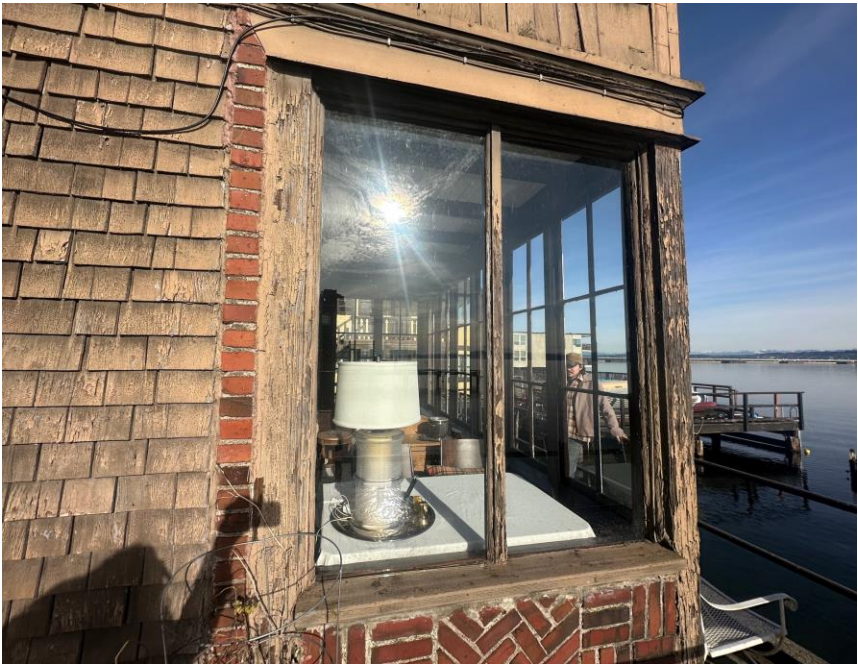
WINDOW 112_5

112_4	DESCRIPTION & CONDITION	SCORE
Window	two fixed single panes with a center mullion allows moisture into unit	1
Frame	Painted wood frame with softening wood due to rot, metal head flashing	1
Sash	stopped in glass has no sash	NA
Glass	clear panes with deteriorating wood stops	2
Paint	poor condition brown paint flaking to bare wood	0/1
Sill	non-original pressure treated wood sill	1
Casing	NA	NA
Hardware	NA	NA

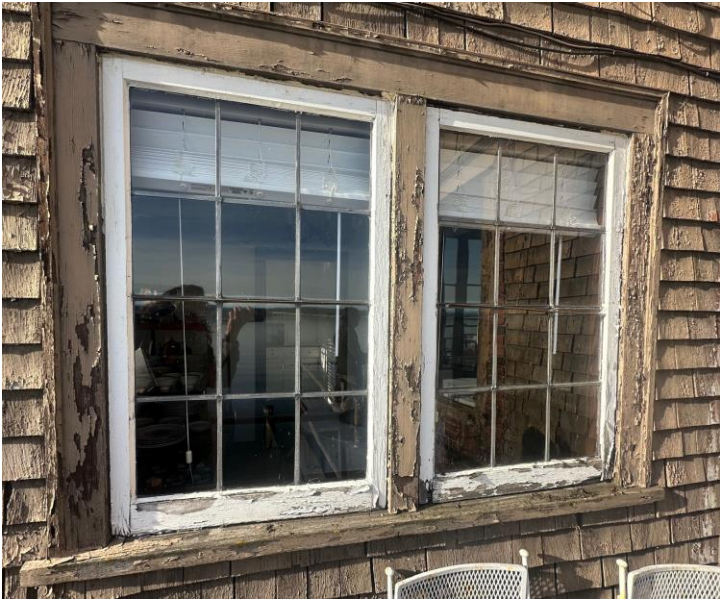
WINDOW 112_6

112_5	DESCRIPTION & CONDITION	SCORE
Window	two leaded glass casements with center mullion allows moisture into unit	1
Frame	Painted wood frame with softening wood due to rot	1
Sash	two 12-light wood casements in poor condition	1
Glass	each sash has 12 clear leaded glass panes with a horizontal saddlebar	2
Paint	poor condition brown paint flaking to bare wood	0/1
Sill	non-original pressure treated wood sill	1
Casing	NA	NA
Hardware	NA	NA
