Subject: Gas Works Park Cracking Towers – Pedestrian Appurtenance Removal Certificate of Approval Application

Certificate of Approval Request

GAS WORKS PARK "CRACKING TOWERS": EMERGENCY SELECTIVE DECONSTRUCTION

Re: Condition Survey
Gas Generator
Gas Works Park
MTE Project No. S1062

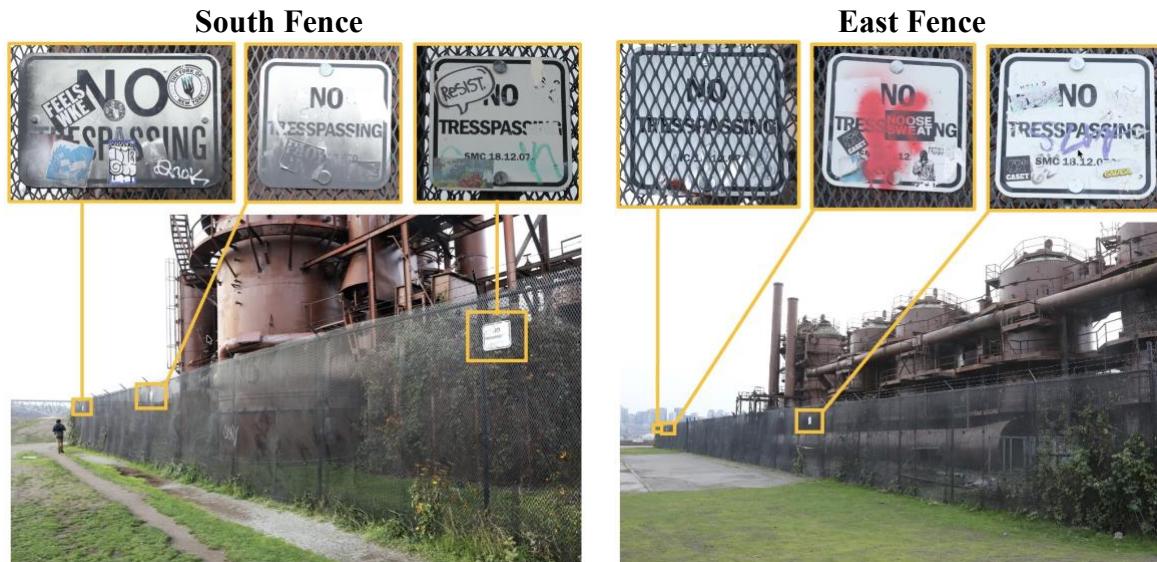
above the ground. Three “NO TRESPASSING” signs were posted on the east fence, and three signs were posted on the south fence; see Figure 2. As depicted in Figure 2, several of these signs contained graffiti, decals, and/or stickers on the front surface of the sign that partially obscured legibility of the sign.

Figure 2. Photographs taken during GEAR’s November 12, 2025, site inspection, depicting numerous “NO TRESPASSING” signs posted on the south (left) and east (right) sides of the perimeter fence.

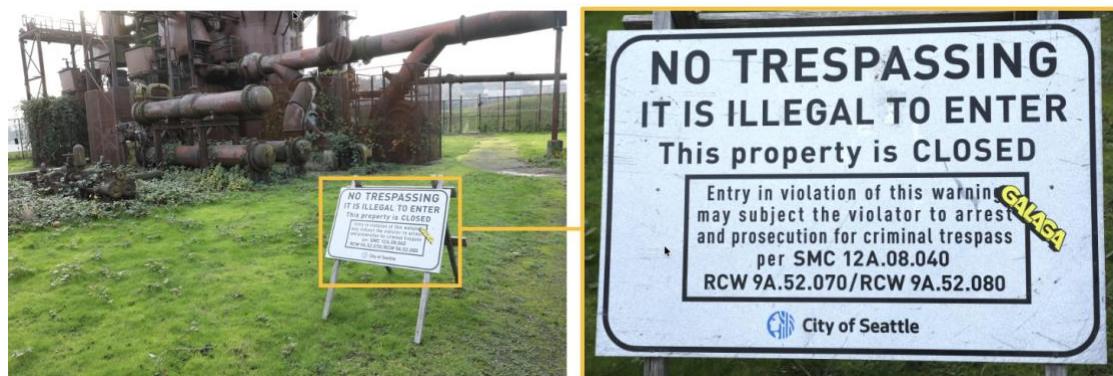
In addition, at the time of GEAR’s inspection, a portable A-frame sign was located in the interior of the fenced perimeter near the (locked) gate on the east side of the perimeter fence; see Figure 3. The sign, approximately 2 feet wide by 3 feet long, contains black-colored text on a white background that reads: “NO TRESPASSING,” “IT IS ILLEGAL TO ENTER,” “This property is CLOSED;” see Figure 3. Below this text, the sign reads, “Entry in violation of this warning may subject the violator to arrest and prosecution for criminal trespass,” with indication of the applicable SMC and RCWs; see Figure 3. In addition, during GEAR’s inspection, a second A-board sign with this same text was observed in a stored position beneath the structure; the sign contained a significant amount of graffiti which occluded and obscured the legibility of the text.

Figure 3. A photograph taken during GEAR’s November 12, 2025, site inspection, depicting a portable A-frame “NO TRESPASSING,” “IT IS ILLEGAL TO ENTER” sign.

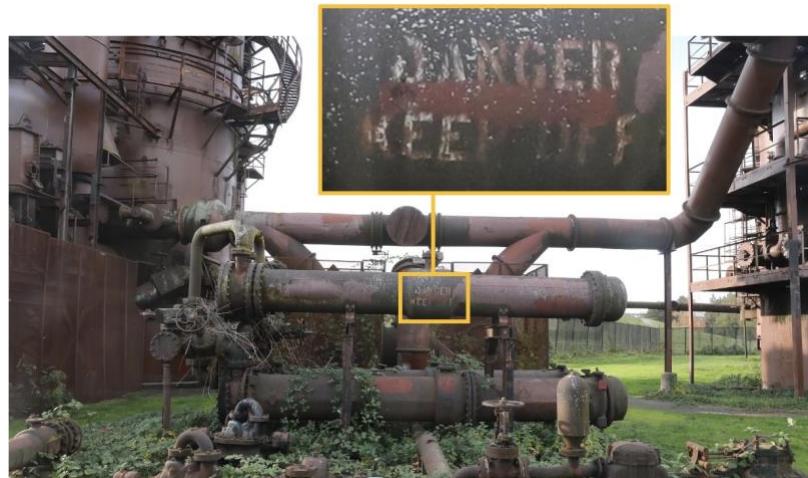
Finally, there are several areas on the subject structure (e.g., piping, tanks) that contain written text indicating “DANGER,” “KEEP OFF.” For example, Figure 4 depicts piping on the east side of the structure with this admonition.

Figure 4. A photograph taken during GEAR’s November 12, 2025, site inspection, depicting the text “DANGER,” “KEEP OFF” on a section of piping on the east side of the subject structure.

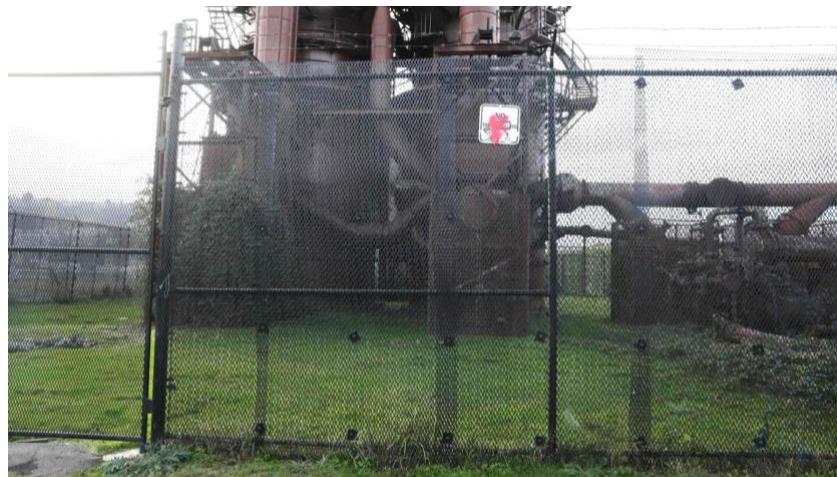
The Gas Works Park structure is enclosed around its perimeter by a metal grating fence, with three rows of barbed wire installed at the top of the fence; see Figure 5. Relative to the ground on the exterior sides of the fence, the metal-grated fence measures approximately 9 feet, 4 inches to 10 feet, 2 inches tall in height, with the barbed wire extending the height of the fence to approximately 10 feet, 4 inches to 11 feet, 2 inches. The interior of the fenced area is accessed (by authorized personnel) via a gate on the east side of the perimeter fence; the gate is locked and secured via a chain and padlock. Additional, non-functional gates (i.e., welded shut) are present in other areas around the perimeter fence.

Figure 5. A photograph taken during GEAR’s November 12, 2025, site inspection, depicting a section of the metal-grated fencing and barbed wire that extends around the perimeter of the subject enclosure.

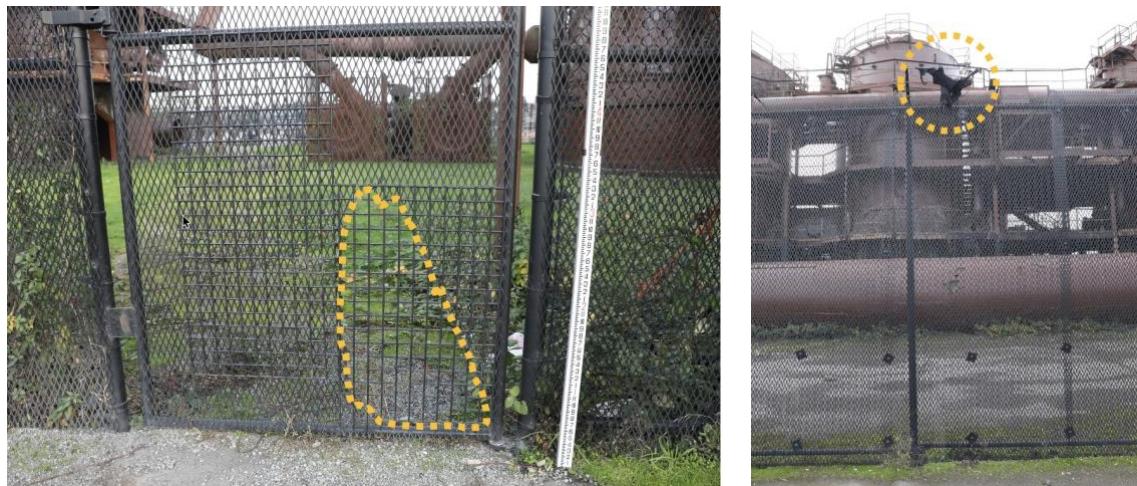
Observations by GEAR during the site inspection suggest there have been previous attempts to overcome the fencing and/or access the interior area within the perimeter fencing. For example, on the west side of the perimeter fencing in the former location of a gate (currently welded shut), an irregular-shaped section of metal grating had been removed from the lower portion of the grate, with an additional piece of metal grating welded over the missing section; see Figure 6. In addition, at the time of GEAR's inspection, a torn/ripped garment was present on the barbed wire on the east side of the perimeter fencing; see Figure 6. It was not possible to determine whether the presence and condition of the garment was the result of an individual climbing over the top of the fence or whether the garment was thrown and/or placed on top of the fence. Furthermore, as described above, the "NO TRESPASSING" signs around the fence perimeter contained graffiti, decals, and/or stickers, suggesting that individuals had obtained an elevated height—i.e., up to the approximate 8-foot height at which the signs were posted—to vandalize these signs. In addition, while there were no fixed objects or structures around the exterior of the perimeter in proximity to the fencing, there were portable, non-fixed objects in the park (e.g., that, if moved, could facilitate climbing and/or penetration of the fence). For example, at the time of GEAR's inspection, several trash bins were located adjacent to the fence on the northwest side of the perimeter. The trash bins were unsecured and measured approximately 3½ feet tall.

Figure 6. Photographs taken during GEAR's November 12, 2025, site inspection. *Left*) A photograph depicting a missing section of metal fencing on the west perimeter (with additional metal-grating welded over the missing section). *Right*) A partially torn/ripped garment on the barbed wire at the top of the fencing on the east perimeter.

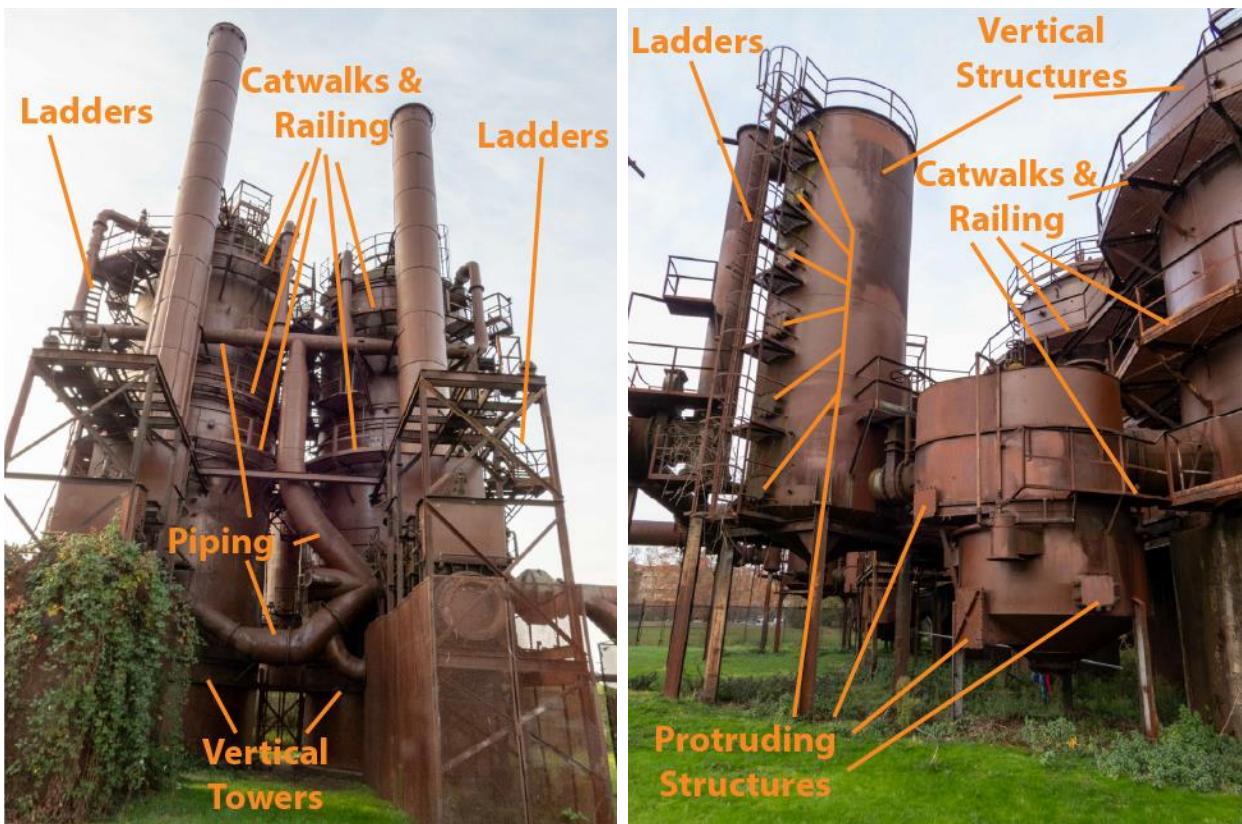
During the November 12, 2025, inspection, GEAR observed different types of structures at Gas Works Park. There were the main vertical towers and structures. There were also pedestrian appurtenances, such as, catwalks, ladders and railing (and the supporting structures for them); see Figure 10. There were also components such as piping and other protruding structures that were welded or bolted on to the vertical components and towers.

Figure 10. Photographs of the structures at Gas Works Park. There were the main vertical towers and structures. There were also pedestrian appurtenances such as catwalks, ladders and railing (and the supporting structures for them). There were also components such as piping and other protruding structures that were welded or bolted on to the vertical components and towers.

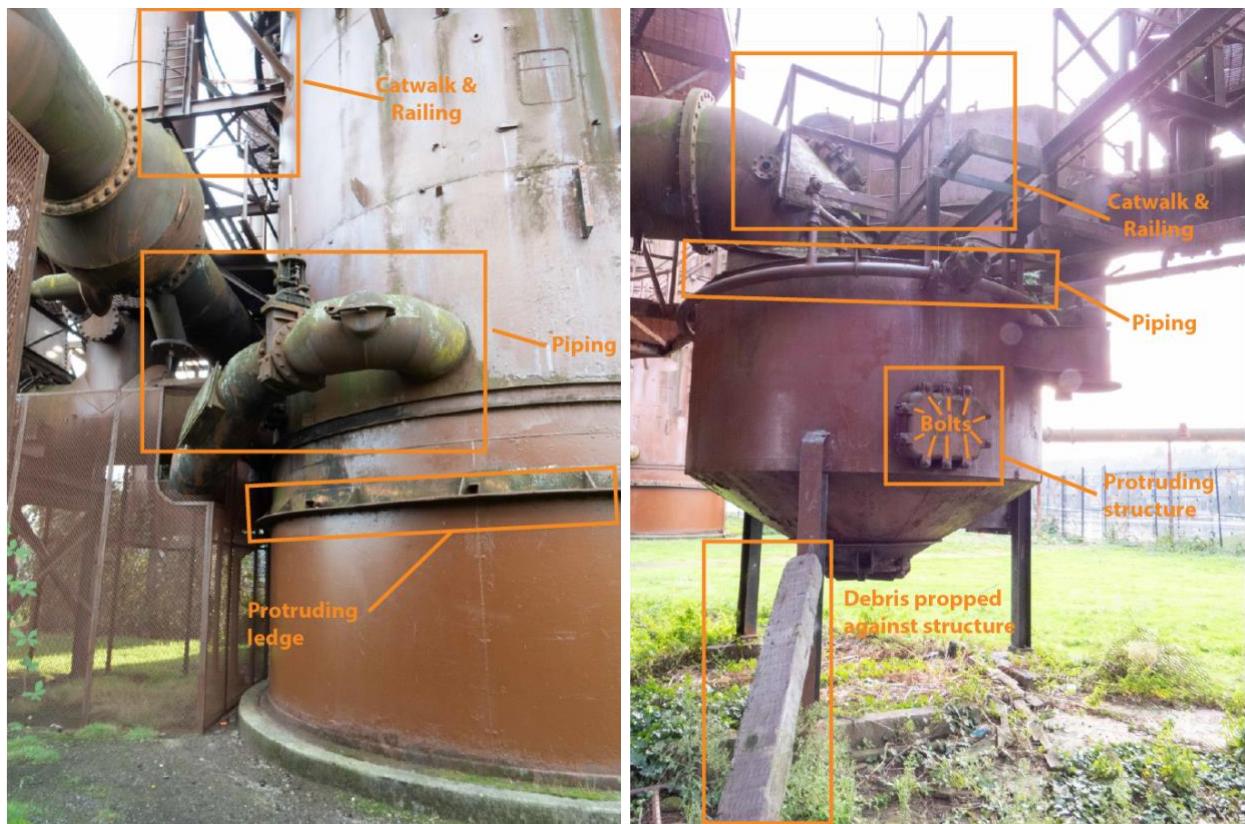
On the south towers there was a protruding ledge that was approximately 6 feet above a concrete slab that protruded approximately 8 inches from the vertical tower wall; see Figure 11, left. Above the protruding ledge was piping that was less than 11 feet in height from the protruding ledge below and further in height was a catwalk and railing. In another area, there was a protruding structure that was approximately 7 to 8 feet above the ground and protruded approximately 7 inches from the vertical wall; see Figure 11, right. This structure had bolts that provided additional areas for finger holds. Above the lower protruding structures there was piping and a catwalk and railing within 11 feet in height.

Figure 11. *Left)* A protruding ledge on a tower that was approximately 6 feet above a concrete slab that protruded approximately 8 inches from the vertical tower wall. Above the protruding ledge was piping that was less than 11 feet in height from the protruding ledge below and further in height was a catwalk and railing. *Right)* A protruding structure that was approximately 7 to 8 feet above the ground and protruded approximately 7 inches from the wall. This structure had bolts that provided additional areas for finger holds. Above the lower protruding structures there was additional piping and a catwalk and railing within 11 feet. At the time of the inspection, there was debris that was propped against the structure.

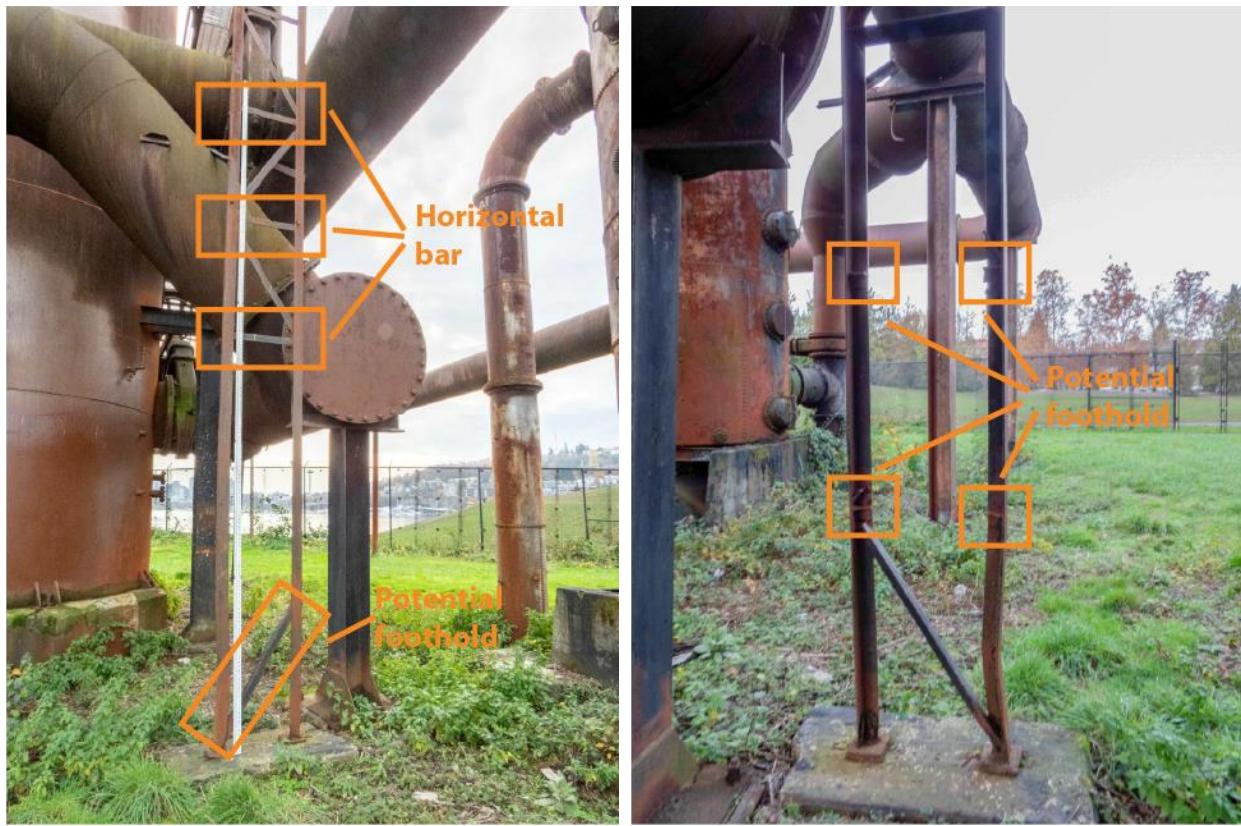
Figure 12. *Left)* Horizontal metal bars. The lowest horizontal bar was approximately 9 feet in height and narrow in diameter that provided a graspable surface that fingers could wrap around. Below this horizontal bar there was a diagonal bar that could provide a foothold to assist in reaching the horizontal bar. *Right)* The other side of the same structure. There were horizontal ledges that could provide potential footholds.

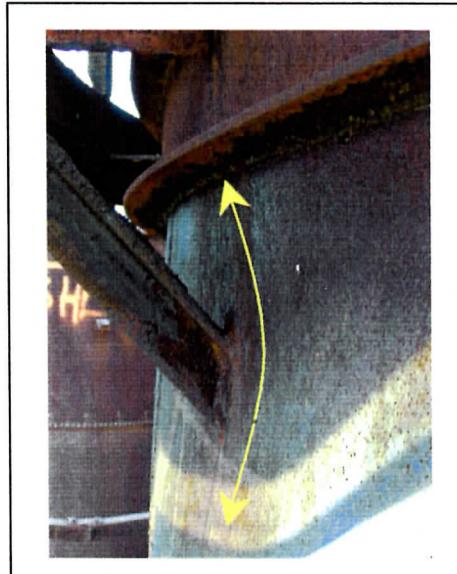
1. Supporting Level 2 catwalk, shell depressions at the catwalk knee braces along the south side.

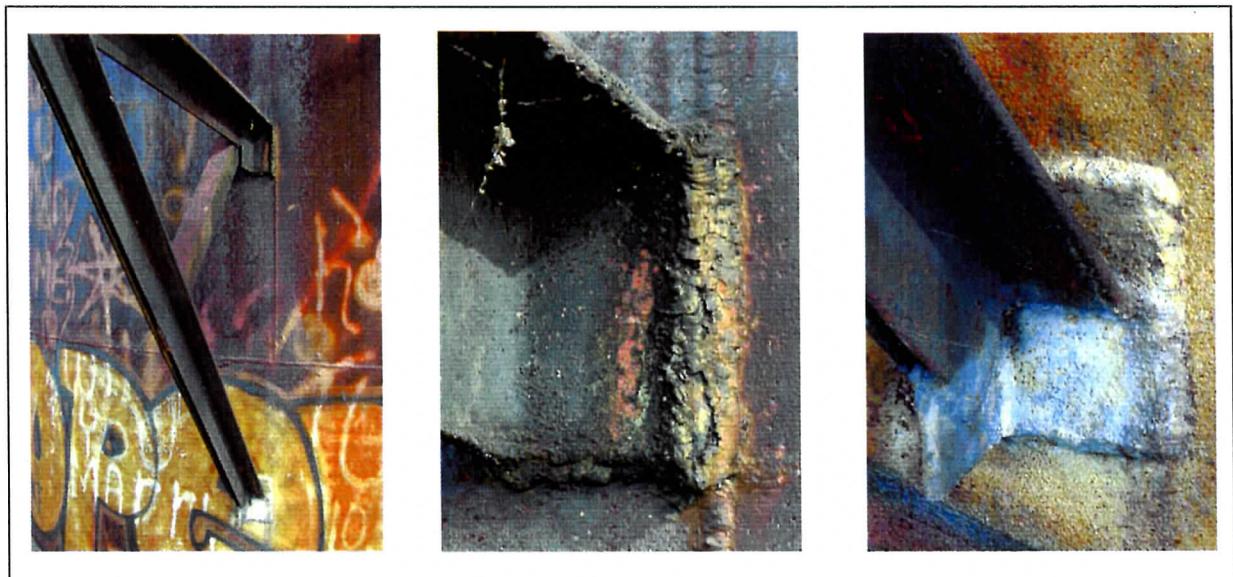
2. Typical stair support brace system.

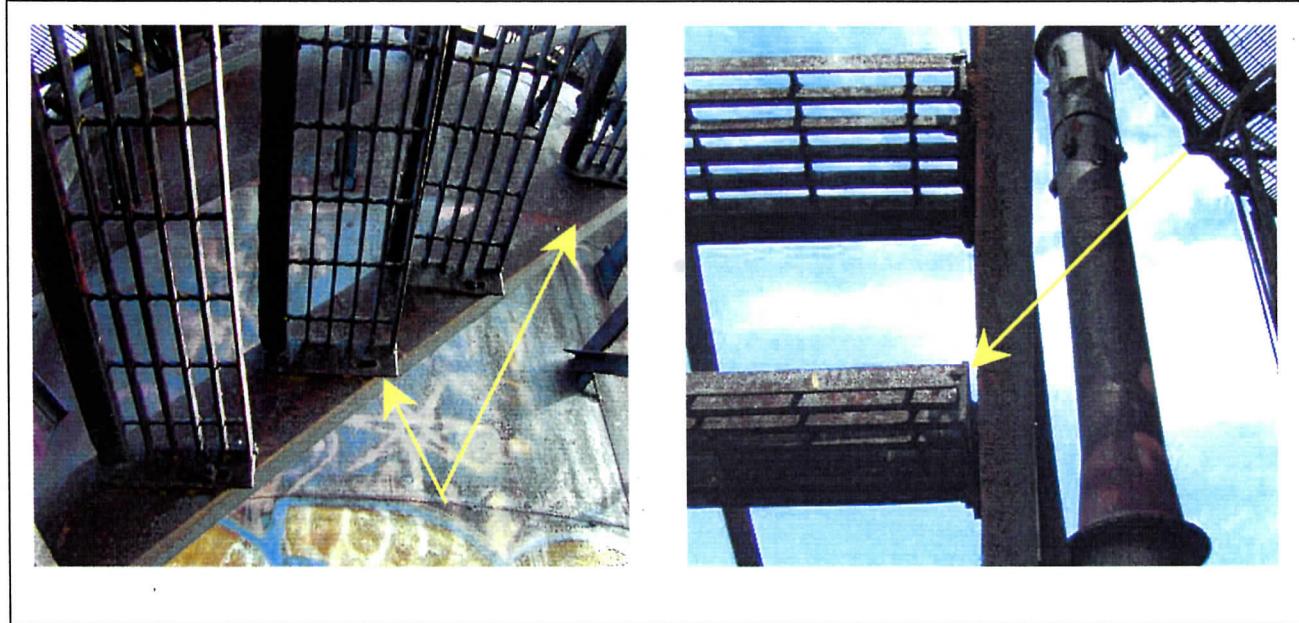
3. South stairway from catwalk levels 2 to 3 has missing stair steps. Bolts have failed at various treads due to corrosion-separating some stringer channels from grating steps. Catwalk grating has numerous panels missing and is heavily corroded. None of the stair or catwalk grates appear to be in a safe or usable condition.

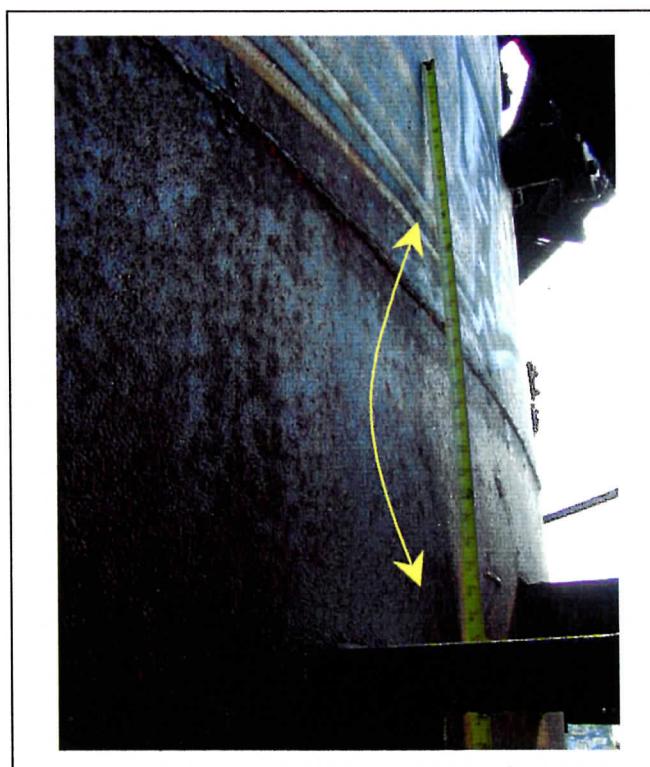
4. Deformations and buckles in shell walls at the south elevation of catwalk Level 1. Depressions and buckles are 1" nominally out of plane.

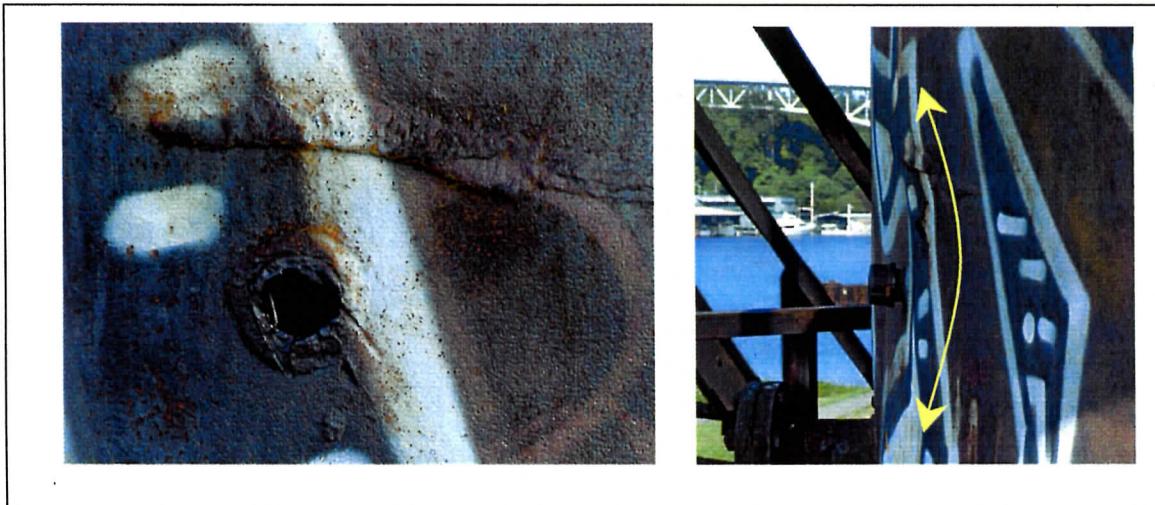
5. A repair weld was made to a tear/crack in the shell at catwalk Level 2. The shell also has a depression at this nozzle location.

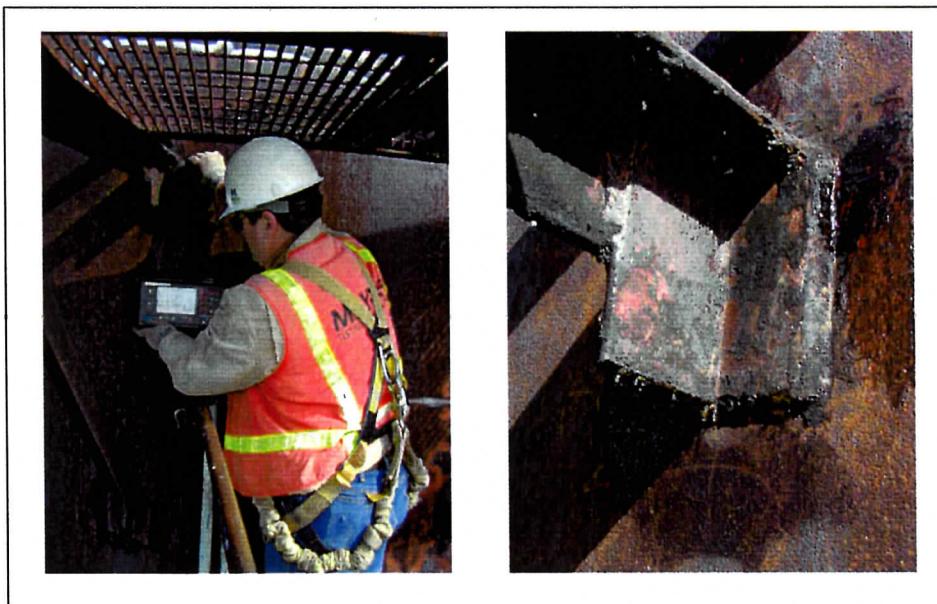
6. Welds of catwalk support systems appear to be in fair condition with no apparent in service failures.

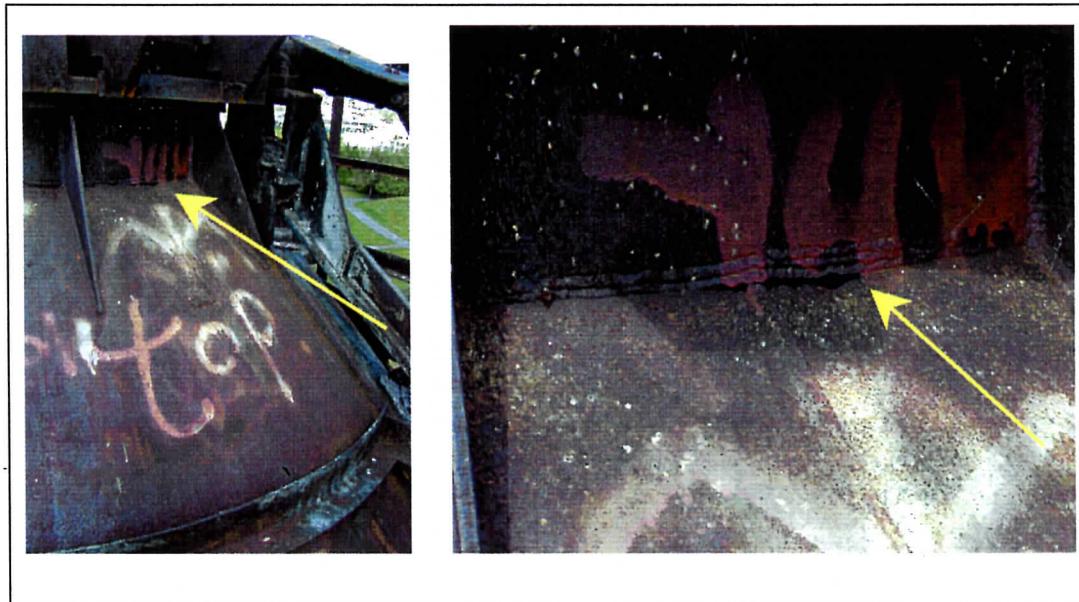
7. The conical roof section at top of vessel has holes corroded completely through its wall at manway fit-up connection joint. Thickness readings taken here ranged from 0.370", 0.360", and 0.160".

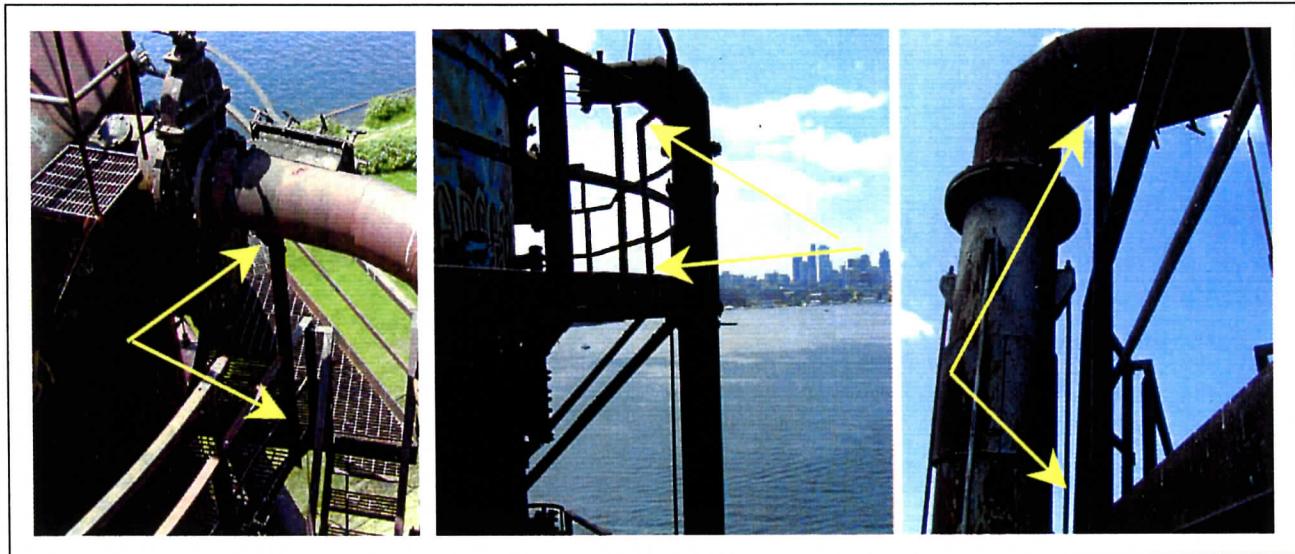
8. Vessel's upper piping is largely supported by upper catwalk framing. In one case, corrosion has left a 10' section of piping almost entirely resting on stanchion angle being carried by catwalk.
