# McGilvra Elementary School

## Historic Wood Window Refurbishment & Glazing Replacement

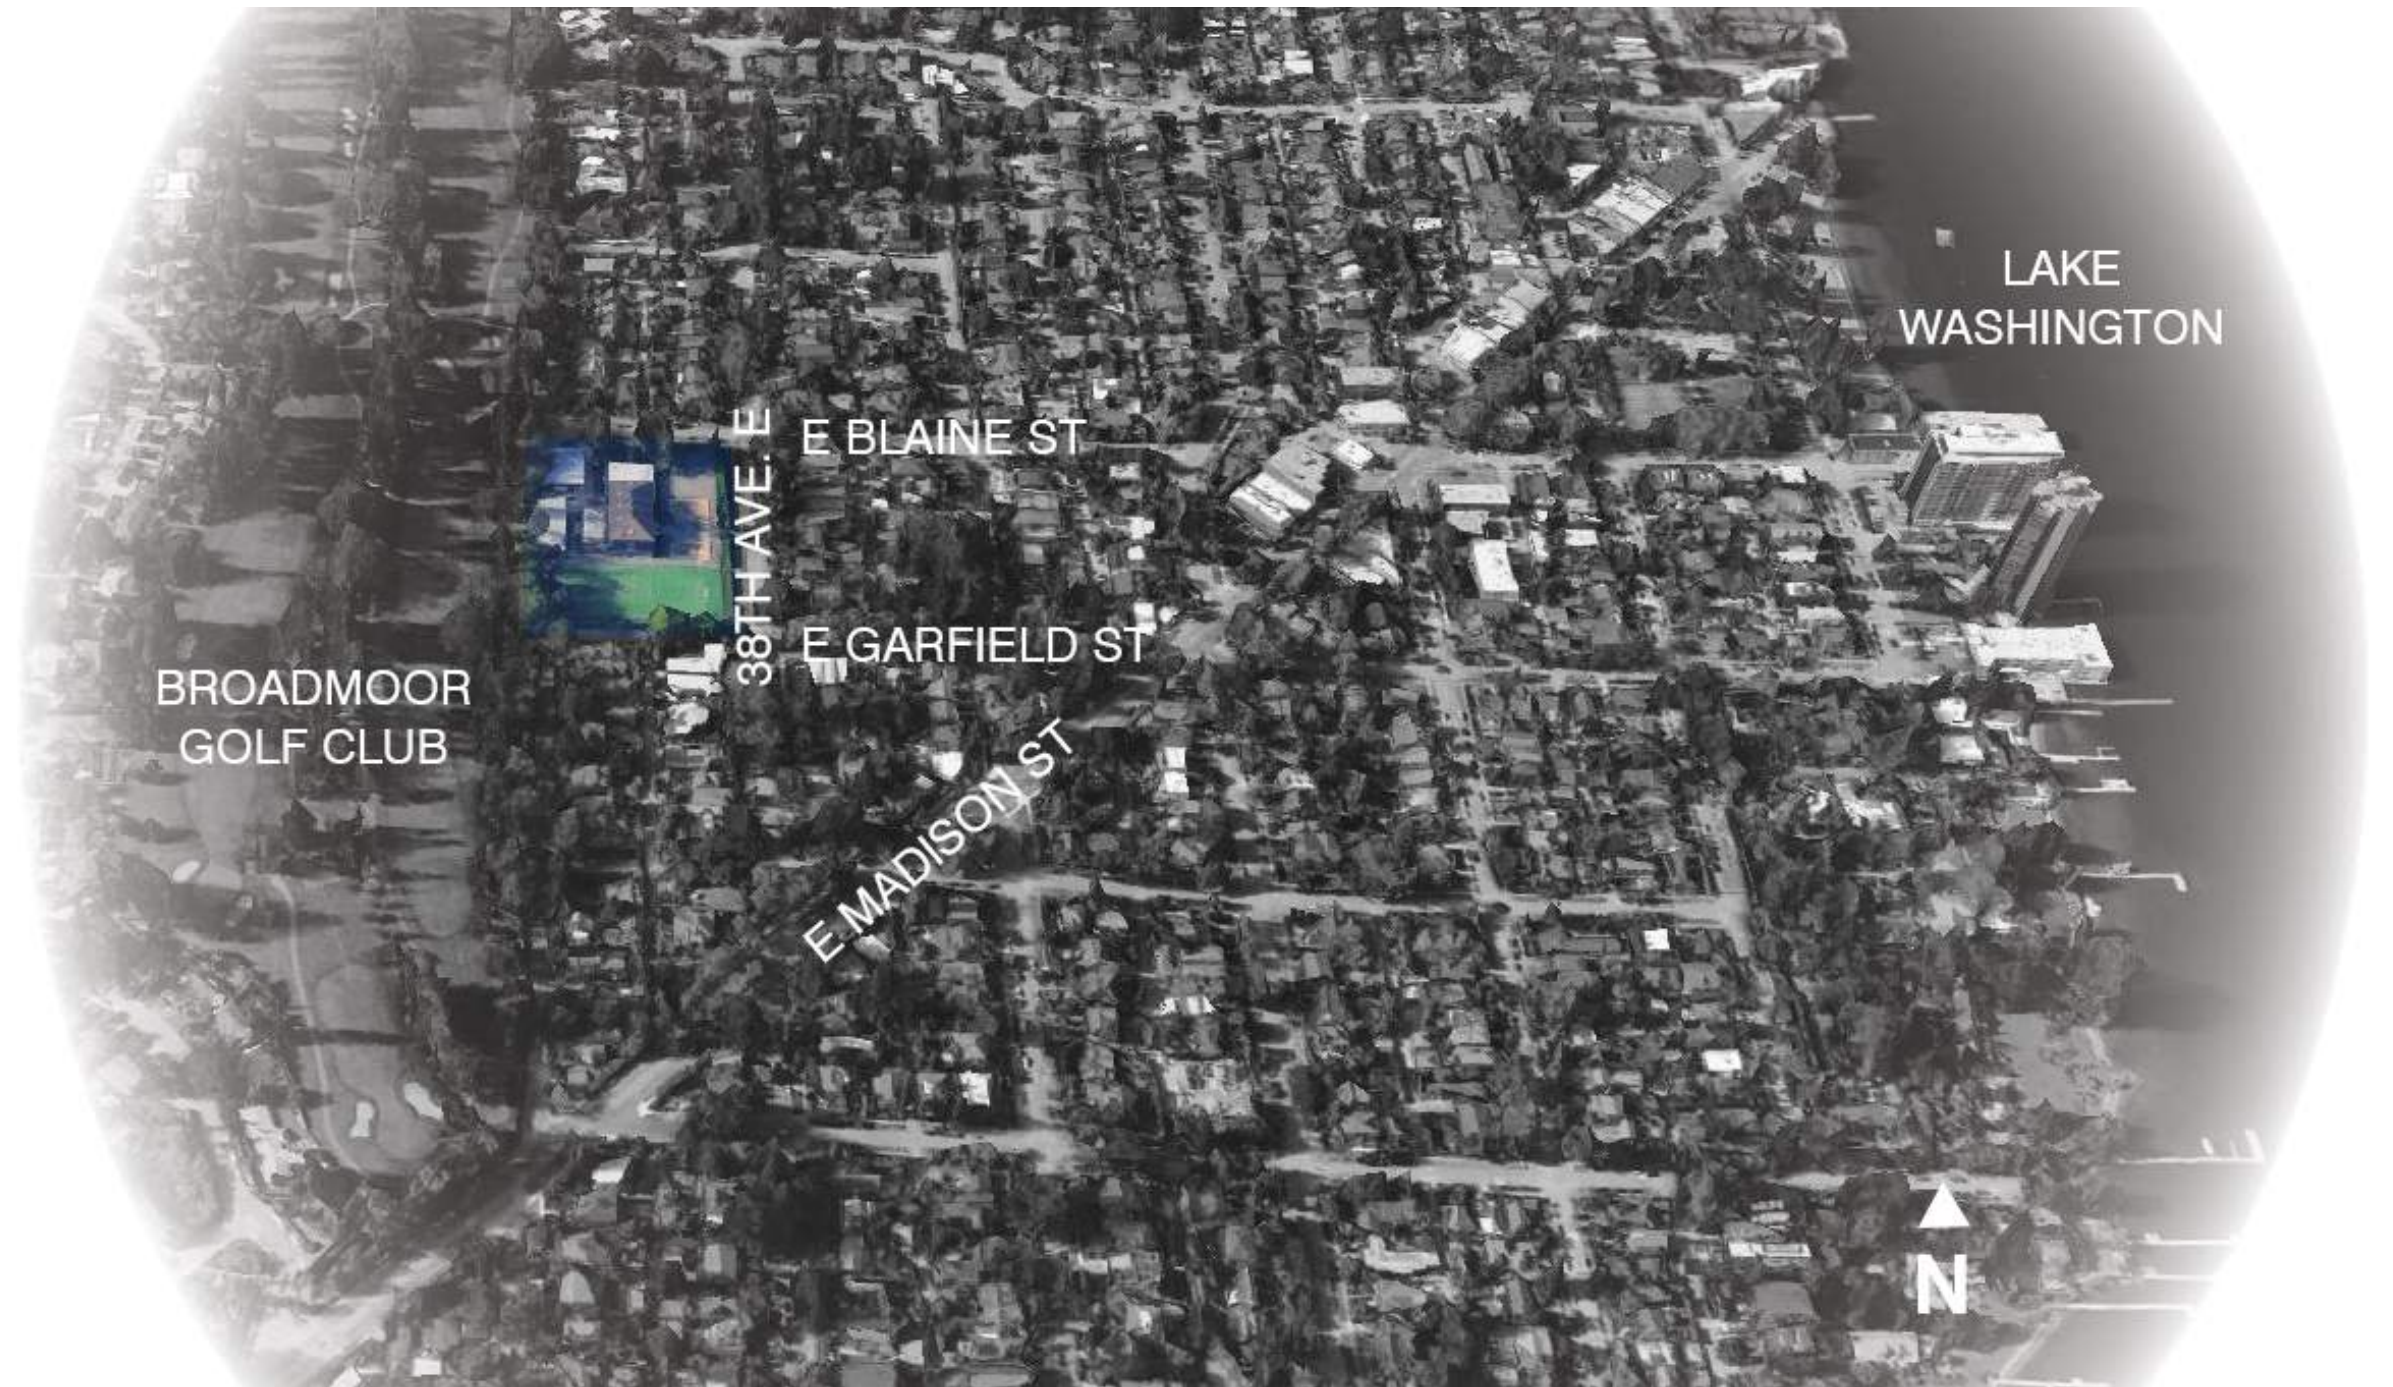
## 1.1 Project Narrative

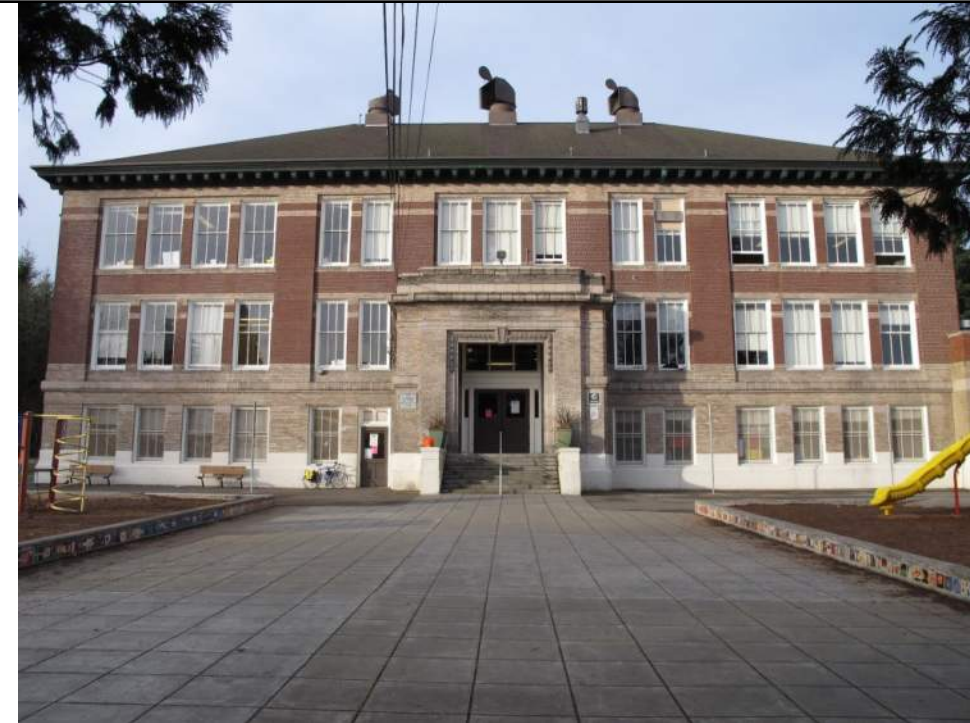
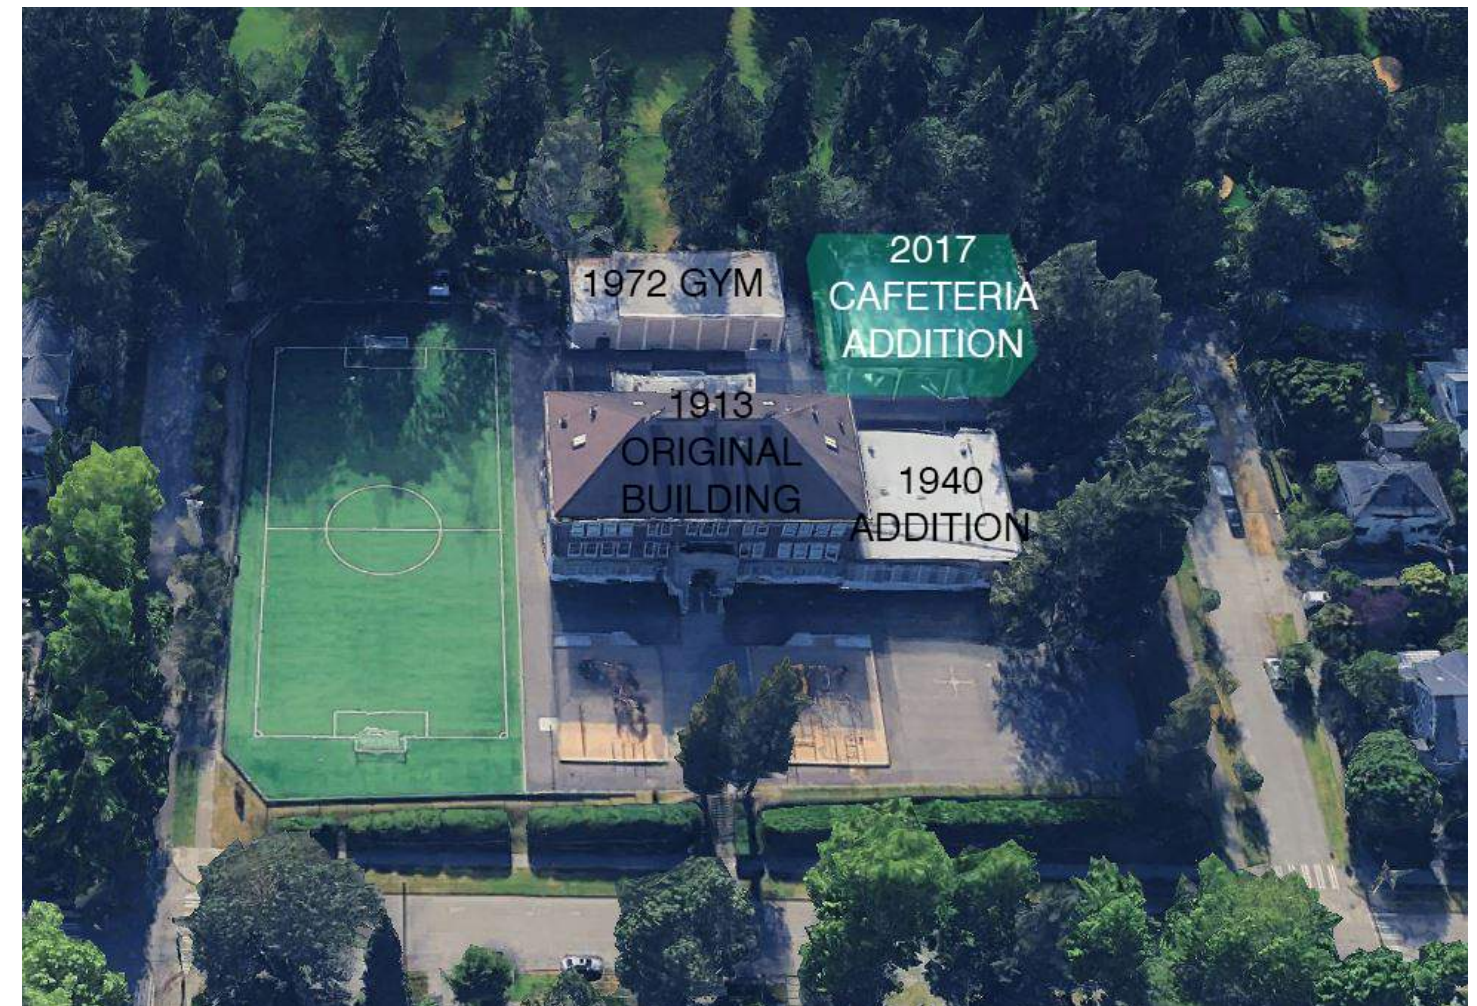
# McGilvra Elementary-Historic Wood Window Refurbishment & Glazing Replacement

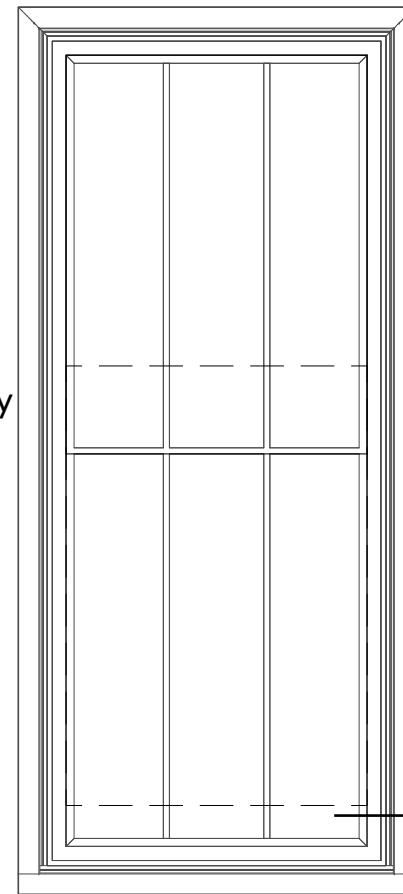
**Note: Other than potential replacement of deteriorated wood components and paint, the intent is to perform refurbishment rather than modification or replacement of historic elements and allow the work performed to be reversable.**

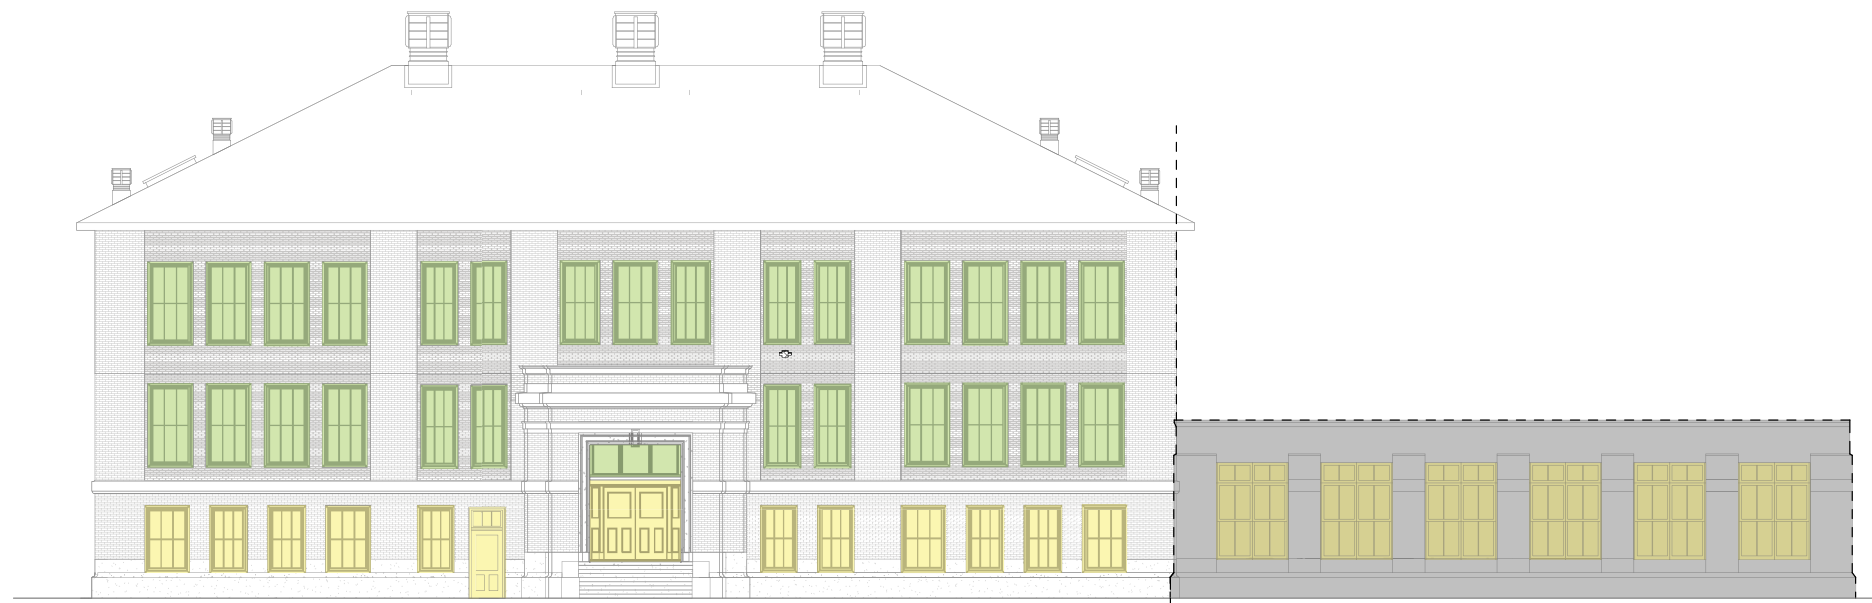
The South double doors from the playfield are falling apart with cracks in the panels with daylight coming through.

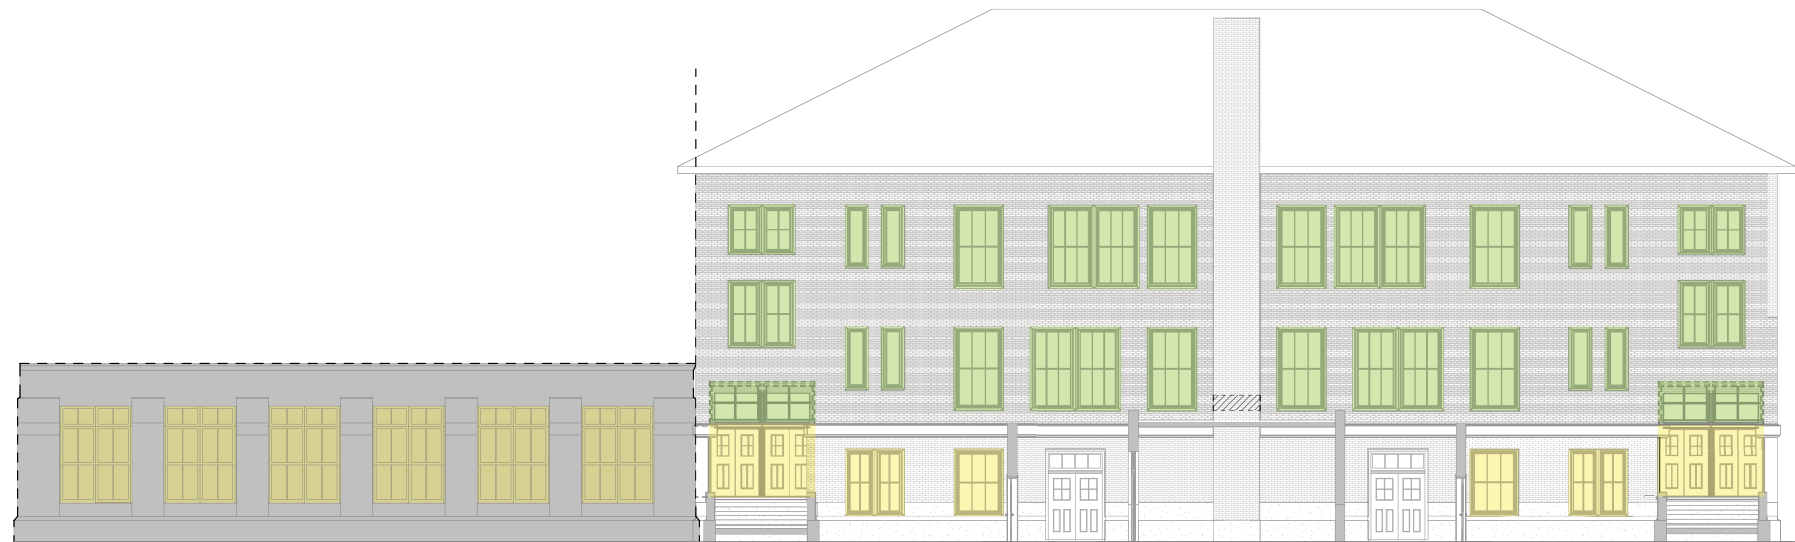
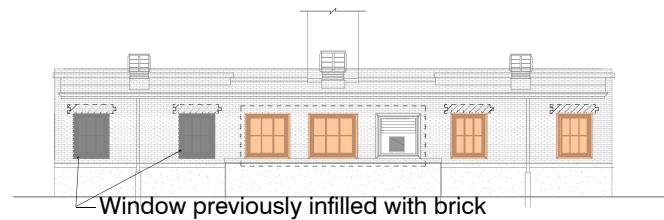
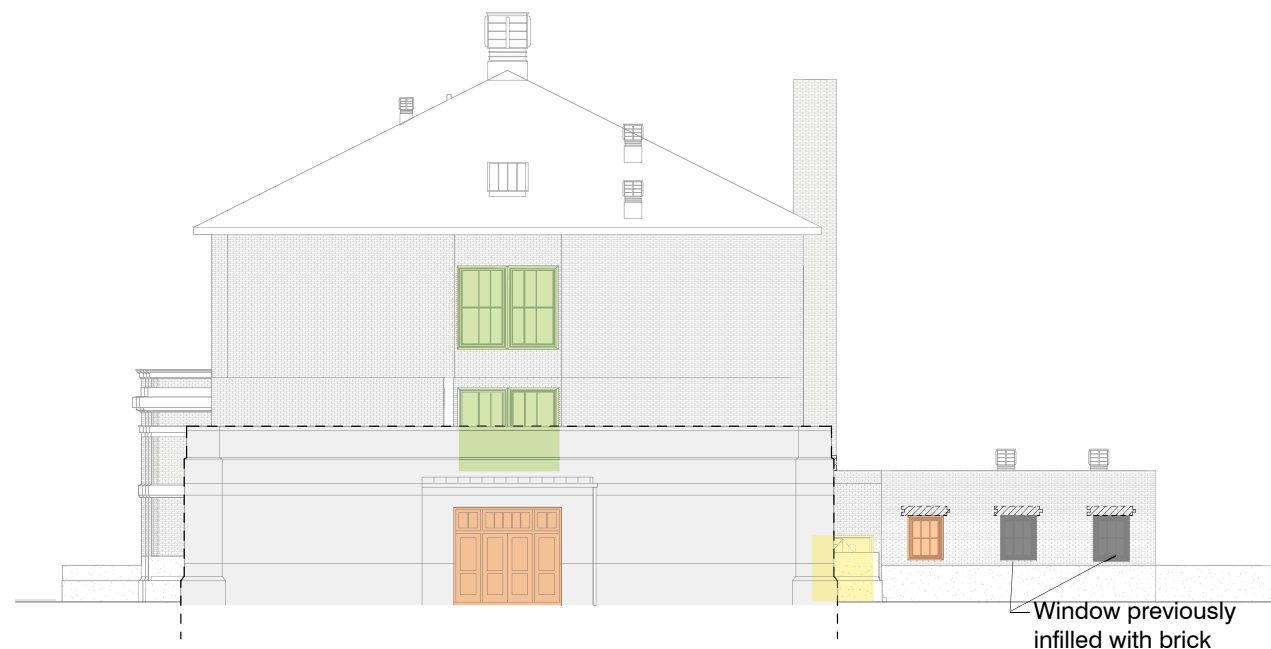
## \*GENERAL NOTES\*

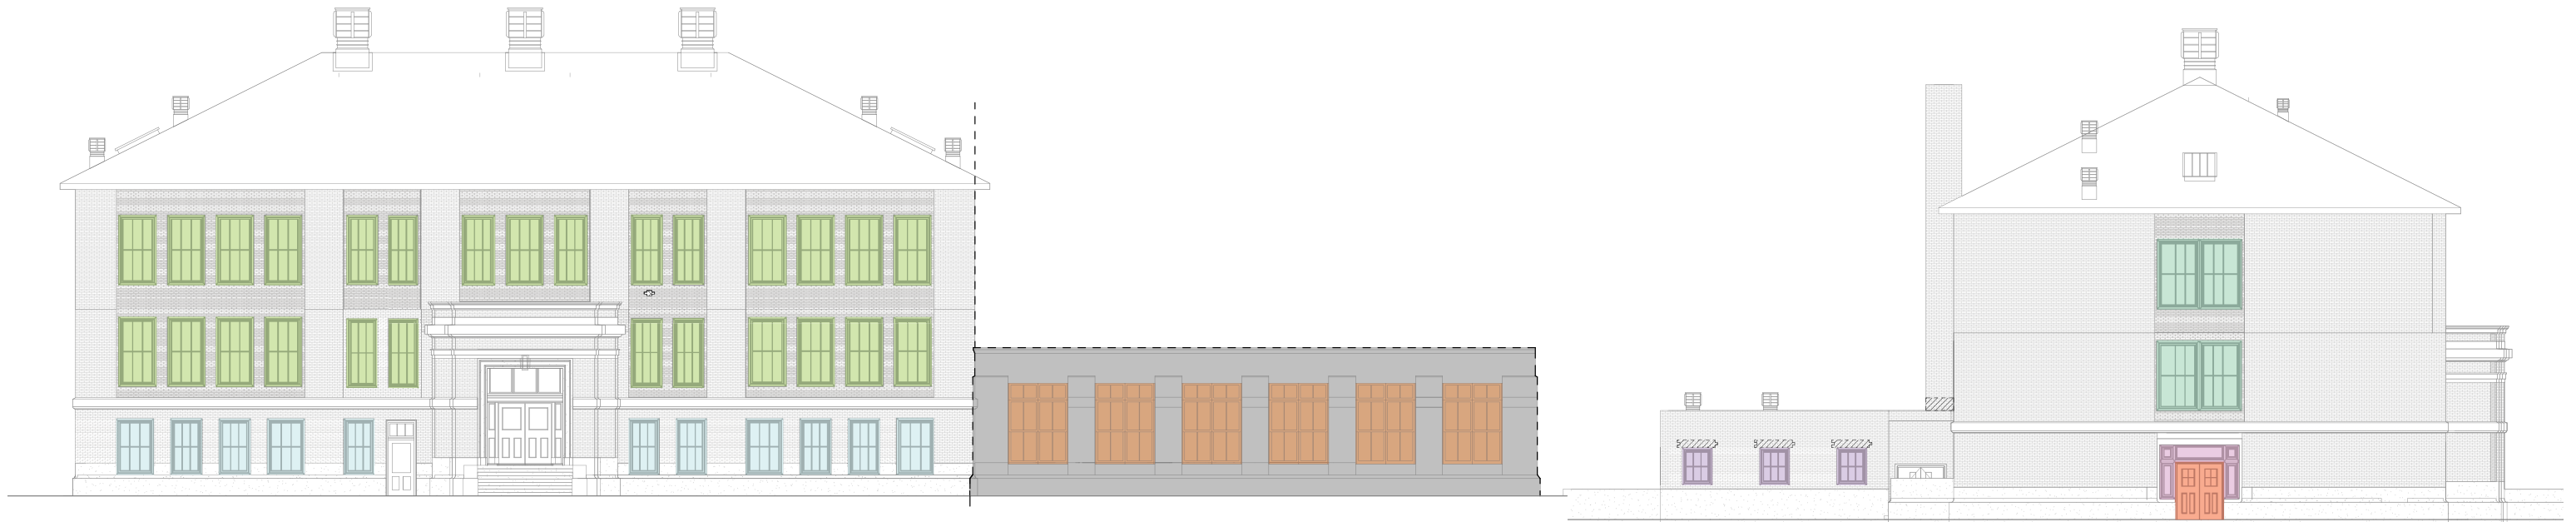
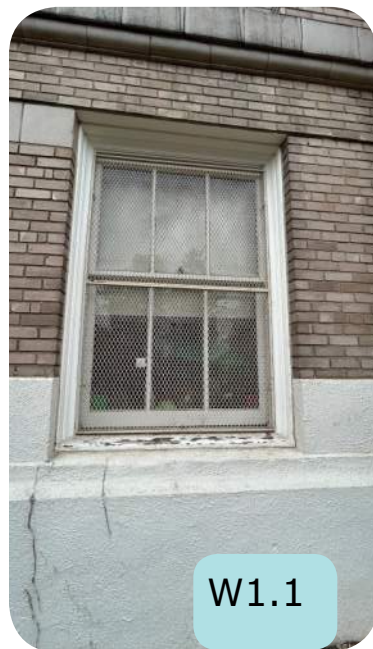
### 3.1\_Window Types/ Condition Photos

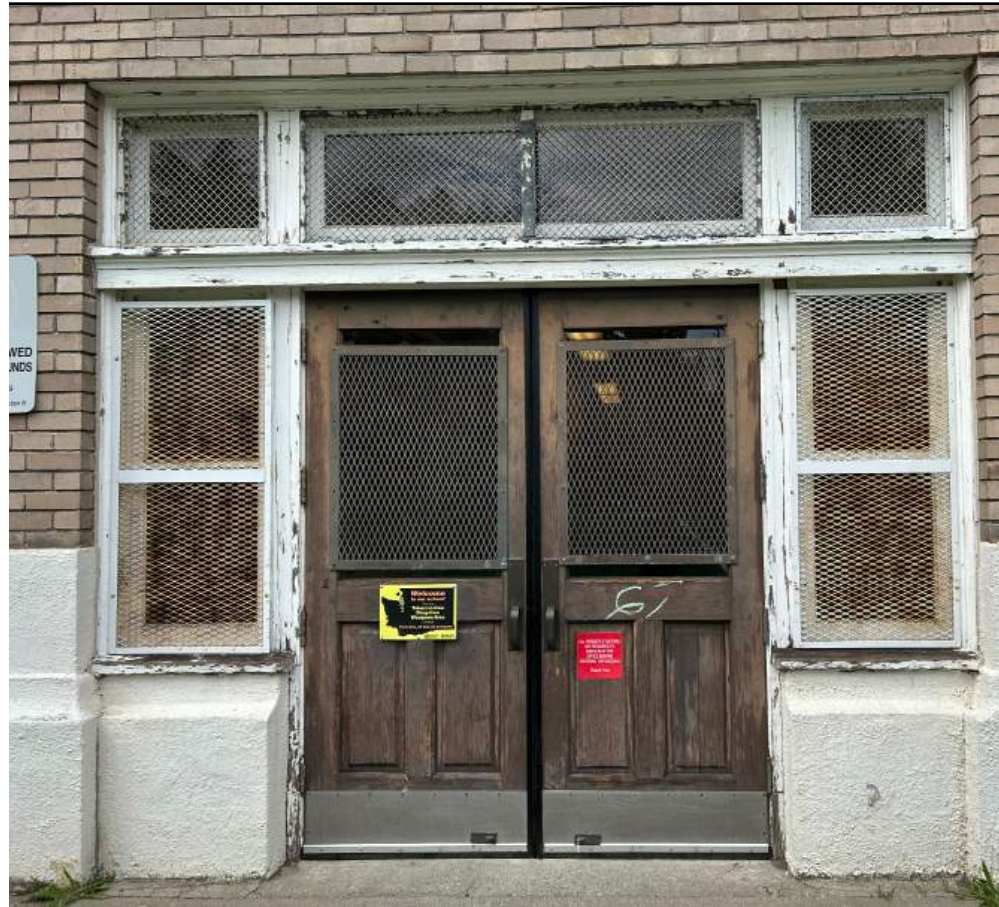
## **SOUTH CORRIDOR DOUBLE DOOR:**

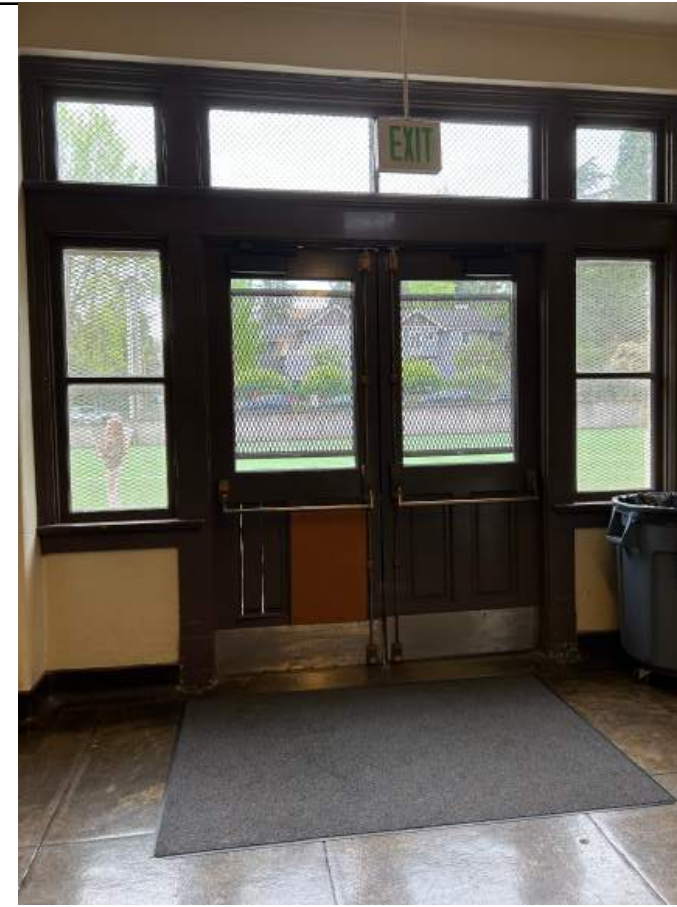
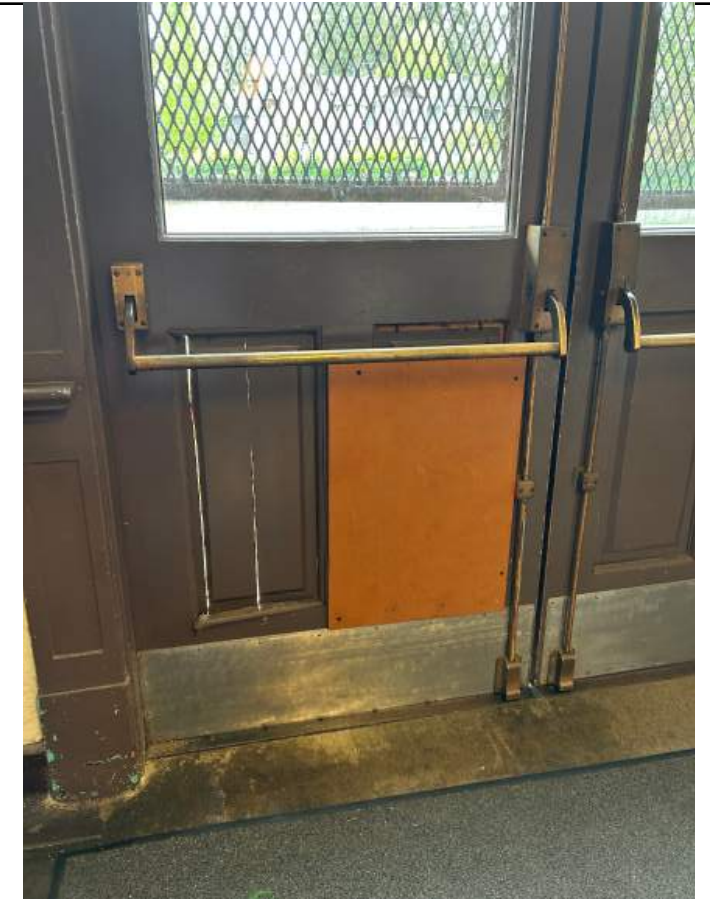
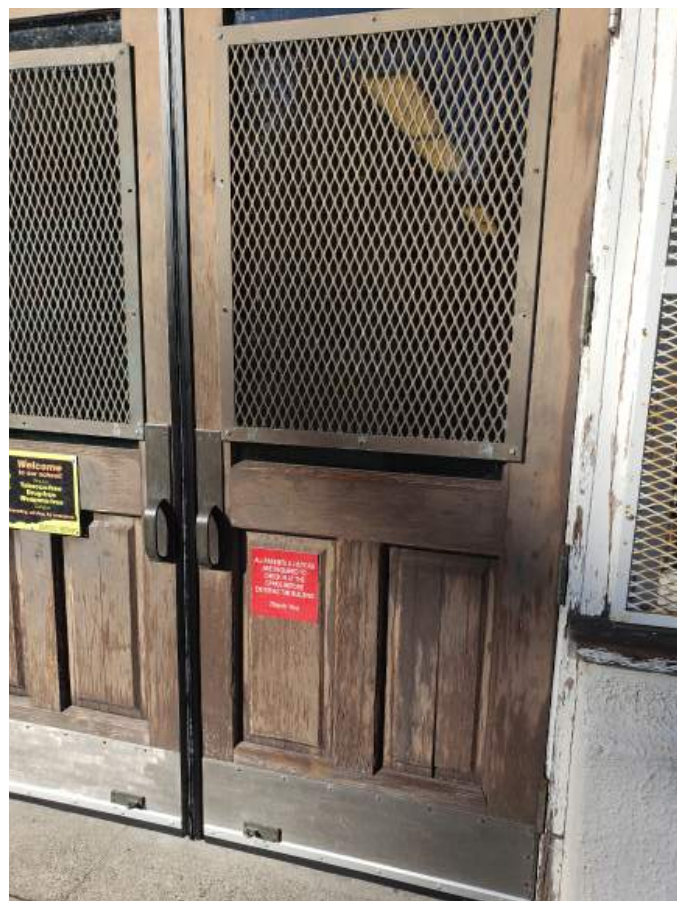
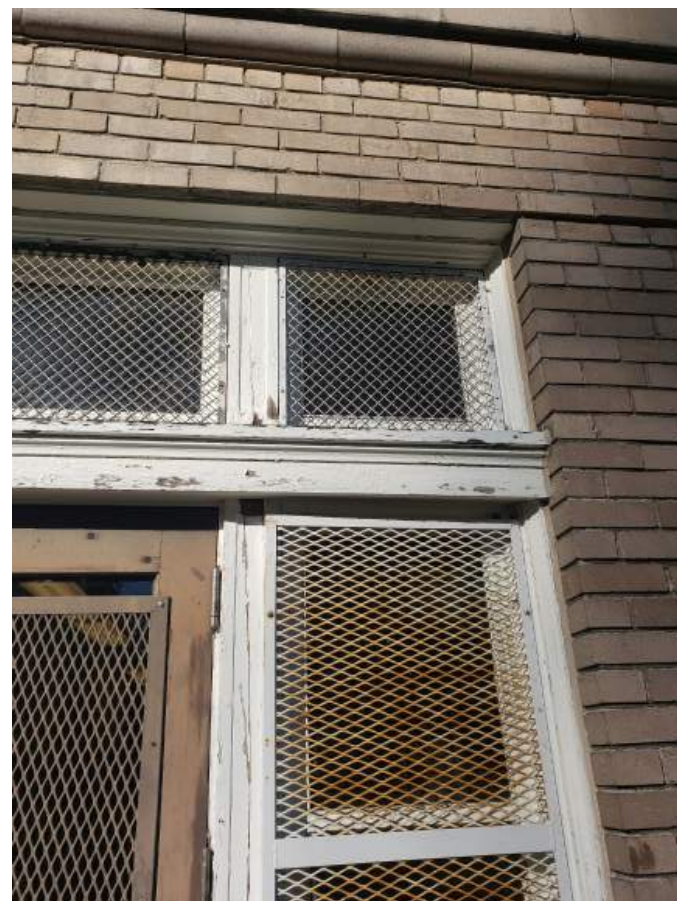
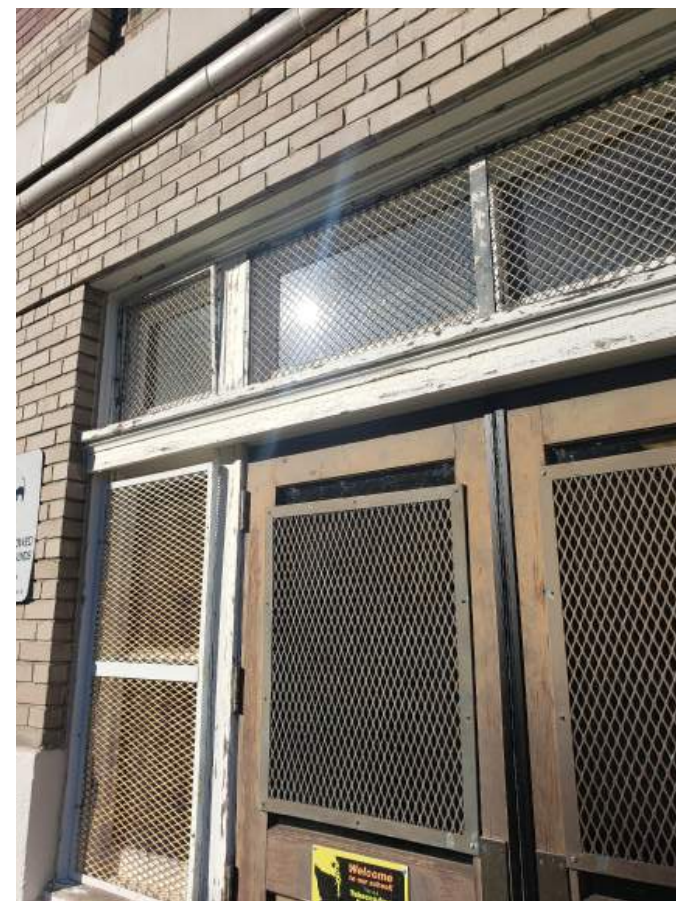
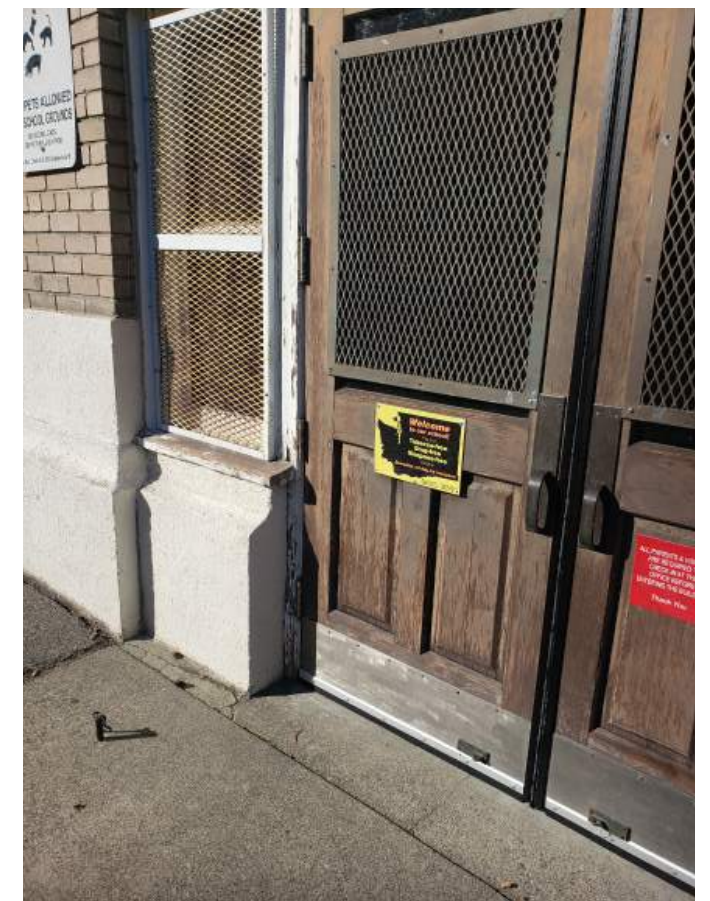
The transom also has similar damage due to smaller casing area for debris to collect within the protective, expanded, steel mesh, and further weathering due to its south facing orientation

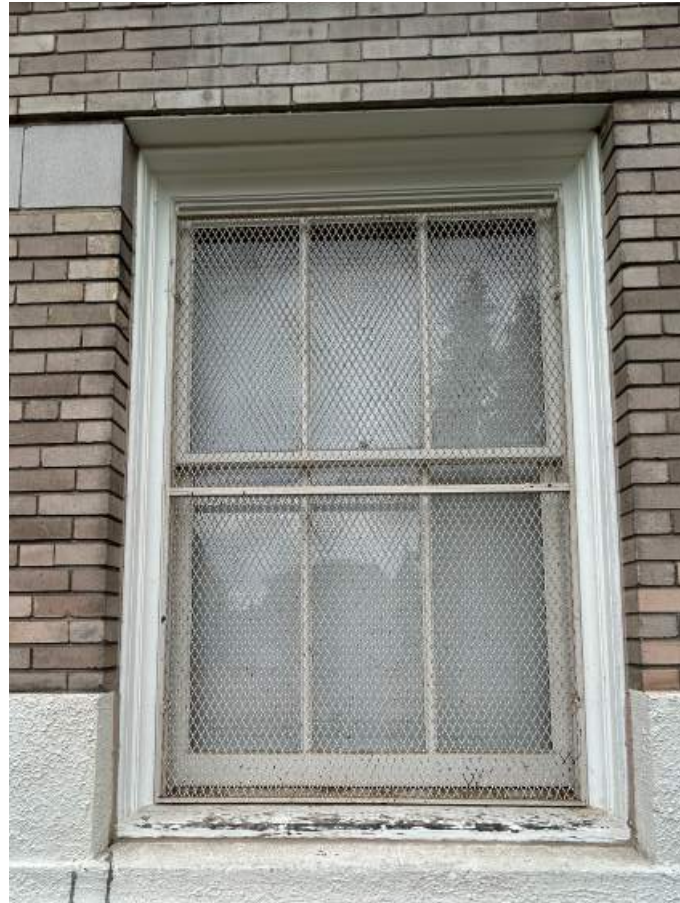
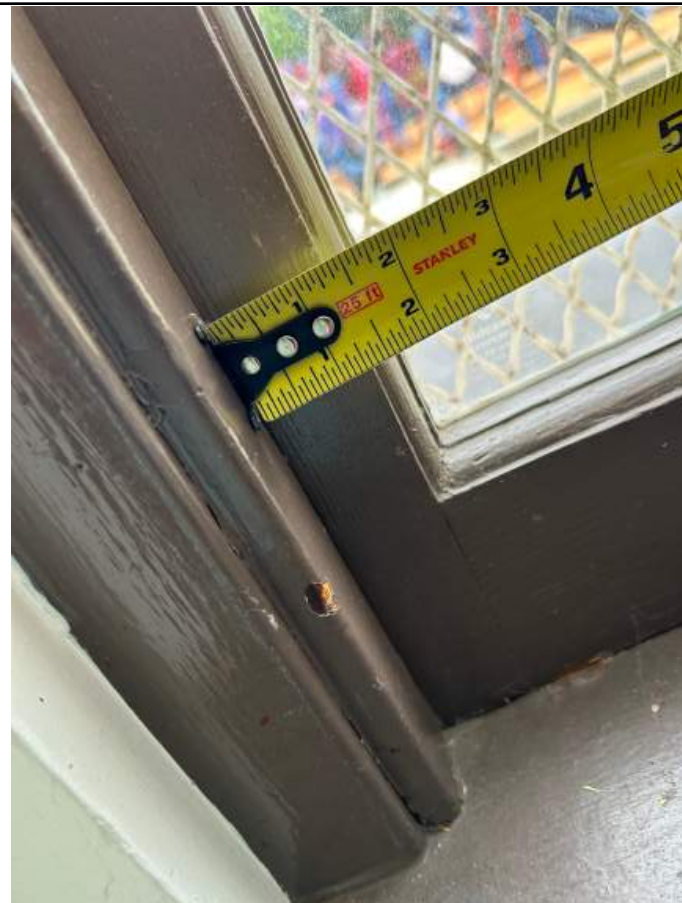
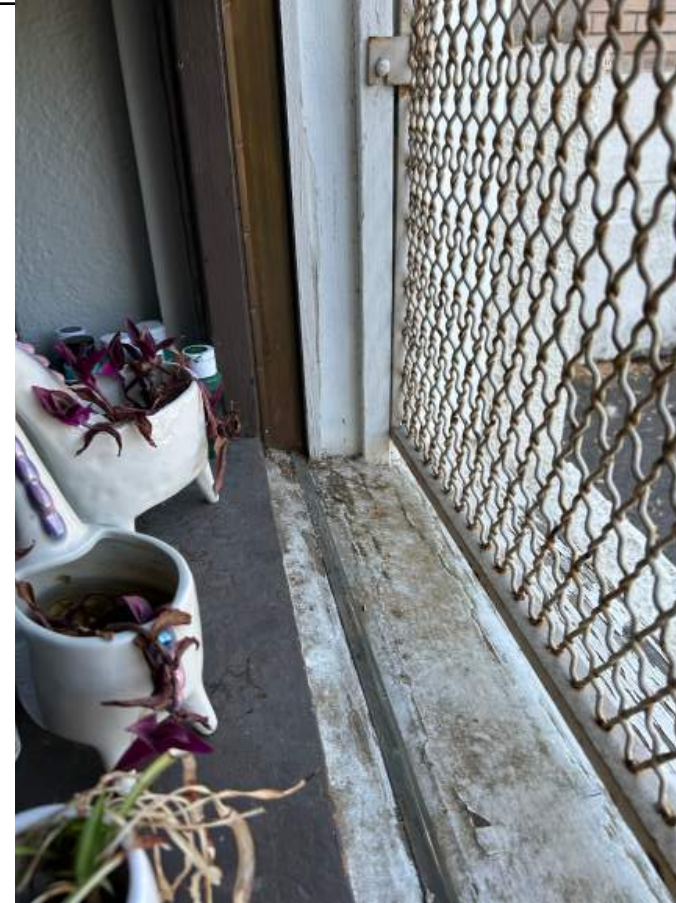
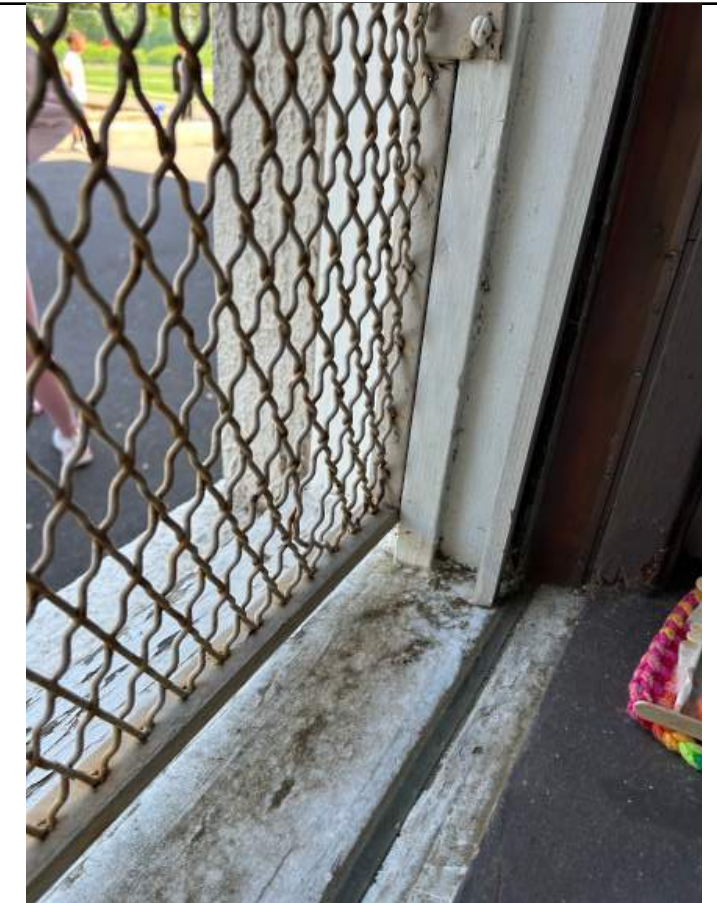
## **1913 GROUND FLOOR CLASSROOM WINDOWS:**

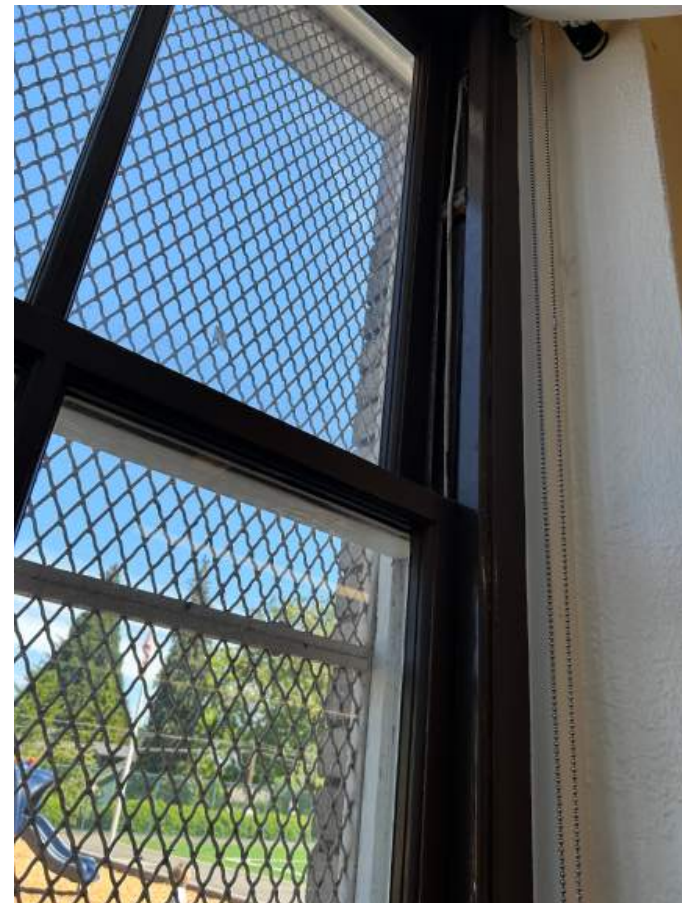
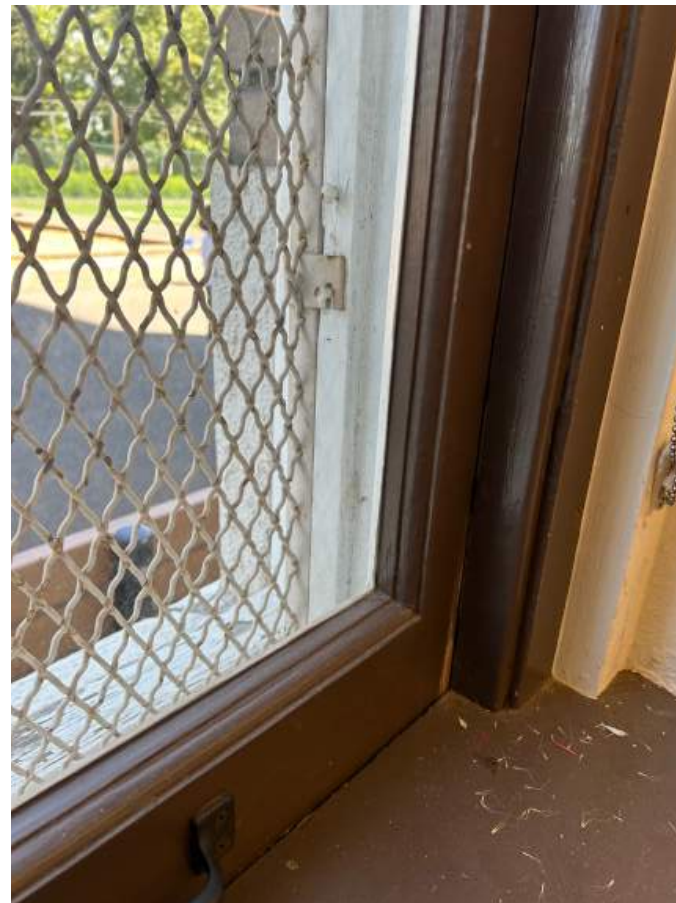
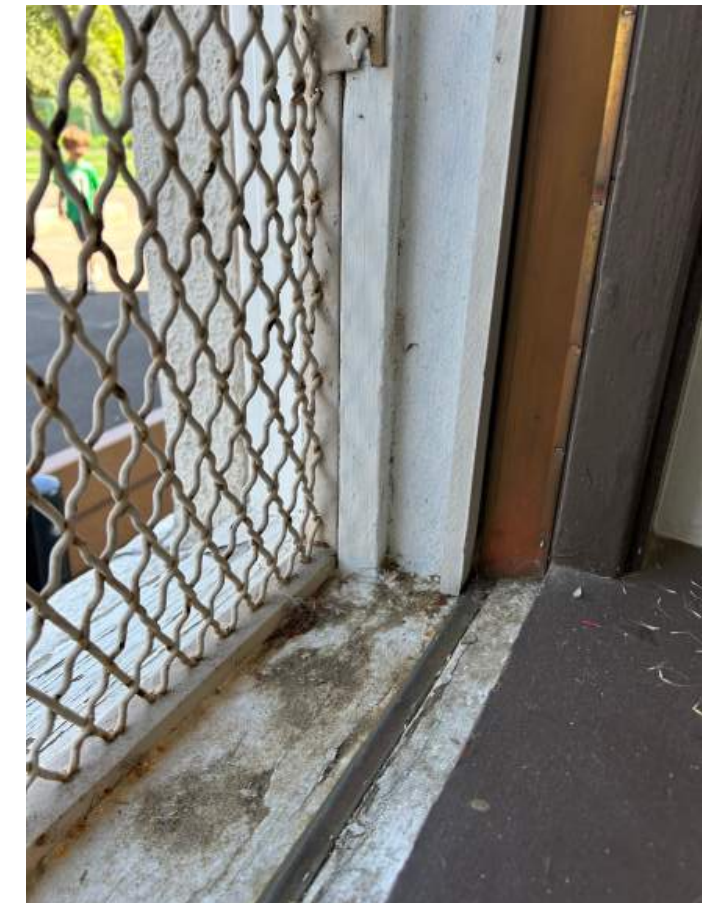
# McGilvra Elementary-Historic Wood Window Refurbishment & Glazing Replacement

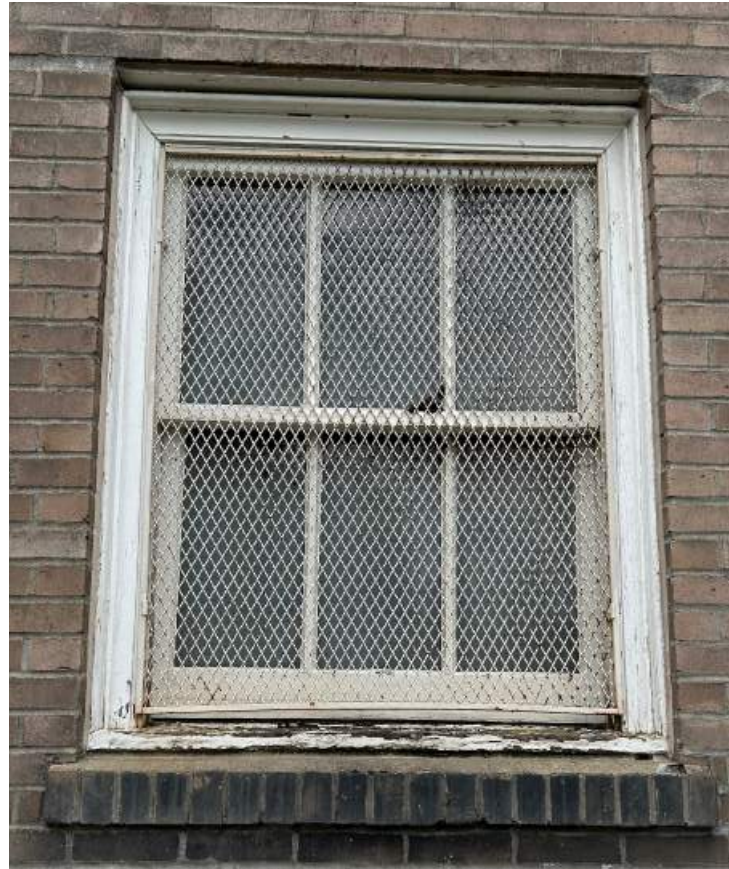
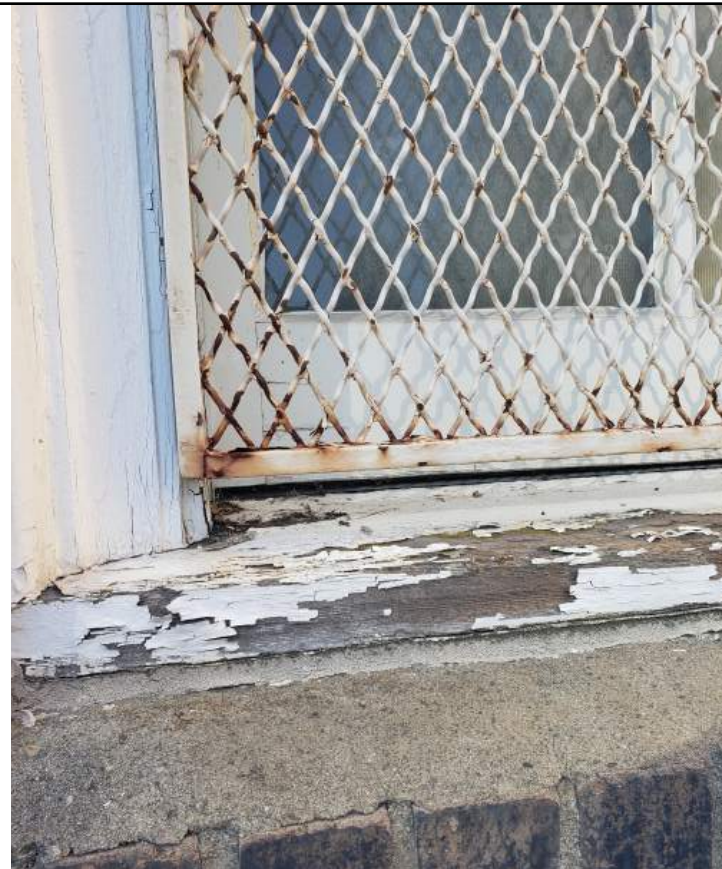
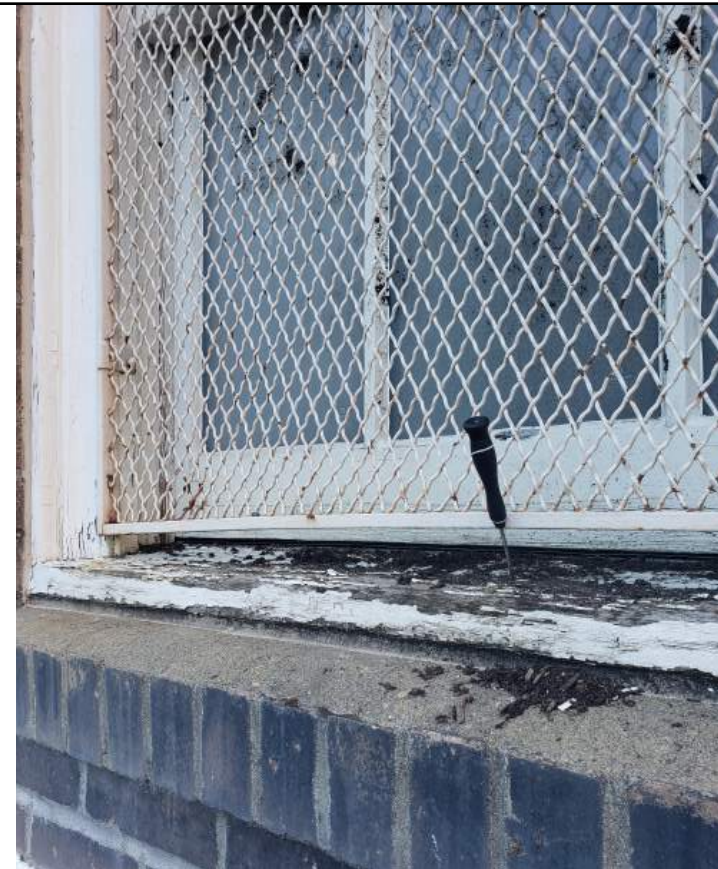
## **GROUND FLOOR RESTROOM WINDOWS:**
