# McGilvra Elementary School

## Historic Wood Window Refurbishment & Glazing Replacement

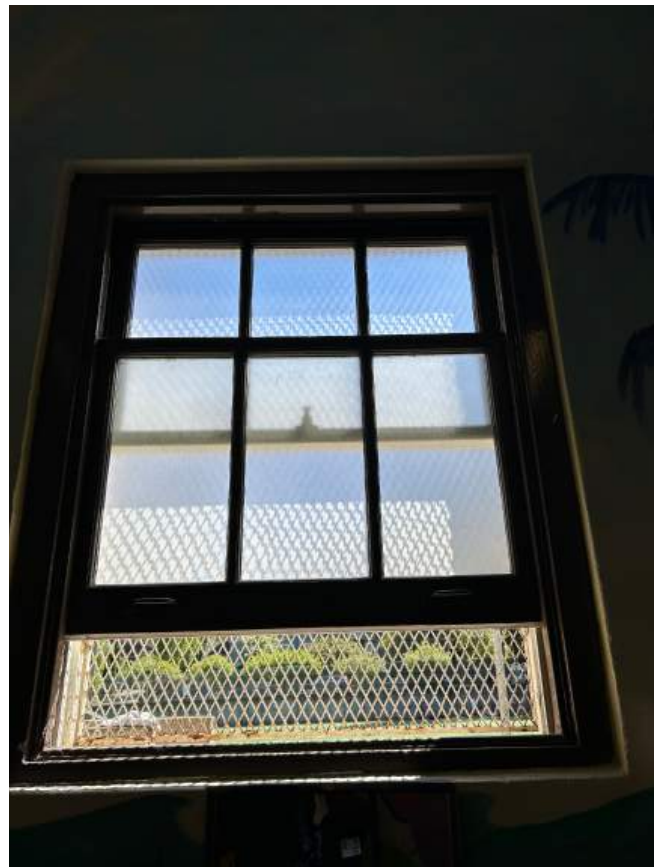
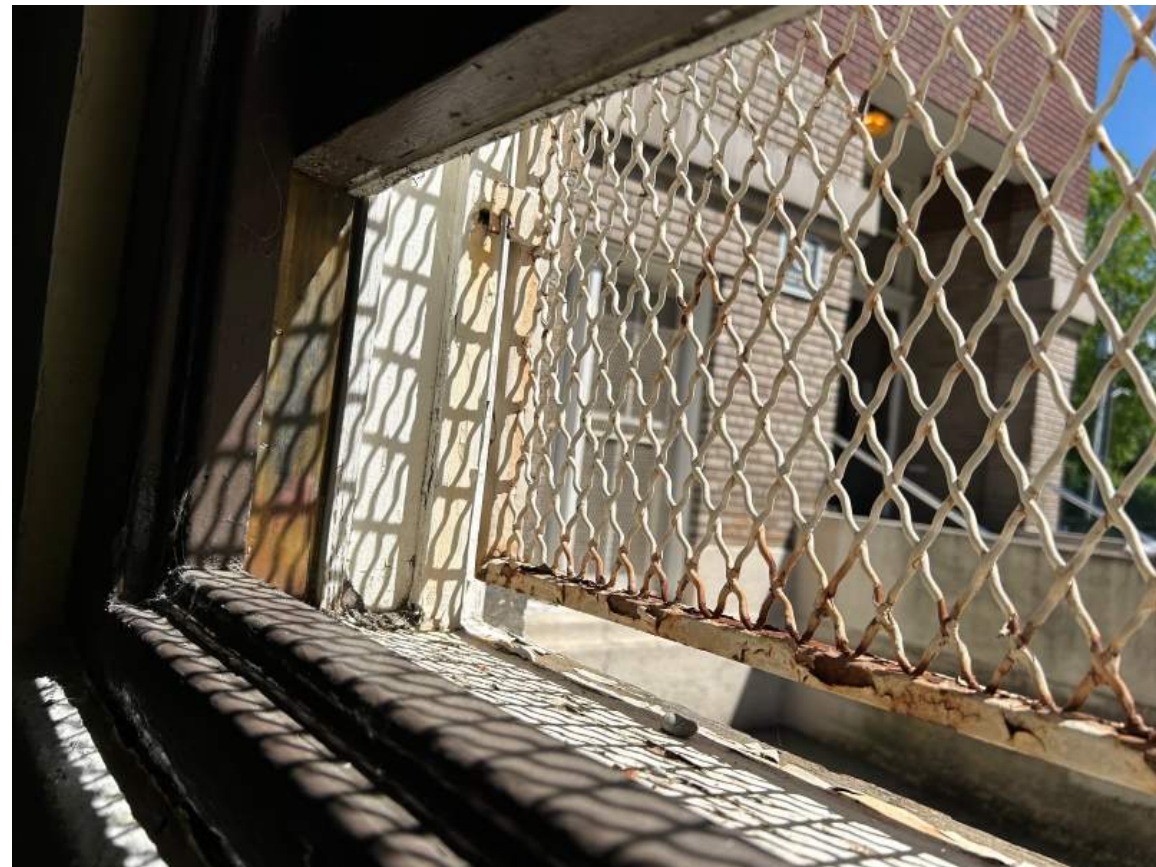
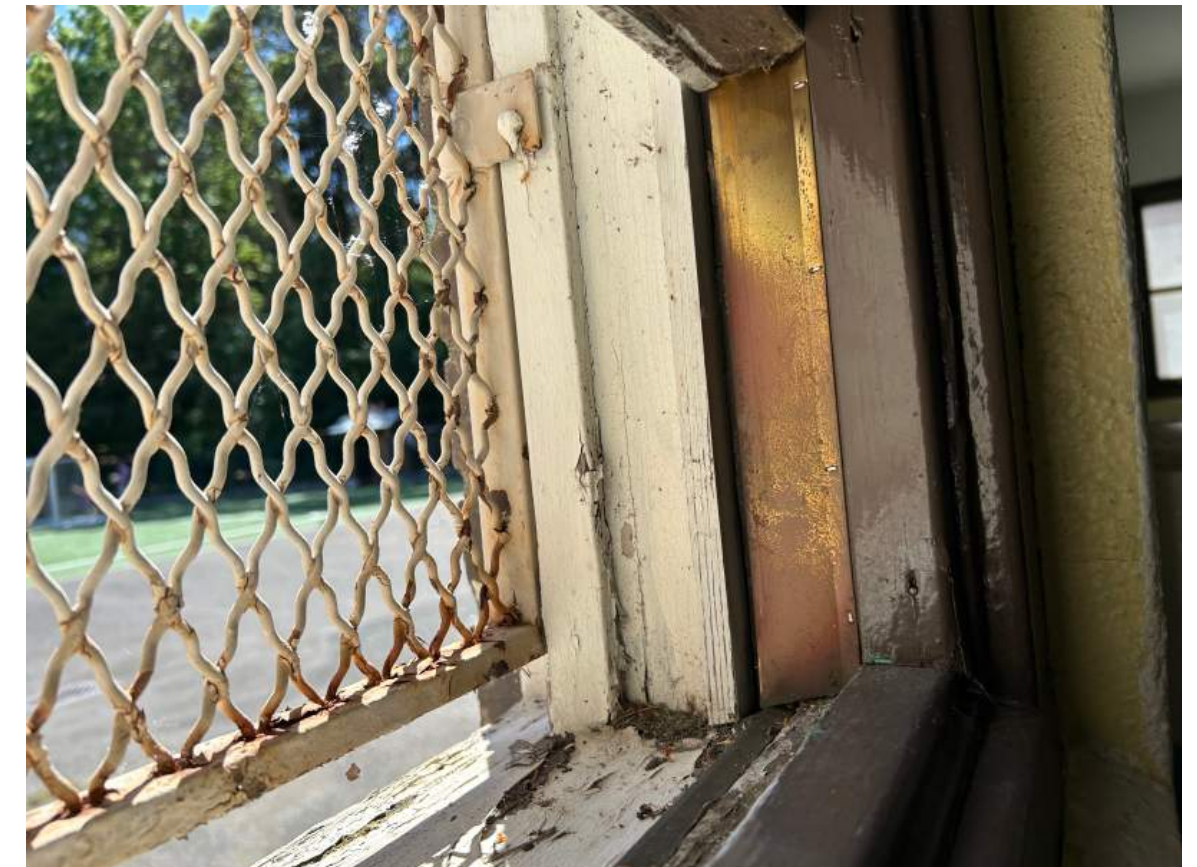
# McGilvra Elementary-Historic Wood Window Refurbishment & Glazing Replacement

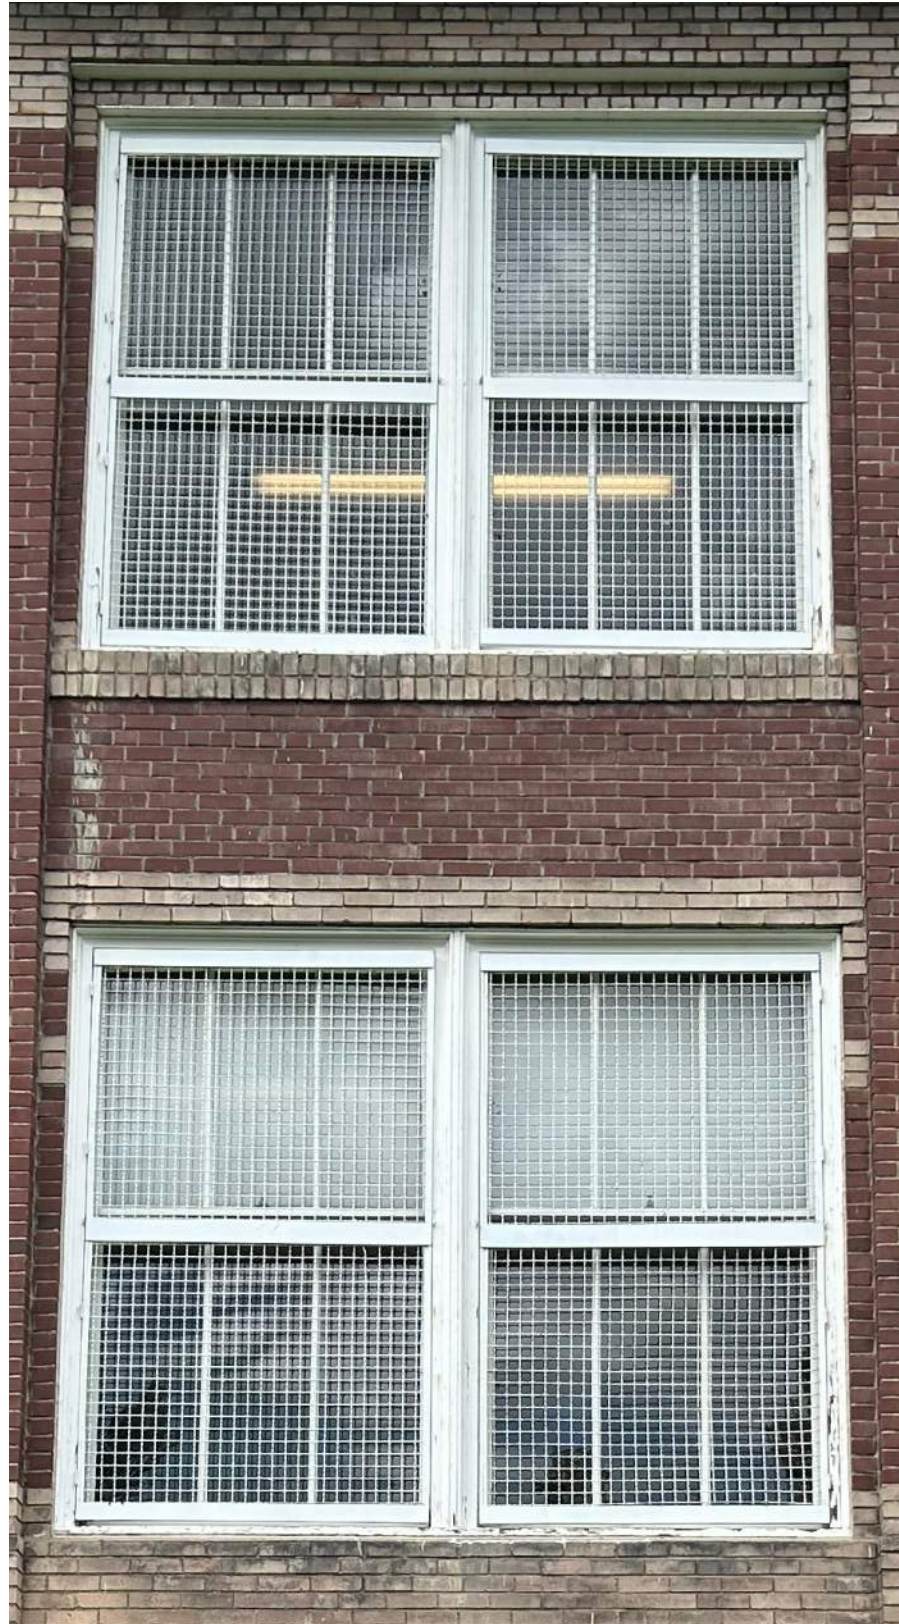
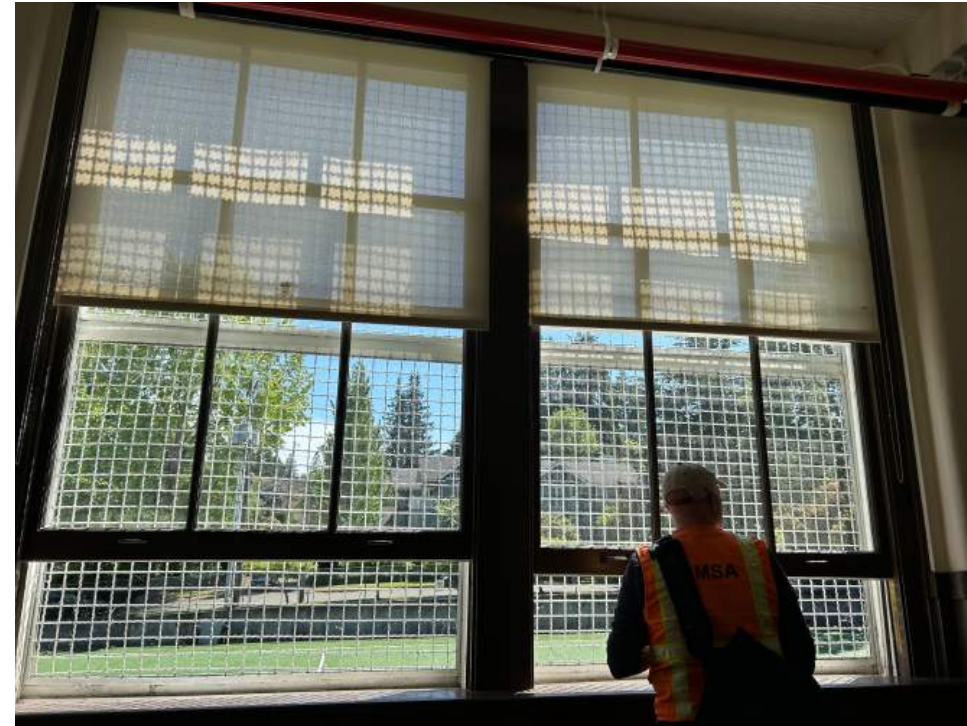
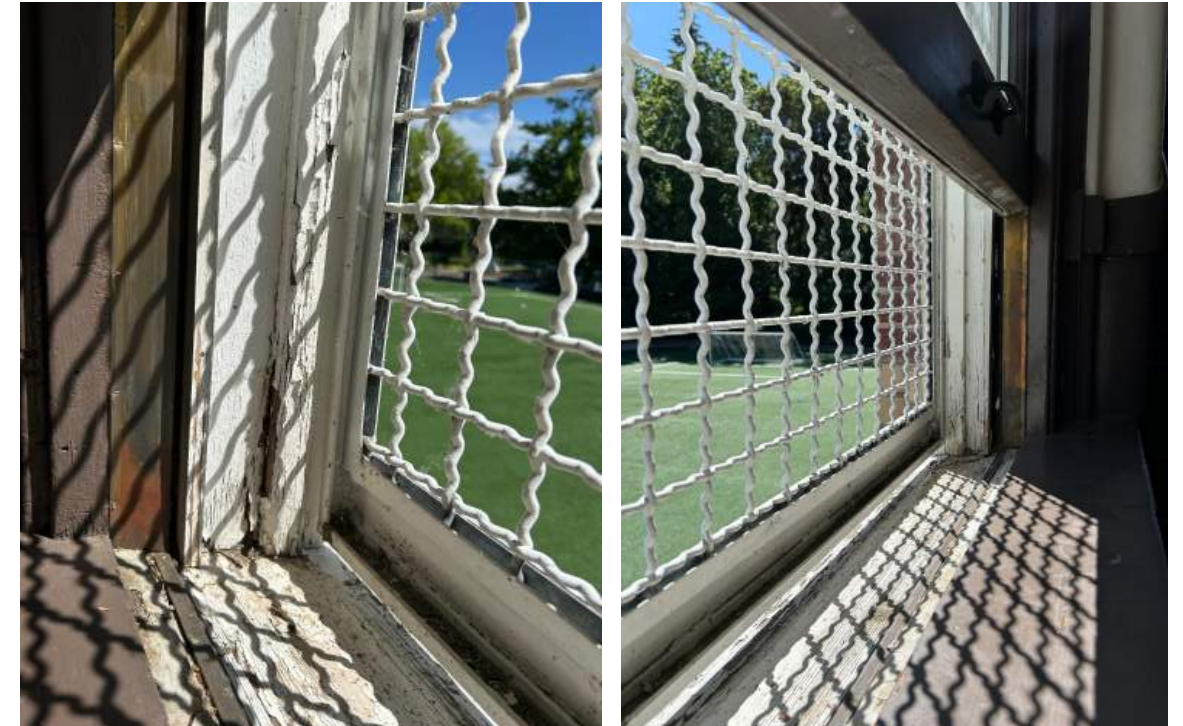
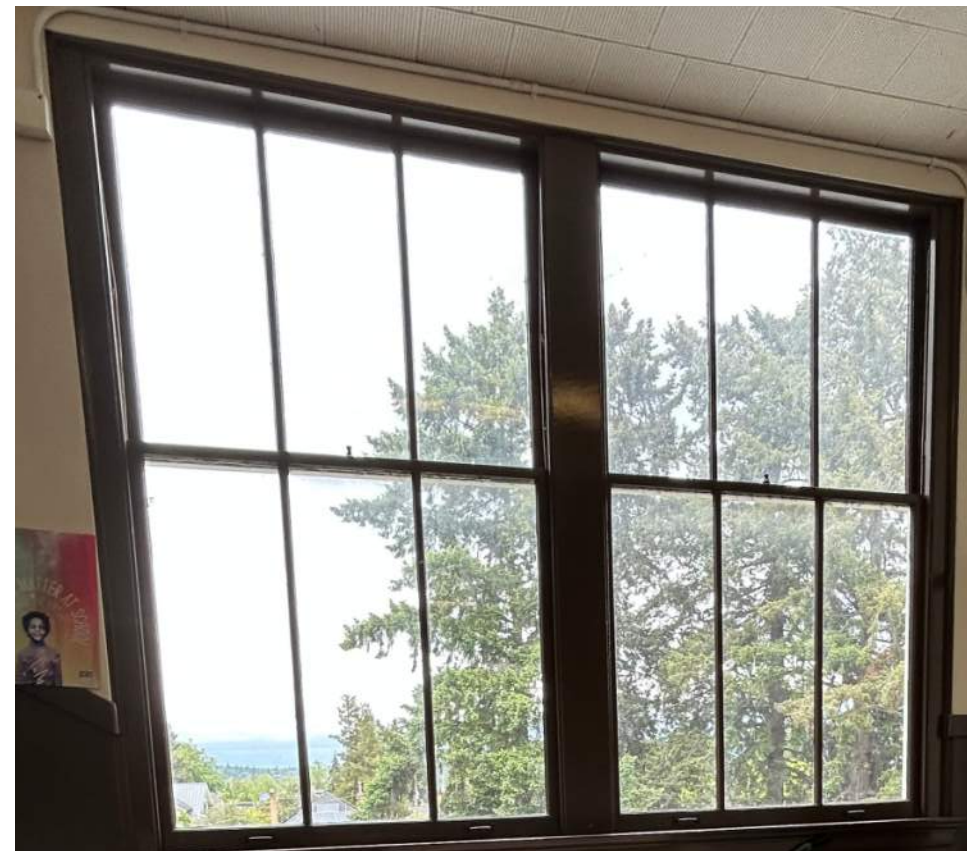
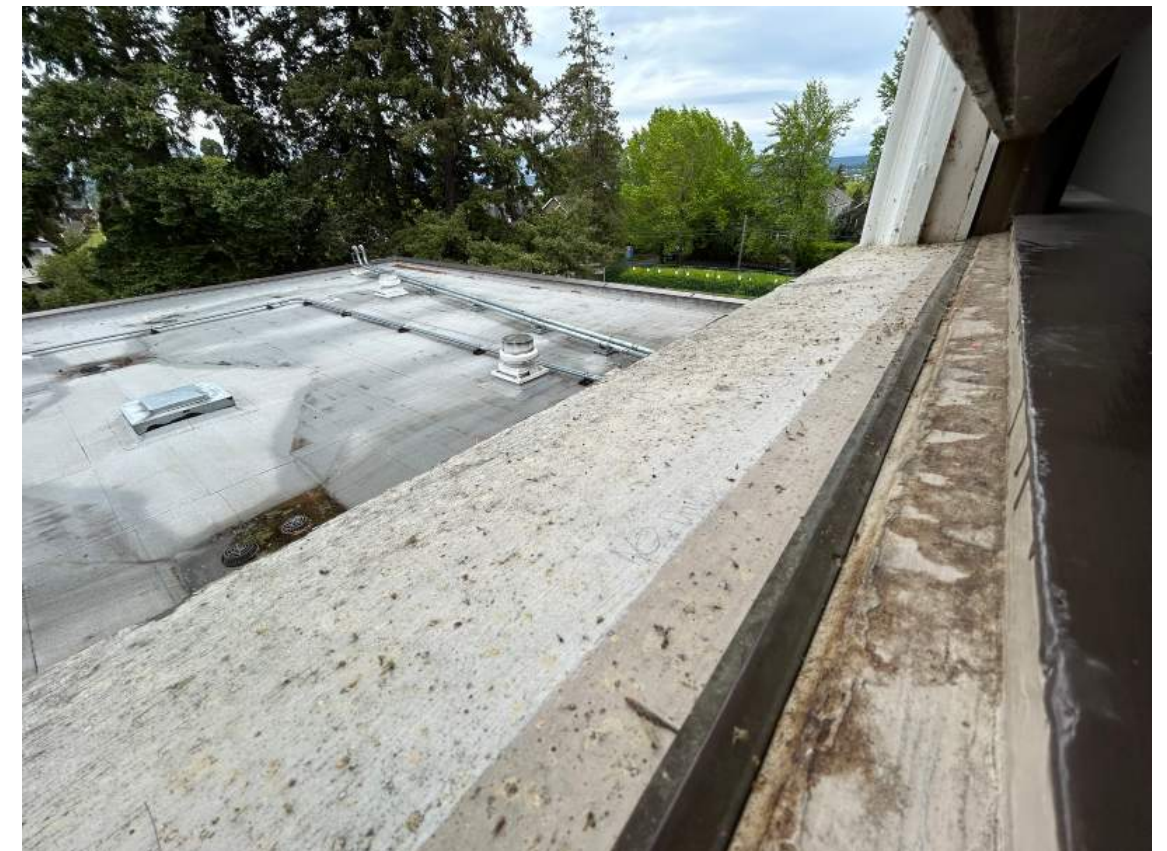
# McGilvra Elementary-Historic Wood Window Refurbishment & Glazing Replacement

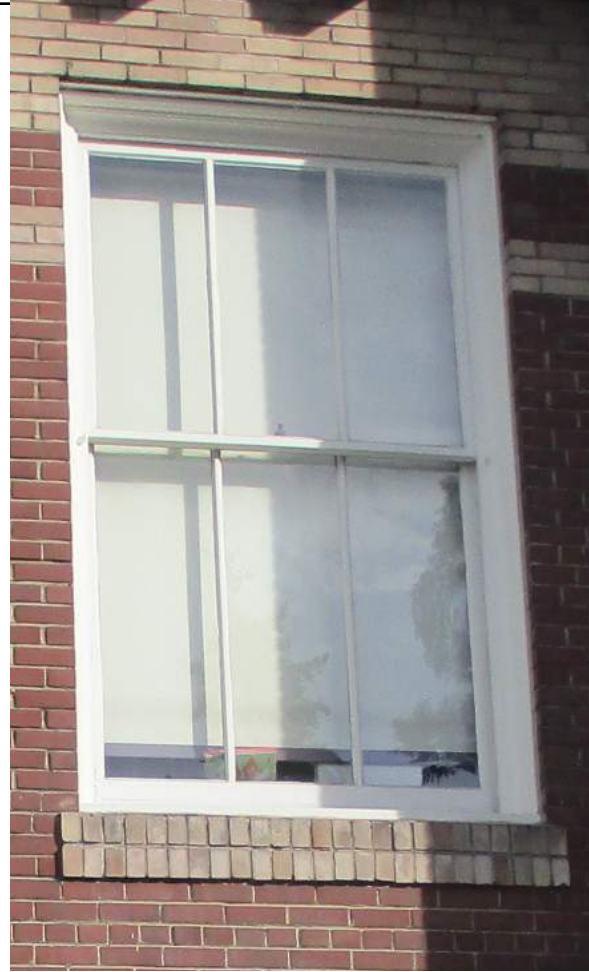
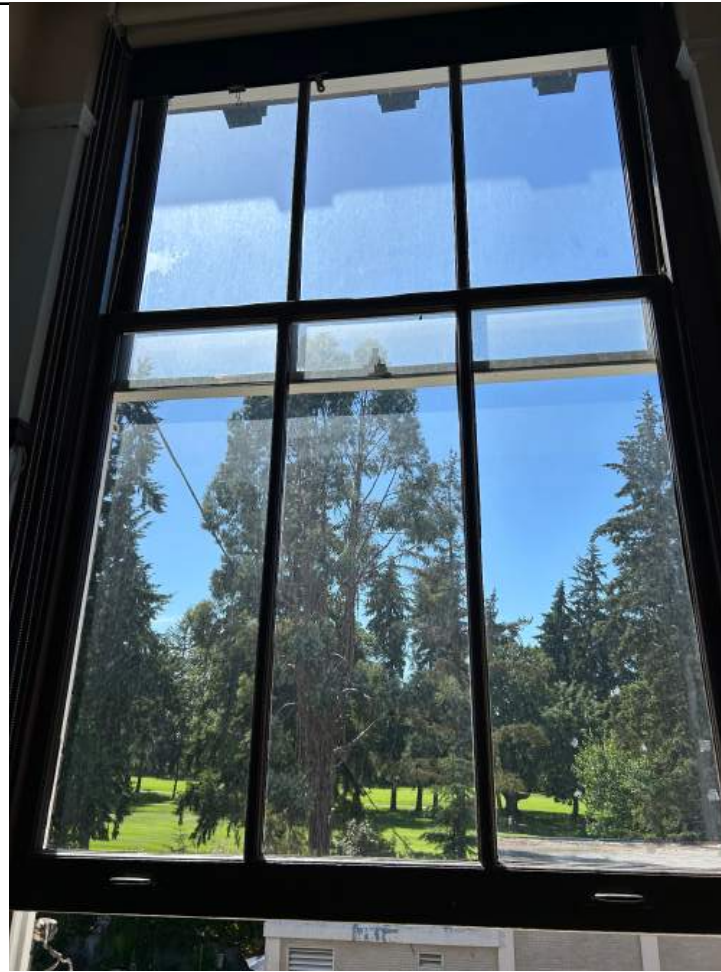
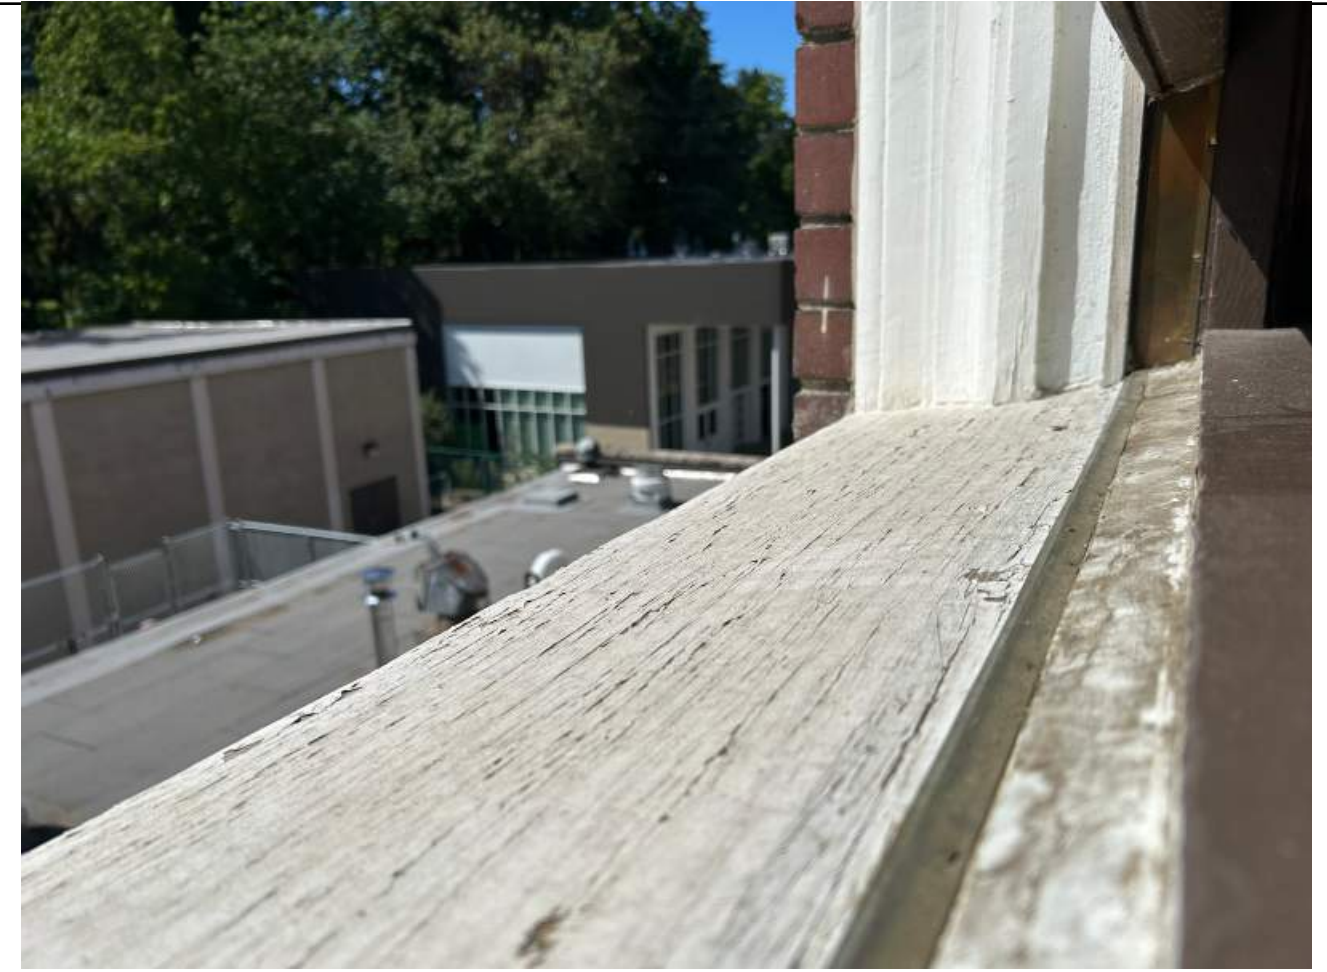
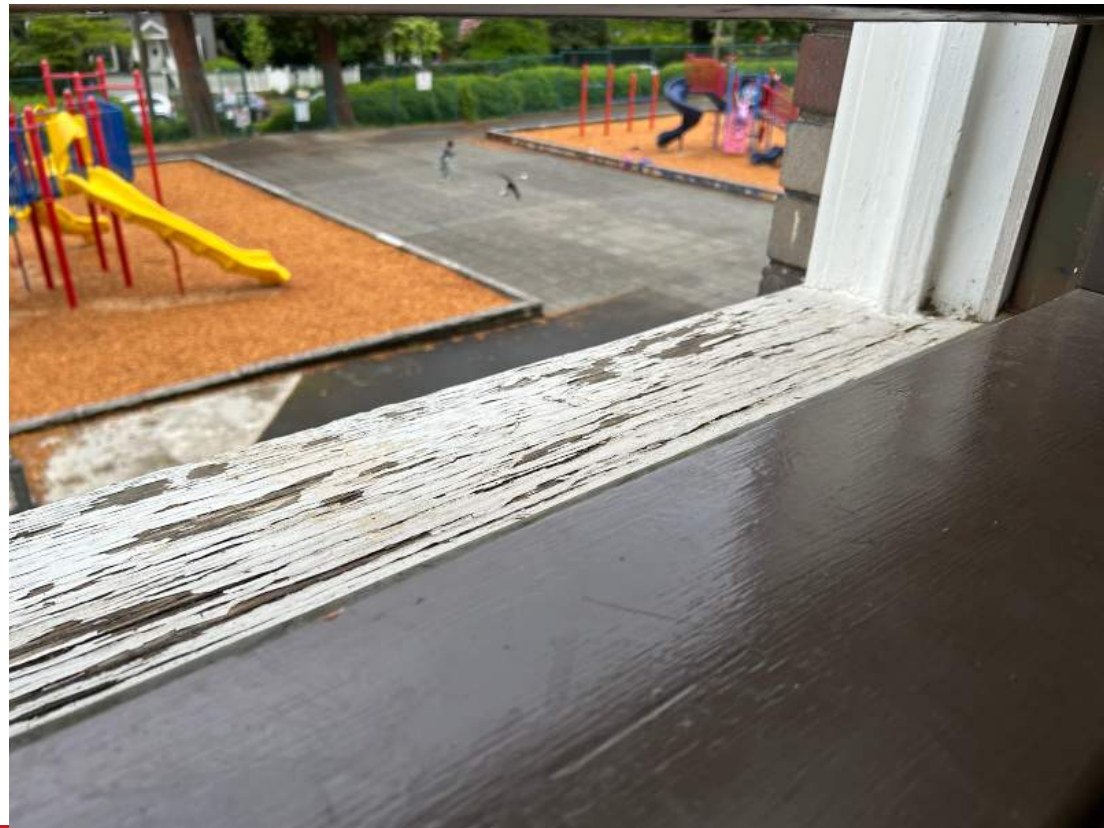
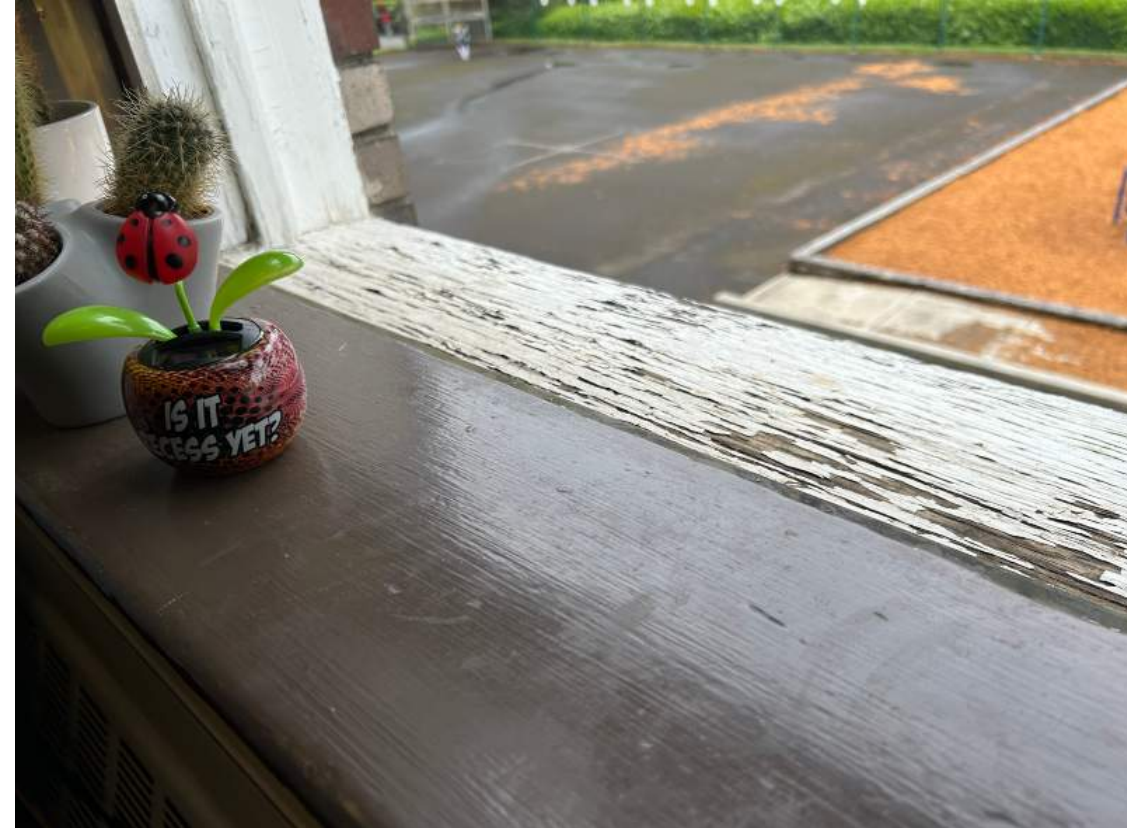
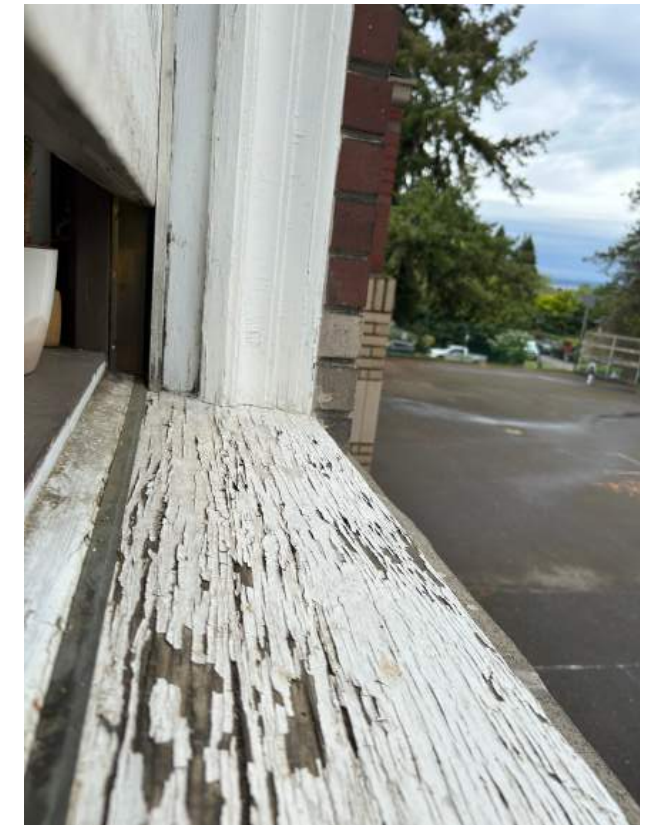
The interior case work shows some signs of wear, with chips or scratches in the paint, but overall is in good condition.

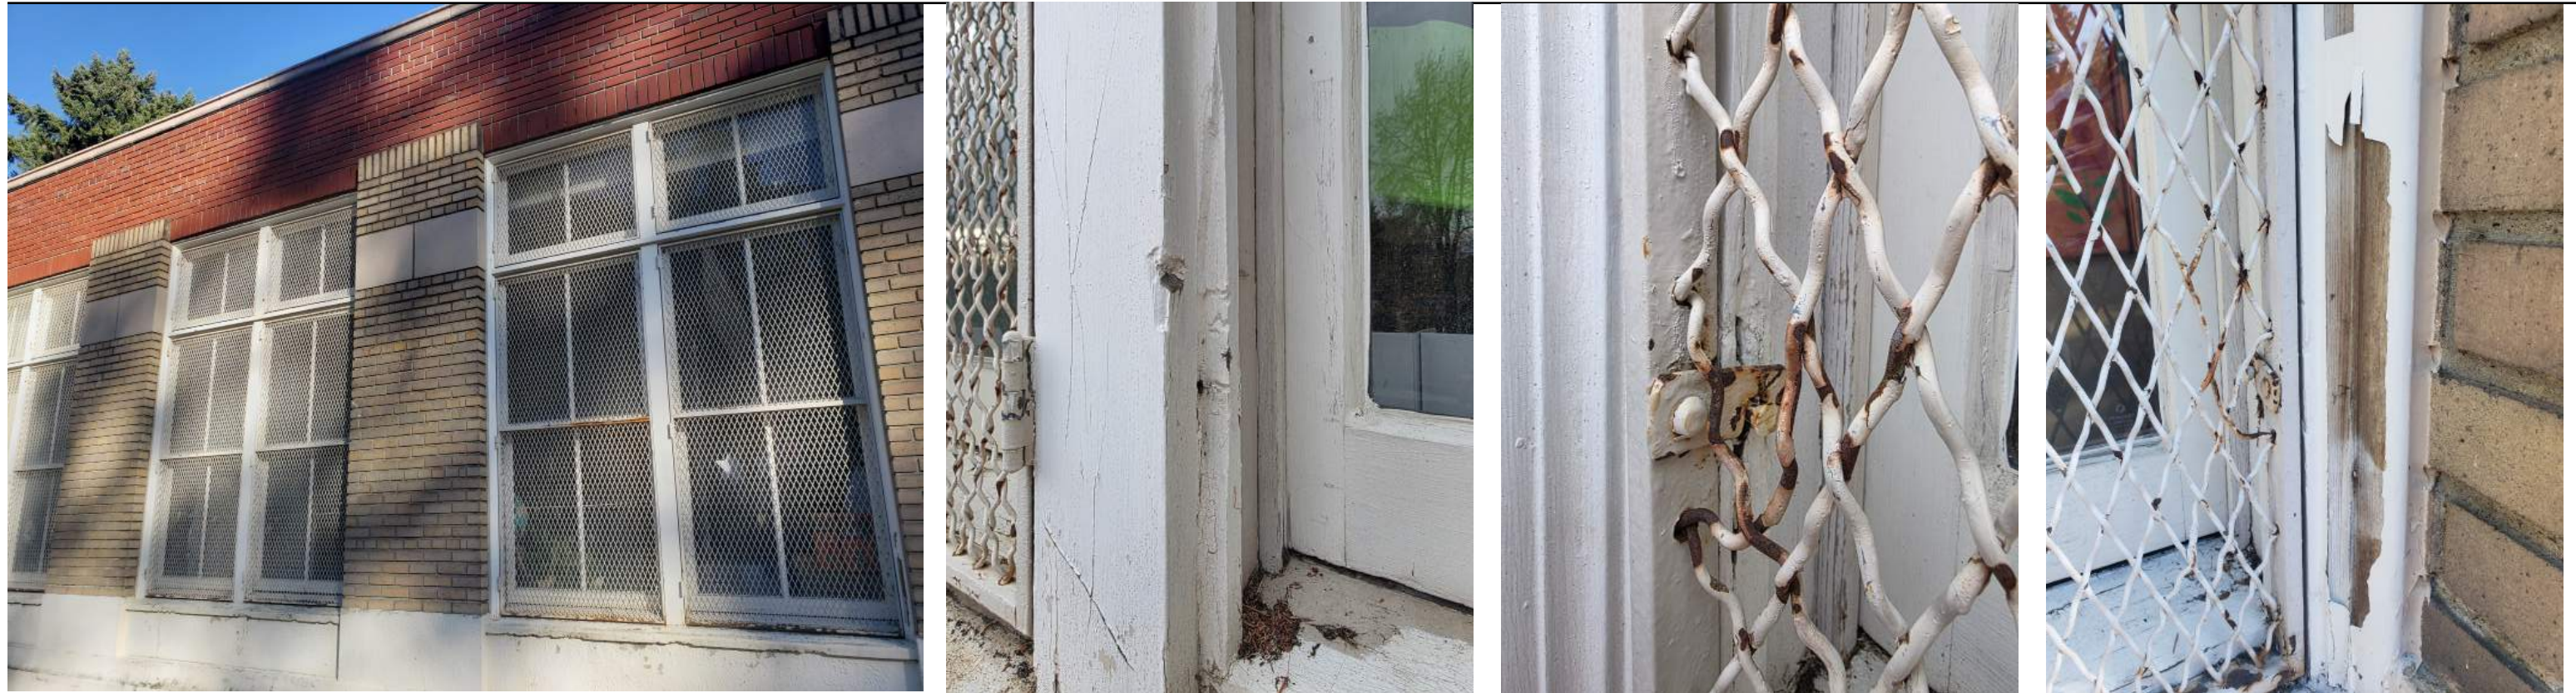
## **1940 WINDOWS:**

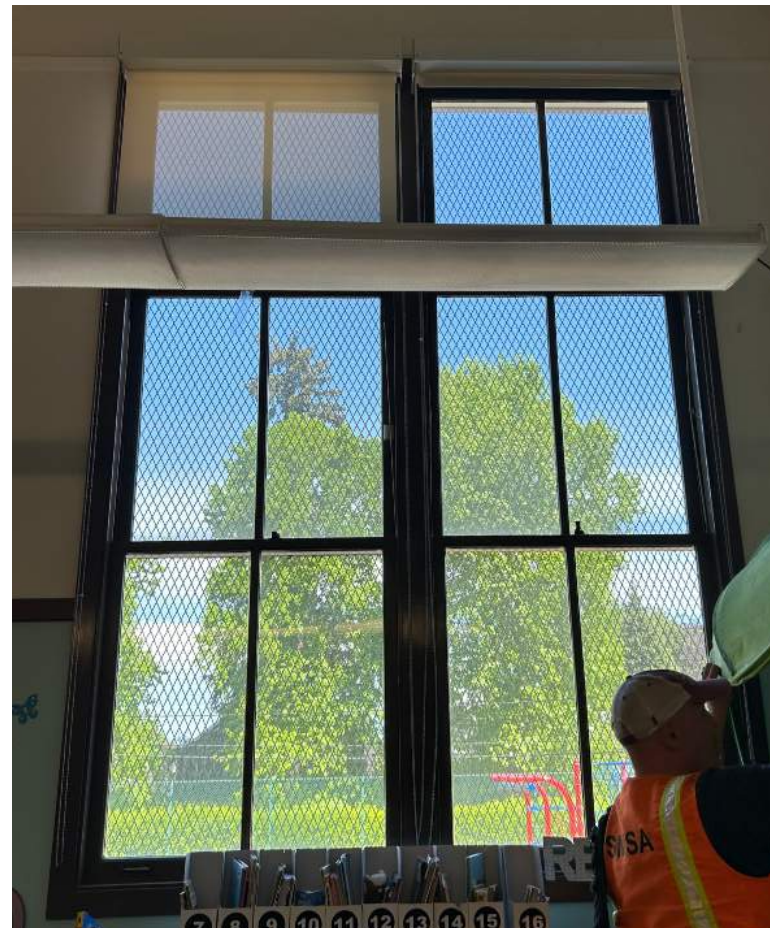
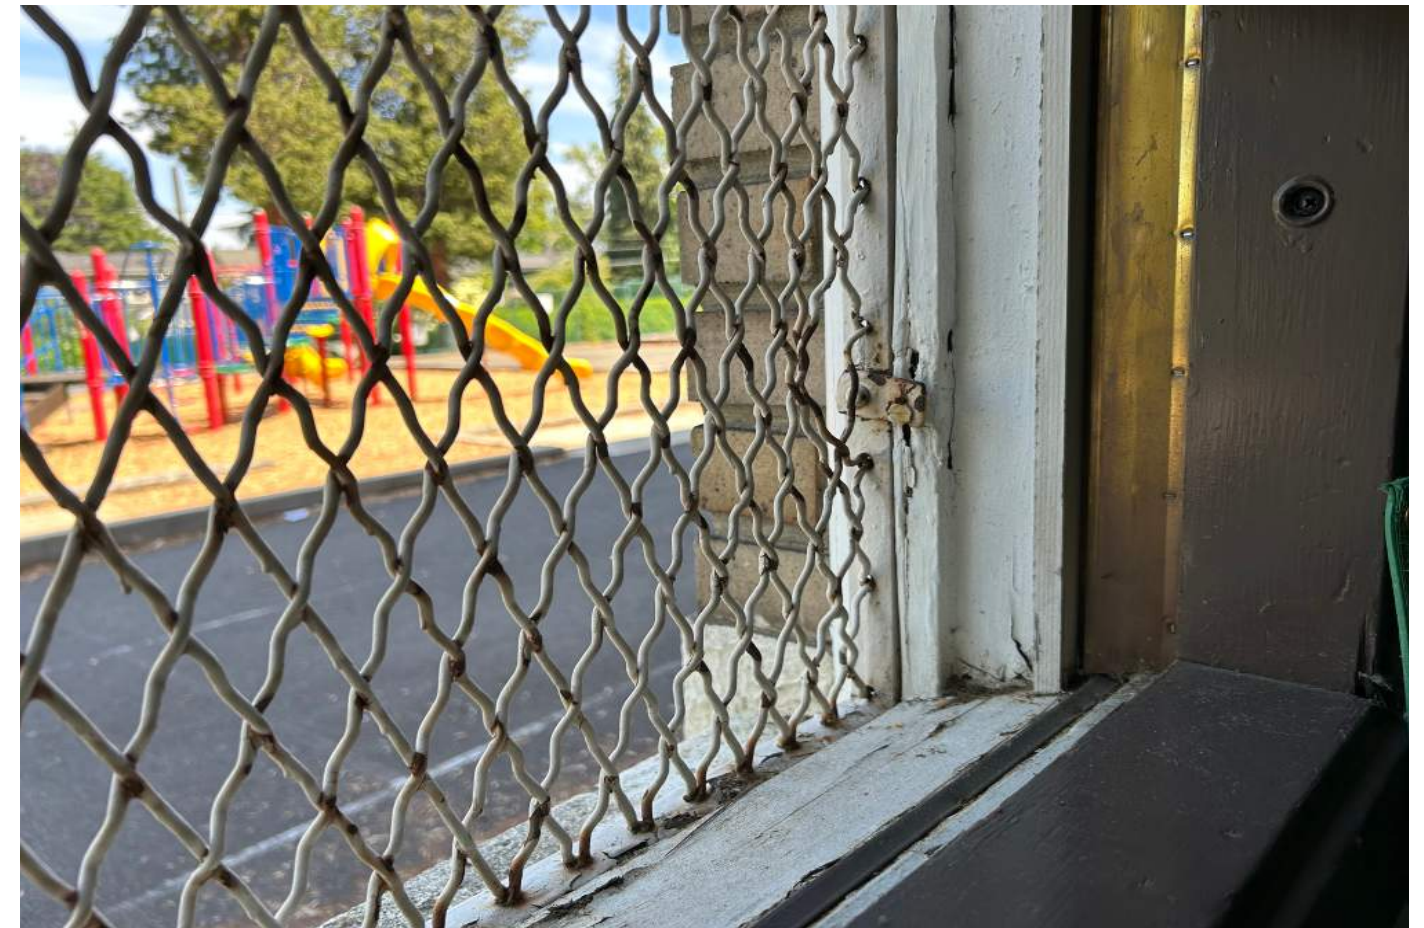
The interior case work shows some signs of wear, with chips or scratches in the paint, but overall is in good condition.

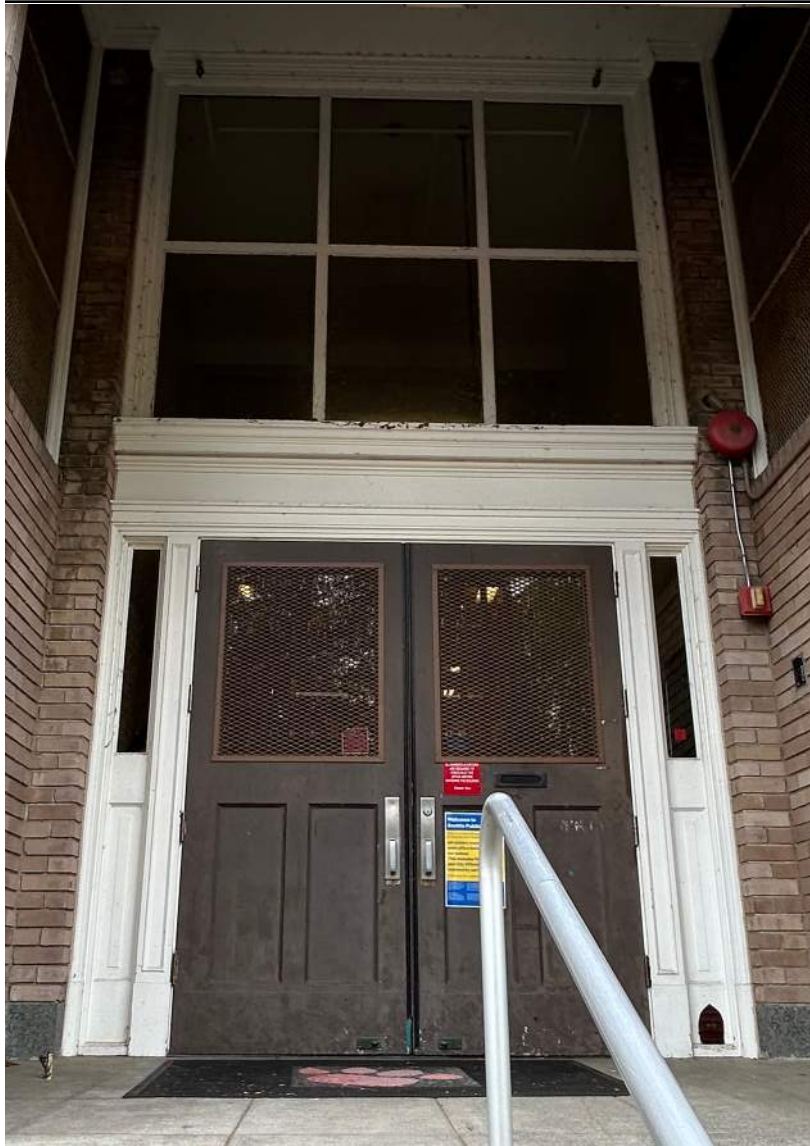
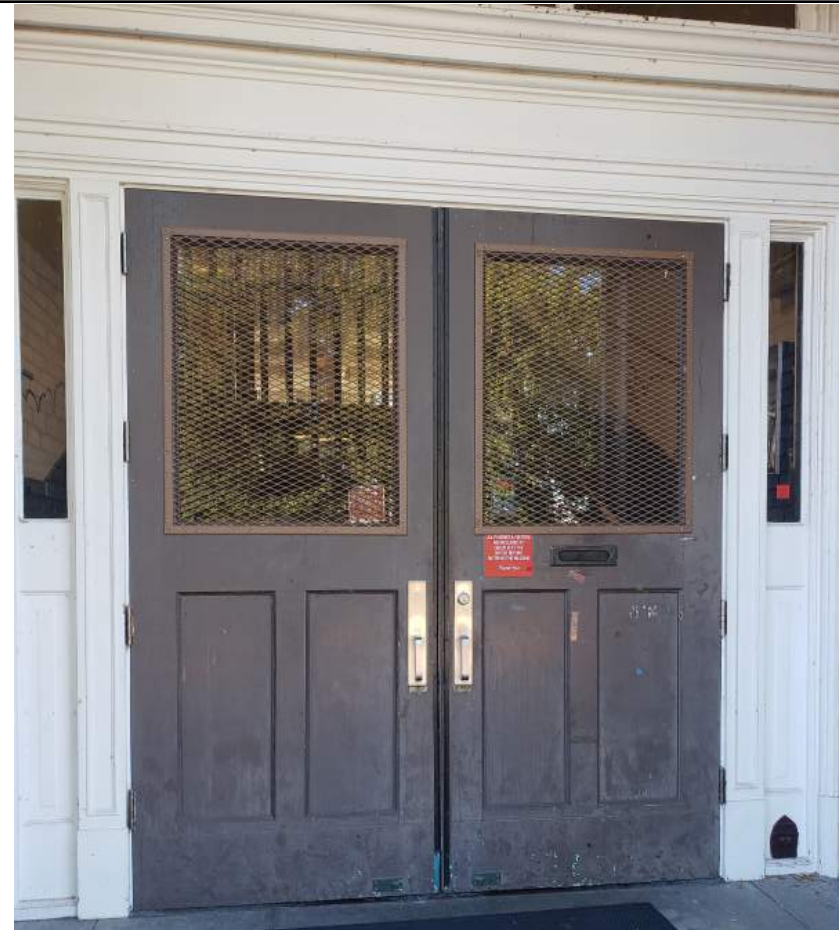
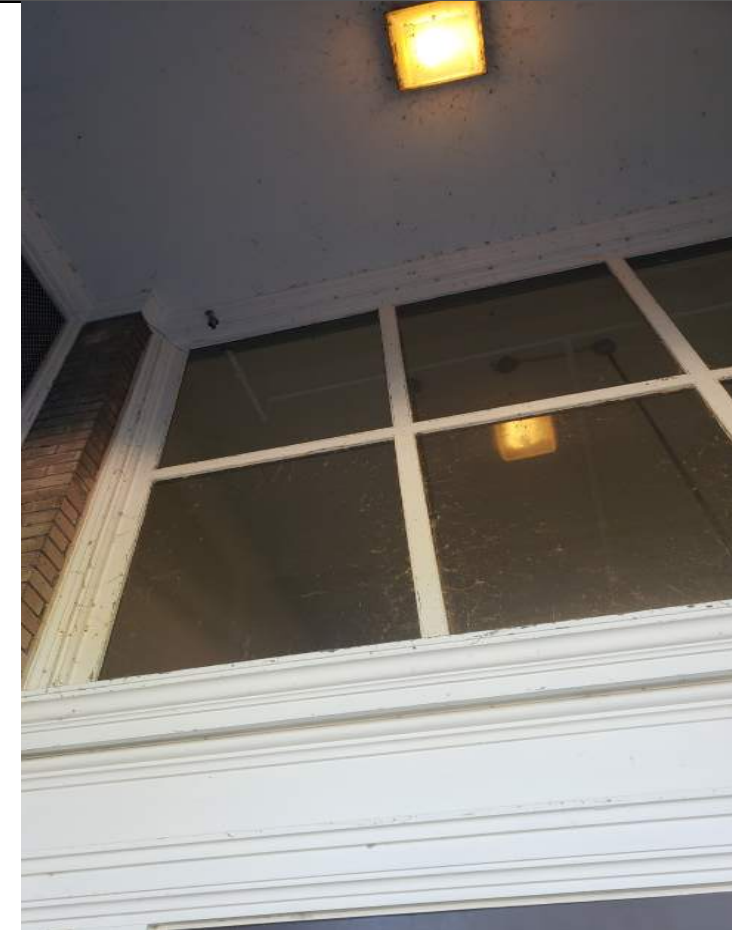
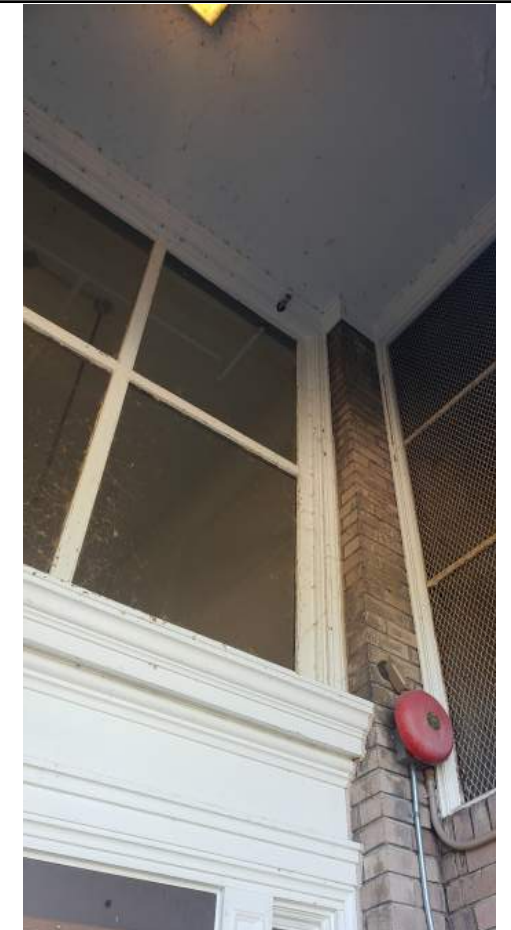
## **1913 DOOR, SIDE LITE, AND TRANSOMES**

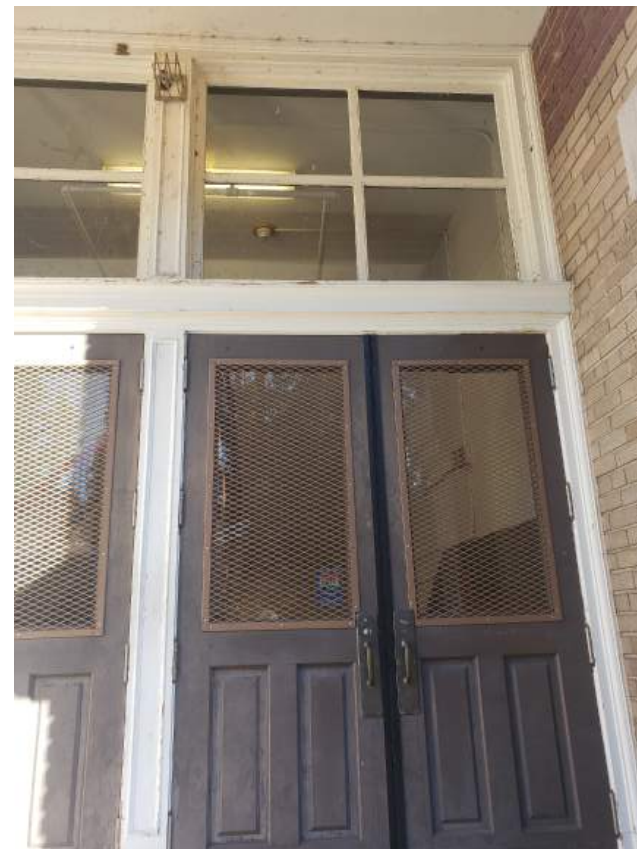
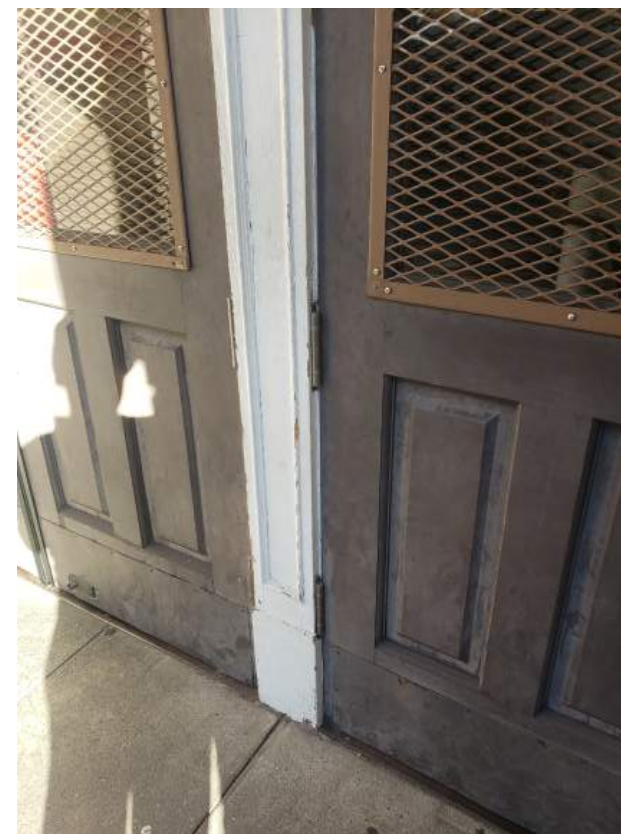
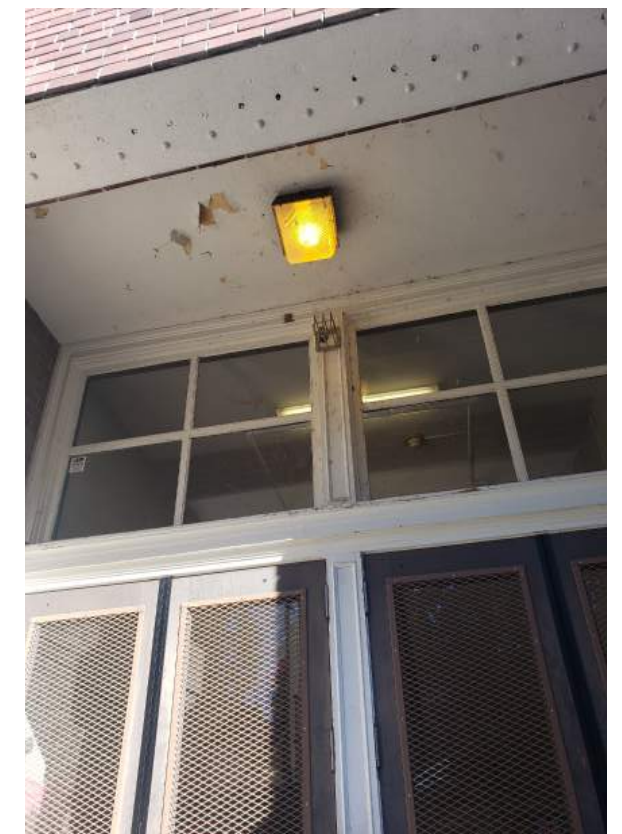
The transoms, thanks to their position, are in good condition with some wear visible in the paint.

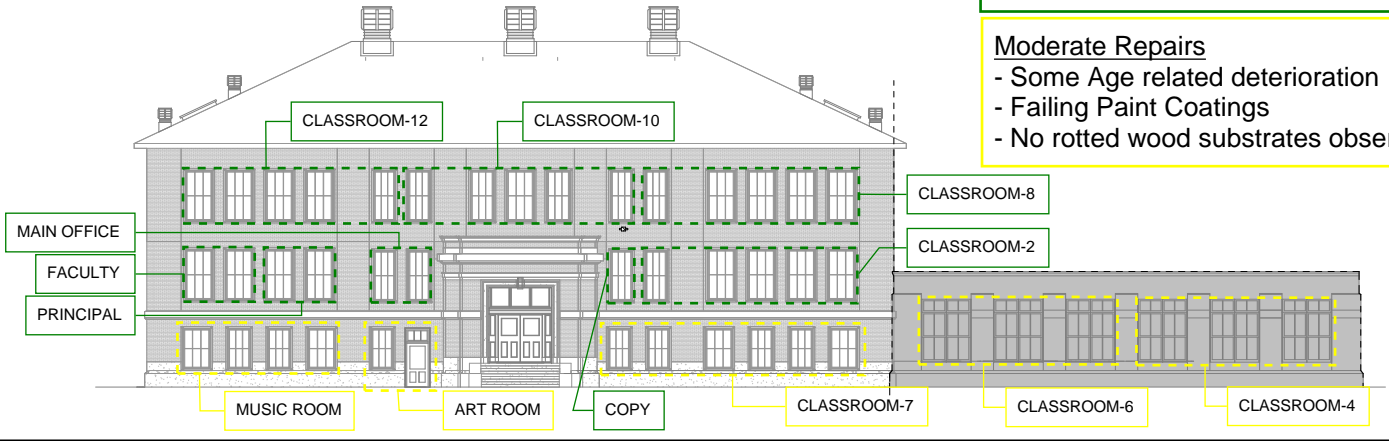
**Minor Repairs**  
- Refurbished in the last 20 years  
- Minor paint Damage

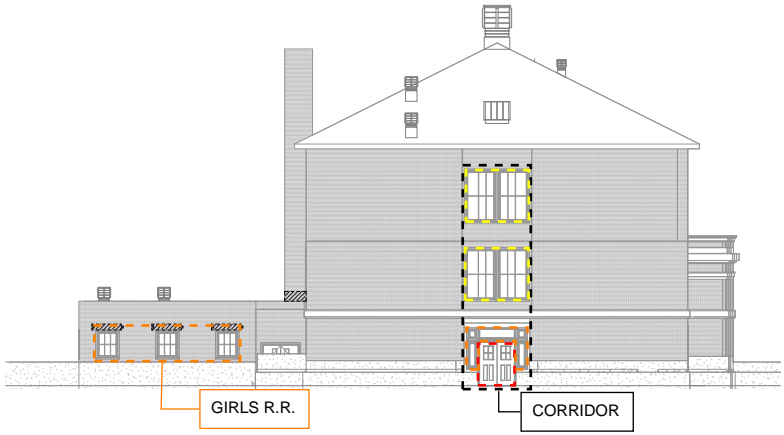
**Heavy Repairs**  
- Age related deterioration  
- Failing Paint Coatings  
- 1/4 inch deep soft/ rotted wood substrates observed. Select areas of soft/ rotted wood greater than 1/4 inch

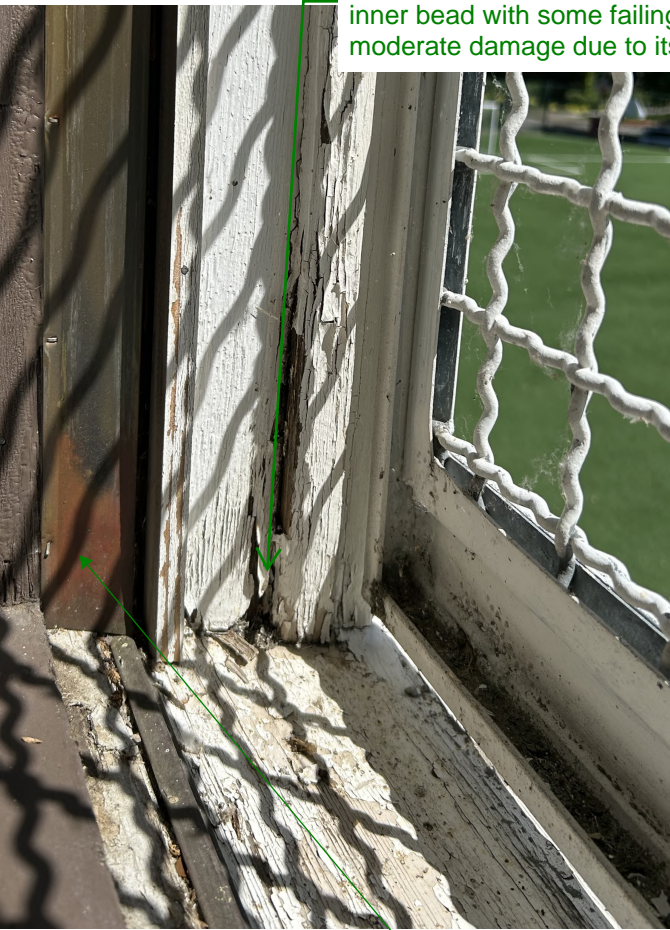
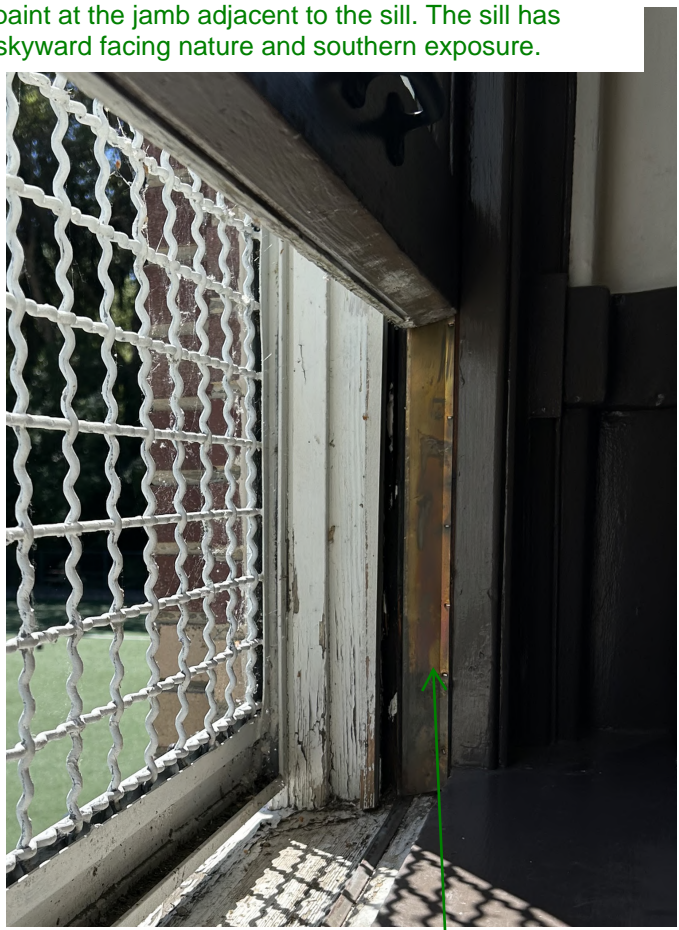
The metal jamb frame is in good condition
