# McGilvra Elementary School

## Historic Wood Window Refurbishment & Glazing Replacement

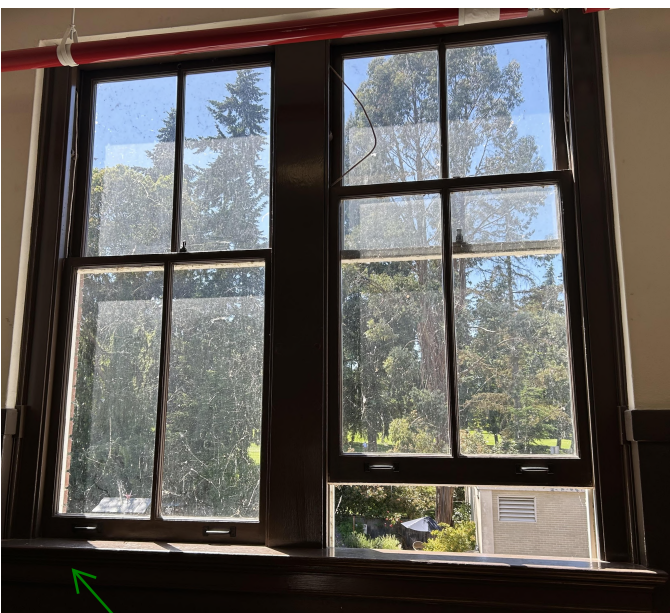
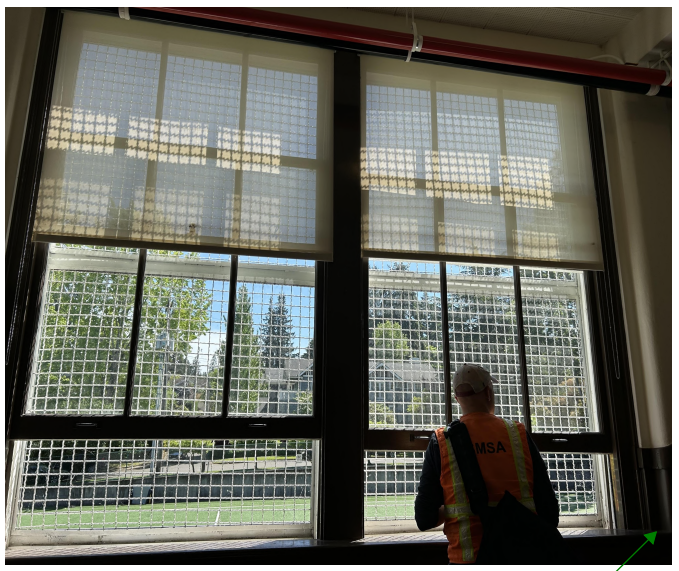
The Interior case work shows some signs of wear, with chips and scratches in the paint but overall is in good condition

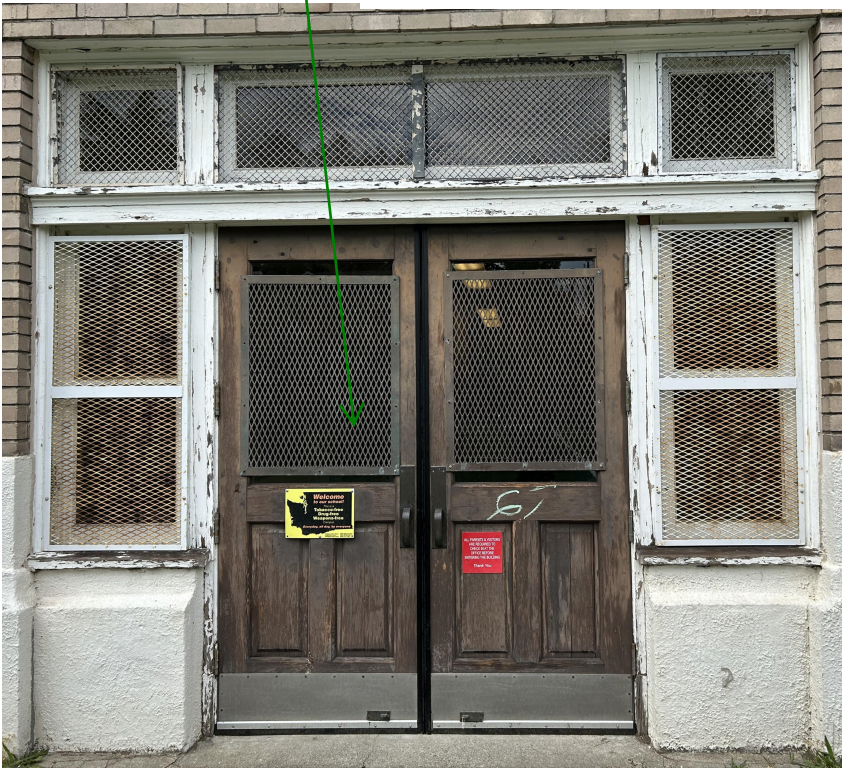
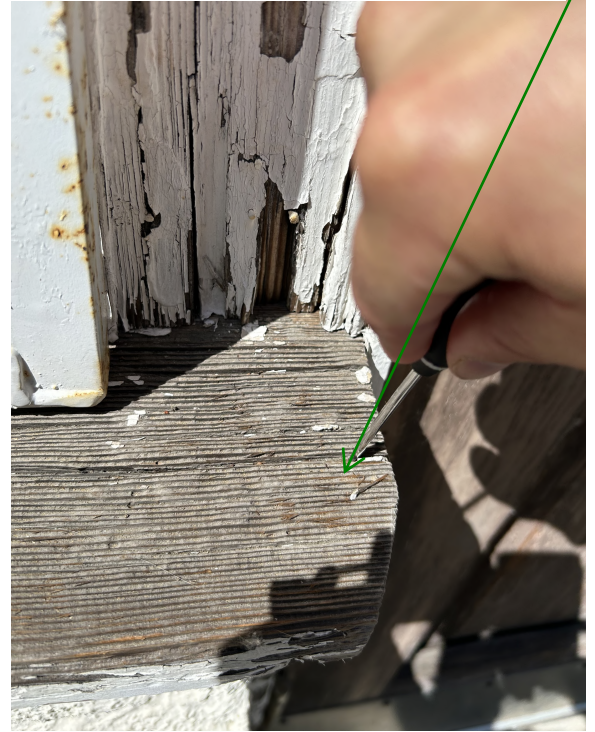
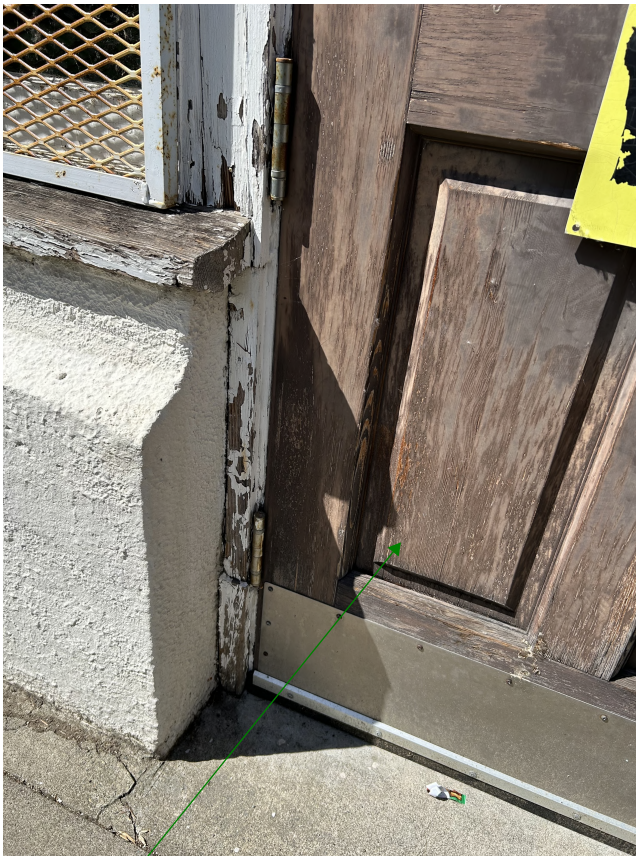
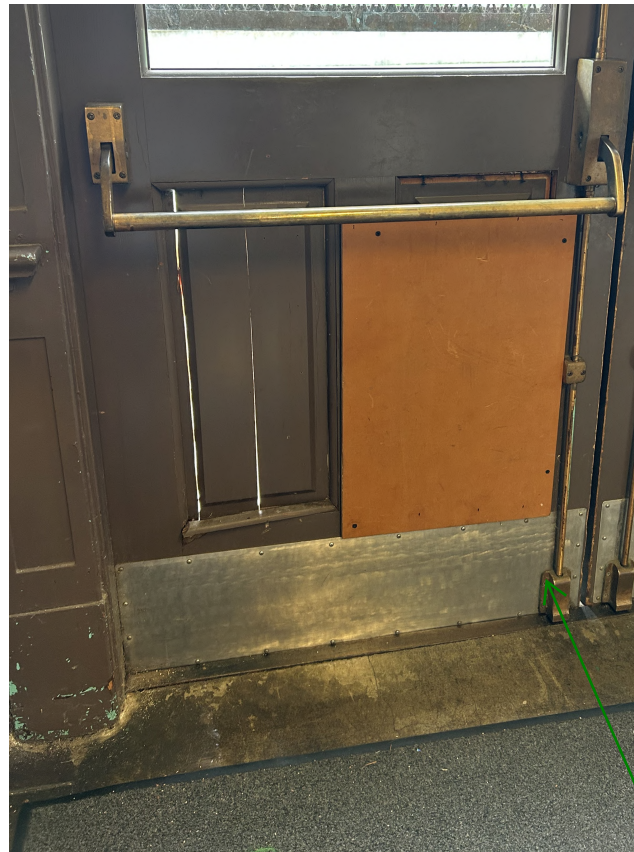
The door panel has cracks in the panels with daylight coming through and plywood attached to the interior side to hold the panels in place. Heavy weathering of the door due to its southern exposure with faded paint. Interior side has brass hardware. Unknown whether hardware is original or historic.

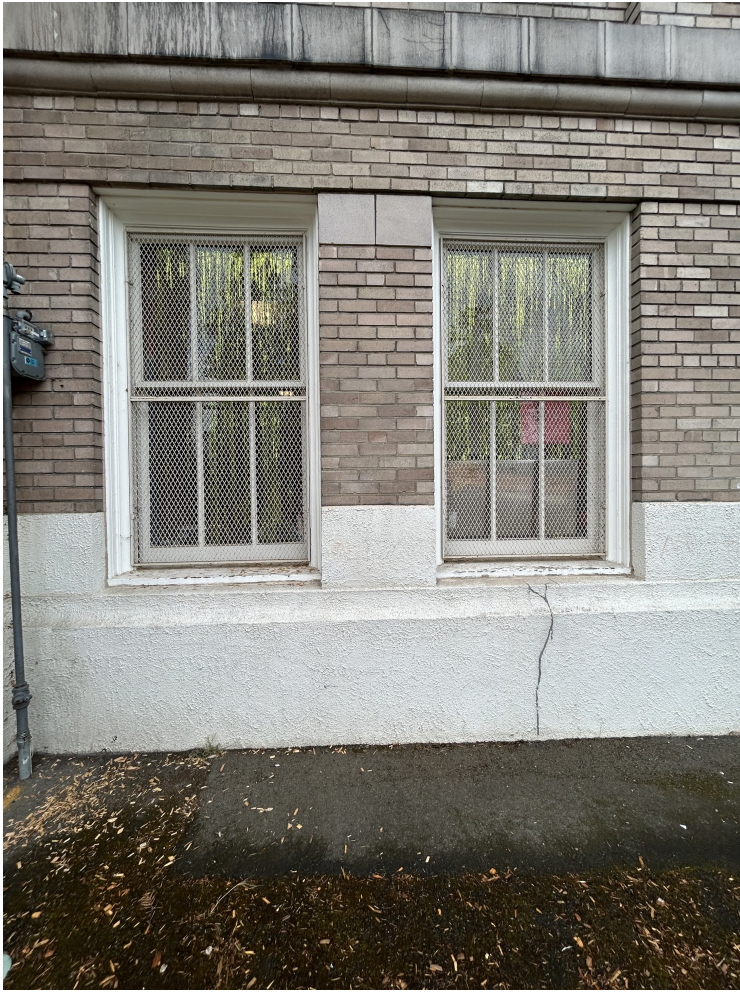
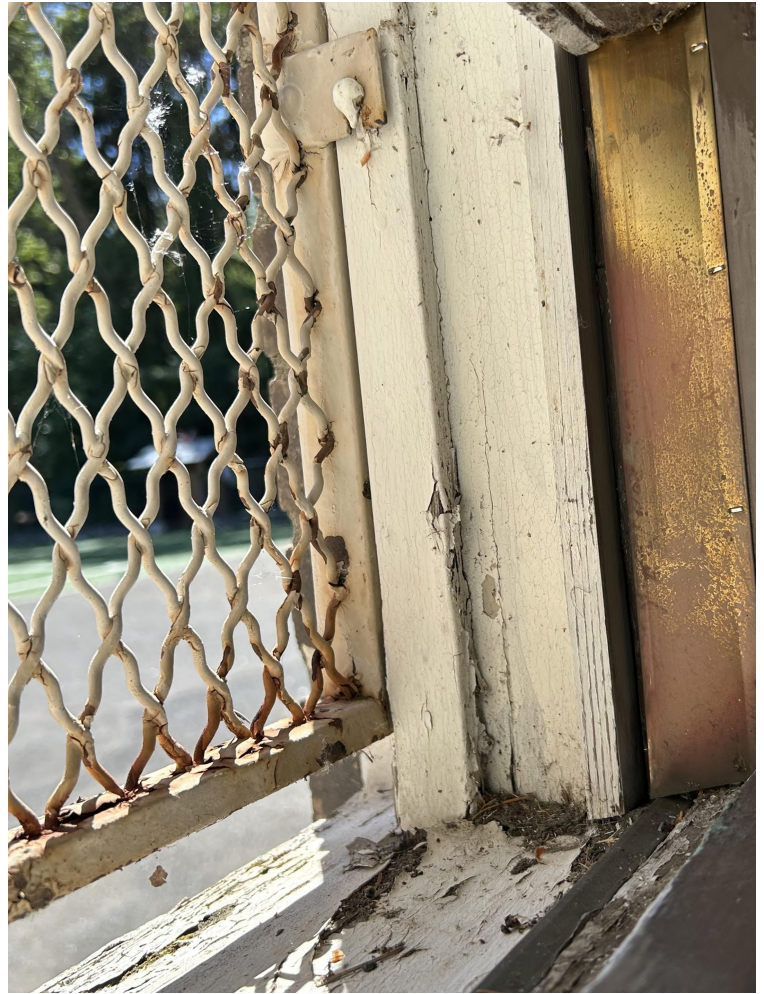
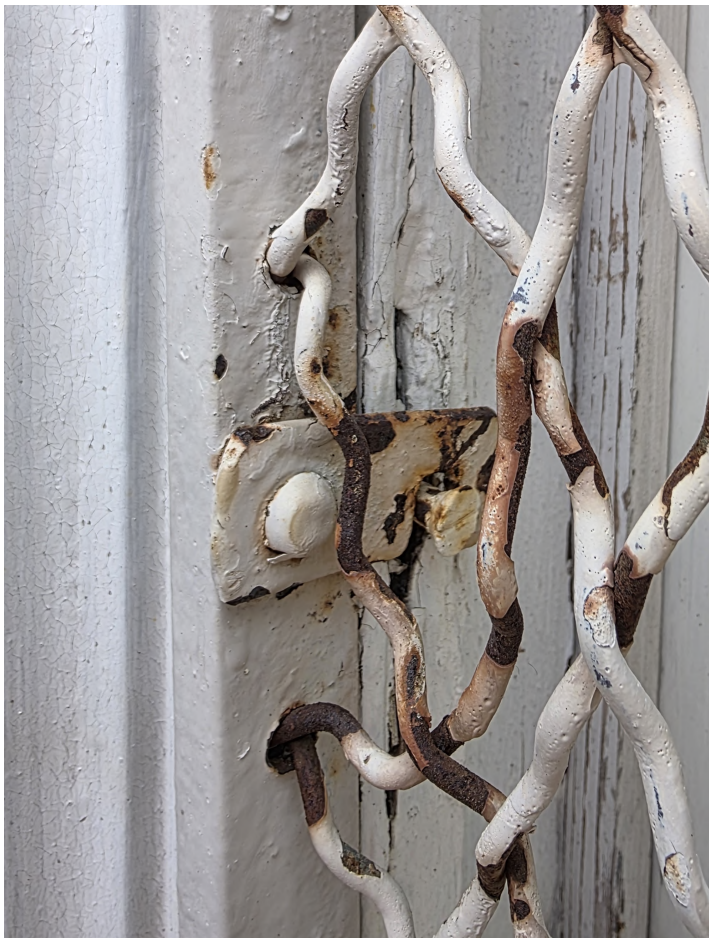
1913 Ground floor, classroom windows have protective expanded steel mesh on the exterior. There are some damage to the wood window frame where the expanded steel mesh is attached. The exterior window sill has moderate damage due to its skyward facing nature. Some wear observed at base of jamb and sill intersection.

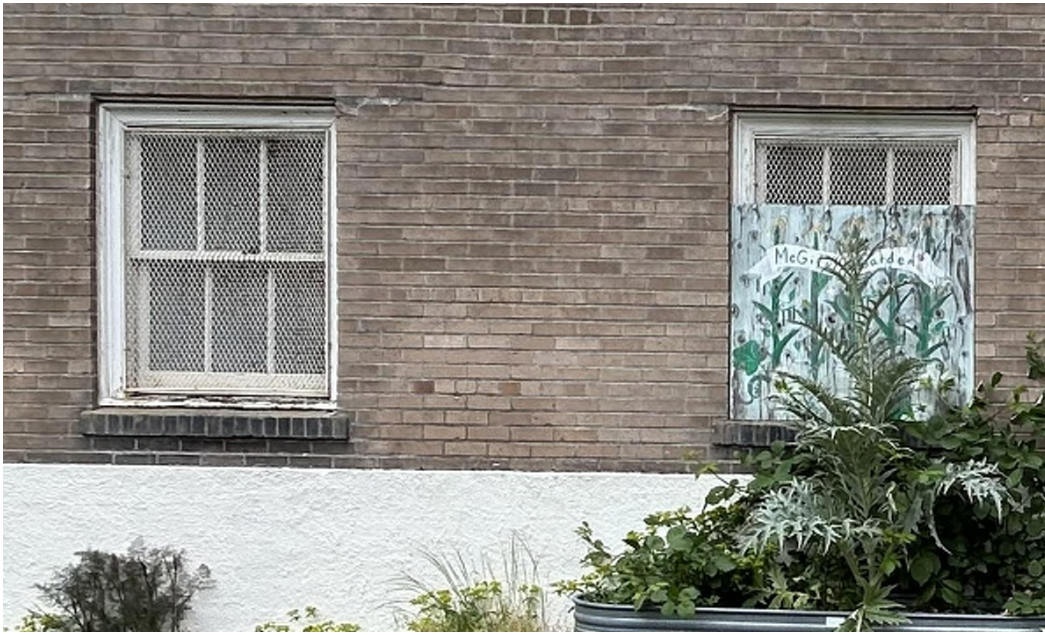
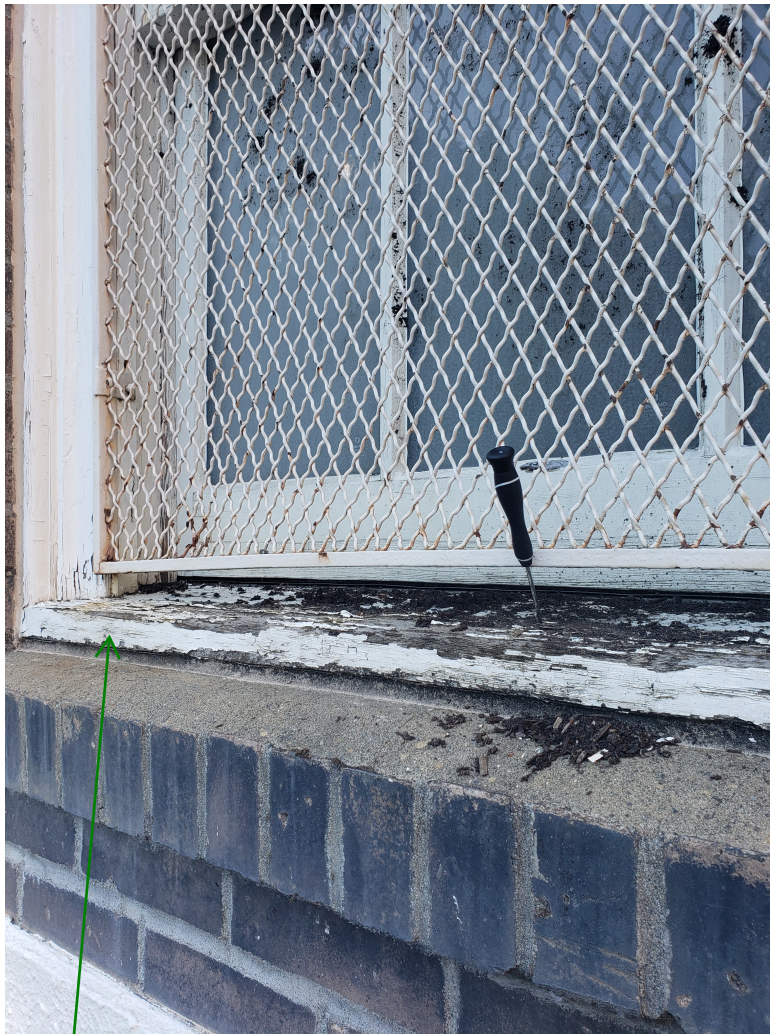
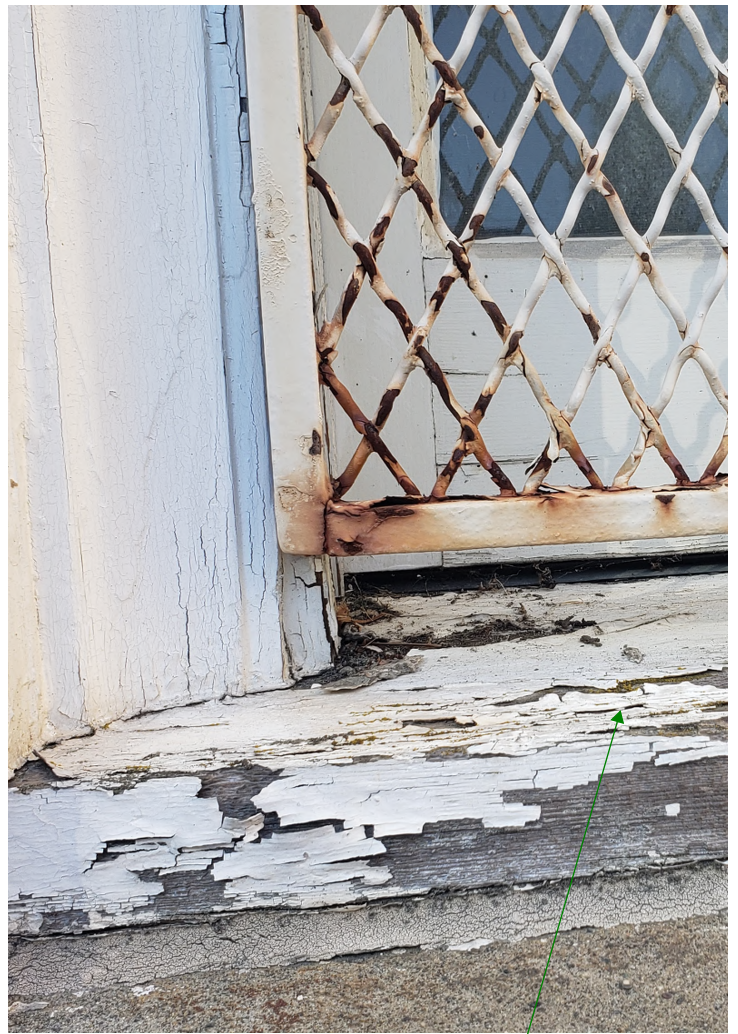
The restroom window sills at the 1913 projecting one story building at the rear are rotted due to the protective expanded, steel mesh and smaller window area causing leaves and debris to fill the window cavity.

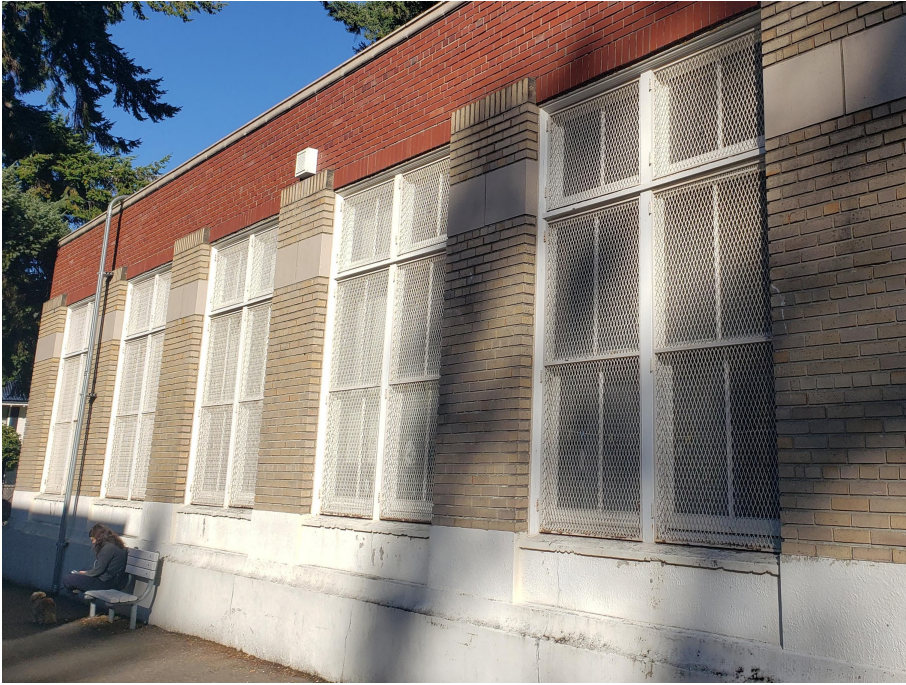
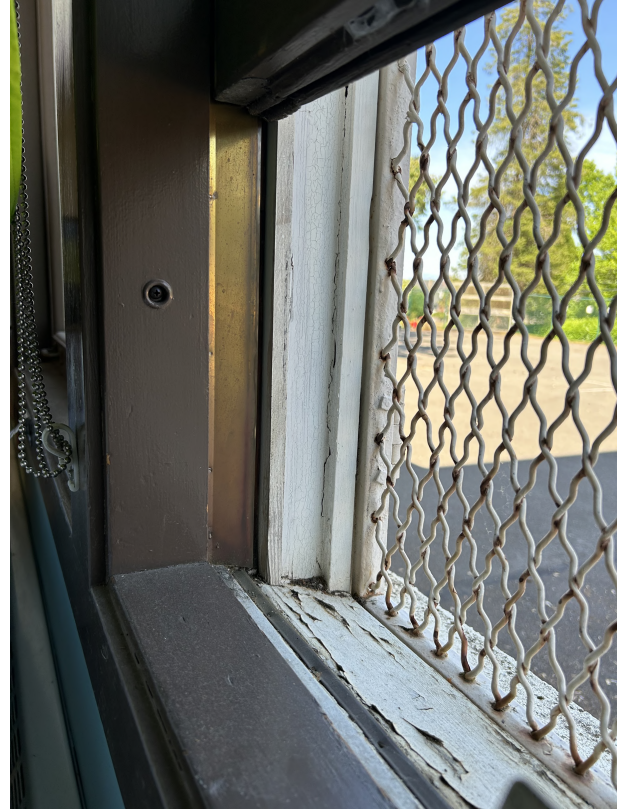
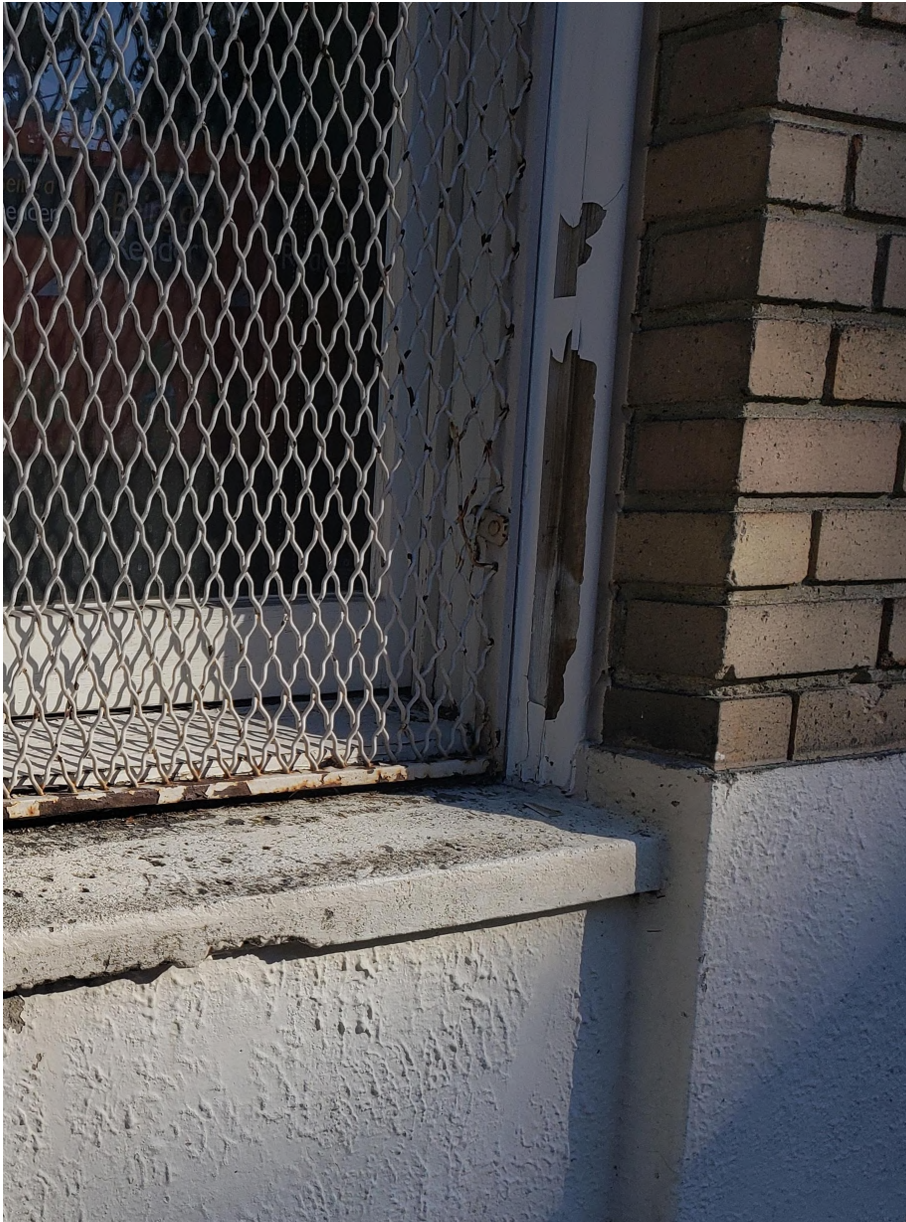
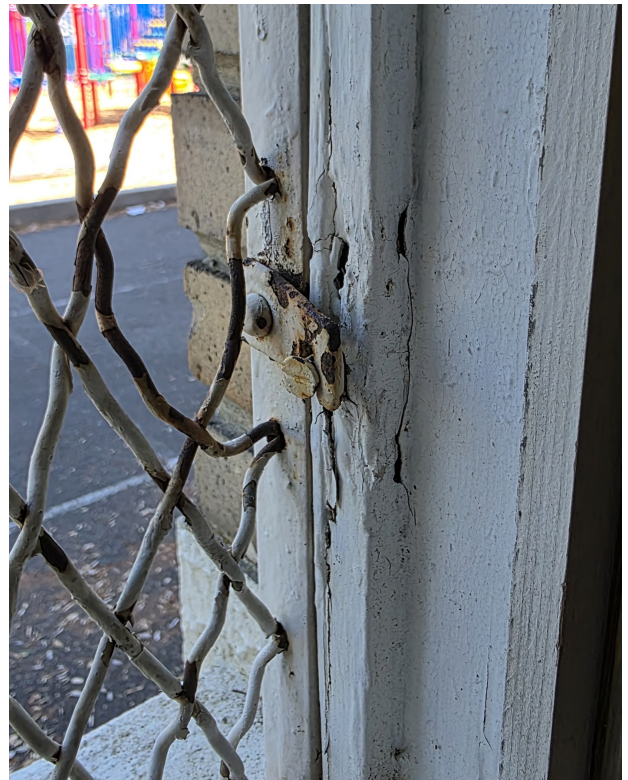
1940 Ground floor, classroom windows have protective expanded steel mesh on the exterior. There are some damage to the wood window frame where the expanded steel mesh is attached along with chips in the paint on the jambs. The exterior window sill has moderate damage due to its skyward facing nature.

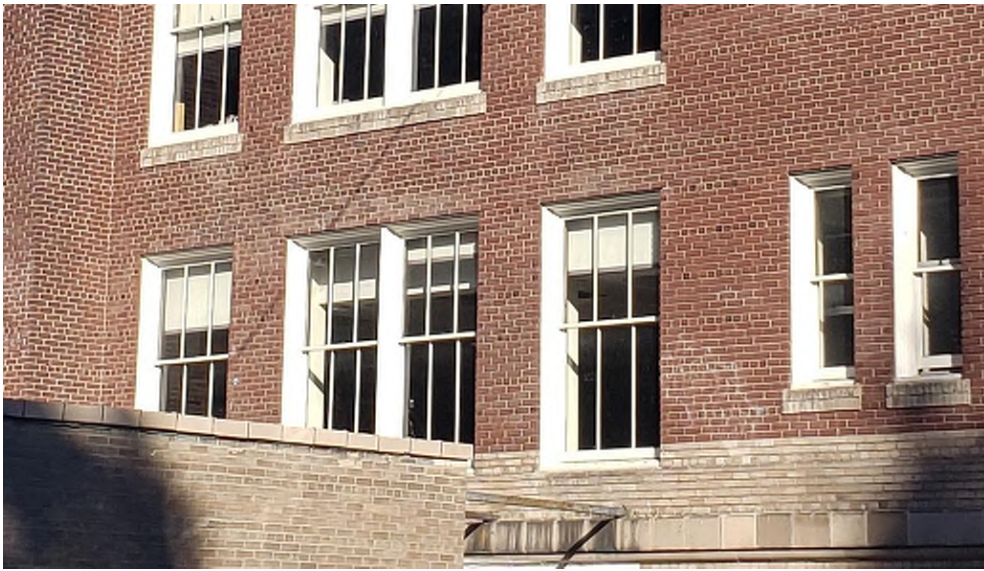
The Second floor Library window are in fair condition with minor chips in the paint observed on the jambs and some damage observed on the exterior sill due to its skyward facing nature.

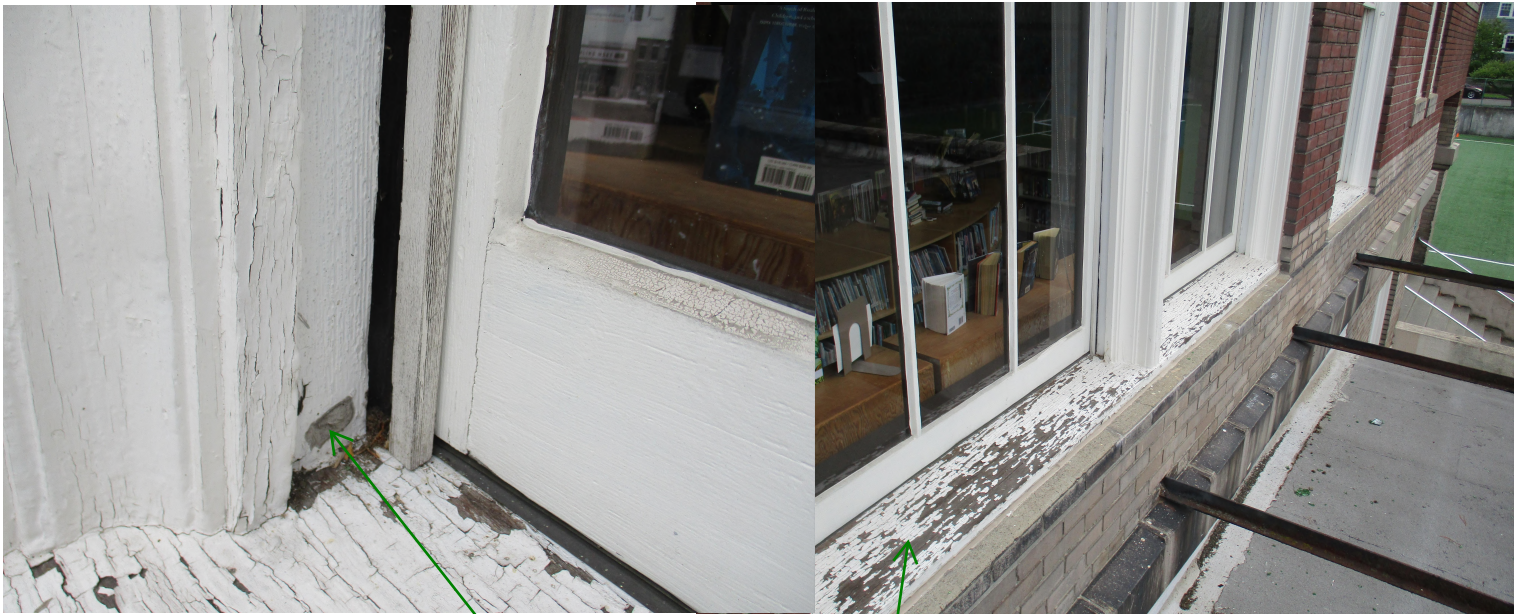
Faded paint on the exterior window sills

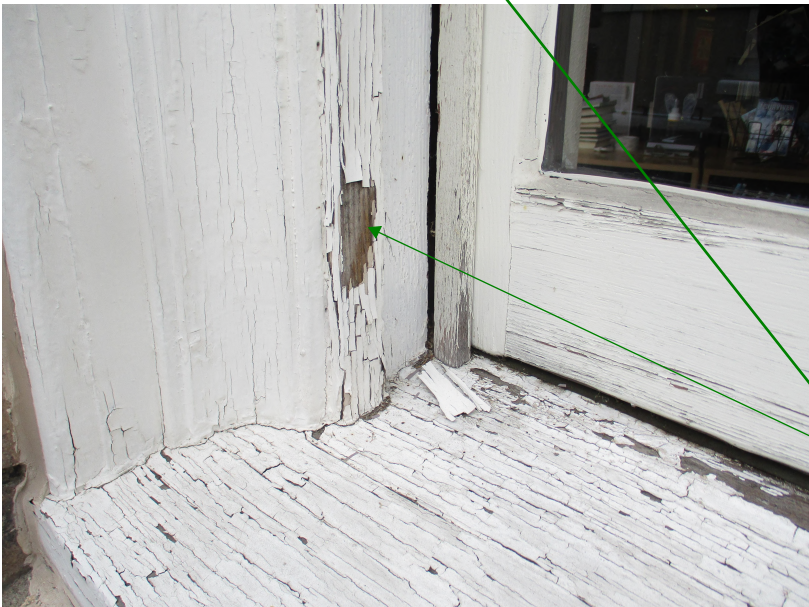
Minor chips and wear on jambs and window frame

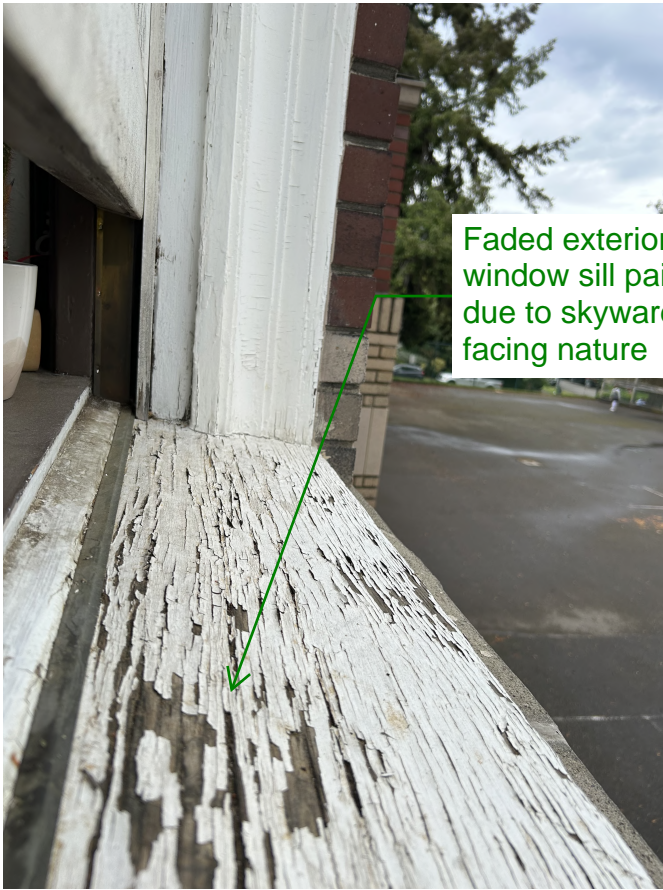
Faded exterior window sill paint due to skyward facing nature

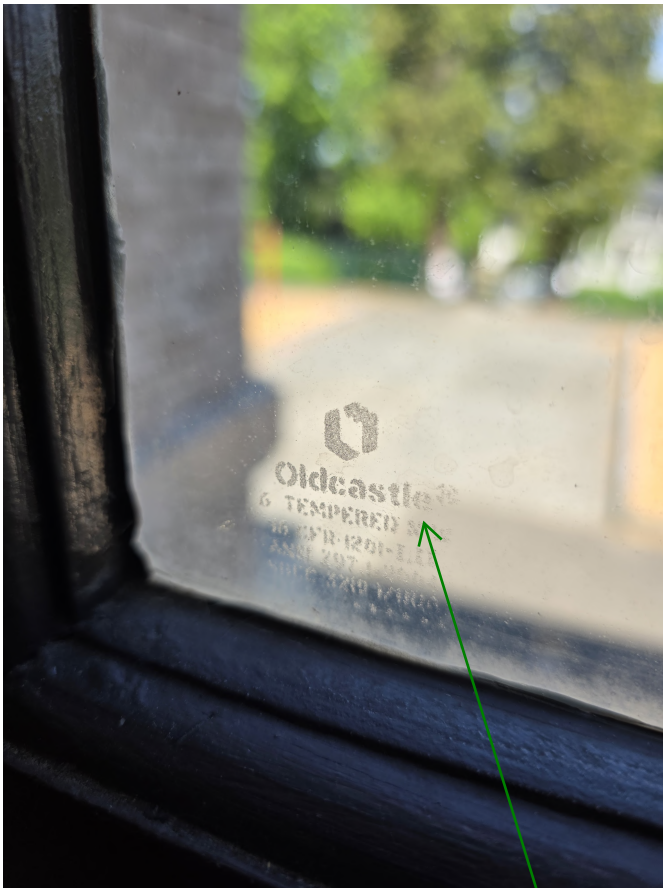
Previously replaced window glazing

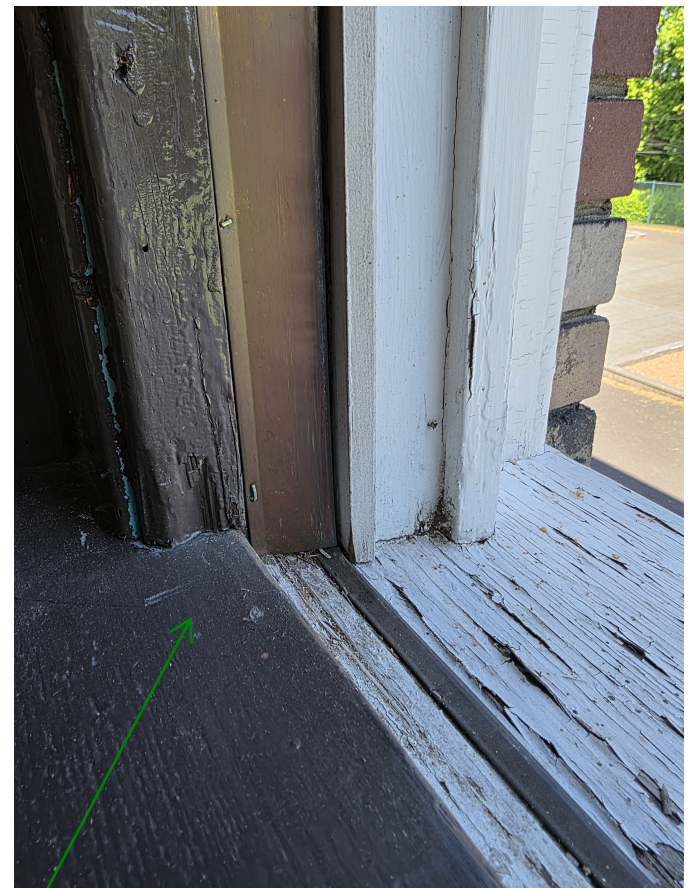
Interior case works in good condition with some chips or scratches in the paint

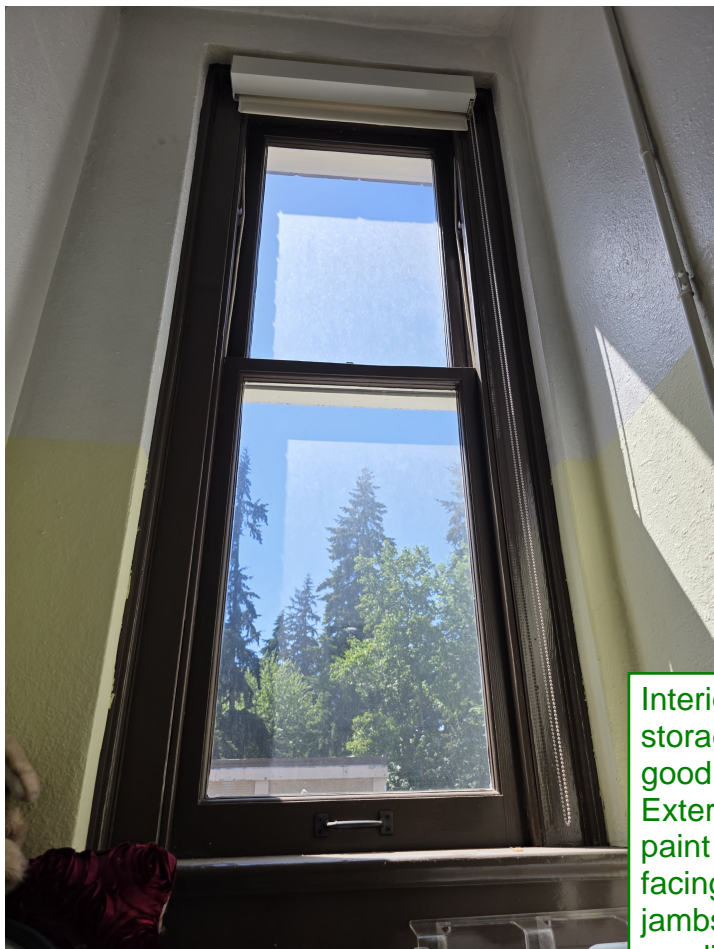
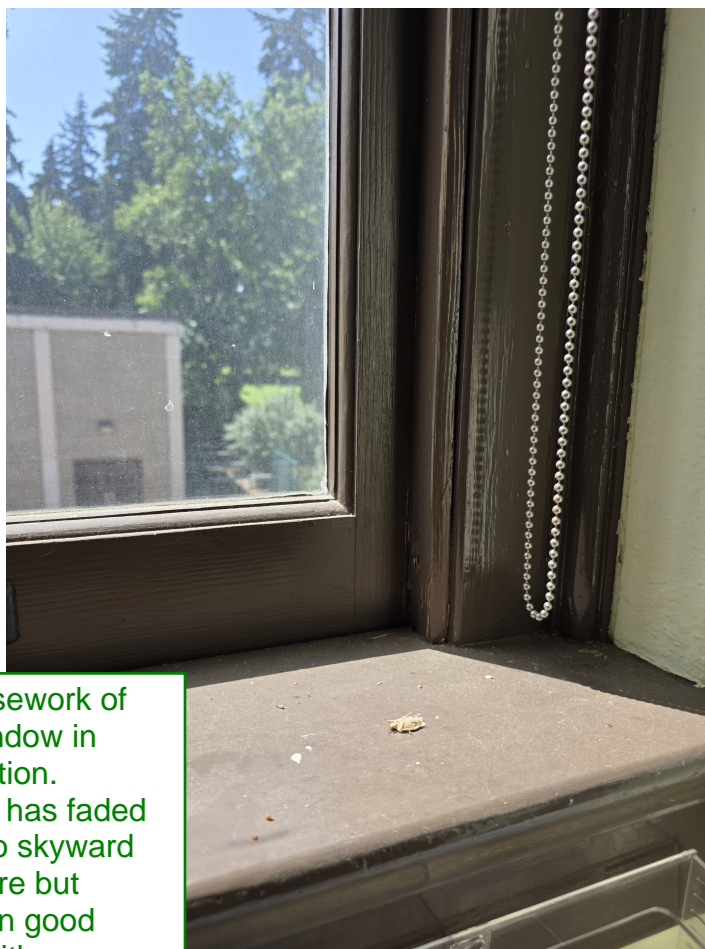
Interior Casework of storage window in good condition. Exterior sill has faded paint due to skyward facing nature but jambs are in good condition with some weathering at the base where it intersects sill.

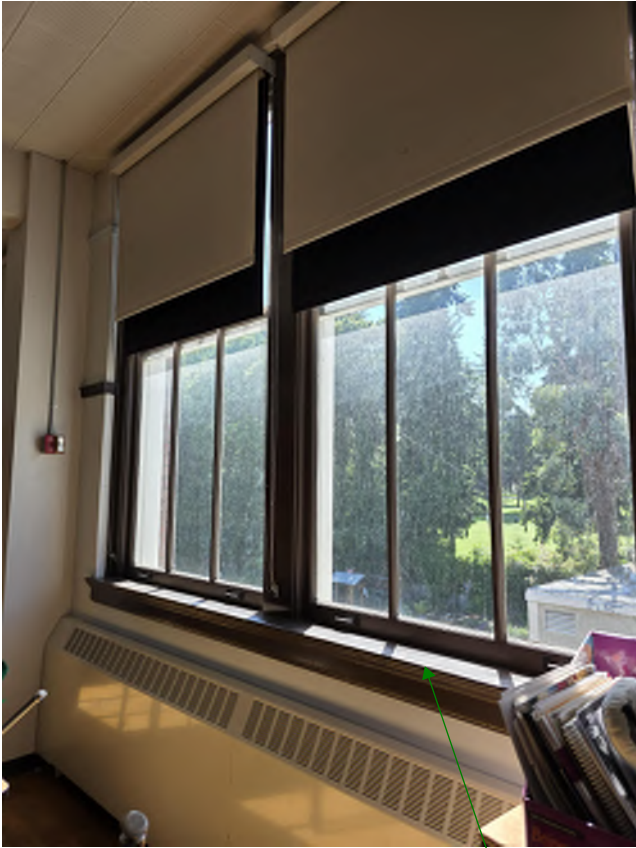
Interior casework and paint in good condition

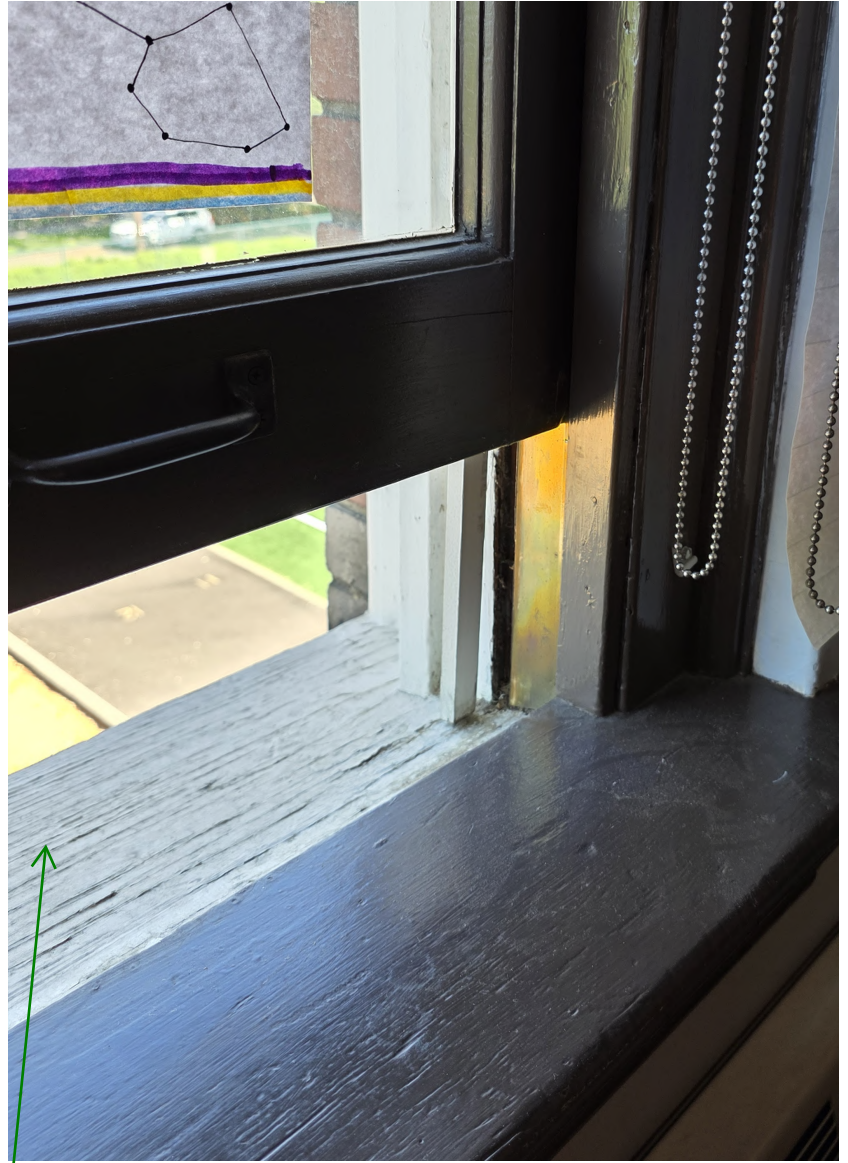
moderate weathering on exterior window sill.

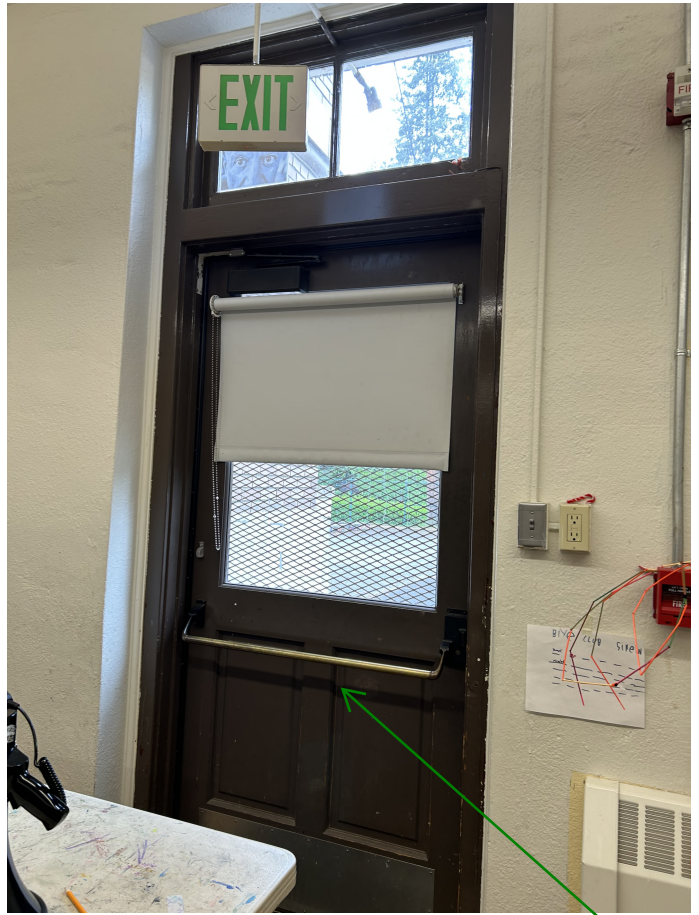
Interior paint, frame, trim and door panel is in good condition.

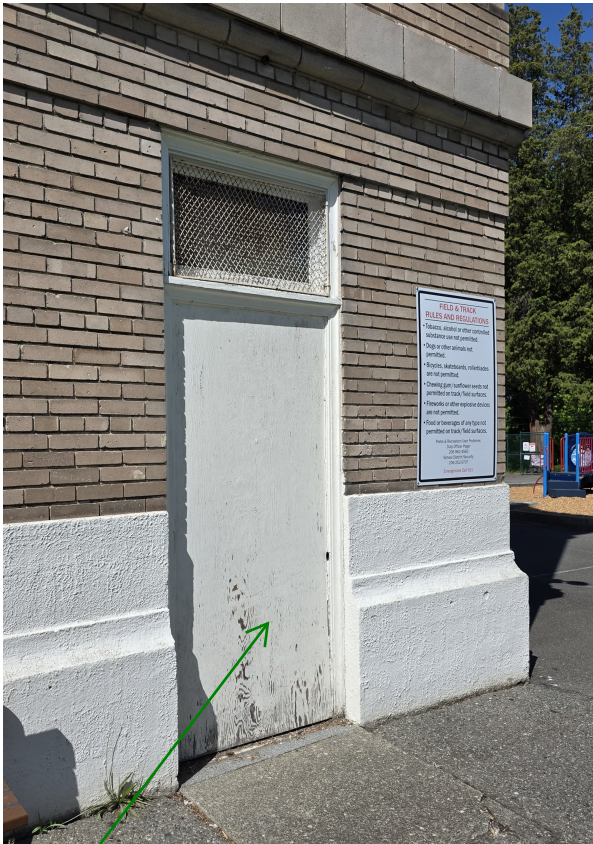
South East, ground floor corner door at music room was infill in 2002 when cafeteria was relocated

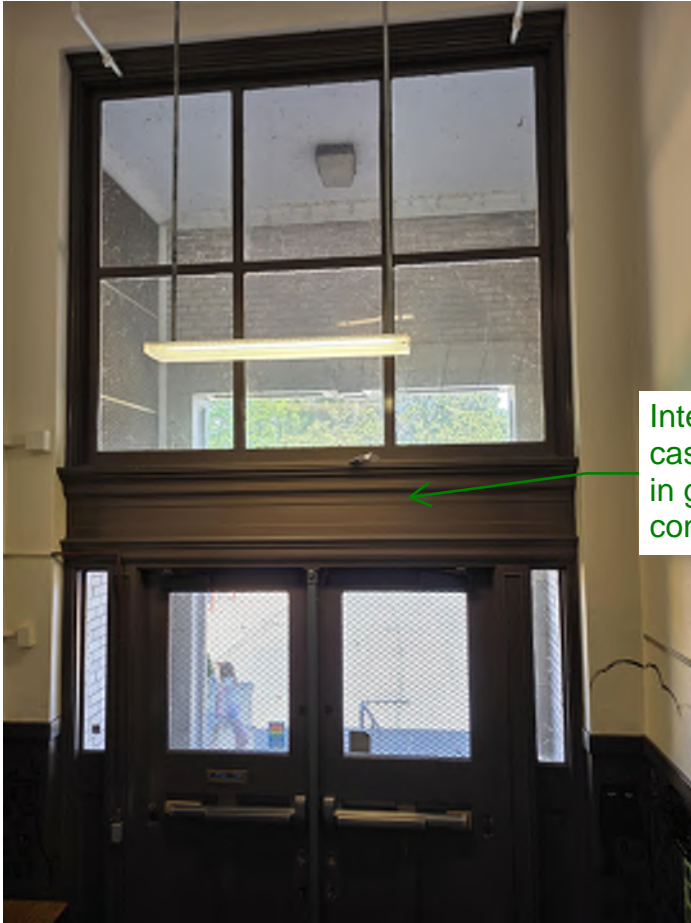
Interior casework is in good condition

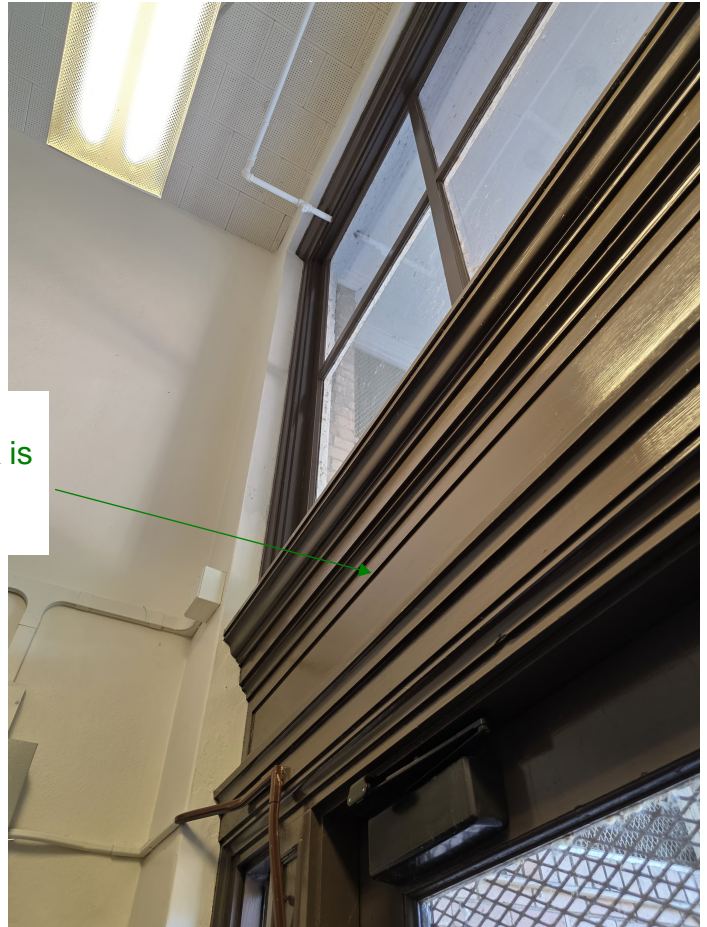
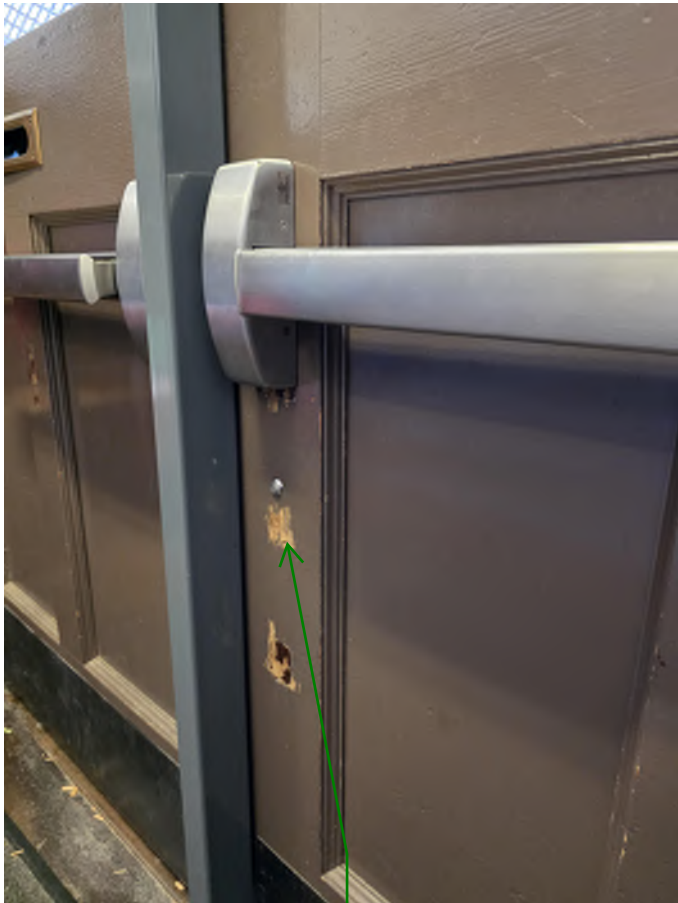
Hardware different from other doors are on main entry door. Traces of previous hardware removed remain

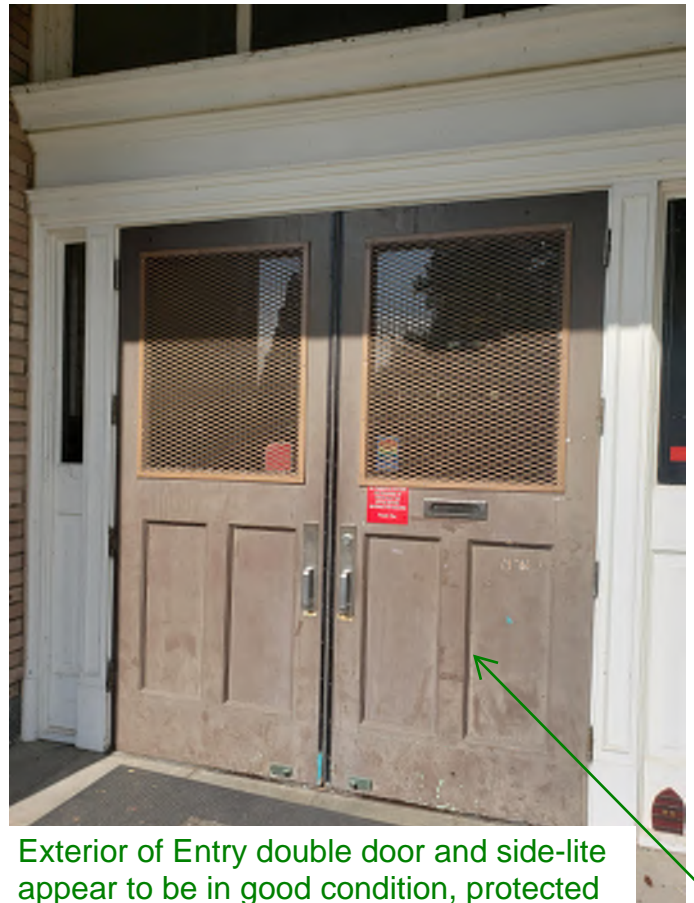
Exterior of Entry double door and side-lite appear to be in good condition, protected from the weather by entry protrusion. The paint appears faded due to its consistent use over the years

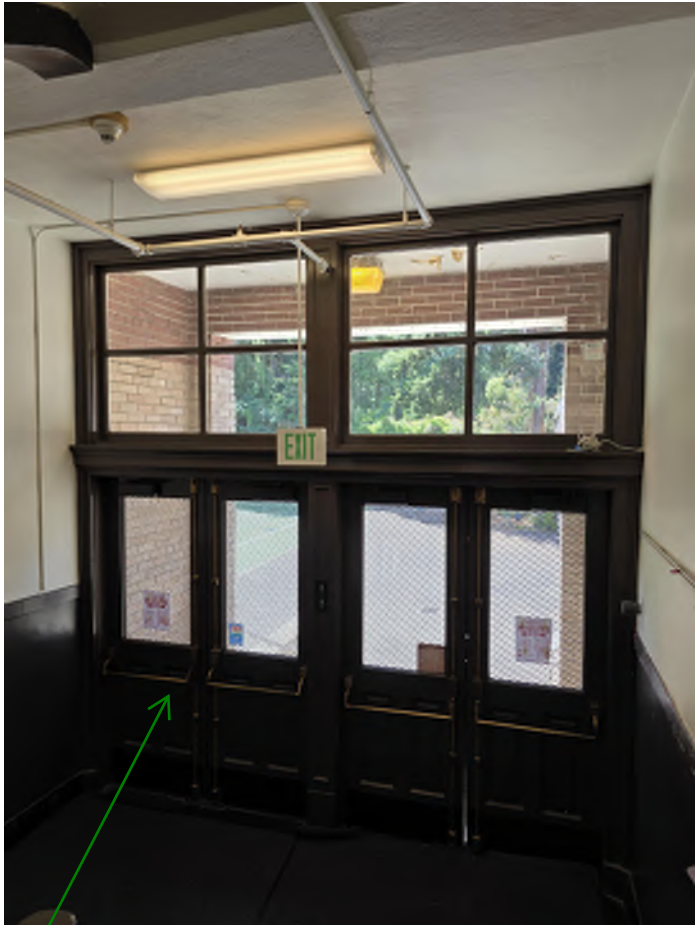
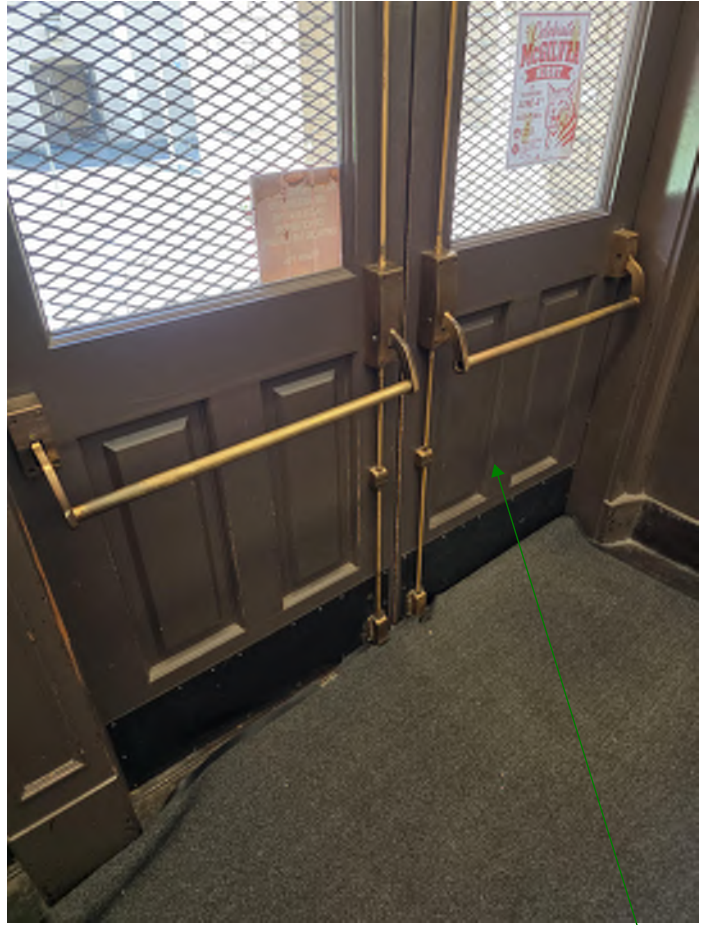
Brass door hardware. Unknown whether they are original or historic match. Back double door interior side is in good condition with some scratches to the paint
