# McGilvra Elementary School

## Historic Wood Window Refurbishment & Glazing Replacement

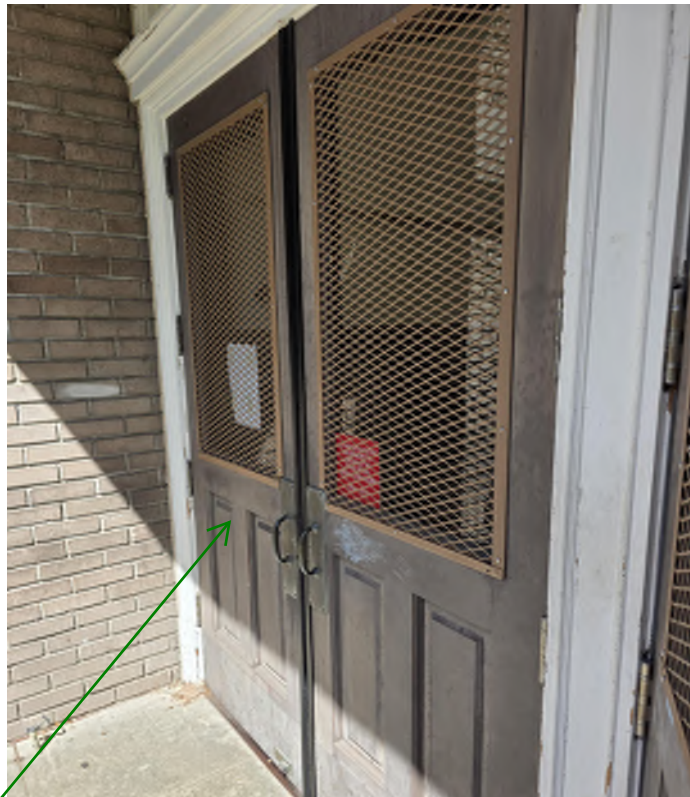
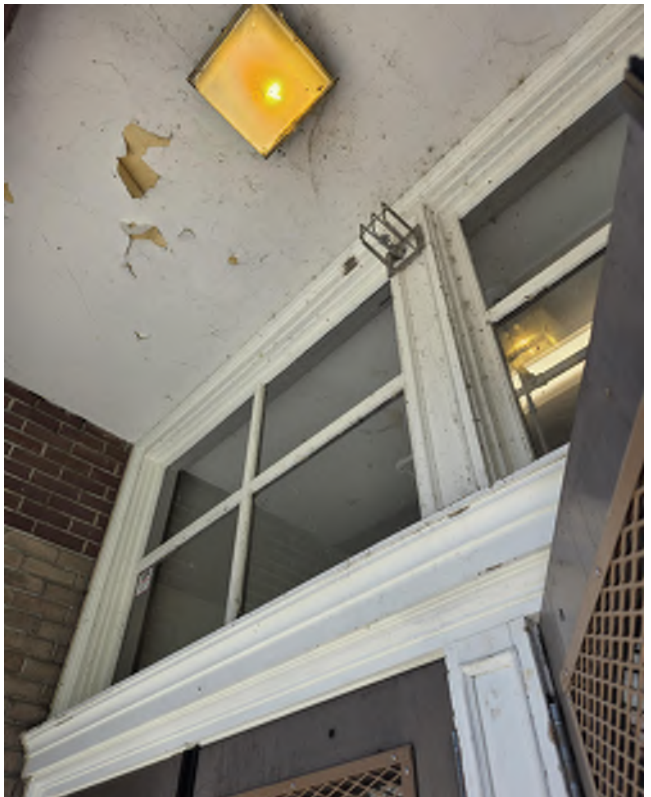
Exterior of Back double door and transom is in good condition, protected from the weather by doors setback with floor above providing protection from the elements. The paint appears faded due to its consistent use over the years.

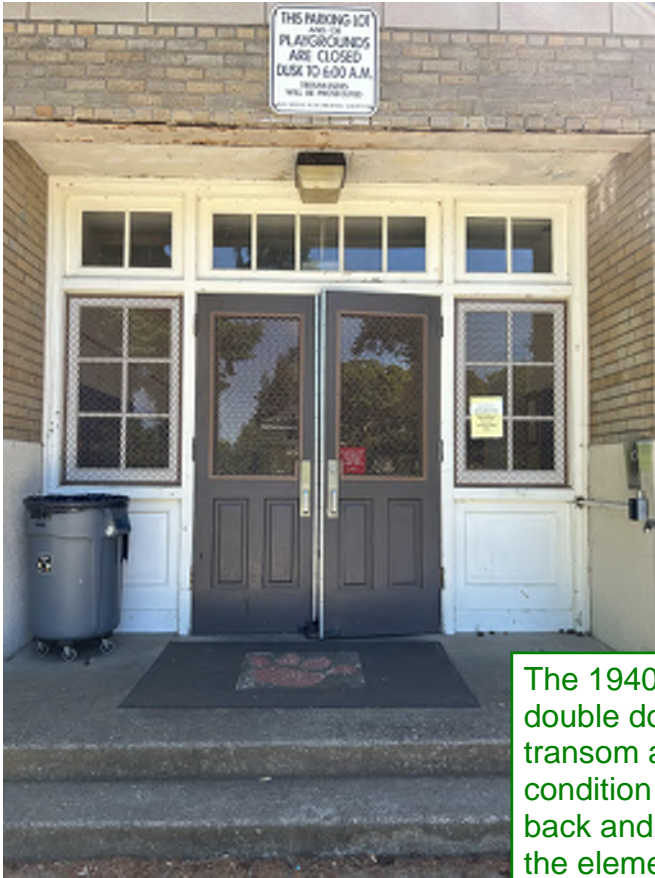
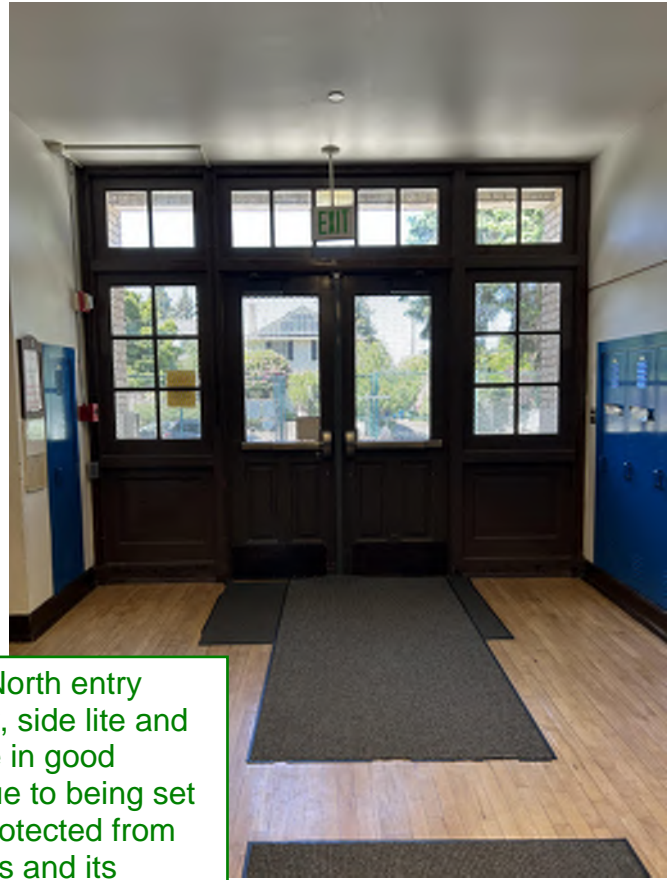
The 1940, North entry double door, side lite and transom are in good condition due to being set back and protected from the elements and its orientation to the North. Some fading of the paint on the exterior is observed from regular use over the years.

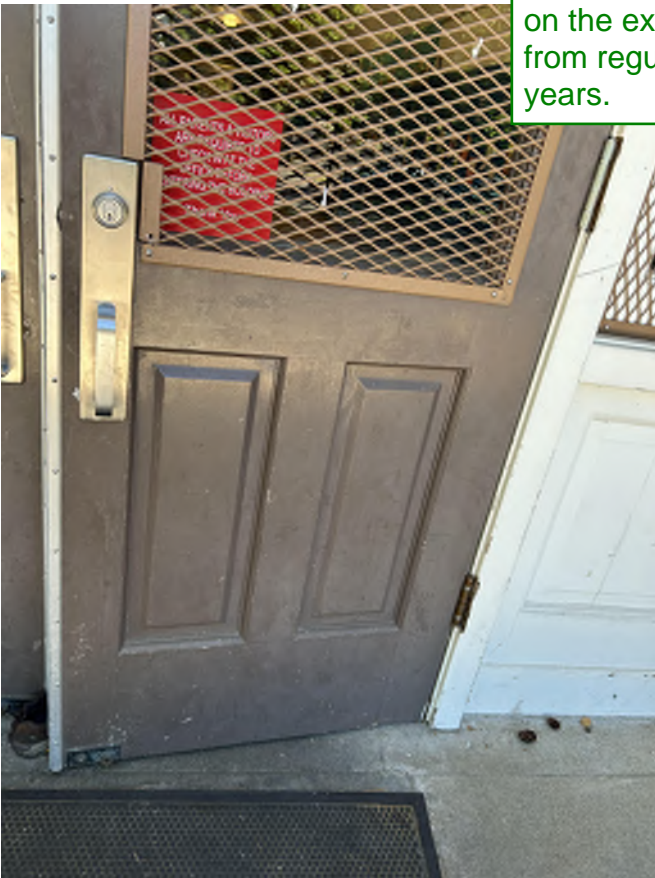
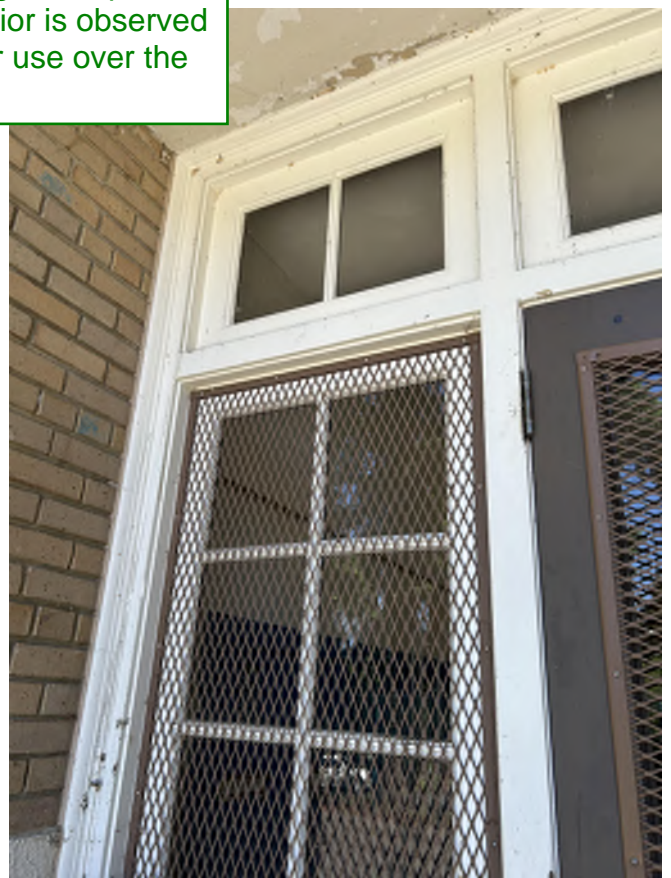
# MCGILVRA ELEMENTARY WOOD WINDOW & DOOR REPAIRS

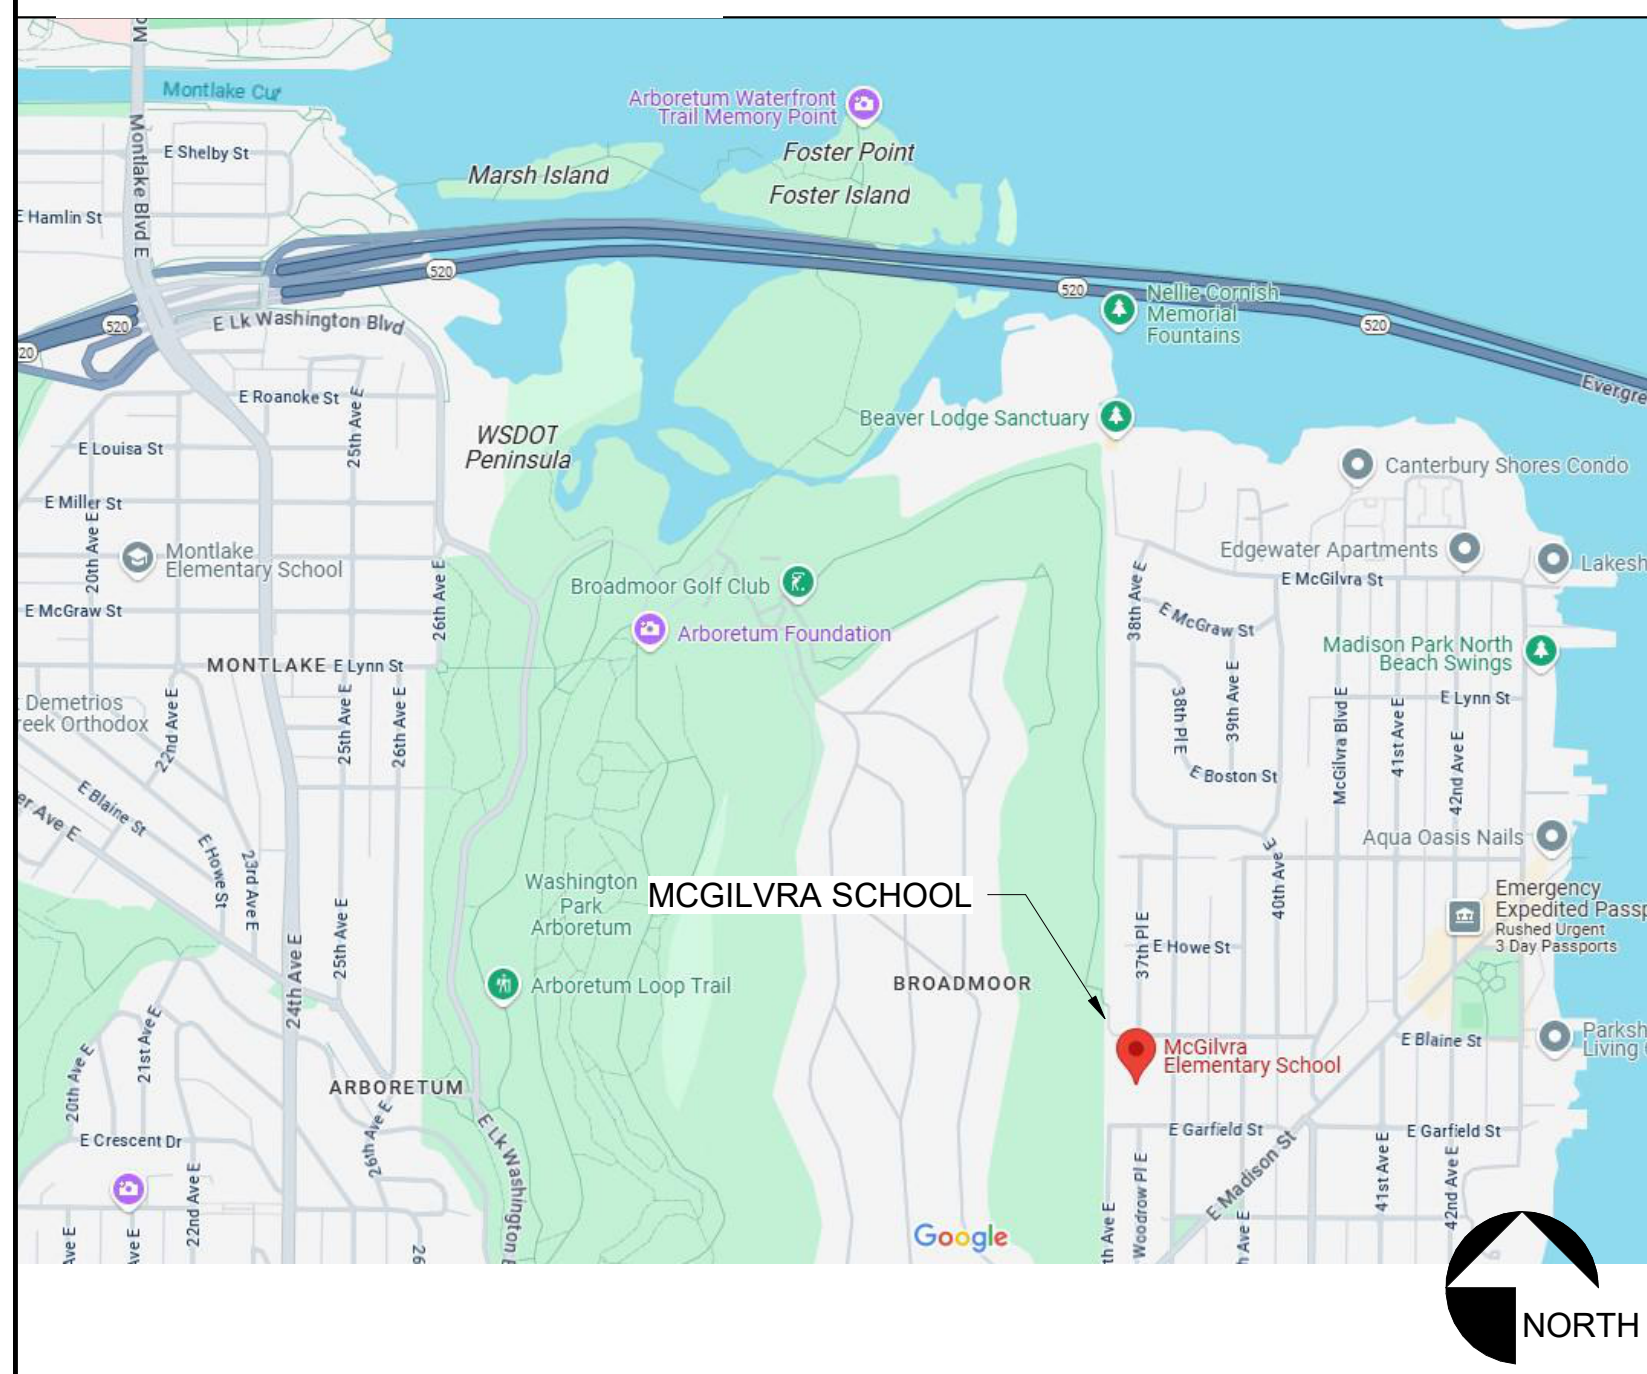
### PROJECT DIRECTORY

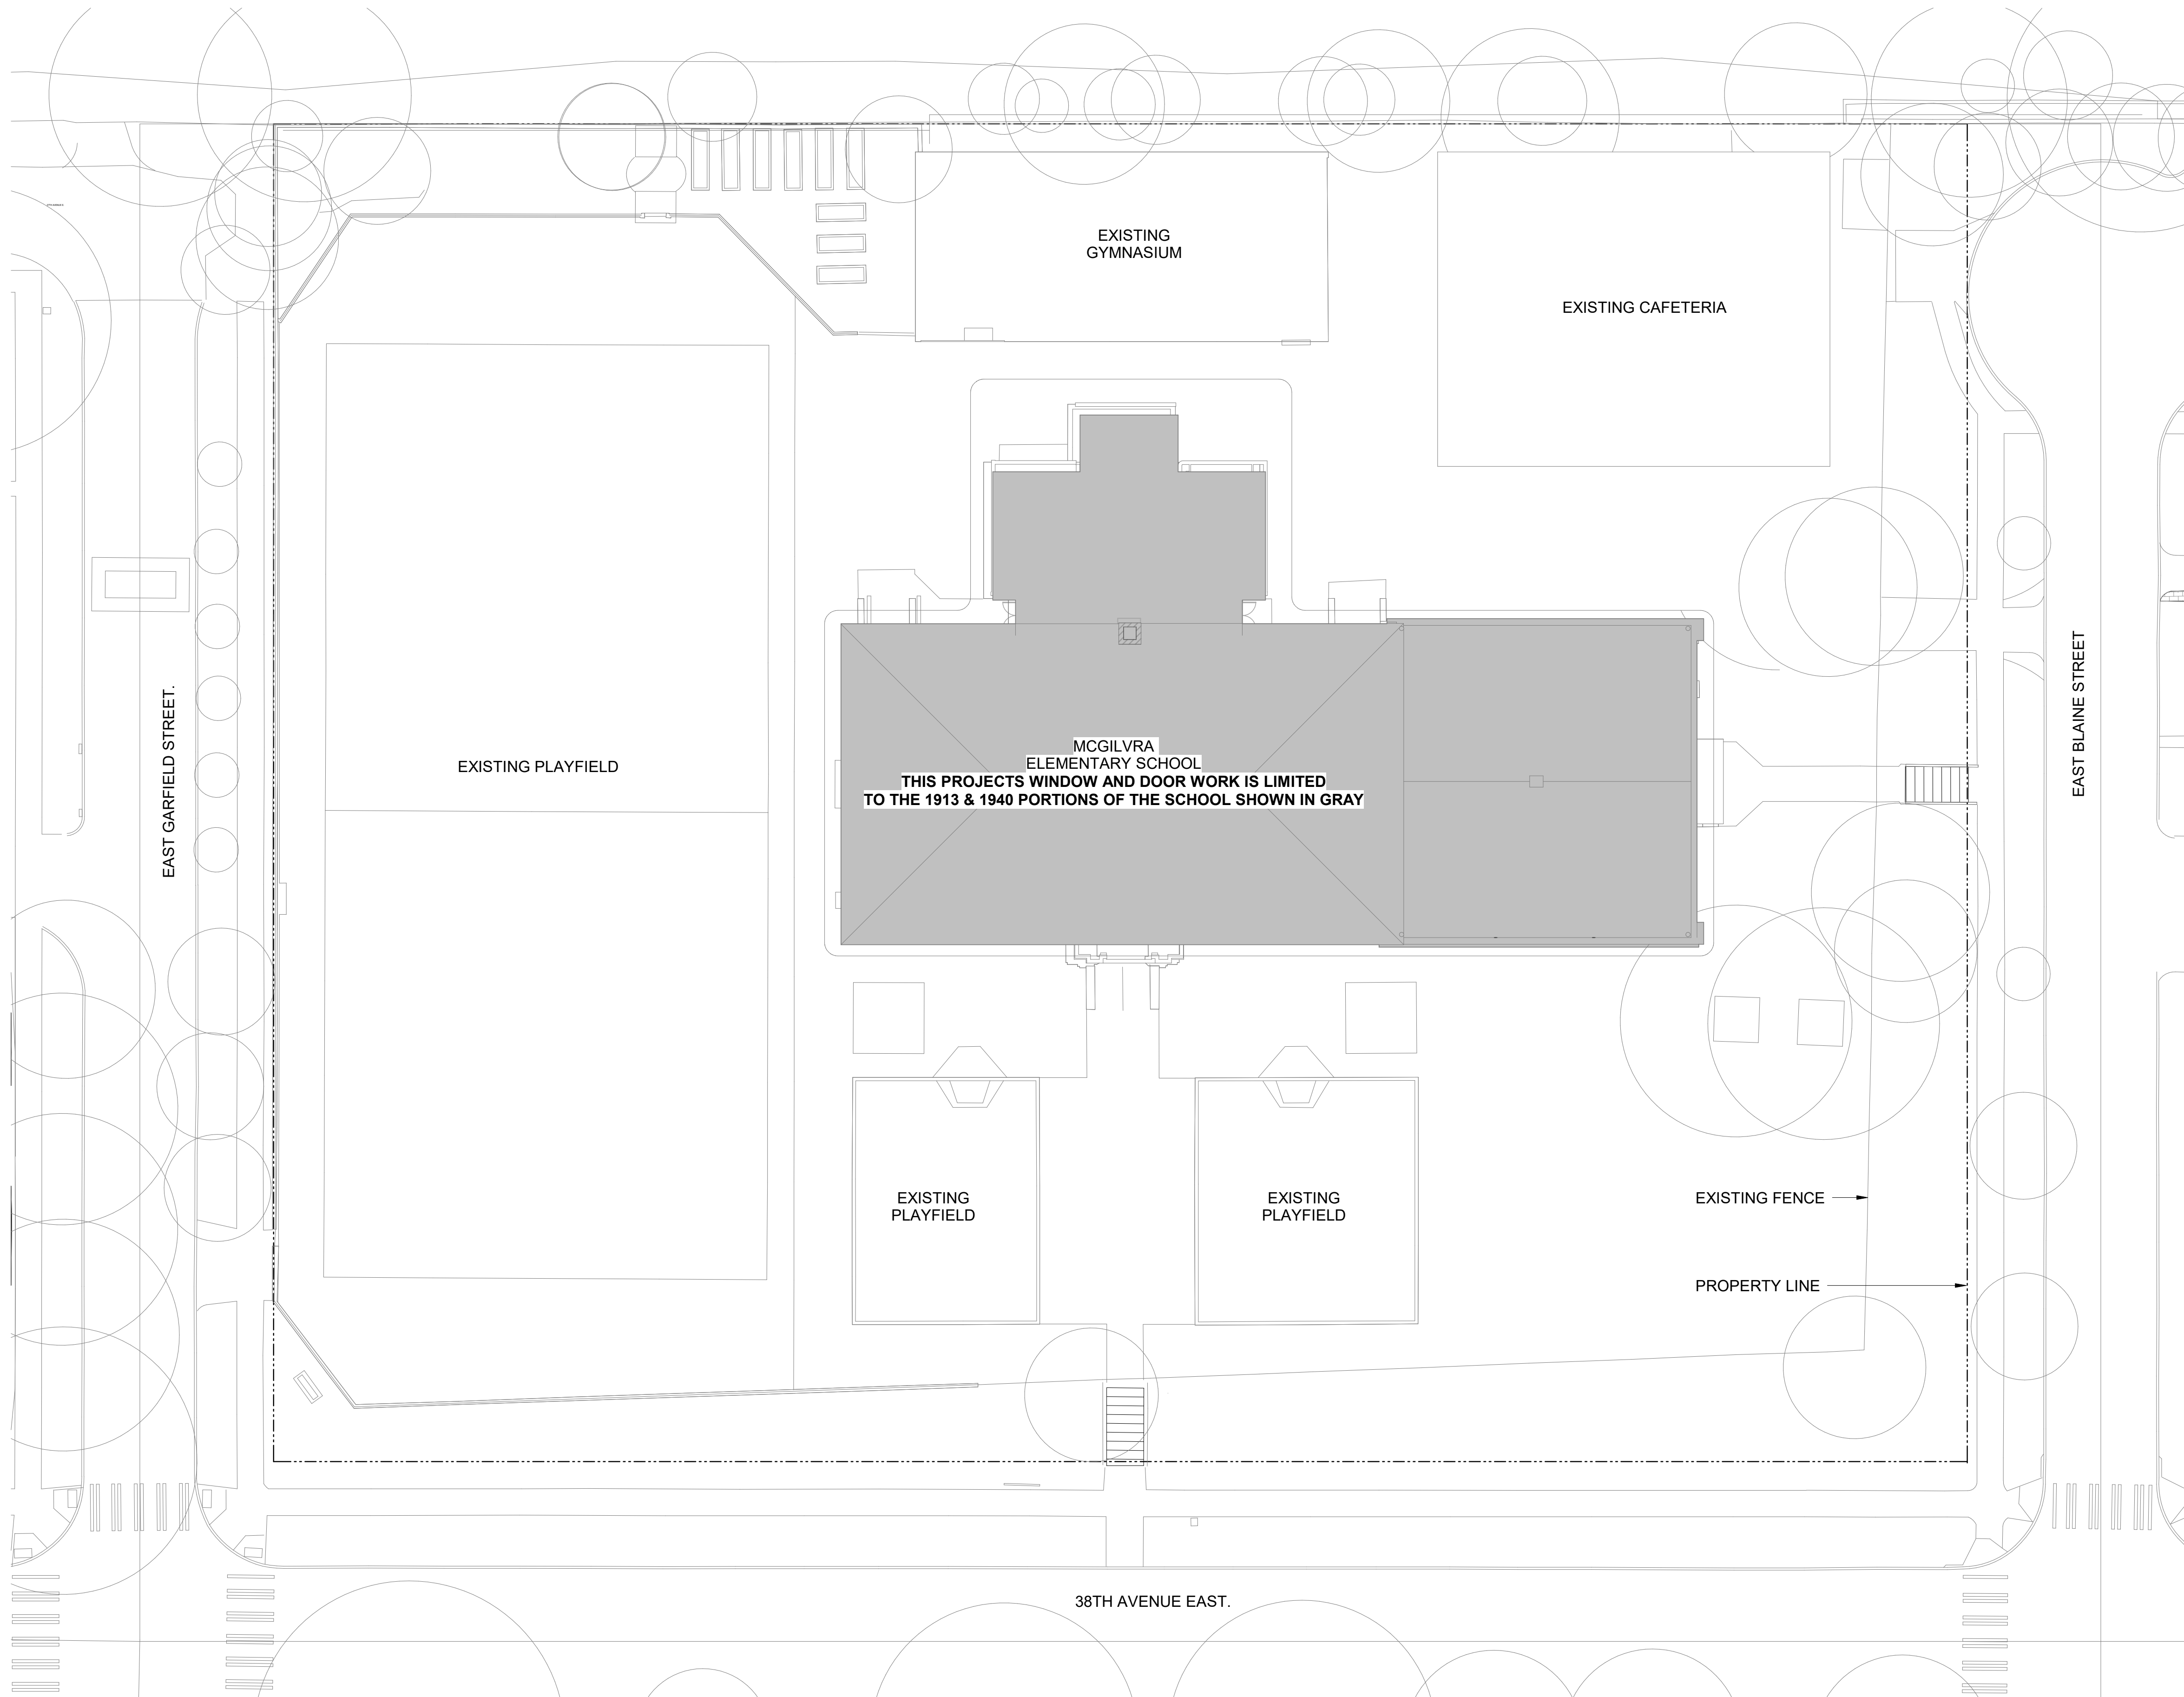
MCGILVRA  
ELEMENTARY SCHOOL  
THIS PROJECTS WINDOW AND DOOR WORK IS LIMITED  
TO THE 1913 & 1940 PORTIONS OF THE SCHOOL SHOWN IN GRAY

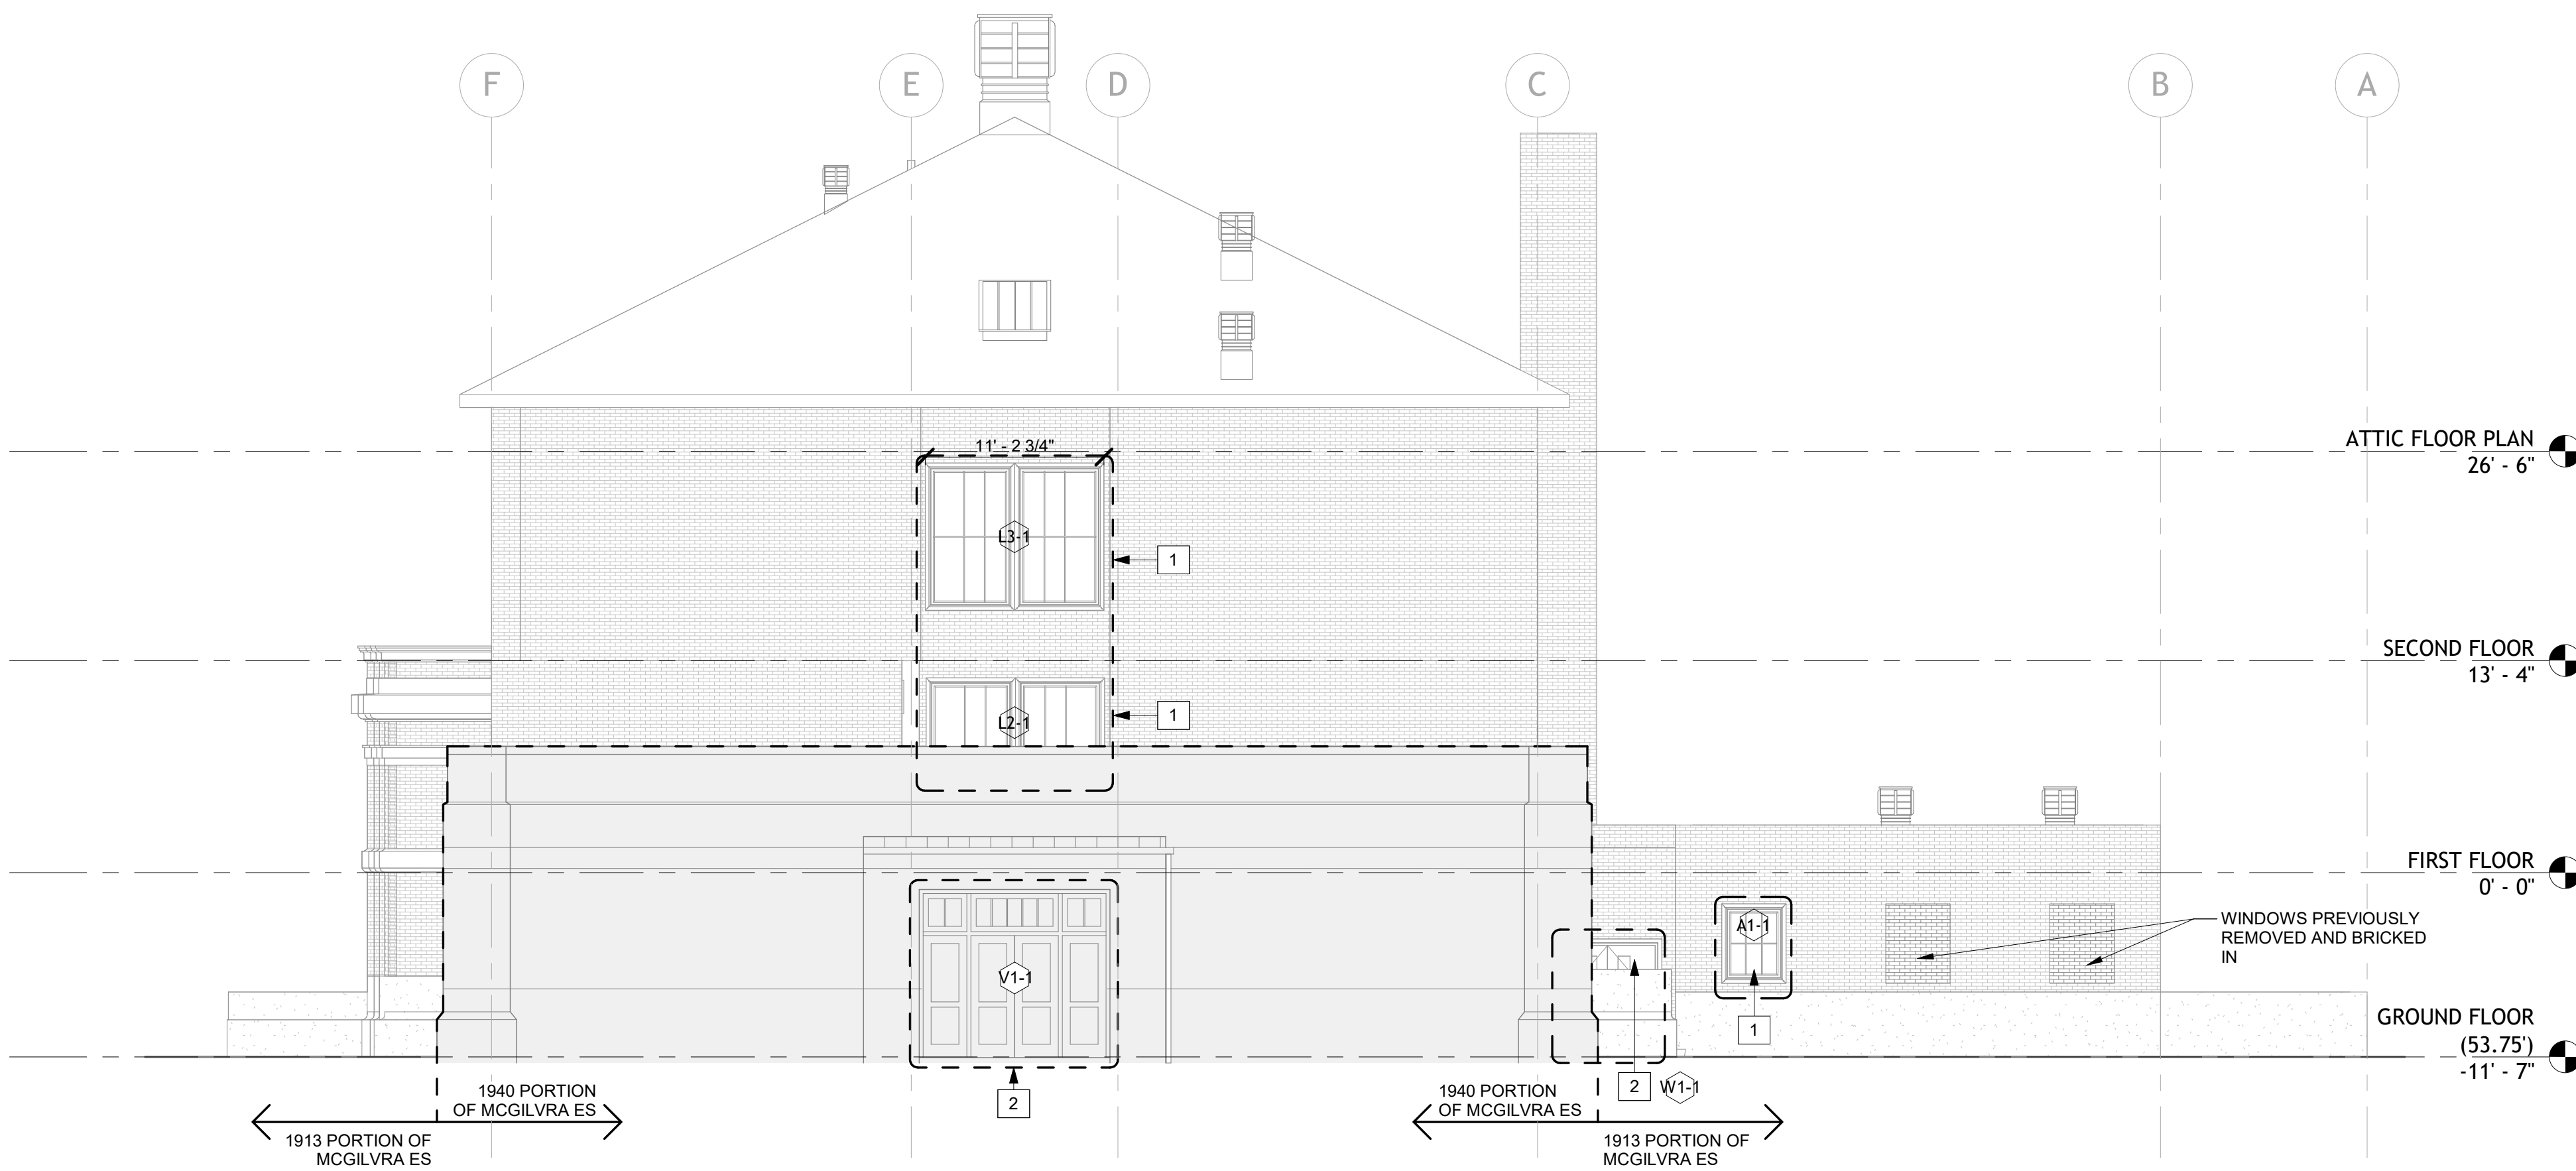
1 SITE PLAN  
1" = 20'-0"

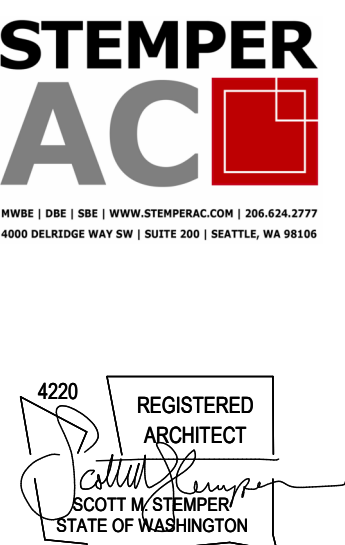
**MCGILVRA ELEMENTARY SCHOOL**  
 WOOD WINDOW & DOOR REPAIRS  
 1617 38TH AVE E,  
 SEATTLE, WA 98112

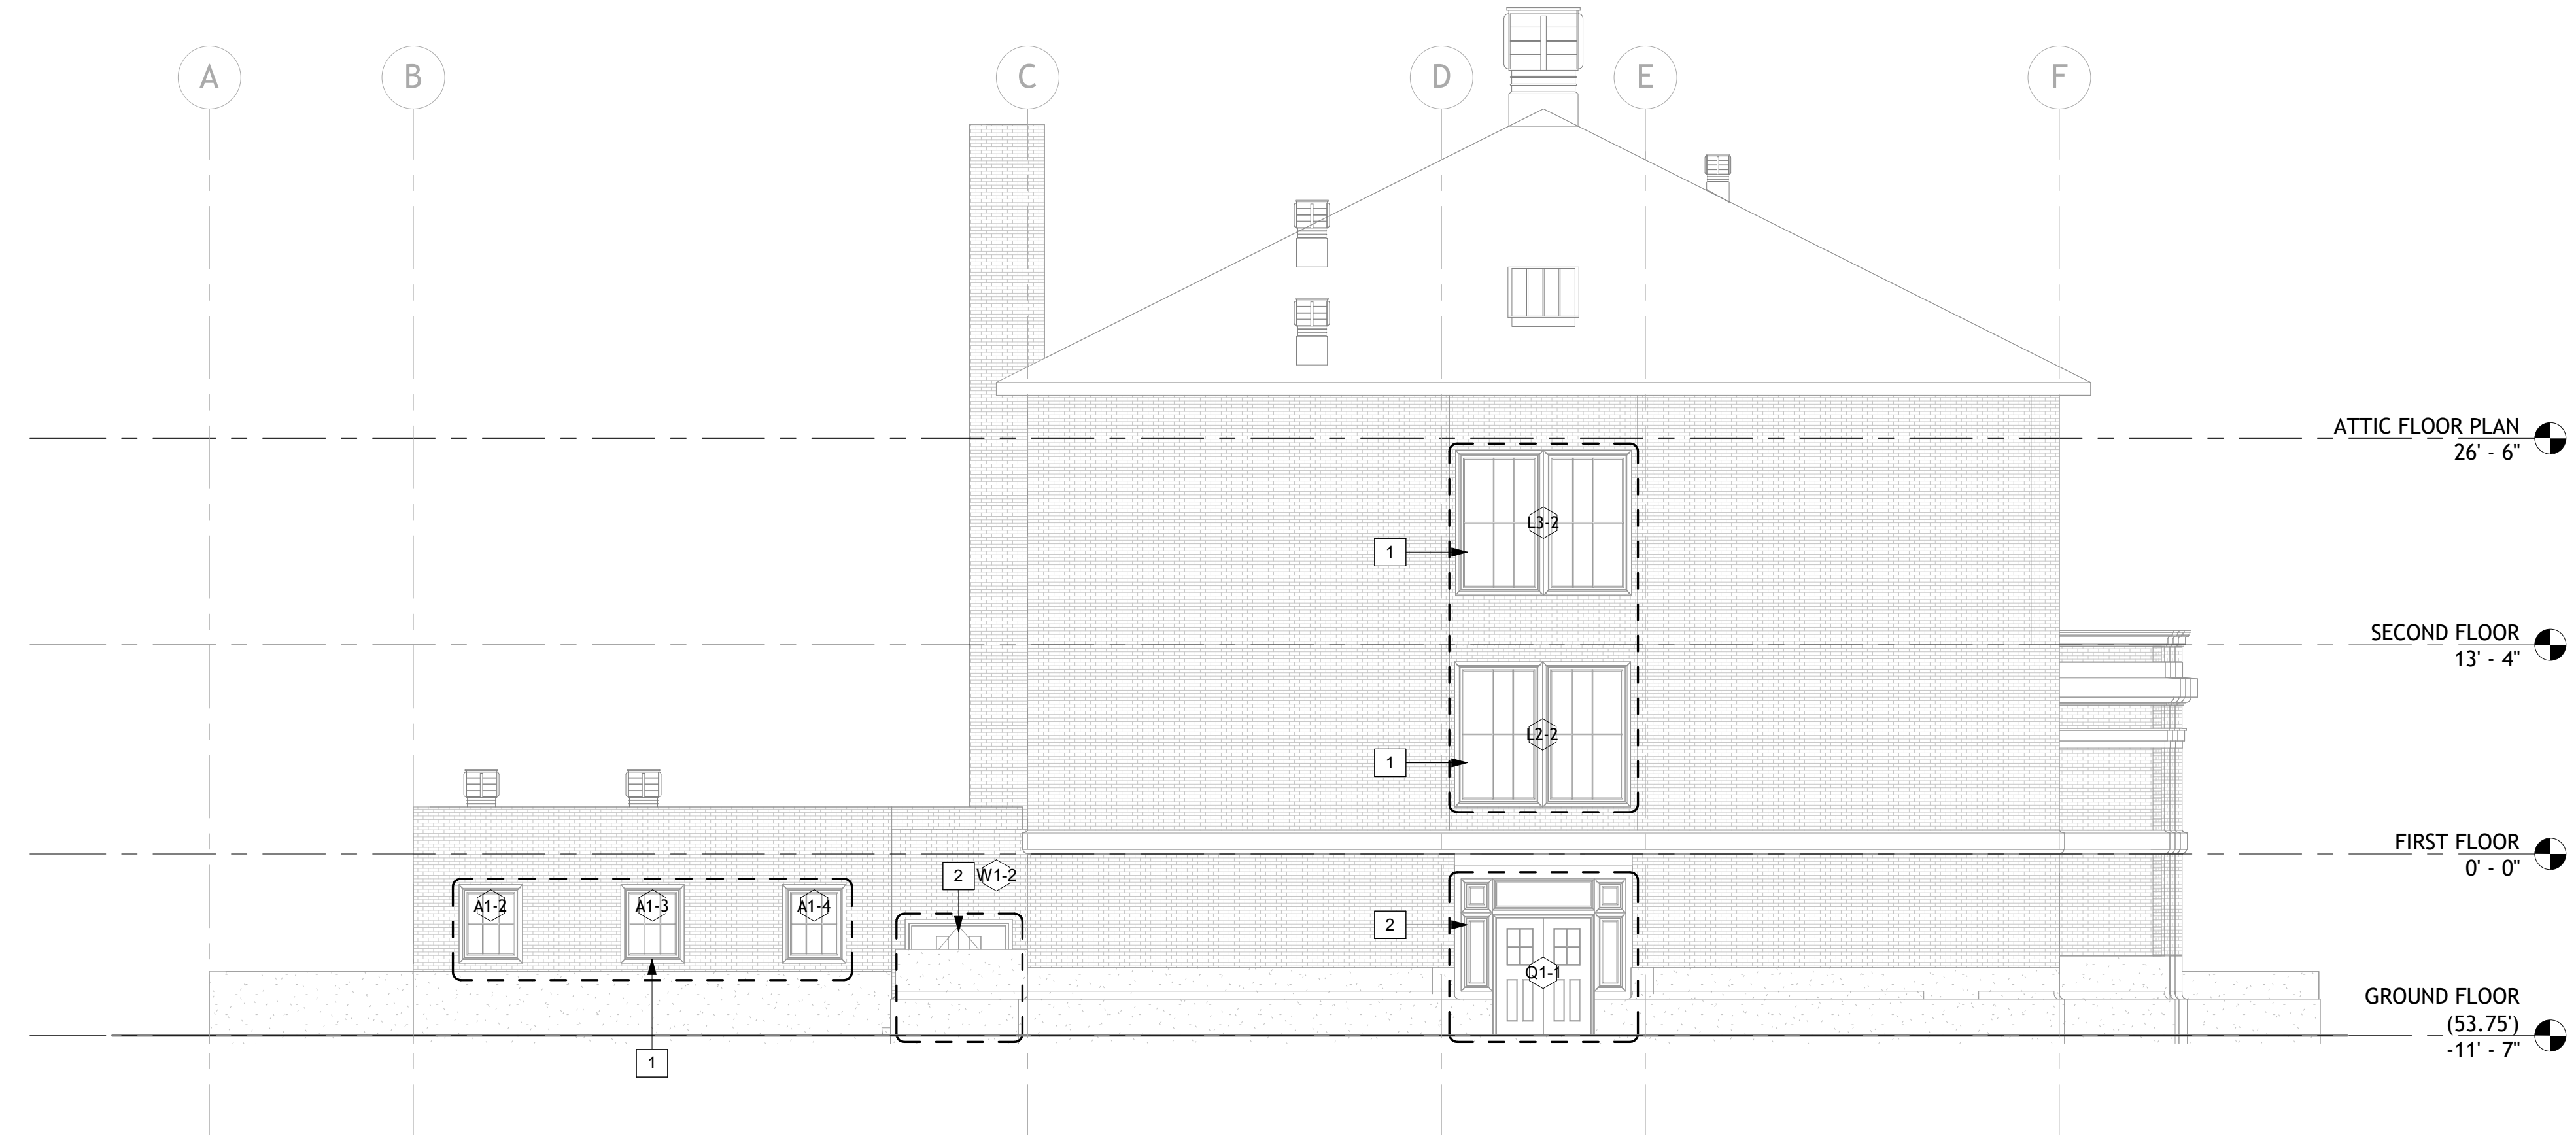
ELEVATION GRAPHIC LEGEND	
#	KEYNOTE
U1-1	WINDOW TYPE
U1-1	WINDOW NUMBER
U1-1	FLOOR LOCATION
