## **Sand Point Naval Air Station – Building**

## **Limited Condition Assessment**

**Project:** Mercy Housing Northwest – Building 9 Door Replacement  
7101 62nd Avenue NE  
Seattle, WA 98115

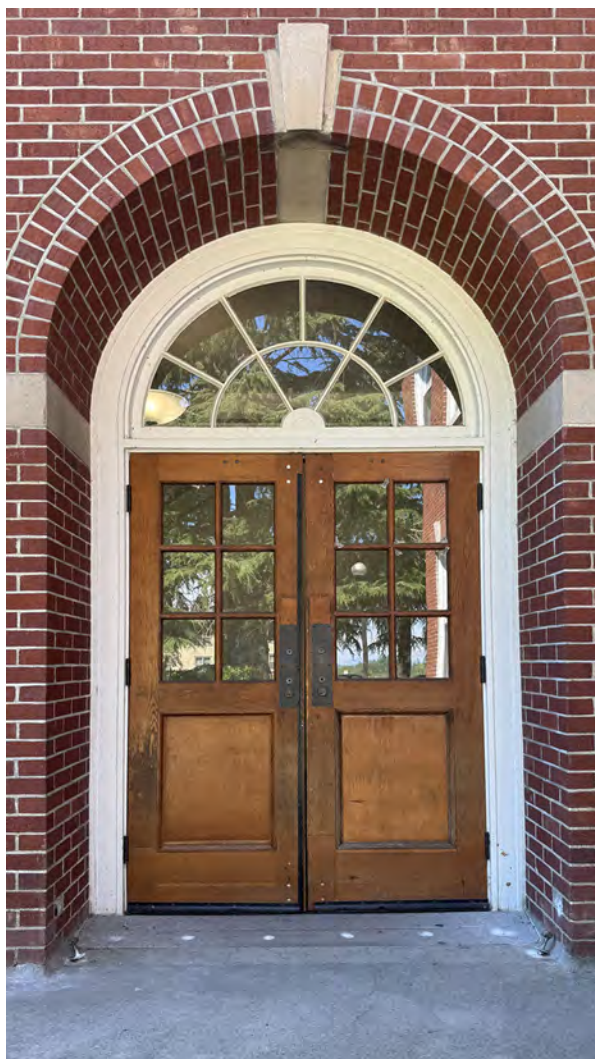
Door pair S-ST04-01 shows the poor condition of the wood as a result of weather exposure and evidence of efforts to access the building. This includes damage to the panel from brute force attacks and recent replacement of several of the upper lights. Several of the doors show previous efforts to repair rails and stiles that were severely damaged during the period of vacancy. Weatherization astragals were added to the door pairs in an effort to improve their performance but most have been damaged, or removed in part or in whole during efforts to gain access.

*Fig. 01: Door pair S-ST04-01*

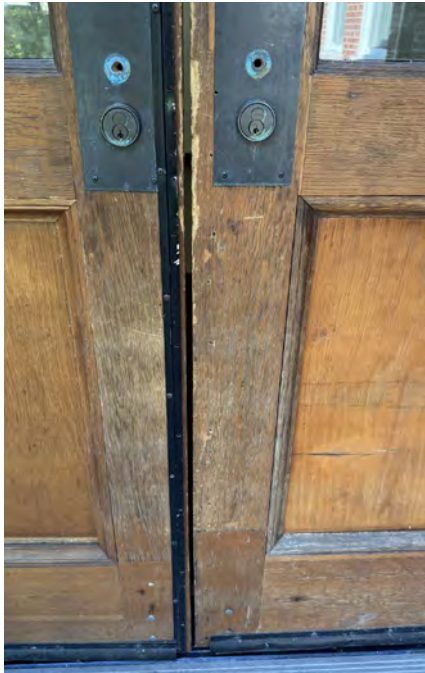
*Fig. 03: Rail damage from forced entry efforts.*

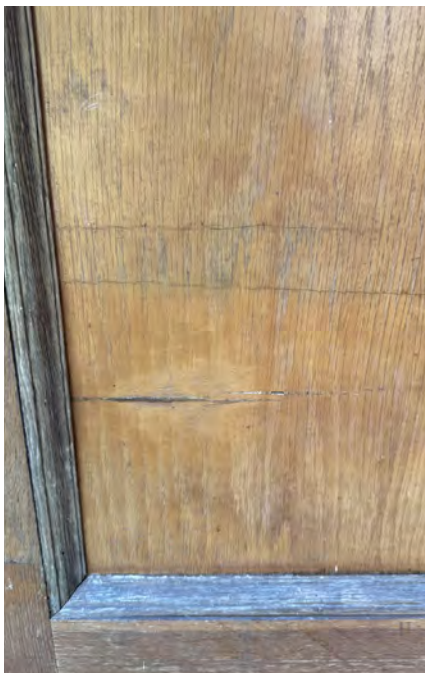
*Fig. 06: Damaged panel from forced entry efforts.*

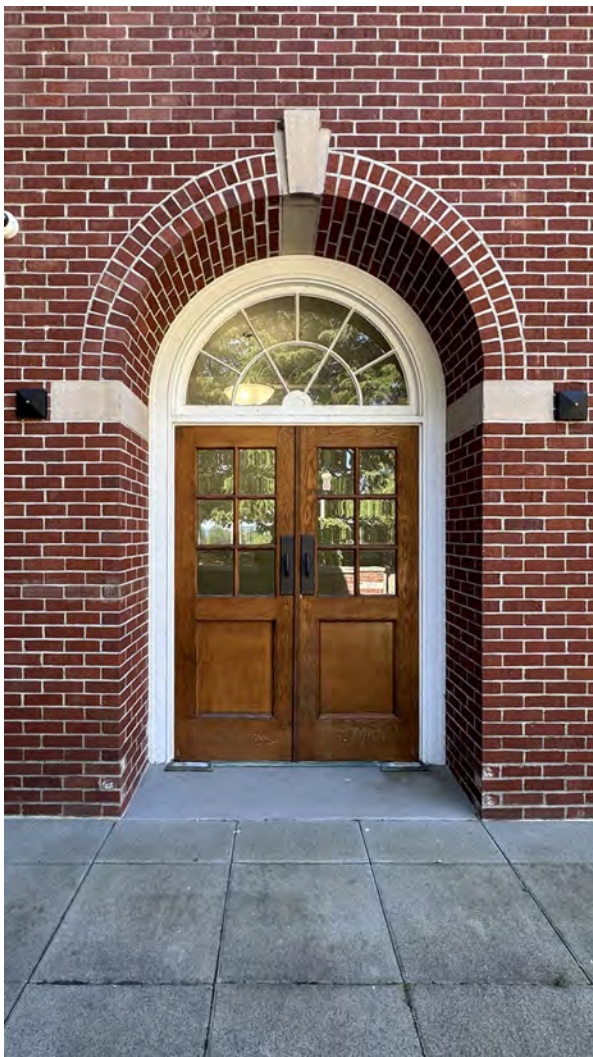
This, and door pairs S-ST03-07, S-ST02-05, S-ST2-07, S-ST01-04, S-ST01-06, N-ST03-01, and N-ST04-04 are permanently fixed by set screws through top rail into the door frame. A permanent wooden moulding has been attached to cover the gap between the doors for weatherization and to prevent the insertion of tools. Door pair S-ST03-05 is in relatively good condition compared to most of the doors. The existing rot and wear from the period of vacancy and neglect patched and the finishes still in good repair. Exceptions are noted in photo captions.

*Fig. 08: Fixed door pair S-ST03-05*

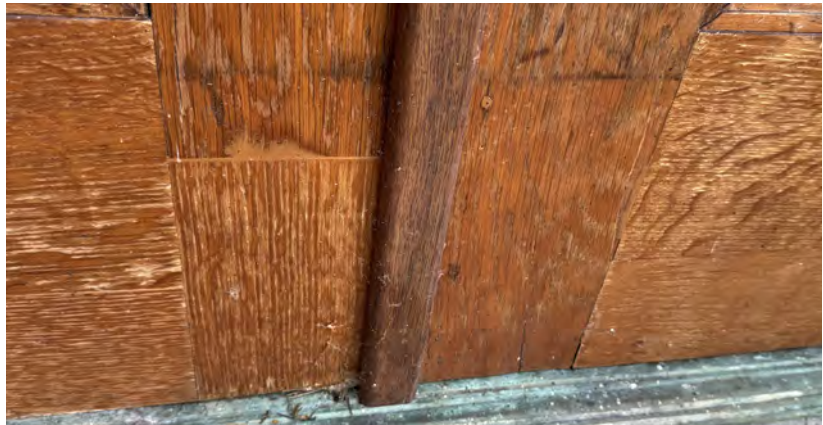
*Fig. 11: Door repairs to rot during previous rehabilitation.*

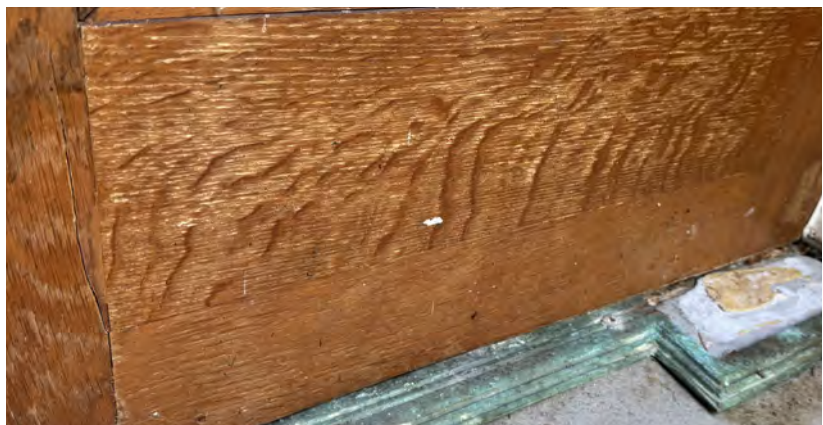
*Fig. 12: Door repairs to rot during previous rehabilitation.  
Check in wood veneer. A crack in the stile veneer is present.*

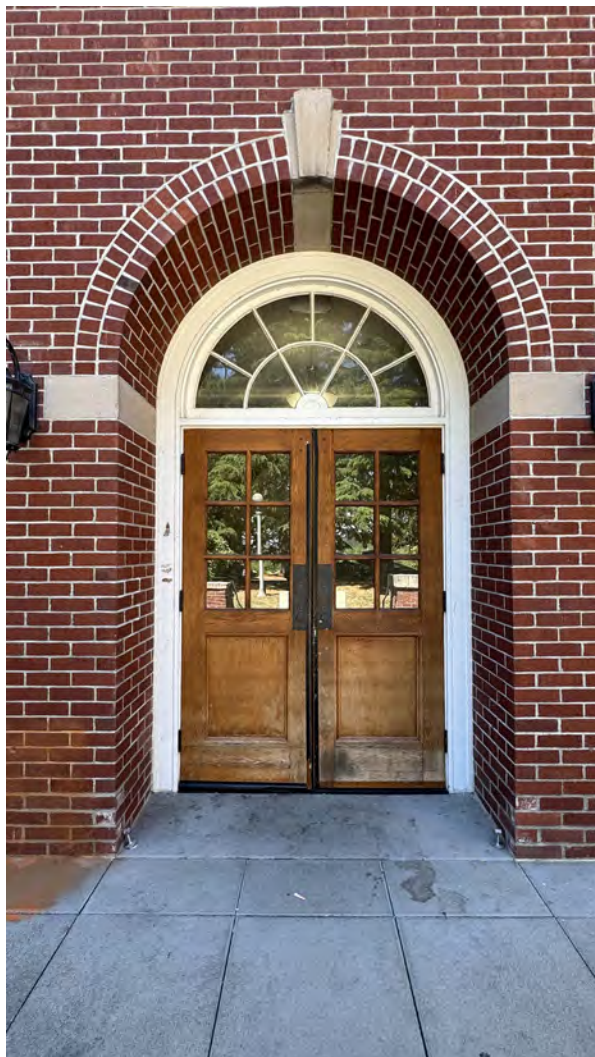
This door pair is in poor condition and has been damaged both by efforts to gain entry to the property and failure of its protective finishes. Like many of the operable pairs the weather stripping has been removed to allow for tools to be forced in between the leaves to force their opening. This has occurred so frequently that some door pairs can now be opened by rocking or forcing the leaves apart bare handed. Loss of the finish material has resulted in the exposure of wood to the open air allowing moisture to infiltrate the veneer and trim materials causing them to gray and rot. Note that in Figure 18 the left-hand leaf sits permanently forward as a result of repeated forced entries.

*Fig. 13: Door pair S-ST03-06*

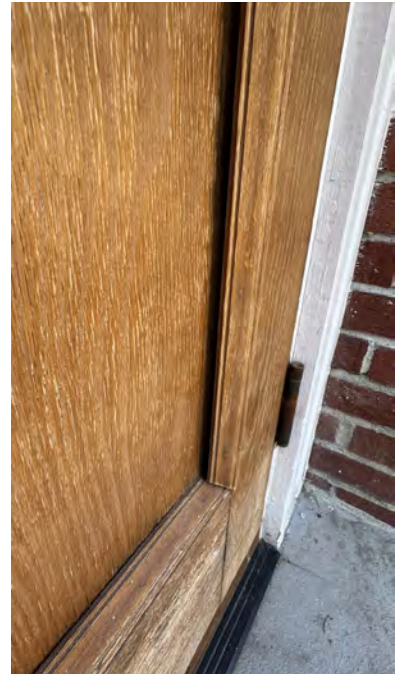
*Figs. 16 & 17: Damage from moisture infiltration at failing seals at joints causing swelling and separation of components.*

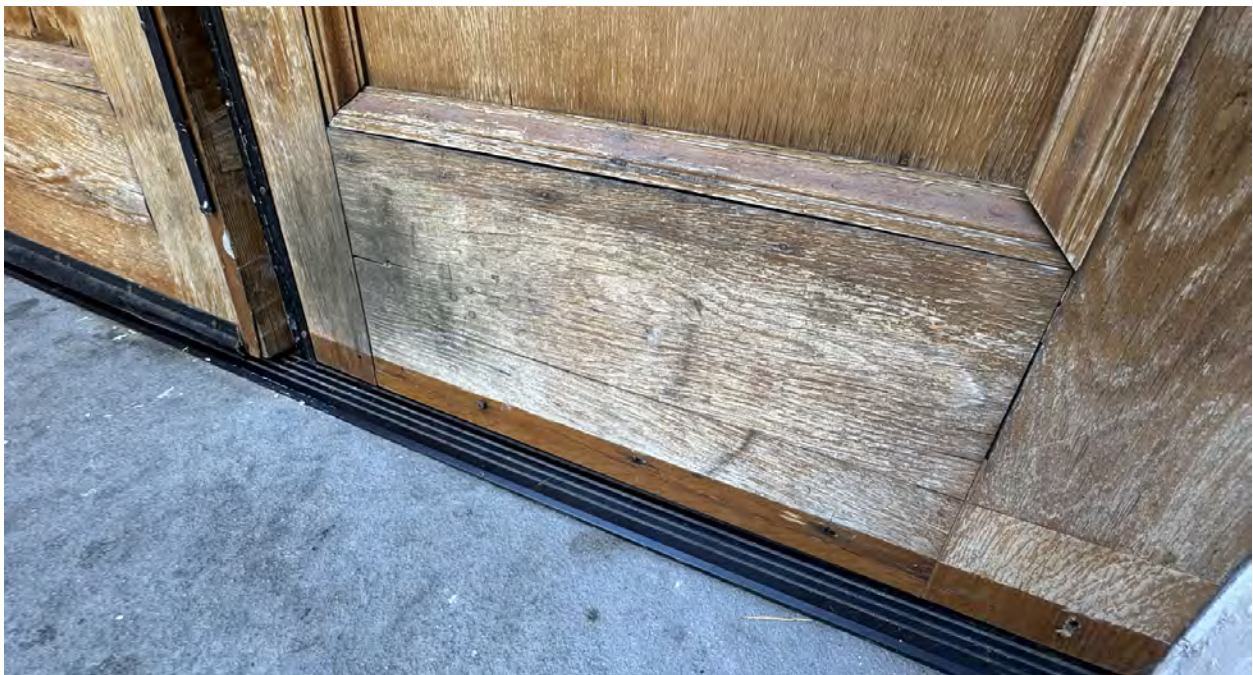
*Fig. 18: Damage from moisture infiltration at failing seals at joints causing swelling and separation of components. Loss of finish due to weathering has allowed moisture to infiltrate assembly.*

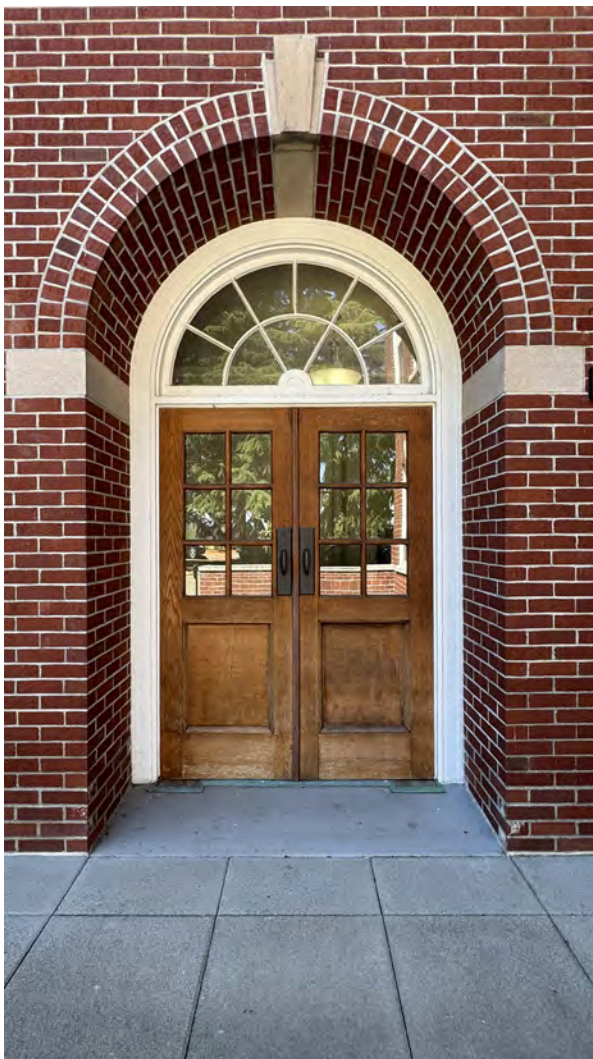
This fixed door pair is also in poor condition and has been damaged both by the failure of its protective finishes. Loss of the finish material has resulted in the exposure of wood to the open air allowing moisture to infiltrate the veneer and trim materials causing them to gray and rot. As noted in some of the documentation some of the veneer materials are cupping and pulling away from the door structure as a result of moisture infiltration and differential swelling and or shrinkage exacerbating the issue.

*Fig. 19: Fixed door pair S-ST03-06*

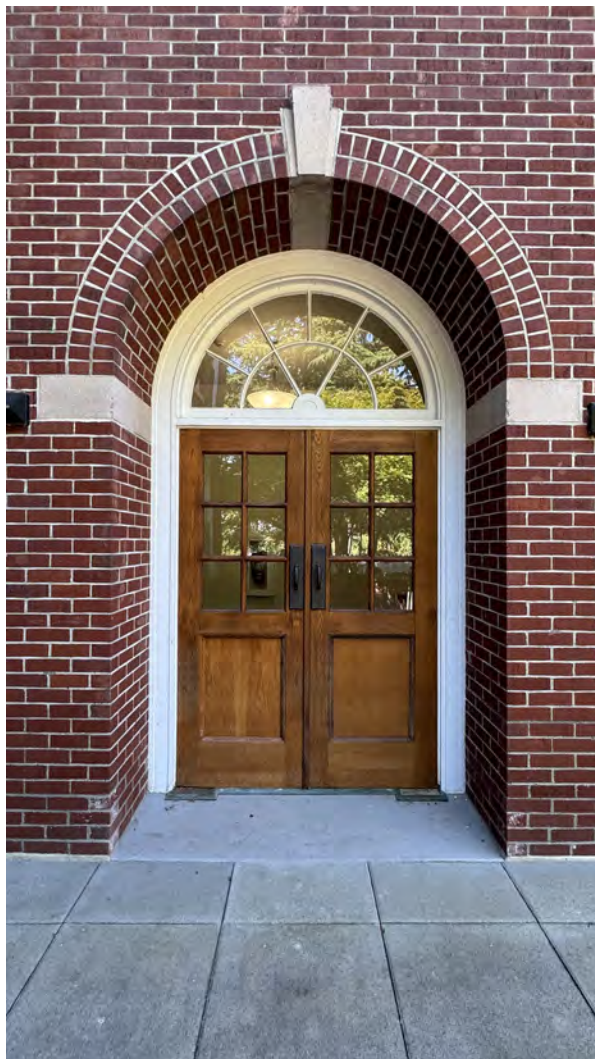
This fixed door pair is in decent condition though signs of moisture infiltration are present and worsening. This door was heavily patched during refurbishment as evidenced by the many patches at the base of both door leaves. The discoloration of the wood prove the earlier period of neglect is still evident but generally still appears to be protected by varnish. Noted was the loss of varnish at the moulding elements at the inset panel, their discoloration and separation beginning to occur, which will allow moisture to leach into the seam and cause swelling and rot.

*Fig. 25: Fixed door pair S-ST02-05*

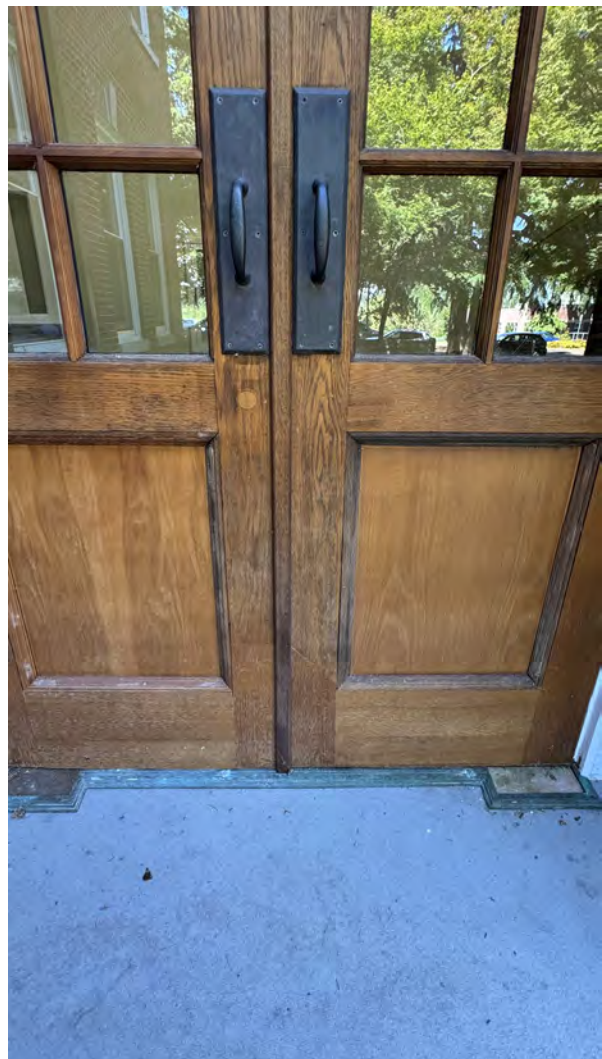
*Fig. 26: Detail of doors S-ST02-05. Showing patch and repair from previous water damage.*

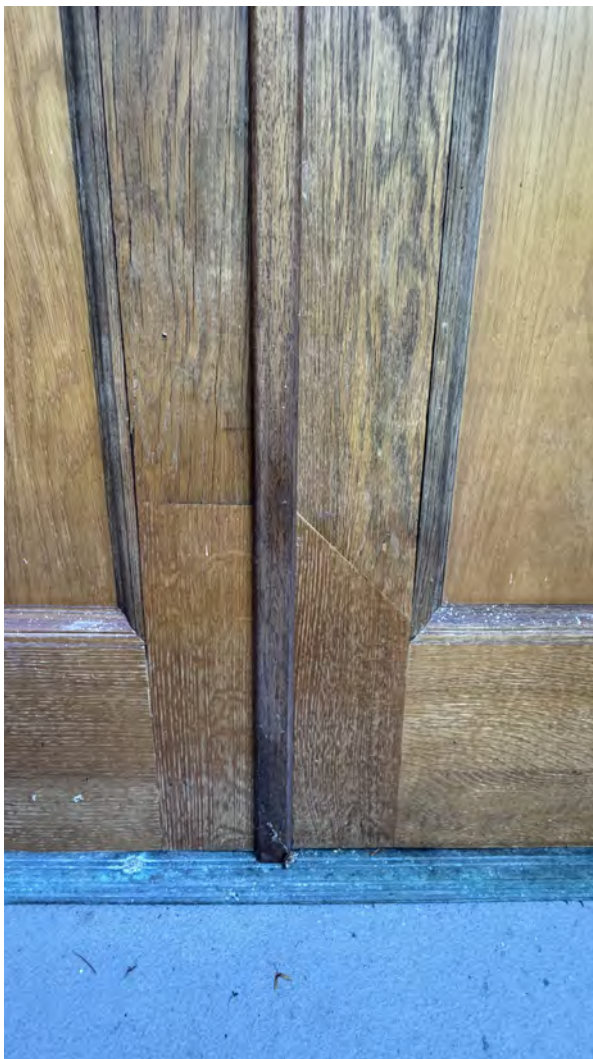
*Fig. 27: Showing patch and repair from previous water damage.*

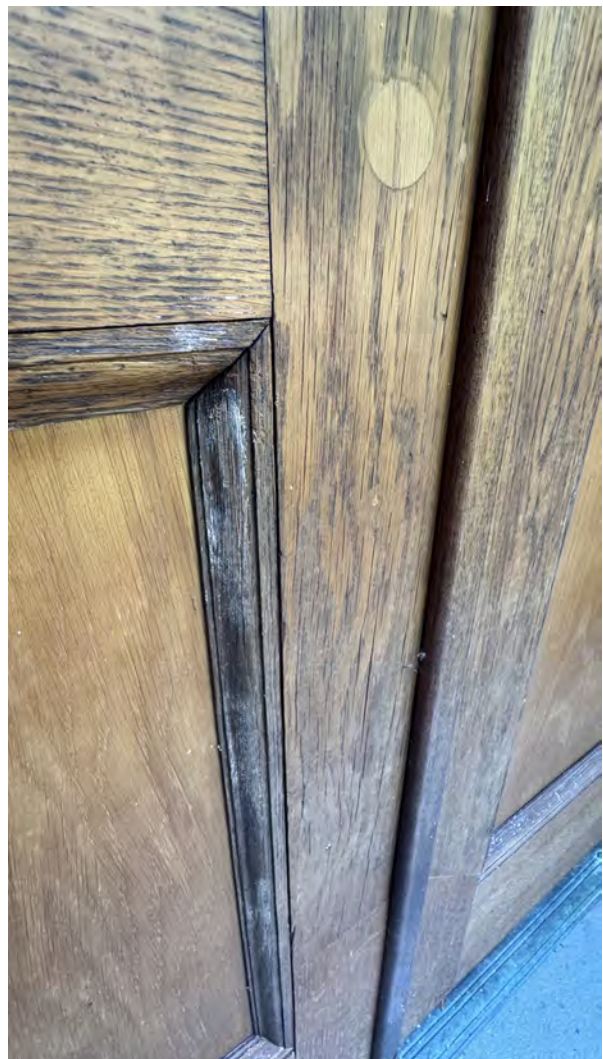
*Fig. 28: Discoloration of wood from loss of protective finish.*

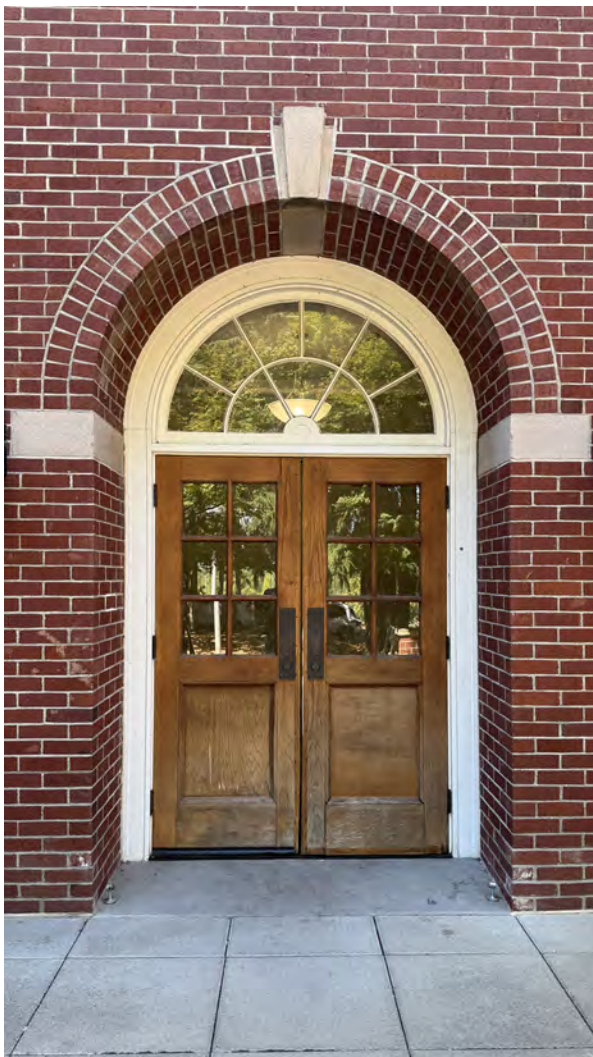
This door pair is also in poor condition. The lower portion of the door especially showing exposure to the elements through loss of finish resulting in discoloration and differential swelling between members now exposed to moisture. This door has also been damaged by forced entry efforts, the astragals stripped and leaves scarred from the insertion of tools to force the locking bolts. As noted in the details some of the veneer at the base of the door is cupping due to water infiltrating behind the material and causing it to swell and split.

*Fig. 29: Door pair S-ST02-06*

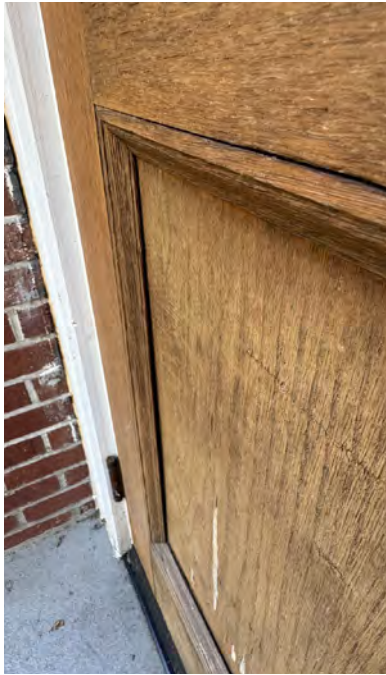
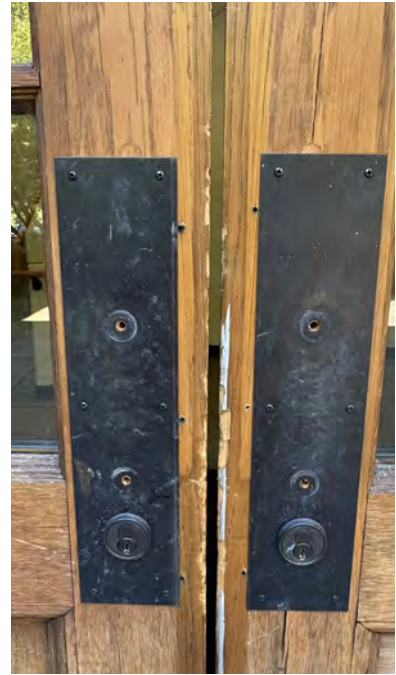
*Fig. 31 & 32: Separation of door components from moisture infiltration.*

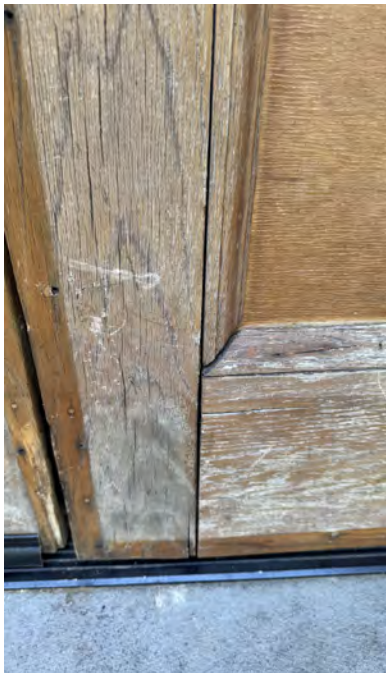
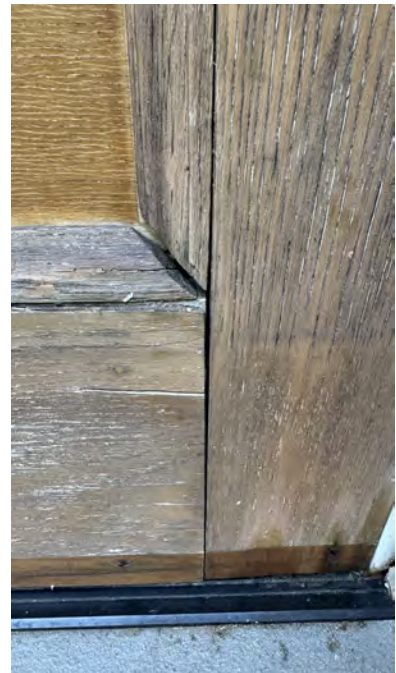
*Fig. 34, 35, and 36: Damage from moisture infiltration of failing finishes at joints causing swelling and separation of components. Details of cupping and swelling wood components.*

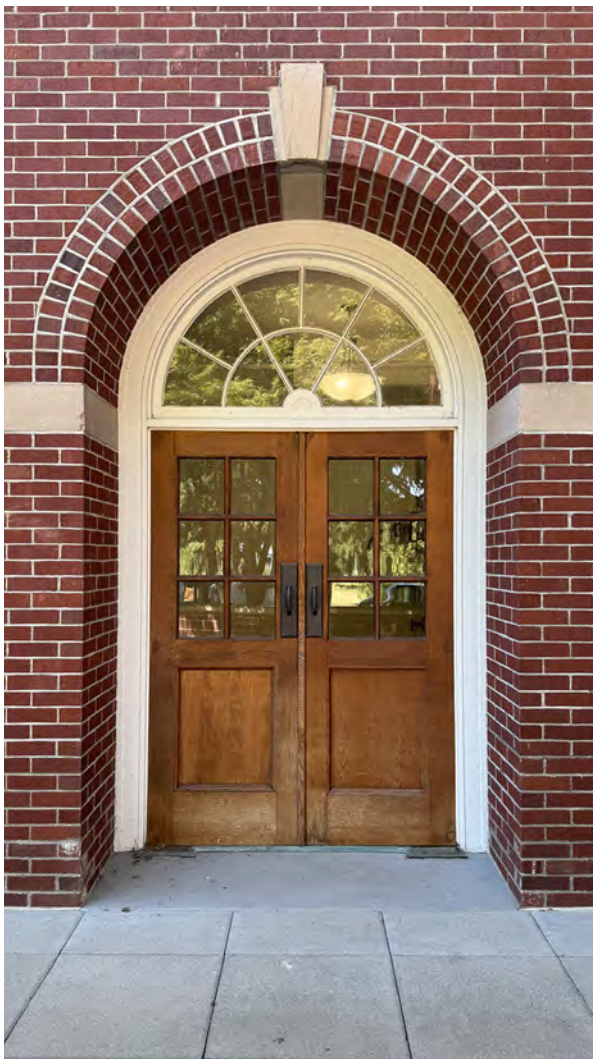
This fixed door pair is in reasonable condition, though it also exhibiting loss of finish resulting in direct exposure of the wood to the elements causing discoloration and swelling of the veneer members and moulding at the inset panels as documented in the detail photos.

*Fig. 37: Fixed door pair S-ST02-07*

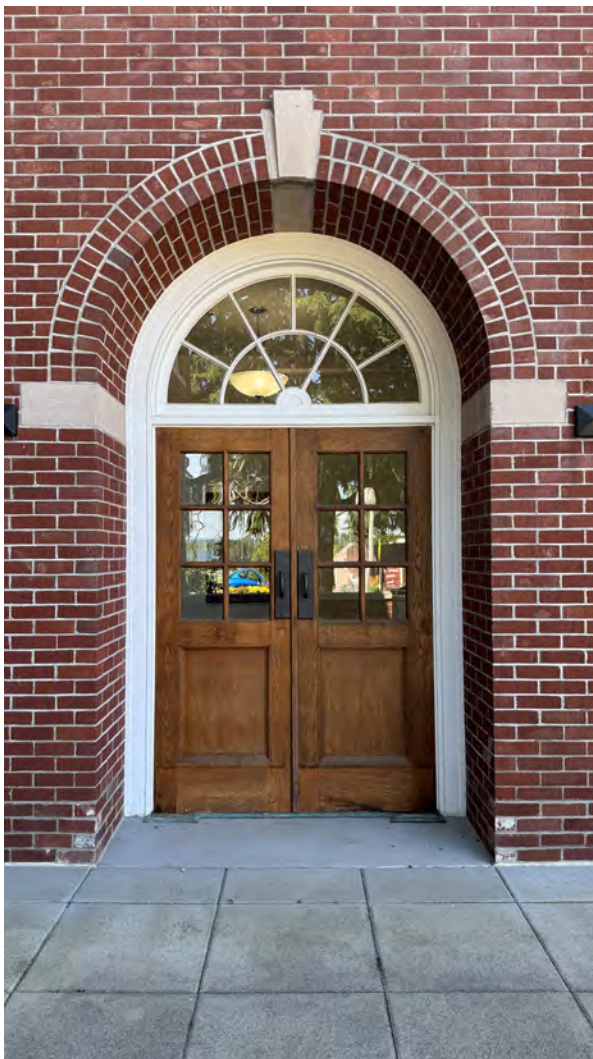
This fixed door pair is in decent condition. Most of the discoloration appears to be from previous exposure before rehabilitation and removal of a kick plate at the base of the door, as evidenced by the difference in visibility of the grain from the less exposed material.

*Fig. 43: Fixed door pair S-ST01-04*

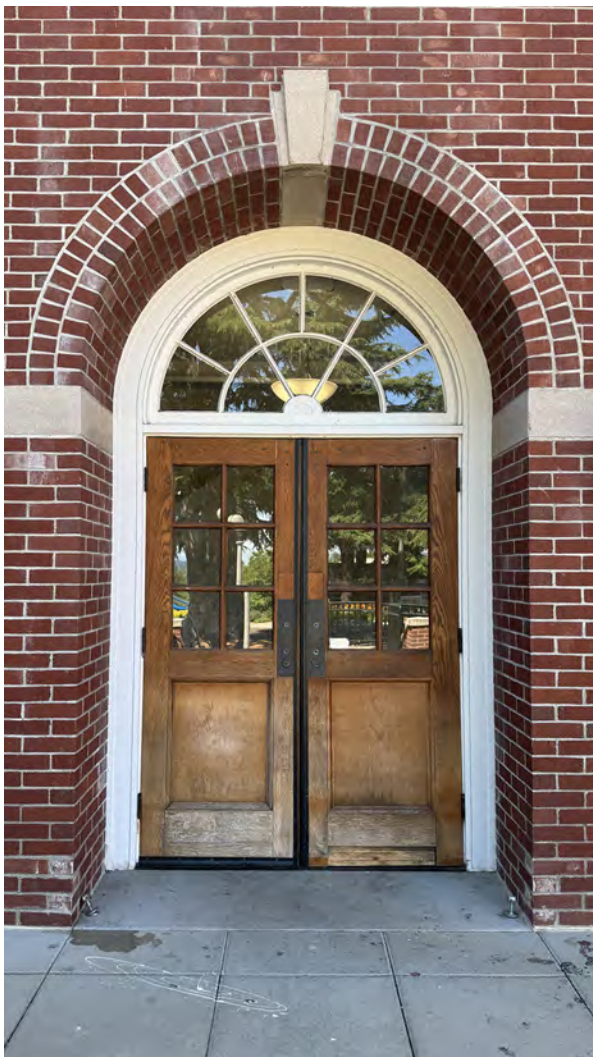
This door pair shows evidence of damage from both forced entry and exposure to moisture. Here again the weather stripping has been removed to allow for tool access to force the doors. This forcing has likely contributed to the split occurring at the stile and rail joint adjacent to the door hardware seen in figure 50 to the right. Generally the portion below the mid-point rail show bleaching from lack of protection. As the details in figures 52-54 illustrate this lack of protection has resulted in the swelling and cupping of the veneer layer, some to the point of loss.

*Fig. 47: Door pair S-ST01-05*

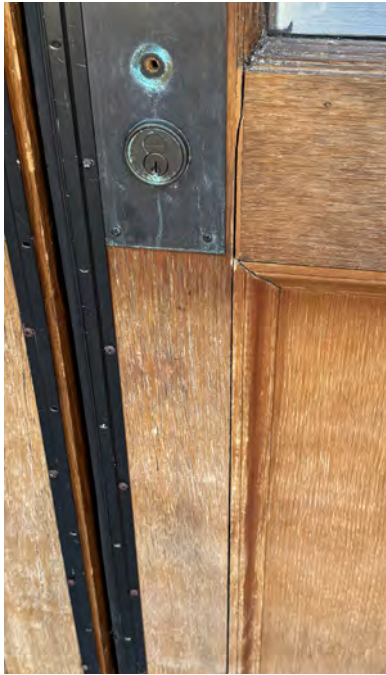
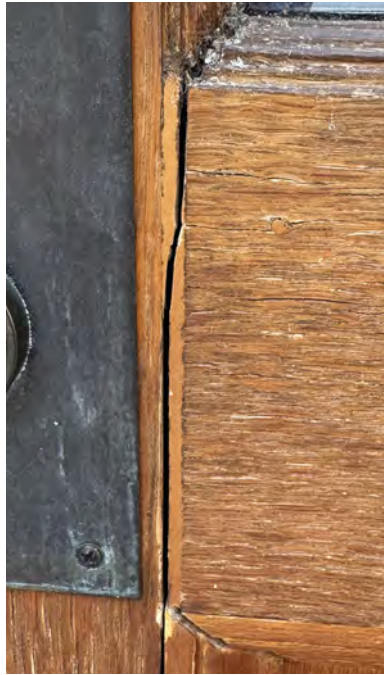
*Figs. 49 & 50: Detail of failure of earlier door repair at stile to rail joint. Split occurring along length of stile connection.*

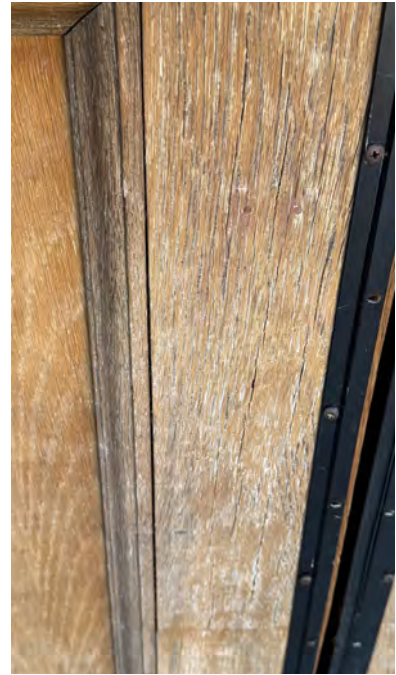
*Fig. 51: Detail of dry and cracking wood.*

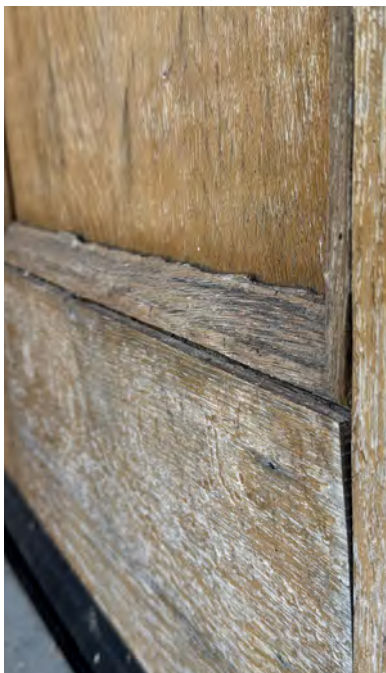
*Fig. 52: Detail showing cupping of veneer from drying.*

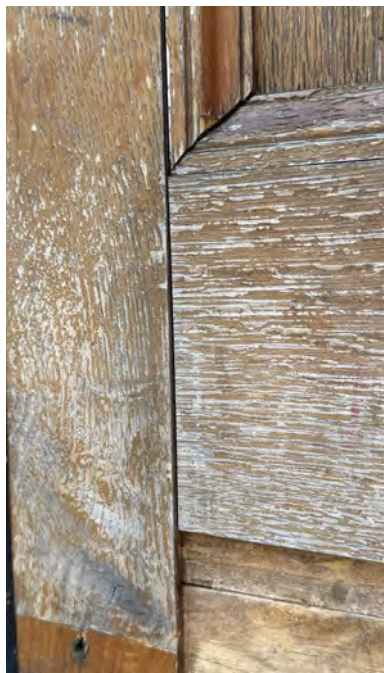
*Fig. 53: Detail showing loss of veneer material at base.*

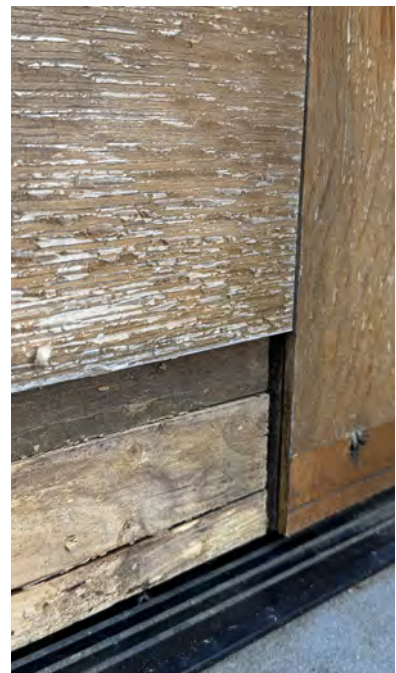
*Fig. 54: Detail showing loss of veneer material at base.*

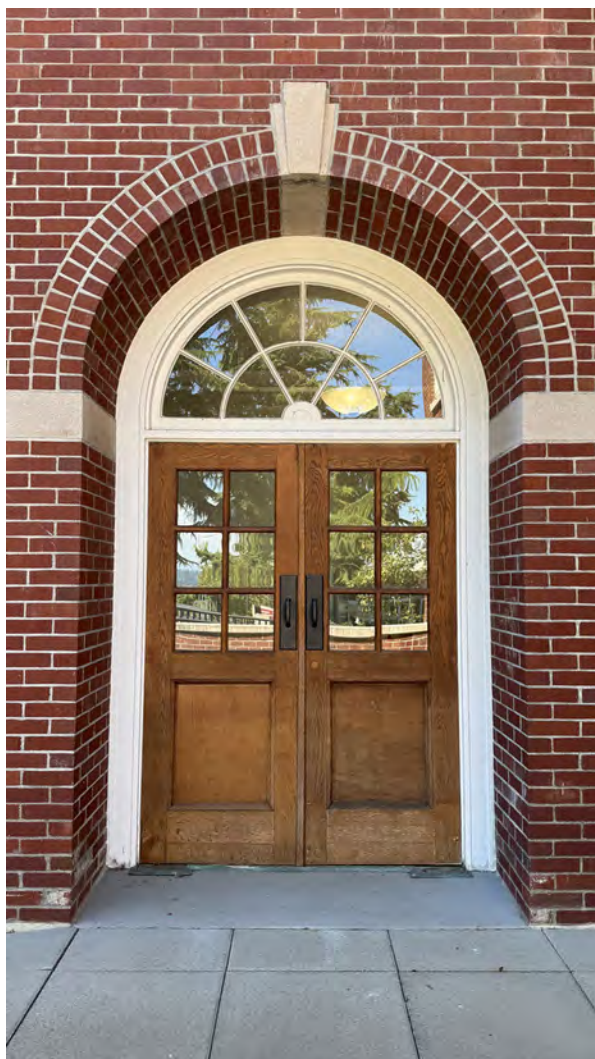
This fixed pair is also in poor condition with most of the issues occurring at the lower portion of the door where exposure to weather is greatest and where morning solar exposure on this east elevation is most extreme. The lower portion of the door shows loss of finish, bleaching from sun exposure and the patches from the rehabilitation show evidence of moisture infiltration resulting in swelling resulting in greater exposure of the edge of material.

*Fig. 55: Fixed door pair S-ST01-06*

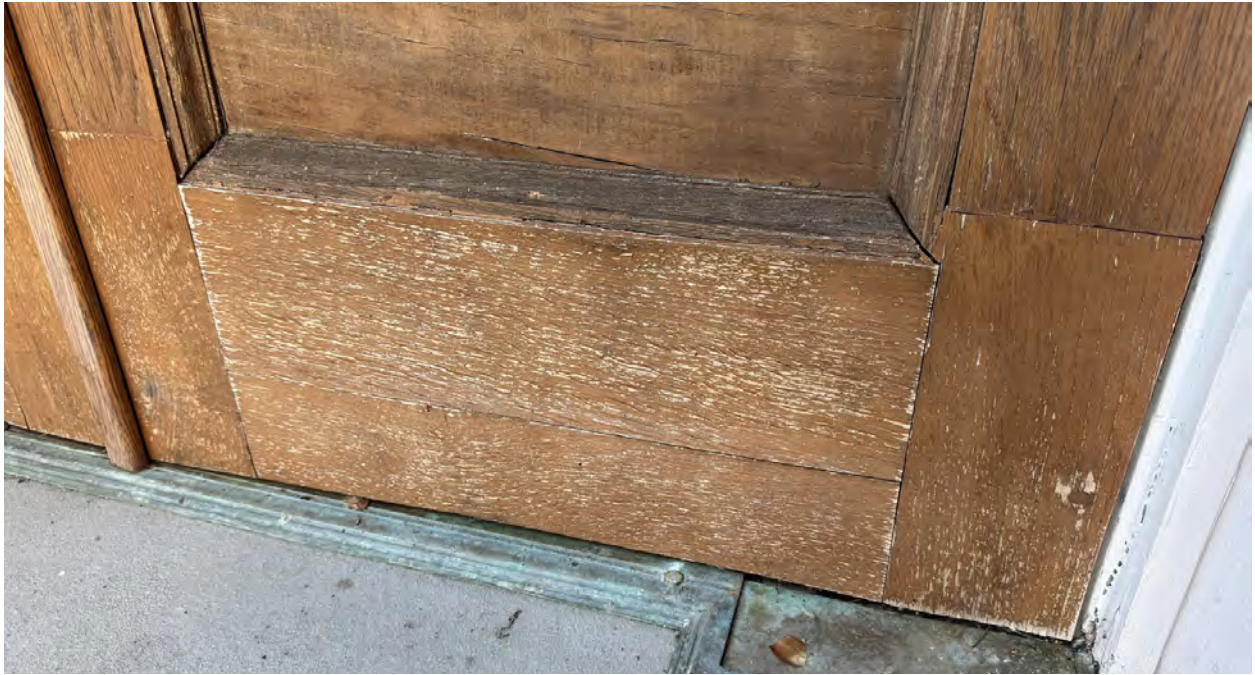
*Fig. 57: Previous repairs showing gaps and butt joints misaligning created by differential shrinking.*

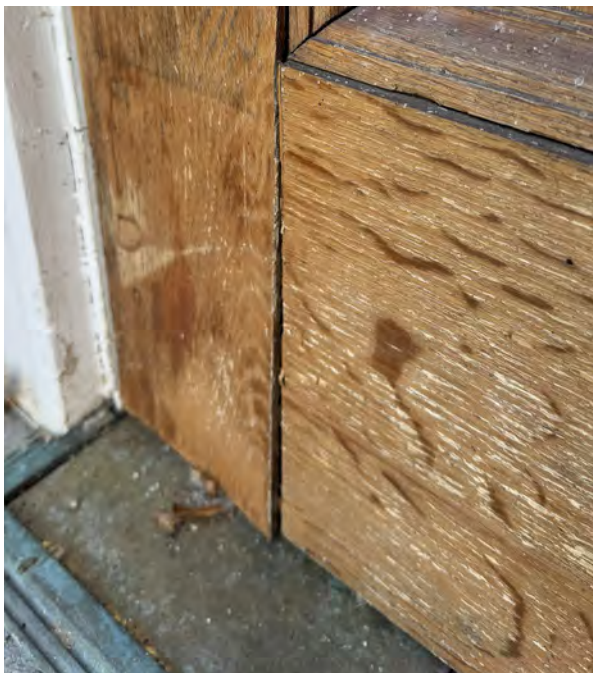
*Fig. 58: Detail of misalignment due to swelling of repair wood.*

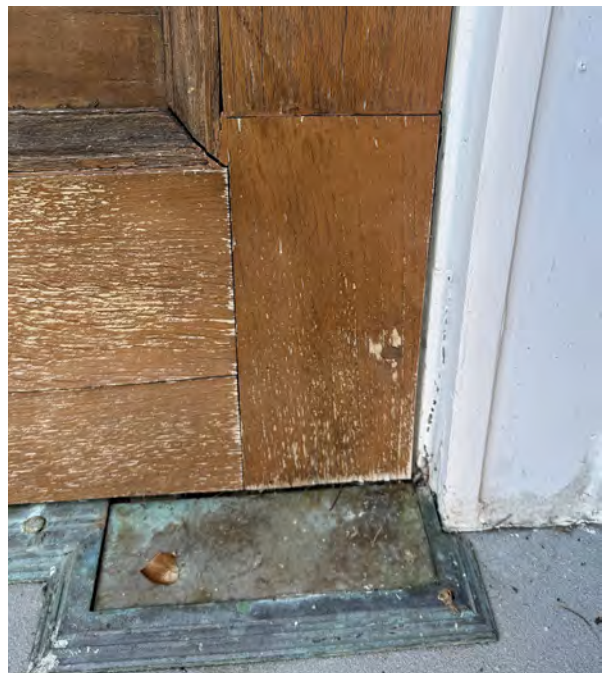
*Fig. 59: detail of wood patch at base of door.*

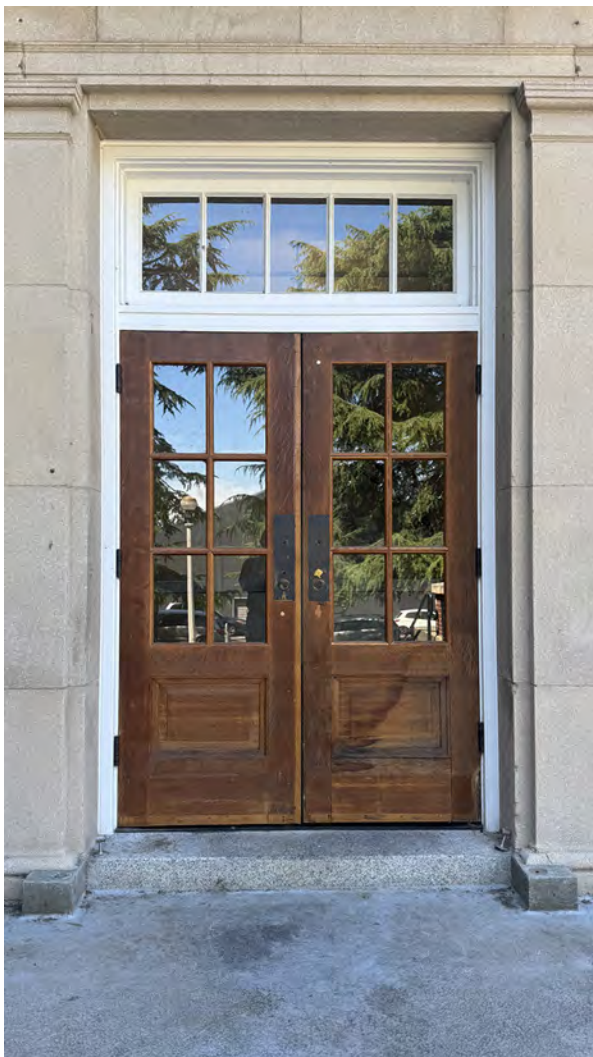
This fixed pair door has had its center mullion removed to allow for tools to be inserted into the crack between leaves. Seams show loss of filling compound resulting in exposed edge grain at the stile and rail joints. This occurs both at the top and bottom of the door. The door hardware has been badly damaged by tools in an effort to remove the door locks. The lower right portion of the door shows loss of finish and a portion of the veneer below the lowest right-hand hinge has been lost.

*Fig. 60: Fixed door pair N-ST03-01*

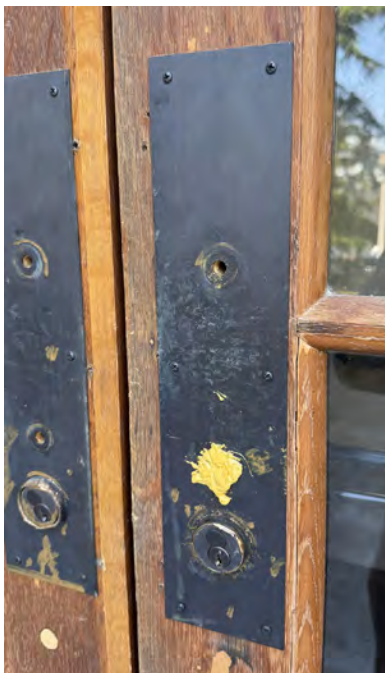
*Fig. 65: Damage to locks in effort to gain entry.*

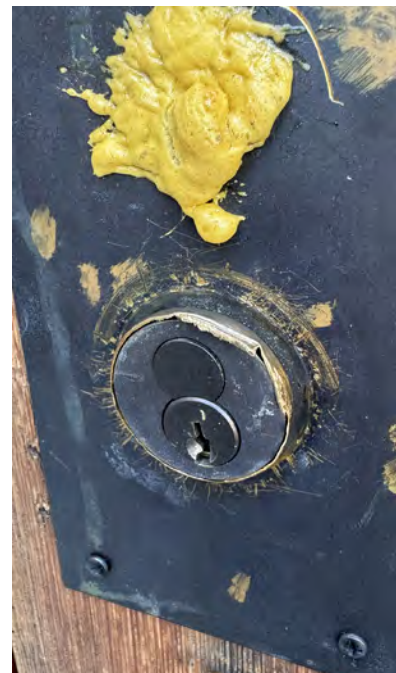
*Fig. 67: Detail of damage to locks in effort to gain entry.*

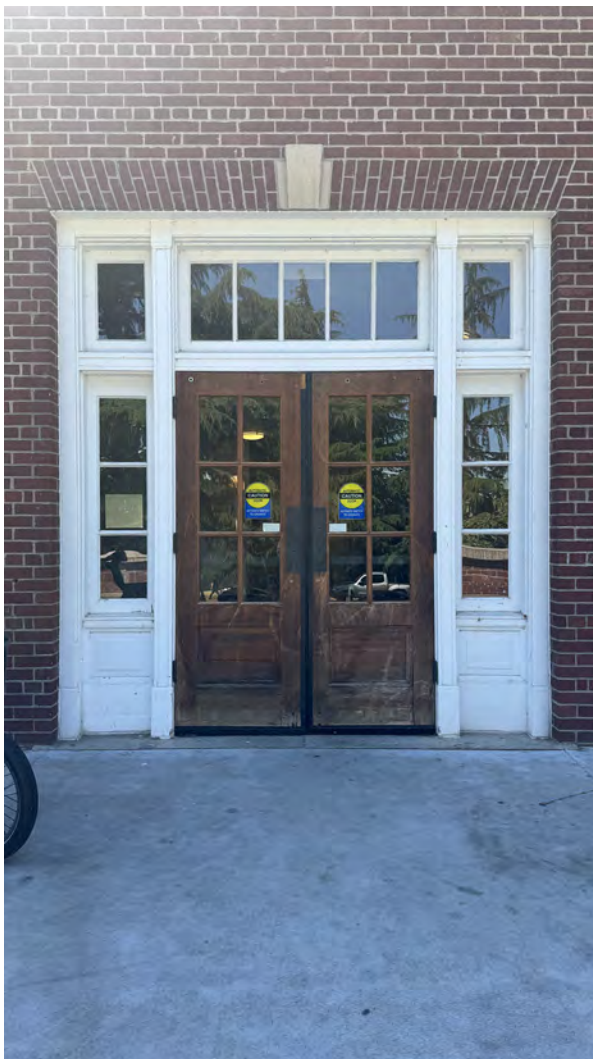
This door pair on automatic operators is in very poor condition. Loss of finish has resulted in moisture infiltration and differential shrinkage at joints exposing end grain of the rails at stile and rails joints and exposure of the wood trim at the panels insets to moisture, causing swelling. The inset panels have been badly damaged by repeated forced entry. Daylight is visible through cracks in the panels and between the door leaves. The weather stripping has been removed from the astragals. Rotting and drying have resulted in loss of the veneer material as illustrated in detail images on pages 26-29.

*Fig. 68: Automatic door pair NM115-01*

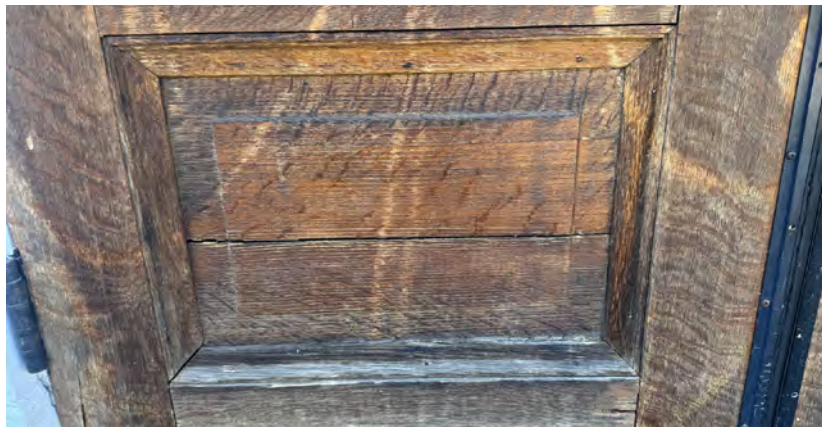
*Fig. 72: Detail, exterior view of cracked panel of left-hand leaf from brute force entry attempts.*

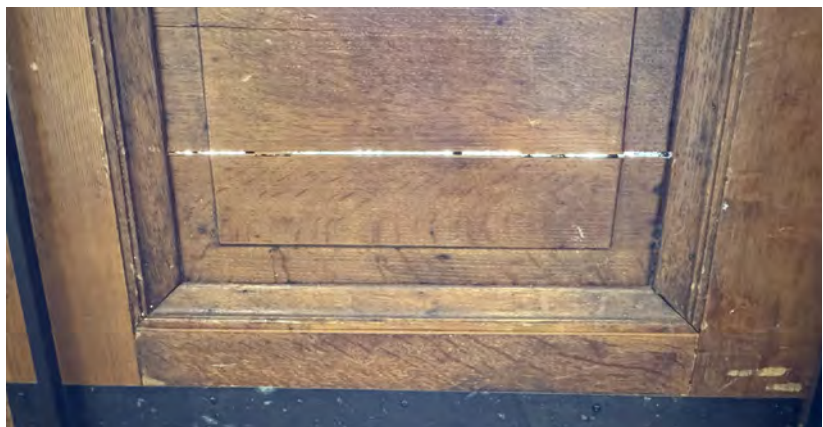
*Fig. 74: Detail, interior view of cracked panel of left-hand leaf from brute force entry attempts.*

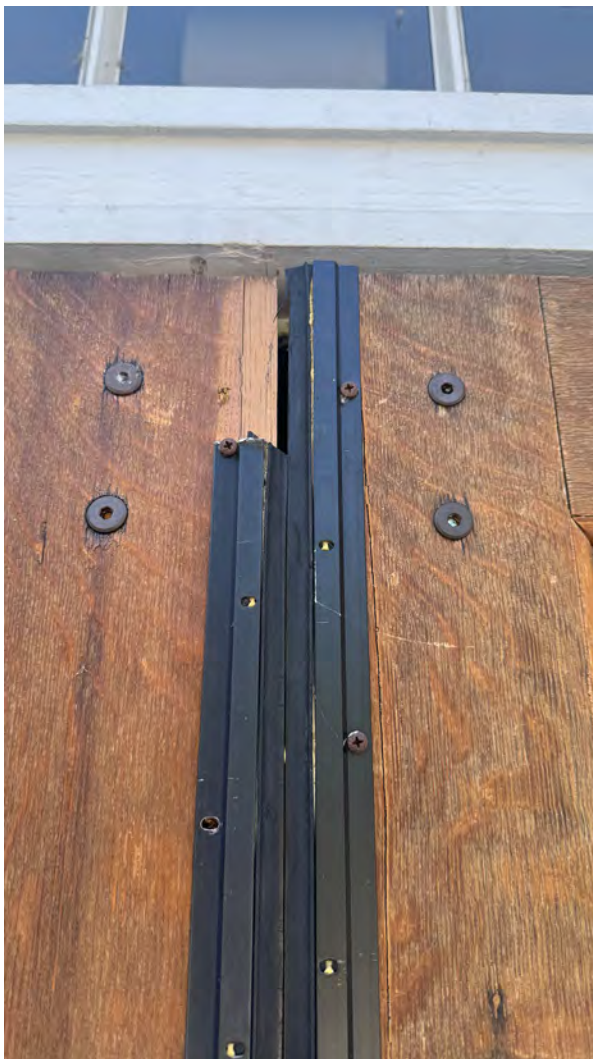
*Fig. 75: Loss of portion of astragal in effort to gain access.*

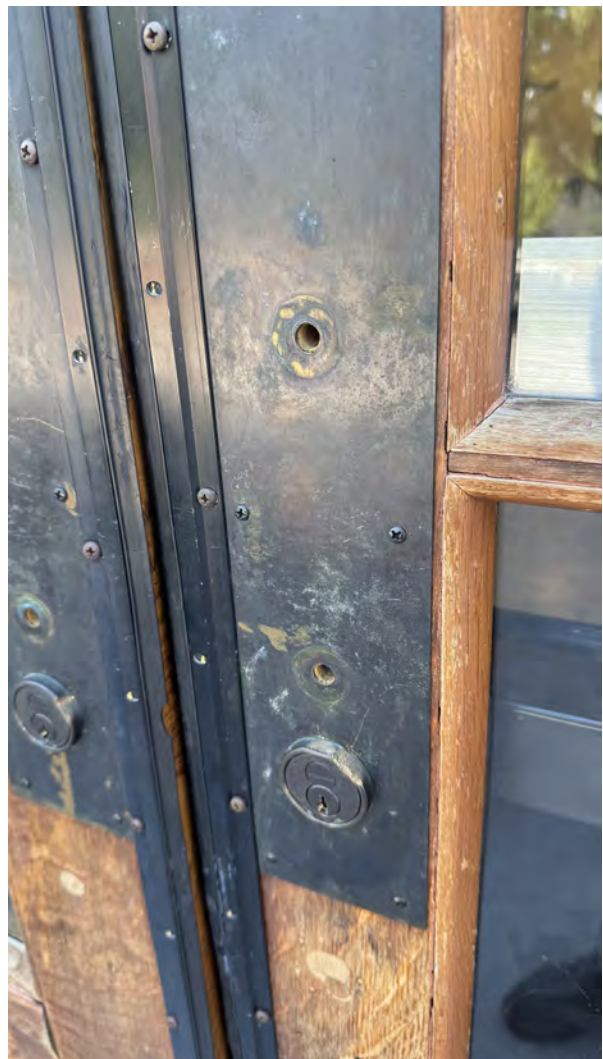
*Fig. 76: Damage to door lock hardware from brute force entry efforts.*

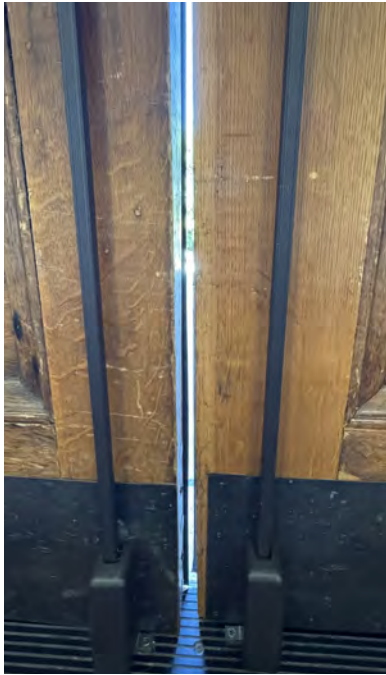
*Fig. 77: Wide gap between leaves.*

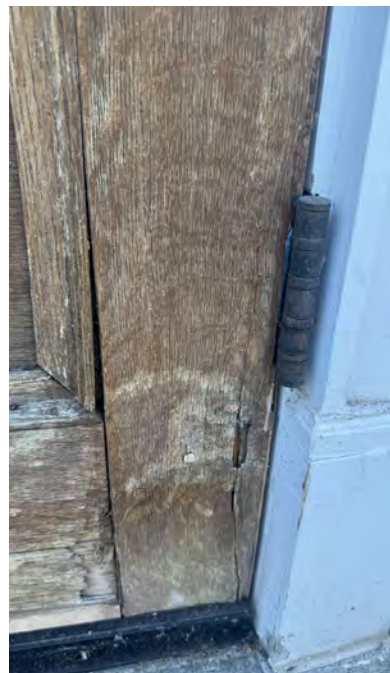
*Fig. 81: Detail of loss of veneer material due to moisture & rot. These doors have also suffered damage from rocking and force.*

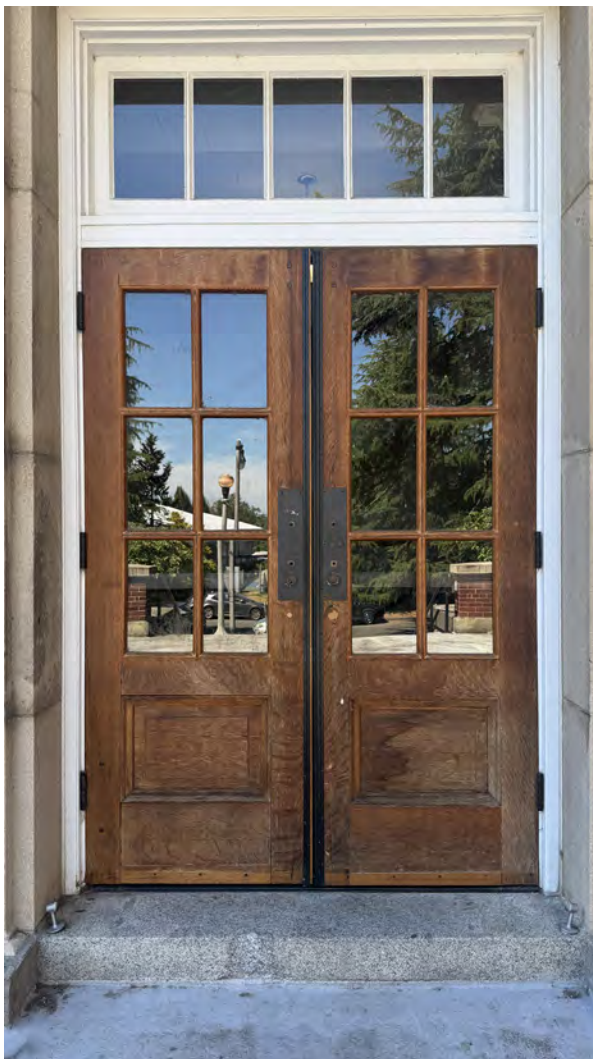
This door pair is in very poor condition. Issues include loss of finish, damage to the inset panels from entry attempts, loss of weather stripping at the astragals, loss of color from solar exposure, moisture infiltration, and repeated attempts to remove the door hardware with tools. Evidence of differential shrinkage is also apparent at stile and rail joints and at the window muntins.

*Fig. 83: Door pair N-ST04-04*

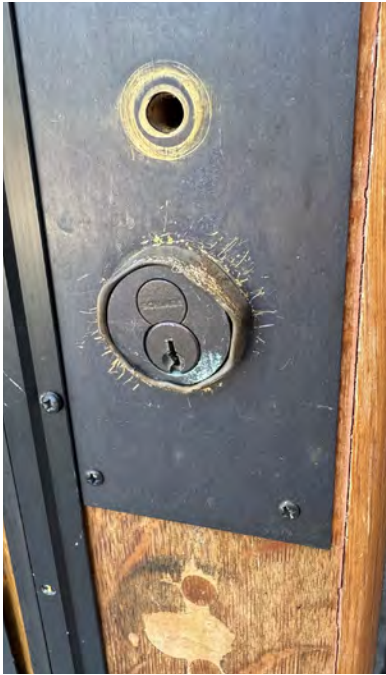
*Fig. 85: Detail of damage to locks.*

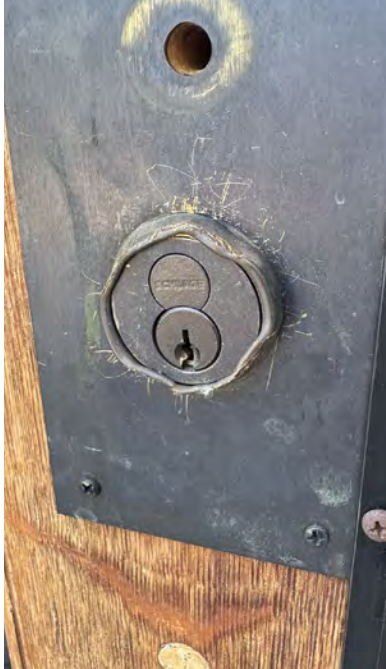
*Fig. 88: Detail of damage to locks.*
