## **Sand Point Naval Air Station – Building**

## **Limited Condition Assessment**

**Project:** Mercy Housing Northwest – Building 9 Door Replacement  
7101 62nd Avenue NE  
Seattle, WA 98115

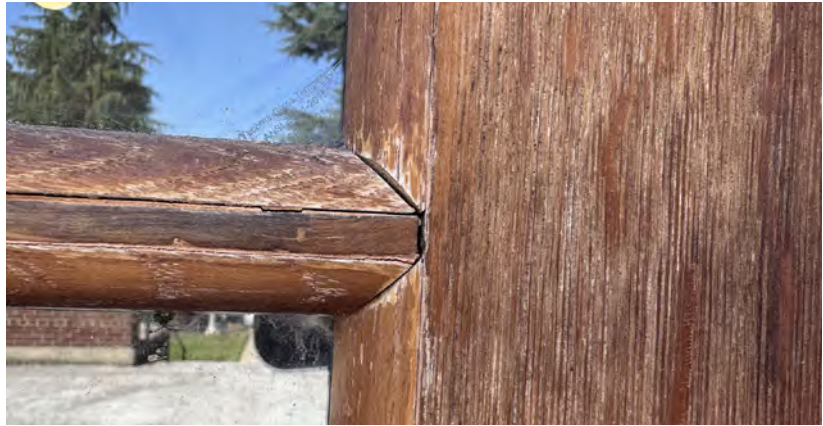
*Fig. 86: Separation at joints from differential swelling.*

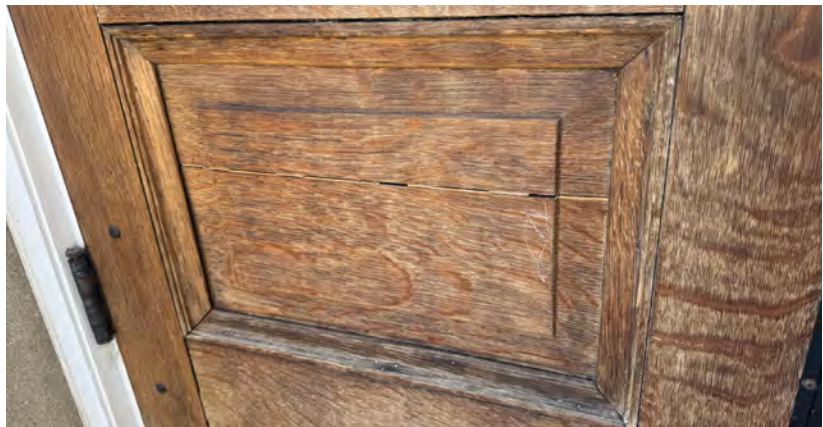
*Fig. 87: Detail of cracked panel of left-hand door from forced entry attempts.*

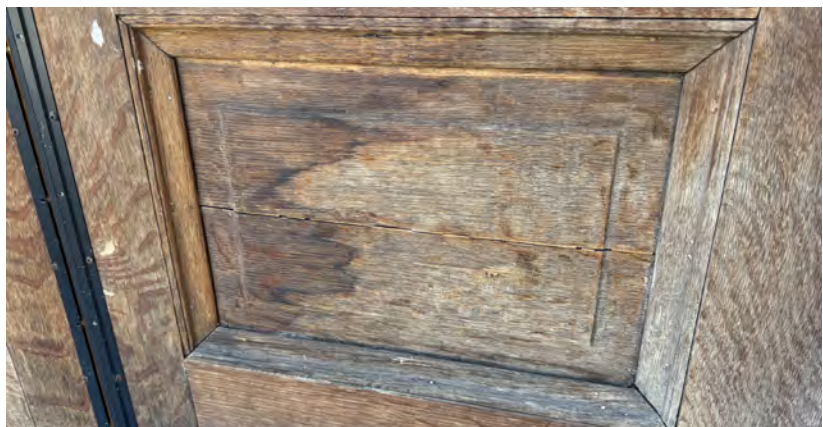
*Fig. 89: Detail of cracked panel of right-hand door from forced entry attempts.*
