## **Sand Point Naval Air Station – Building**

## **Limited Condition Assessment**

**Date:** July 13, 2026

**Project:** Mercy Housing Northwest – Building 9 Door Replacement  
7101 62nd Avenue NE  
Seattle, WA 98115

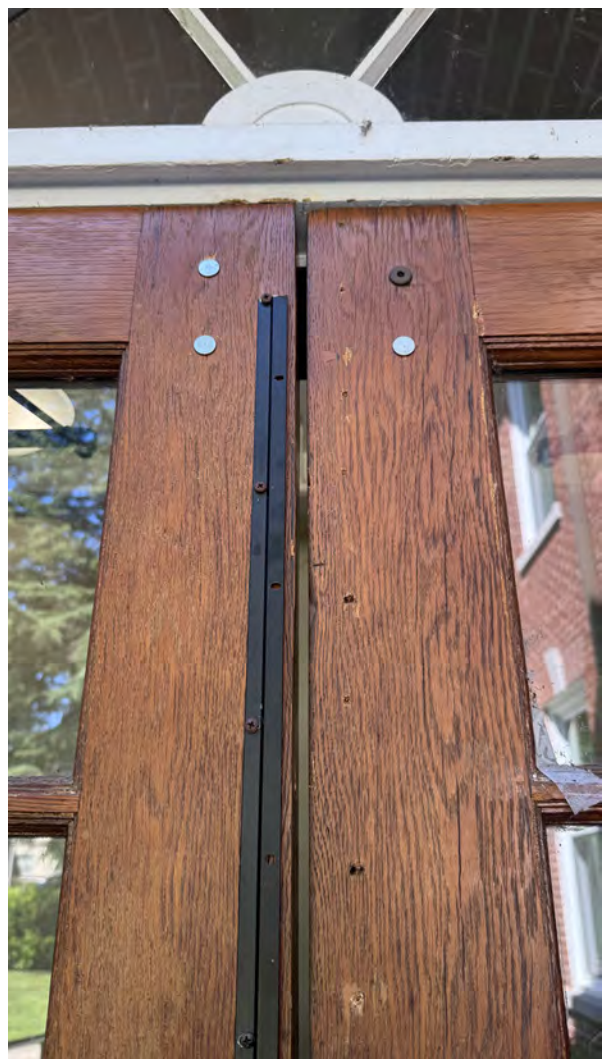
*Fig. 02: Damaged and removed astragals at door pair S-ST04-01.*

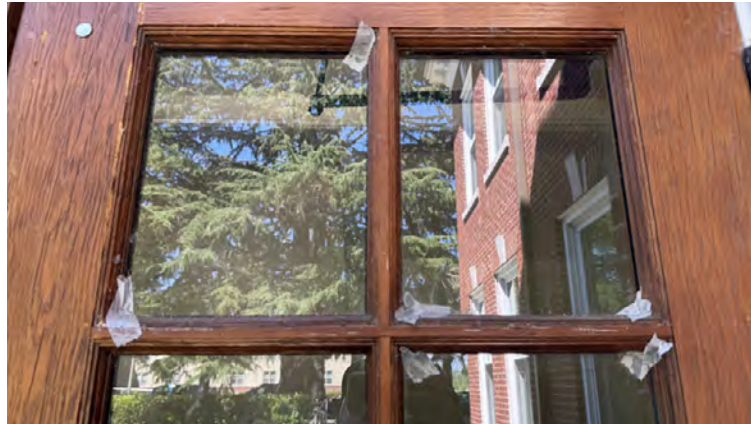
*Fig. 04: Right panel of door pair S-ST04-01 following recent repair of broken lights.*

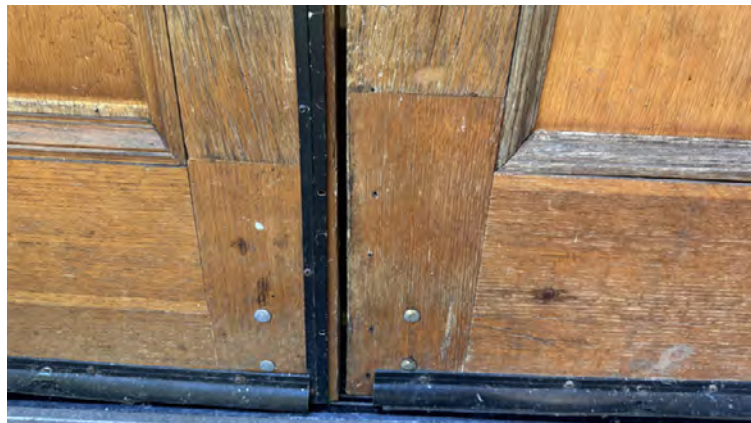
*Fig. 05: Door pair S-ST04-01 shows previous rail and stile patches, and removal of astragal.*

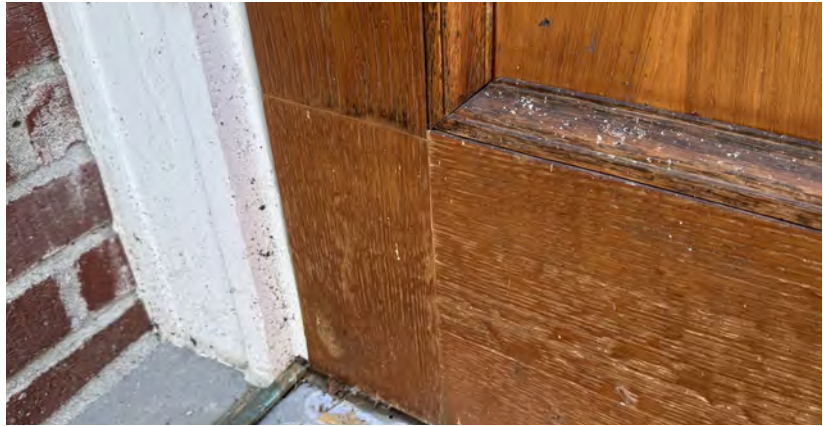
*Fig. 10: Door repairs to rot during previous rehabilitation.*

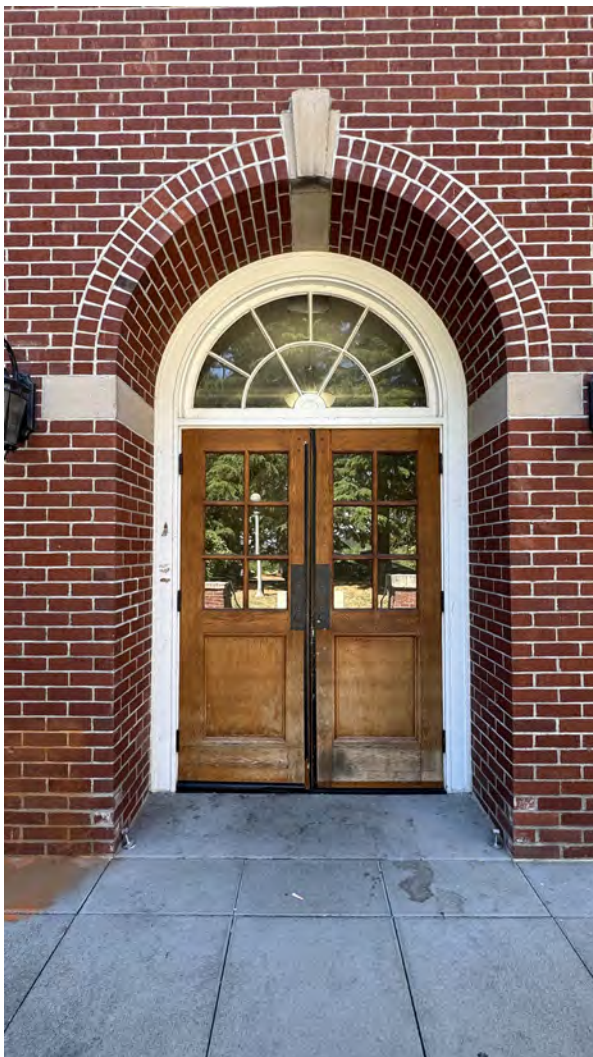
This door pair is in poor condition and has been damaged both by efforts to gain entry to the property and failure of its protective finishes. Like many of the operable pairs the weather stripping has been removed to allow for tools to be forced in between the leaves to force their opening. This has occurred so frequently that some door pairs can now be opened by rocking or forcing the leaves apart bare handed. Loss of the finish material has resulted in the exposure of wood to the open air allowing moisture to infiltrate the veneer and trim materials causing them to gray and rot. Note that in Figure 18 the left-hand leaf sits permanently forward as a result of repeated forced entries.

*Fig. 13: Door pair S-ST03-06*

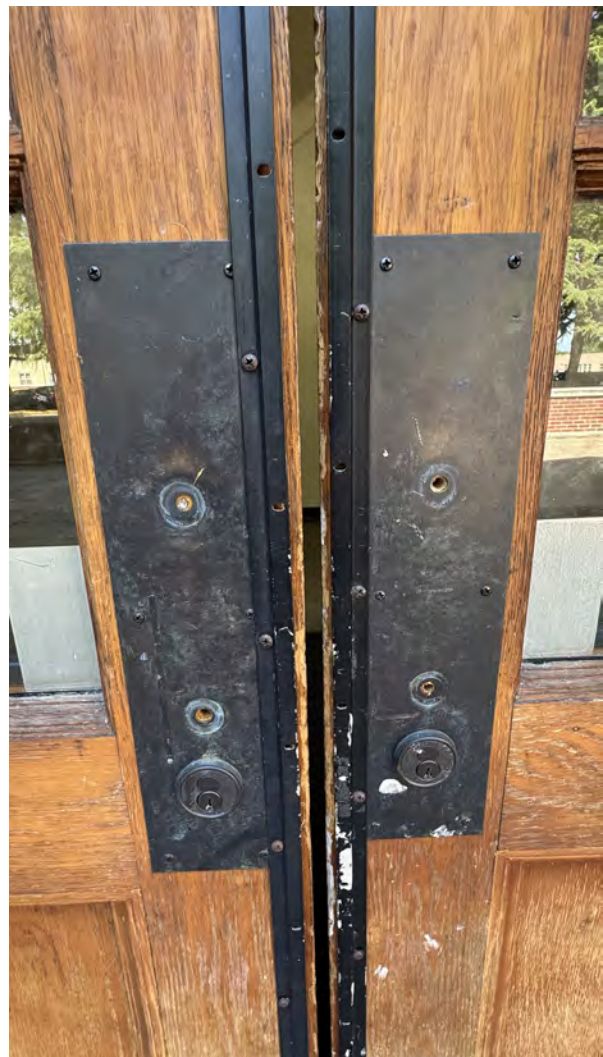
*Fig. 14: Detail of damage from forced entry at doors S-ST03-06*

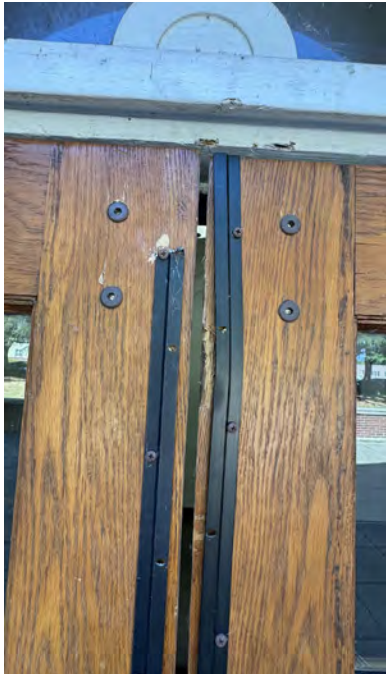
*Fig. 15: Damaged astragal from forced entry.*

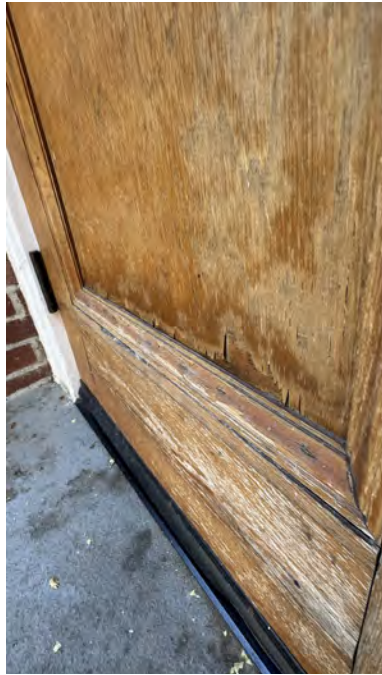
*Figs. 16 & 17: Damage from moisture infiltration at failing seals at joints causing swelling and separation of components.*

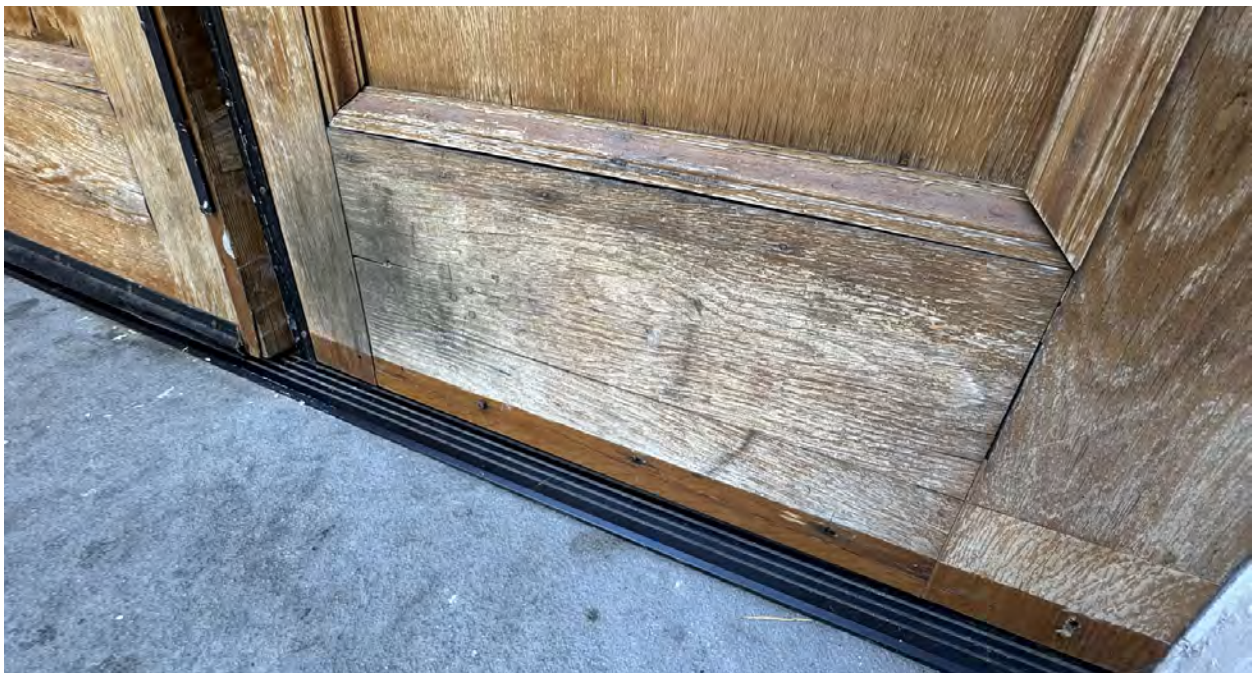
*Fig. 18: Damage from moisture infiltration at failing seals at joints causing swelling and separation of components. Loss of finish due to weathering has allowed moisture to infiltrate assembly.*

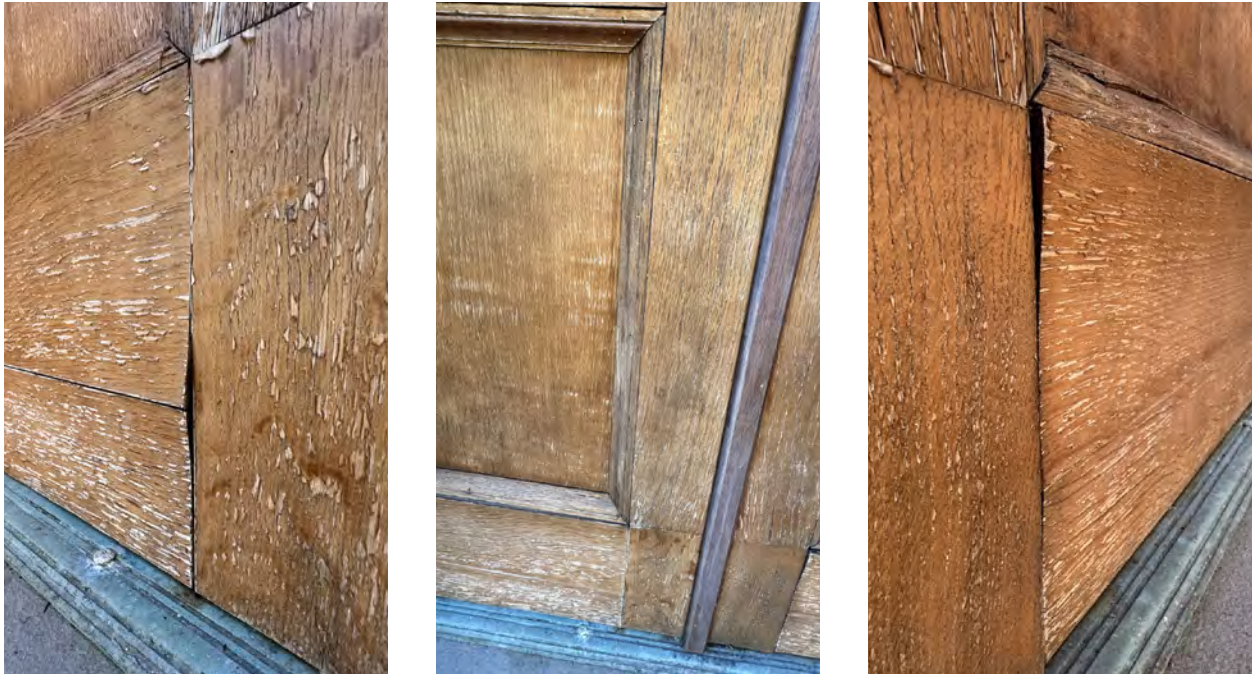
*Figs. 21, 22, & 23: Damage from moisture infiltration at failing seals at joints causing swelling and separation of components. Details of cupping and swelling wood components.*

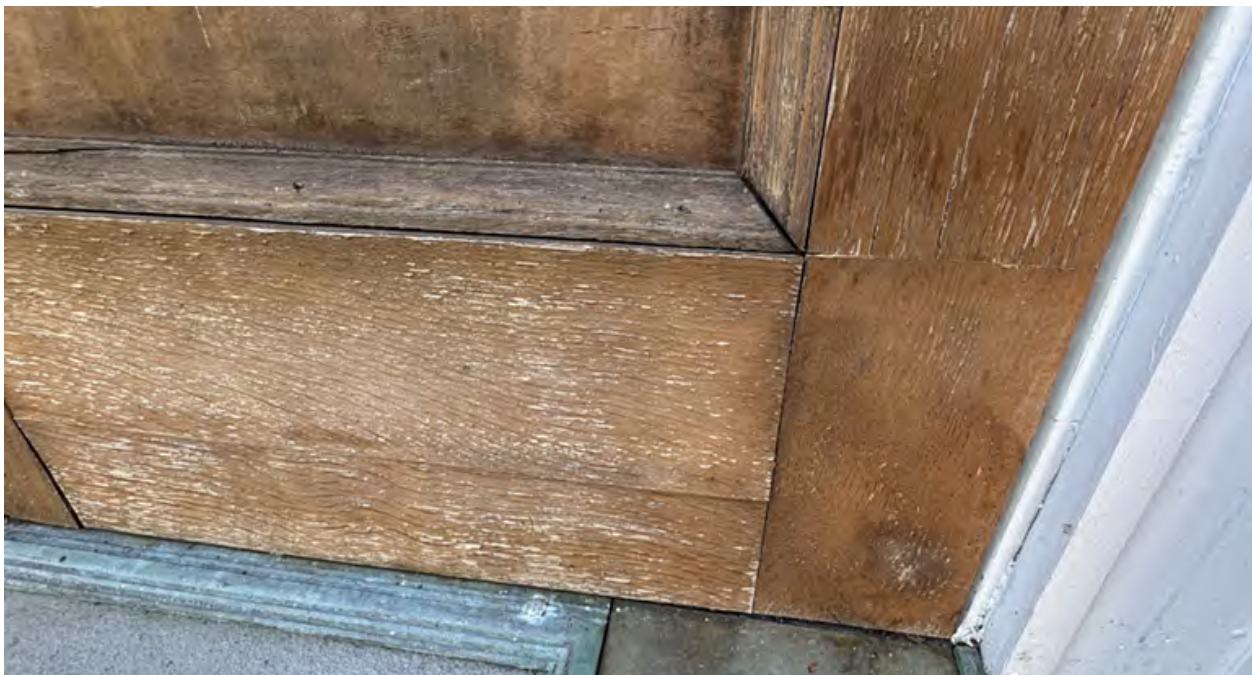
*Fig. 24: Damage from moisture infiltration of failing finishes at joints causing swelling and separation of components. Details of cupping and swelling wood components.*

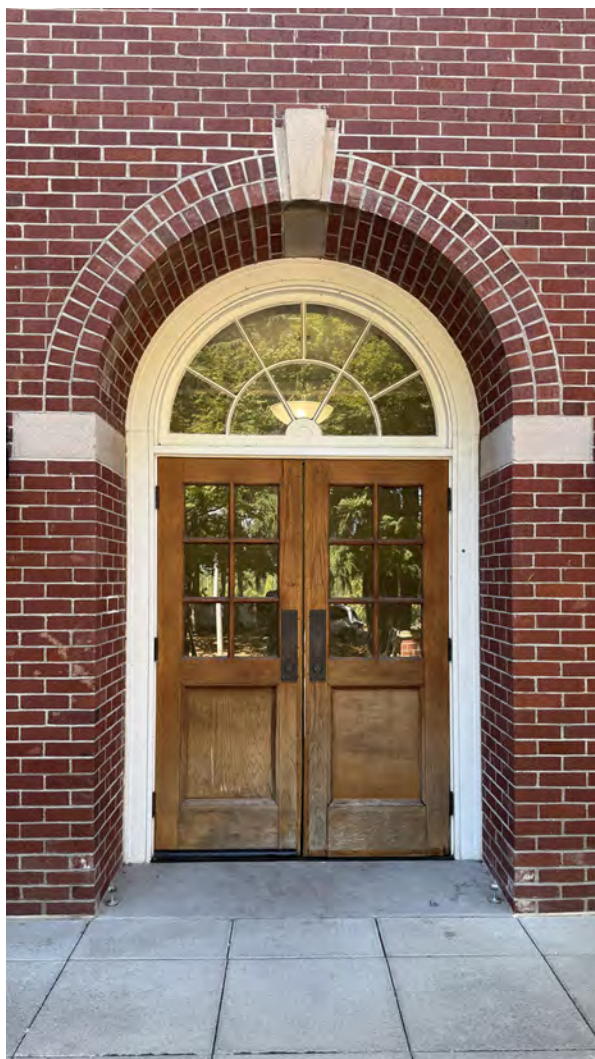
This door pair is also in poor condition. The lower portion of the door especially showing exposure to the elements through loss of finish resulting in discoloration and differential swelling between members now exposed to moisture. This door has also been damaged by forced entry efforts, the astragals stripped and leaves scarred from the insertion of tools to force the locking bolts. As noted in the details some of the veneer at the base of the door is cupping due to water infiltrating behind the material and causing it to swell and split.

*Fig. 29: Door pair S-ST02-06*

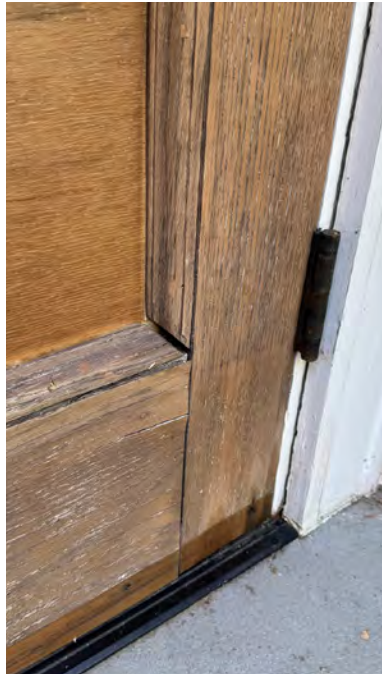
*Fig. 31 & 32: Separation of door components from moisture infiltration.*

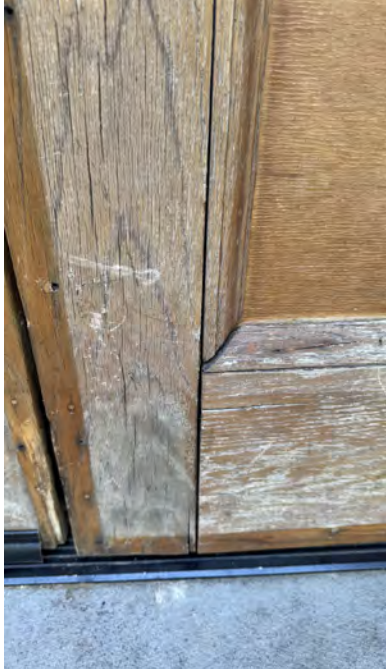
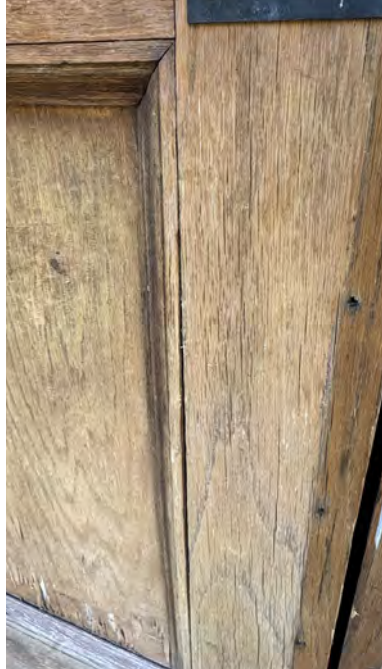
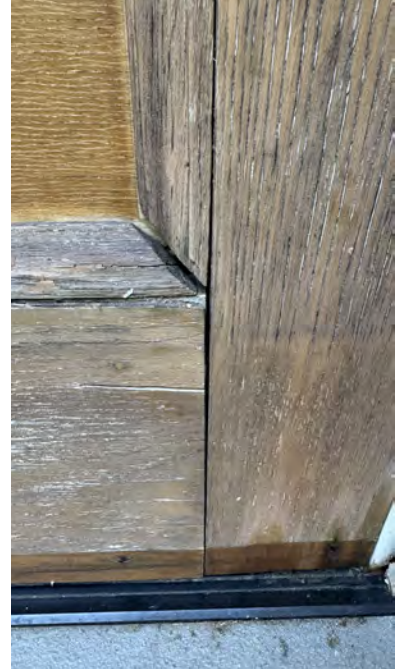
*Fig. 34, 35, and 36: Damage from moisture infiltration of failing finishes at joints causing swelling and separation of components. Details of cupping and swelling wood components.*

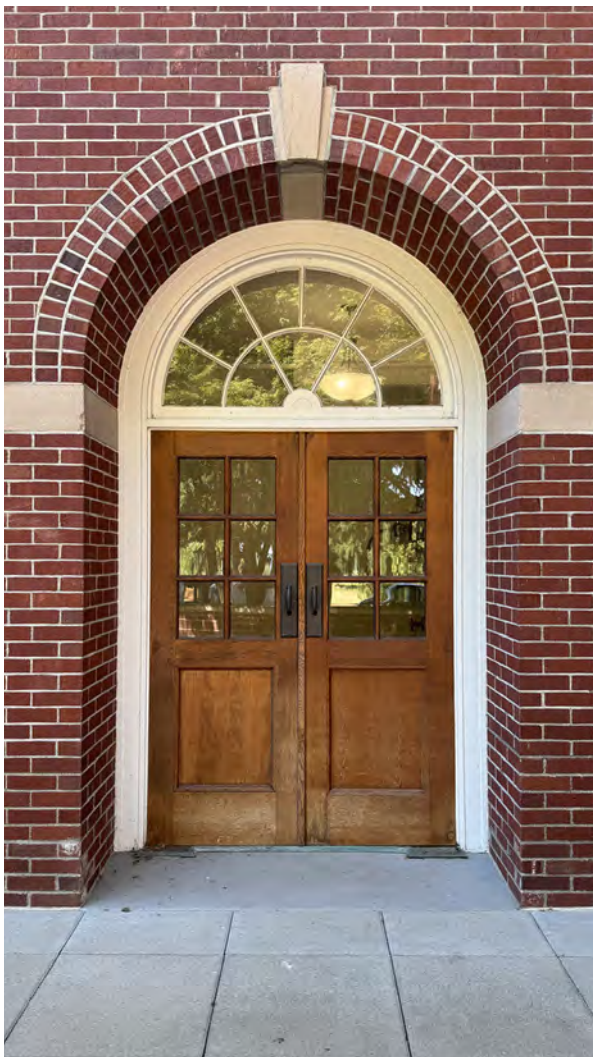
This fixed door pair is in reasonable condition, though it also exhibiting loss of finish resulting in direct exposure of the wood to the elements causing discoloration and swelling of the veneer members and moulding at the inset panels as documented in the detail photos.

*Fig. 37: Fixed door pair S-ST02-07*

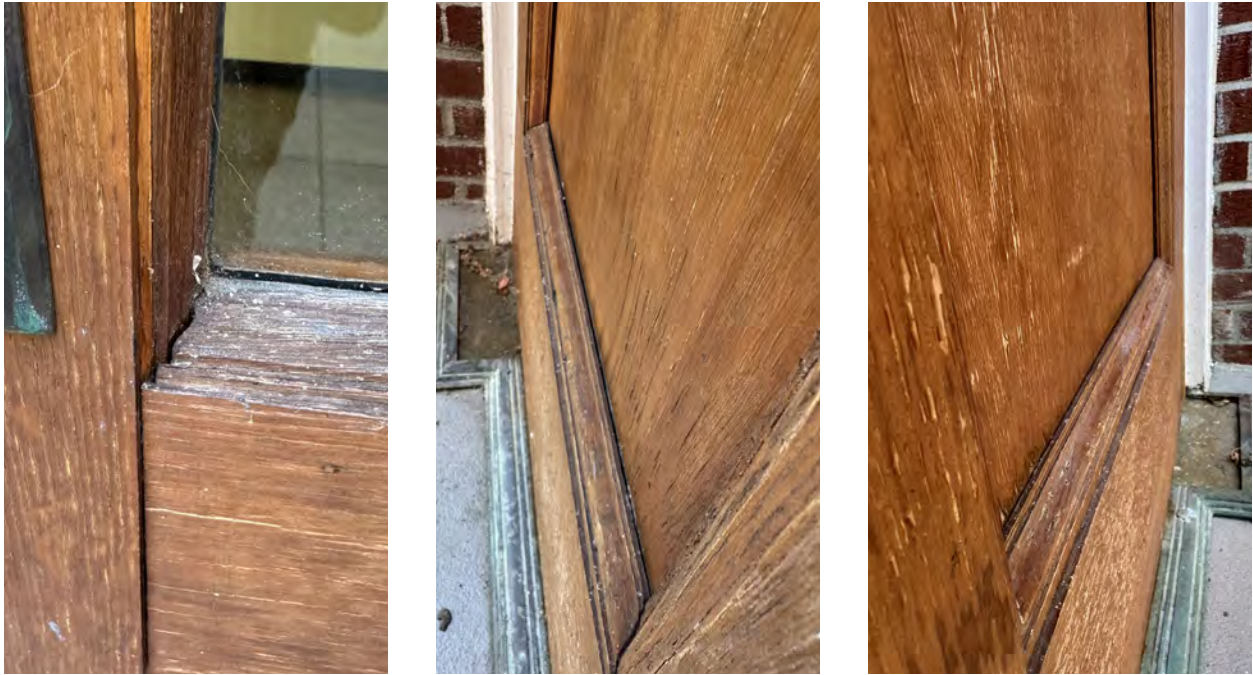
*Figs. 39, 40, and 41: Details showing points of moisture infiltration from failing finishes at joints causing swelling and separation of components.*

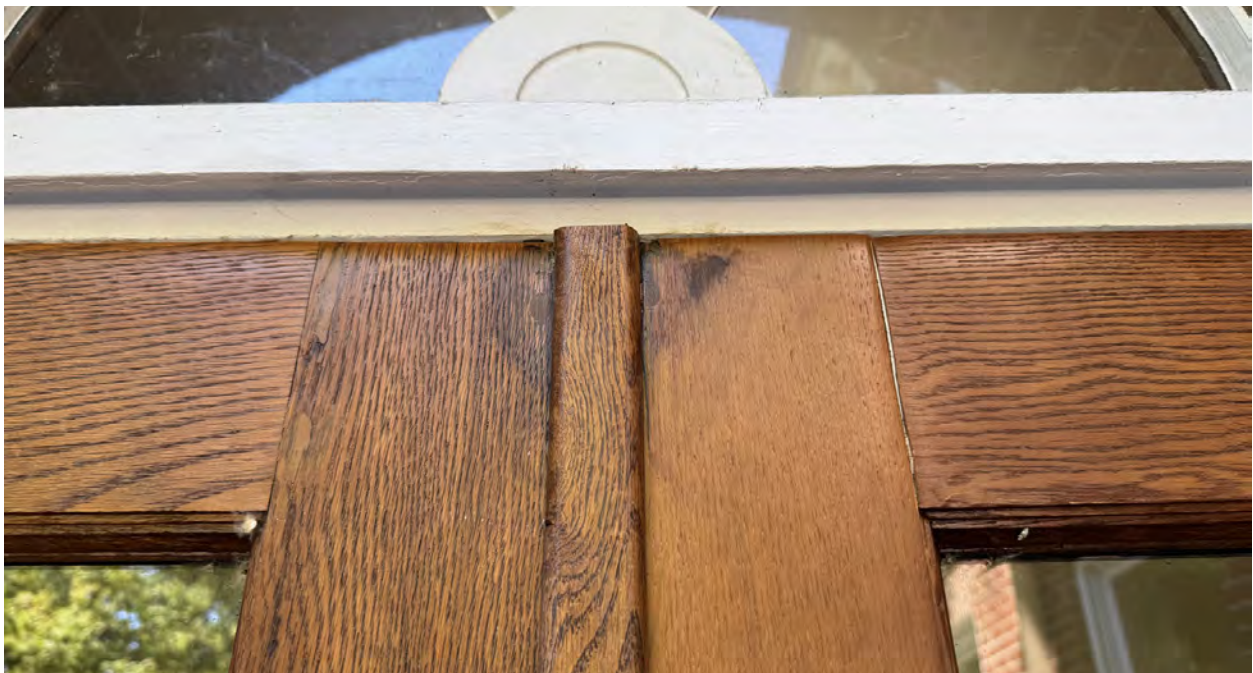
*Fig. 42: Previous repair to doors visible at the rail and stile joints.*

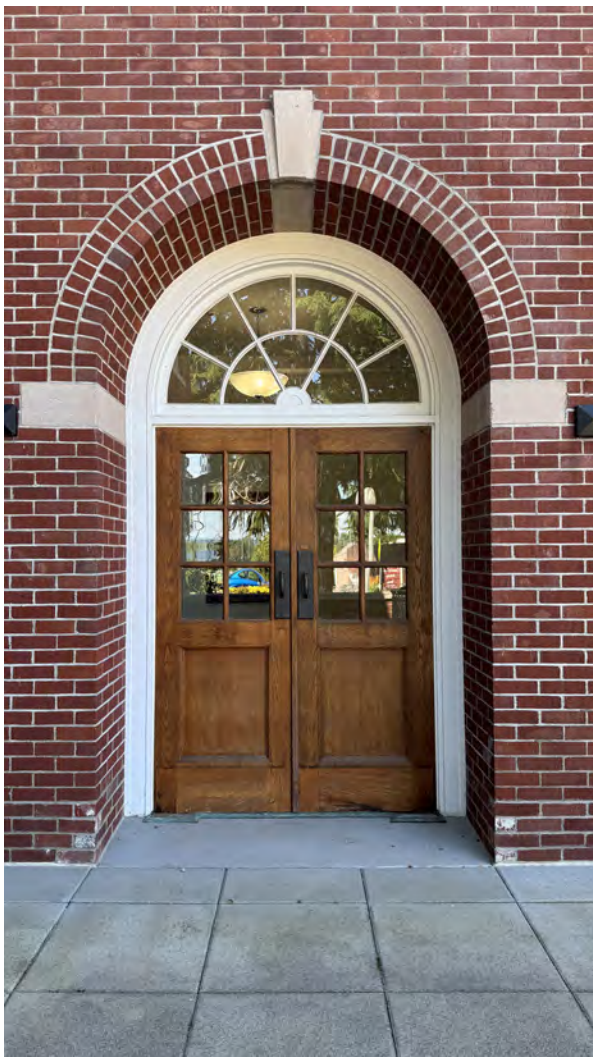
This fixed door pair is in decent condition. Most of the discoloration appears to be from previous exposure before rehabilitation and removal of a kick plate at the base of the door, as evidenced by the difference in visibility of the grain from the less exposed material.

*Fig. 43: Fixed door pair S-ST01-04*

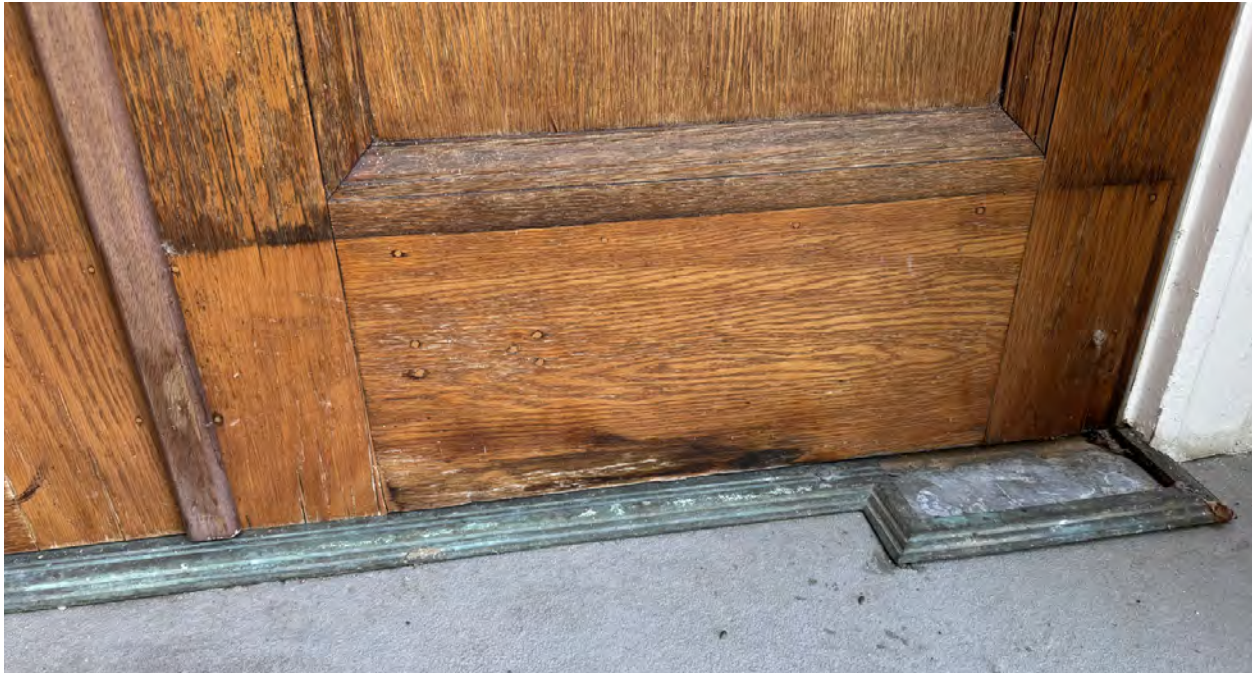
*Fig. 45: Evidence of previous rot at base of door.*

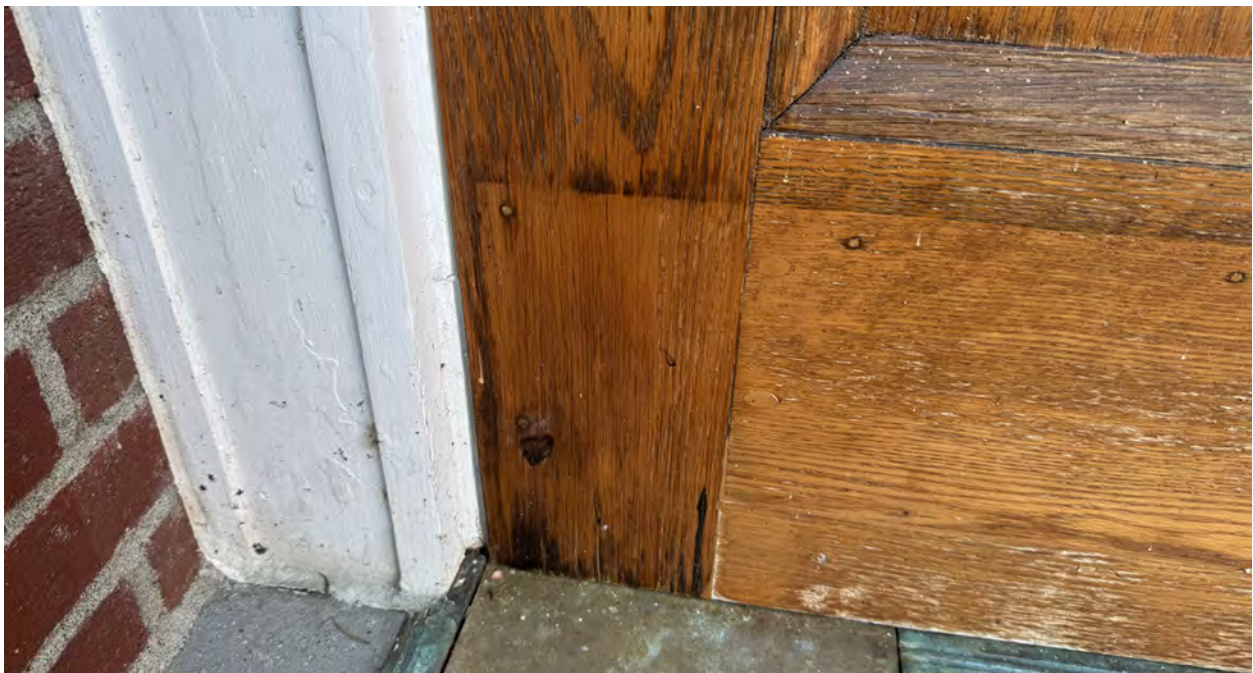
*Fig. 46: Evidence of previous rot at base of door.*

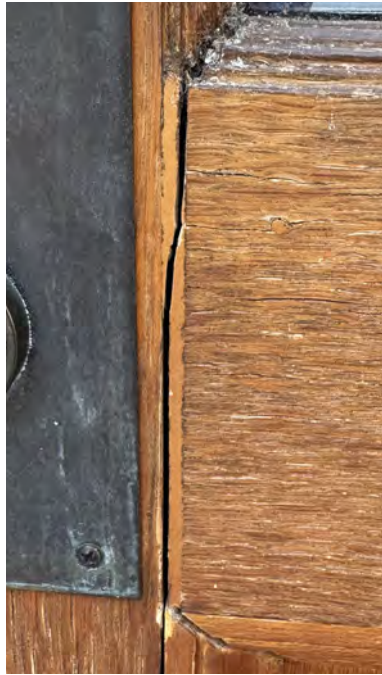
*Figs. 49 & 50: Detail of failure of earlier door repair at stile to rail joint. Split occurring along length of stile connection.*

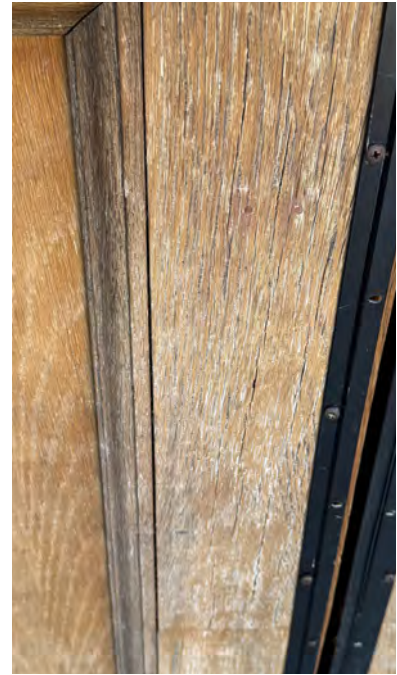
*Fig. 51: Detail of dry and cracking wood.*

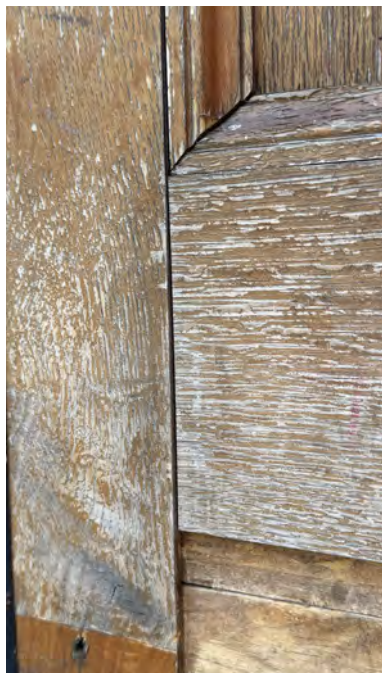
*Fig. 53: Detail showing loss of veneer material at base.*

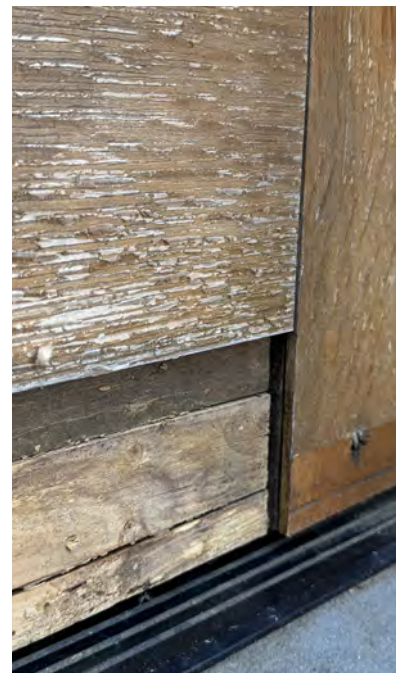
*Fig. 54: Detail showing loss of veneer material at base.*

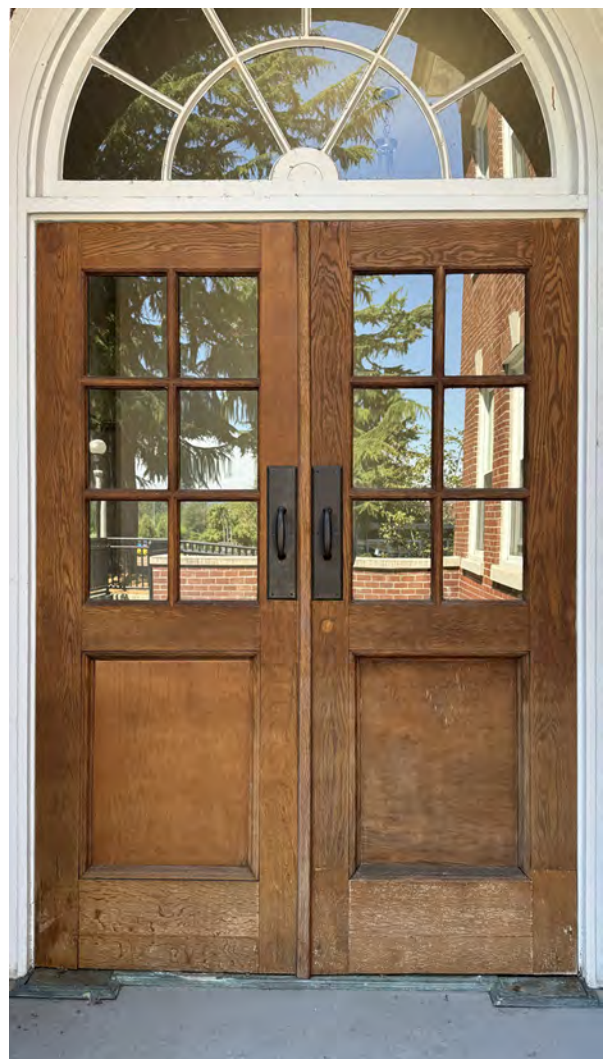
*Fig. 56: Detail of door pair S-ST01-06*

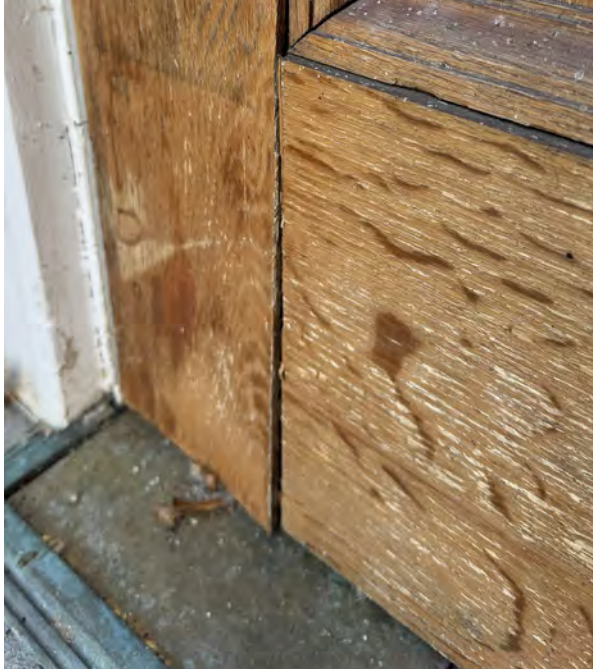
*Fig. 58: Detail of misalignment due to swelling of repair wood.*

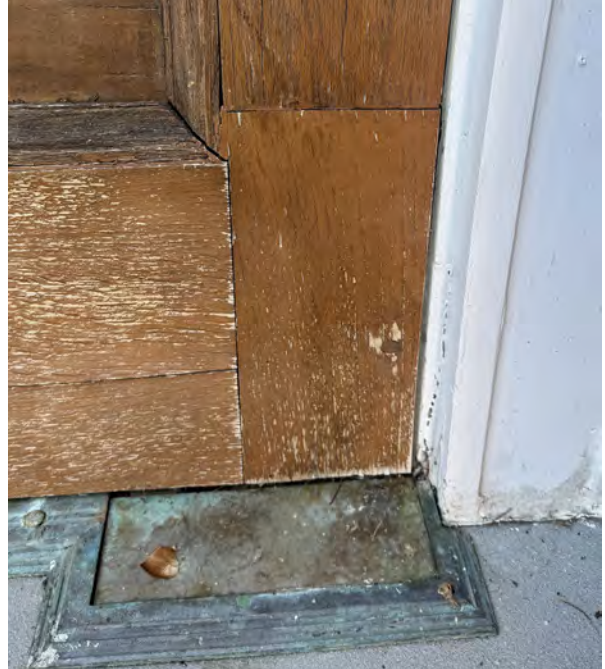
*Fig. 59: detail of wood patch at base of door.*

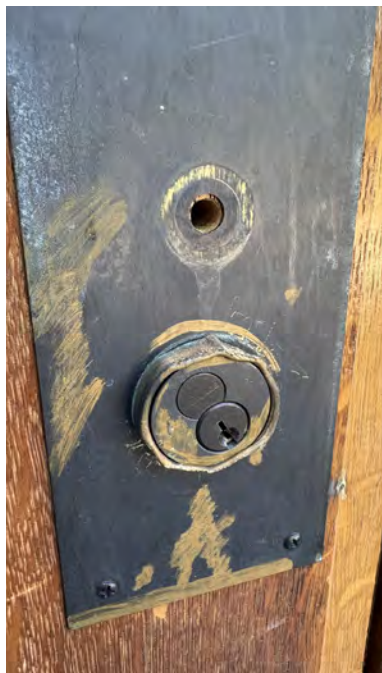
*Fig. 66: Detail of damage to locks in effort to gain entry.*

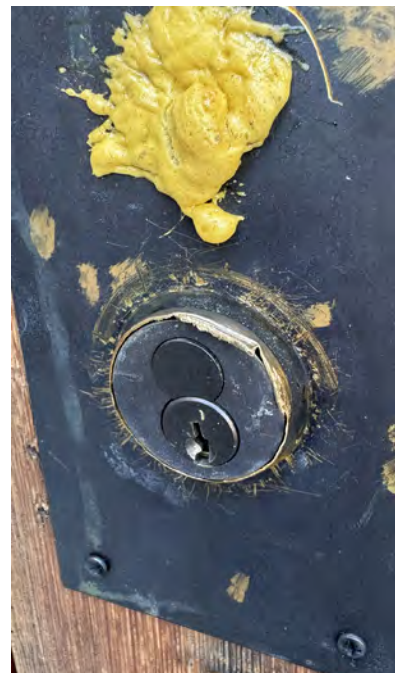
*Fig. 67: Detail of damage to locks in effort to gain entry.*

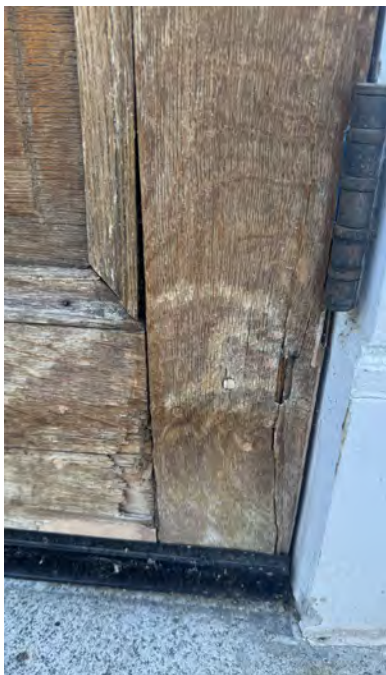
*Fig. 73: Loss of veneer material from moisture intrusion.*

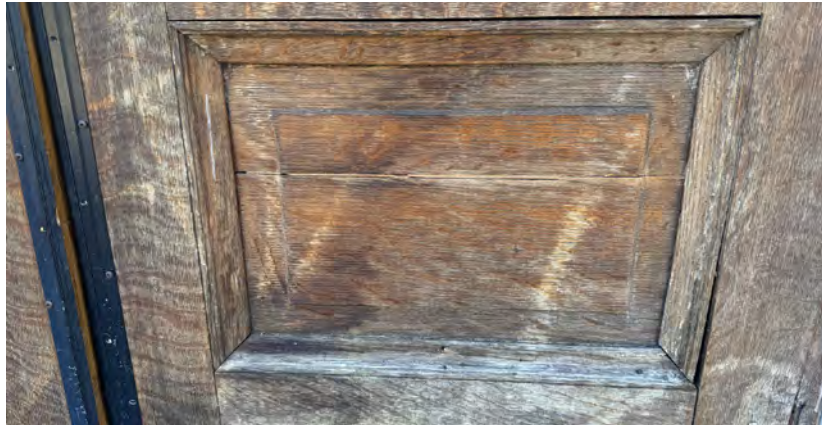
*Fig. 71: Detail, exterior view of cracked panel of right-hand leaf from brute force entry attempts.*

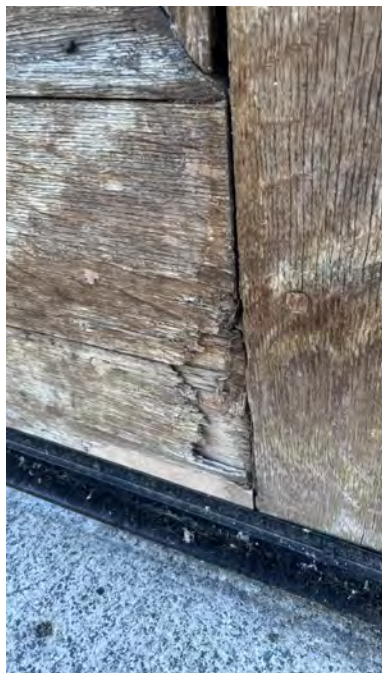
*Fig. 81: Detail of loss of veneer material due to moisture & rot. These doors have also suffered damage from rocking and force.*

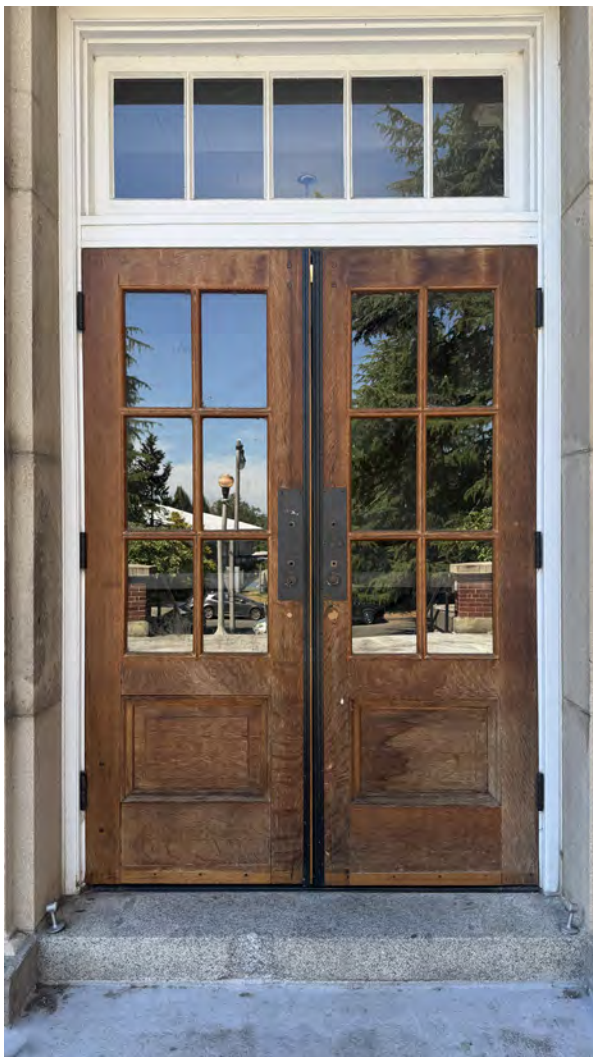
This door pair is in very poor condition. Issues include loss of finish, damage to the inset panels from entry attempts, loss of weather stripping at the astragals, loss of color from solar exposure, moisture infiltration, and repeated attempts to remove the door hardware with tools. Evidence of differential shrinkage is also apparent at stile and rail joints and at the window muntins.

*Fig. 83: Door pair N-ST04-04*

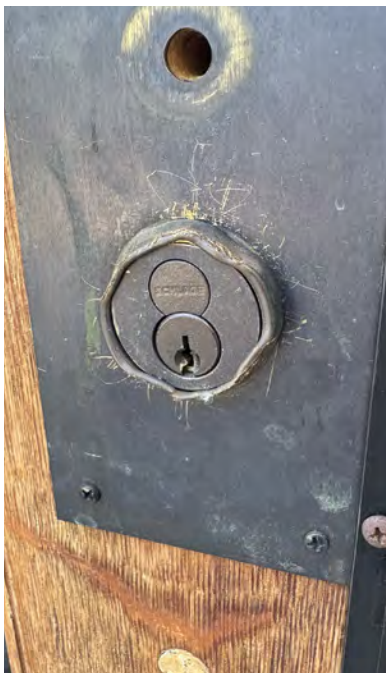
*Fig. 88: Detail of damage to locks.*

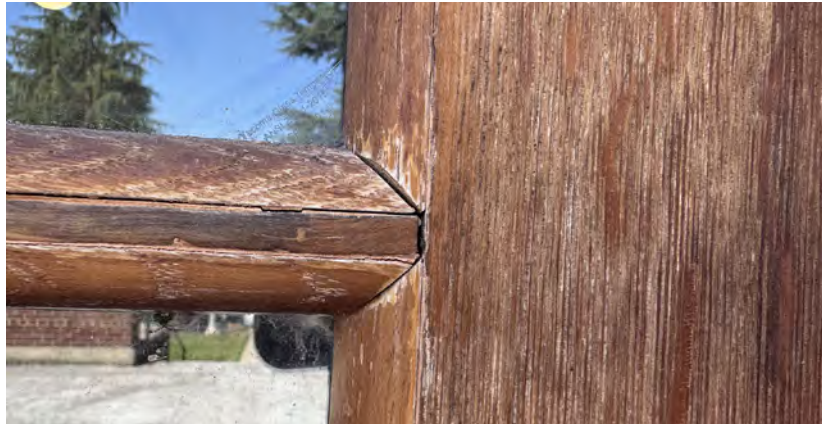
*Fig. 86: Separation at joints from differential swelling.*

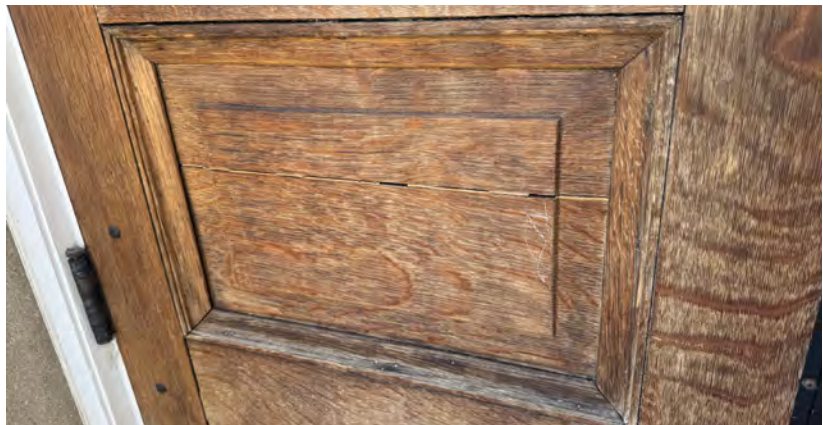
*Fig. 87: Detail of cracked panel of left-hand door from forced entry attempts.*

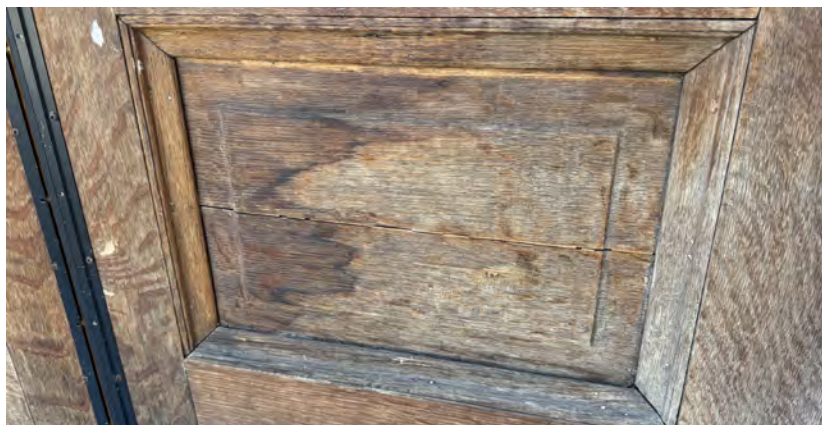
*Fig. 89: Detail of cracked panel of right-hand door from forced entry attempts.*
