**Seattle Parks and Recreation  
LETTER OF INTEREST (LOI)**

The Bullitt House  
1125 Harvard Ave. E, Seattle

**RE: Bullitt Estate - Facility Condition Final Report**

## BULLITT ESTATE FACILITY CONDITION REPORT

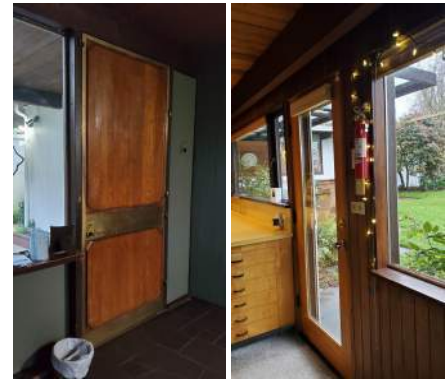
Exterior glazing generally consists of single-pane glass with wood stops. Skylight assemblies consist of pre-formed non-insulated plastic glazing, including the ridge of the “A-Frame” roof where glazing is tied into existing asbestos containing “Transite” siding. Water intrusion has been reported and damage is observed at several locations including window sills and interior finishes.

Existing Wood Entry Doors

The current door and glazing assemblies do not meet City of Seattle Energy Code requirements for non-residential buildings and would need to be upgraded if the structure were converted for public use. Upgrades would require substantial modification to the existing openings and would likely require additional structural work. Replacement is further complicated by the existence of regulated materials and potential landmark considerations. Since the extent of work related to these upgrades cannot accurately be determined at this time, OAI has not prepared a cost estimate for this item.

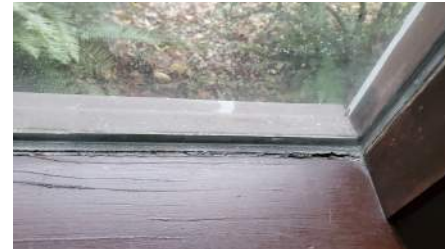
Existing Single-Pane Glazing

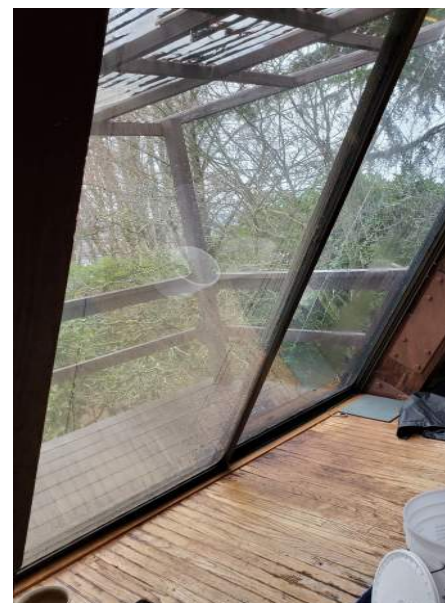
Existing Sloped Sliding Glass Door

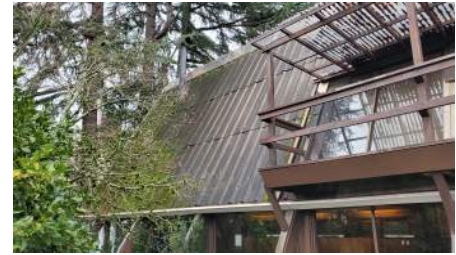
A primary portion of the structure is of “A-Frame” construction, with exterior cladding as the primary waterproofing component. The roof assembly at this location consists of corrugated “transite” cladding installed over exposed roof decking and includes little to no thermal insulation. Pre-formed plastic glazing panels create a skylight along the ridge and are integrally installed into the “transite” cladding. Interior leaks have been observed along the ridge line, and exterior gutters are in need of repair or replacement.

Existing “A-Frame” Roof Portion

- **A-Frame Roof:** The existing “transite” cladding of the A-Frame contains asbestos and any work at this location will require full abatement as a regulated material. Replacement roof cladding may need to be replaced with an aesthetically similar material due to landmark considerations, which is complicated by limited material options. The addition of thermal insulation to meet energy code will place added loads on the structure and may require additional structural upgrades. Existing skylights will need to be replaced with insulated glazing to meet energy code, and gutters cannot be replaced without impacting asbestos containing “transite” cladding. Because of these complications, OAI does not believe it’s feasible to replace this roof portion without making other substantial upgrades to the structure.

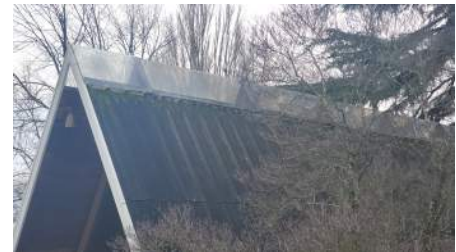
Existing Plastic-Glazed Ridge Skylight

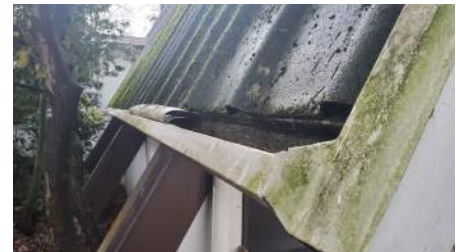
Existing A-Frame Roof Gutter

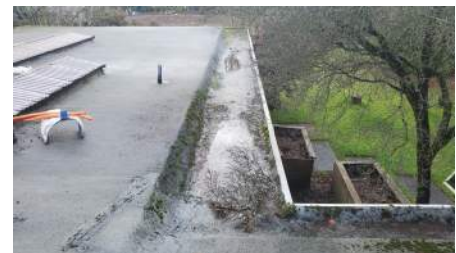
Existing Low-Slope Roof Drainage

- **Low-Slope Roof:** Low-slope membrane roofing can be replaced but will require upgrades to meet current energy code including additional thermal insulation and insulated skylight glazing. Further structural evaluation of the added roof loads may be required and is not included in the cost estimate. Refer to **Exhibit B1** for replacement cost estimate.

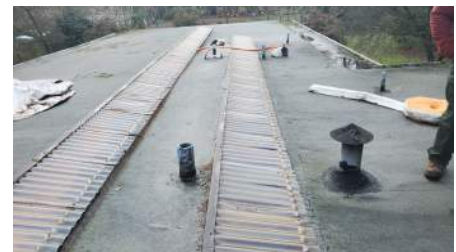
Low-Slope Plastic Skylight Glazing

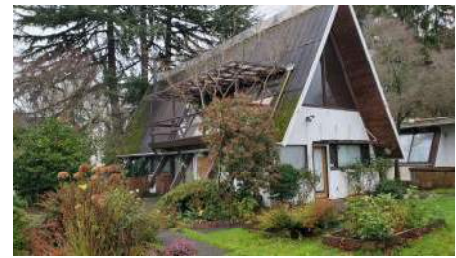
Accessible Exterior Approach

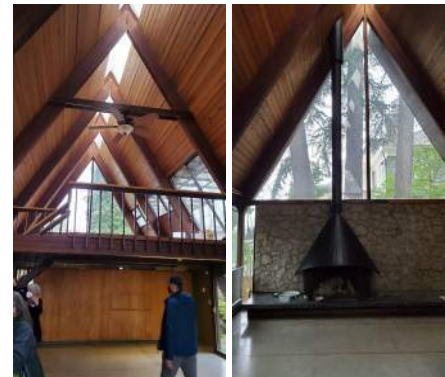
Lower Level Assembly Area

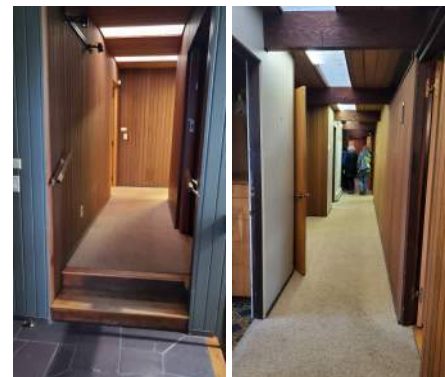
Non-Accessible Paths of Travel

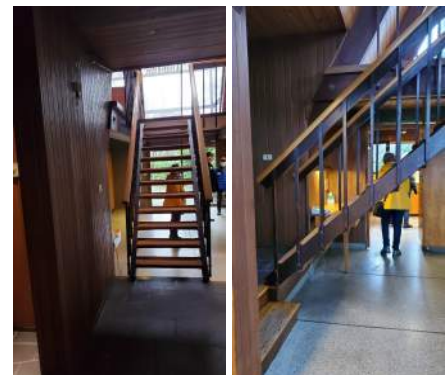
Existing stairs and guardrails do not meet current life-safety codes and would need to be upgraded for public use.

- Stair handrails do not meet the minimum 42” height and do not extend 12” past the top and bottom risers 12”. Risers cannot be open and require tactile strips along the treads.
- Guardrail openings exceed the maximum spacing of no more than 4” and do not meet the required height of 42”.

Existing Main Stairs and Railings

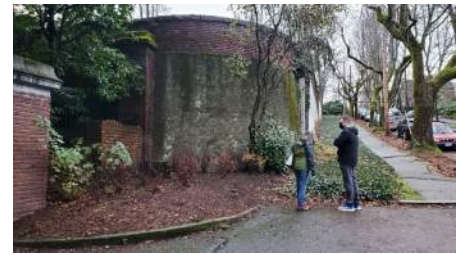
Wall from SW Corner of Bullitt Estate

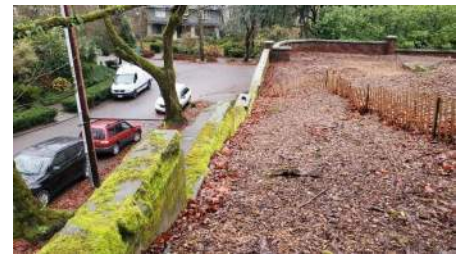
New areas for public access are proposed at a level above most retaining walls, including the Cass Turnbull Garden which is currently under construction. The change in elevation between the existing sidewalk and public access areas creates the need for new fencing or ornamental guardrails to prevent fall hazards to the general public.

Proposed Public Space at Retaining Wall

Given the visibility of the retaining wall from the street and from the Bullitt estate, we would recommend either ornate fencing or a cable guardrail system. The lower section of the gate structure seen in the photo below is representative of an appropriate ornamental rail. While cable systems are less visible and more cost effective, they do require periodic maintenance such as adjusting the cable tensions. The estimated cost for retaining wall guardrails is included in **Exhibit B3**.

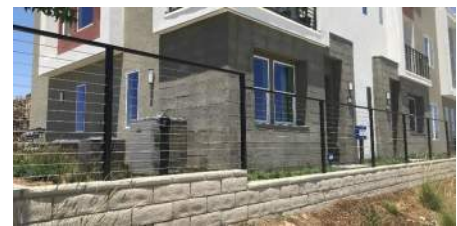
Example of cable guardrail system

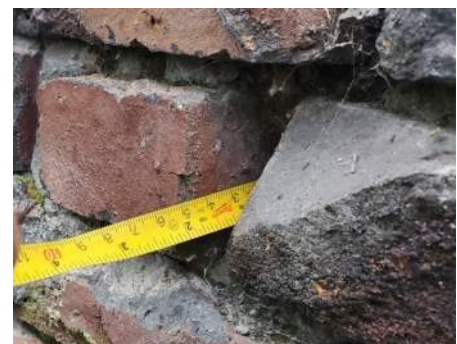
**Masonry Re-Pointing:** The mortar bed at all exposed masonry locations has considerably deteriorated and should be repaired. OAI recommends the repointing of all exterior masonry including masonry walls along the South retaining wall, masonry pilasters along the West retaining wall, and masonry walls at the West site entry stair. The estimated cost for masonry repointing is included in **Exhibit B4**.

Mortar Bed Erosion at Masonry

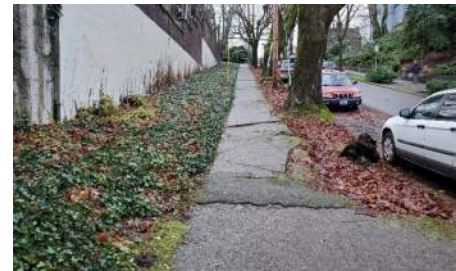
The predominant ground cover along East Prospect Street is ivy and there is evidence of the ivy attaching itself to the retaining wall. It was also observed that the sidewalk along E Prospect (Photo A-4.8) is significantly compromised from tree roots and substandard products such as asphalt paving in lieu of concrete paving. Our recommendations for the South wall include:

South Retaining Wall at E. Prospect

- Replace asphaltic paving with new concrete sidewalks in accordance with SDOT requirements.
- Clear and grub landscape bed to remove ivy root systems and replant with appropriated ground cover.

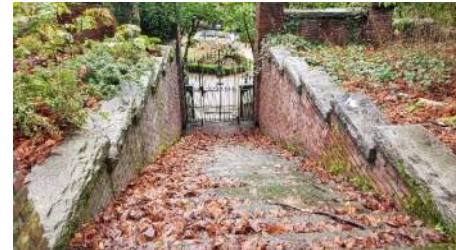
West Site Access Stair

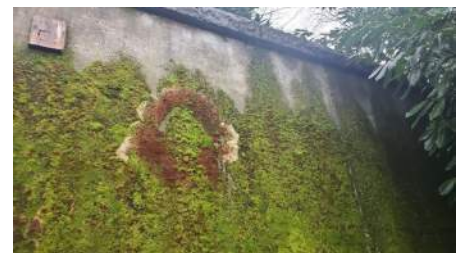
The west retaining wall is a concrete structure lined with masonry pilasters spaced at approximately 24'-0" on center. As noted in the attached structural report, structural reinforcing steel appears to be exposed through the concrete at some locations. Significant amounts of organic growth and water migration are also observed on this wall. The extent of water migration and steel reinforcement exposure cannot be fully determined until after the plant growth is removed via pressure washing or other means.

Organic Growth at West Wall

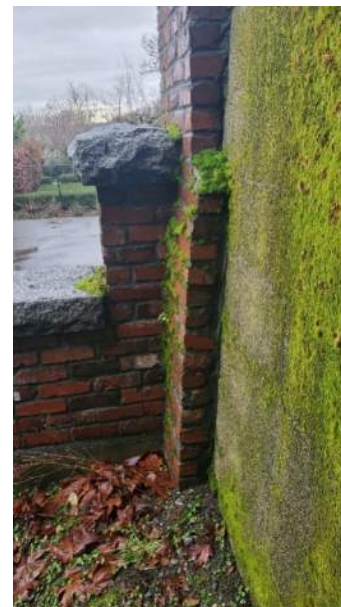
Organic Growth at North Wall

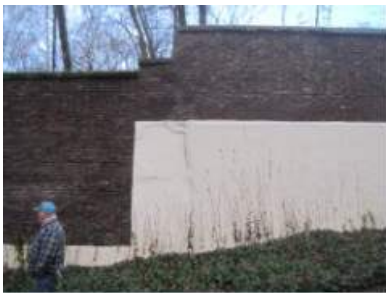
The south retaining wall is constructed of 16" thick concrete walls at the base, the mason drilled an exploratory hole in the wall approximately 3'-0" above the ground and the wall was 16" thick. The wall construction is visible from the top and the upper portion of the wall is constructed of an 8" concrete walls and 4" brick veneer. The south wall has no pilasters along the length of the wall. The top of the wall has 7"x18" concrete caps.

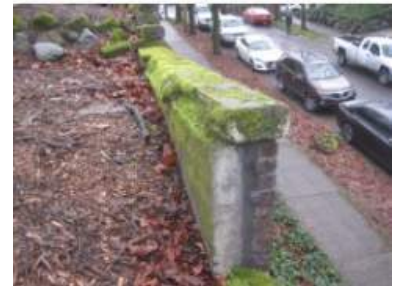
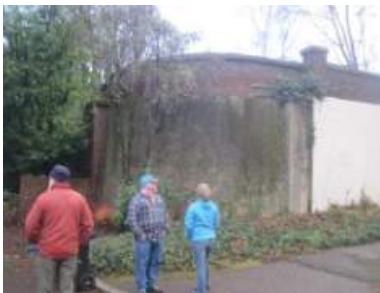
The west wall is constructed of concrete with concrete pilasters. The pilasters are spaced far apart and appear to be cosmetic; they are covered in brick veneer. The maintenance staff dug a hole at the front of the wall so the foundation could be visually verified. Only the toe of the footing was visible; the top of the footing is 8" below grade, 20" deep and protrudes 18" out from the face of the wall. It was not feasible to excavate the back side of the footing during the site visit. The top of the wall has 7"x18" concrete

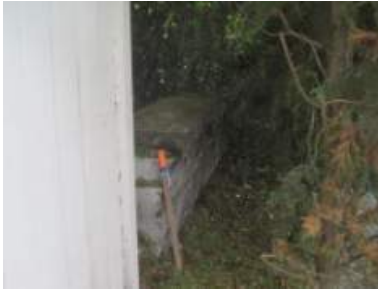
The majority of the north wall was not accessible during our first visit and therefore we re-visited the site on March 4, 2022 to review the structural condition of the retaining wall that runs along the north sides of the property. We reviewed the existing drawings that were available and performed a visual inspection only, we utilized no destructive testing.

As noted previously reported, the west end of the north wall is in good condition but has some visible, rusting rebar and the top of the wall has 7"x18" concrete caps. We accessed the neighbor's property and reviewed the remainder of the north wall during this site visit.

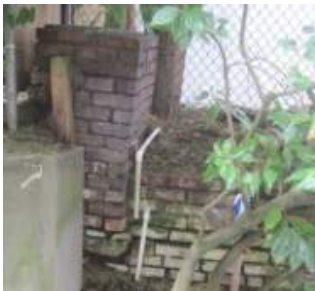
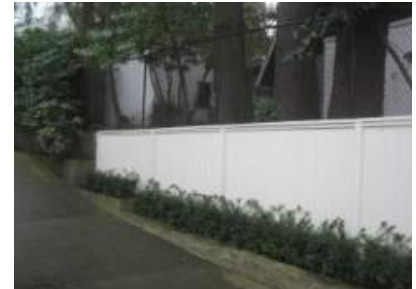
The area of the north wall that is south of the neighbor's pool is constructed of brick and retains no soil, the soil is at approximately the same height on both sides of the wall. 40'-0" of the property line directly south of the neighbor's house is retaining approximately 4'-0" of soil with geo-cloth pinned back to the soil wall. The geo-cloth is hidden by a white fence that runs along the driveway. A failing, 14'-0" long brick wall and pilaster retaining 2'-6" of soil are directly east of the white fence and geo-cloth retaining wall. The rest of the north property line to the east is at street level and no soil is retained.

We were able to see the west end of the north wall which had some visible, rusting rebar. The top of the wall has 7"x18" concrete caps.

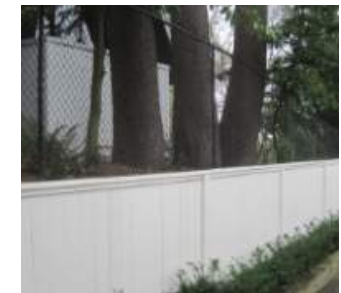
5. The area of soil that is retained by the geo-cloth is not a permanent solution and is prone to failure over the long term. The hazard is the collapse of the geo-cloth retaining system into the neighboring property.

*Recommendation: Three large trees are approximately 3'-0" from the retained soil edge. The proximity of the trees precludes the use of a stepped retaining wall and the proximity to the property line precludes the use of a cantilevered concrete retaining wall with a conventional footing. We recommend consulting a Geotechnical Engineer for the most economical options which may include a driven pile retaining wall system.*

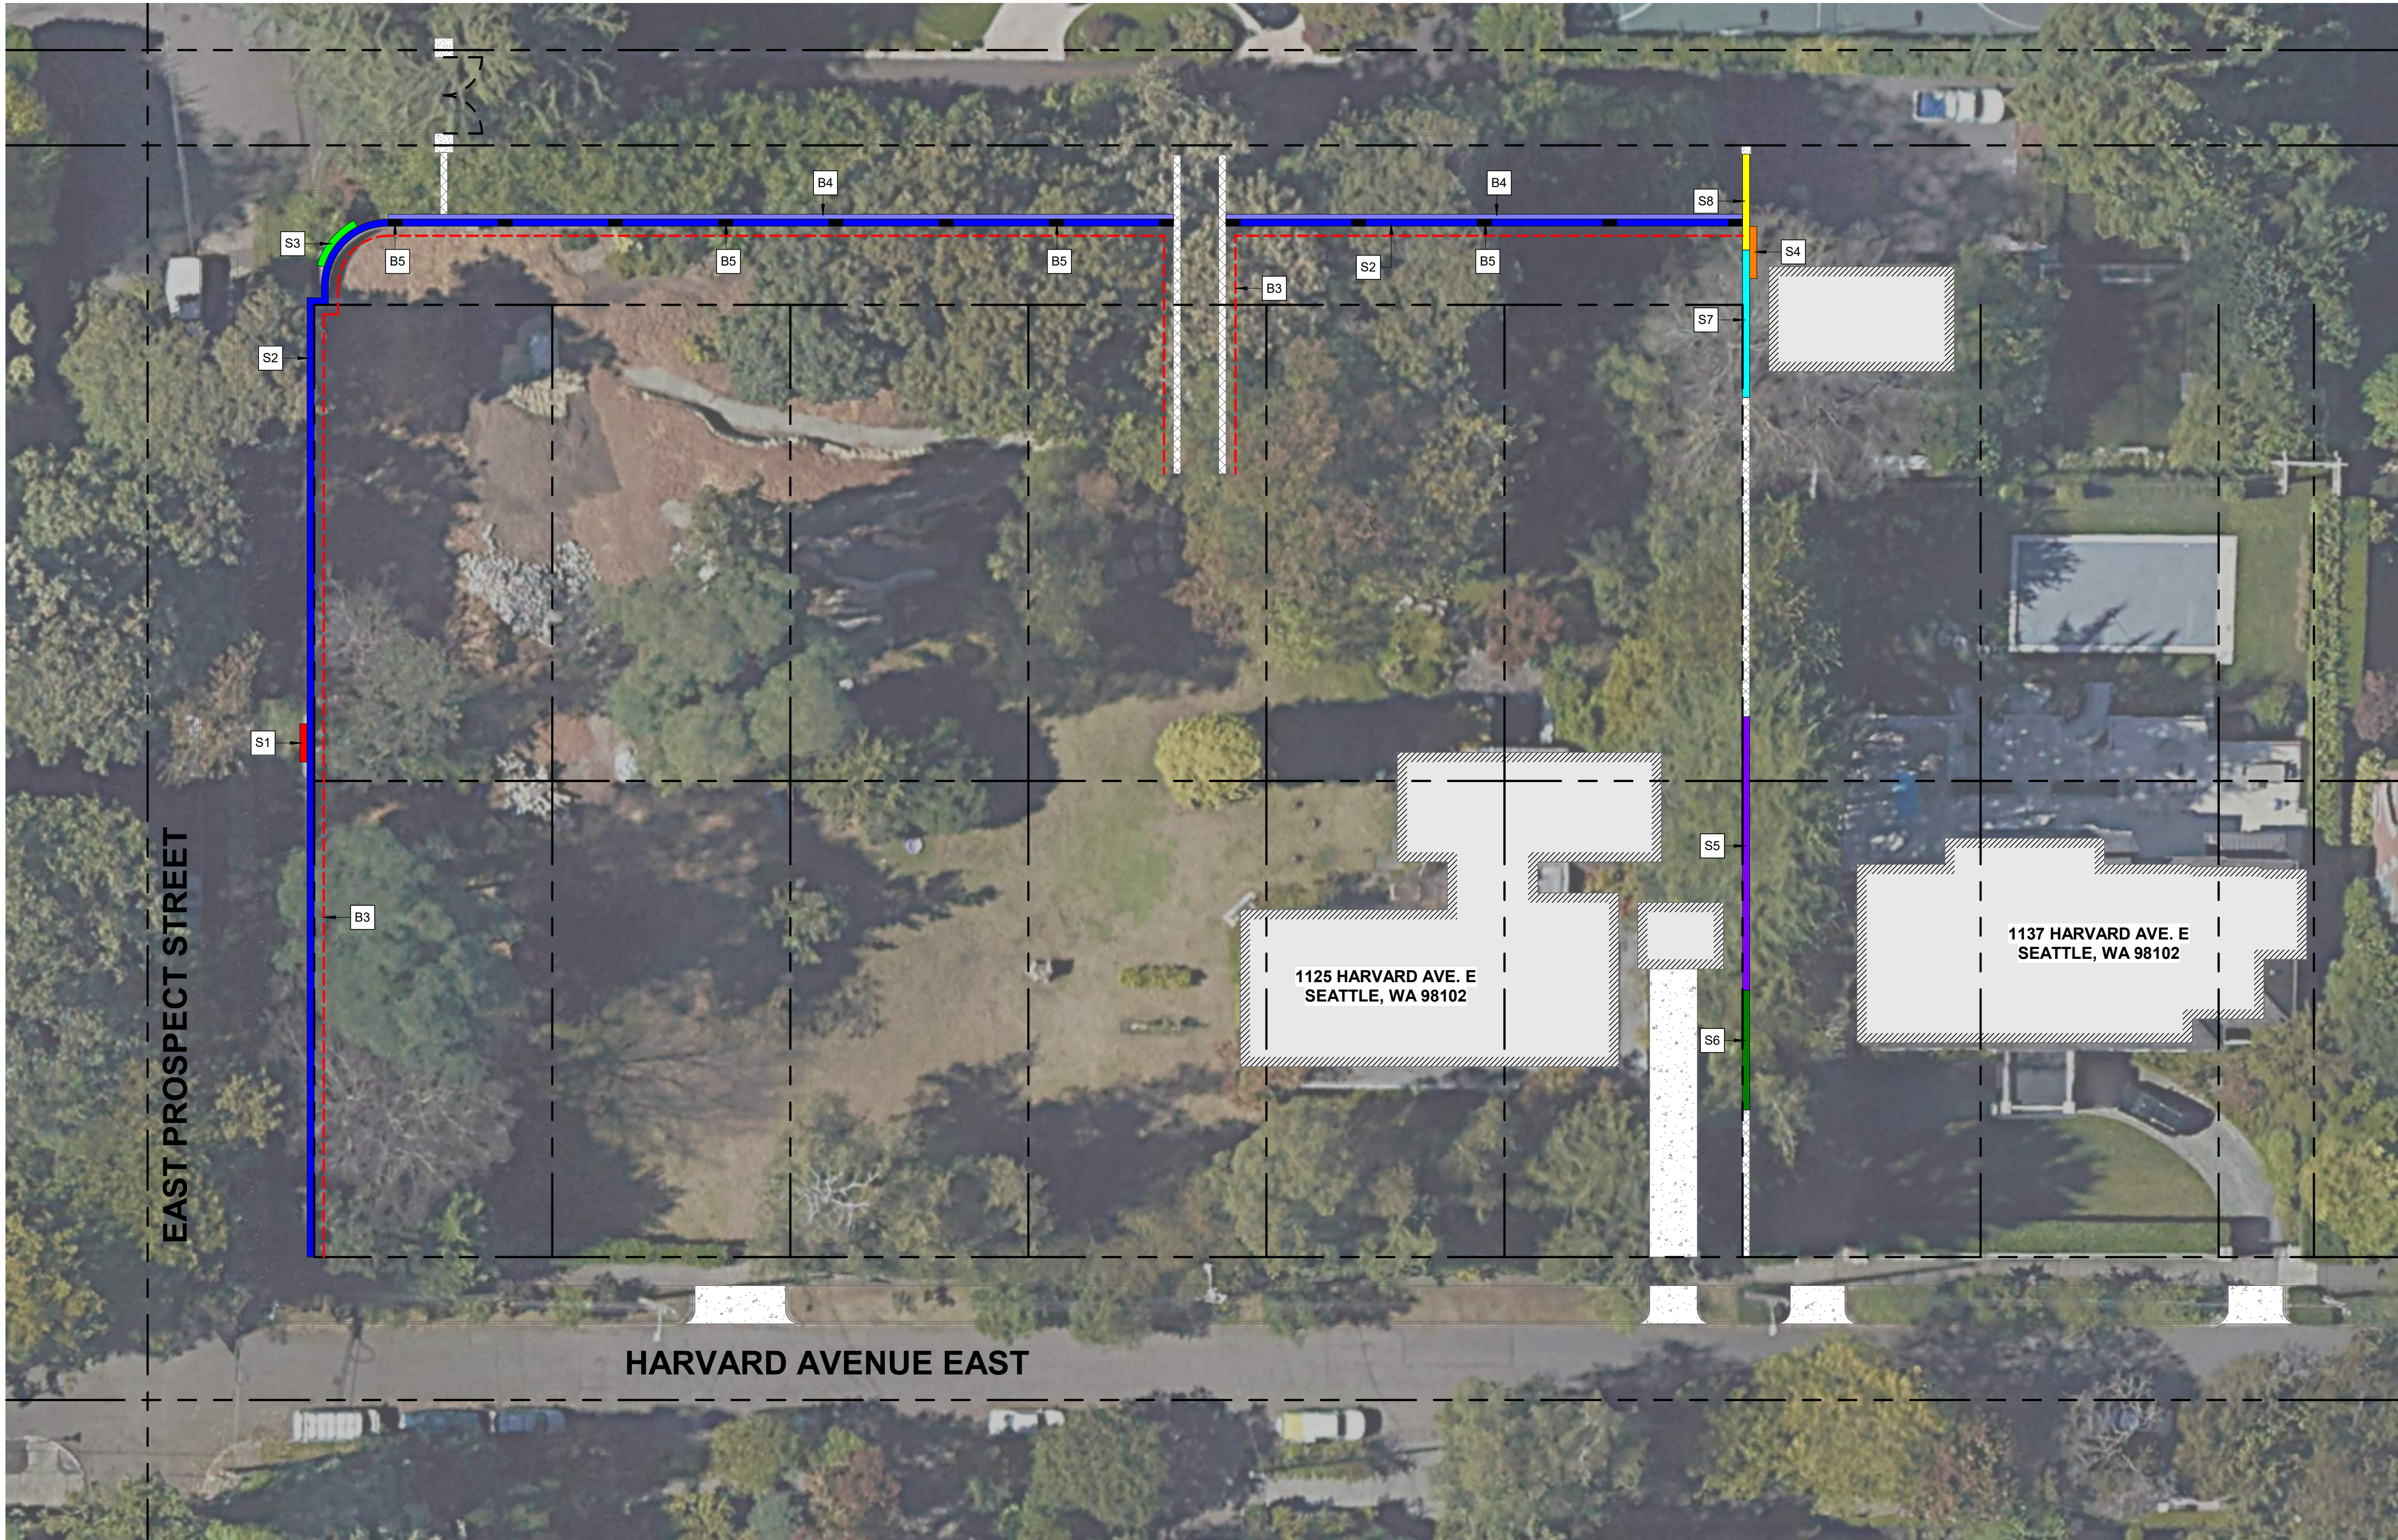
## REFERENCE SITE PLAN

| S1 SOUTH WALL - LARGE VERTICL CRACK. REF STRUCTURAL REPORT | S5 NORTH WALL - GEO-CLOTH RETAINING SOIL. REF STRUCTURAL REPORT | B3 SOUTH & WEST WALL - (N) GUARDRAIL . REF ARCH REPORT |
| S2 SOUTH WALL - CONCRETE CAPS NOT SECURED. REF STRUCTURAL REPORT | S6 NORTH WALL - FAILING BRICK WALL. REF STRUCTURAL REPORT | B4 WEST WALL - MASONRY REPOINTING. REF ARCH REPORT |
| S3 SOUTH WALL - SEVERAL VERTICL CRACKS. REF STRUCTURAL REPORT | S7 NORTH WALL - CONCRETE CAPS NOT SECURED. REF STRUCTURAL REPORT | B5 WEST WALL - MASONRY PILASTERS LOCATIONS APPROX. REF ARCH REPORT |
